NBS TECHNICAL NOTE **1134**

Guidelines for the Installation of Solar Components on Low-Sloped Roofs

Robert G. Mathey
Walter J. Rossiter, Jr.

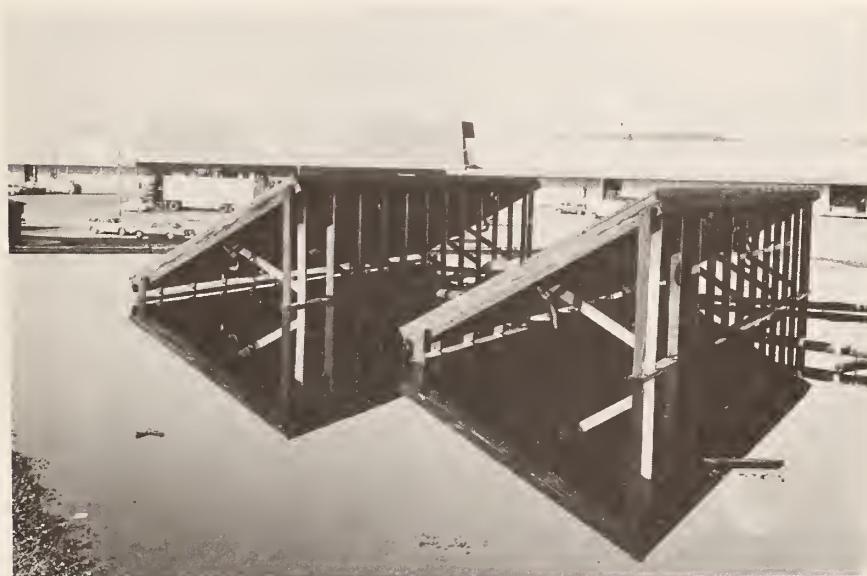
Figure C.2 Ponded Water Over 2 inches (50 mm)
Deep Around Collectors

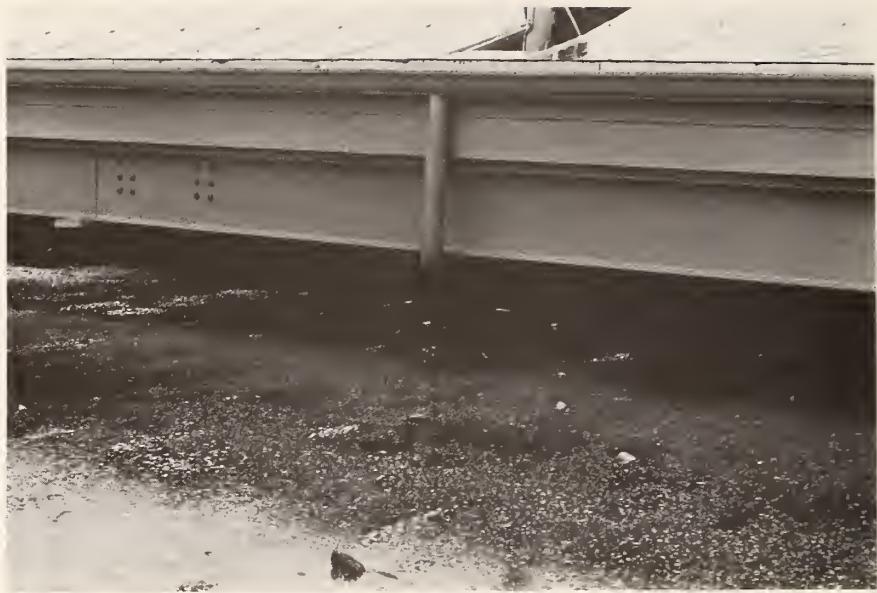
Figure C.3 Ponded Water on Roof Surface Extending Under Large Wooden Platform Supporting Solar Reflectors

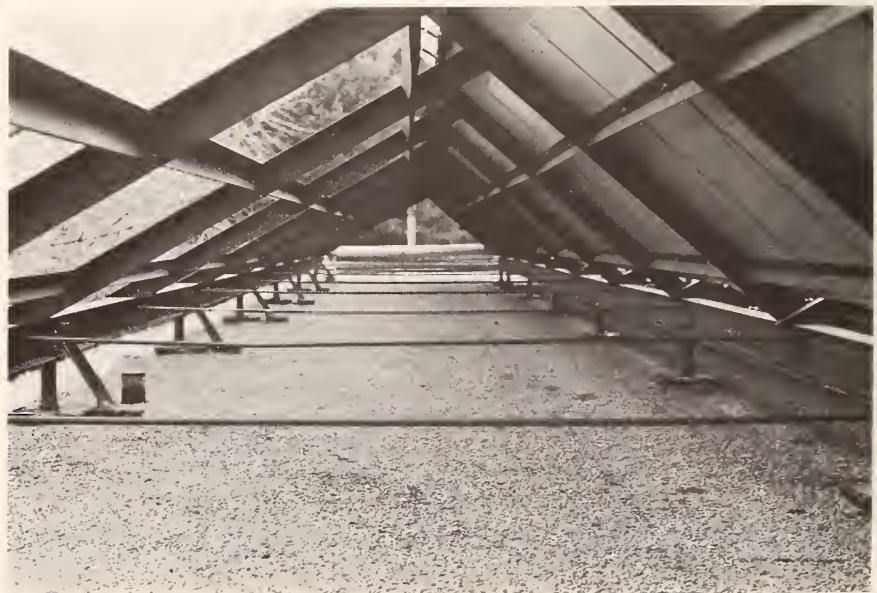
Figure C.4 Steel Columns Extending Through Roofing Support Collector Frames

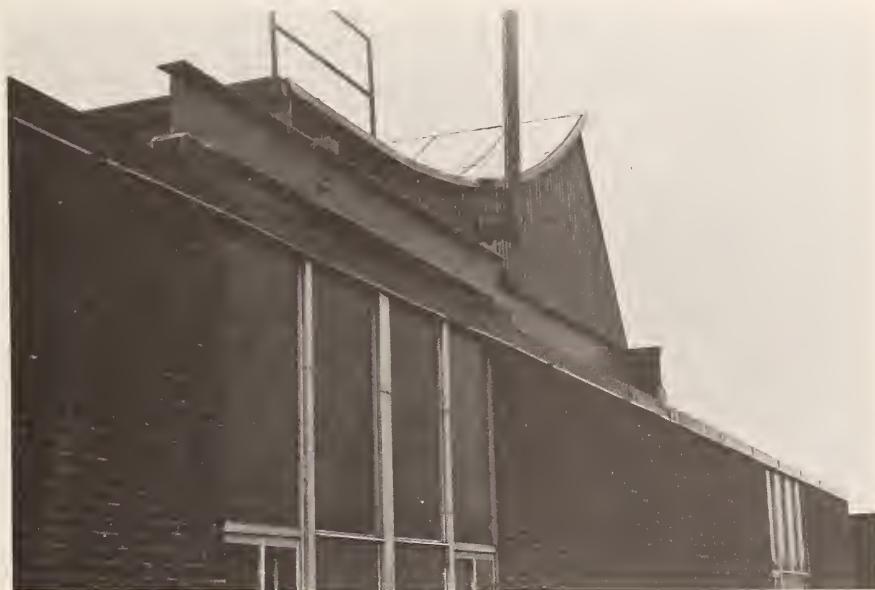
Figure C.6 Large Wooden Reflector Frame Supported by Exterior Walls and Columns of the Building

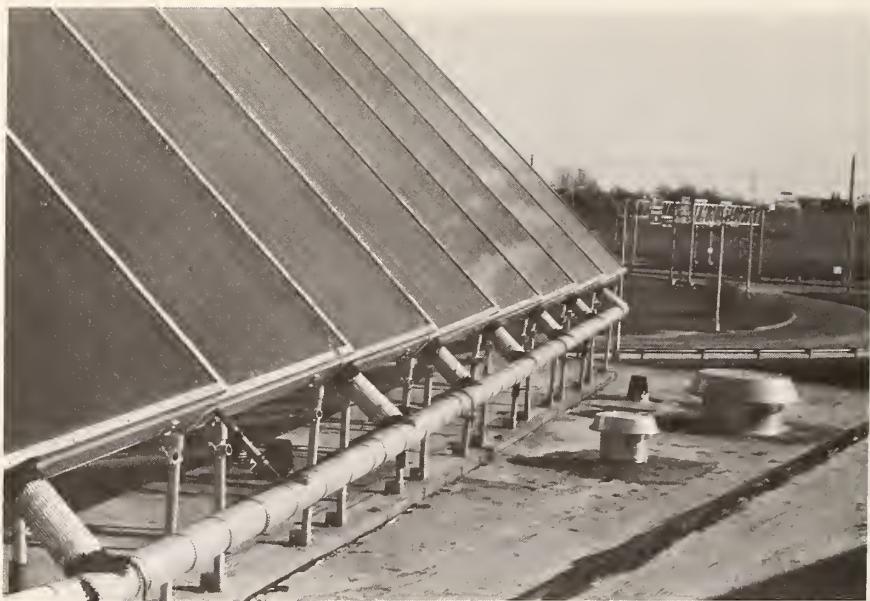
Figure C.7 Collector Frame Supported by Wooden Sleeper Mechanically Fastened to the Roof

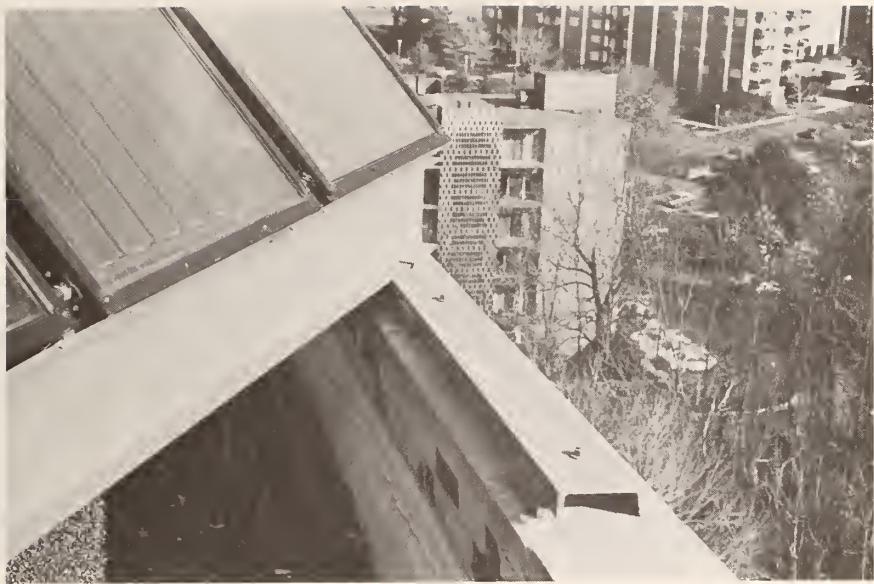
Figure C.9 Attachment of Collector Support Beam Using a Steel Clip Welded to a Channel which is Bolted to a Parapet Wall

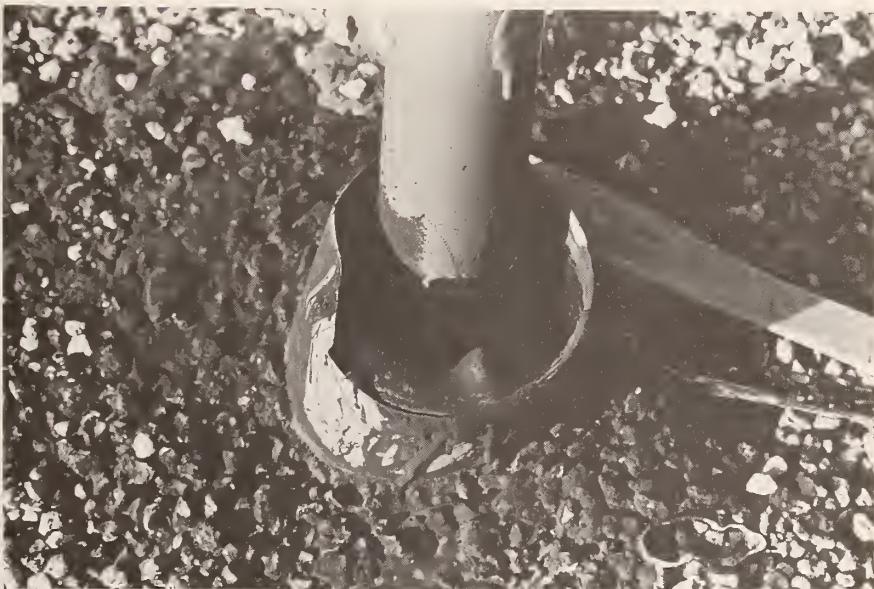
Figure C.10 Collector Support Column in a Tilted Pitch Pocket

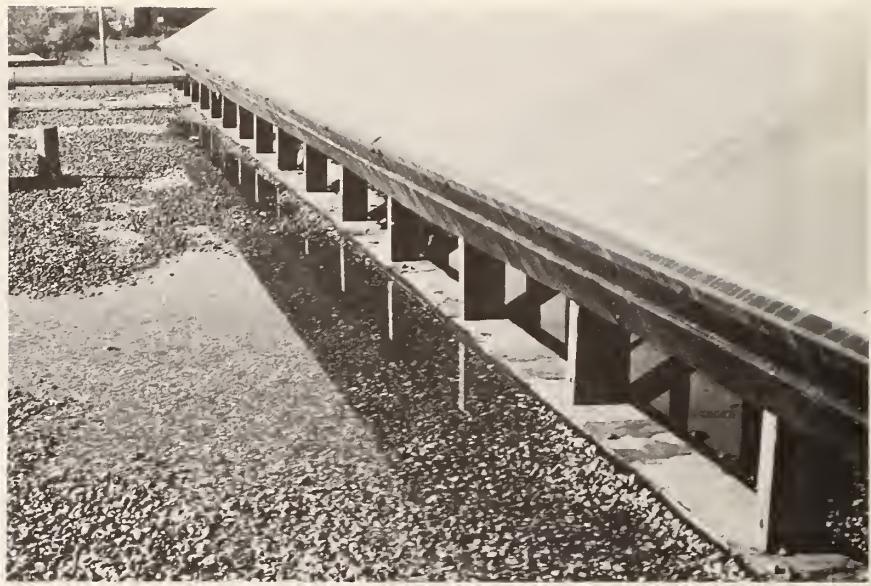
Figure C.11 Wooden Sleeper Mechanically Attached to Roof

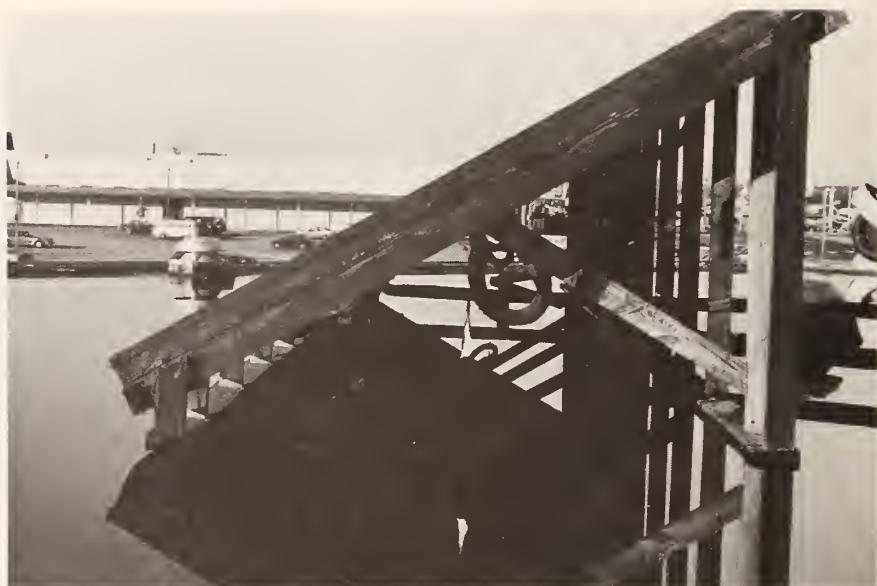
Figure C.12 Ponded Water Above the Bottom Surface of the Wooden Sleepers

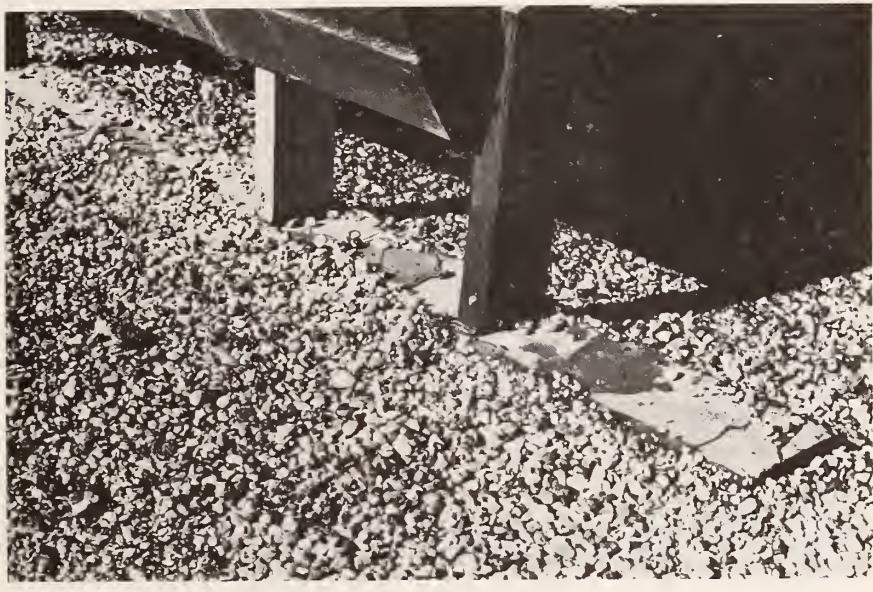
Figure C.13 Sleeper Which Had Sunk into Asphalt Flood Coat and Aggregate Surfacing

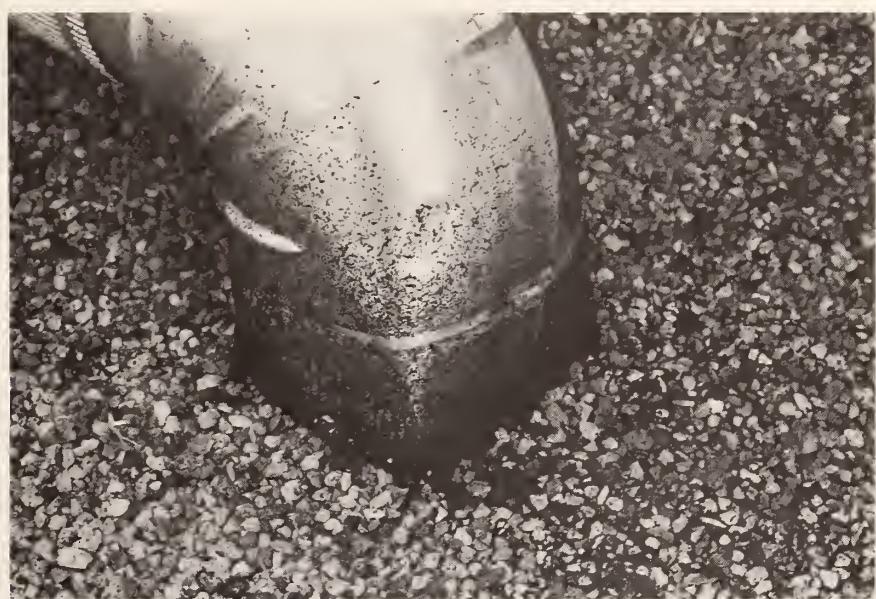
Figure C.14 Pipe Penetration for Which The Type of Flashing was Not Determined

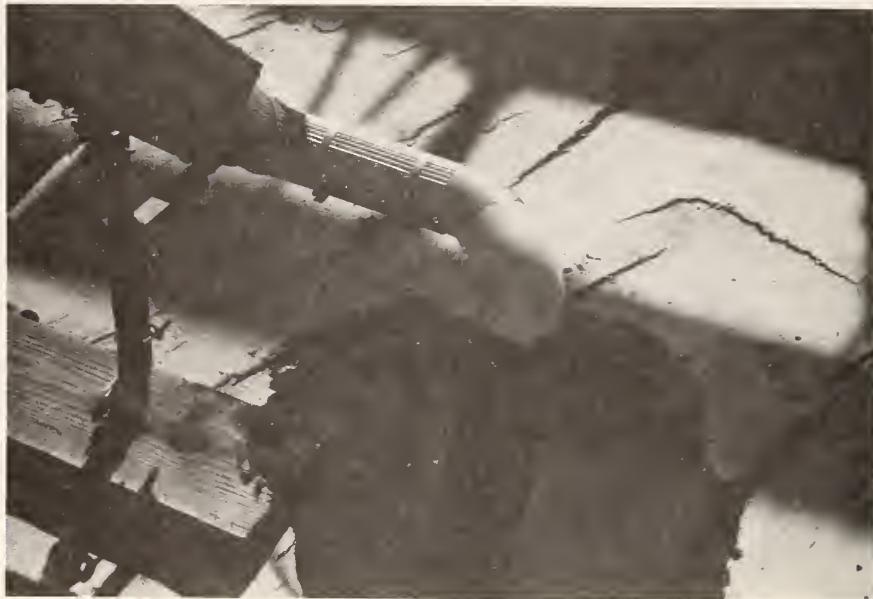
Figure C.15 Excessive Quantity of Asphalt Around Pipe Penetration With Undetermined Type of Flashing

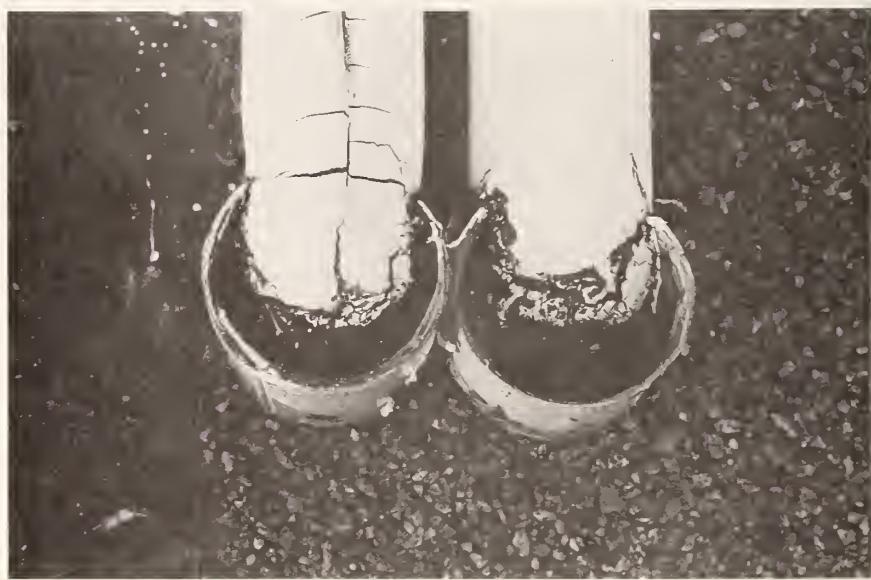
Figure C.16 Pitch Pockets for Pipe Penetrations

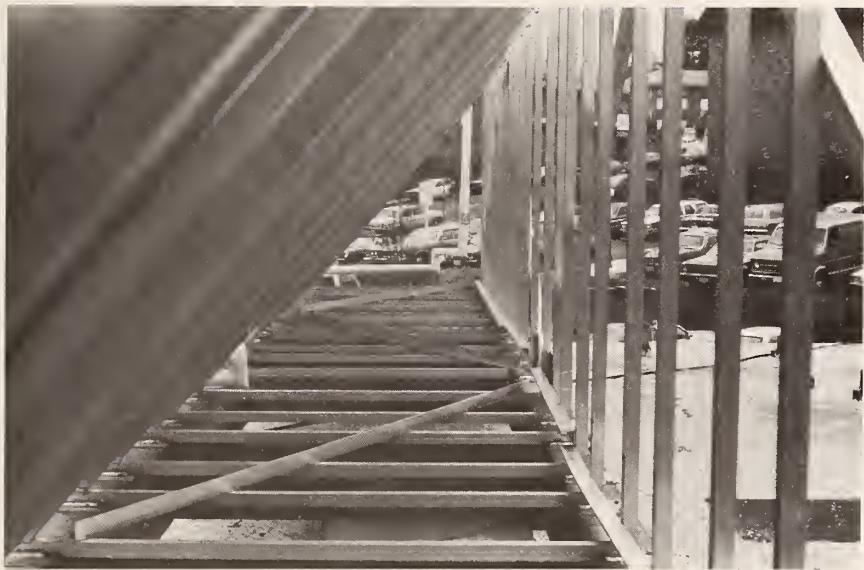
Figure C.17 Inadequate Clearance Between Steel Collector Frames and Roofing

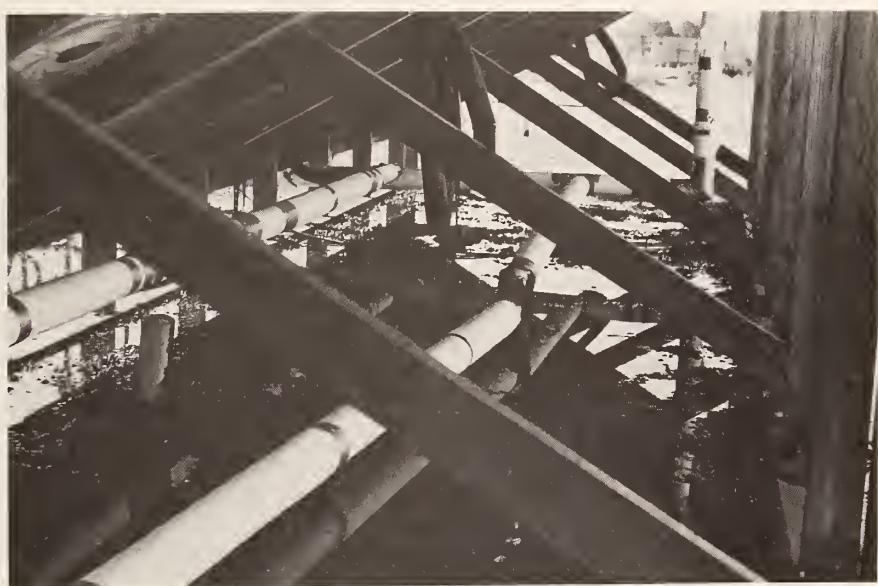
Figure C.18 Inadequate Clearance Between Wooden Collector Frames and Roofing

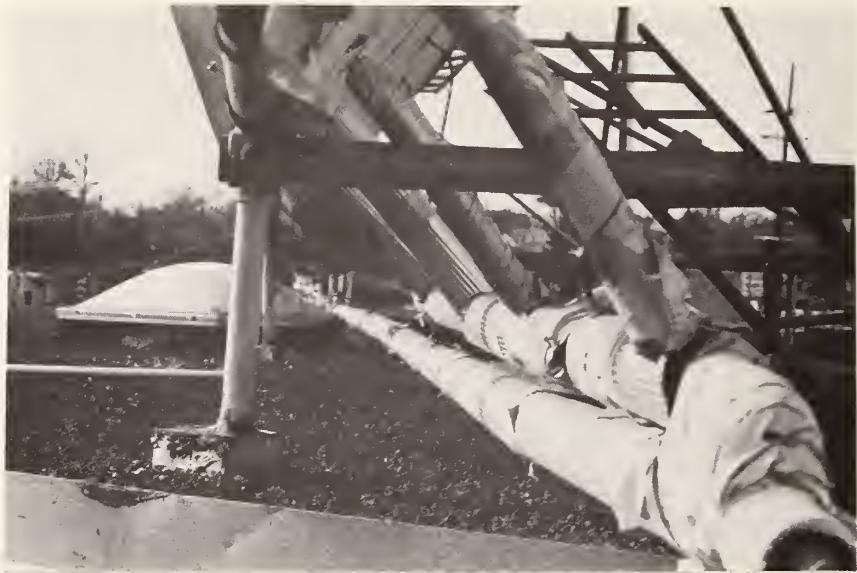
Figure C.19 Piping Located Close to Roof Surface

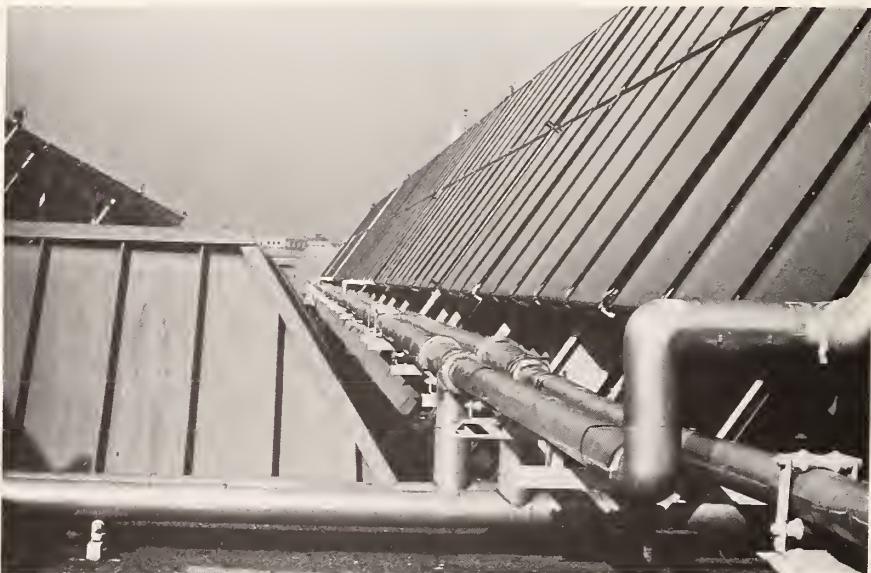
Figure C.20 Inadequate Clearance Between Front of Collector Array and a Mansard Style Roof Projection

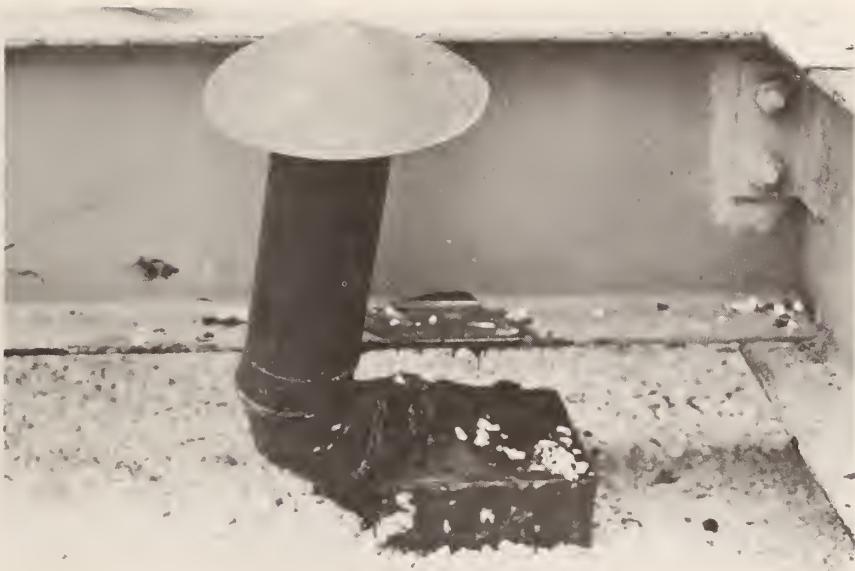
Figure C.21 Vent Pipe Modified to Allow for Solar Collector Installation

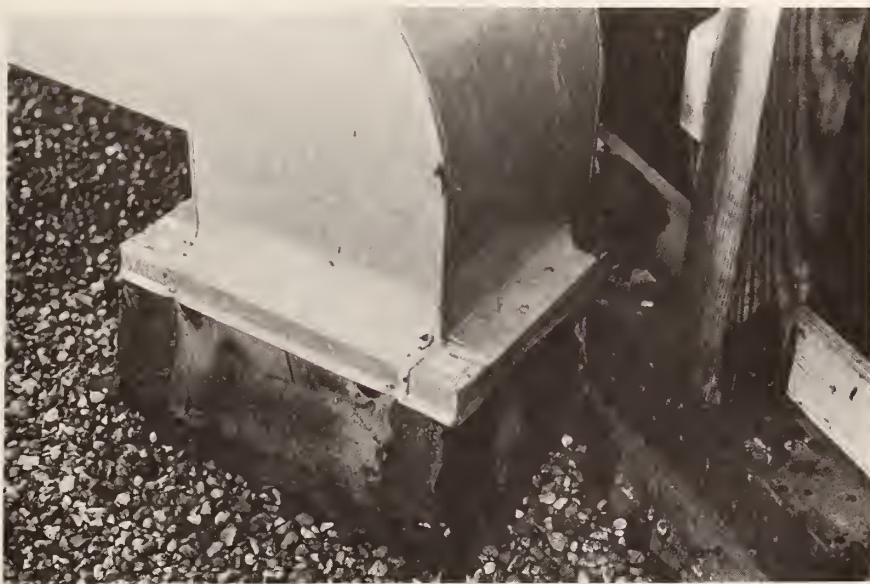
Figure 22. Modification of a Curb Supporting a Ventilator

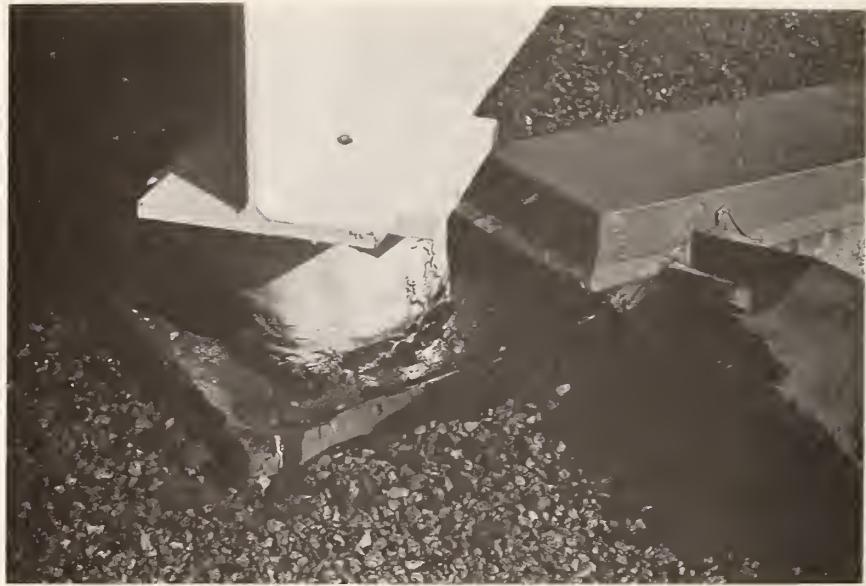
Figure C.23 Penetration of Collector Support Column at the Edge of the Roof

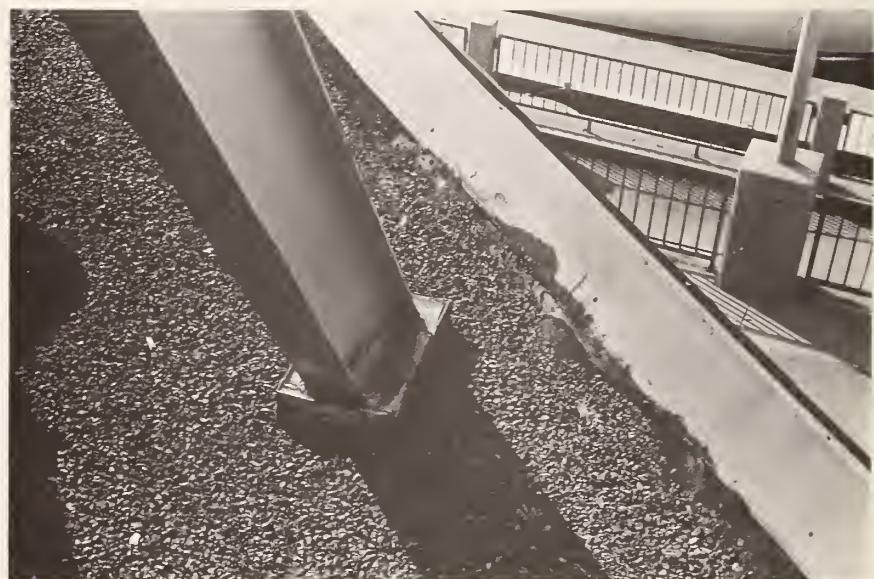
Figure C.24 Solar Penetration Adjacent to the Edge of the Roof

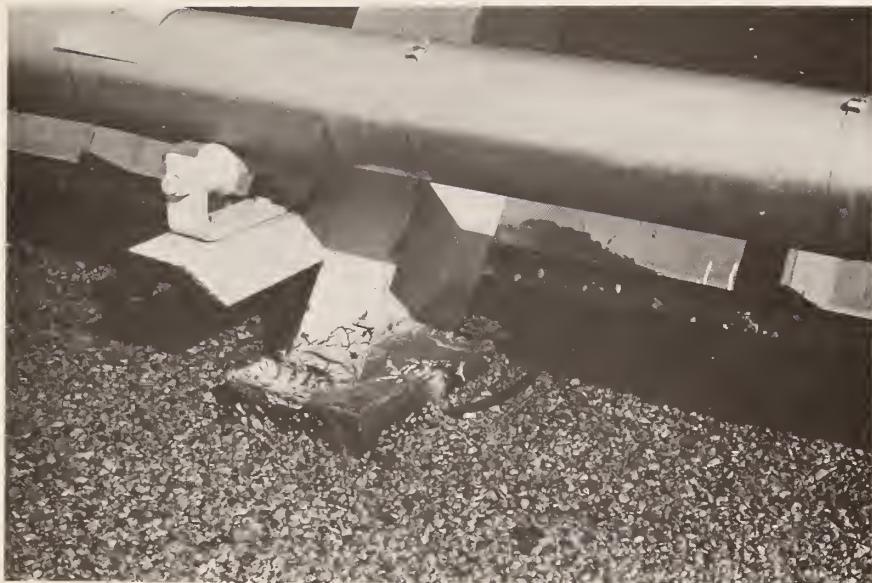
Figure C.25 Pipe Roller Support Attached to Collector Frame

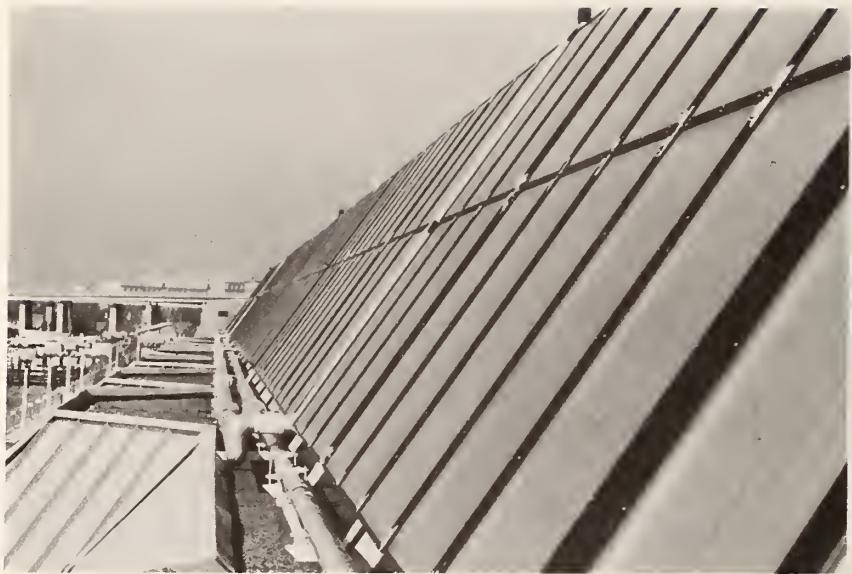
Figure C.27 Collector Array Installed Near Roof Edge

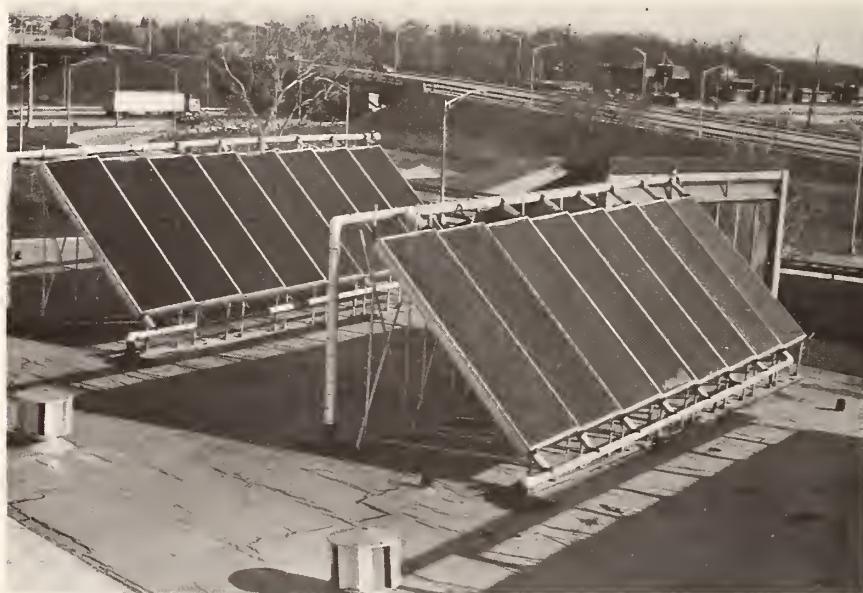
Figure C.28 Installation Having Adequate Access Around Collector Arrays

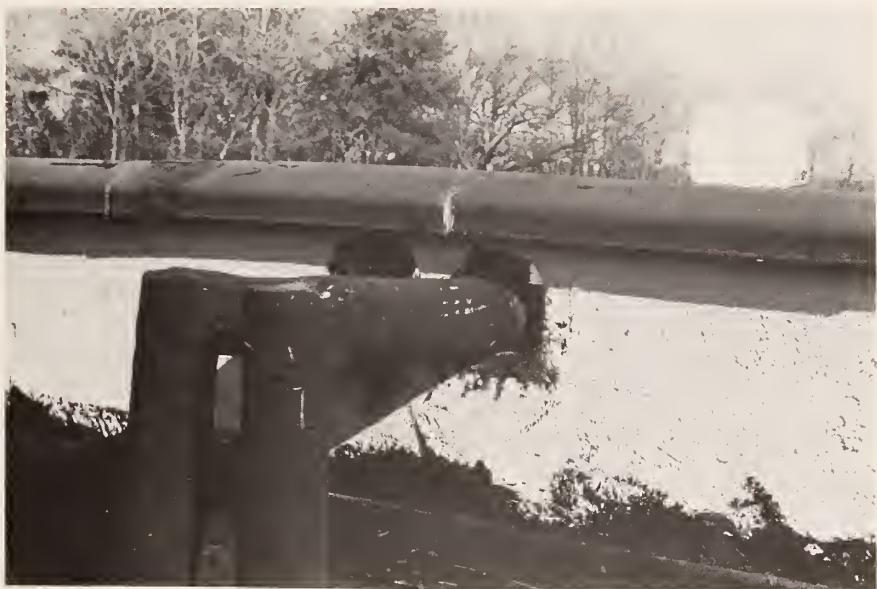
Figure C.29 Fire Wall Penetrated by Solar Piping

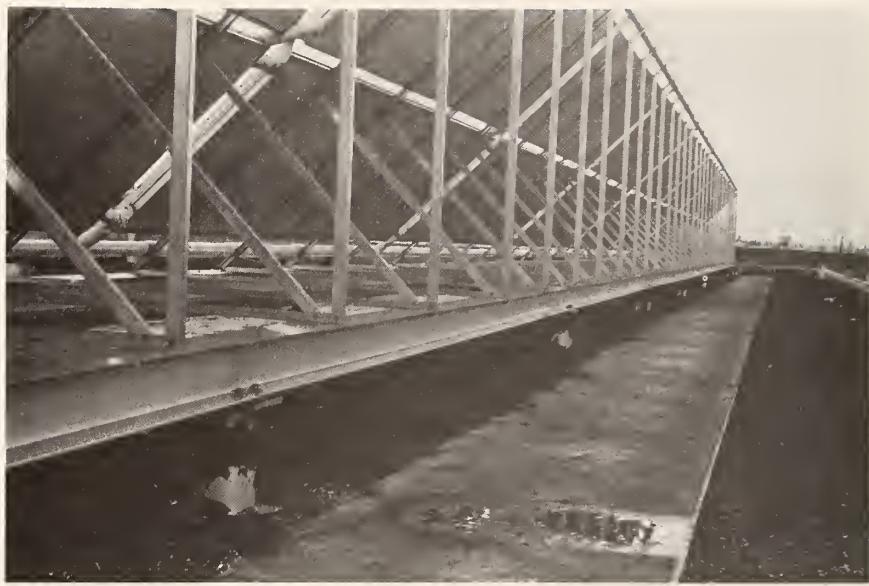
Figure C.31 Coated Felt Walkway on Roofing

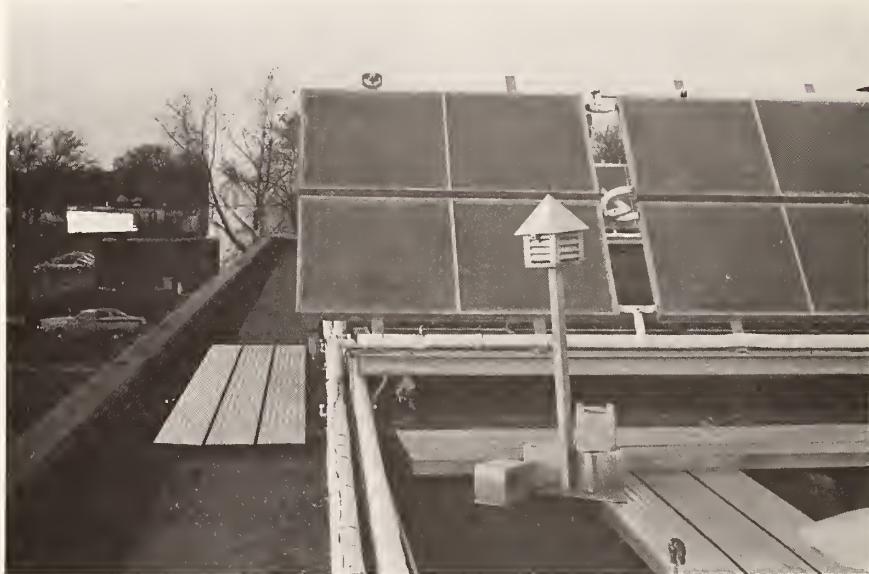
Figure C.32 Hollow Aluminum Sections Used as Walkways

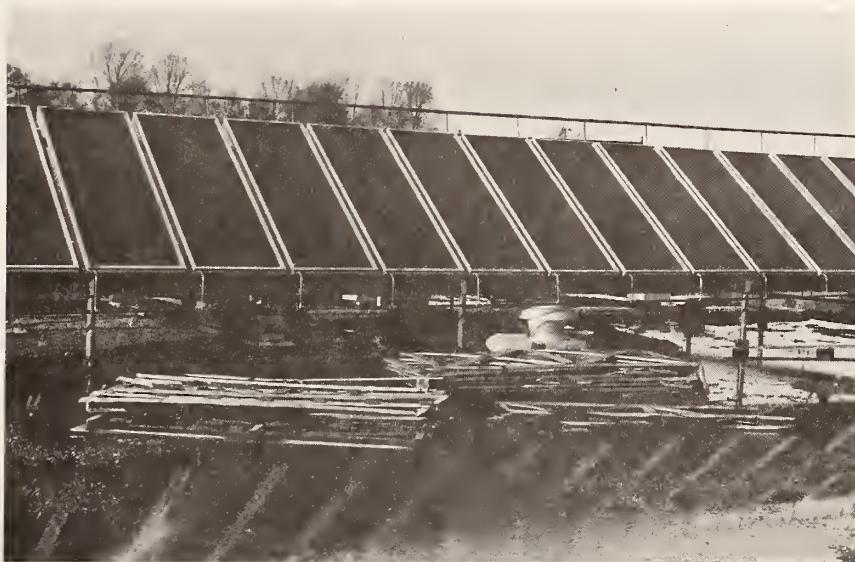
Figure C.34 Debris On Roof from Solar Installation

Commentary: Debris on the roof may be a source of puncturing or other damage to the membrane. Debris may clog drains or reduce the rate of drainage resulting in unwanted accumulation of water on the surface of the roof.
