# Weld Repair of the U.S. Capitol Dome

A Report to the Office of the Architect of the Capitol on Project  
900265 K

This report describes some options for weld repairs to the outer shell of the dome on the U.S. Capitol. During the past 140 years, corrosion products have built up within many of the joints, leading to cracking of some of the iron castings that form the shell. Since the dome is a national landmark, the goal is to restore the structural integrity of the original castings, replacing as few of the components as is absolutely necessary. While mechanical joining of the fractures or filling of the gaps with epoxy are alternative procedures, a fused (leak-tight) and ductile joint is preferred. A major challenge is that the castings were produced with 1850's technology, so the composition is far different from current castings that are designed for weld repair. Therefore, we chose to develop some alternative approaches, designed specifically for the dome castings. Of the various options, oxyacetylene braze welding (a flame repair process where the filler metal melts at a temperature below that of the casting) with low-fuming bronze (about 60Cu-40Zn) worked best. The bronze

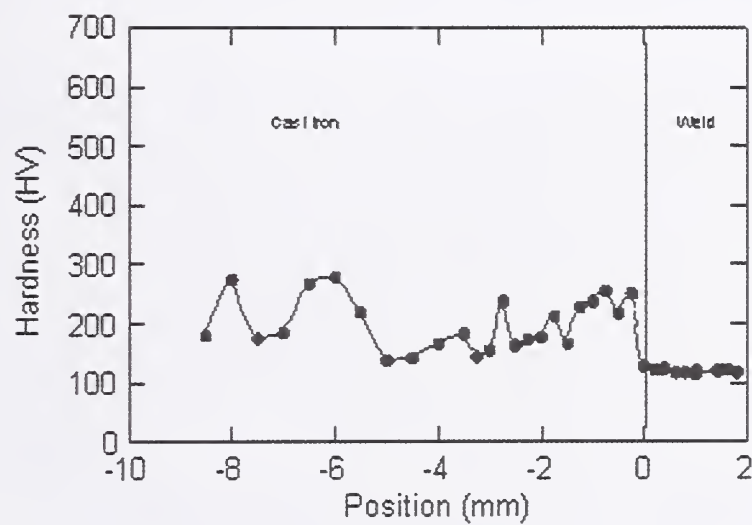
Figure 13. Hardness traverse across specimens WM-2, showing a much lower hardness (no martensite) in the HAZ than that for PA-7. Compare to Figure 3.

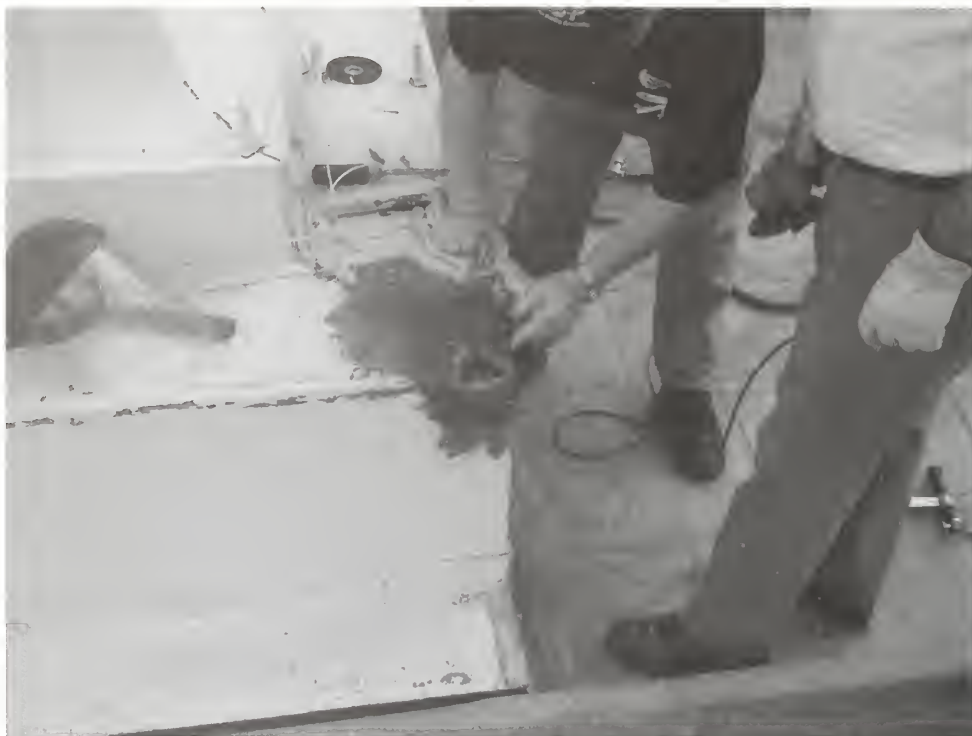
Figure 14. Repair Location 1: Two corners cracked free, flat orientation.

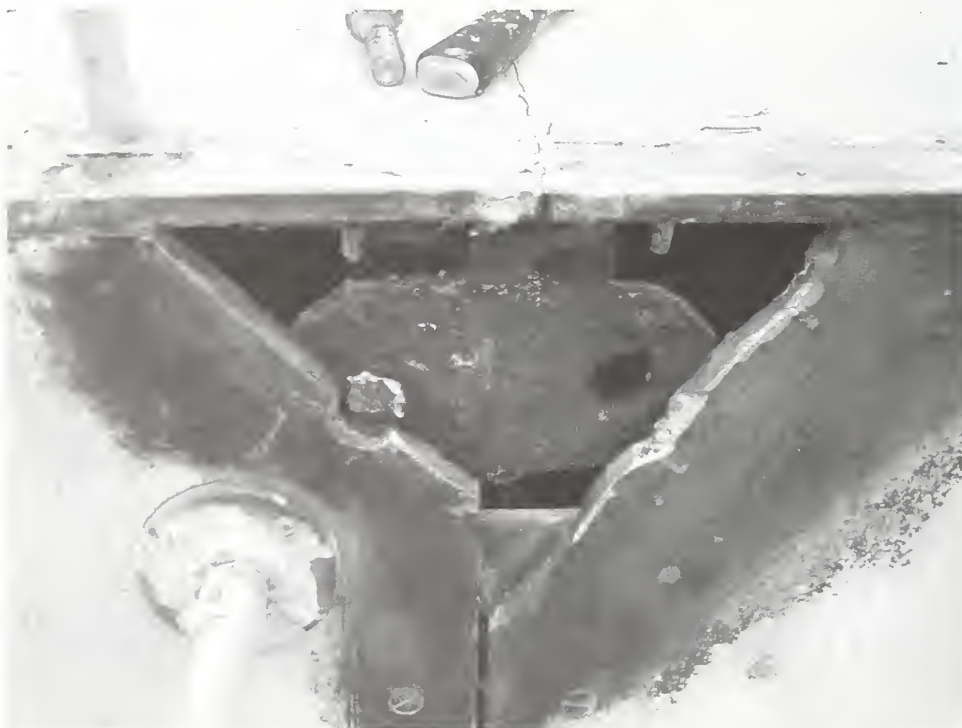
Figure 15. Repair Location 2: Two corners cracked free, vertical orientation.

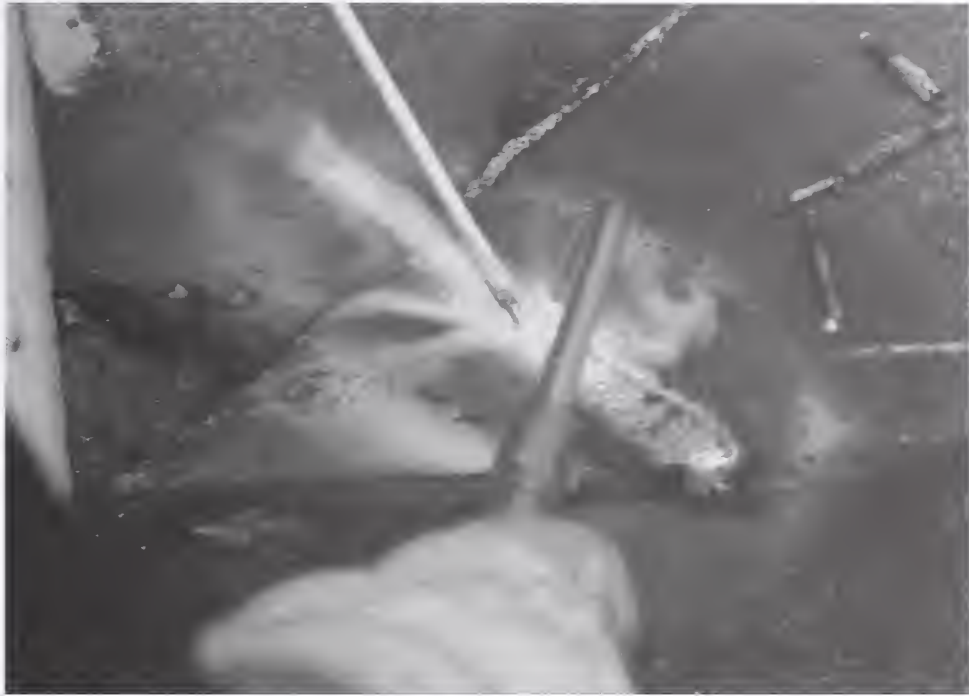
Figure 16. Location 1: Making the repair by braze welding.

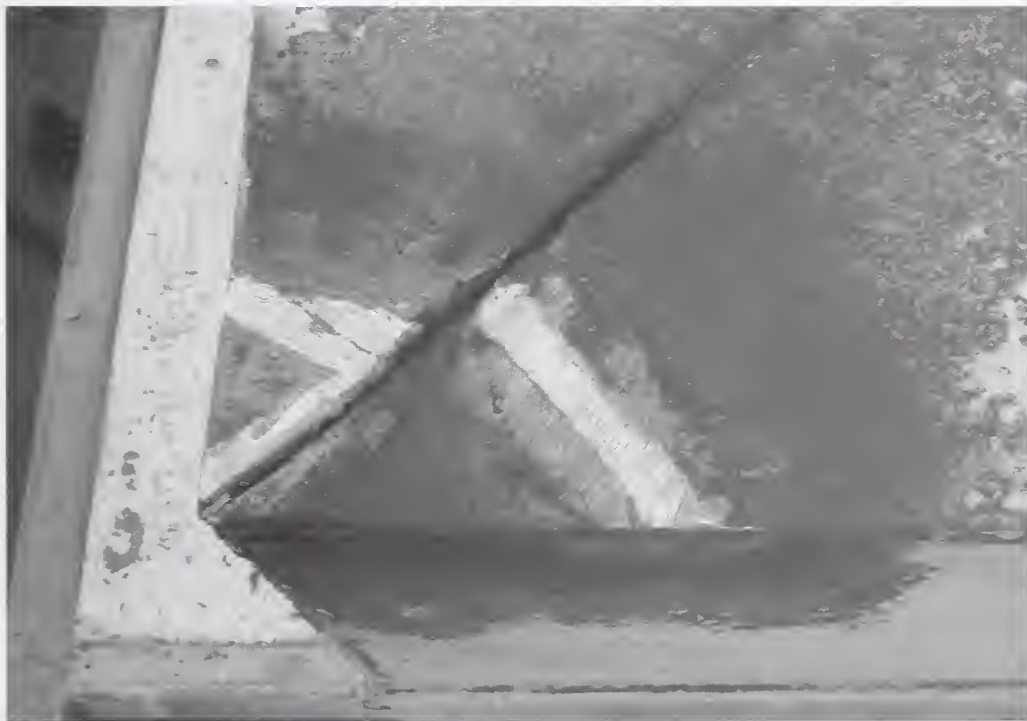
Figure 17. Location 1: After finish grinding.

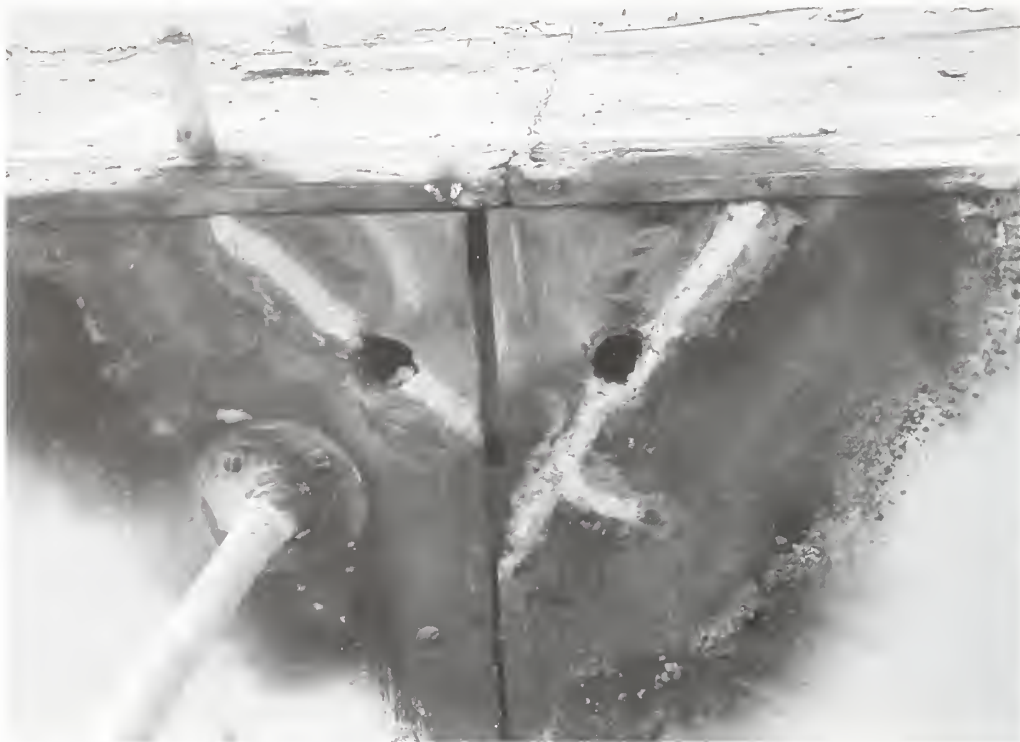
Figure 18. Location 2: After finish grinding.
