**NIST Technical Note 1886**

# **An Experimental and Computational Study of Precast Concrete Moment Frames under a Column Removal Scenario**

September 2015

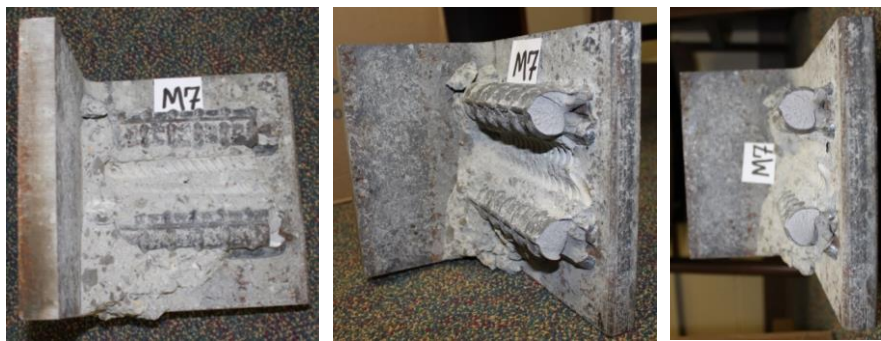
**Figure 4-4.** Fractured anchorage bars from lower left connection to center column (OMF specimen).

After reaching the ultimate load at point *e*, the load dropped sharply to only 25 % of its peak value. This drop in load was associated with fracture of the #10 anchorage bars welded to the bottom connecting angle on the left side of the center column (see connection detail in Figure 2–3). Fracture of the anchorage bars was evidenced by widening of the gap between the left beam and the center column, as indicated in Figure 4–2(e). The anchorage bars fractured at the end of the flare-bevel-groove weld on the connecting angle, as is evident in Figure 4–4, which shows the connecting angle and welded anchorage bars recovered from the specimen after the test.

anchorage bar fracture at the lower link plate assembly on the left side of the center column (see Figure 4-4). This failure occurred at  $\Delta = 5.7$  in (144 mm) (see Figure 4-2(e)) and was associated with the peak vertical load.

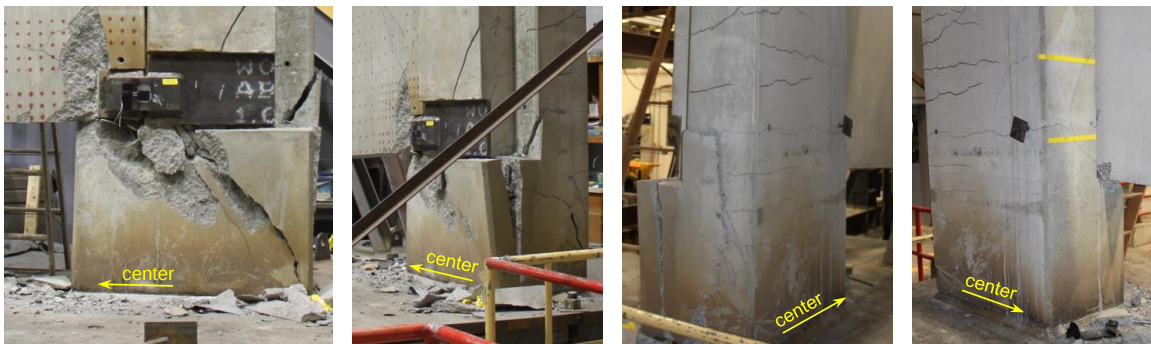
**Figure 4-5.** Final damage to right end column viewed from several angles (OMF specimen).

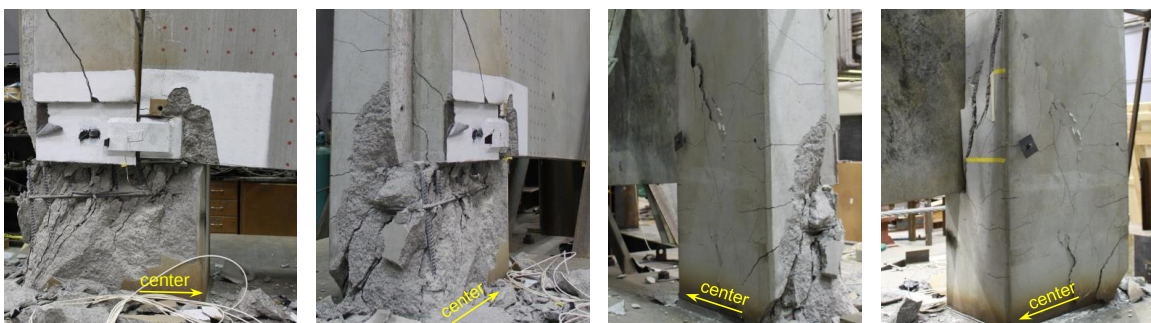
**Figure 4-6.** Final damage to left end column viewed from several angles (OMF specimen).

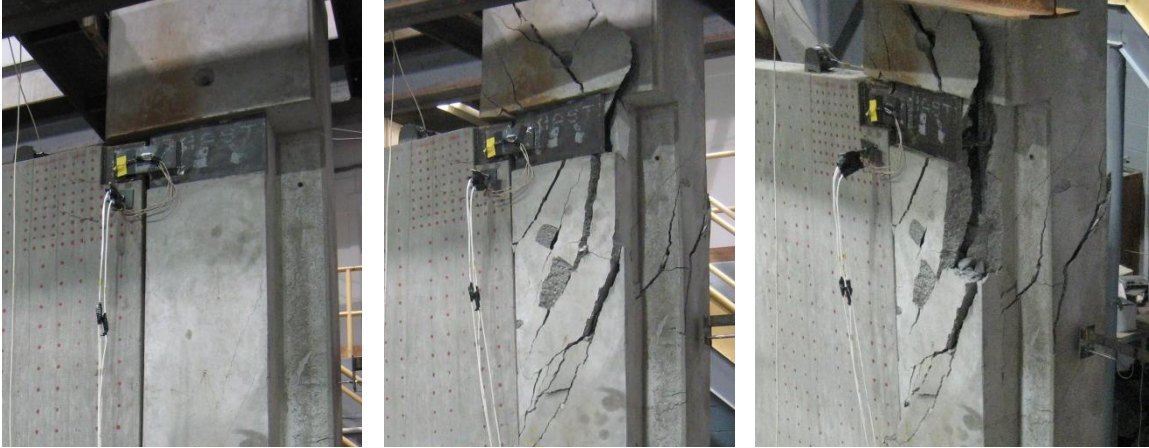
At point *h* in Figure 4–1, the upper column plate detached from the right end column, similar to the failure observed previously on the left end column at point *d*. As indicated in Figure 4–2(h), this failure was accompanied by cracking and spalling of concrete on the right end column, which is shown more clearly in Figure 4–7. Large deformations of the link plates were observed, as shown in Figure 4–8, which were indicative of extensive yielding. Concave out-of-plane bending occurred at the upper link plate [Figure 4–8(a)], where tensile forces caused the beam to pull away from the column, and convex out-of-plane bending occurred at the lower link plate [Figure 4–8(b)], where compressive forces caused the beam to bear against the column. Finally, as the load continued to decrease and large chunks of concrete spalled from the specimen, the test was terminated at a center column displacement of  $\Delta = 17.8$  in (452 mm).

**Figure 4–7.** Detachment of upper column plate from right end column (OMF specimen).

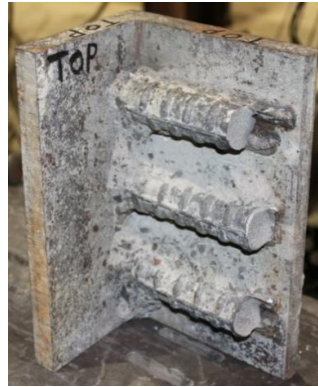
**Figure 4–27.** Fractured anchorage bars from lower left connection to center column (SMF specimen).

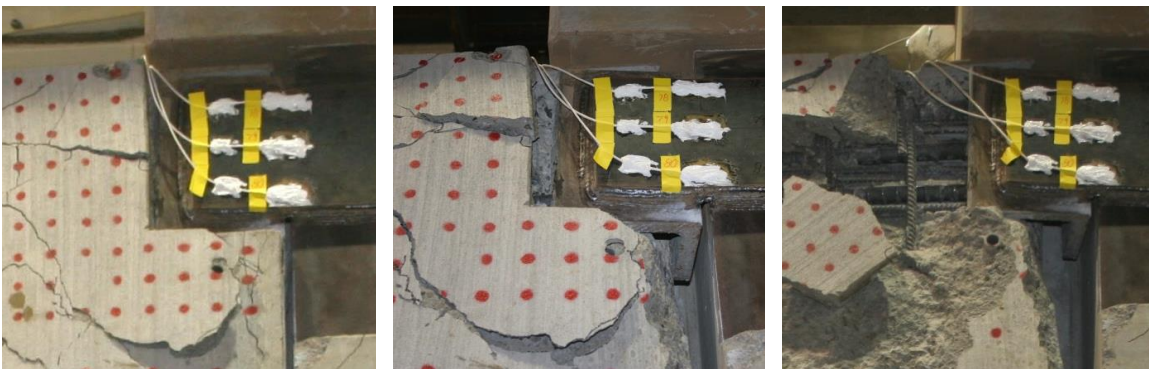
After the drop in load at point *d* in Figure 4–25, the load increased again up to point *f*, reaching an ultimate peak of 188 kip (836 kN) at a displacement of  $\Delta = 6.69$  in (170 mm). Between points *e* and *f*, the specimen continued to develop additional capacity through arching action, with the bottom corners of the beams pressing outward against the end columns. The sharp drop in load at point *f* was associated with bond failure of the upper anchorage bars at the right end column, resulting from the formation of splitting cracks and spalling of the concrete covering the upper anchorage bars near the right end column. Initial surface cracking at this location is indicated in Figure 4–26(d), and the progression of splitting failure and spalling is more evident in Figure 4–26(e). Finally, at point *f*, extensive spalling had occurred, and a substantial gap that had opened between the right beam and the right end column provided evidence of bond failure, as indicated in Figure 4–26(f). Close-up photographs in Figure 4–28 illustrate the progression of spitting failure and concrete spalling that resulted in bond failure at this location.

**Figure 4–28.** Progression of splitting failure and concrete spalling at upper anchorage bars at right end column (SMF specimen).

It is noted that the bond failure of the anchorage bars (Figure 4–28) may have been influenced by the inverted installation of the SMF spandrel beams (see Section 3.1). If the longer anchorage bars had been at the top of the beams, as designed, bond failure may have been somewhat delayed, or anchorage bar fracture may have occurred instead. However, such differences would not be expected to significantly change the overall response of the specimen. Computational modeling (discussed in Section 5.1) showed that the inverted beams had only a small influence on the computed response of the SMF specimen.

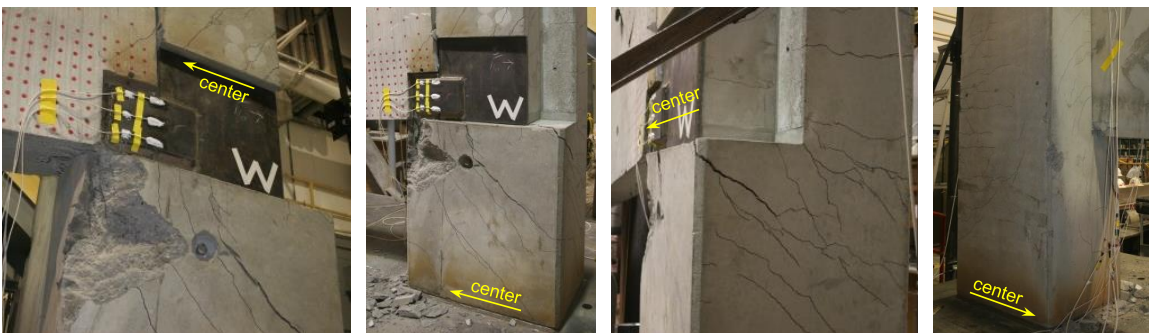
**Figure 4–29.** Final damage to right end column viewed from several angles (SMF specimen).

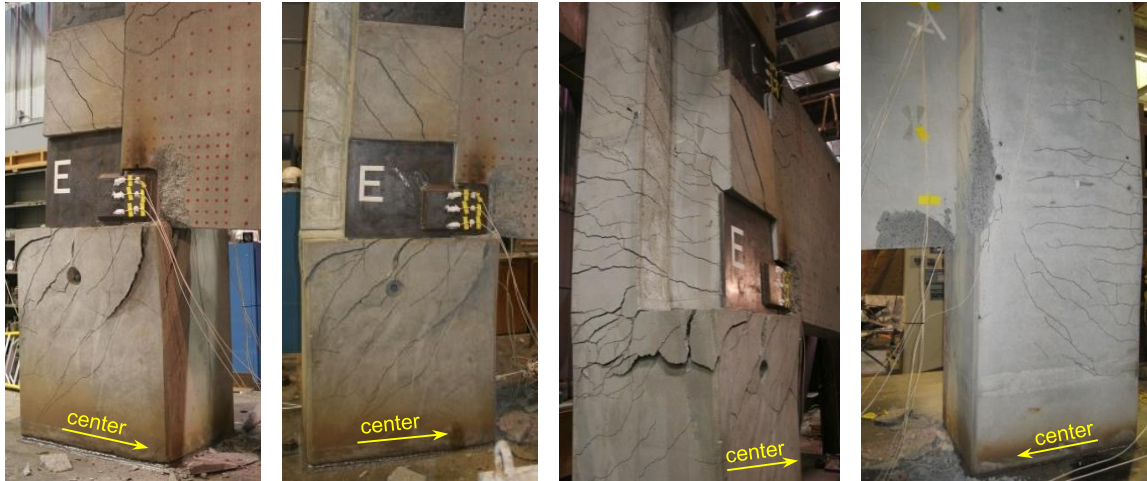
**Figure 4-30.** Final damage to left end column viewed from several angles (SMF specimen).

side, which is evident in Figure 4–30. From point *g* in Figure 4–25, the load gradually decreased, falling to 78 % of the ultimate load at point *h*. Finally, as the load continued to decrease and large chunks of concrete spalled from the specimen, the test was terminated at a center column displacement of  $\Delta = 17.8$  in (452 mm).
