NBSIR 84-2959

Corrosion of Materials Used in Steam Generating Boiler Systems

U.S. DEPARTMENT OF COMMERCE
National Bureau of Standards
Center for Materials Science
Metallurgy Division
Gaithersburg, MD 20899

Final Report

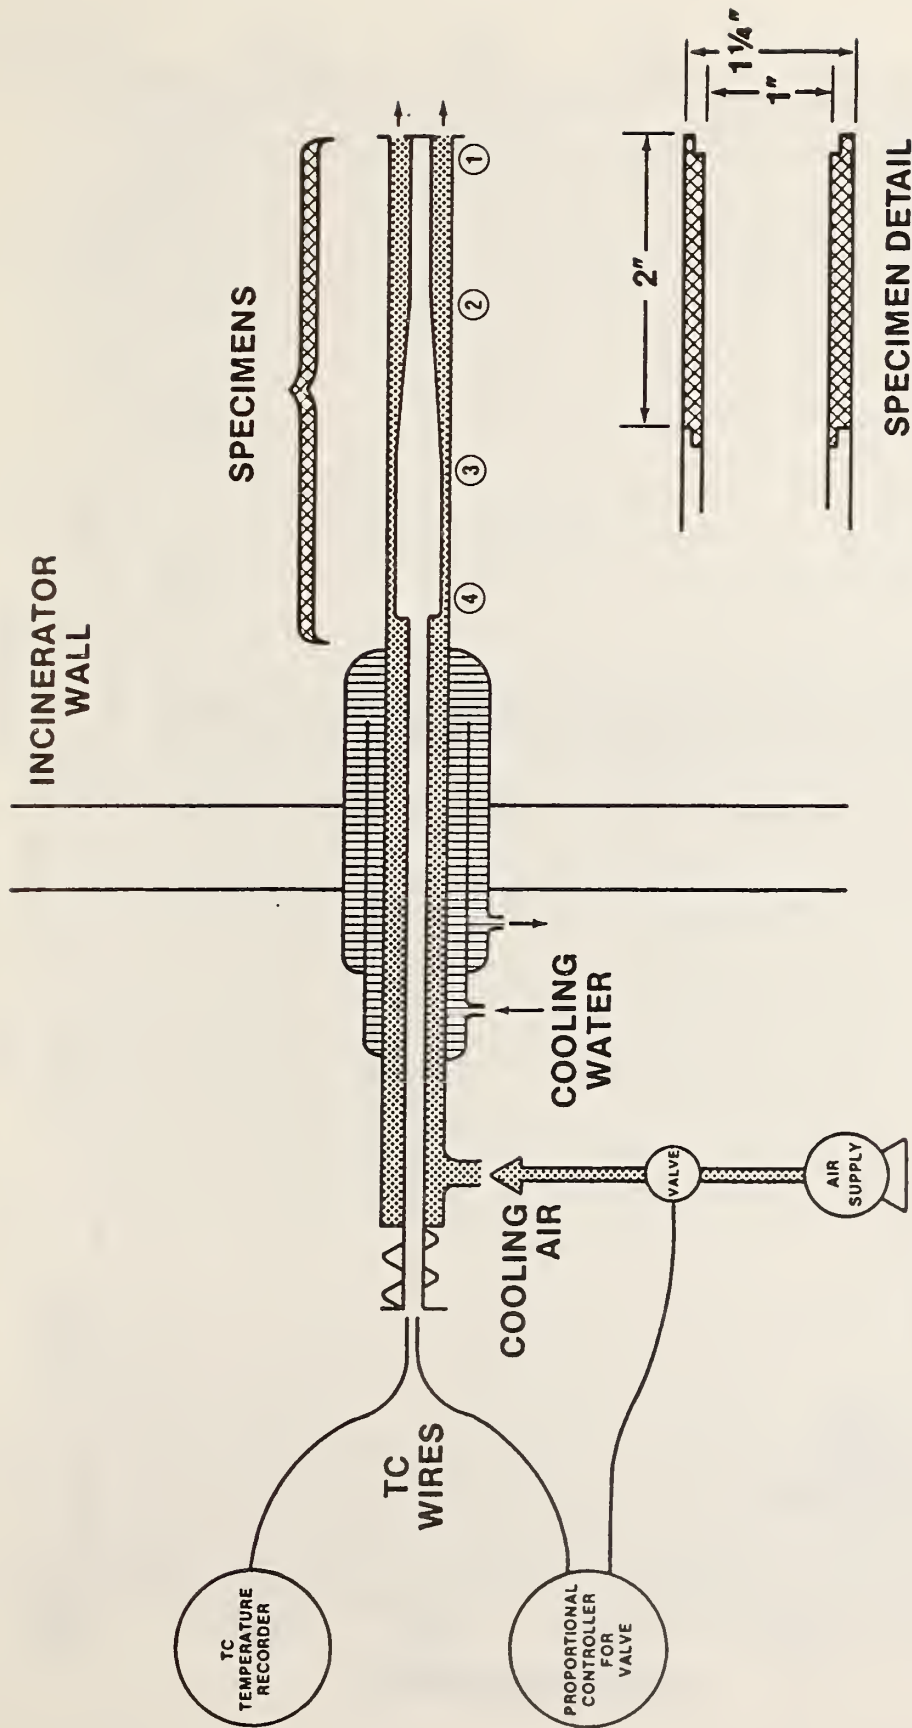
The probe was designed so that four sets of five different alloys (20 coupons) could be exposed at one time. Figure 1 illustrates the basic design of the probe, and shows the location of the four thermocouples along the length of the probe at the surface of four coupons. The temperature was maintained below a preset maximum as sensed by the thermocouple nearest the end of the probe monitored by a controller actuating an air valve that allowed forced air through the probe as needed. In addition, the velocity of the air varied along the length of the probe as determined by the cross section of the air passage between

the inside wall of the coupons and the constrictor illustrated. Thus, the temperature increased towards the tip of the probe with a temperature differential of approximately 260° C (500° F) from one end to the other.

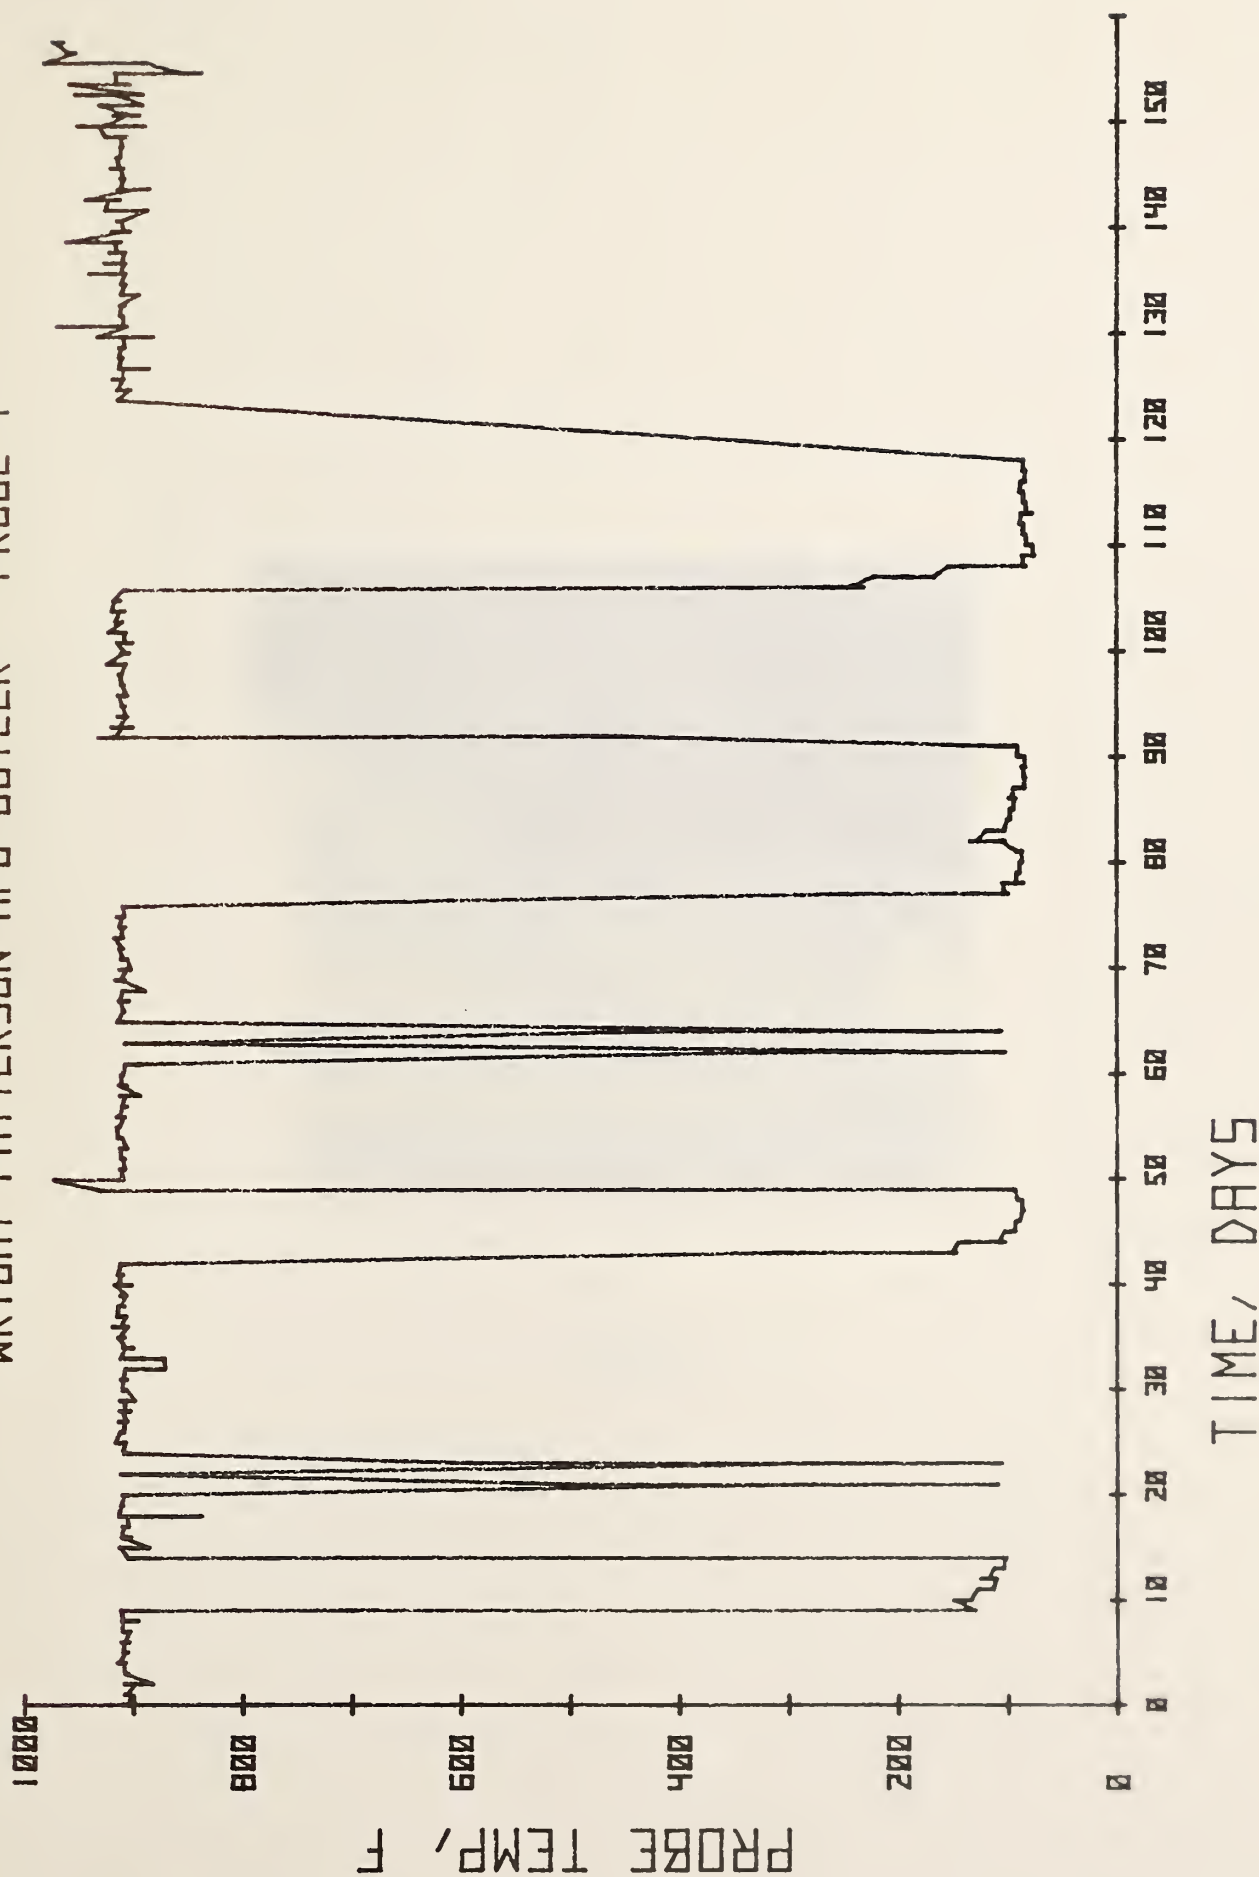
The temperature data taken on WPAFB Probe I are shown in Figure 5 in which the temperature at the end of the probe (thermocouple 01) is plotted as a function of time. The most obvious feature of this plot is the amount of time the system spent below its operating temperature. In fact, the temperature was below 425°C (800° F) for 33% of the 160 days that the measurements were made. However, these temperature excursions occurred only on eight occasions, and lasted from a few hours to over two weeks.

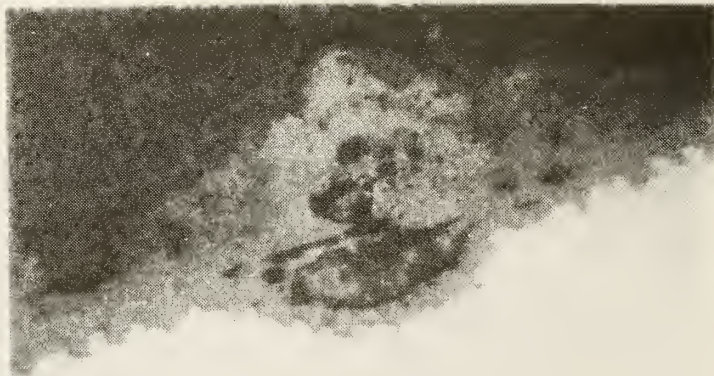
though the surfaces of the five materials were generally etched, the overall degree of attack was slight. Figure 6 is a photograph of one of the more severe pits on the SA213-T11 alloy which also shows the encrusted material above the pit. Examination with the scanning electron microscope revealed greater detail of the make up of this encrustation as seen in Figure 7. In this photograph, distinct layering with suspended particles in the matrix is visible, and is typical of the substance found on the coupon surfaces. The X-ray spectrograph of this encrusted matter identifies the chemical components as illustrated in Figure 8. Iron (FE) is the major constituent followed by silicon (SI) from the silicon carbide refractory on the walls of the boiler, and aluminum (AL) from the aluminum oxide cement that binds the refractory material together are all clearly visible on the spectrum. Sulphur (S), a contaminant of coal, calcium (CA), titanium (TI), phosphorus (P), and arsenic (AS) are all present in lower concentrations. A spectrograph of the alloy is shown in Figure 9, and indicates the presence of iron (FE), chromium (CR), and silicon (SI) as expected.

Examination of the cross sectional surface of the specimens revealed that the encrustation was anywhere from less than 1 mil (.04 mm) to more than (3 mm) 0.125 in. thick, and was always thicker on the down stream side of the coupon. When viewed with a low power microscope, it was evident that

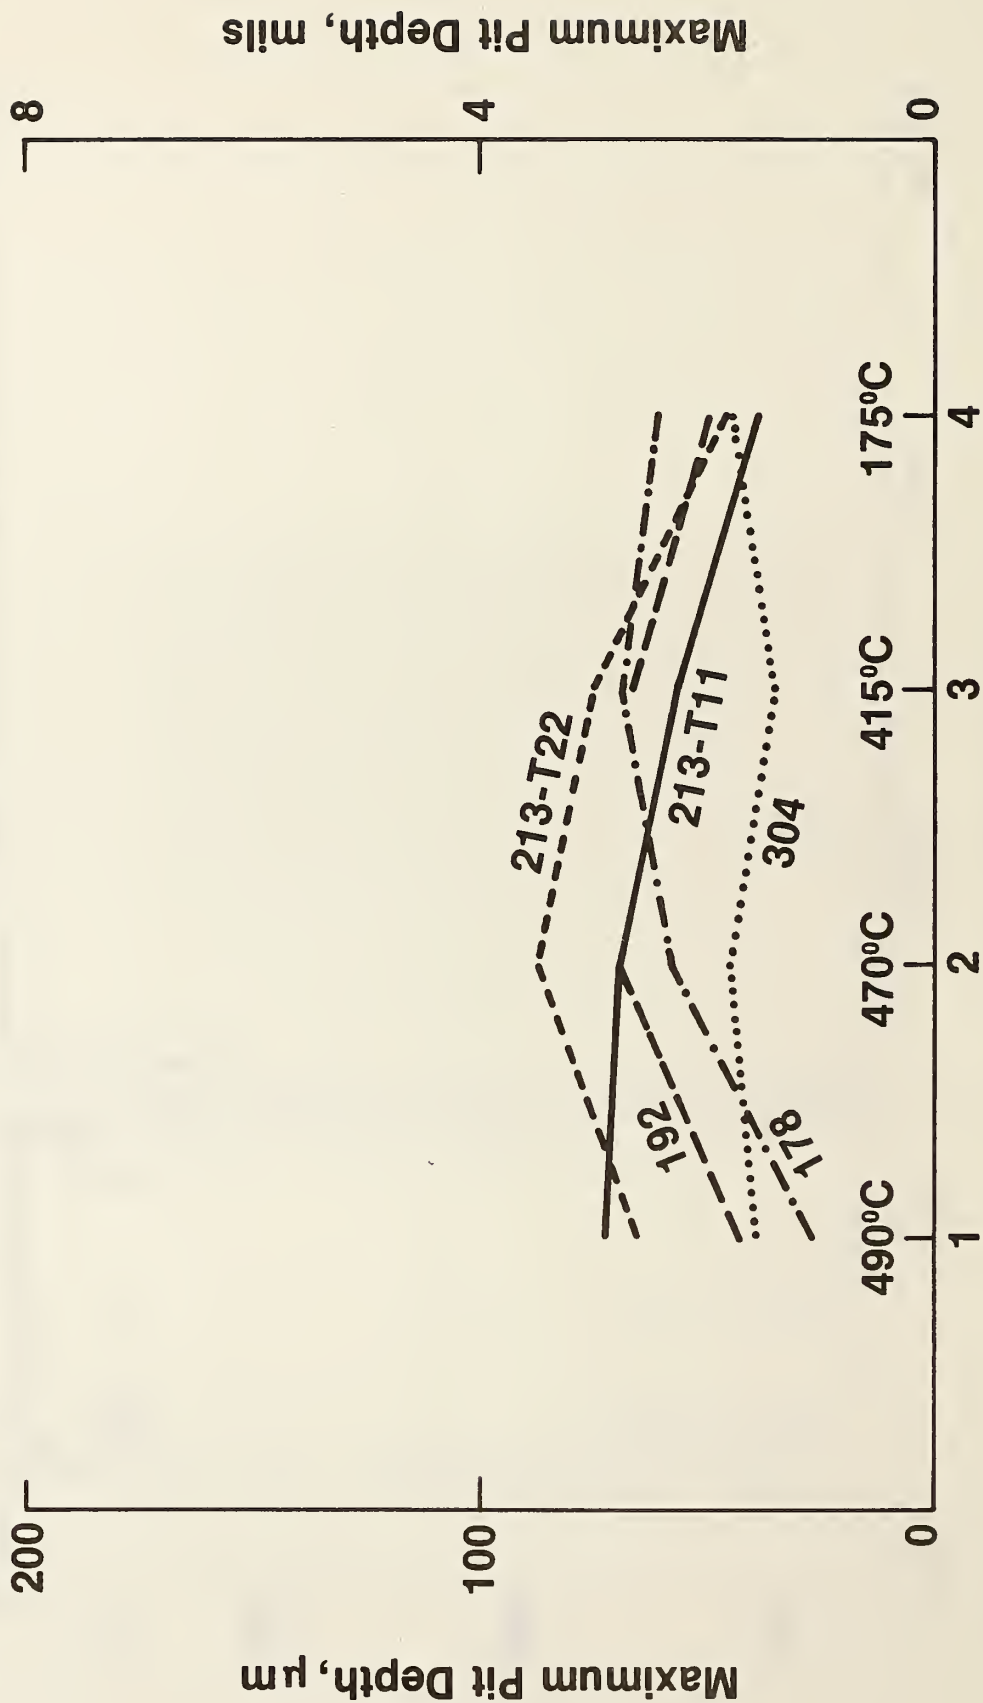
Figure 10

The maximum pit depth data after six months of exposure are shown on Figure 10, and illustrate the degree of pitting at the four positions along the probe for each of the alloys. These data show that the 304 stainless steel, in general, developed less pitting attack than the other four materials, and that the SA213-T22 ferritic steel underwent the most severe attack. The effect of temperature or position on the probe was not as large as expected. In fact, the degree of pitting for the 304 stainless steel remained low and almost constant for all temperatures. SA178, however, showed an increase in pitting resistance as the temperature increased to 490° C (910° F) toward the end of the probe. Based on these data and the deepest pit found for each material, a rate of pit growth was calculated for each material as listed in Table 2. The highest rate of pit growth found for any of the alloys at the WPAFB coal burning facility was 191 um/yr (7.5 mils/yr) for the SA213-T22, and the lowest rate of pit growth was 99 um/yr (3.9 mils/yr) for 304 stainless steel.

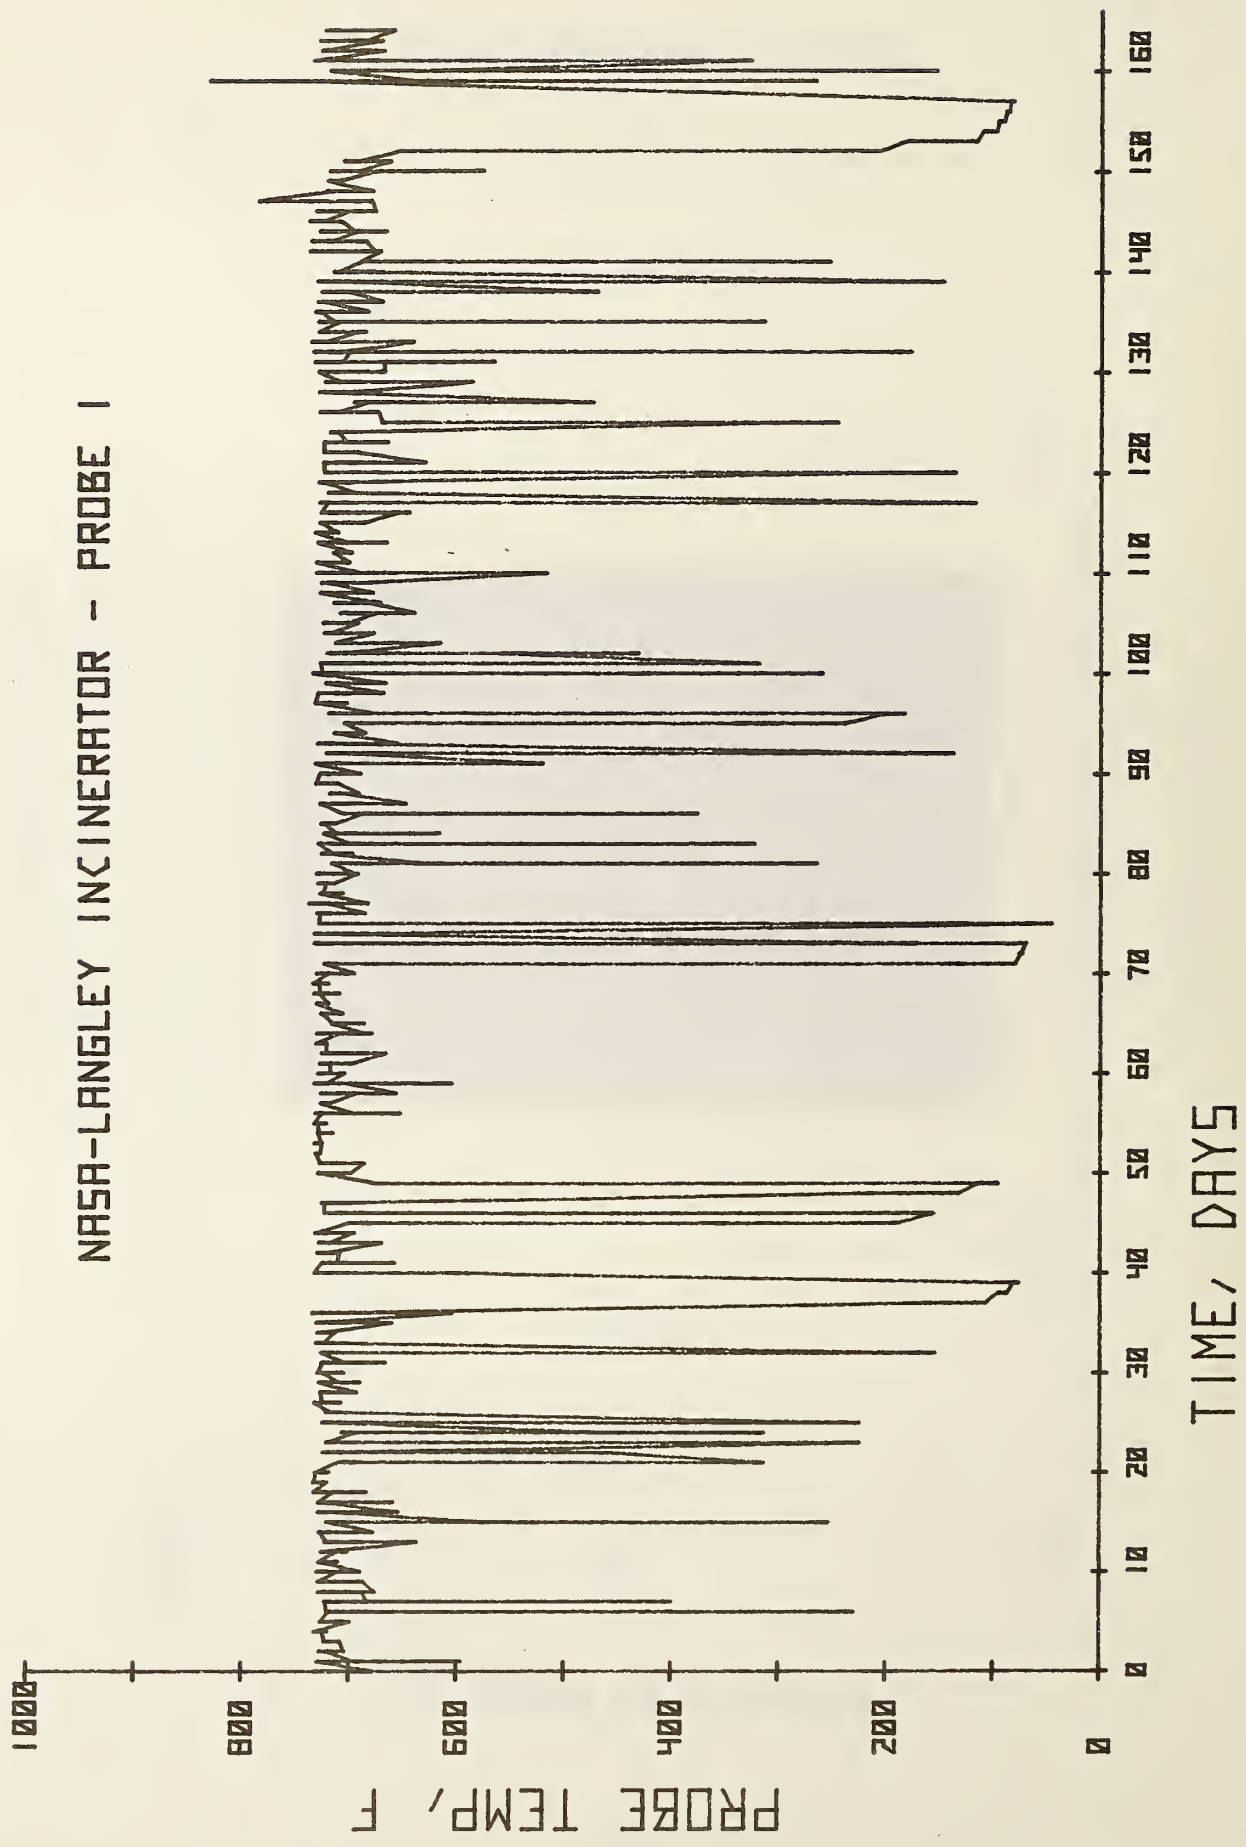
Figure 12

The temperature characteristics of this refuse burning facility were found to be very different from those observed at the WPAFB Facility as shown in Figures 12, 13, 14. The frequency of the temperature drop is much higher at the N/L Facility, and is of the order of once every three to five days. Over a period of 166 days the temperature dropped below 315° C (600° F) on 37 occasions amounting to 16% down time of the total period as measured with Probe I, and dropped 31 times over a period of 180 days or 10% down time for Probe II. Generally the temperature was down for only a few hours, but it was recorded on two occasions to remain low for about a week. The N/L Probe III temperature data showed that it was down only 6% of the time with 19 temperature excursions over the 48 day period of exposure.

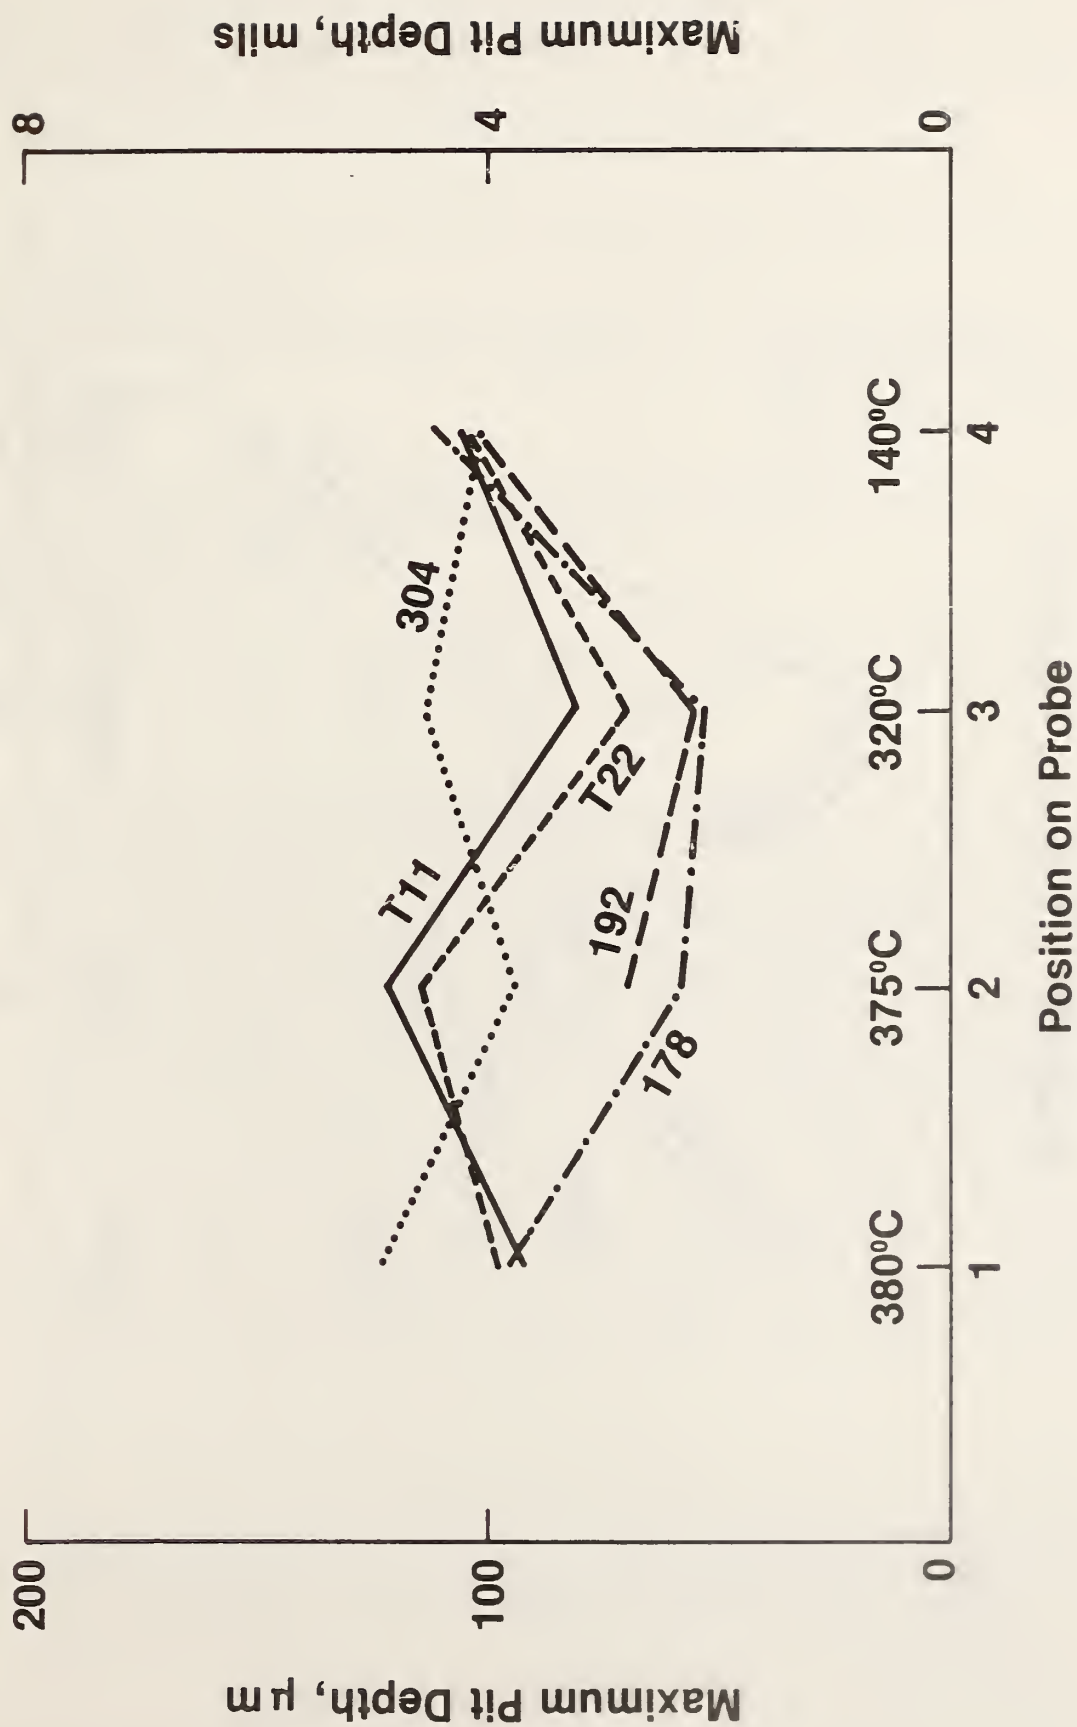
Figure 29

The pit depth data for N/L Probe II, exposed for six months, and N/L Probe III, exposed for three months, are shown respectively in Figures 29 and 30. Pit depths were not measured on N/L Probe I. Examination of these data indicates that the coupons exposed for three months experienced more severe pitting attack than the coupons exposed for six months. This is attributed to the period of the year that the probes were exposed. N/L Probe II was exposed through the winter months from September to April,

and N/L Probe III was exposed through the spring and summer months from April to July when grass clippings, loaded with moisture, become an additional burden to the incinerator. The manager of the NASA/Langley Facility estimated that during the summer months, grass clippings were 10 to 15% of the refuse. In fact, clippings were so plentiful on some occasions, especially after a weekend, that the operator had to feed the refuse carefully to avoid smothering the flames in the incinerator. Thus, the additional moisture in the combustion gases, during those months that the N/L Probe III was in place, increased the corrosion attack on the coupons.

In general, the data show that the 304 stainless steel underwent a fairly constant rate of attack over the exposure conditions of N/L Probes II and III. With the exception of the 304 stainless steel, the other four alloys displayed an increased rate of pitting for both of the steels with a higher alloy content though the additional molybdenum in the SA213-T22 may have helped keep its pitting below that of the SA213-T11. The plain carbon steels, SA192 and SA178, tended to undergo less pitting than SA213-T22 or SA213-T11. The maximum rate of pit growth, calculated from these data, is listed for both probes in Table 3, and shows that the rate of penetration in N/L Probe II is considerably less than that for N/L Probe III. It is important to note that the 304 stainless steel on Probe II displayed the highest maximum rate of pitting at 228 $\mu\text{m}/\text{yr}$ (9 mils/yr) and SA192 has undergone the lowest maximum pitting rate at 193 $\mu\text{m}/\text{yr}$ (7.6 mils/yr). For N/L Probe III the rates of pit growth are higher, and in this case the SA213-T11 shows the highest maximum rate of pit penetration at 726 $\mu\text{m}/\text{yr}$ (28.6 mils/yr) and 304 stainless steel the lowest rate at 366 $\mu\text{m}/\text{yr}$ (14.4 mils/yr). An evaluation of the effect of temperature shows that the data are not consistent for the two N/L probes, but the 304 stainless steel does tend to show an increase in pit depths at the higher temperature toward the tip end of the probes. This inconsistent effect of temperature may be a reflection of the temperature fluctuations of the incinerator for the following two reasons. First, this temperature change raises stresses within the oxide and the encrusted material leading to cracks in the encrustation which, in turn, exposes the underlying metal to the corrosive atmosphere. Second, and perhaps more important, these temperature drops cause condensation of moisture and other condensable matter that can lead to corrosive attack of the coupons or boiler tubes. Such cracks are readily apparent in the photomicrographs of Figures 15, 18, 19. Thus, these large temperature fluctuations can override any corrosion effects at the higher temperatures.
