**Federal Building and Fire Safety Investigation of the
World Trade Center Disaster**

Passive Fire Protection

Federal Building and Fire Safety Investigation of the World Trade Center Disaster

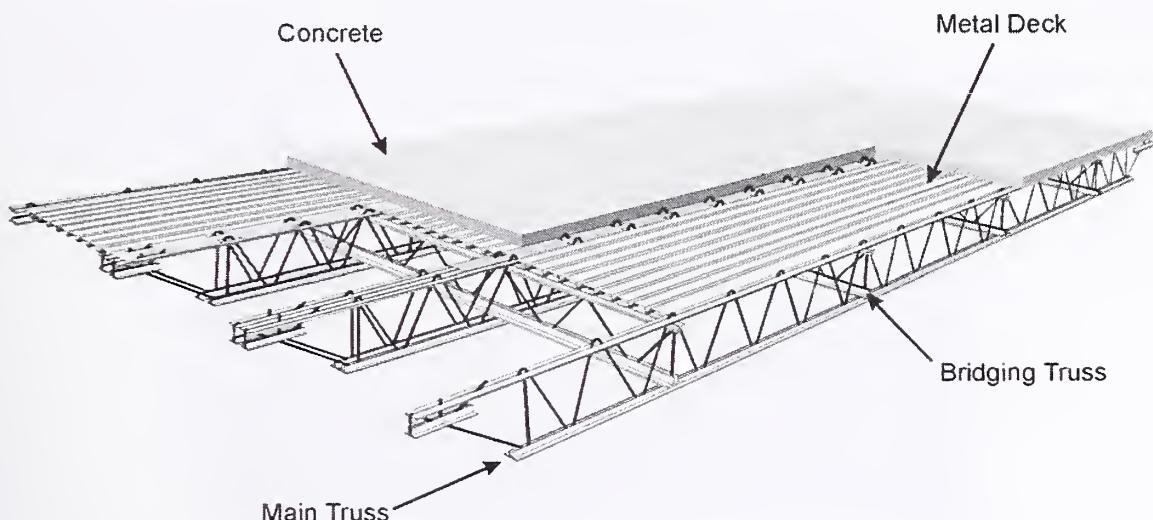
Figure 3–2. Schematic of composite floor truss system.

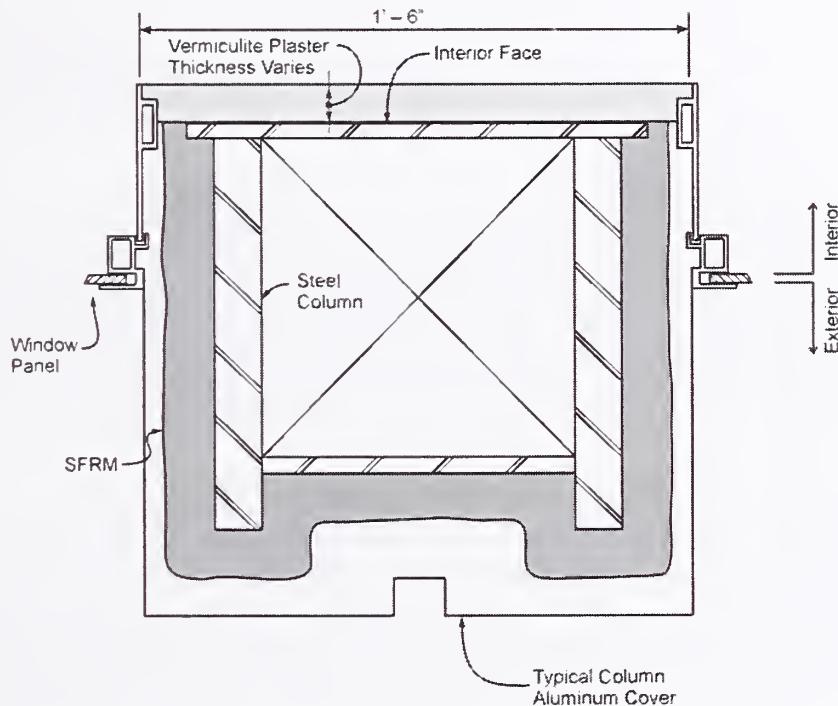
Figure 3-4. Thermal insulation for perimeter columns.

For the inside face of the columns, Alcoa proposed to apply a high “k” value (thermal conductivity) material. This application would provide thermal protection while permitting heat migration from the room air to the column steel under service conditions. Figure 3-4 illustrates the thermal protection design for the perimeter columns.

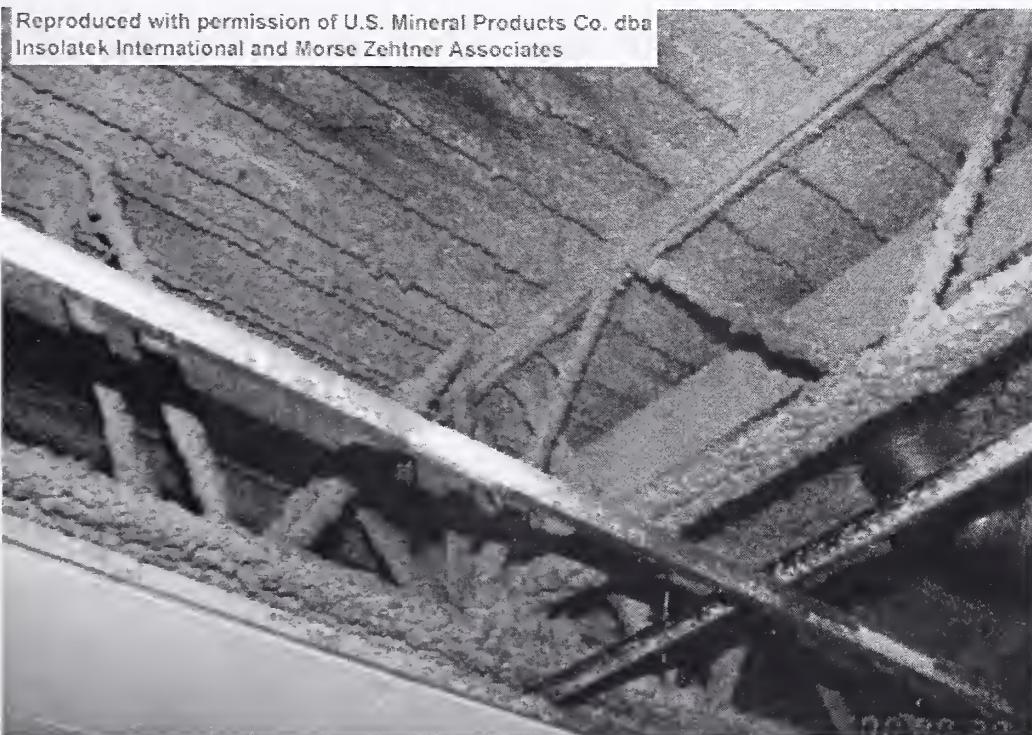
Figure 3–5. Intersection of main truss and bridging truss showing general good coverage of SFRM on truss members but thickness varies on web bars.

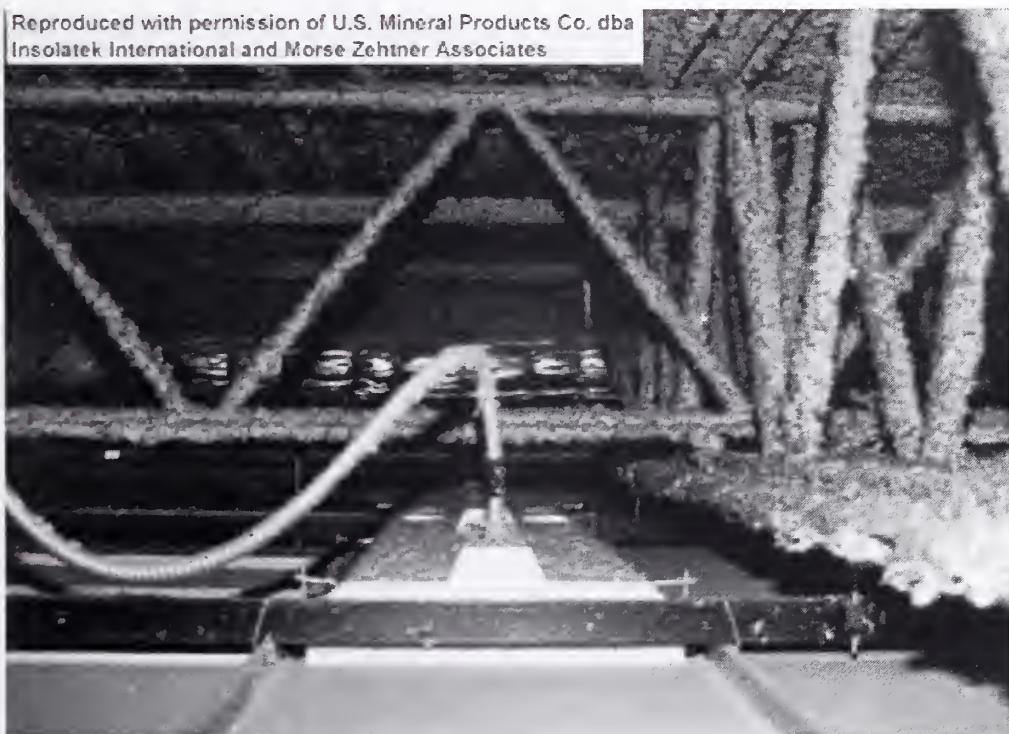
Figure 3–6. Intersection of main truss and bridging truss showing thinner SFRM on members of bridging truss.

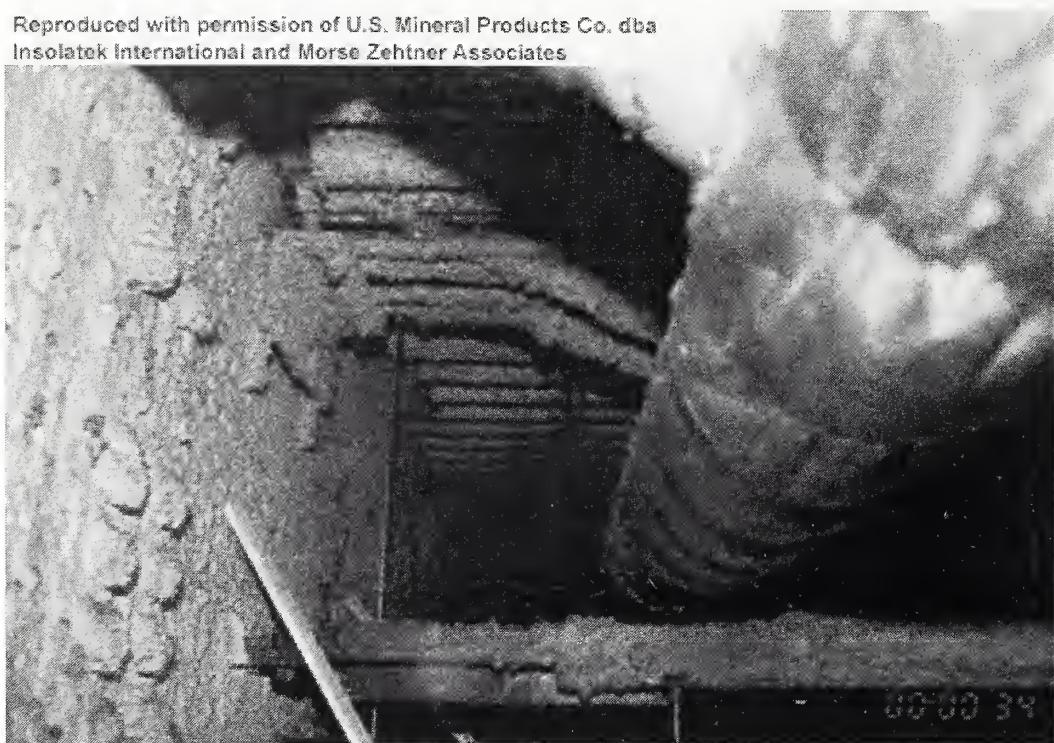
Figure 3–7. Connection of main truss to spandrel beam showing relatively thin SFRM on truss seat and no SFRM on damper.

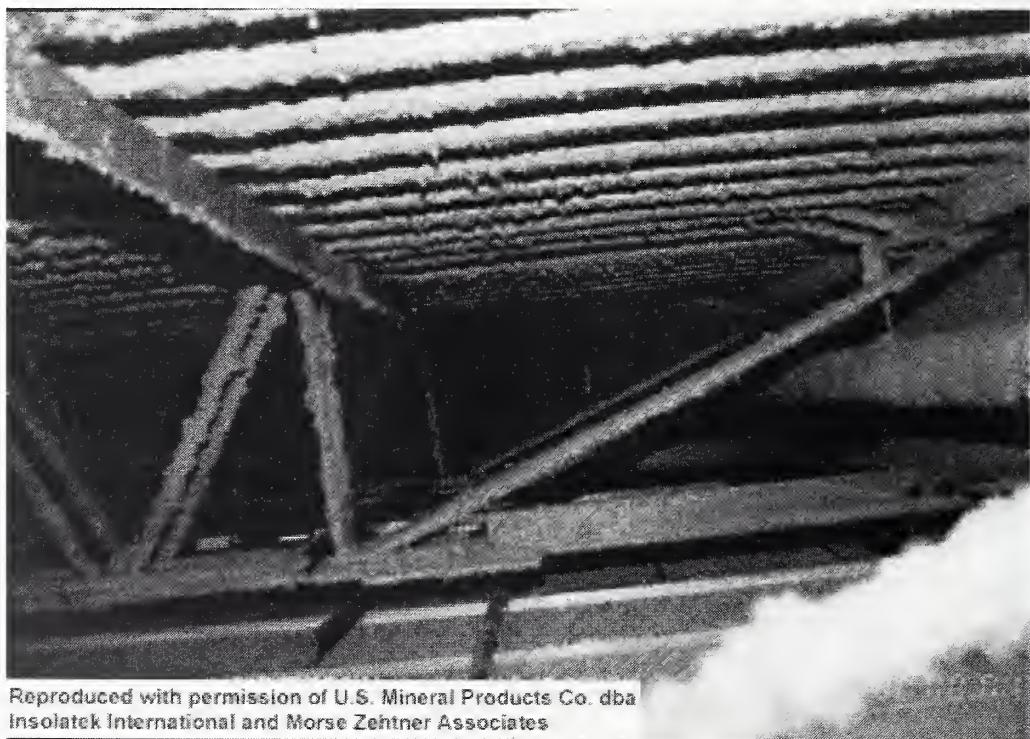
Figure 3–8. End of main truss showing low thickness of SFRM on truss members and no SFRM on damper saddle.

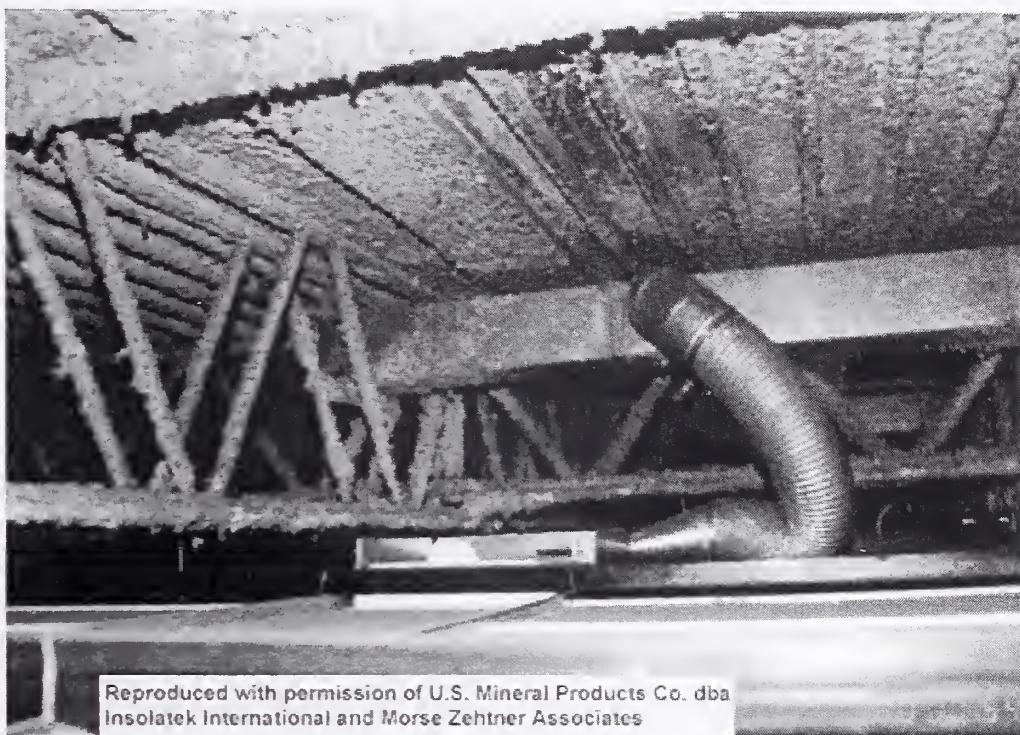
Figure 3–9. Intersection of main truss and bridging truss showing thin SFRM on the ends of some web bars; SFRM was not applied to the metal decking.

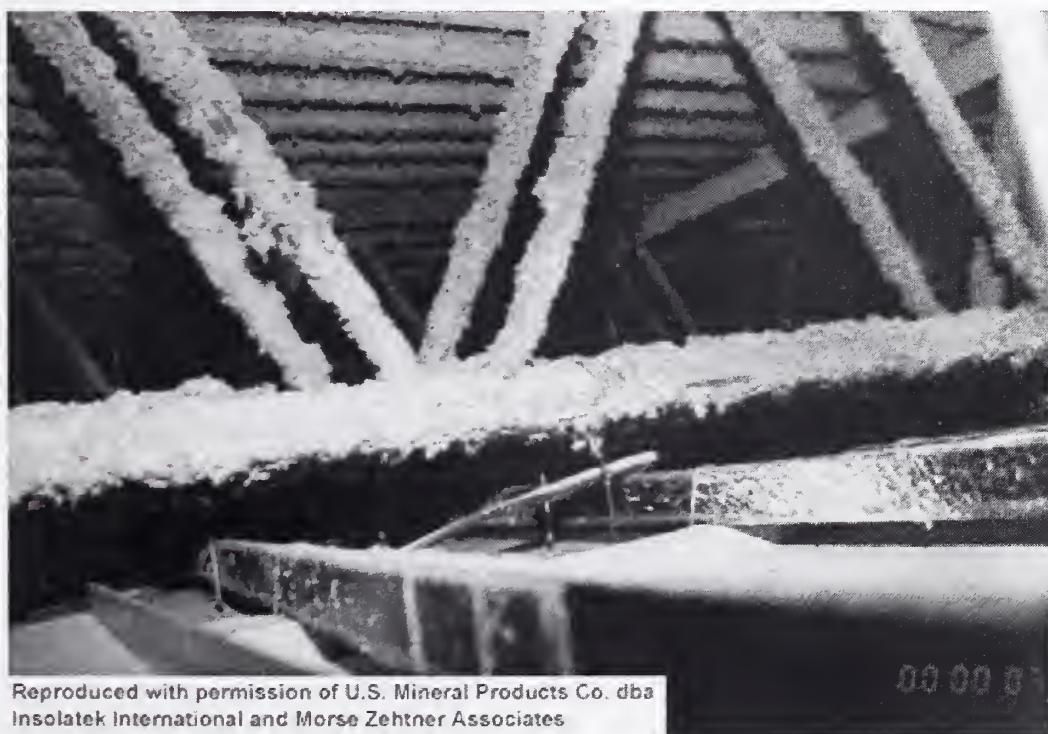
Figure 3–10. Example of damage to SFRM during installation of utilities.

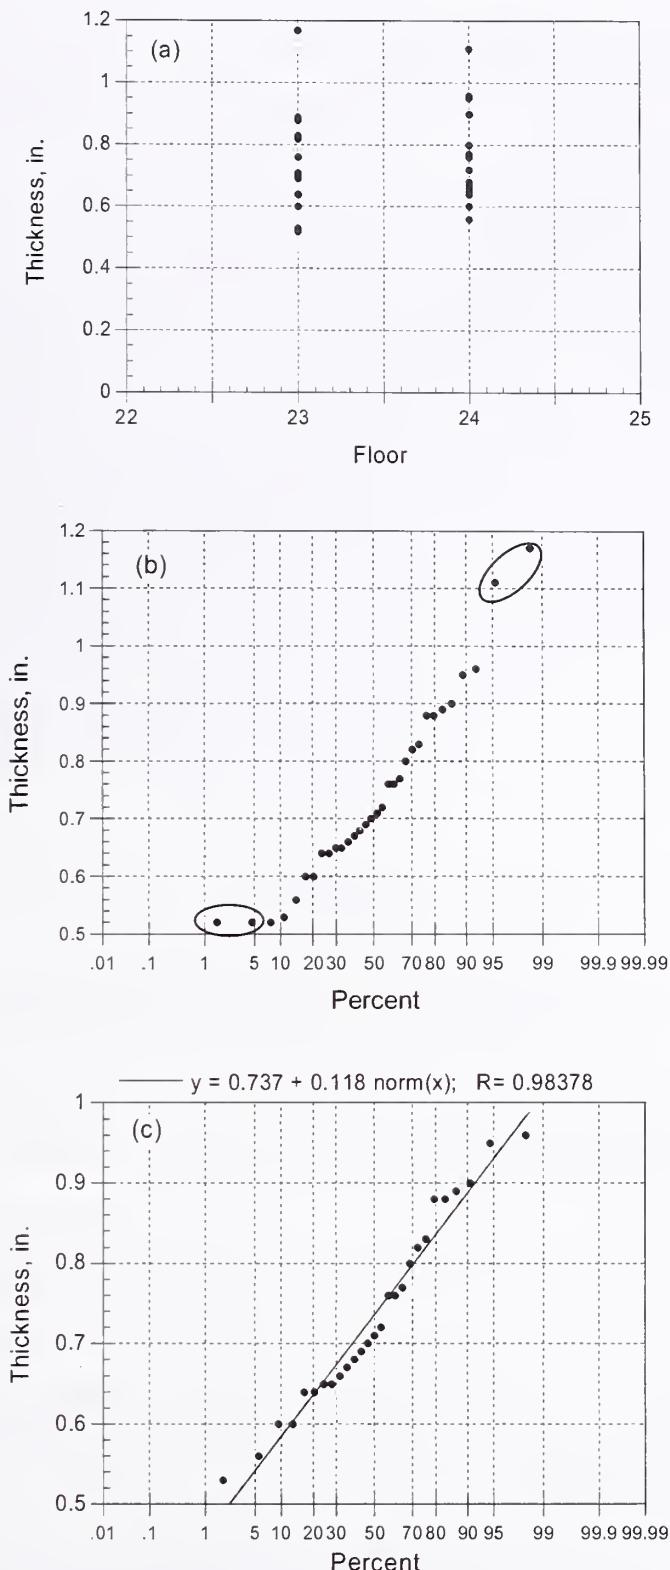
Figure 4-1. (a) Dotplot of average thickness from floor trusses for floors 23 and 24, (b) normal probability plot of all average thickness values, and (c) normal probability plot of average thickness with four values (six points) excluded.

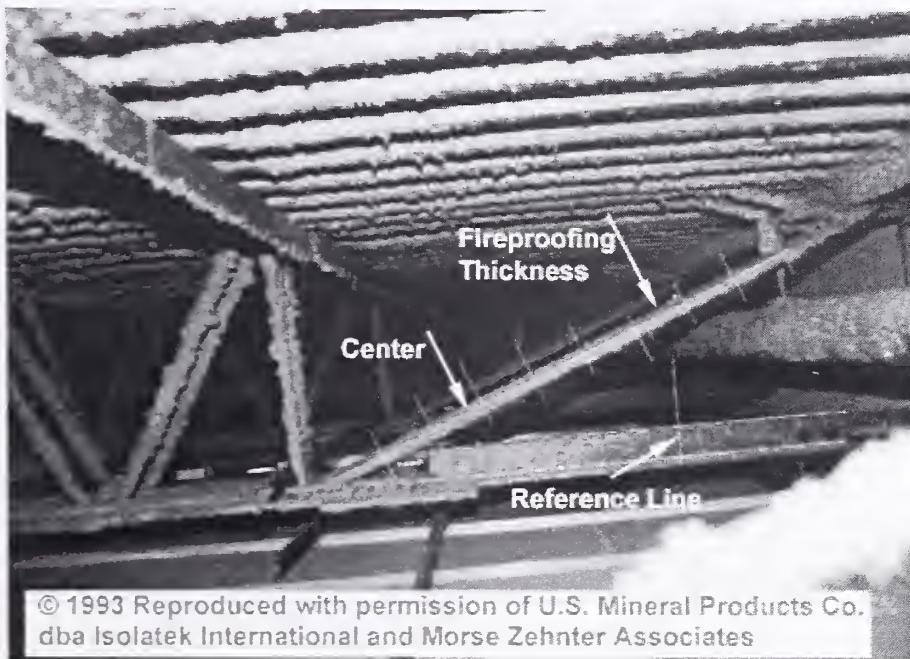
Figure 4-2. Example of measurement procedure used to estimate SFRM thickness from photographs.

- Each measurement in pixels was multiplied by the scaling factor (in./pixel) to estimate the bar radius plus SFRM thickness. This provides two measurements at each cross section.
- The radius of the bar was subtracted to provide the estimate of the SFRM thickness.

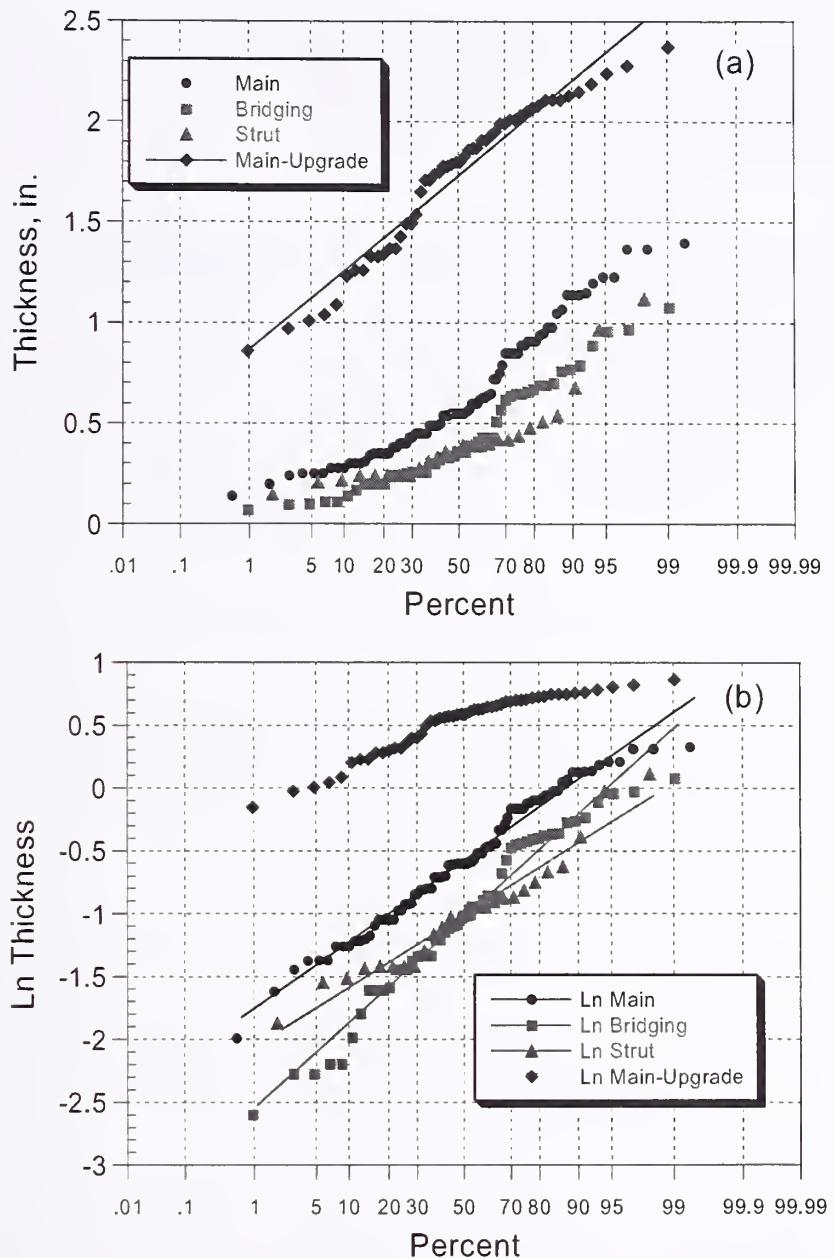
Figure 4-3. (a) Normal probability plot of estimated SFRM thickness based on photographs, and (b) normal probability plot of natural logarithms of thickness (Data provided by PANYNJ).

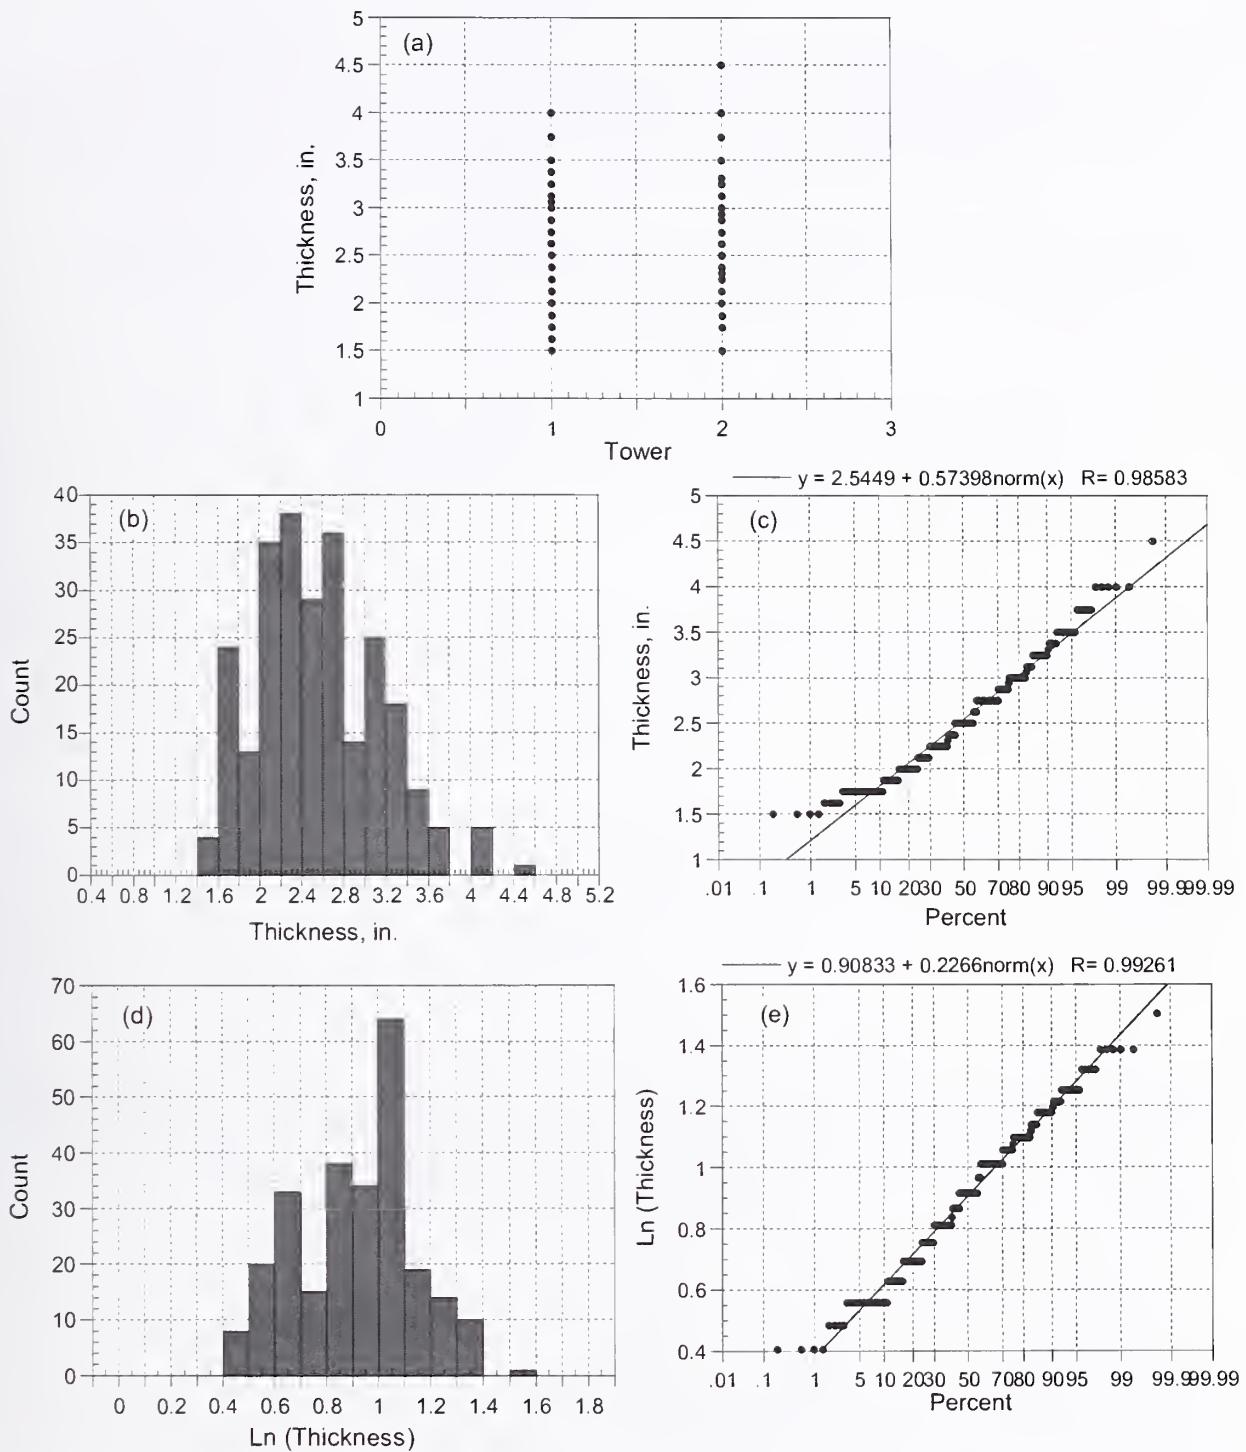
Figure 4-4. (a) Dotplot of individual thickness measurements on floor trusses from Port Authority Construction Audit Reports, (b) histogram of thickness measurements, (c) normal probability plot of thickness measurements, (d) histogram of natural logarithms of thickness measurements, and (e) normal probability plot of natural logarithm of thickness measurements.

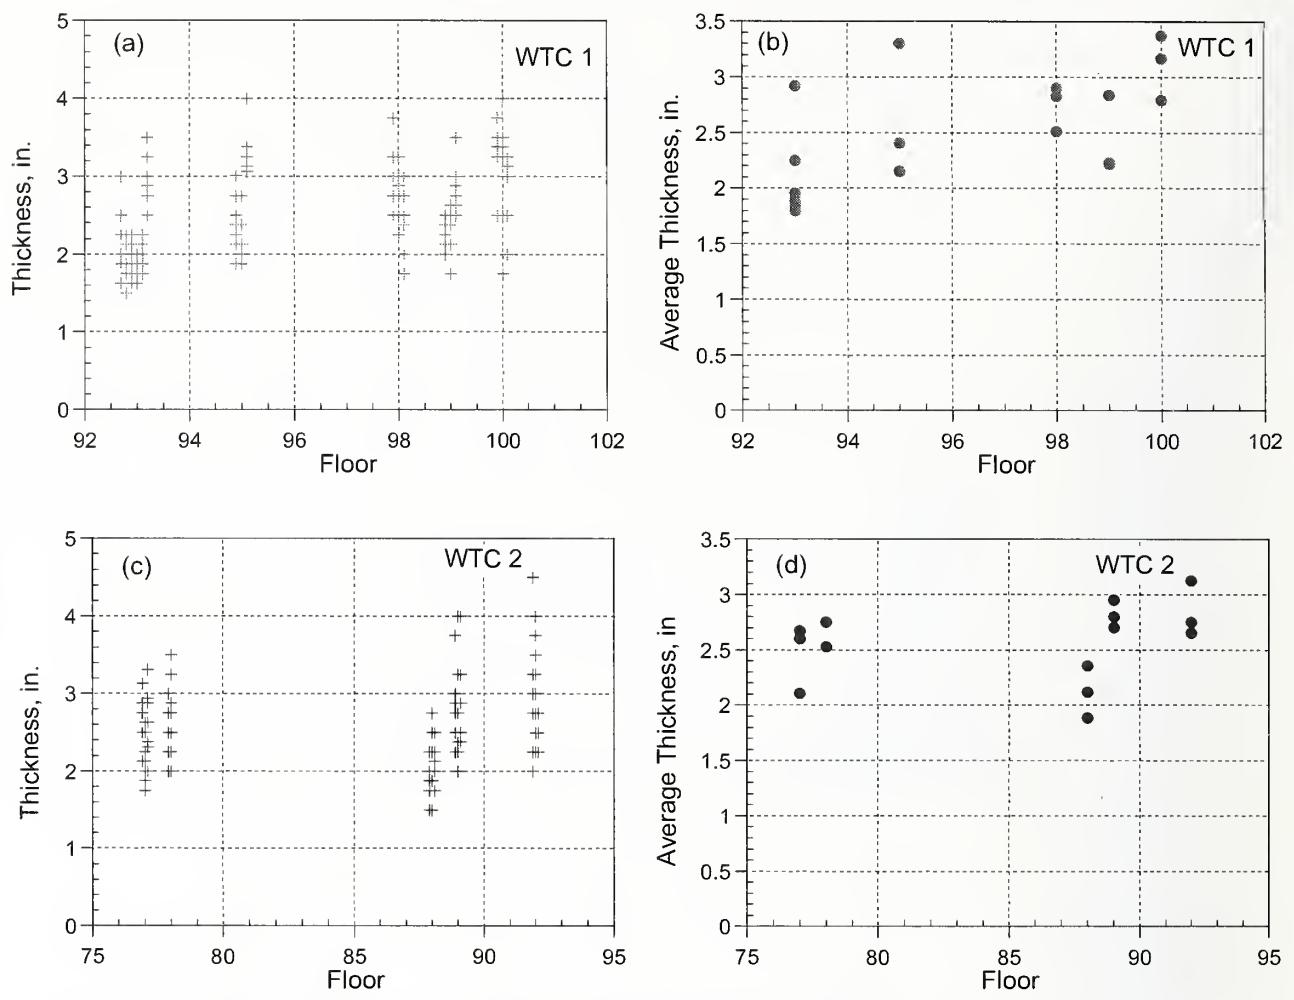
Figure 4-5. SFRM thickness on floor trusses in upgraded portions of WTC towers: (a) individual measurements in WTC 1, (b) average thickness in WTC 1, (c) individual measurements in WTC 2, and (d) average thickness in WTC 2 (data provided by PANYNJ).

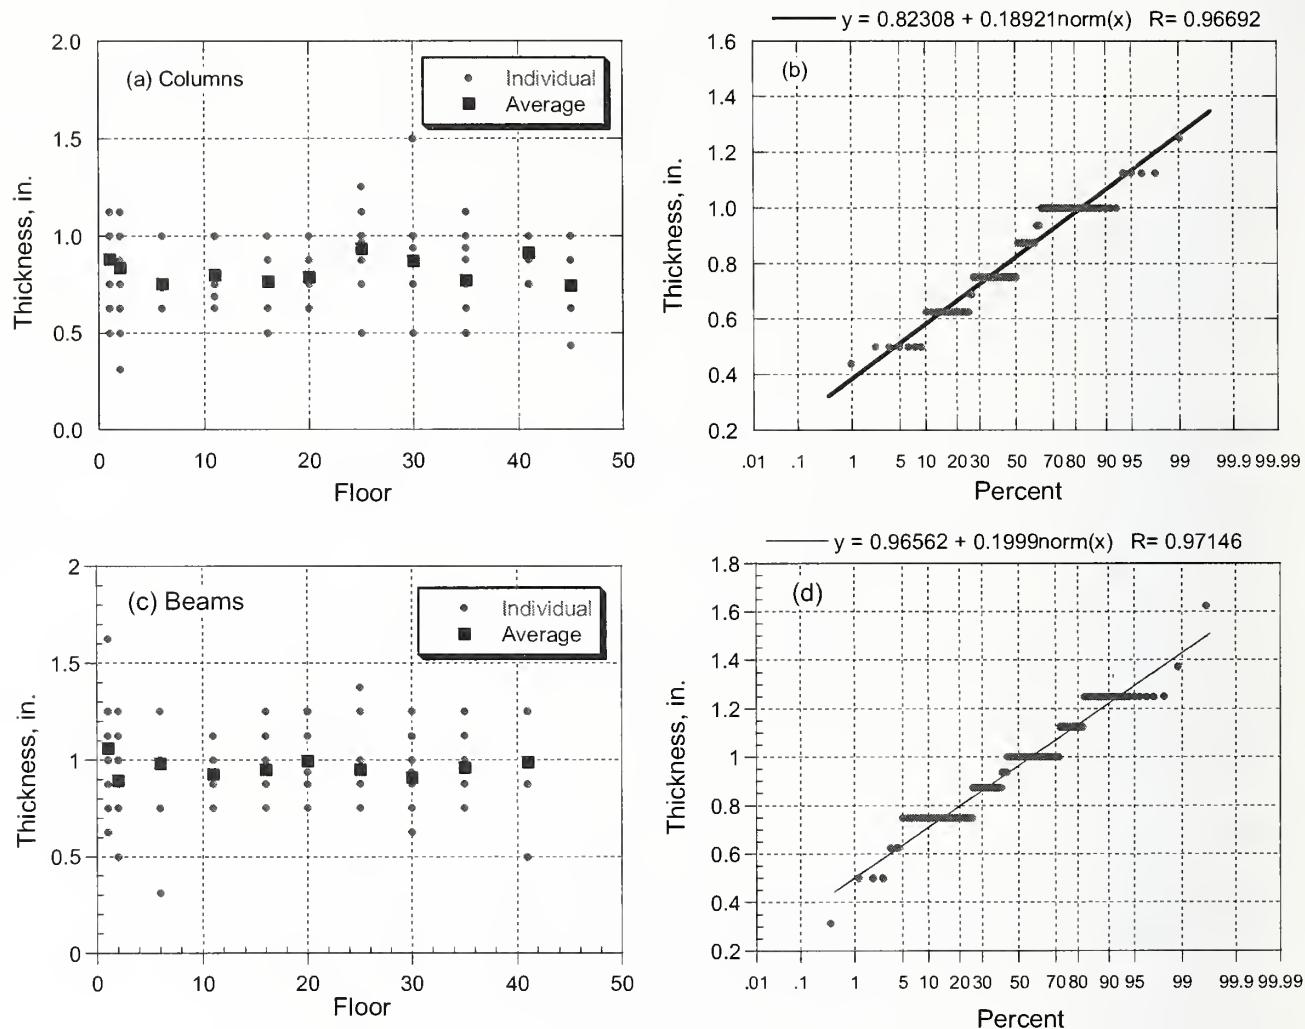
Figure 4-6. Thickness of re-applied SFRM in elevator shaft 10/11 of WTC 1: (a) Individual and average thickness for core columns, (b) normal probability plot of individual measurements on columns, (c) individual and average thickness for core beams, and (d) normal probability plot of individual measurements on beams (data provided by PANYNJ).

Fig. 4-6 is lower than the variation observed in the floor trusses. This is not unexpected because the planar surfaces of the beams and columns result in more uniform application of the sprayed fire-resistive material than for the slender truss members. This results in reduced differences in the average thickness of SFRM on different members and less variability within a member.

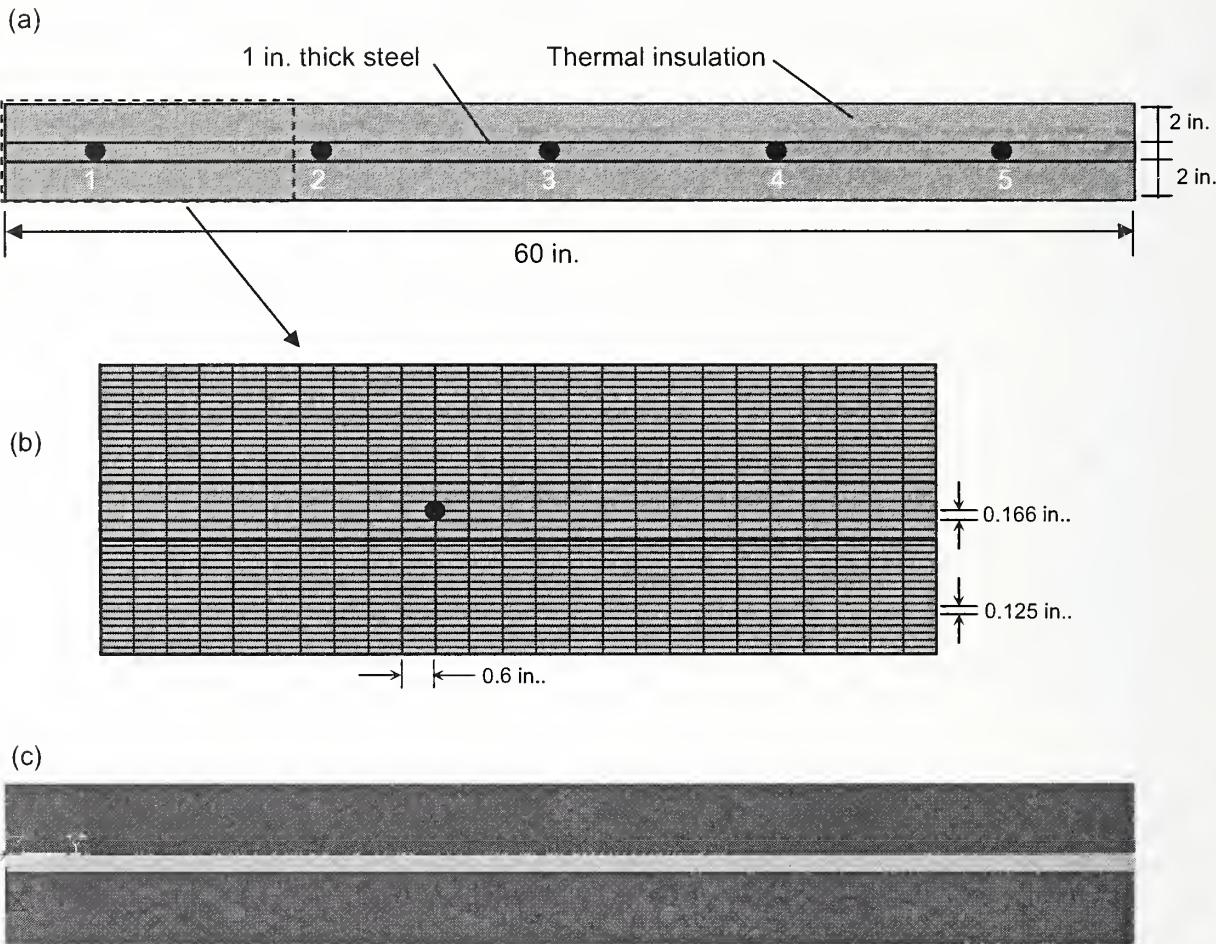
Figure 5–1. Model used to study effects of SFRM thickness and variability of thickness on steel temperature: (a) physical model used in analyses (points 1 to 5 are locations where temperatures are monitored), (b) finite element mesh used to represent physical model, and (c) finite element model to represent variable thickness of SFRM (purple) (the elements in red represent material of high thermal conductivity).

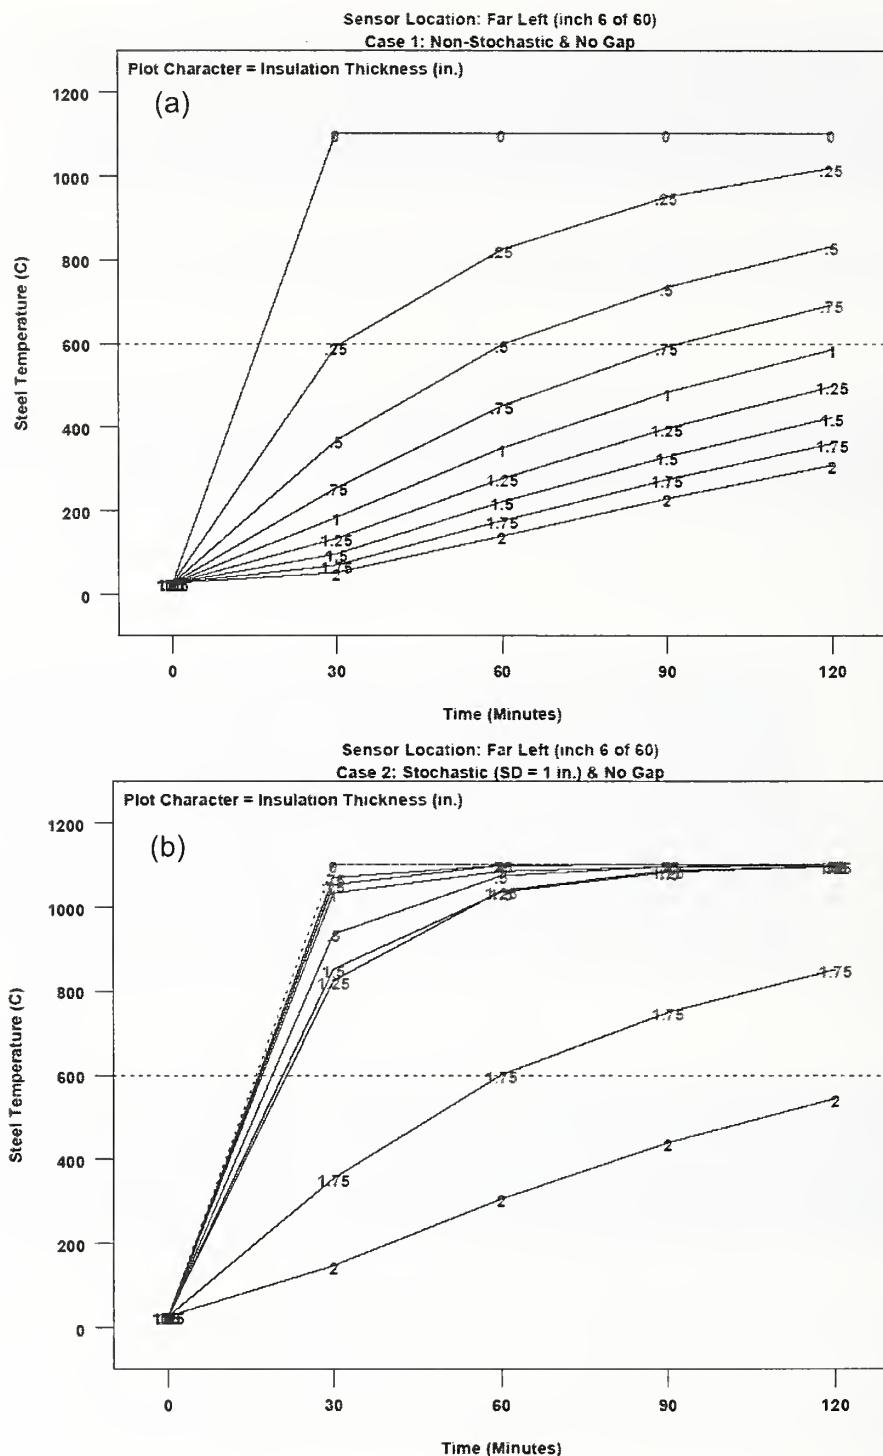
Figure 5–3. Variation of steel temperature (at a point 6 in. from end of plate) with time for different average thicknesses of fire-resistive material (shown as numbers on the curves): (a) uniform thickness, and (b) variable thickness with standard deviation = 1 in.

Fig. 5-3 (b), the thickness varies with a standard deviation of 1 in. The time to reach a temperature of 600 °C is used as a measure of relative performance. It is seen that the presence of high variability in thickness has a detrimental effect on the protection provided by the fire-resistive material. For example, for a uniform thickness of 0.5 in., it takes about 60 min for the steel at point #1 to reach 600 °C, but when the standard deviation of the thickness is 1 in., the average thickness has to be 1.75 for the same level of thermal protection.

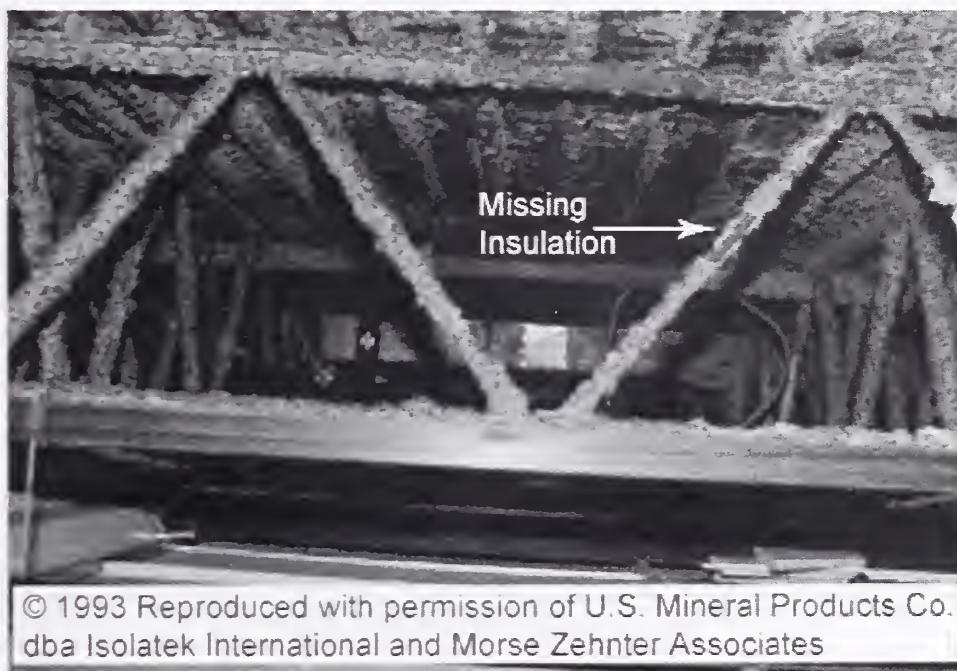
Figure 5–4. Example of “gap” in fire-resistant material on diagonal member of a bridging floor truss.

In addition to the effect of variation in thickness, it is important to understand the effect of missing SFRM over a portion of a member. As an example, Fig. 5-4 shows missing SFRM from a diagonal of a bridging truss of the WTC towers floor system. Note that this photograph is from a lower story and may not be representative of conditions in the upper stories, especially following the upgrade of thermal insulation. Figure 5-5 (a) shows an example of a numerical model with missing fire-resistant material. In this case, there is 12 in. of missing SFRM on the steel plate, which is otherwise protected by 2 in. of uniform thickness fire-resistant material. Figure 5-5 (b) shows the temperature contours (isotherms) at time equal to 50 min. For comparison, Fig. 5-5 (c) shows isotherms at the same time in a plate with no gap in the fire-resistant material. As expected, the bare steel at the missing fire-resistant material is at the gas temperature, but more importantly the “gap” in SFRM leads to a “leakage” of heat into the interior steel.

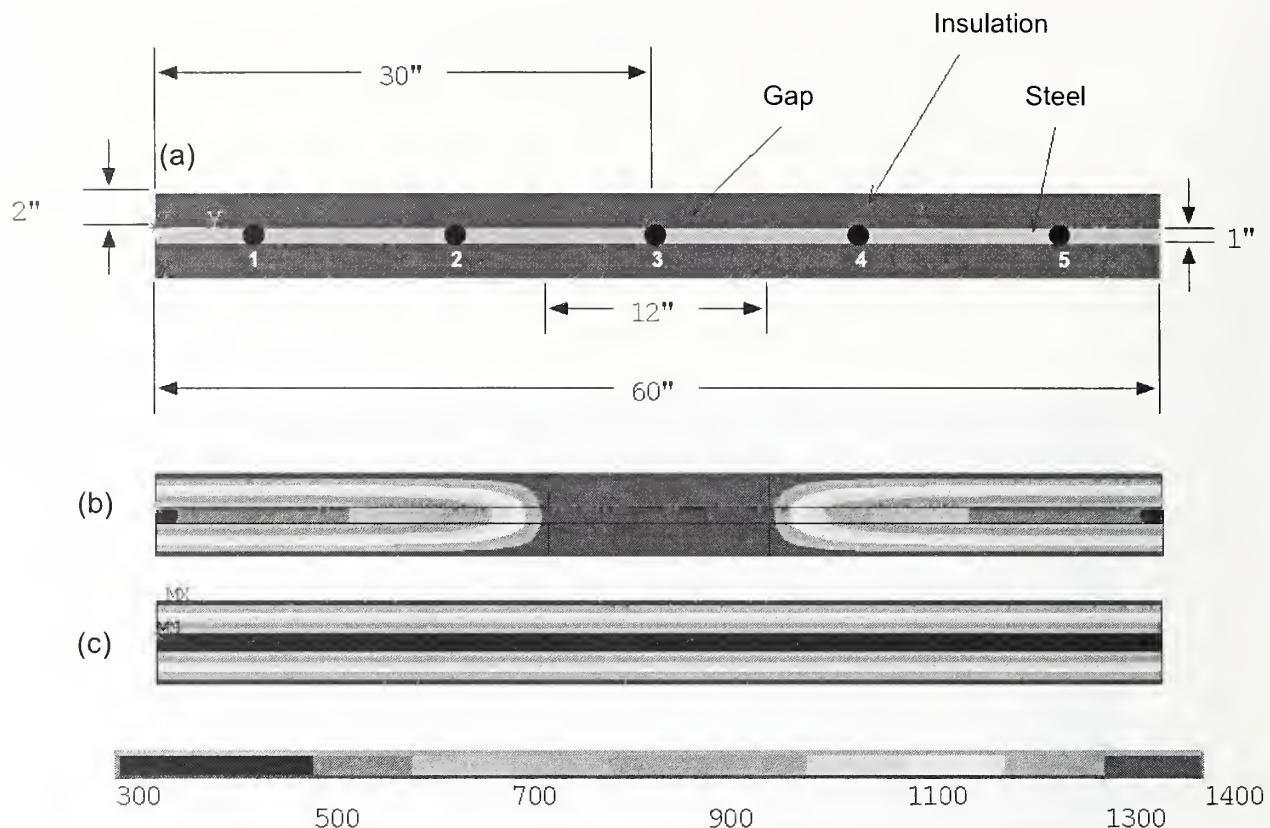
Figure 5–5. Effects of gap in fire-resistive material: (a) model of plate with SFRM having 2 in. uniform thickness and 12 in. gap, (b) isotherms (K) at time = 50 min with 12 in. gap, and (c) isotherms without gap.

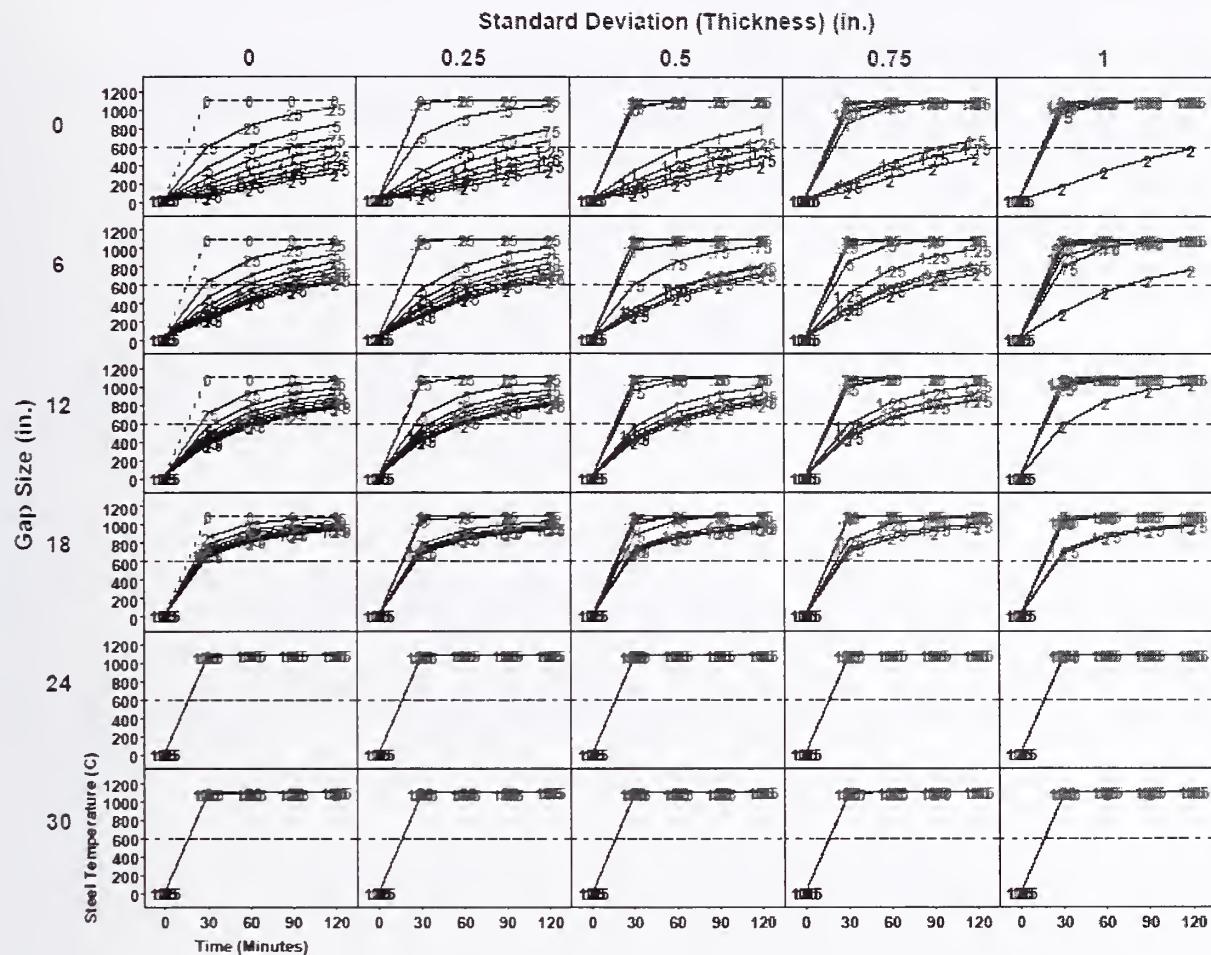
Figure 5-6. Example of plot matrix from sensitivity study of the effects of missing SFRM and variability of SFRM thickness on steel temperature. Each graph is a temperature history of the steel at point #2 (see Fig. 5-5 for location) for different thicknesses of SFRM.

trend of the curves in going downward from the top of a column in Fig. 5-6. The National Institute of Standards and Technology (NIST) does not have sufficient information to determine the frequency of occurrence of these gaps or their typical locations within the fire-affected floors. Therefore, gaps in insulation were not considered in the thermal modeling.

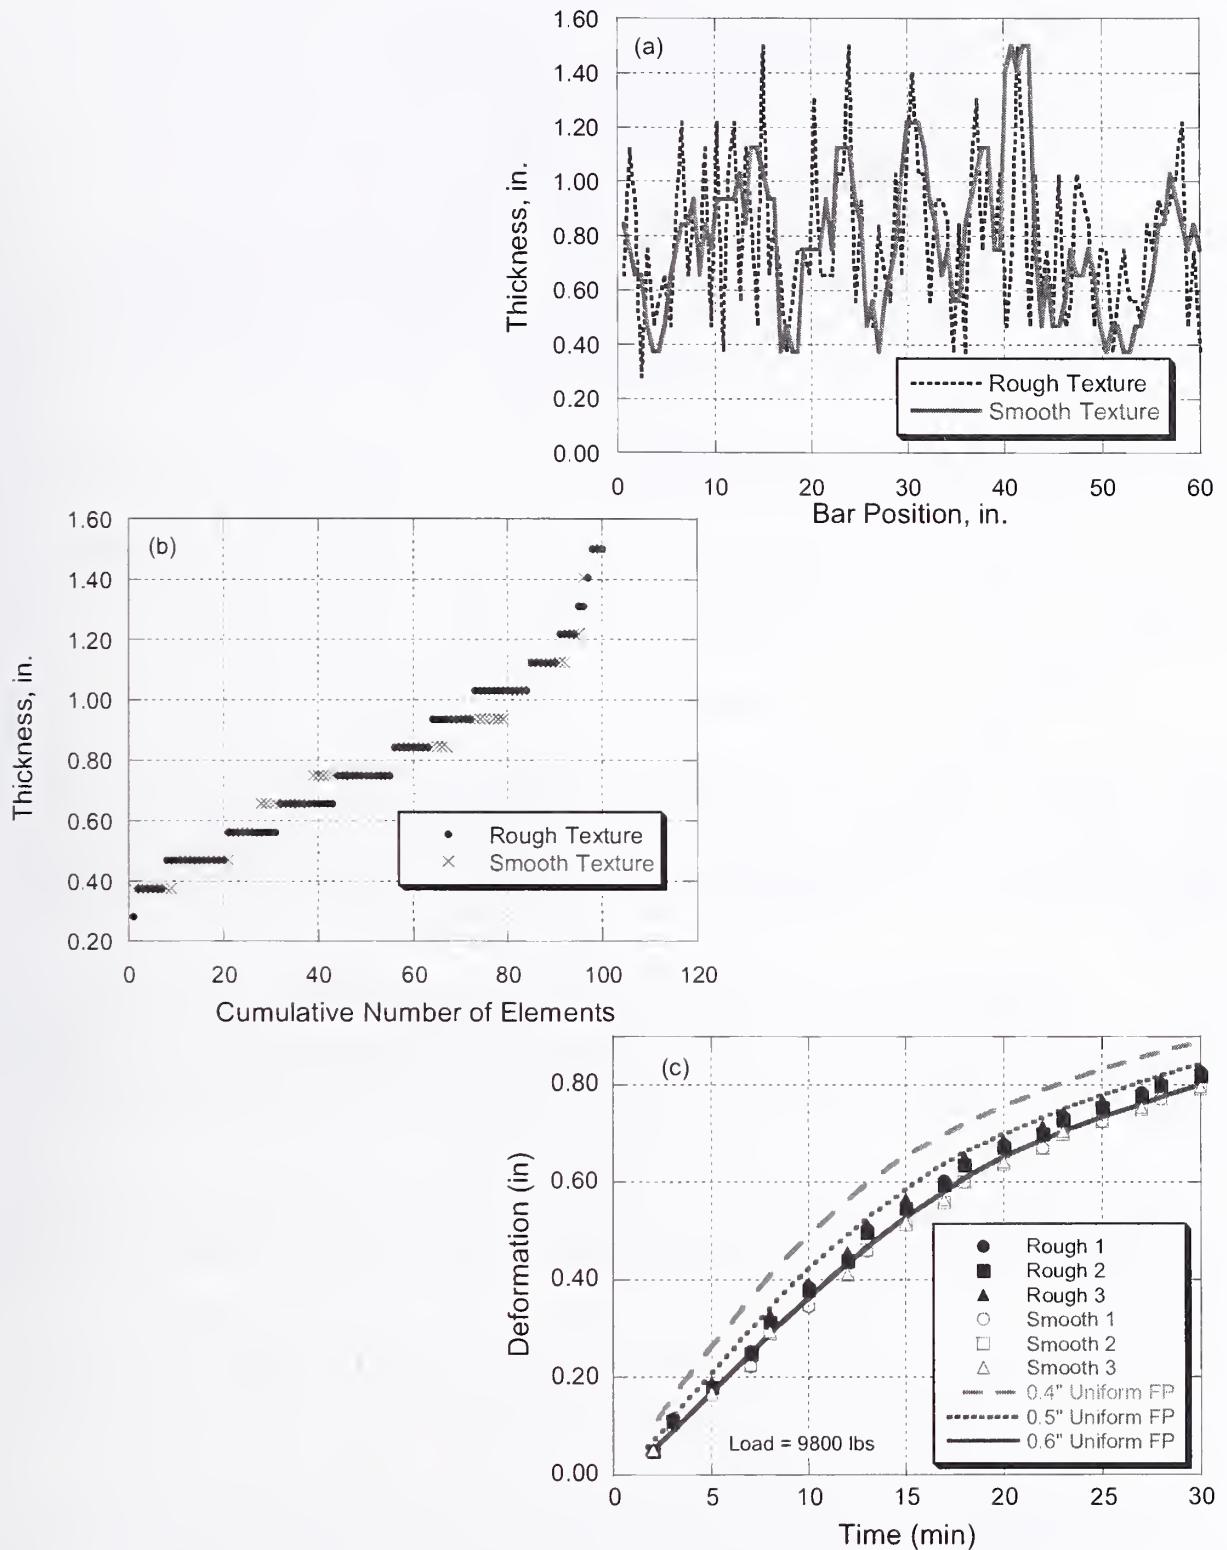
Figure 5-7. (a) Randomly generated thickness profiles with average thickness of 0.75 in. and standard deviation of 0.3 in., (b) cumulative element size, and (c) deformation of 1 in. bar compared with deformation for uniform thickness of thermal insulation.
