**Federal Building and Fire Safety Investigation of the
World Trade Center Disaster**

Passive Fire Protection

Federal Building and Fire Safety Investigation of the World Trade Center Disaster

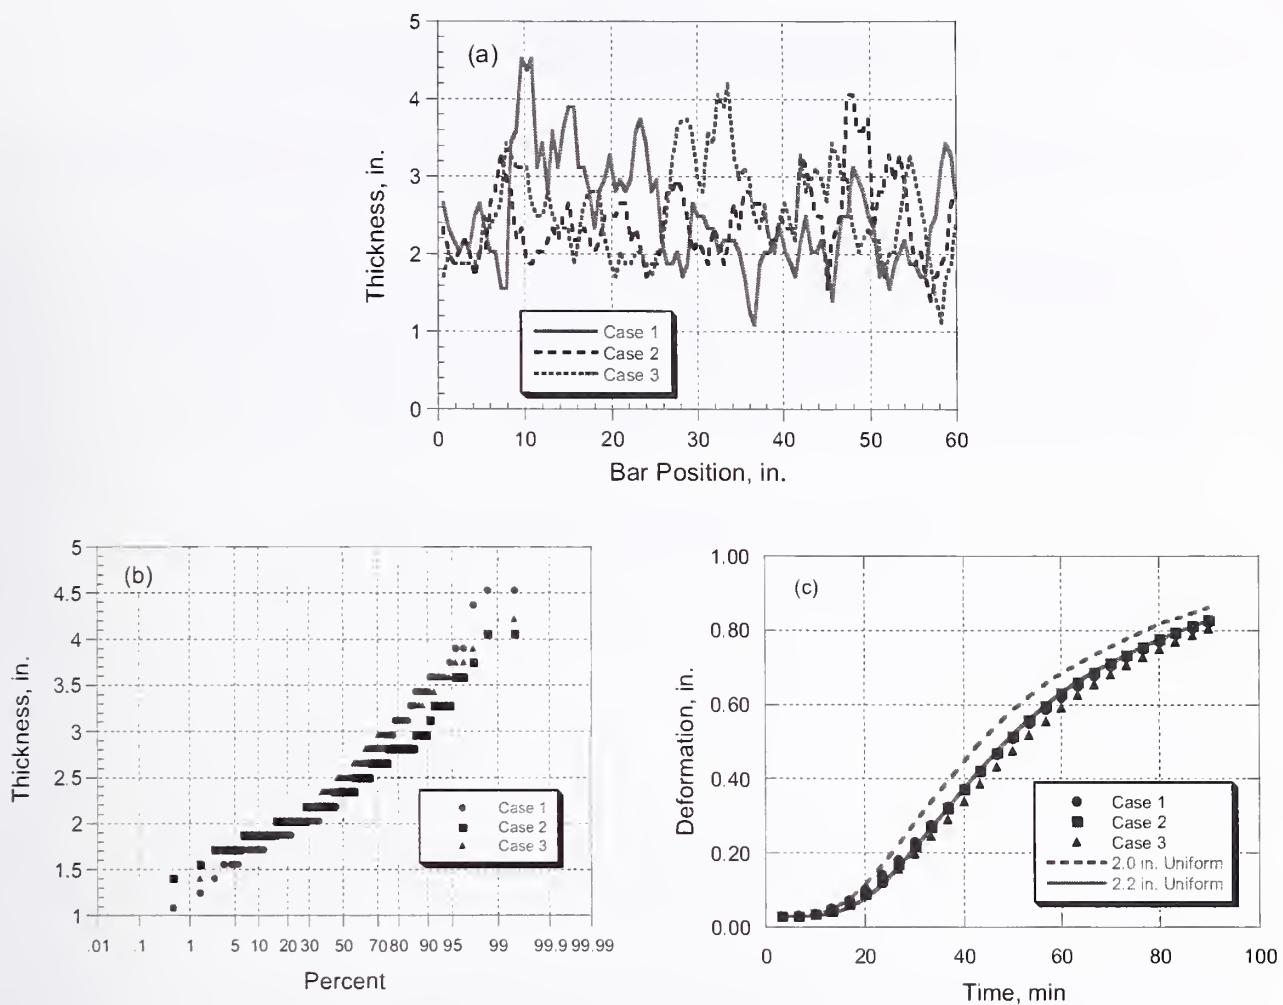
Figure 5-8. (a) Randomly generated thickness profiles with average thickness of 2.5 in. and standard deviation of 0.6 in., (b) normal probability plots of thickness values, and (c) deformation of 1 in. bar compared with deformation for uniform thickness of thermal insulation.

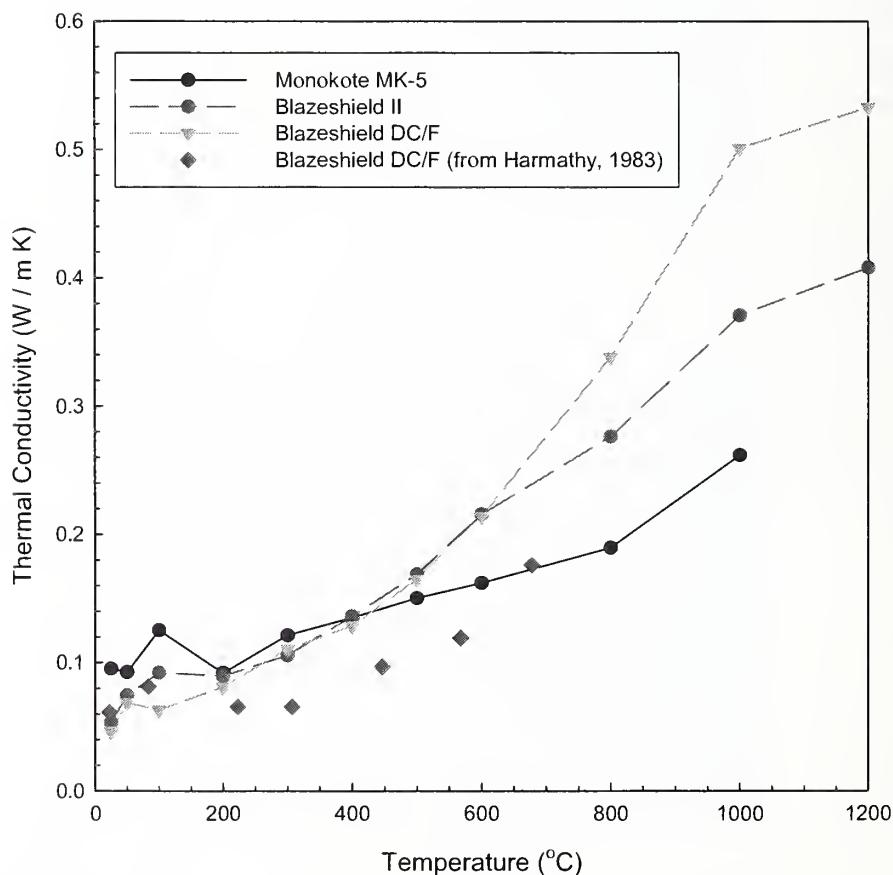
**Figure 6–4. Thermal conductivities of the three SFRMs as a function of temperature.**

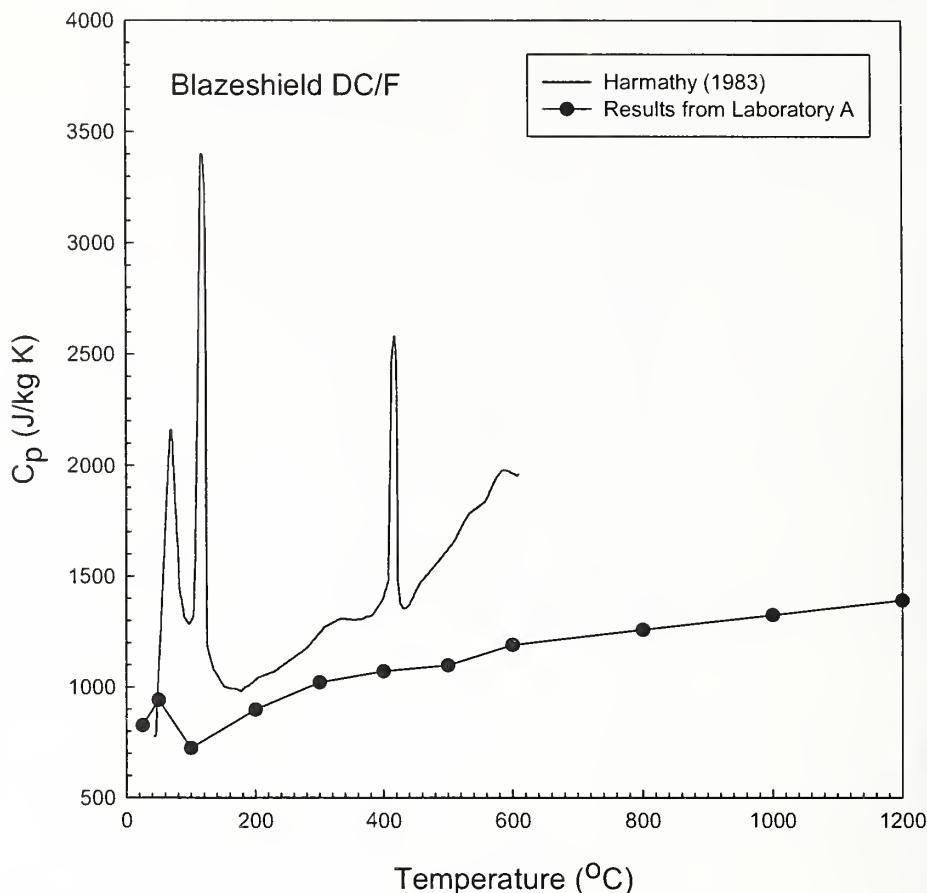
Figure 6-5. Comparison of BLAZE-SHIELD DC/F specific heat capacity measurements from Harmathy (1983) with present results from Laboratory A.

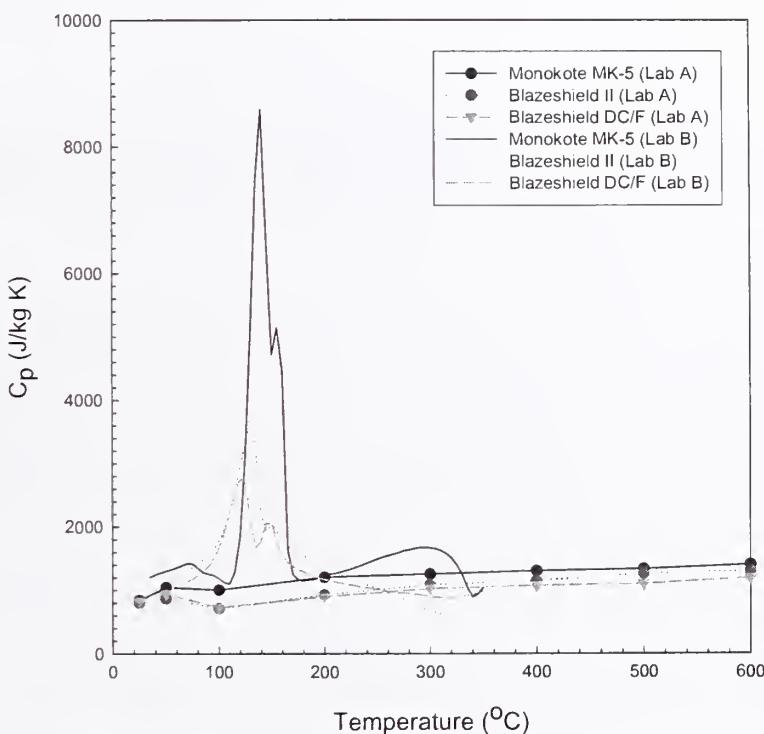
Figure 6-6. Comparison of specific heat capacity measurements from Laboratory B with results from Laboratory A.

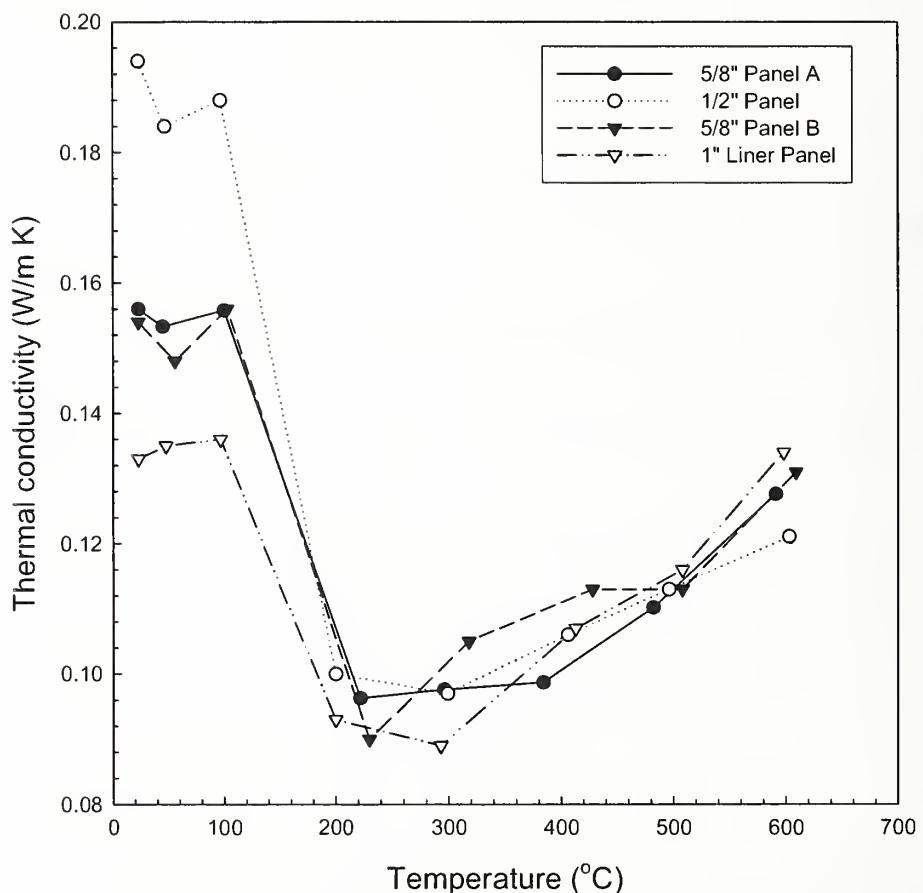
**Figure 6–9. Thermal conductivities of the four gypsum materials as a function of temperature.**

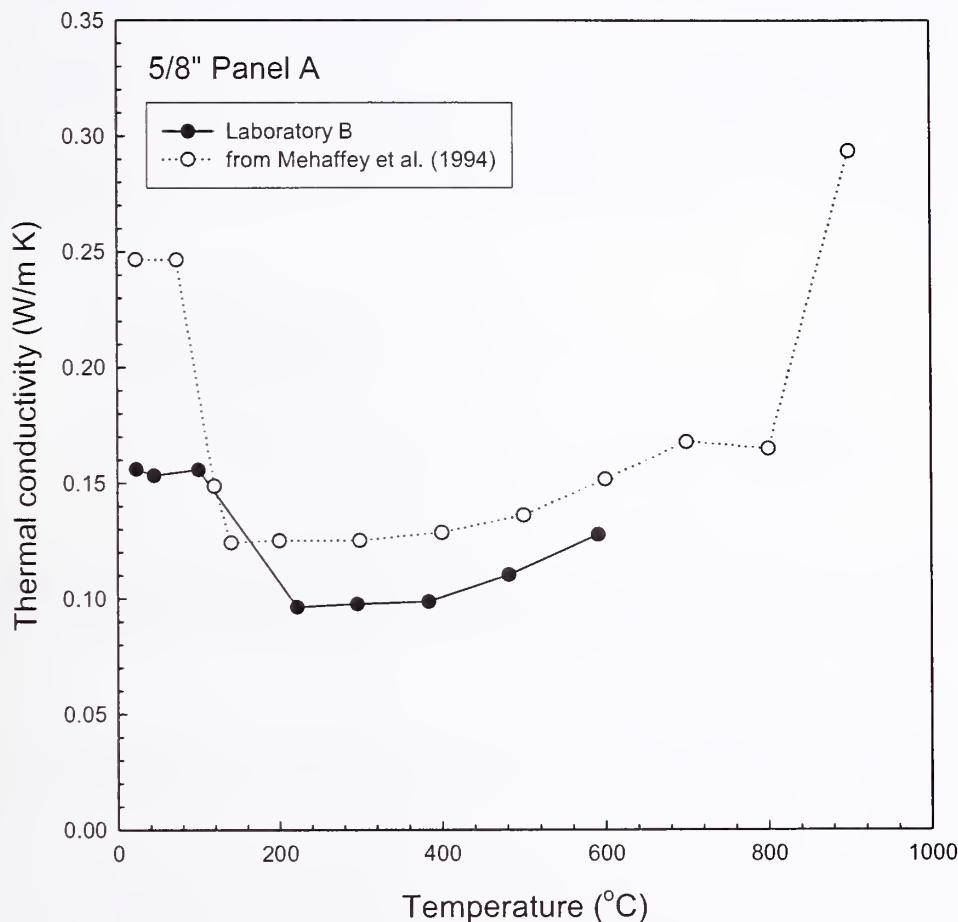
Figure 6-10. Comparison of the thermal conductivity measurements from Laboratory B with the data from Mehaffey et al. (1994) for 5/8 in. thick gypsum panel A.

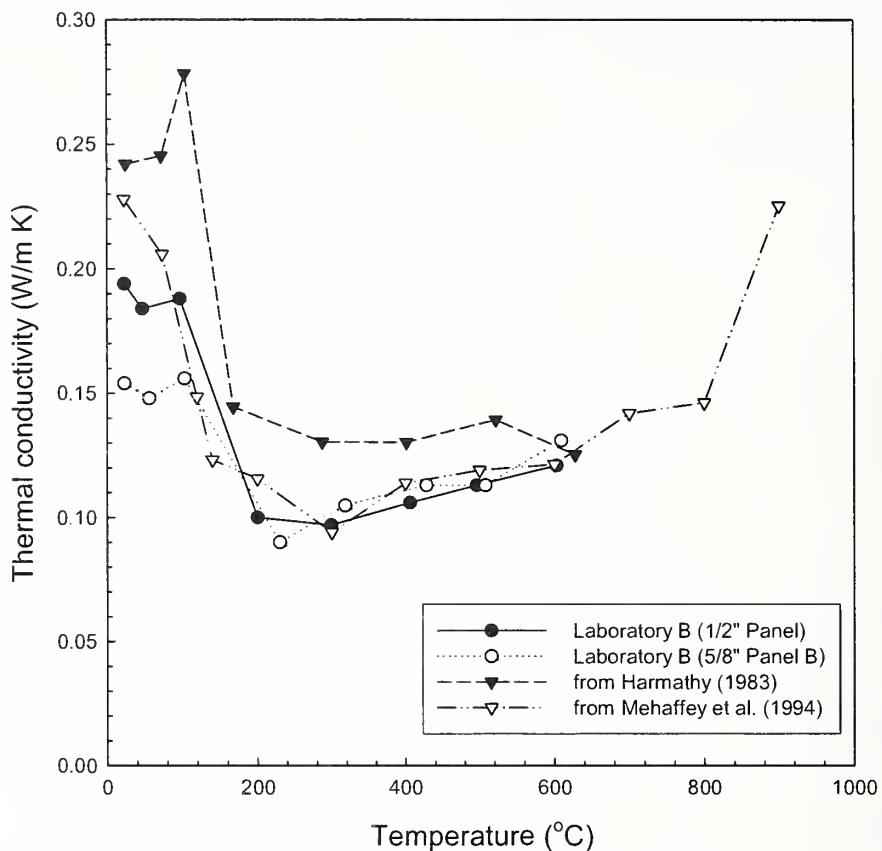
Figure 6-11. Comparison of thermal conductivity measurements from Laboratory B with other literature values for ½ in. thick gypsum panel and 5/8 in. thick gypsum panel B.

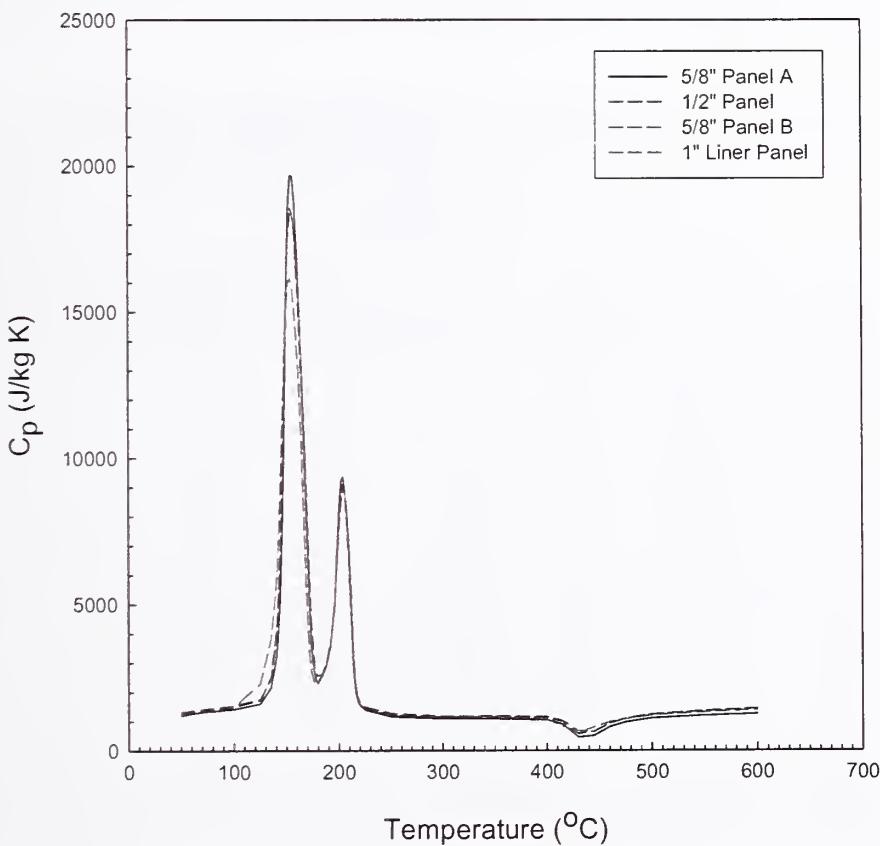
Figure 6-12. Comparison of specific heat capacities for the four gypsum materials.

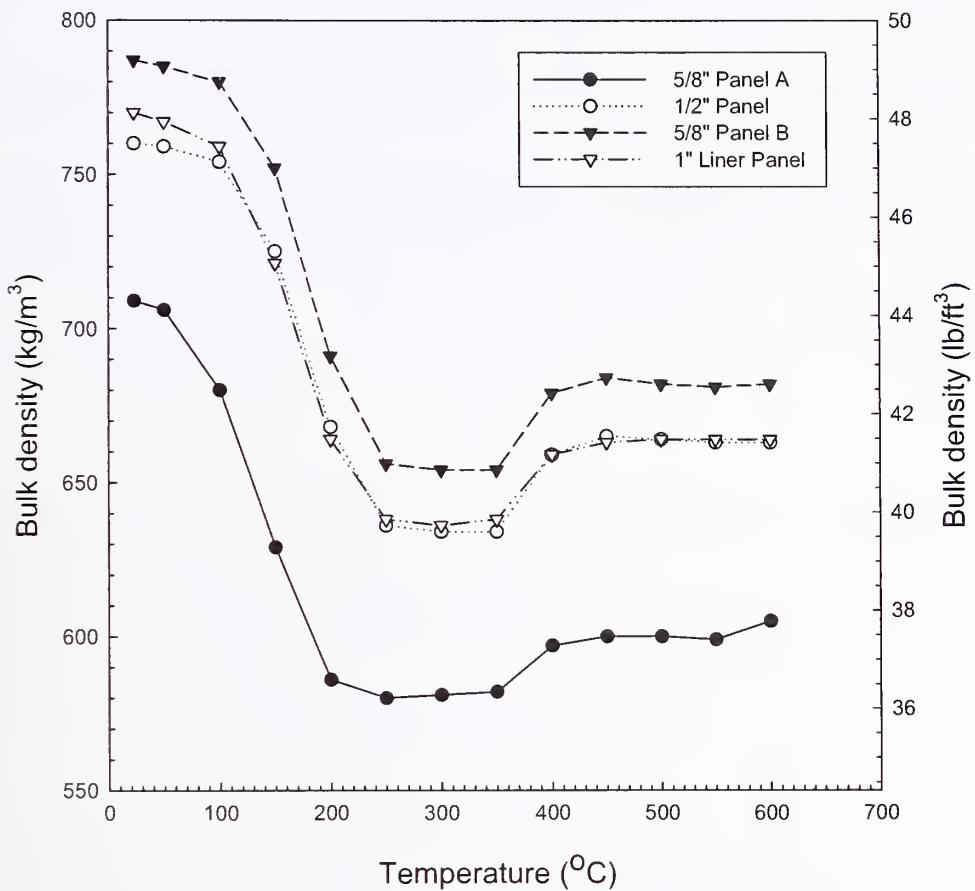
Figure 6–13. Bulk densities of the four gypsum materials as a function of temperature.

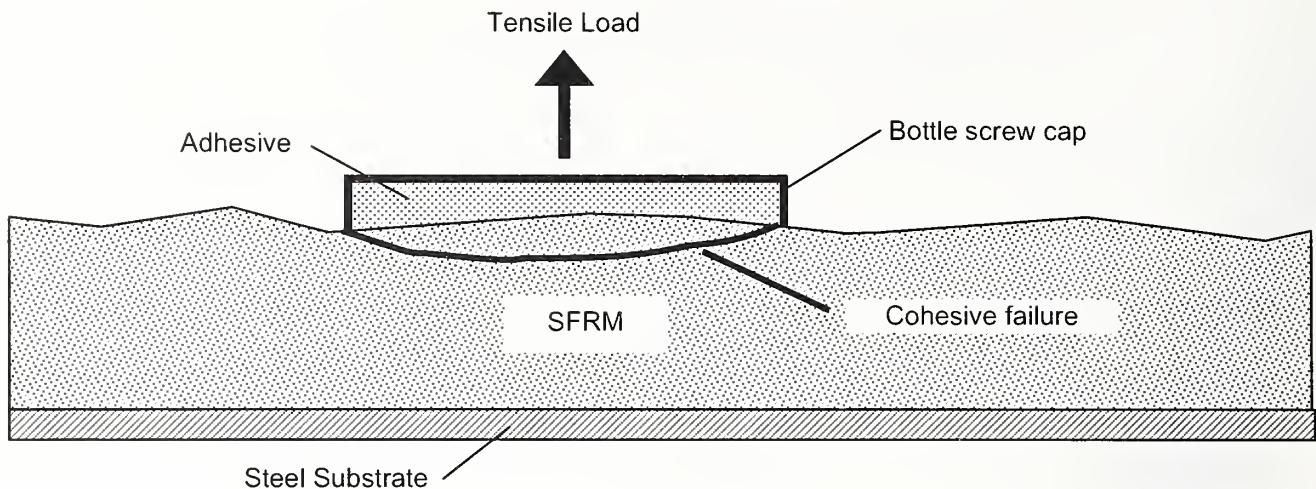
Figure 7–1. Bond strength test using screw cap in accordance with ASTM E 736.

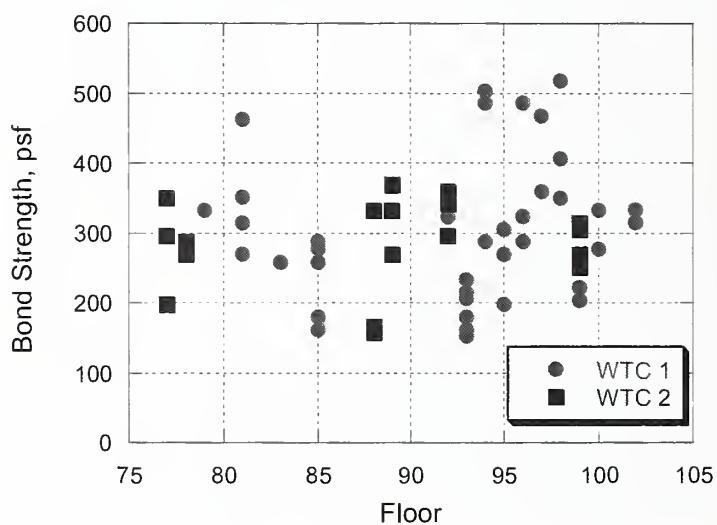
Figure 7–4. In-place bond strength of BLAZE-SHIELD Type II using ASTM E 736 from Port Authority test reports during the period 1997-1999.

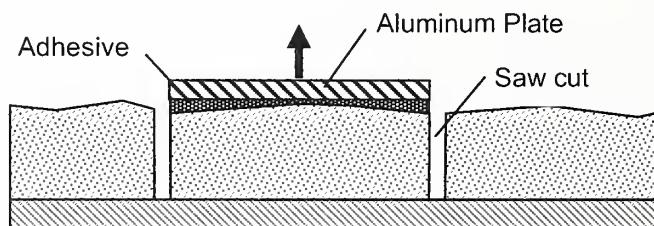
Figure 7–6. Schematic of “pull-off” test method used to measure cohesive and adhesive strengths.

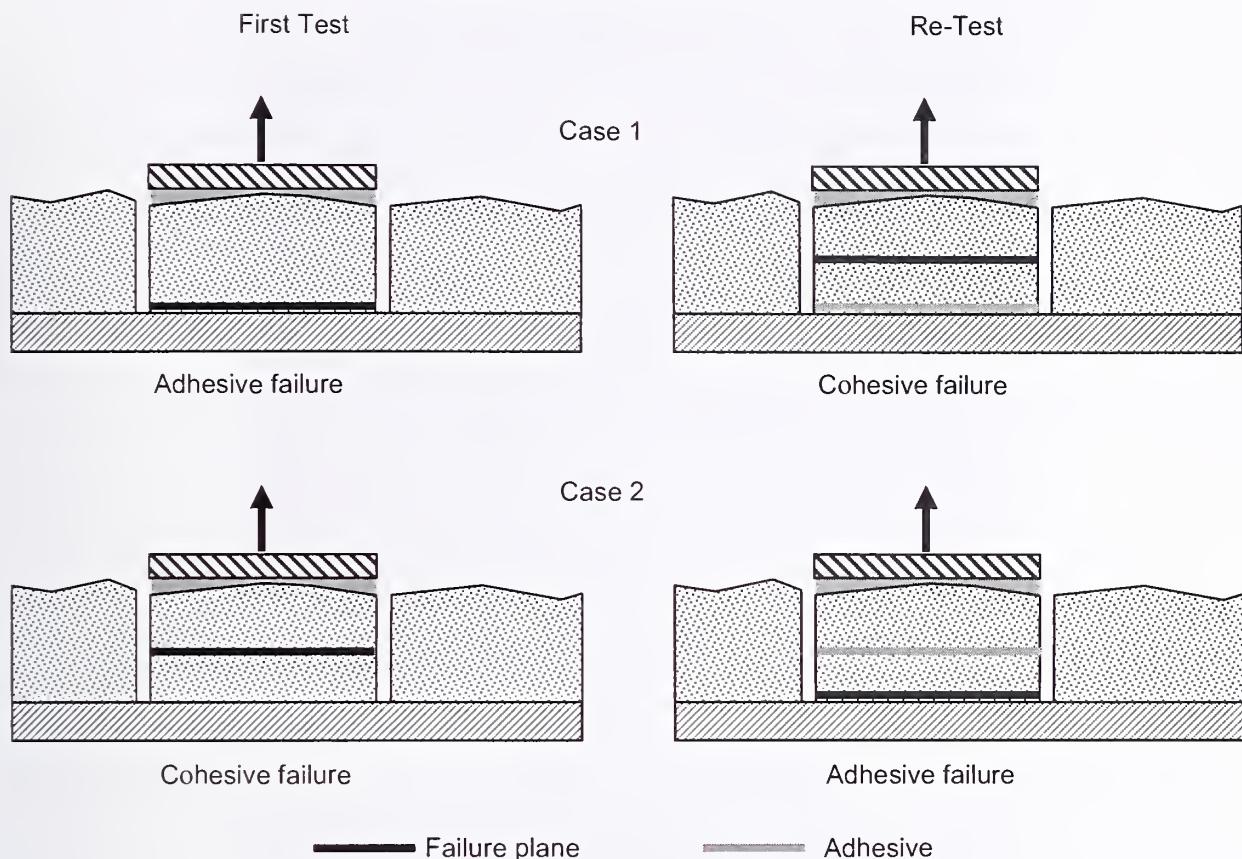
Figure 7-7. Technique used to measure both “adhesive” and “cohesive” strength in the same specimen.

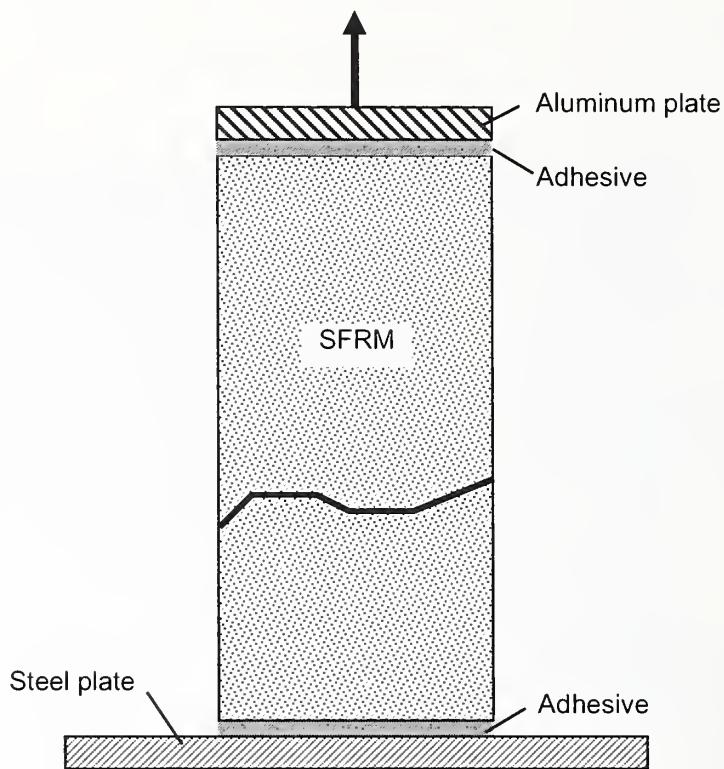
Figure 7–8. Method to measure cohesive strength parallel to SFRM surface (in-plane cohesive strength).

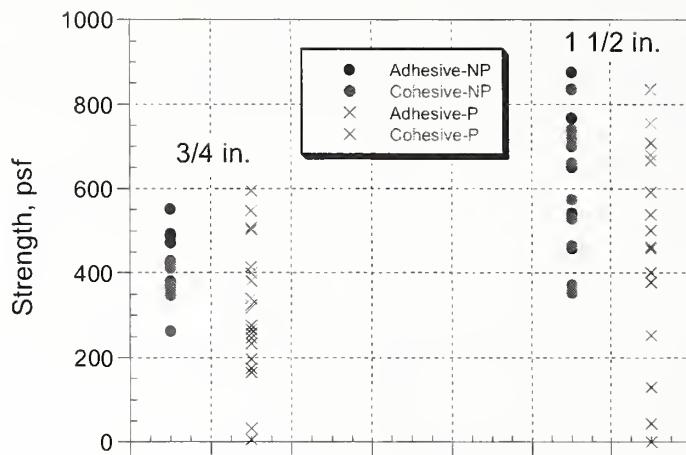
Figure 7-27. Comparison of adhesive strength with cohesive strength normal to surface (P = primed steel, NP = bare steel).

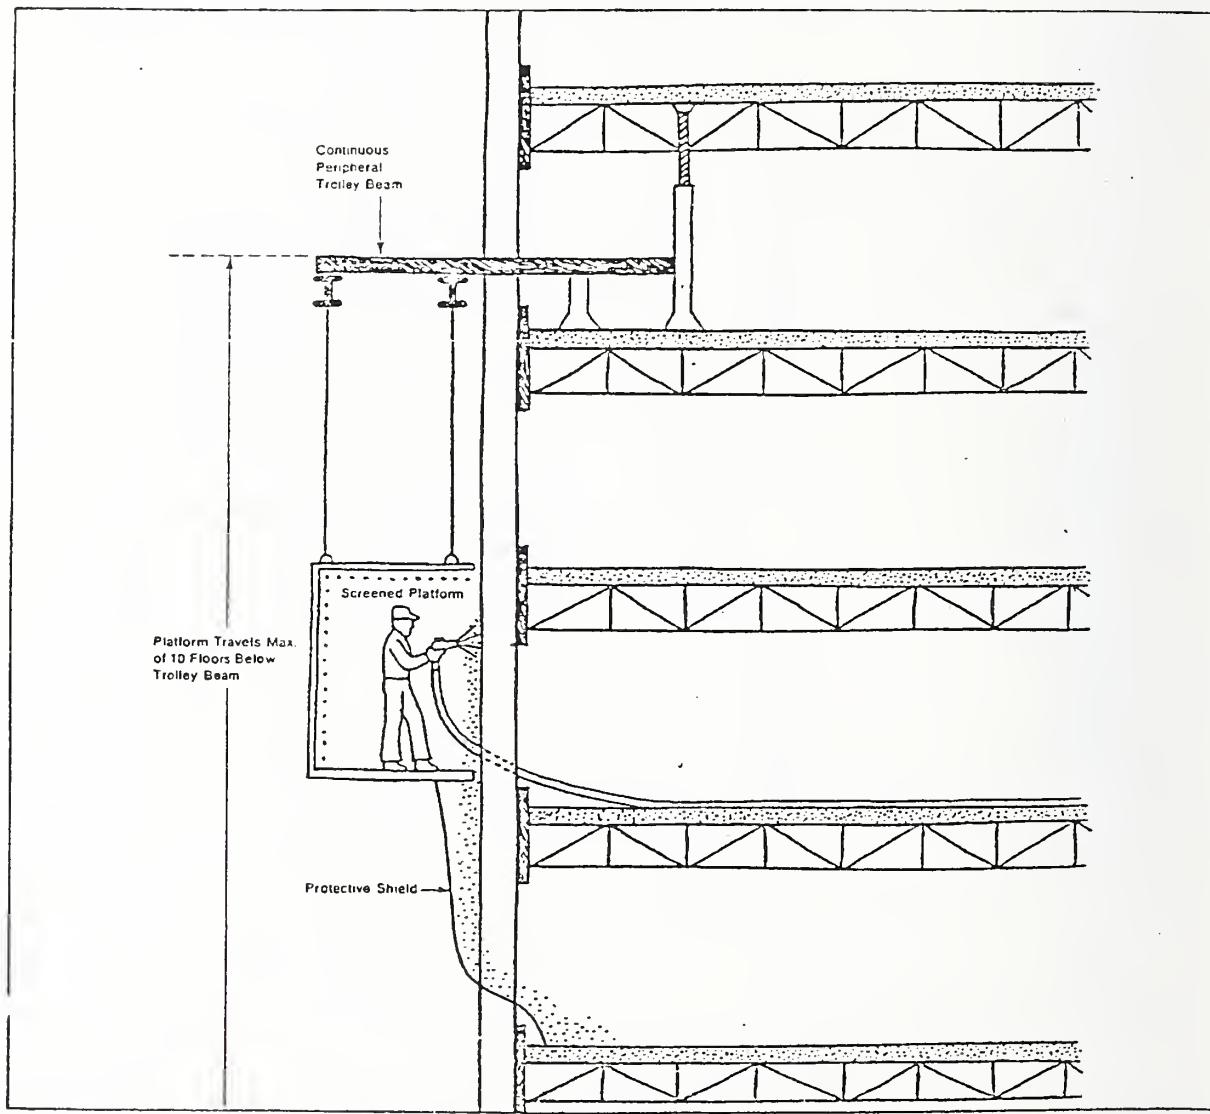
Sketch illustration of spraying of fireproofing from enclosed cage and screen

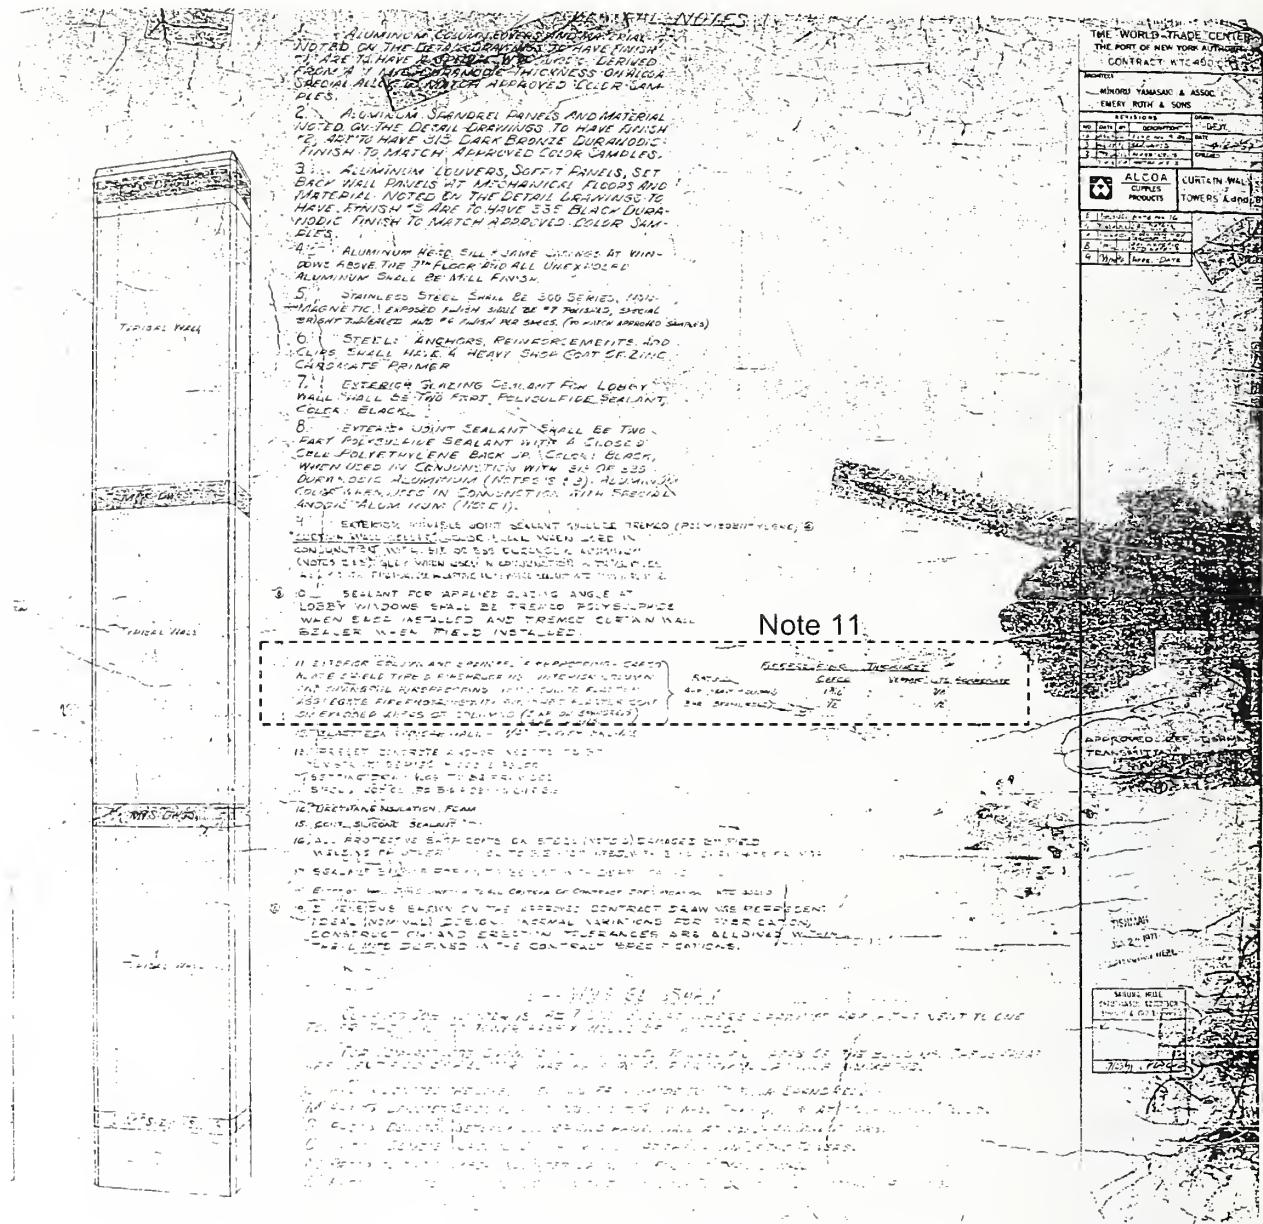
Figure A-25. Portion of “General Notes” page of the Alcoa curtain wall drawings and blow-up of Note 11 indicating the thermal insulation thickness for the exterior columns and spandrels (116-LERA).

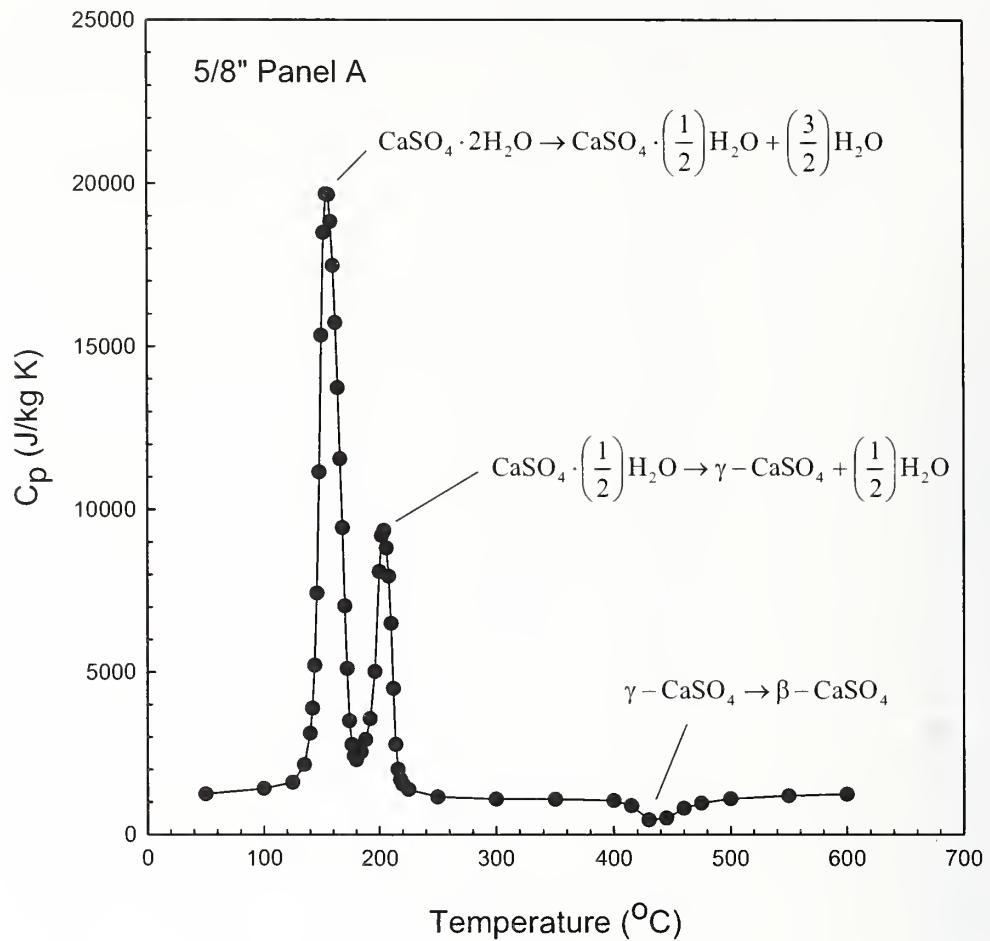
Figure B-1. Specific heat capacity of 5/8 in. gypsum panel A.

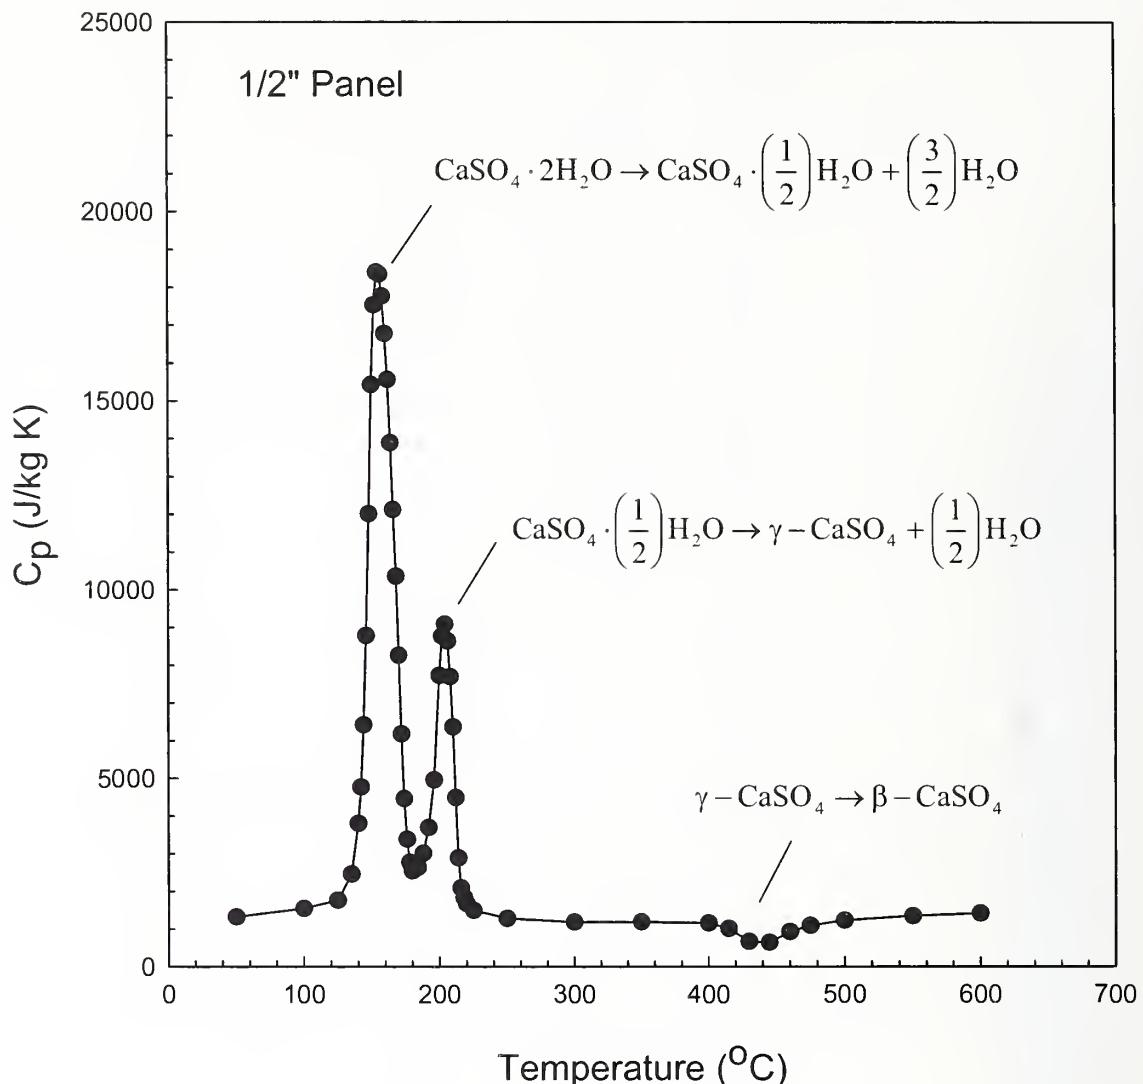
Figure B-2. Specific heat capacity of 1/2 in. gypsum panel.

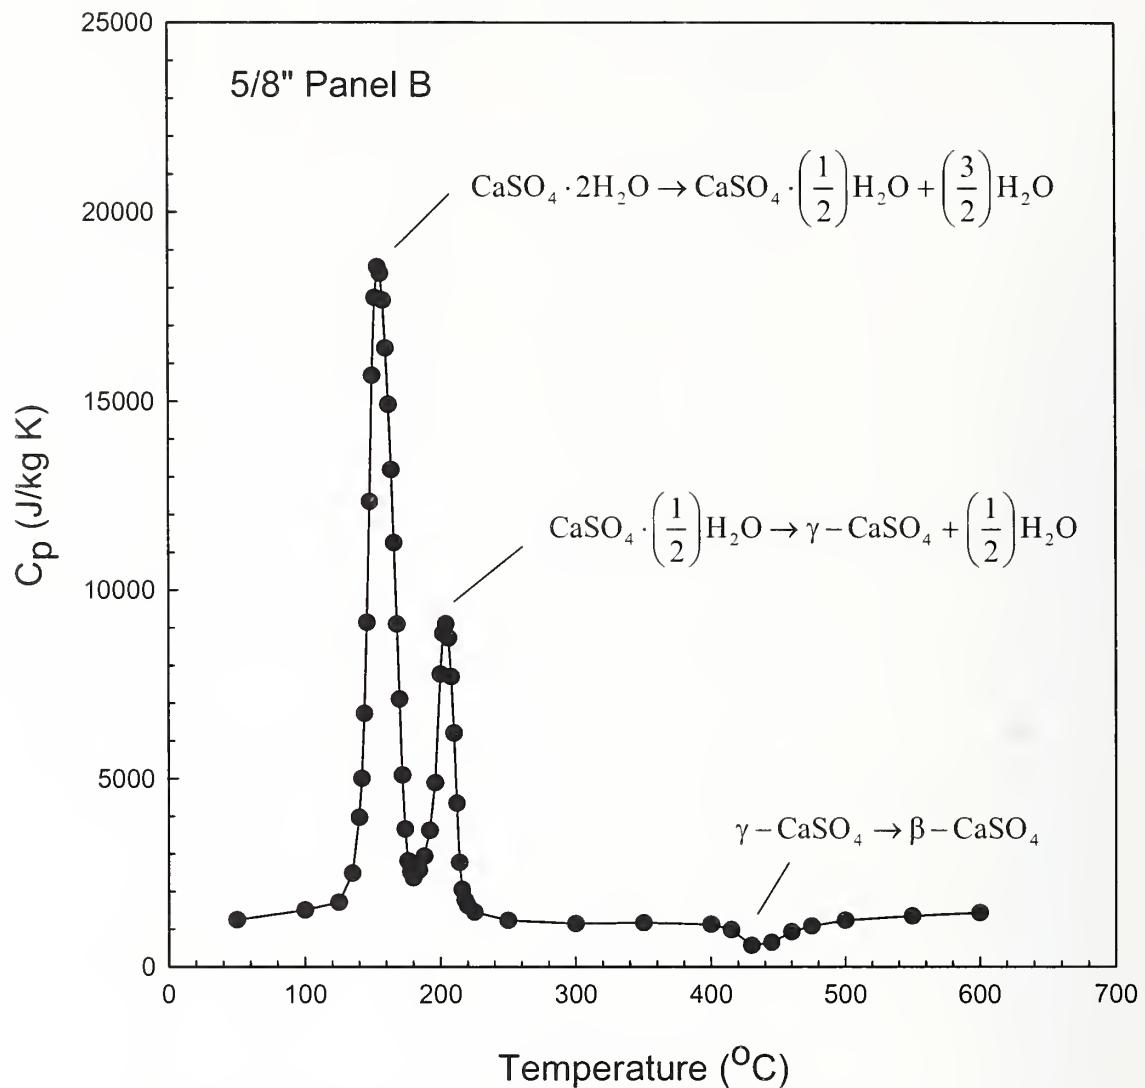
Figure B-3. Specific heat capacity of 5/8 in. gypsum panel B.

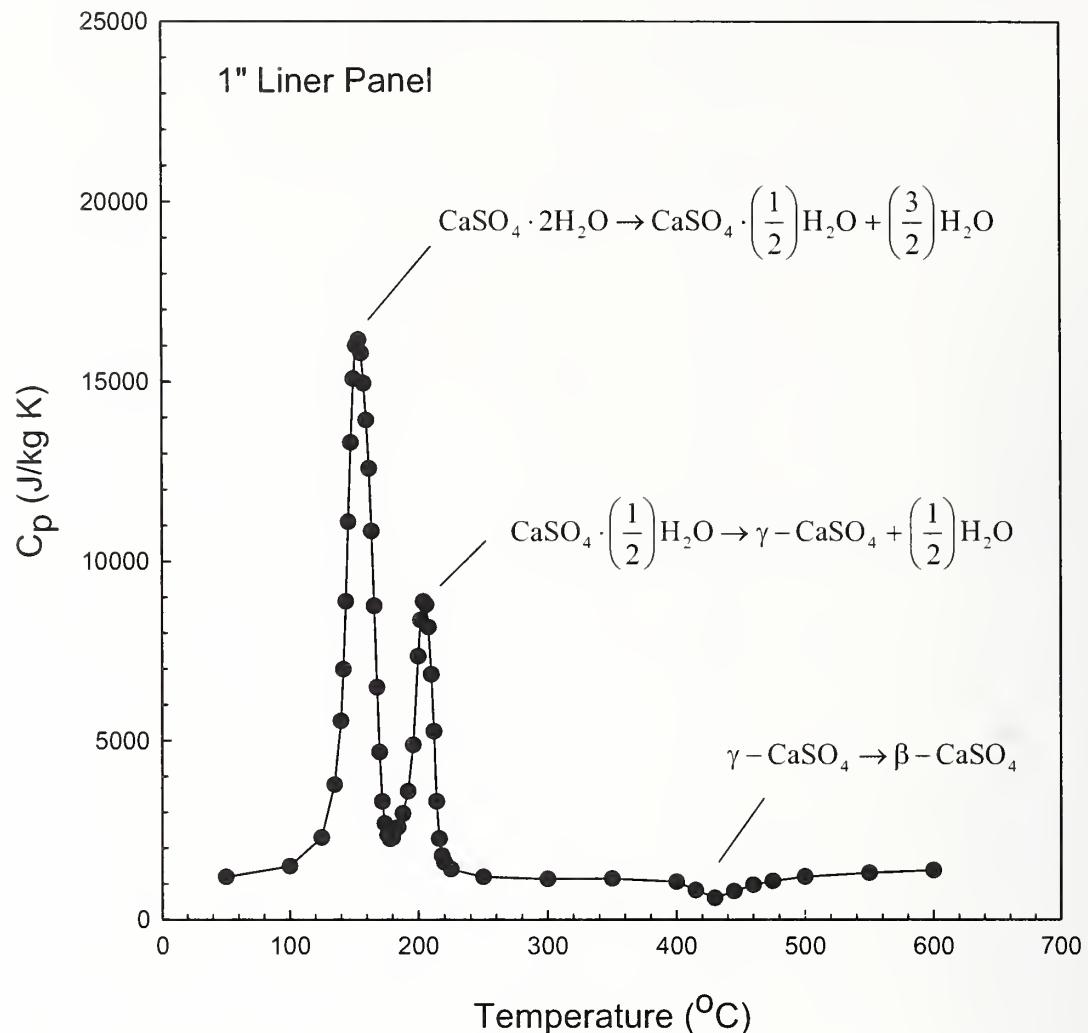
Figure B-4. Specific heat capacity of gypsum 1 in. liner panel.

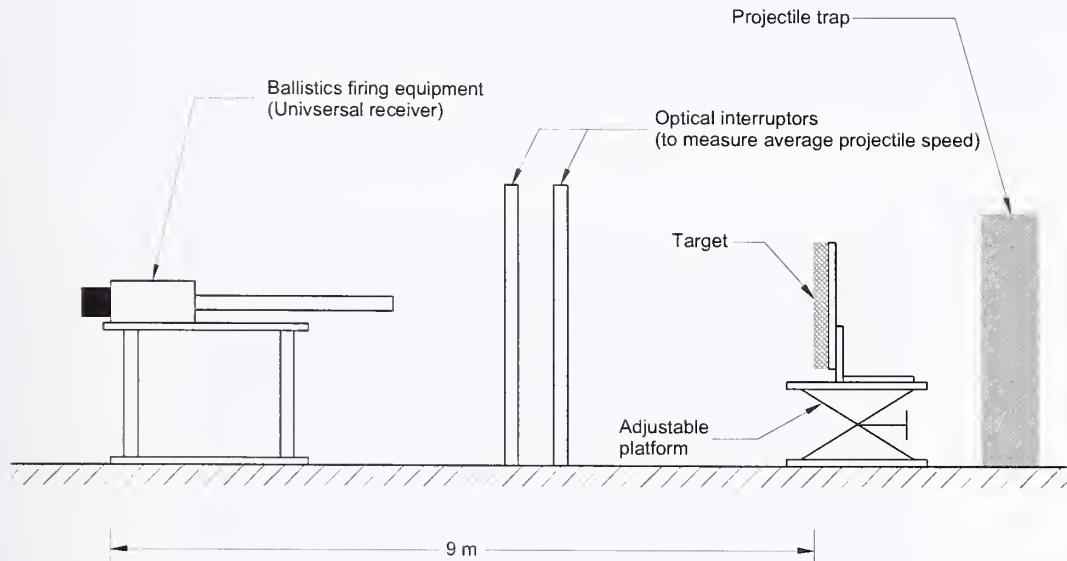
Figure C-1. Schematic of the ballistic research test facility.

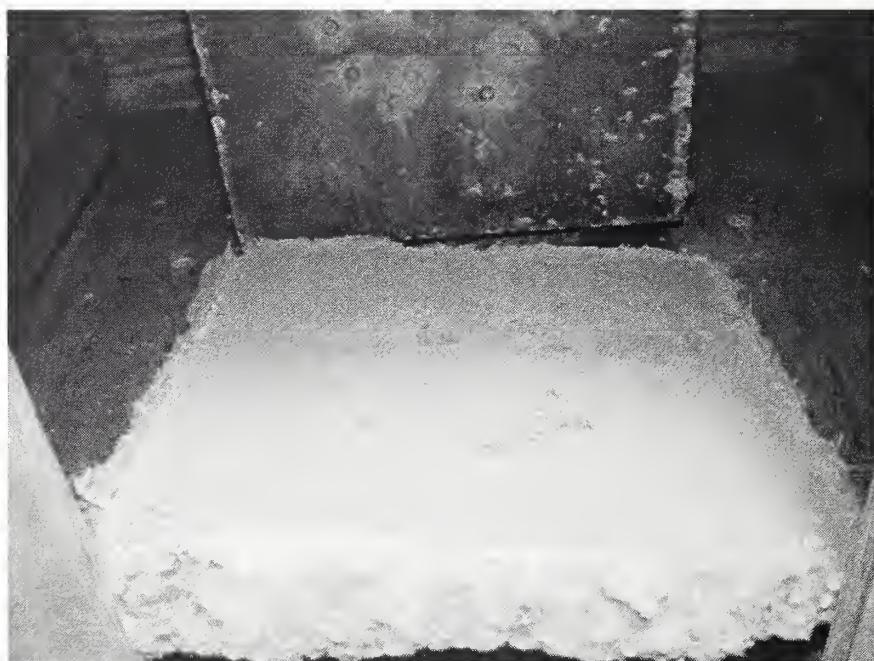
Figure C-4. Photograph showing damage to the SFRM after a ballistic impact at 0 degree. The SFRM layer completely separated from the steel plate.

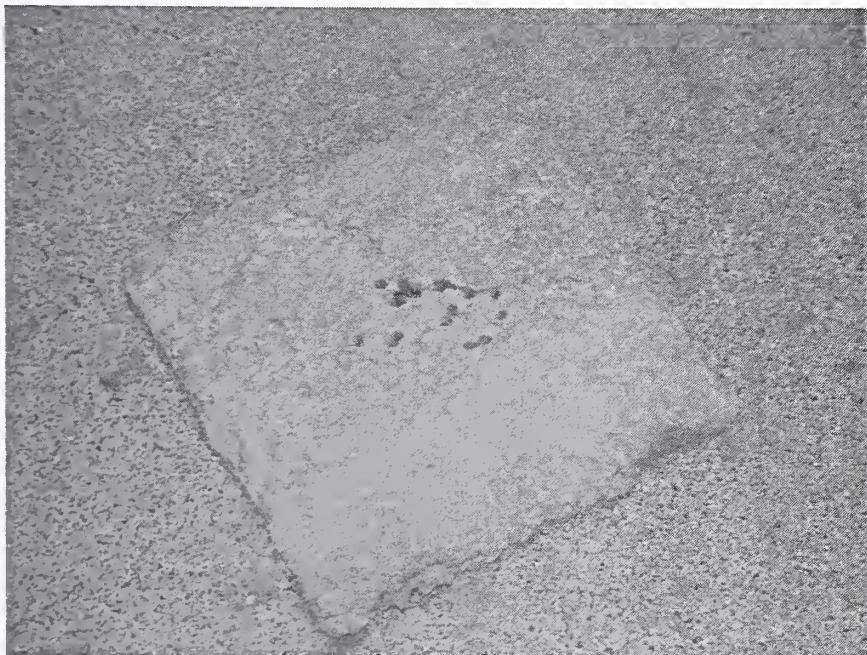
Figure C-5. Photograph showing damage to the SFRM after a ballistic impact at 20 degree. The SFRM layer completely separated from the steel plate and landed on the floor.

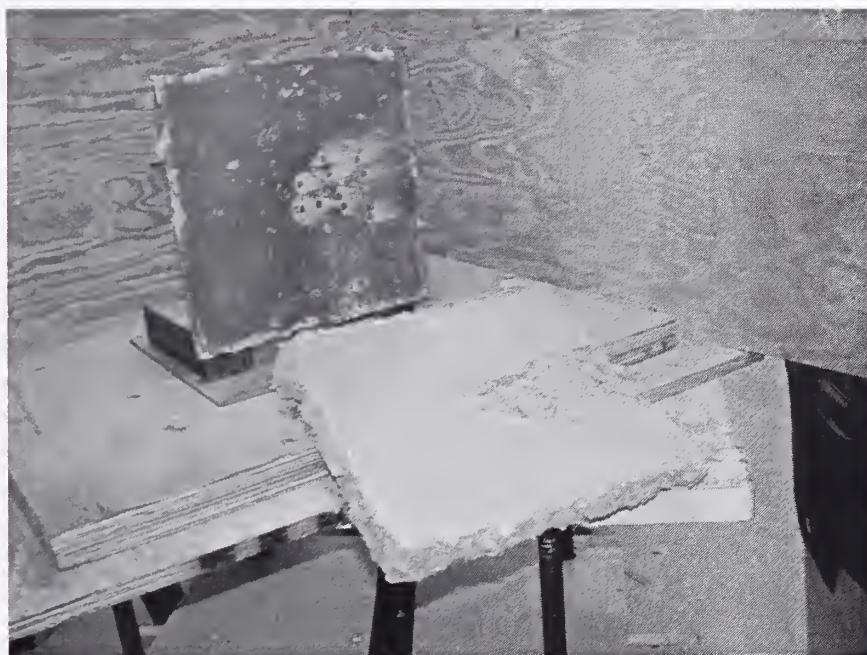
Figure C-6. Photograph showing damage to the SFRM after a ballistic impact at 40 degree. The SFRM layer completely separated from the steel plate.

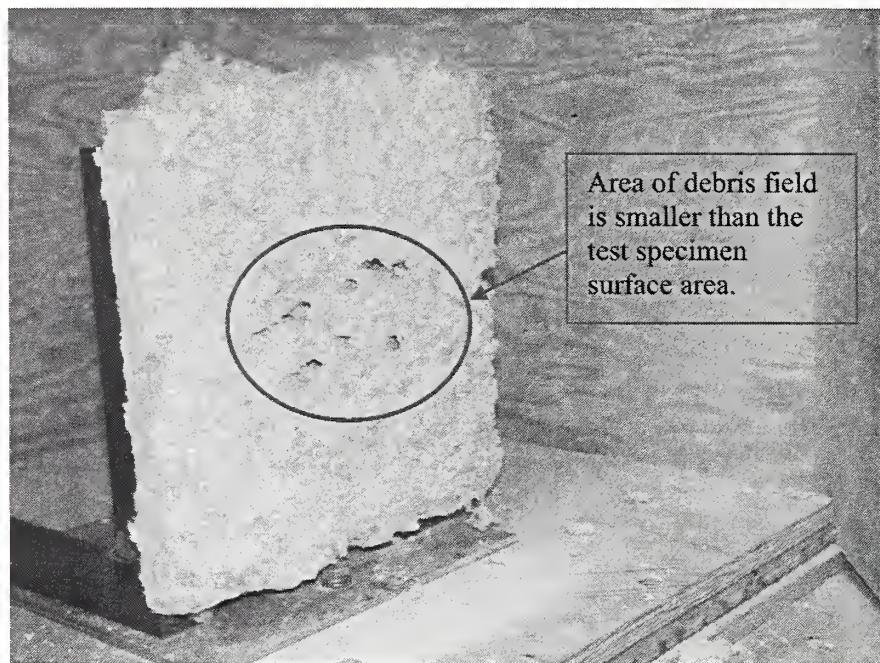
Figure C-7. Photograph showing damage to the SFRM after a ballistic impact at 60 degree. The SFRM layer did not separate from the steel plate.

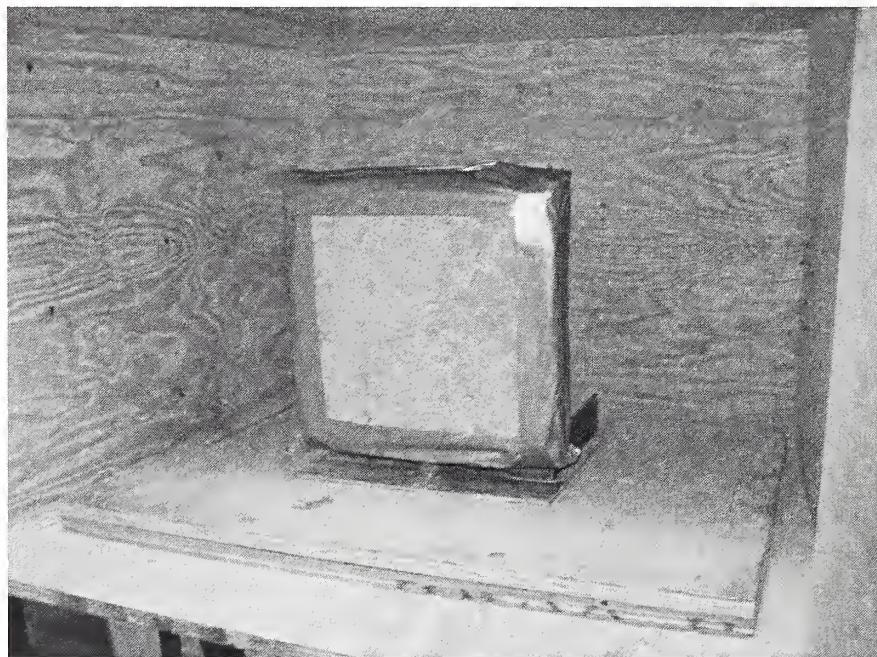
Figure C-8. Photograph showing the edges of the SFRM duct taped to the steel plate before the ballistic tests at 0 degree.

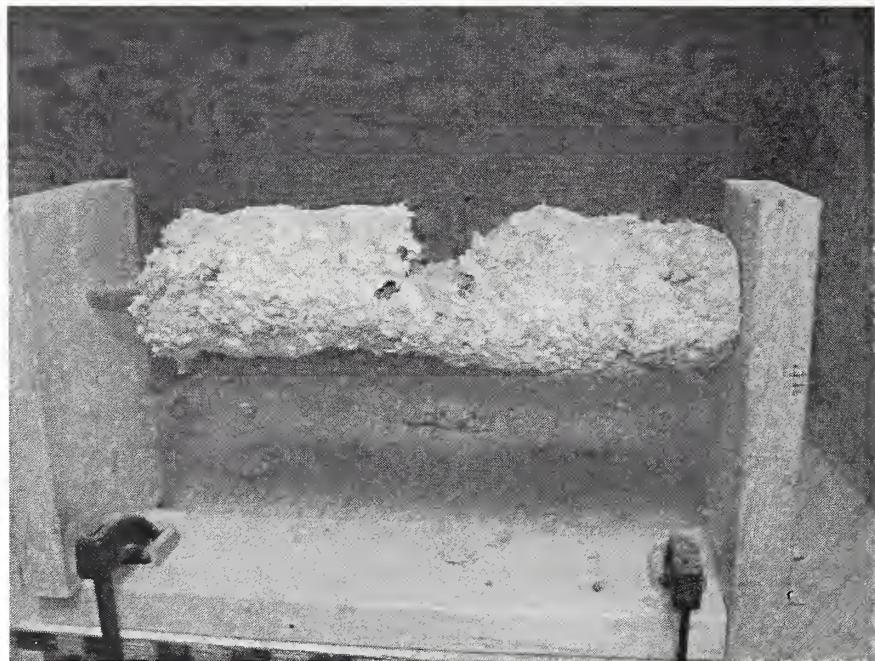
Figure C-9. Photograph showing damage to the SFRM on an unprimed steel bar (BAR01) after a ballistic impact at 0 degree using the small universal receiver.
