**Federal Building and Fire Safety Investigation of the
World Trade Center Disaster**

Passive Fire Protection

Federal Building and Fire Safety Investigation of the World Trade Center Disaster

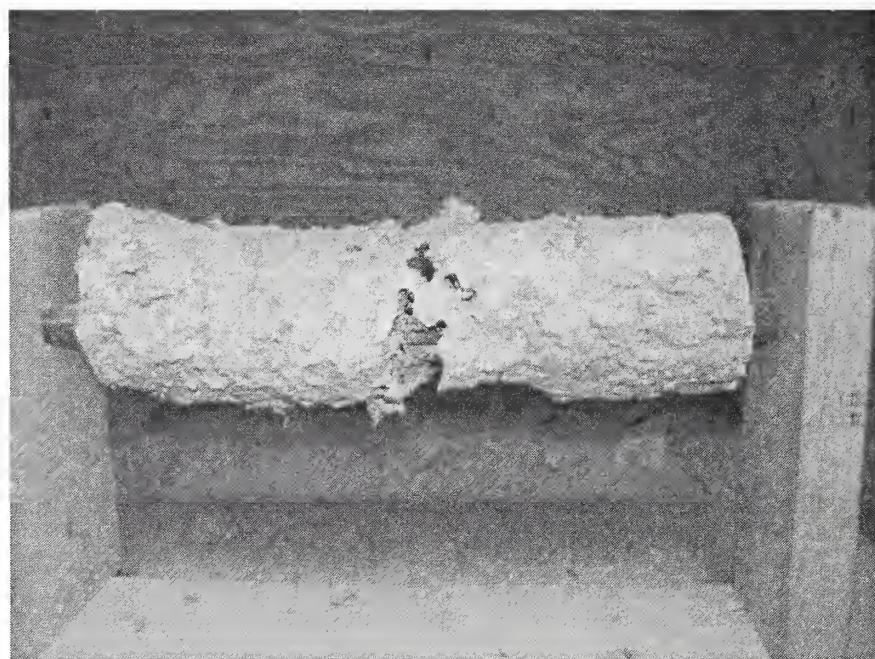
Figure C-10. Photograph showing damage to the SFRM on a primed steel bar (BAR02) after a ballistic impact at 0 degree using the small universal receiver.

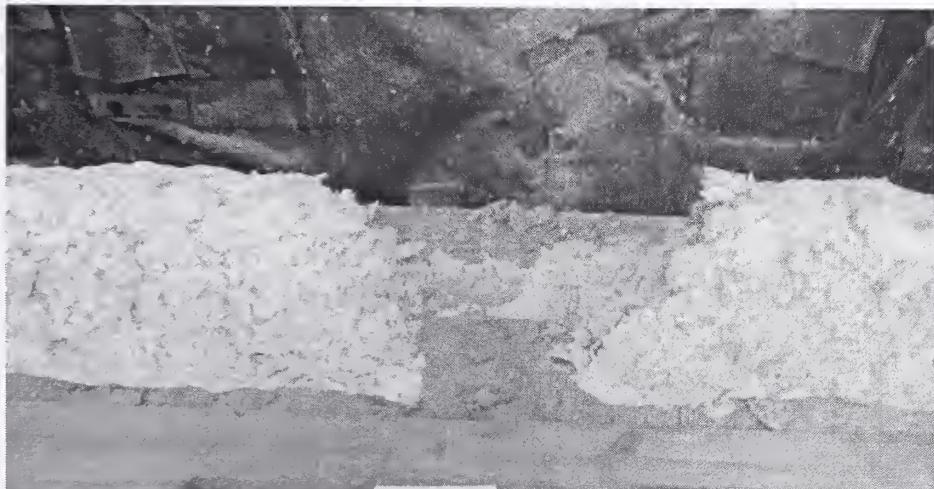
Figure C-11. Photograph showing damage to the SFRM on unprimed steel bar (BAR04) after a debris impact at 0 degree using the large universal receiver.

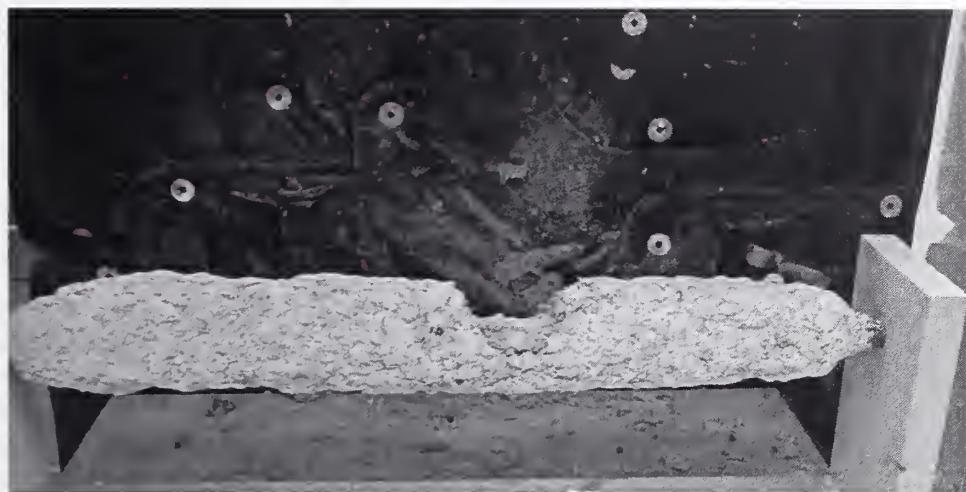
Figure C-12. Photograph showing damage to the SFRM on unprimed steel bar (BAR05) after a debris impact at 0 degree using the large universal receiver.
