Black Hawk Helicopter Vibration Analysis Due to Main Rotor Damage, Directional Constituents of the Resultant Vibrations

ARL-TR-2442

March 2001

Survivability/Lethality Analysis Directorate, ARL

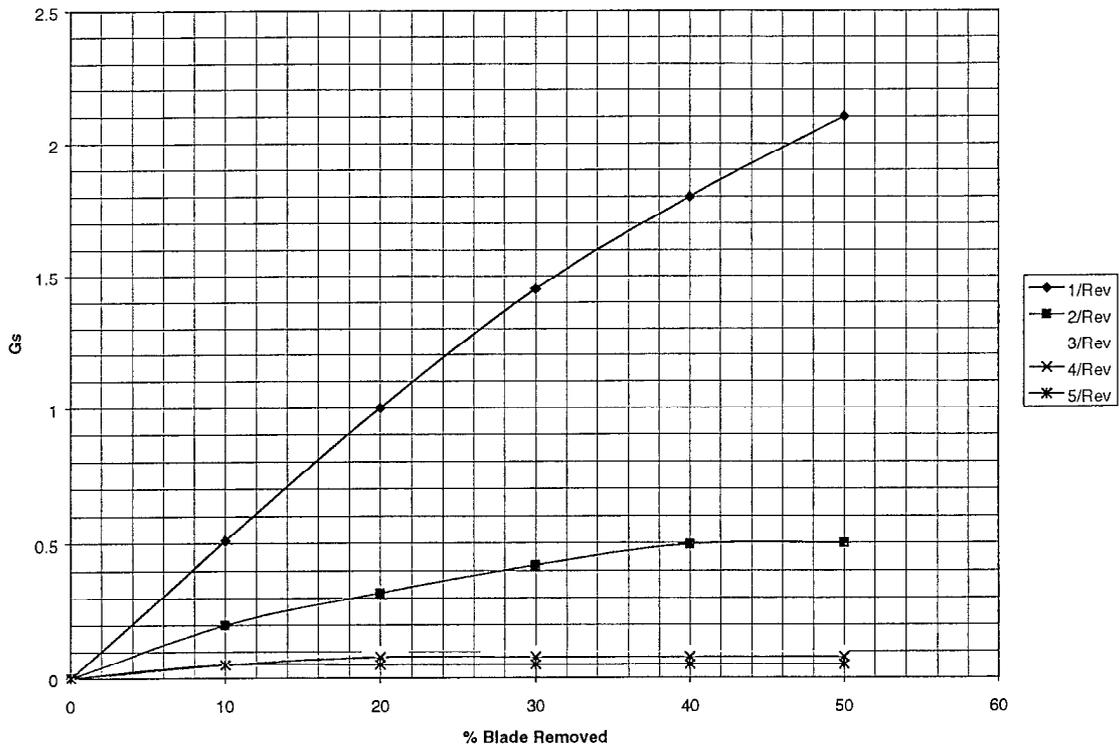
First, the resultant vibrations are shown in Figure 1 as G 's (gravitational pull) vs. percent of the removal of the outer blade section.

Figure 1. Cockpit resultant vibrations G's vs. percent of blade removed.

There is a predominate 1/Rev frequency getting through to the cockpit that ordinarily would be filtered out for undamaged blades of the set of four, and there is also a significant 2/Rev. The higher frequencies have low amplitudes, and it should be noted that the 4/Rev would be the only frequency transmitted if no damage were present.

From Figure 1, it was found that the 1/Rev is the biggest resultant vibration, and the makeup in Figure 2 shows that the vertical cosine component is the biggest constituent followed by the lateral sine. The longitudinal cosine and vertical sine follow next in absolute amplitude. In a normal undamaged rotor, none of these 1/Rev vibrations would occur for a 4-bladed rotor.

From Figure 1, it is seen that the dominant cockpit vibration comes from 1/Rev, which is the frequency of the main rotor (1×258 rpm) followed by the 2/Rev (2×258 rpm) in amplitude. As the frequency increases, the amplitude of vibration decreases as would be expected except if there is no resonance in the system. A separate study would be needed to determine how these vibrations might fatigue the structure of the aircraft or affect a pilot's ability to fly the aircraft.

Figure 1 shows the cockpit vibration to be above 2 G's for the high-speed condition with half of one blade's outer portion lost. Further performance analysis would be needed to determine the helicopter's residual capability to survive or the pilot's capability to perform. Helicopter first principles can be found in works by Chopra [2], McCormick [3], and Saunders [4].

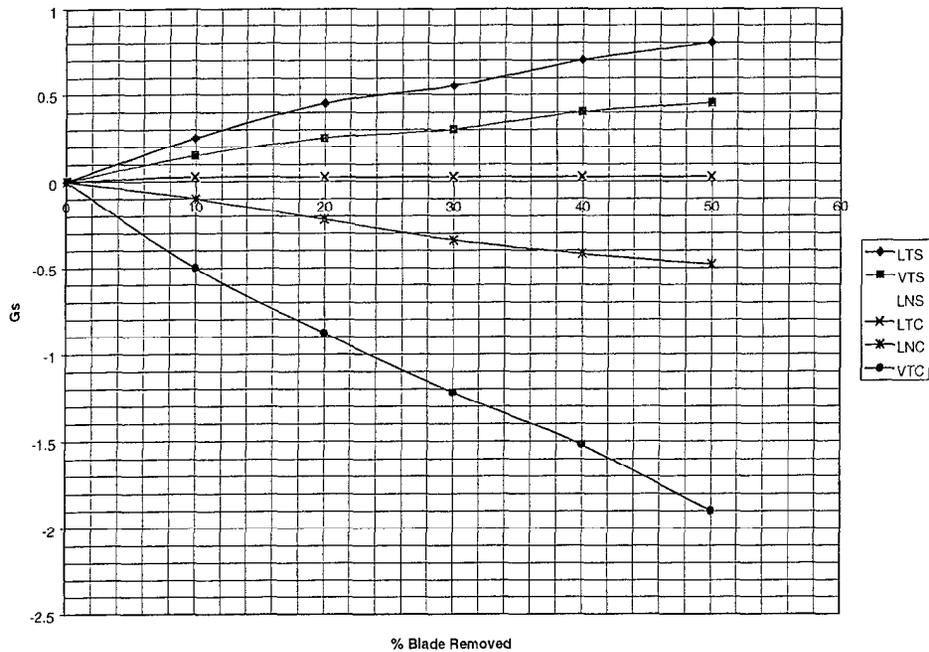
Next, the individual harmonics are viewed one at a time, and the directional cosine and sine components are distinguished. In Figure 2, the legend is defined as follows:

- LNC = Longitudinal Cosine Vibration
- LNS = Longitudinal Sine Vibration
- LTC = Lateral Cosine Vibration
- LTS = Lateral Sine Vibration
- VTC = Vertical Cosine Vibration
- VTS = Vertical Sine Vibration

Figure 2. 1/Rev cockpit constituent vibrations G's vs. percent of blade removed.

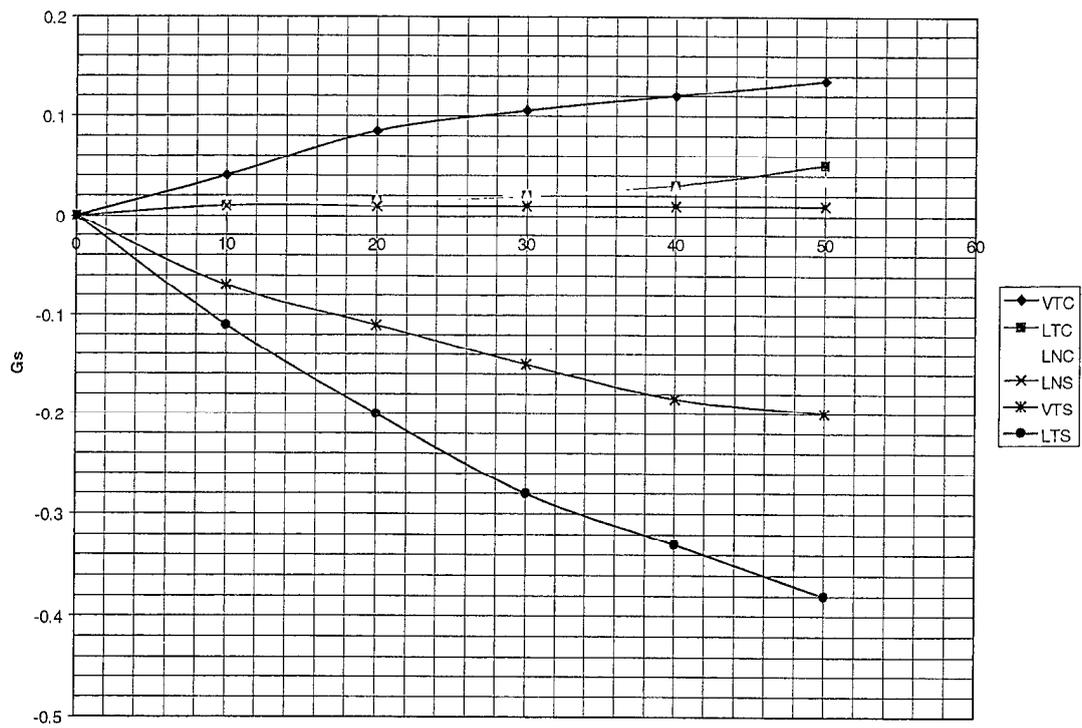
Next in order are the 2/Rev vibrations illustrated in Figure 3. In a normal undamaged rotor, none of these 2/Rev vibrations would occur for a 4-bladed rotor.

Figure 3. 2/Rev cockpit constituent vibrations G's vs. percent of blade removed.

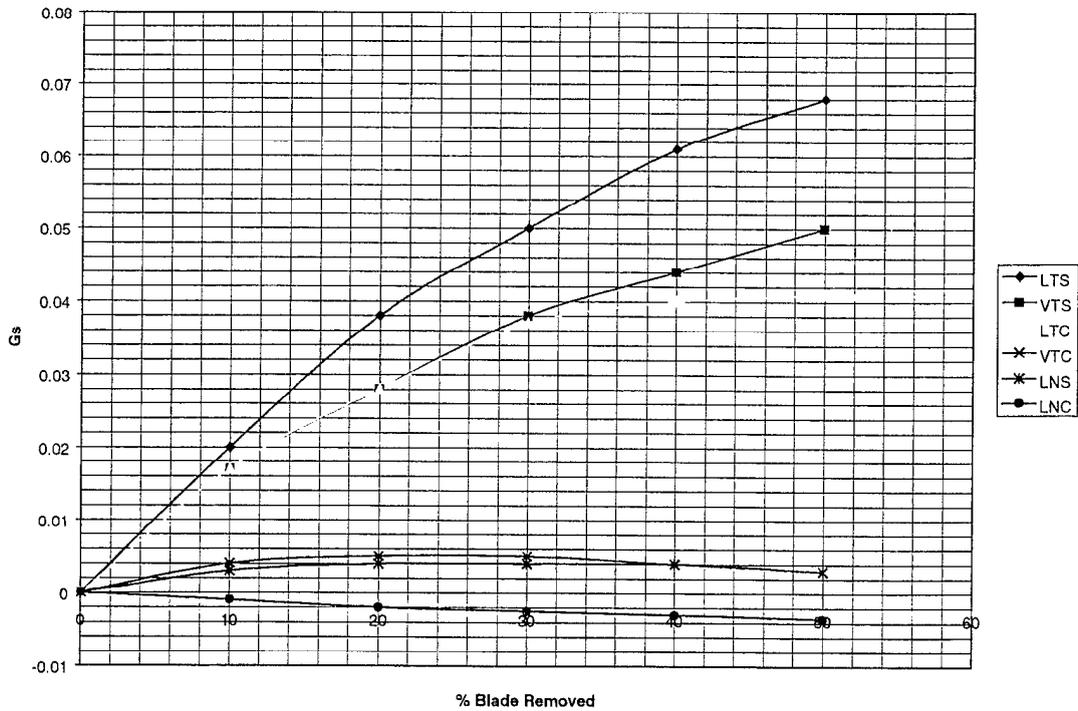
Next are the 3/Rev vibrations illustrated in Figure 4. In a normal undamaged rotor, none of these 3/Rev vibrations would occur for a 4-bladed rotor.

Figure 4. 3/Rev cockpit constituent vibrations G's vs. percent of blade removed.

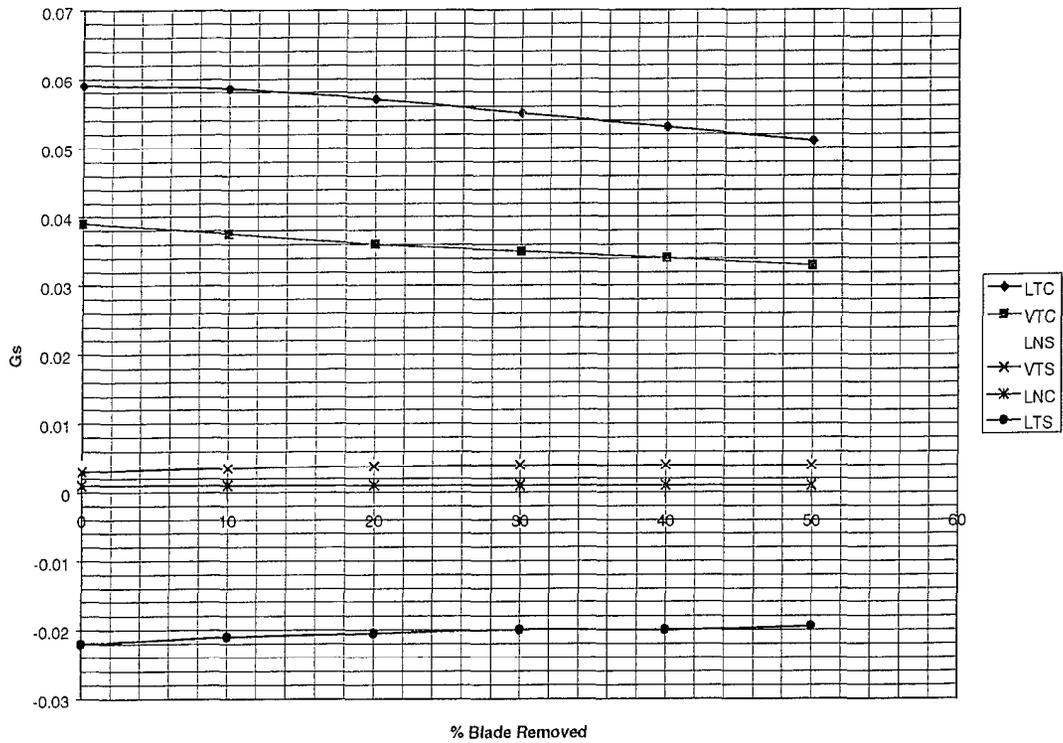
The 4/Rev vibrations are illustrated in Figure 5. Notice that the vibrations for the undamaged blade (at 0% blade removed) are not zero. This is significant and points to the fact that 4/Rev is an integer number of the blades in the rotor and is not filtered out; it is an inherent vibration that always exists. Also notice that the amplitudes of these inherent vibrations are relatively low compared to the 1/Rev that exists when a blade is damaged. These are inherent 4/Rev vibrations that are always present in the cockpit for a 4-bladed rotor.

Figure 5. 4/Rev cockpit constituent vibrations G's vs. percent of blade removed.

As the damage of one blade of the rotor set increases by increasingly more of the outer blade being removed, the vibrations get worse as would be expected. All of the vibrations except the 4/Rev go through the origin of the charts because, in the undamaged state, the frequencies are filtered out and are not transmitted to the fuselage. This is the natural state of the helicopter. The only natural inherent vibration of an undamaged helicopter are the 4/Revs.

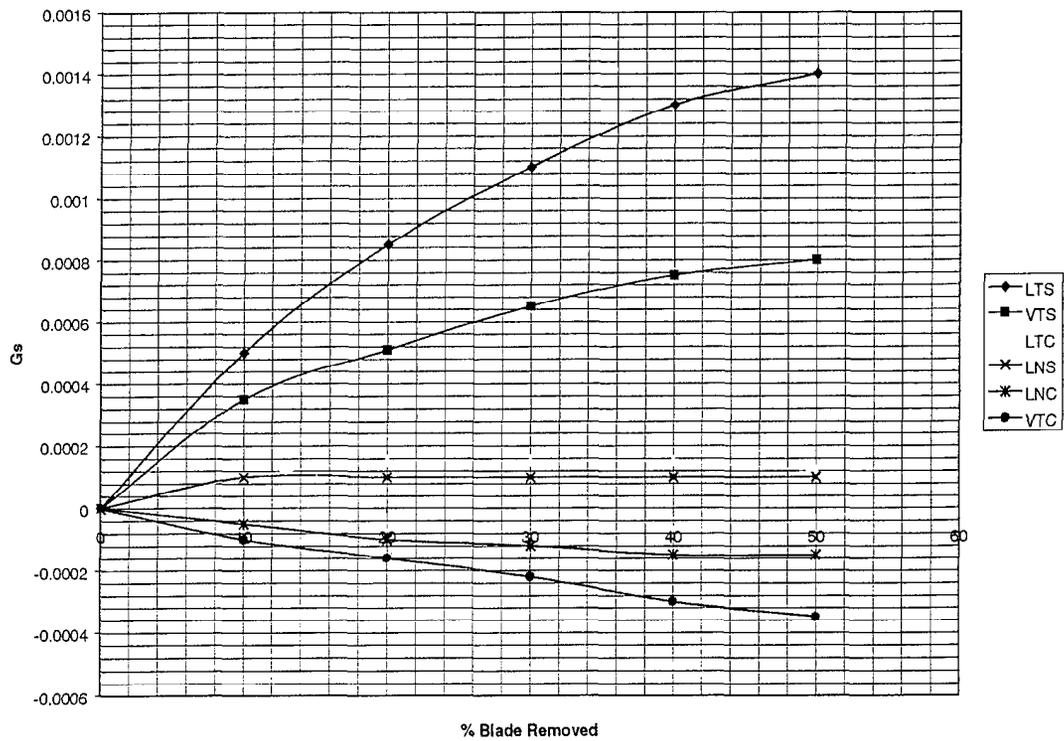
Finally, the 5/Rev vibrations are illustrated in Figure 6. The amplitudes are very small, which is as expected for the higher frequencies. Therefore, there is no need to continue to list the higher frequencies. None of these vibrations would occur for an undamaged 4-bladed rotor.

Figure 6. 5/Rev cockpit constituent vibrations G's vs. percent of blade removed.
