# Above the Flood: Elevating Your Floodprone House

FEMA 347/ May 2000

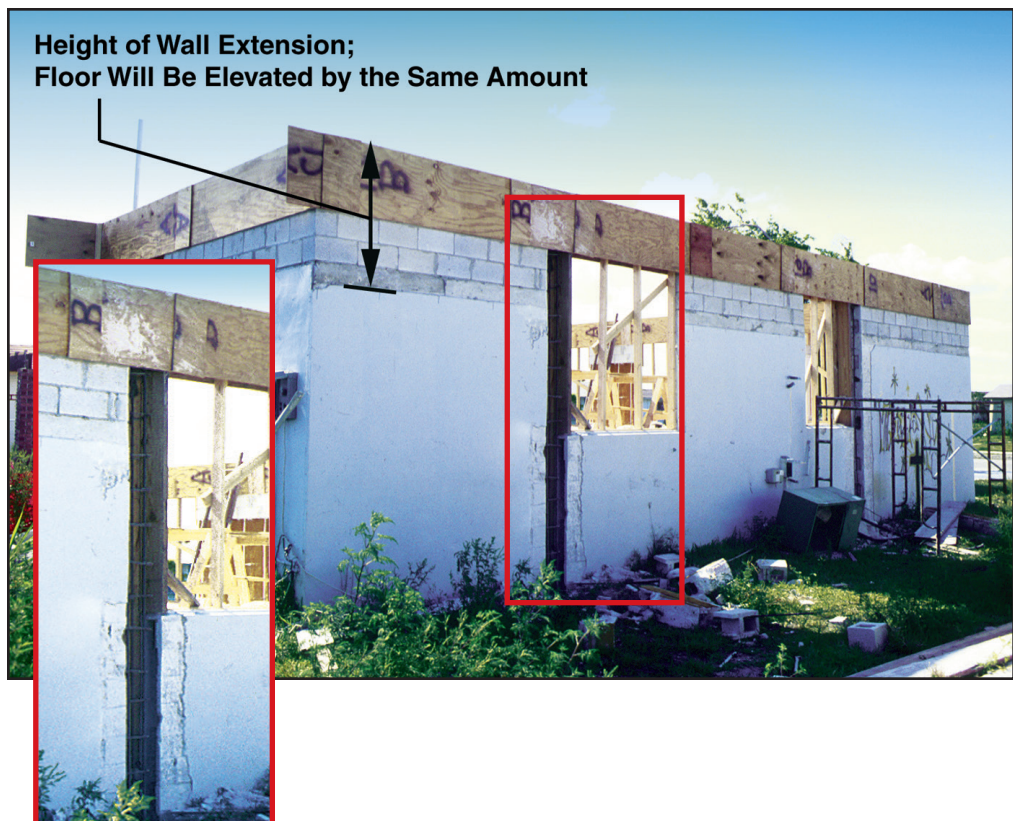
Another view of the extended walls. The vertical cuts in the walls next to the windows are for concrete tiedown columns that will be cast in place to further strengthen the extended walls against wind loads. The owner of this house was able to meet the elevation requirement by raising the floor only a few feet, as indicated by the amount that the walls have been extended.

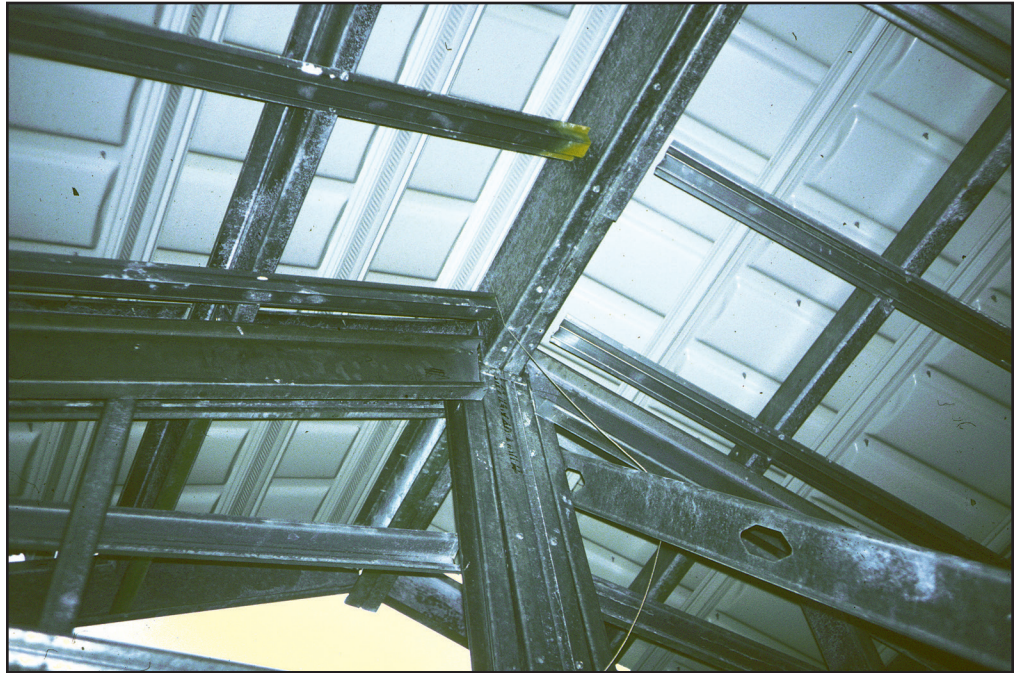
One advantage of metal framing is its relatively light weight. An additional advantage is that the screws used to attach metal-frame components provide strong connections.

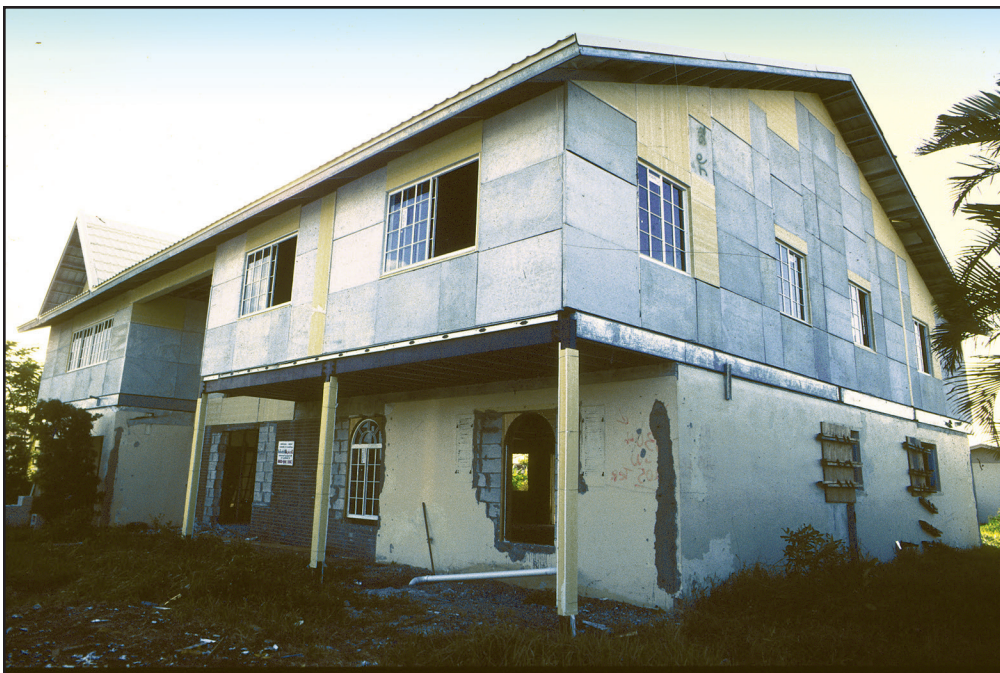
**Figure 59**

The exterior  
walls consist of  
prefabricated  
concrete panels.  
Innovative techniques  
such as those  
employed in this  
project are helping  
homeowners who  
need practical and  
economical methods  
of repairing and  
protecting their  
houses.
