# Pillar and Roof Span Design Guidelines for Underground Stone Mines

Information Circular 9526

Gabriel S. Esterhuizen, Dennis R. Dolinar, John L. Ellenberger, and  
Leonard J. Prosser

DHHS (NIOSH) Publication No. 2011-171

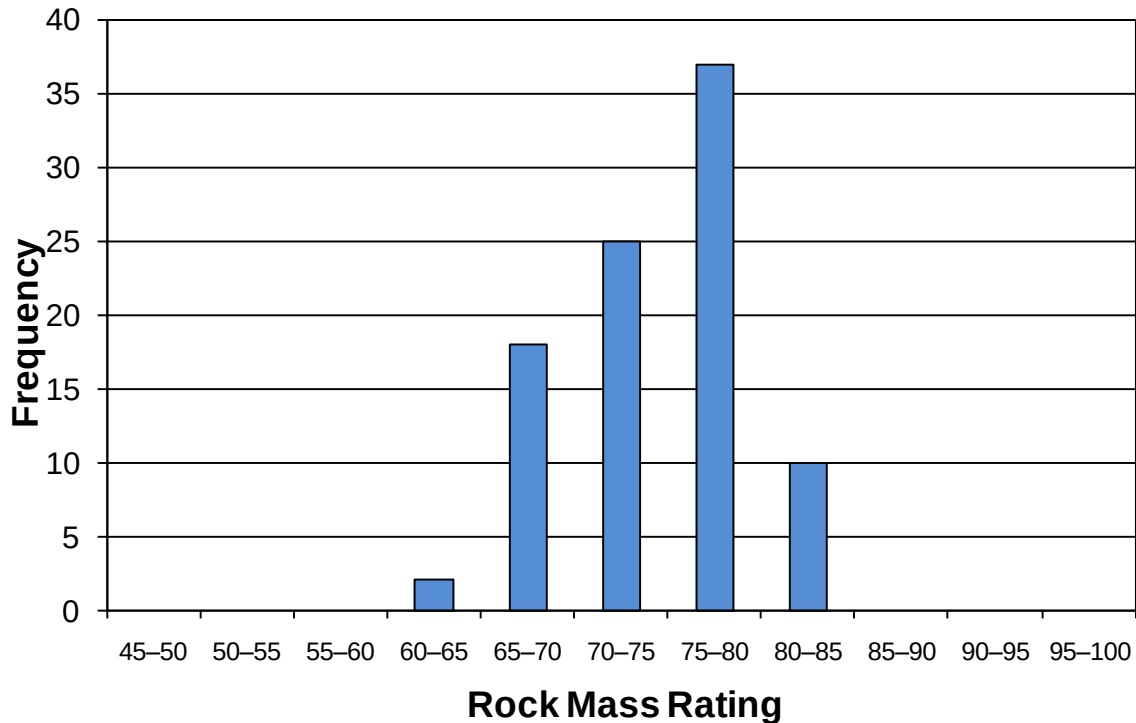
In all cases the data collection for rock mass rating was conducted approximately 2 m (6 ft) from the floor of the mining horizon. The rating results, therefore, do not describe the detail of the rock layering in the immediate roof, but rather represent the typical rock mass conditions within the formation being mined. The rock mass ratings are presented in terms of the RMR-system [Bieniawski 1989] which classifies the rock mass on a scale of 0 to 100, with higher numbers indicating stronger rock masses. The RMR values fell within a narrow range, and the ratings for the immediate roof were not expected to be significantly different from the remainder of the formation. Figure 2 shows the distribution of RMR values obtained in this study. The values range from 60 to 85, which lay within the “good” to “very good” quality categories, according to the RMR classification tables [Bieniawski 1989].

**Figure 2.** Distribution of rock mass rating (RMR) values in stone mines obtained by direct classification of rock exposure in underground stone mines and laboratory testing of rock cores.

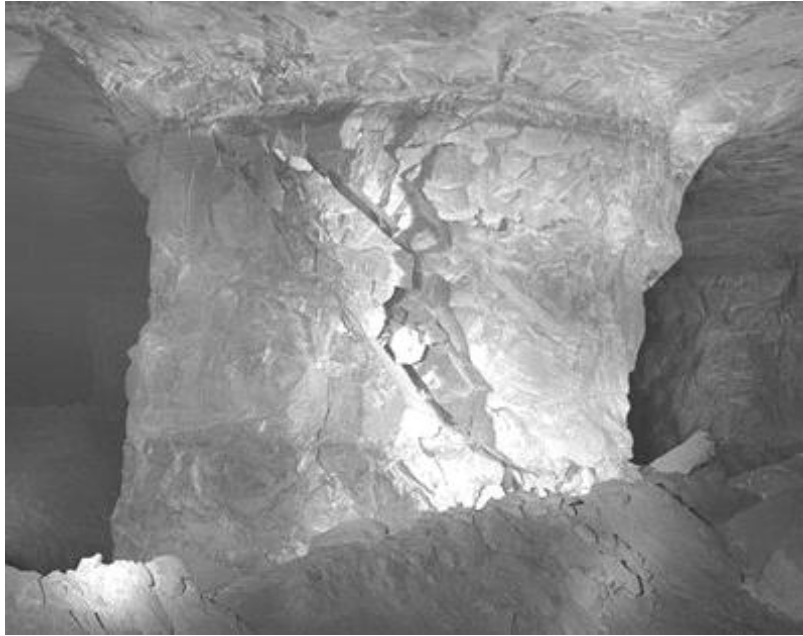
**Figure 4.** Partially benched pillar that failed along two angular discontinuities. Width-to-height ratio is 0.58 based on full benching height; average pillar stress is about 4% of the UCS.

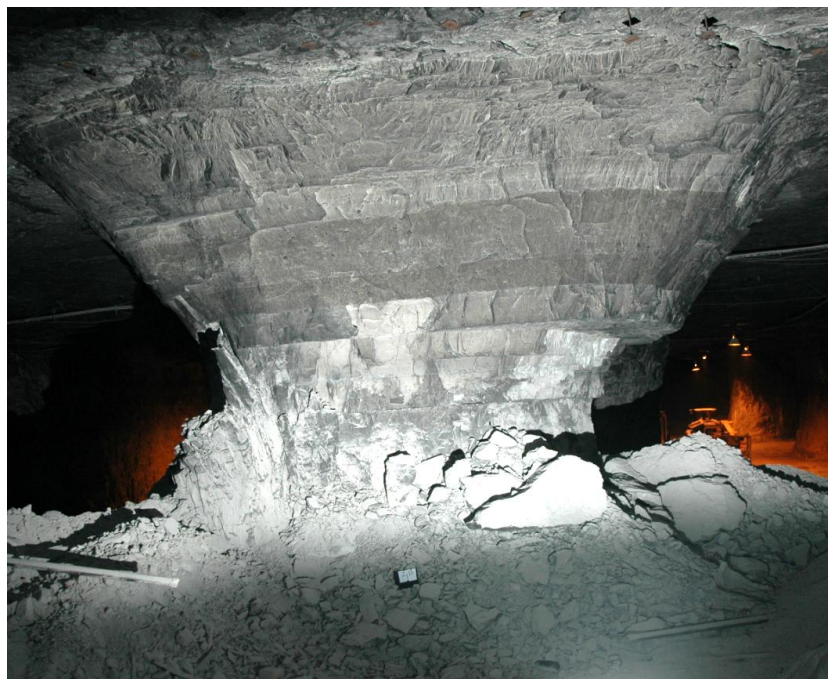
**Figure 5.** Pillar that had an original width-to-height ratio of 1.7, but failed by progressive spalling. Thin, weak beds are thought to have contributed to the failure. The average pillar stress was about 11% of the UCS prior to failure.

The pillars shown in Figures 5 and 6, listed as case 10 and 11 in Table 3, are examples of pillars that appear to have failed by this mechanism. In both cases the average pillar stress was only about 11% of the UCS of the limestone beds at this mine. Other pillars at the same mine seemed to be at an early stage of the same failure mechanism, where spalling is associated with the presence of weak, soft bands within the pillar. Figure 17 is an illustration of a partially failed pillar that appears to have failed by the same mechanism.

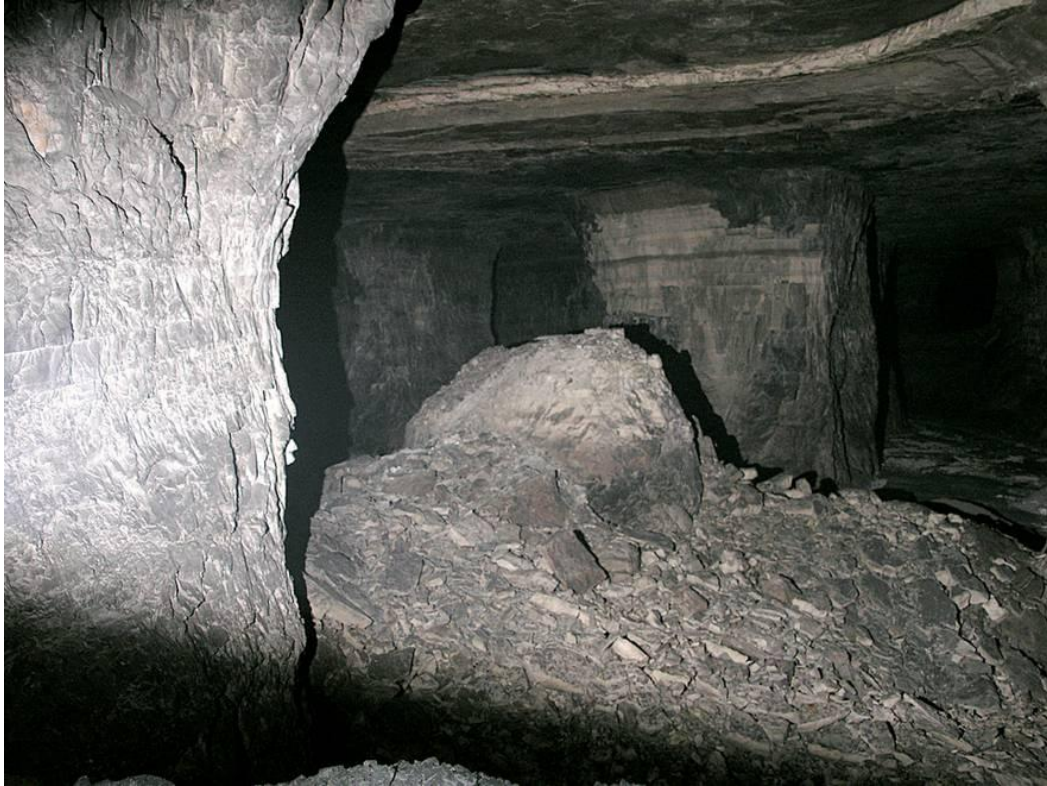
**Figure 6.** Remaining stump of a collapsed pillar in an abandoned area.

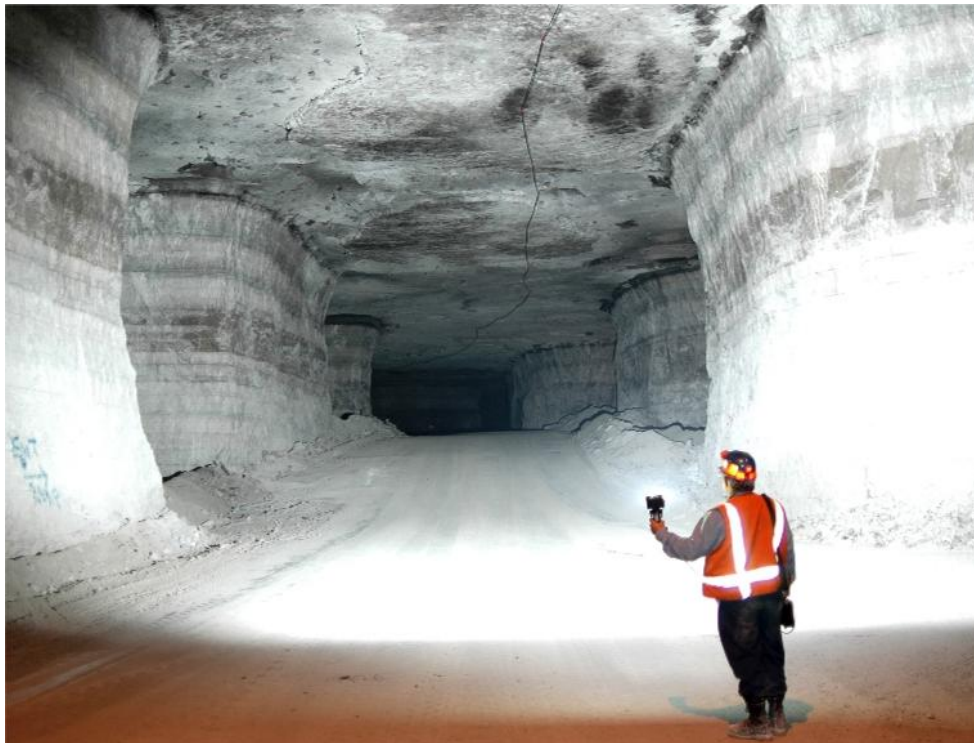
**Figure 8.** Stable pillars in a limestone mine at a depth of cover of 275 m (900 ft). Slightly concave pillar ribs formed as a result of minor spalling of the hard, brittle rock.

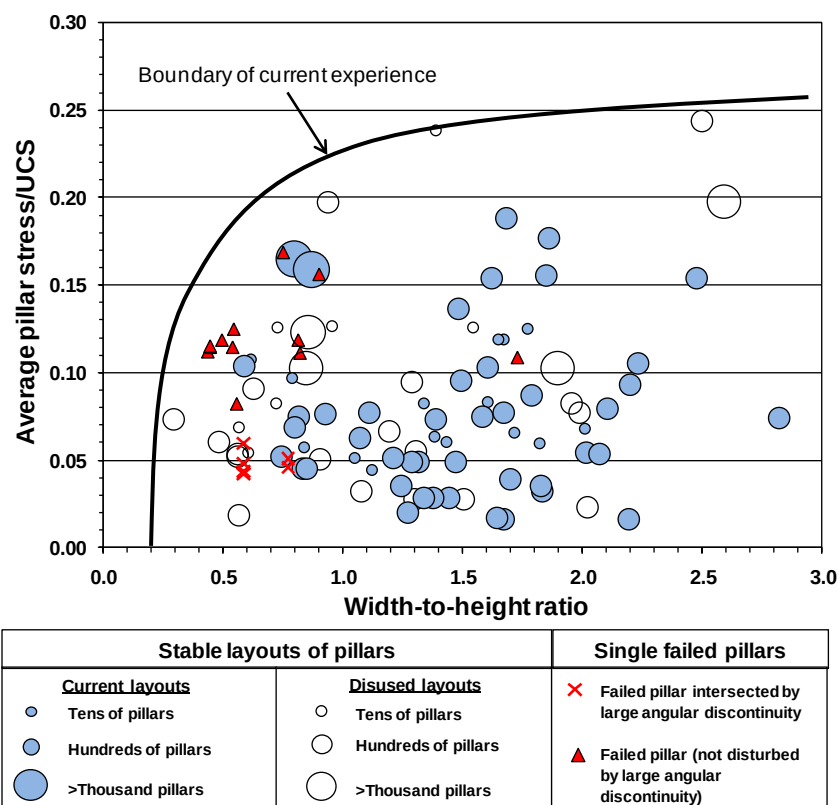
The pillar layouts that were surveyed by NIOSH are presented in Figure 10 which shows the normalized pillar stress against the width-to-height ratio. The pillar stress is normalized by the average UCS of the intact rock (obtained from Table 1). Figure 10 also includes data points representing the 18 failed pillars (that are presented in Table 3), the failures associated with the presence of large, angular discontinuities, information on the approximate number of pillars in each layout and indicates whether a pillar layout is no longer in use. A bounding curve was drawn around the case histories, which represents the limit of current experience with stone mine pillar performance.

**Figure 10.** Chart showing pillar performance based on a survey of 34 underground stone mines.

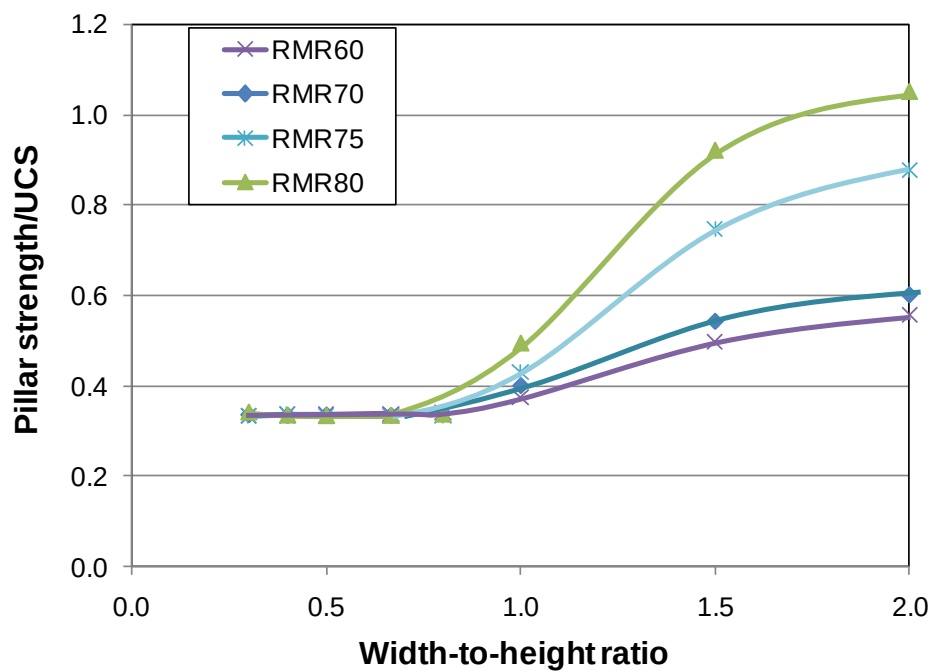
weaker than predicted by the models because of the increasing importance of local discontinuities on pillar stability. As the width-to-height ratio increases beyond 1.0, the pillar strength will increase rapidly as confinement is generated [Lunder 1994]. Figure 11 shows numerical model results [Esterhuizen 2006] in which both the spalling and shearing failure modes were modeled. The results show how the width-to-height ratio and the rock mass rating affect pillar strength. In these models it was assumed that spalling occurred when the maximum stress was one third of the UCS, which is higher than observed in limestone formations, and the confining stress is less than 10% of the maximum stress. It can be seen that the pillar strength only starts to respond to the increasing width of the pillar when the width-to-height ratio is greater than 0.7. The results also show that the rate of increase in strength is related to the rock mass rating.

**Figure 11.** Effect of width-to-height ratio and rock mass rating (RMR) on pillar strength, based on numerical model results.

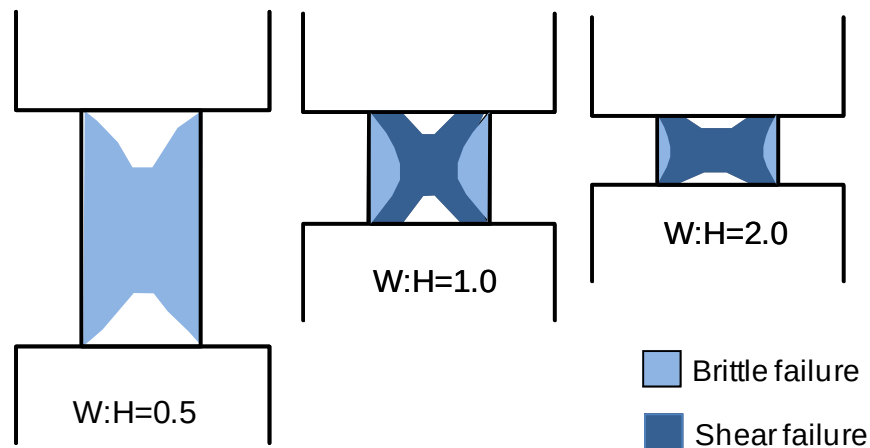
The stress-strain characteristics of the modeled pillars also showed that slender pillars start spalling when they are at or near their peak strength; conversely, wider pillars start spalling well before they reach their peak strength. This implies that if slender pillars show signs of spalling, they may be loaded at or near their ultimate strength, and failure may be imminent. The slender pillars also display a rapid drop in strength after reaching the peak strength, and the wider pillars lose their strength more gradually. A rapid drop in strength can result in violent pillar failure [Salamon 1970].

**Figure 12.** Sections through the center of pillars with different width-to-height ratios showing the extent of brittle and shear failure of the rock mass predicted by numerical modeling.

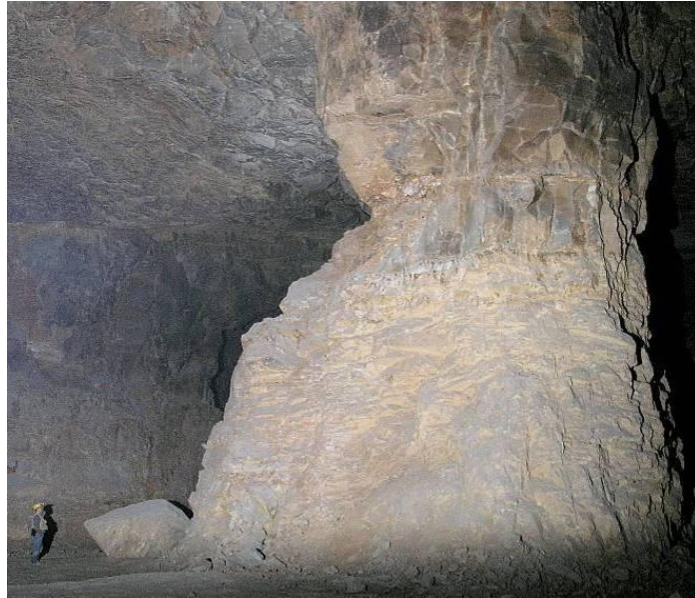
**Figure 14.** Rib failure related to large, angular discontinuities adjacent to a fault zone.

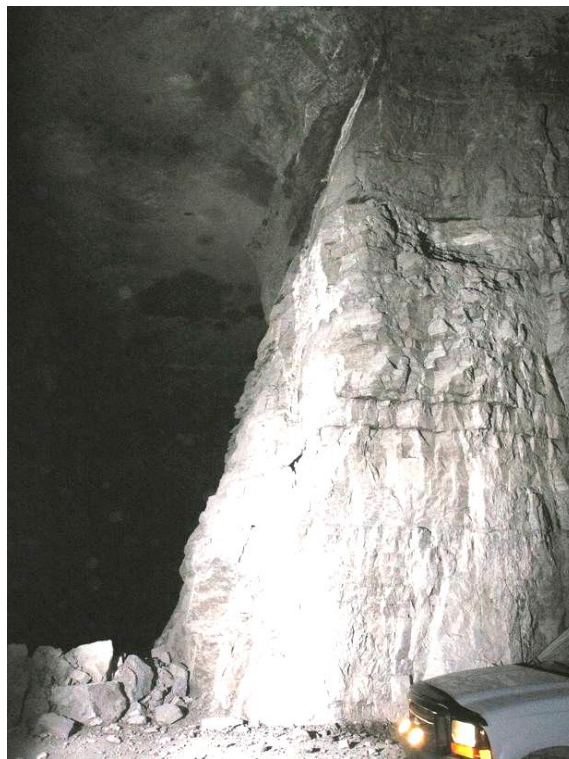
**Figure 15.** Loss of pillar rib at the location of a large roof-to-floor discontinuity in a limestone mine.

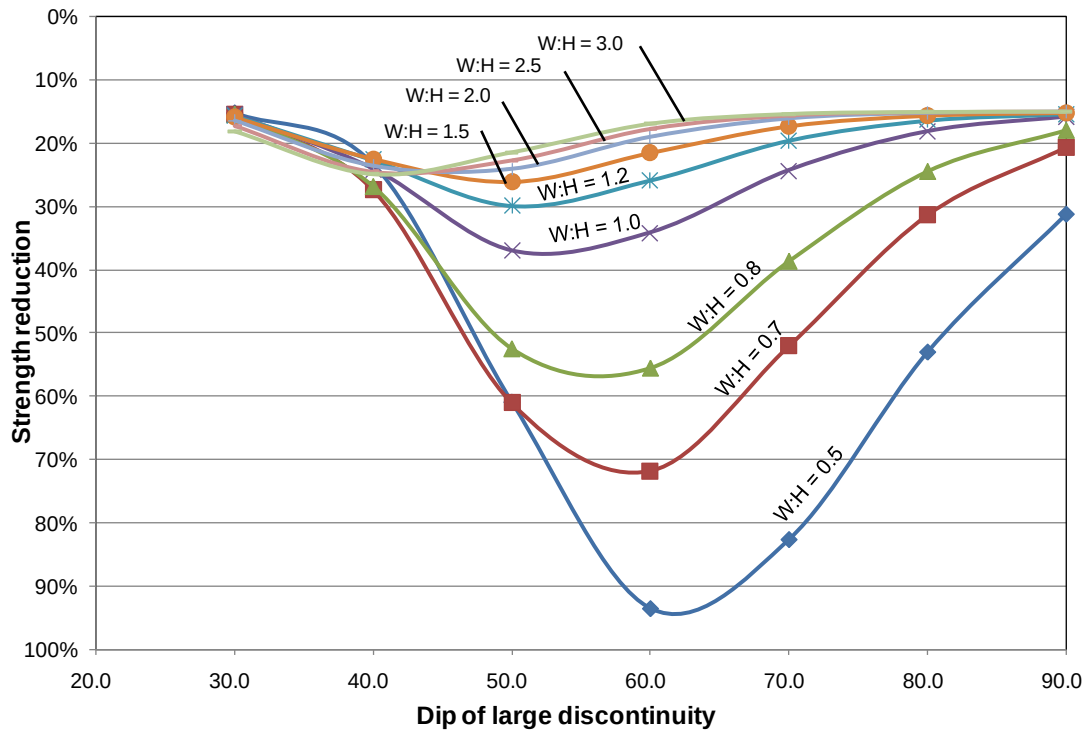
These findings are a further confirmation that excessively slender pillars should be avoided. The pillar strength calculation procedure, described in the Pillar Strength Equation for Stone Mines section, takes into account the weakening effect of large, angular discontinuities.

**Figure 16.** Chart showing the impact of large, angular discontinuities on the strength of pillars, based on the results of numerical models.

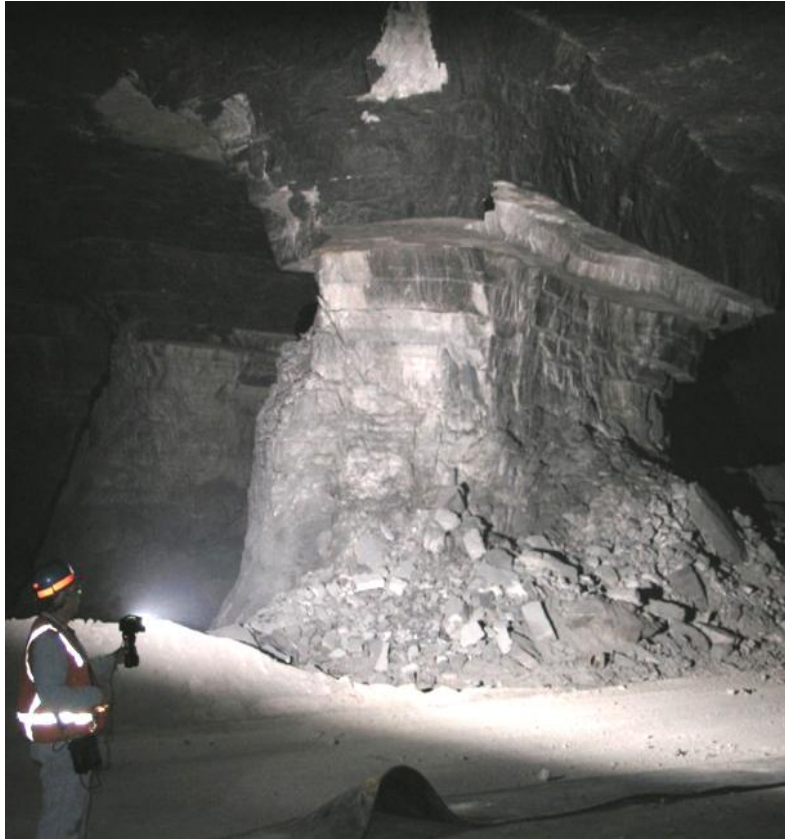
**Figure 17.** Pillar damage observed in rock containing thin, weak bands. Note spalling of the intact rock material between the weak bands.

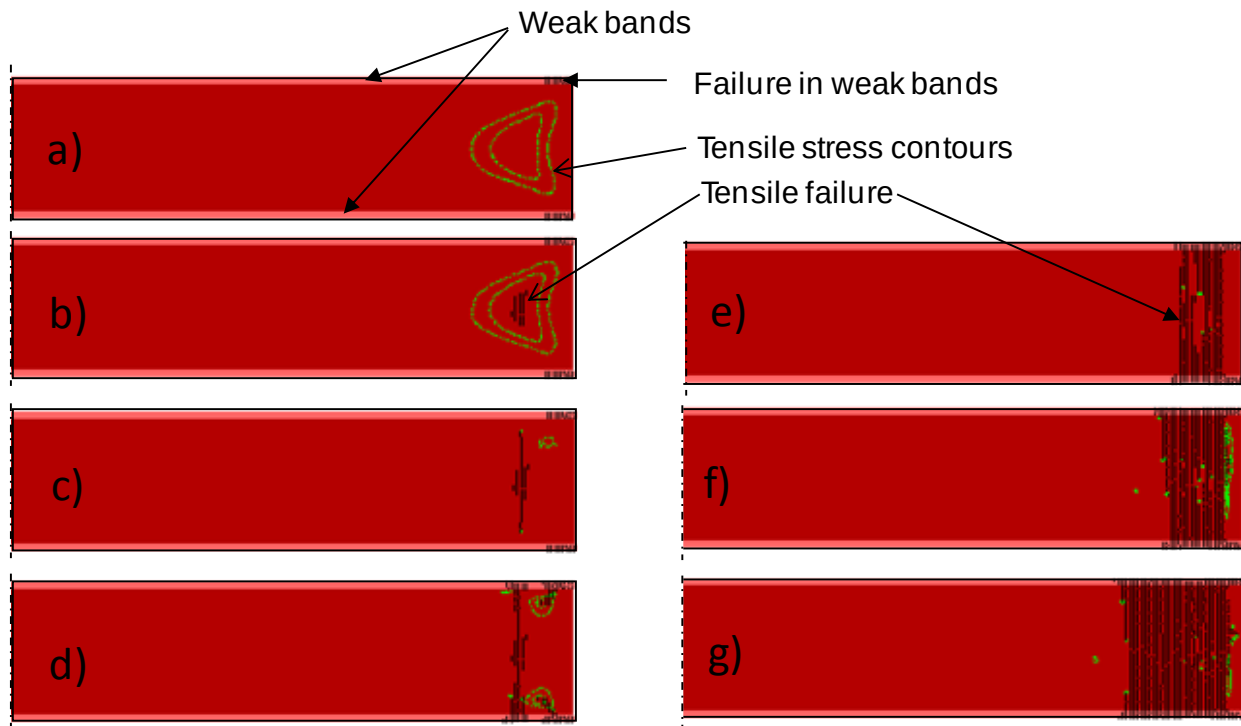
weak bed material. As the loading increases, the tensile stresses increase and tensile failure develops in the stronger slab (Figure 18b), which relieves the initial zone of tension (Figure 18c). As the vertical loading continues to increase, tensile stresses are induced on either side of the initial tensile failure zone and tensile failure continues to occur. The process repeats until the entire slab has failed or the extrusion mechanism is inhibited by frictional resistance between the weak bands and the rock slab. If the tensile failure process is inhibited, the remainder of the slab fails by shearing. The extrusion-tensile failure mechanism can explain the observed progressive spalling of intact rock at relatively low stress.

**Figure 18.** Stages of failure development in a beam of strong rock encased between two weak bands.

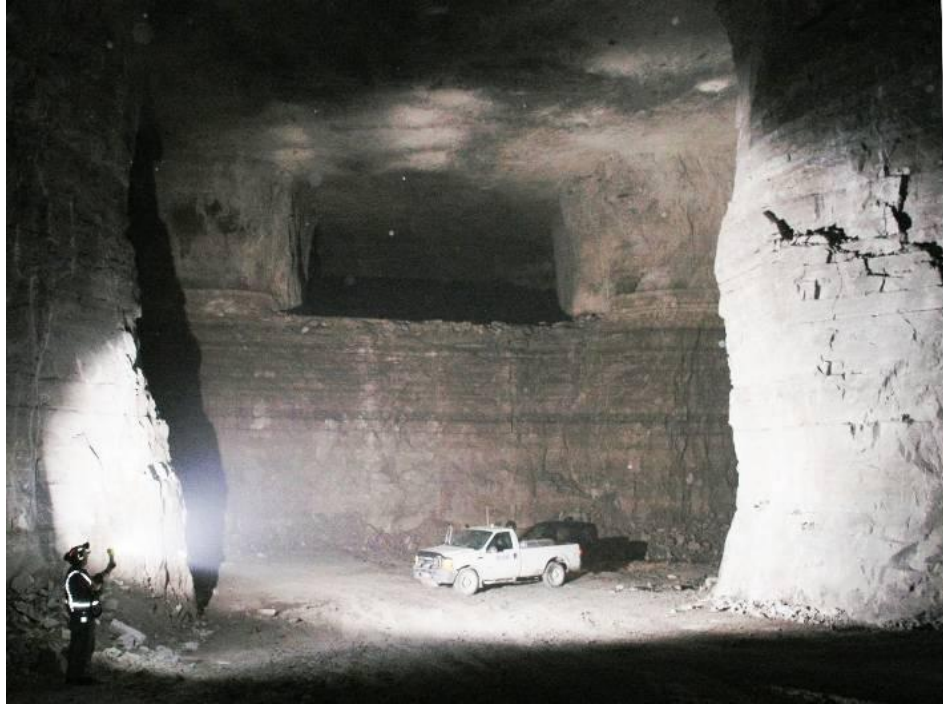
Bench mining of the floor between pillars is a common practice in stone mines where the formation thickness exceeds the practical height of initial development mining. Bench drilling equipment from open pit mines is often used resulting in a highly efficient method of production. Figure 19 shows a floor bench with partially benched pillars on the upper level and fully benched pillars in the foreground. Observations showed that pillars can become unstable at the edge of the benching operations. Table 4 summarizes the cases in which pillar instability was associated with bench mining. Benching operations were halted in two of the observed cases owing to instability of the partially benched pillars. Several cases were observed in which the pillars at the perimeter of the benching area showed signs of increased loading. In addition, instability was observed when bench mining exposed large joint structures in the pillar ribs.

**Figure 19.** Example of bench mining of the floor between pillars in a limestone mine.

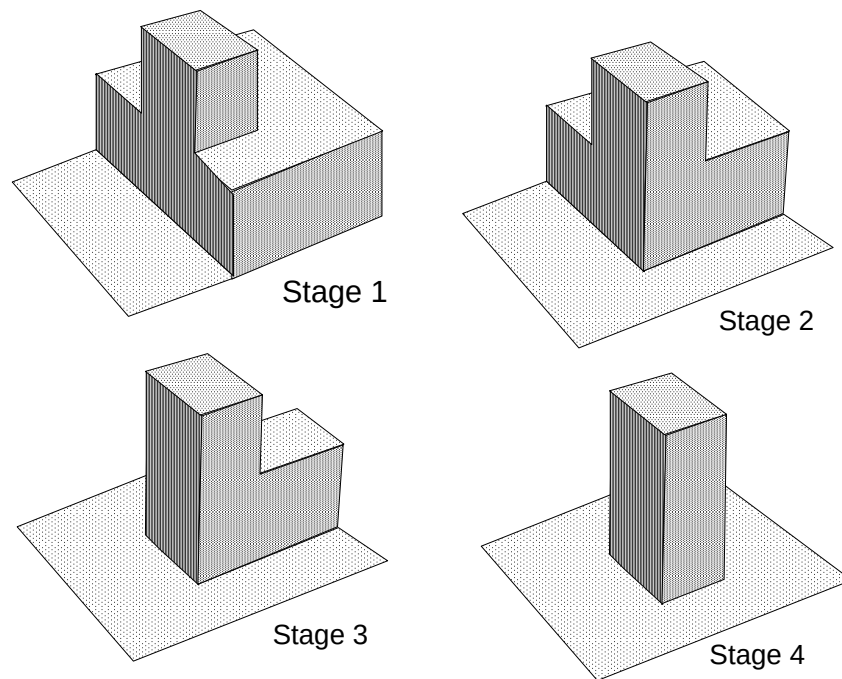
**Figure 20.** Stages of bench mining around a pillar used in the numerical models.

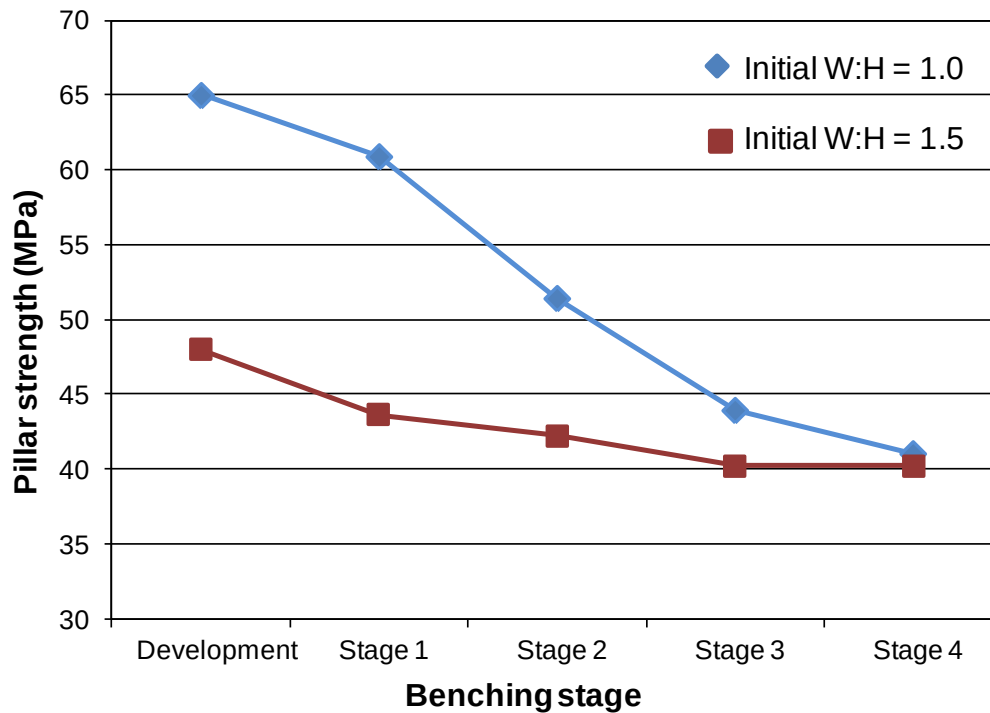
Analyses were conducted for pillars with initial width-to-height ratios of 1.0 and 1.5. The models simulated benching that doubled the height of the pillars. The model results presented in Figure 21 shows that the strength of the pillar with a width-to-height of 1.0 is reduced by about 16% from its initial value of 48 MPa (6,900 psi) to a final value of 40 MPa (5,800 psi). The pillar with a width-to-height ratio of 1.5 experiences a reduction in strength of 37% from the development stage to the fully benched stage. One reason for the smaller strength reduction in the narrow pillar with a width-to-height ratio equal to 1.0 is that the strength is already near the minimum value on development, and increasing the height during benching only causes a small additional reduction in strength.

**Figure 21.** Results of numerical modeling showing strength reduction of pillars with initial width-to-height ratios of 1.0 and 1.5 from initial development through various stages of bench mining. Final width-to-height ratios at Stage 4 are 0.5 and 0.75.

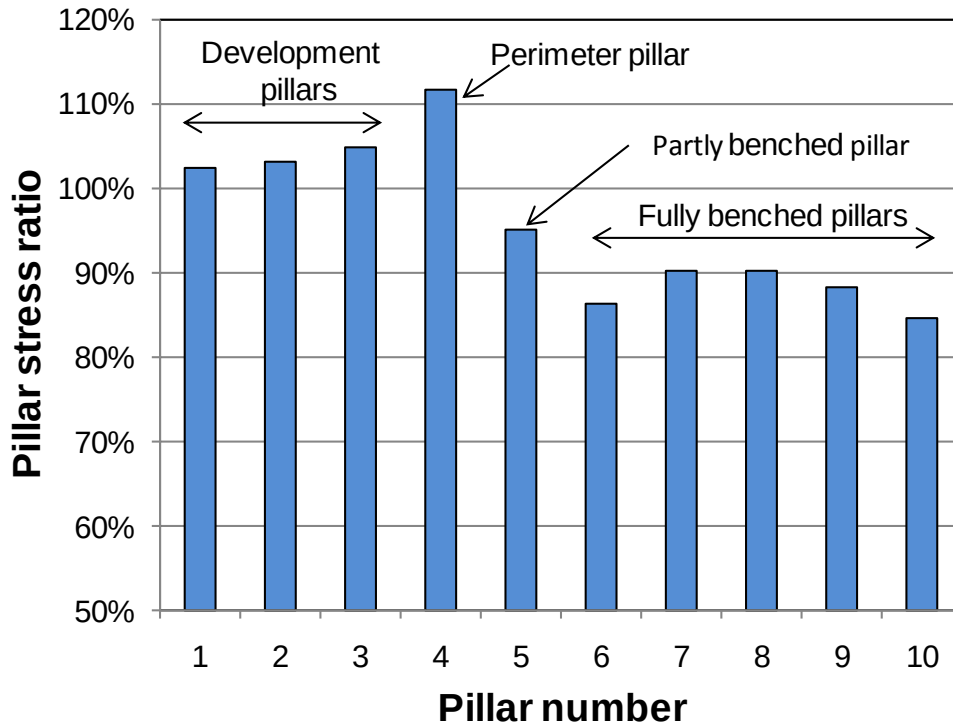
From a pillar design point of view, it is important to also know how bench mining affects the pillar loads while the strength reduction is occurring. Figure 22 shows the average stress in the pillars near benching operations, as obtained from numerical models. The results show that the development pillars at the edge of the benched area are subject to an increase of about 12% in their average stress. The results further show that the stress in the partly benched pillar is lower than the stress in the adjacent pillar that has not been benched yet, indicated as “Perimeter pillar.” The lower stress in the partially benched pillar can be explained by the fact that its stiffness is reduced by the increase in height of one of the sides of the pillar, causing the load to be transferred to the stiffer development pillars. It can clearly be seen that the fully benched pillars are at a reduced stress level, owing to their relatively low stiffness. As benching continues, the stress in the fully benched pillars is expected to gradually increase back to the tributary stress.

**Figure 22.** Results of numerical model showing the average pillar stress during bench mining as a ratio of the average pillar stress prior to bench mining.

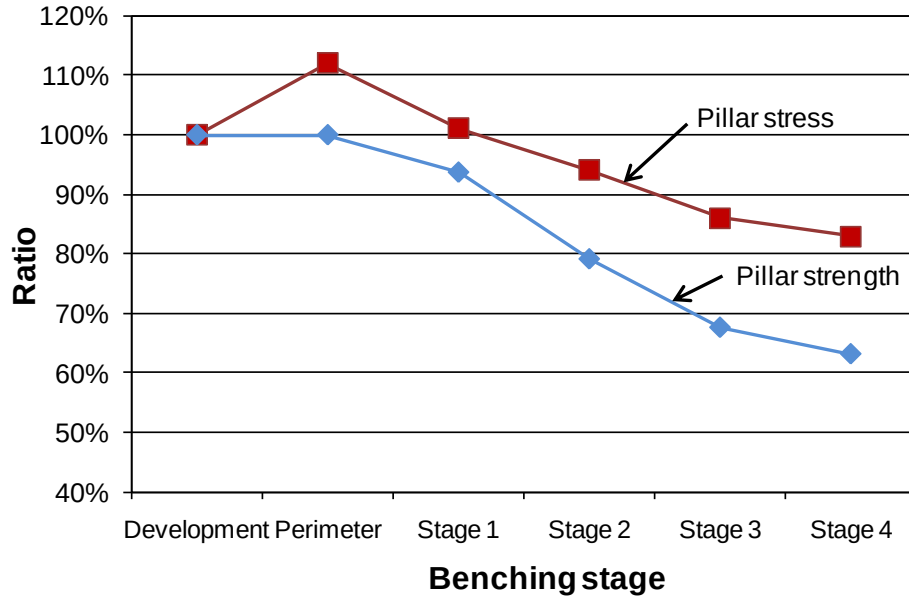
The numerical models confirm that elevated stresses can occur in pillars around the perimeter of a benched area. However, the existence of reduced stresses in the partially benched pillars seems to be in conflict with the field observations, which indicate that elevated stresses exist in the partially benched pillars. Closer inspection of the model results show that stresses are not symmetrically distributed within pillars at the edge of a benched area. Zones of high stress exist within the partially benched pillars; these are likely to contribute to the failure observed in the partially benched pillars in operating mines.

**Figure 23.** Change in the average vertical pillar stress and pillar strength relative to development during various stages of bench mining, for a pillar with a width-to-height ratio of 1.5 based on the results of numerical models.

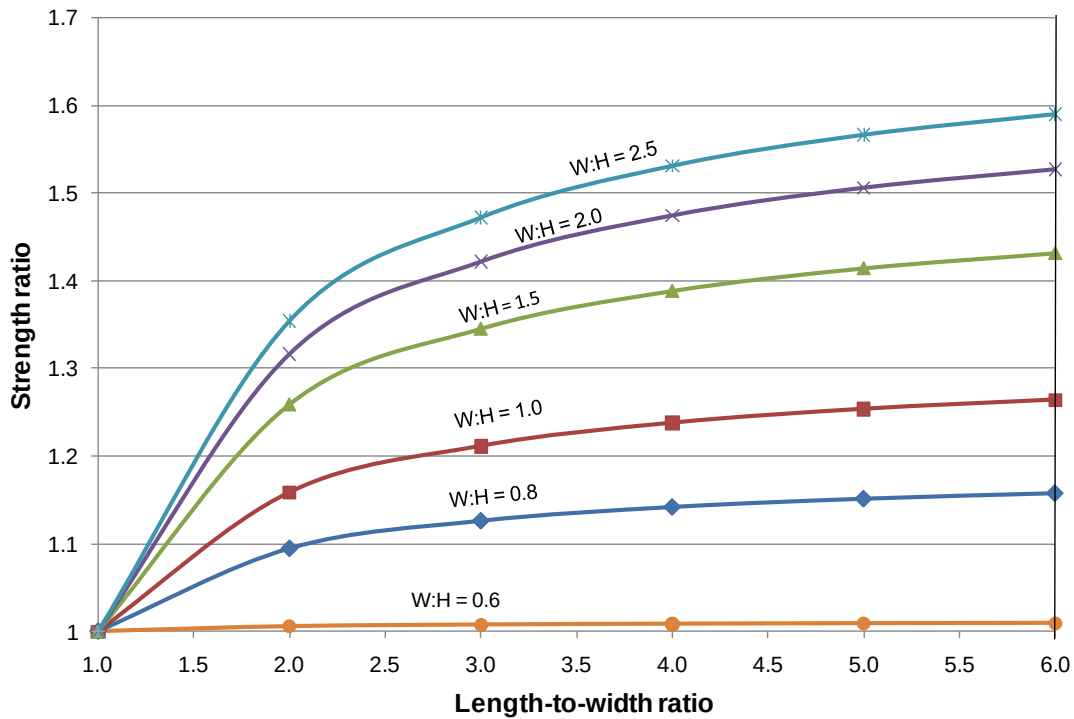
Some of the accepted methods of estimating the effect of length on pillar strength do not account for the fact that the strength increase might be limited when pillars are slender. The methods would generally predict a similar strength increase for all pillars, regardless of the width-to-height ratio. Therefore, when designing slender pillars for brittle rock, it is necessary to consider the width-to-height ratio as well as the length-to-width ratio when calculating the strength of rectangular pillars.

**Figure 24.** Strength increase caused by increasing pillar length for pillars with various width-to-height ratios. Results from calibrated numerical models assuming rock failure initiates as spalling followed by shearing.

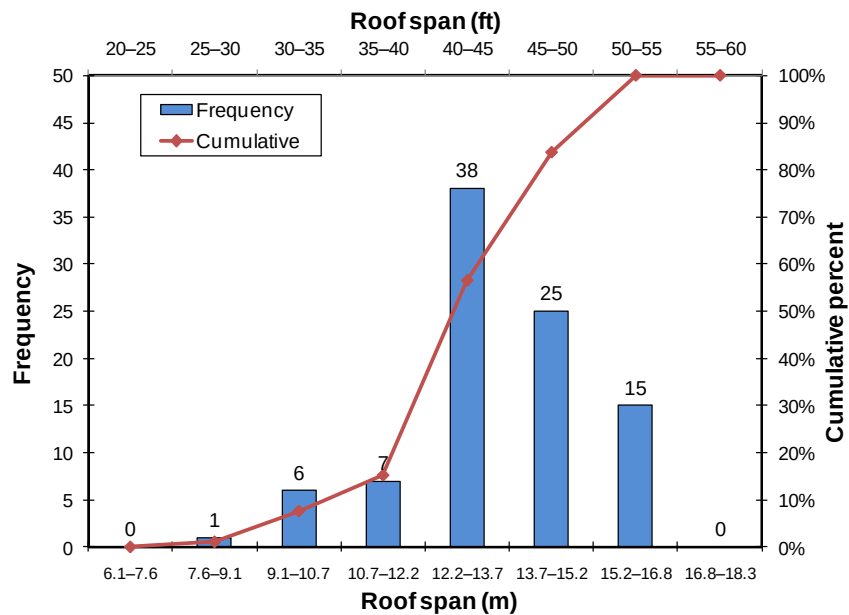
**Figure 26.** Distribution of roof span dimensions measured at 34 different underground stone mines.

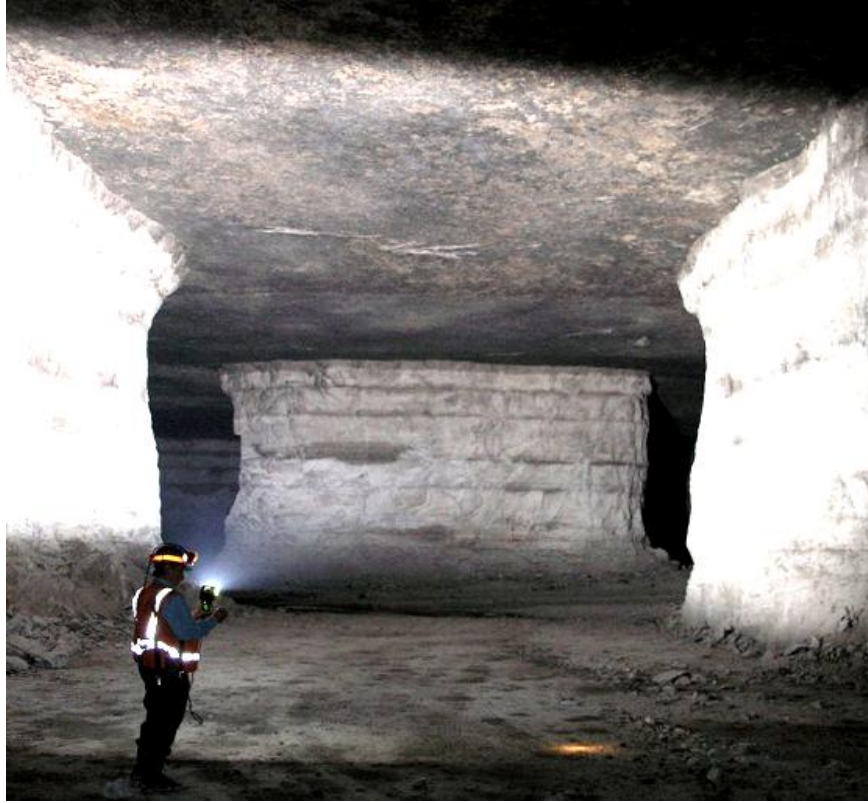
**Figure 27.** Naturally stable 13.4-m (44-ft) wide roof span in a stone mine.

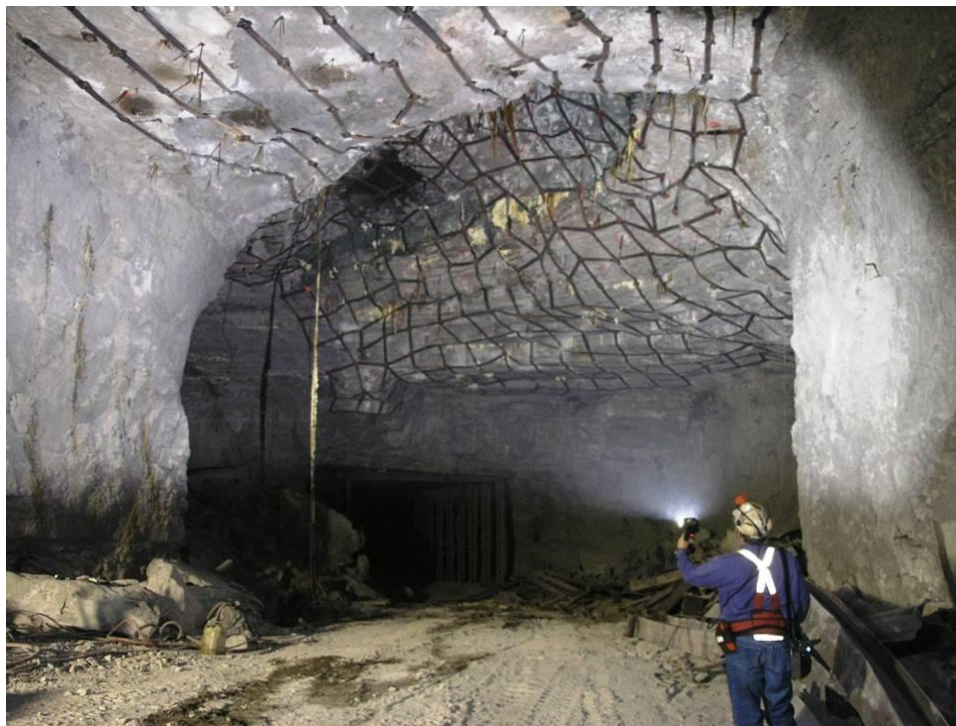
Although the large roof falls only make up a small percentage of the total roof exposure, their potential impact on safety and mine operations can be very significant. Most cases of large roof falls required barricading off or abandonment of the affected entry. When large roof falls occur in critical excavation areas, the repair can be very costly. Figure 28 shows a case where extensive support was required to rehabilitate a large roof fall.

**Figure 28.** Bolts, straps, and injection grouting used to rehabilitate the roof at the site of a major roof fall.

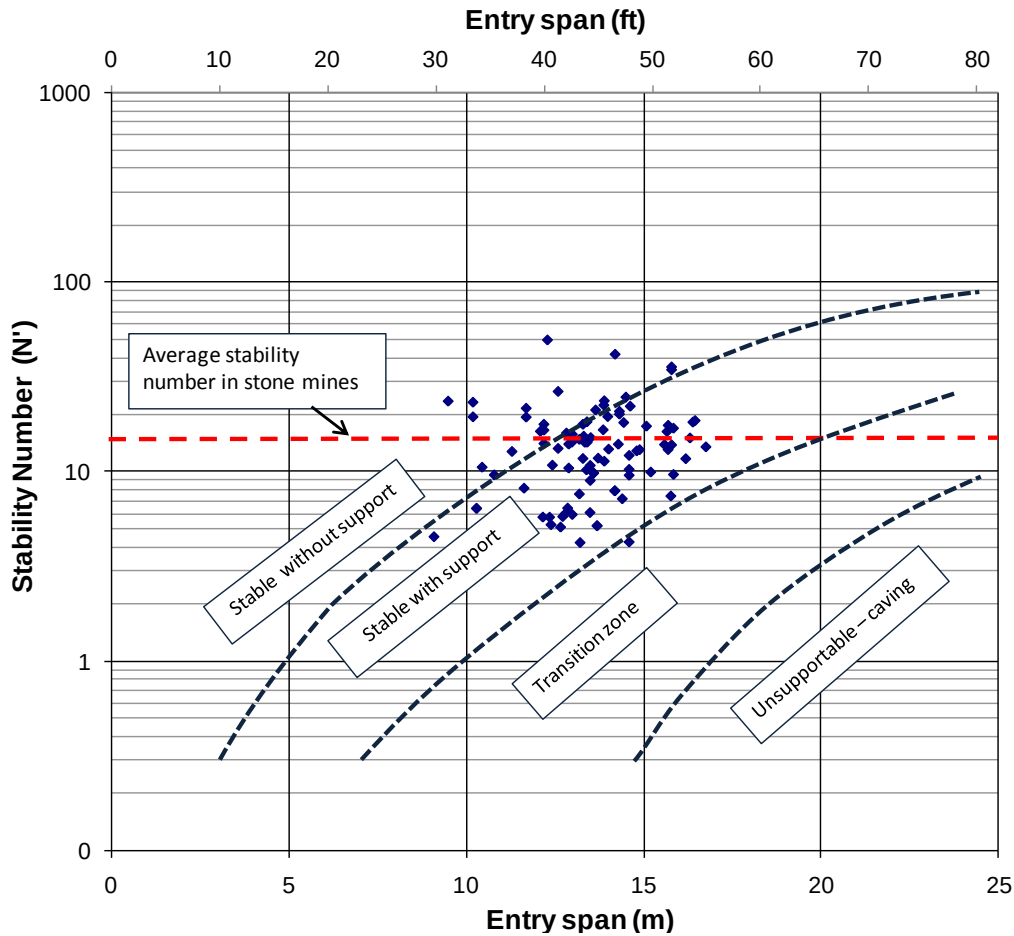
The stability number was calculated for each of the 92 stone mine sites and plotted on the Stability Chart shown in Figure 29. The chart also indicates the average stability number for stone mines as a horizontal dashed line.

**Figure 29.** Stability chart showing stone mine case histories and stability zones, modified after Mathews et al. [1980], Potvin [1988], Nickson [1992], and Hutchinson and Diederichs [1996].

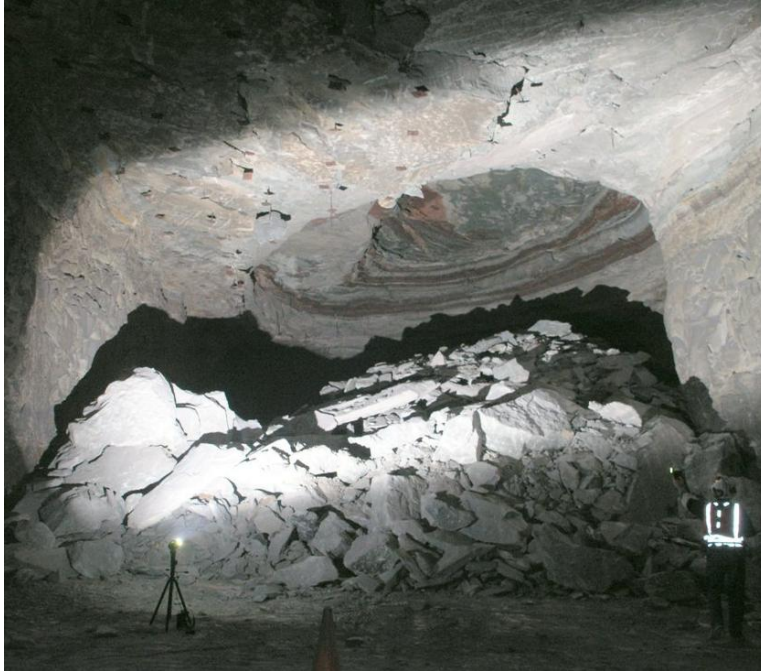
**Figure 32.** Large stress-related, oval-shaped fall that has propagated upwards into weaker, overlying strata in a limestone mine.

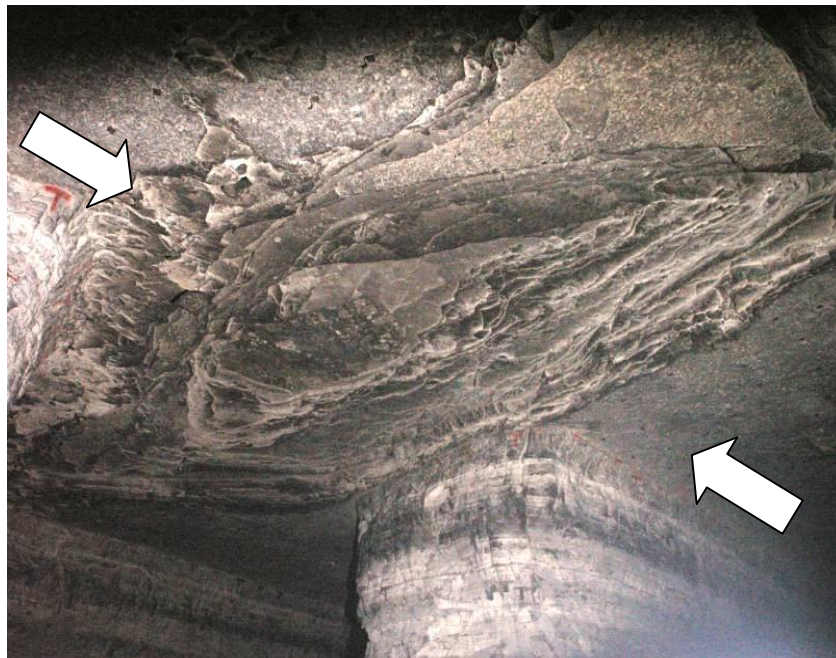
**Figure 33.** Horizontal, stress-induced roof failure that initiated between two pillars. Arrows show measured direction of maximum horizontal stress.

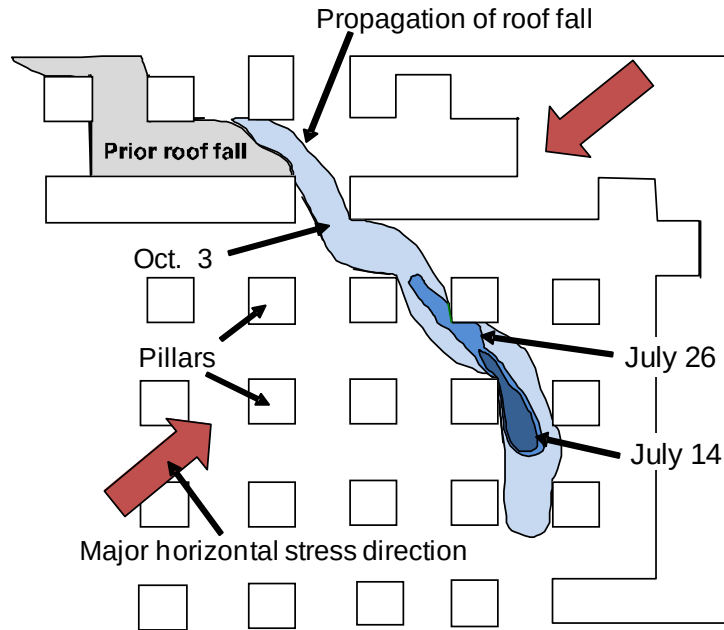
**Figure 34.** Plan view showing the development of a stress-related roof fall in the direction perpendicular to the direction of the major horizontal stress [Iannacchione et al. 2003].

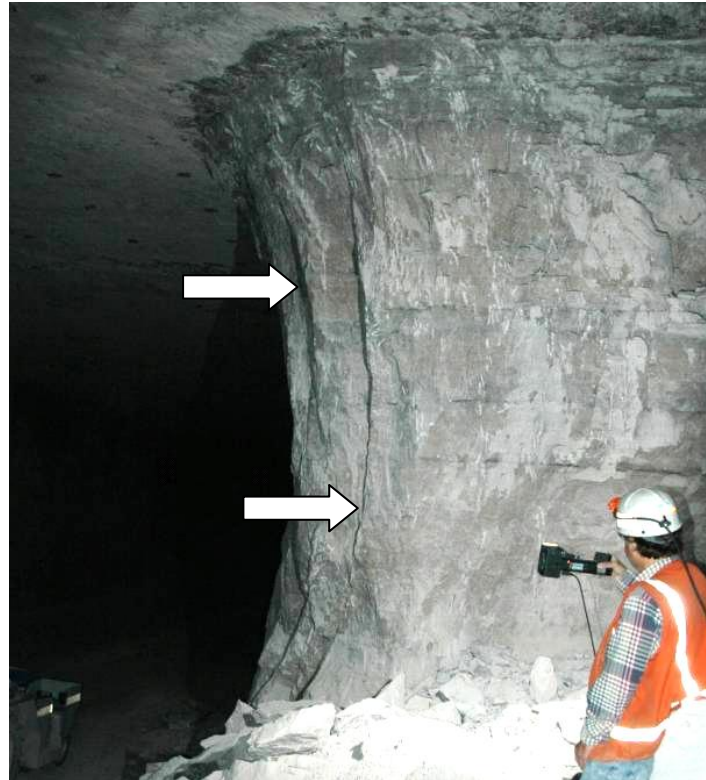
Numerical models were used to investigate how this type of failure might take place and how the presence of widely spaced bedding planes would affect the depth of the potential roof failure [Esterhuizen 2006]. The stability of the roof rocks was assessed by calculating a failure index, which is based on extension failure initiating when the maximum principal stress exceeds 10% of the rock strength. A failure index of less than 1.0 indicates potential rock failure, similar to the traditional factor of safety. The failure index results in Figure 36a show that, in the absence of bedding discontinuities, extension fracturing can extend over the room to form an arch which extends to about 3 m (10 ft) above the roofline. This arch is very similar to the extension fracture observed in the pillar rib, shown in Figure 35.

**Figure 35.** Extension fractures exposed in a pillar rib after the pillar was bisected by a new crosscut.

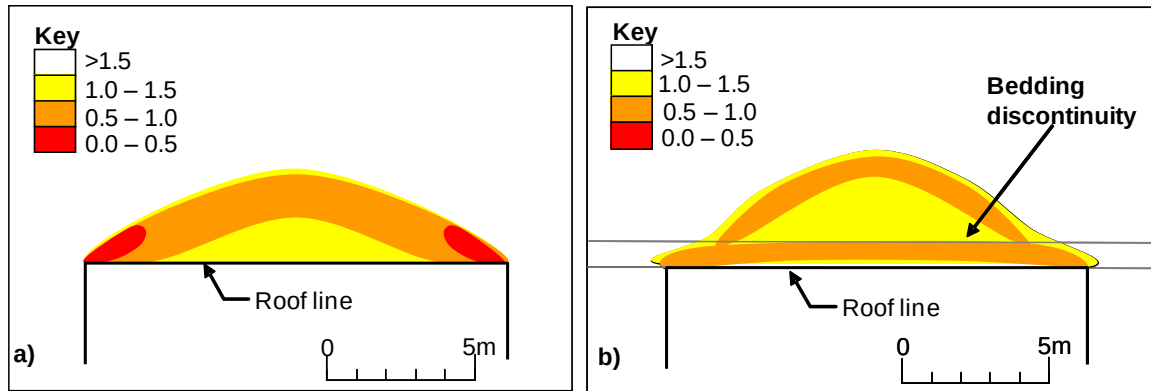
If a single bedding discontinuity is introduced 1 m (3.3 ft) above the roofline, see Figure 36b, the stresses are redistributed by the presence of the discontinuity. A reduction of the horizontal stress occurs in the 1-m (3.3-ft) thick roof beam as it deflects downwards, and some slip occurs along the bedding discontinuities. Separation of up to 2 mm (0.08 in) occurs across the bedding discontinuity near the center of the room. The deflection of the lower beam causes an increase in the stress within the overlying roof, which in turn causes the potential rock failure to extend to about 4 m (13 ft) above the roofline.

**Figure 36.** Vertical cross section through a heading showing rock failure index values (a) without bedding discontinuities and (b) with a bedding discontinuity 1 m (3.3 ft) above the roofline.

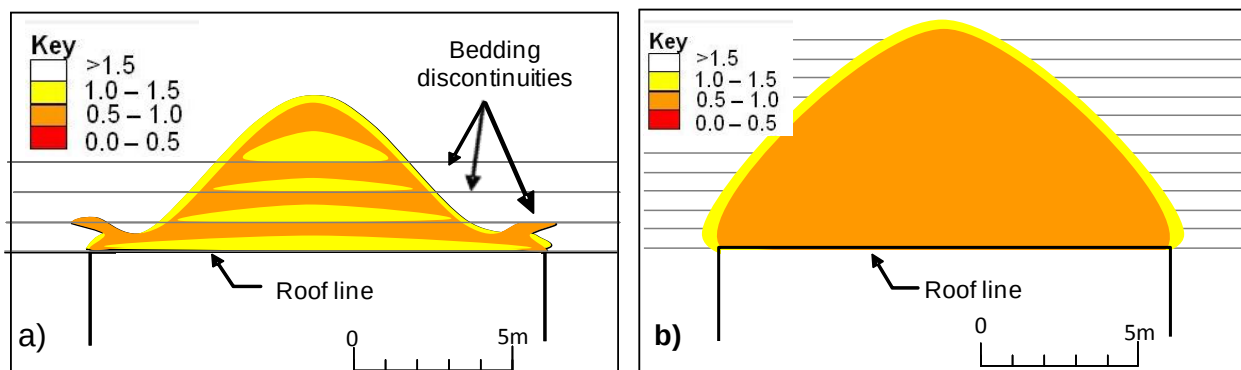
In the final case the roof is modeled as a thinly bedded rock using model elements that assume that each element in the model contains multiple horizontal planes of weakness that can shear. The strength of these ubiquitous weaknesses was set equal to that of the bedding discontinuities described above. The stability index results, in Figure 37b, show that the extent of potential failure is much greater, now extending about 7 m (23 ft) above the roofline. Inspection of the results show that slip along the roof beds allowed more roof deflection to occur, which reduced the confinement in the roof.

**Figure 37.** Vertical cross section through a heading showing rock failure index values (a) with three 1-m thick (3.3 ft) bedding discontinuities in the roof and (b) thinly laminated roof.
