# Pillar and Roof Span Design Guidelines for Underground Stone Mines

Information Circular 9526

Gabriel S. Esterhuizen, Dennis R. Dolinar, John L. Ellenberger, and  
Leonard J. Prosser

DHHS (NIOSH) Publication No. 2011-171

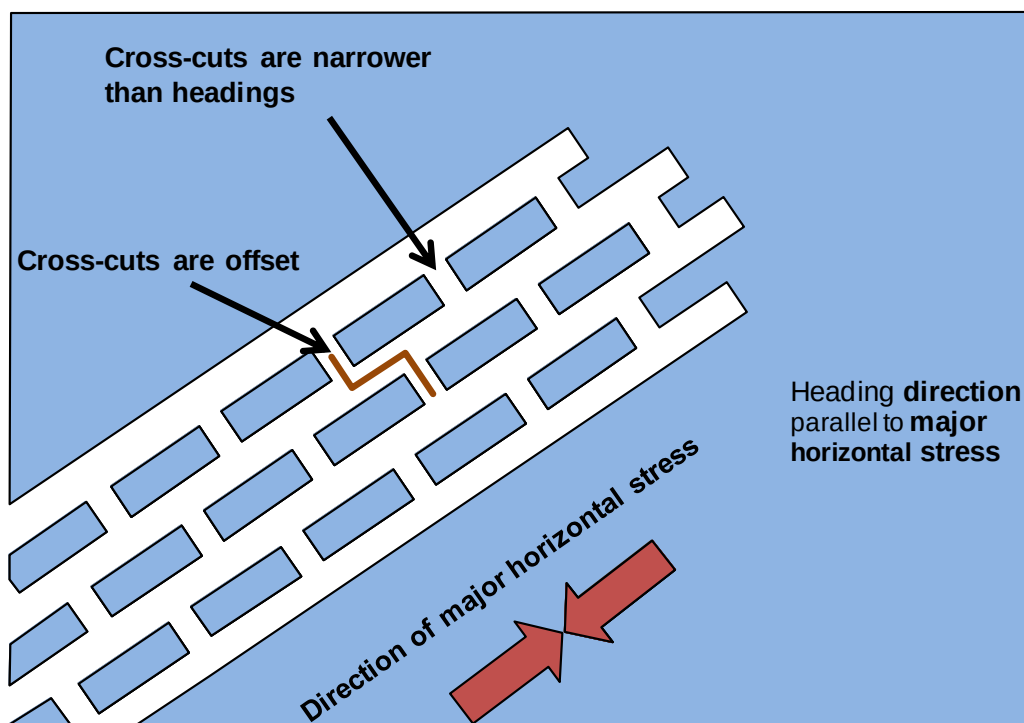
Figure 38 shows a mine layout that has been optimized for horizontal stress. The main heading direction is parallel to the maximum horizontal stress; pillars are elongated so that unfavorably oriented crosscuts are minimized. The crosscuts are narrower than the headings and are offset so that potential stress-related roof falls will abut against solid pillar ribs, rather than snake through the layout.

**Figure 38.** Diagram showing room-and-pillar layout modified to minimize the potential impact of horizontal, stress-related damage.
