## Test Results of Collision Warning Systems on Off-Highway Dump Trucks: Phase 2

**Report of Investigations 9654**

**Todd M. Ruff**

November 2000

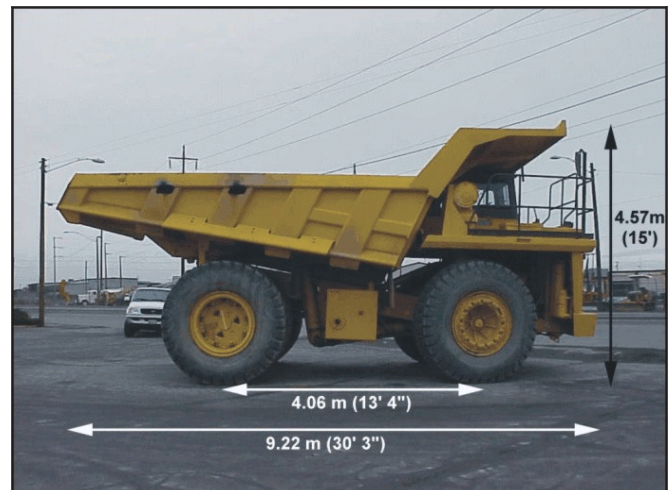
Figure 1.—Side view of Komatsu 210M.

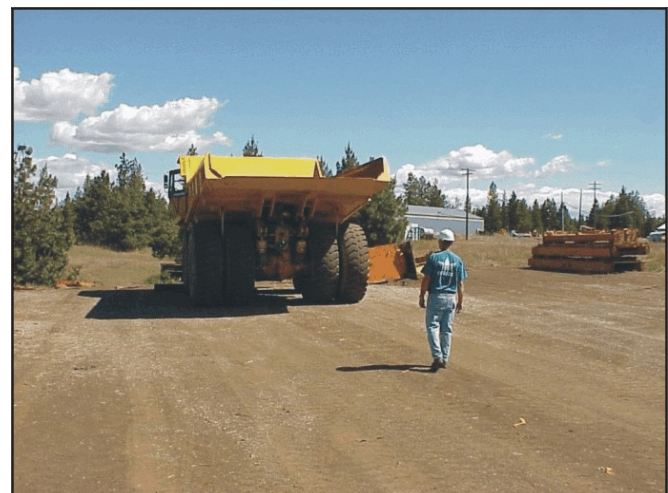
**Figure 3.—Determining detection zone for a person.**

The obstacles to be detected by the collision warning system consisted of either a person or a three-quarter-ton, four-wheel-drive pickup truck with an extended cab (figures 3 and 4). The person for these tests was a man between 178 and 191 cm (70 and 75 in) tall, wearing a hard hat, cotton shirt, and jeans.

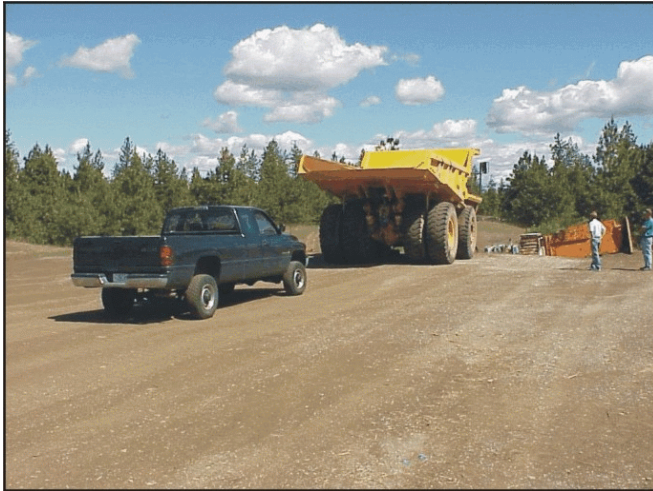
Figure 4.—Determining detection zone for a pickup truck.

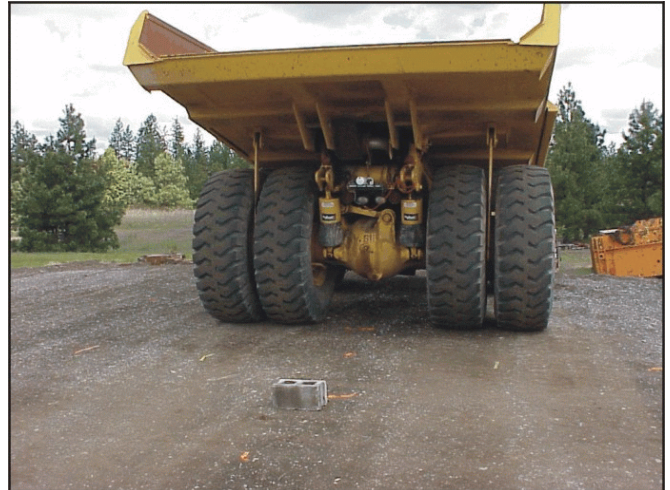
Figure 5.—Detecting a cinder block.

According to SAE J1741, it is desirable that a collision warning system ignore an object the size of a cinder block in the blind spot of the dump truck (figure 5). While this may or may not be important to a mine implementing a collision warning system, researchers at SRL tested each radar system to see how it reacted to a cinder block placed at various distances along the truck's centerline.

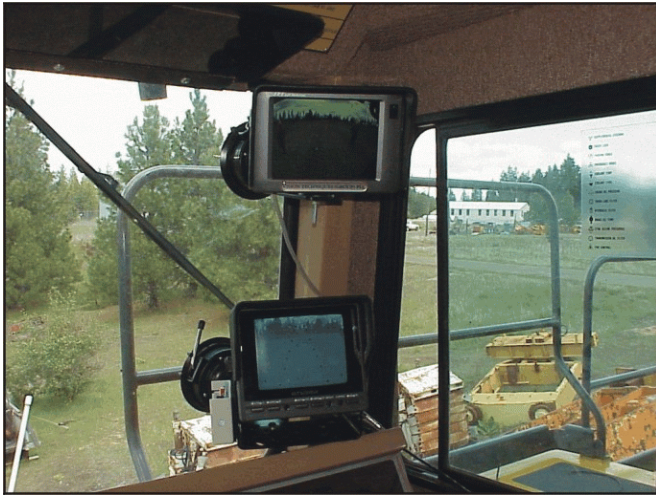
Figure 7.—Two types of monitors mounted in cab of dump truck.

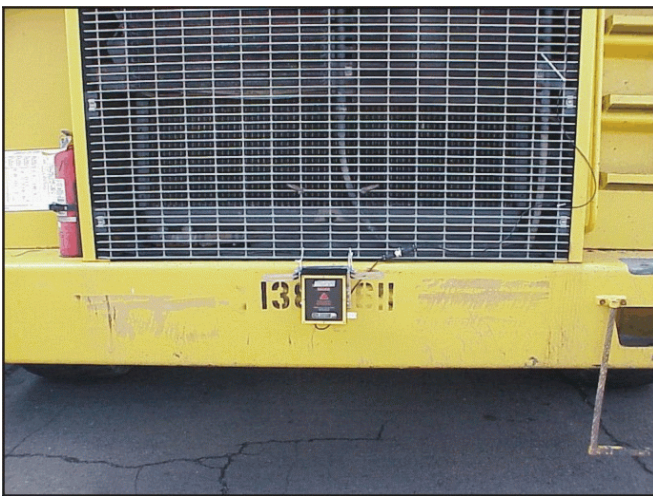
Figure 11.—Ogden radar system mounted on front bumper.

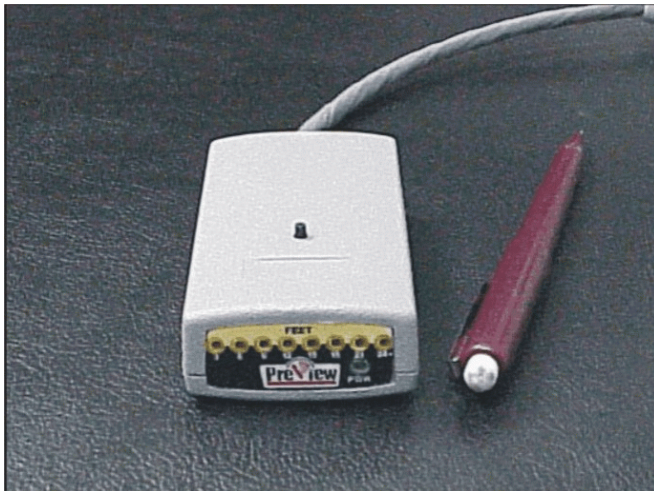
Figure 19.—Preview radar system display.

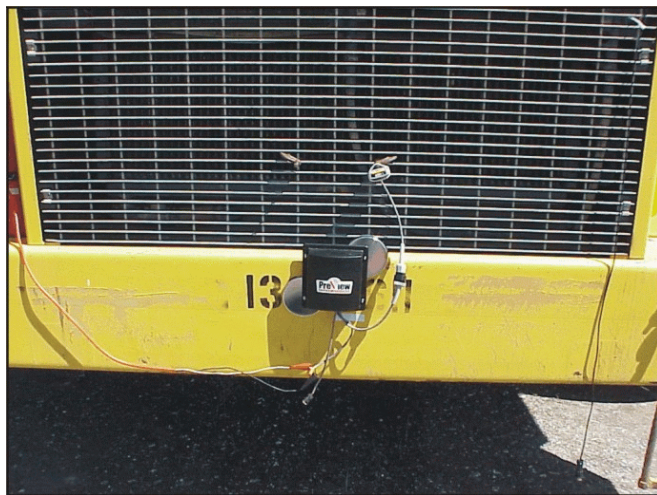
Figure 22.—Preview radar system mounted on front bumper.

The system was then mounted on the front of the dump truck at a height of 94 cm (37 in) (figure 22). Mounting height was not as critical on the front of the truck because no part of the truck extended beyond the bumper. There were no false alarms when the truck was moved forward in a clear field.

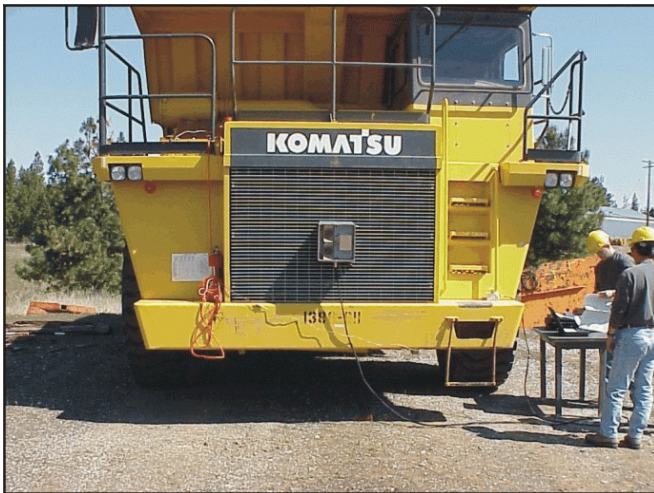
Figure 29.—Ultrawide-band radar system mounted on front grill.

The system was then mounted level on the front of the dump truck at a height of 1.32 m (52 in) (figure 29). Lower mounting heights may cause an increase in false alarms due to detection of the ground. There were no false alarms when the truck was moved forward in a clear field. Cinder block detection again occurred sporadically at a distance of 6.1 m (20 ft).

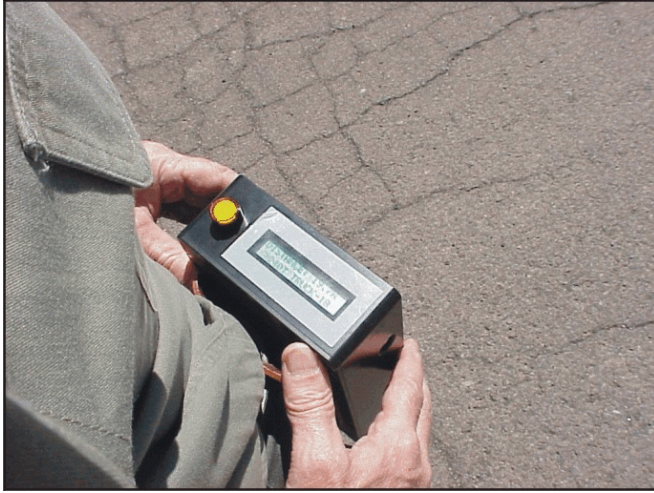
Figure 34.—Buddy system prototype tag on worker's belt.

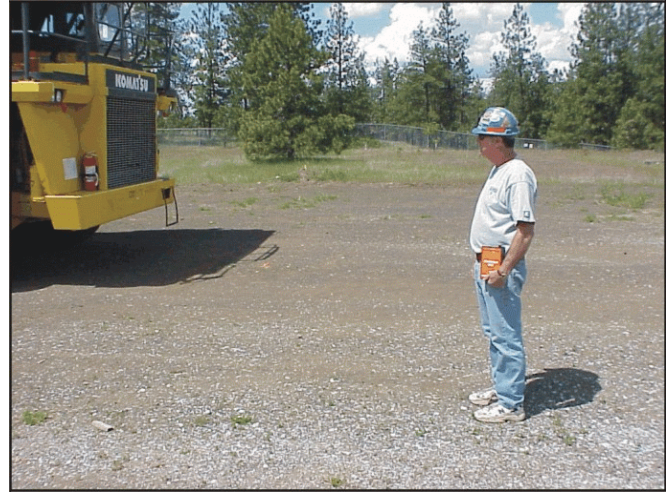
Figure 36.—Determining detection zone of Buddy system and a person.

This system was tested by attaching the tag to the belt of a person who then walked around the truck and noted when an alarm was sounded in the cab and on the tag (figure 36). The loop antenna was placed on the front deck of the dump truck and attached to the railing in a near-vertical position (figure 33). The communications antenna was also placed on the front deck of the truck. The alarm display was monitored by the truck driver.

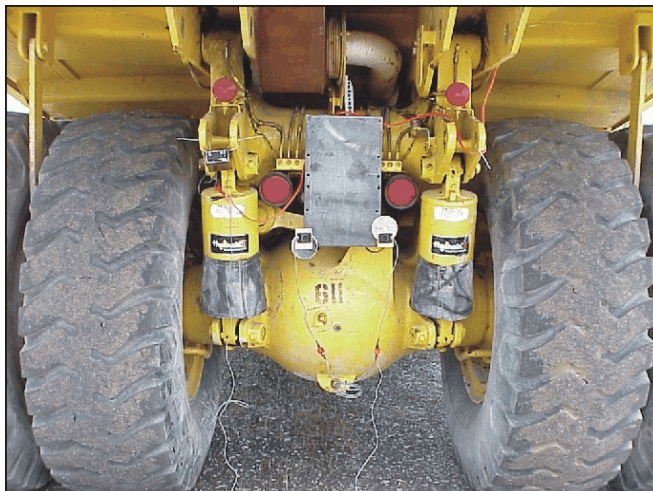
Figure 38.—Rear Guard sensors mounted on rear of dump truck.

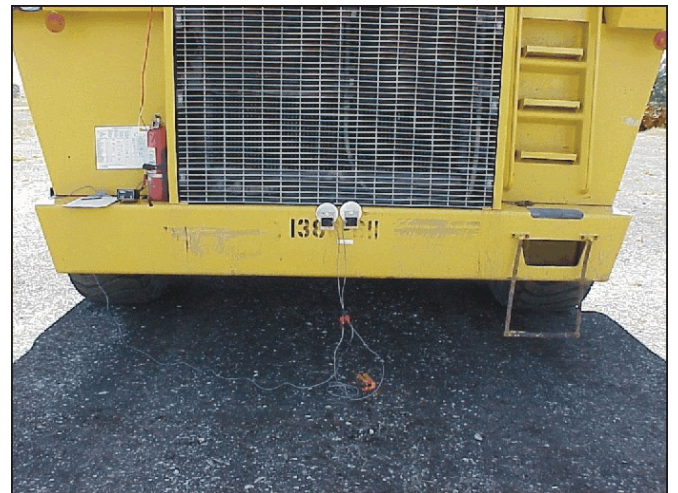
**Figure 42.—Rear Guard system's ultrasonic sensors mounted close together on front bumper.**

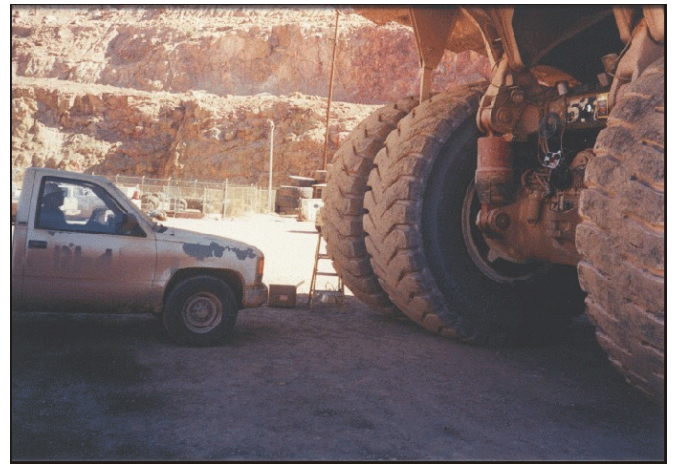
**Figure 45.—Determining detection zone for a pickup Caterpillar 793B.**
