# Unreinforced Masonry Buildings and Earthquakes

Developing Successful Risk Reduction Programs

FEMA P-774 / October 2009

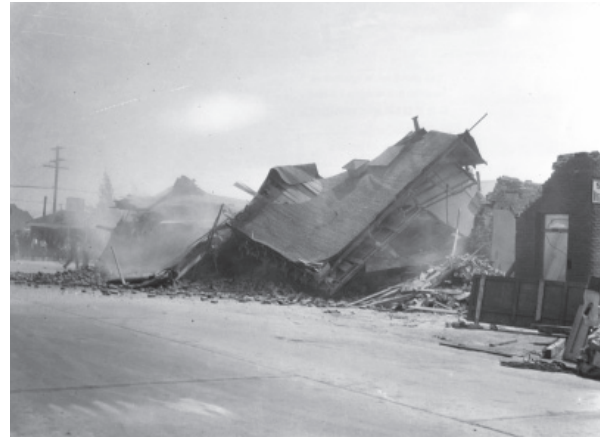
■ **Figure 3. Complete collapse of an unreinforced brick building.**

The most severe level of damage, with the greatest likelihood of fatalities, is complete collapse. After a few seconds of ground shaking in the 1933 Long Beach earthquake, the brick walls holding up the second floor and roof of this building broke apart. That not only caused the fall of hazardous brick debris—it also immediately led to complete collapse. —*Los Angeles Public Library*

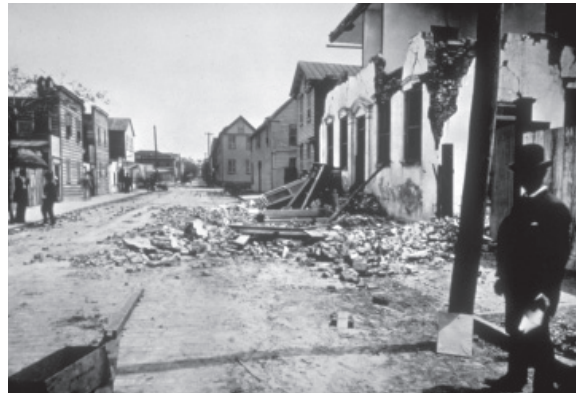
■ Figure 13. Debris resulting from the 1886 Charleston, South Carolina earthquake.  
—NISEE, U.C. Berkeley

**1886 Charleston Earthquake, South Carolina, M 7.7:** Eighty-two percent of the brick buildings suffered more than minor damage, and 7% collapsed or were demolished.<sup>5</sup> See Figure 13, illustrating the debris from collapsing second story masonry walls, which extends beyond the middle of the street.

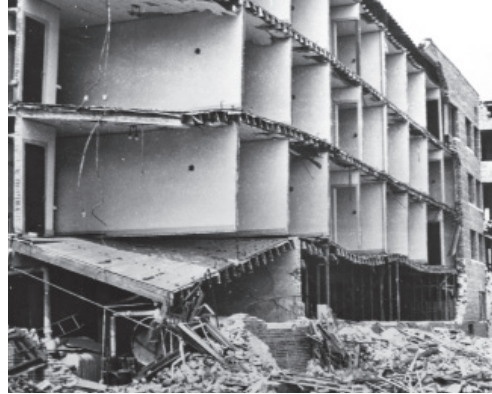
■ Figure 14. Heavily damaged Hotel Californian, 1925 Santa Barbara, California earthquake. —NISEE, U.C. Berkeley

**1925 Santa Barbara Earthquake, Southern California, M 6.2:** The most severe damage from this earthquake occurred among unreinforced brick commercial and residential construction and was a primary motivation for engineers in California to adapt seismic design ideas from Japan into the *Uniform Building Code*. Forty percent of the unreinforced masonry buildings were severely damaged or collapsed.<sup>6</sup> See Figure 14, the Hotel Californian, in which extensive wood-frame and plaster partitions barely managed to hold the building up, after exterior brick walls failed.

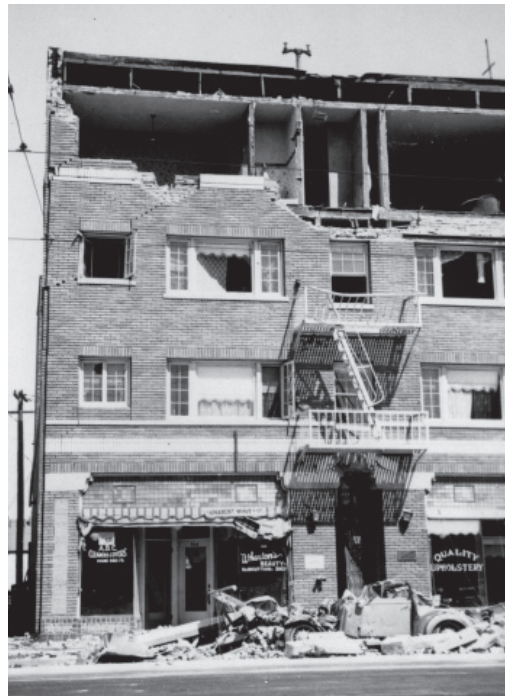
■ Figure 15. URM building damage, 1933 Long Beach, California earthquake. —Los Angeles County Public Library

**1933 Long Beach Earthquake, Southern California, M 6.3:** In the City of Long Beach (adjacent to the City of Los Angeles), 54% of the unreinforced masonry buildings ended up with damage that ranged from significant wall destruction to complete collapse. In 20% of the cases, damage fell in the categories of either damage to more than half the wall area, partial collapse, or complete collapse.<sup>7</sup> See Figure 15, showing parapet (the short walls that often extend around the perimeter of a roof) and top story failure and the effect of the falling masonry debris.

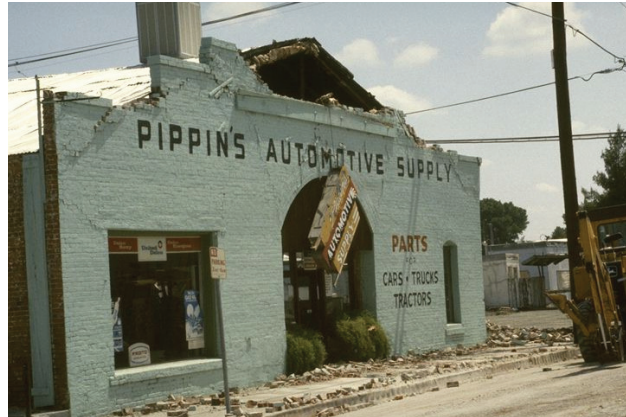
■ **Figure 16. URM building with end-wall failure, 1983 Coalinga, California earthquake.** Robert Reitherman  
—NISEE, U.C. Berkeley

**1983 Coalinga Earthquake, Central California, M 6.2:** Out of 37 unreinforced masonry buildings—the core of the Coalinga business district—only one escaped damage. Sixty percent were damaged to the extent of having more than half of their walls ruined, up to complete collapse.<sup>8</sup> The entire downtown area was cordoned off, until badly damaged buildings could be demolished and the debris removed. See Figure 16, which illustrates a common form of damage, in which the gable (peaked roof) end wall falls.

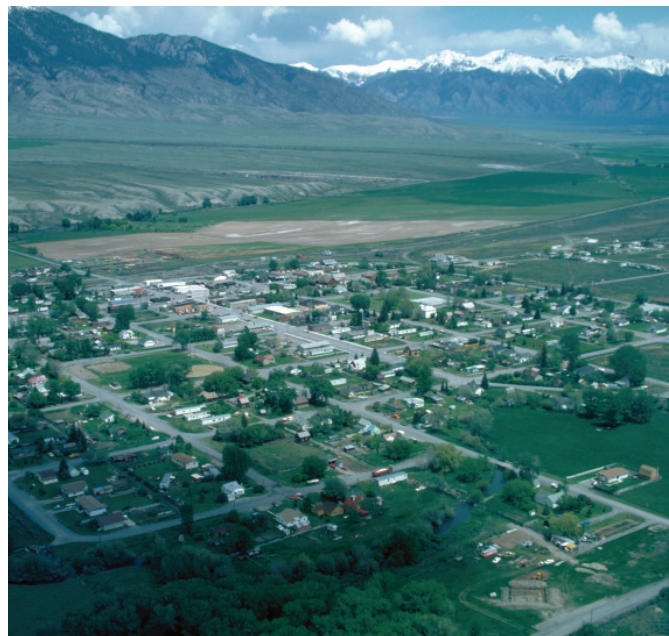
■ **Figure 17. Aerial view of heavily damaged Mackay, Idaho.** The unreinforced masonry buildings on the main commercial street of the small town were badly damaged in the 1983 Borah Peak, Idaho earthquake.  
—NISEE, U.C. Berkeley

**1983 Borah Peak Earthquake, Idaho, M 7.3:** In the town of Challis, Idaho, the only earthquake-related fatalities occurred when an unreinforced masonry wall fell on two children on their way to school. In Mackay, the town's main street buildings, built of unreinforced brick, concrete block, or stone, were all damaged, Eight required demolition. In relative terms, when compared to the size of the town (see Figure 17), this amount of damage constituted a large disaster.

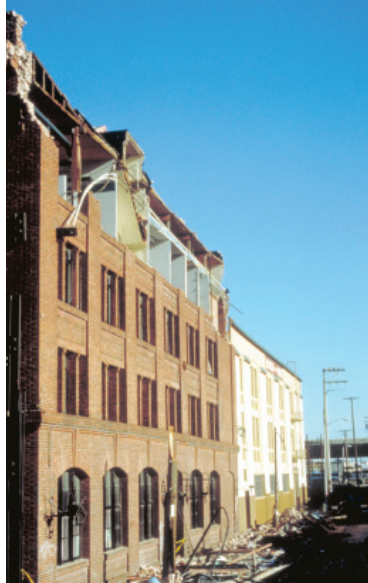
■ **Figure 18. Upper story wall collapse, with resulting fatalities.**

**1989 Loma Prieta Earthquake, Northern California, M 7.1:** In this earthquake, 374 (16%) of the 2,400 unreinforced masonry buildings in the region experienced damage severe enough to require that they be vacated.<sup>9</sup> The earthquake was centered 60 miles south of the San Francisco Bay Area, and the majority of these buildings were subjected to only light to moderate shaking. Figure 18 illustrates an upper-story failure of brickwork, which fell onto the sidewalk and cars below, killing five people.

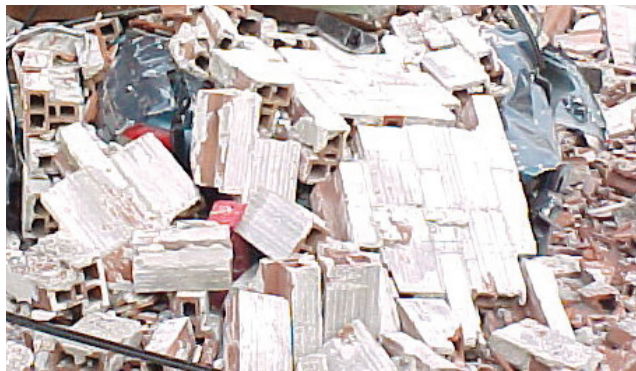
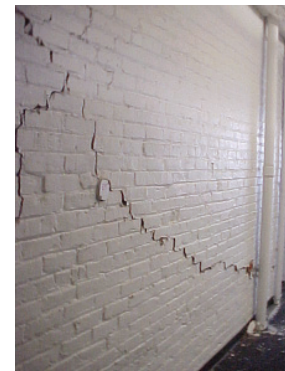
■ **Figure 19. URM building damage, 2001 Nisqually, Washington earthquake.**

At left, hollow clay tile debris from a collapsed wall; at right, diagonal “stair-step” cracking of a brick wall (the crack following mortar horizontal bed joint and vertical head joint lines), a sign of the wall’s inability to resist shear stress from in-plane forces. —André Filiatraut

“URM buildings built before 1950 exhibited the poorest behavior. The most common damage included shedding of brick from parapets and chimneys. Other URM buildings exhibited diagonal ‘stair-step’ cracking in walls and piers, damage to walls in the upper stories, vertical cracking in walls, damage to masonry arches, and damage to walls as a result of pounding. In many cases, fallen brick resulted in damage to objects, such as cars and canopies, outside the building.”<sup>10</sup> See Figure 19.

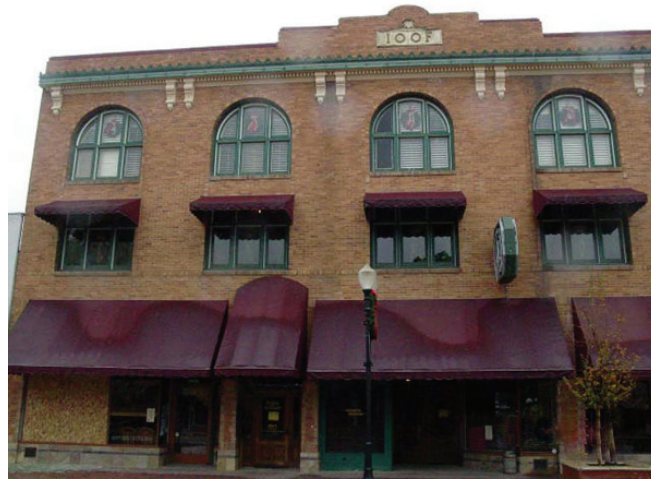
■ **Figure 20. Retrofitted URM building, 2003 San Simeon, California earthquake.**

Retrofitted prior to the earthquake, this unreinforced brick building experienced no damage. —Janise E. Rodgers, NISEE, U.C. Berkeley.

**2003 San Simeon Earthquake, Central California, M 6.5:** Of 53 unreinforced masonry buildings in Paso Robles, the nearest affected city, none of the nine that had been retrofitted experienced major damage. Many of the others were damaged so extensively that they were subsequently demolished. “During earthquakes unreinforced masonry buildings that have not been retrofitted continue to be the most dangerous buildings in California.” One building owner commented afterward: “I’m confident the building would have come down in the quake if we hadn’t done the retrofiting. There were times when we were bleeding so badly in paying for it, we wondered what in the heck we were doing. Now we know.”<sup>11</sup> See Figure 20. The two fatalities in the town were due to the collapse of an unretrofitted, unreinforced brick building.

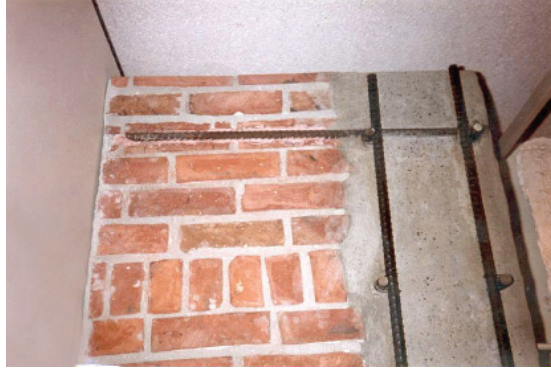
■ **Figure 31. California Capitol Retrofit.**

The strongback column spans from foundation to roof, serving to brace a brick wall against out-of-plane forces. —*Consortium of Universities for Research in Earthquake Engineering*

Another approach is to install columns attached to the walls, which act like splints or *strongbacks* that brace the wall against excessively bowing outward or inward (see Figure 32). Yet another wall strengthening method is to drill holes down through the wall from top to bottom, using machinery adapted from the oil well industry to insert a steel bar and grout. Interior partitions can also help to stiffen the overall box structure and can damp out or absorb its vibrations. Each retrofit brings its

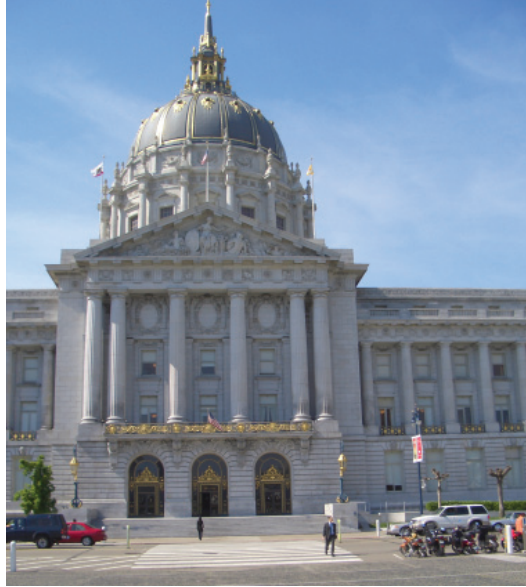
■ **Figure 33. The San Francisco City Hall seismic retrofit, which includes seismic isolators.** —*Robert Reitherman*
