# The World Trade Center Bombing: Report and Analysis

New York City, New York

USFA-TR-076/February 1993

## U.S. Fire Administration Fire Investigations Program

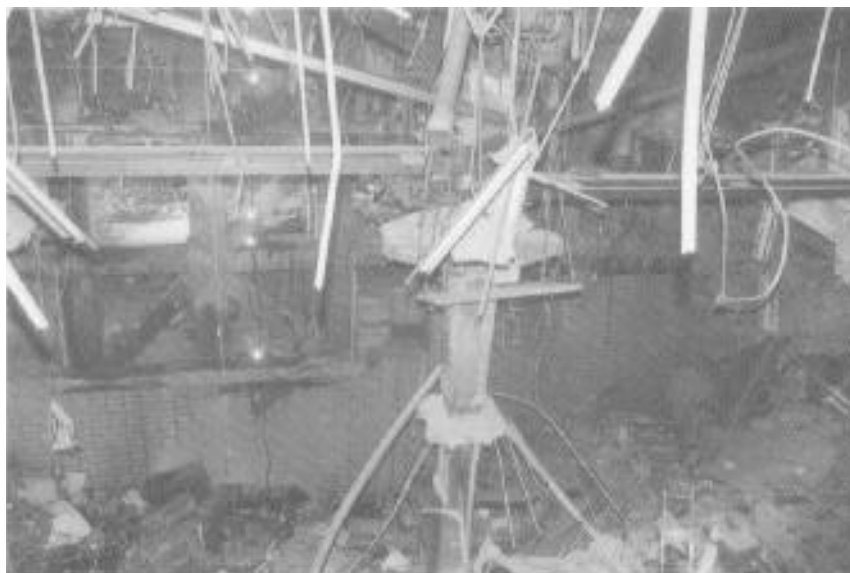
**A view of the crater from the B-1 to B-5 levels. Note the steel column. Horizontal supports were destroyed in some cases, but the columns did not give.**

- An L-shaped crater, approximately 130 by 150 feet at its maximum points, was opened, collapsing reinforced concrete and debris onto levels below.
- At least nine steel columns were heavily damaged and left without lateral support.
- Many walls collapsed, including a concrete block wall adjacent to the blast area that collapsed onto and killed five WTC personnel.
- Doors/enclosure walls of Tower 1 elevator shafts were heavily damaged.

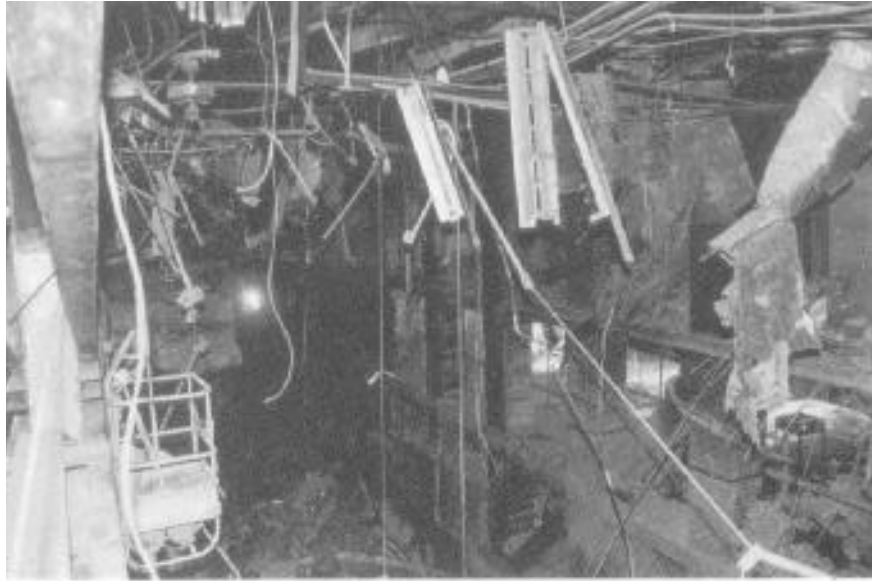
**Firefighter Shea's fall was a long one—some 40 feet. The smoke condition in the crater was such that visible contact with Shea was impossible.**

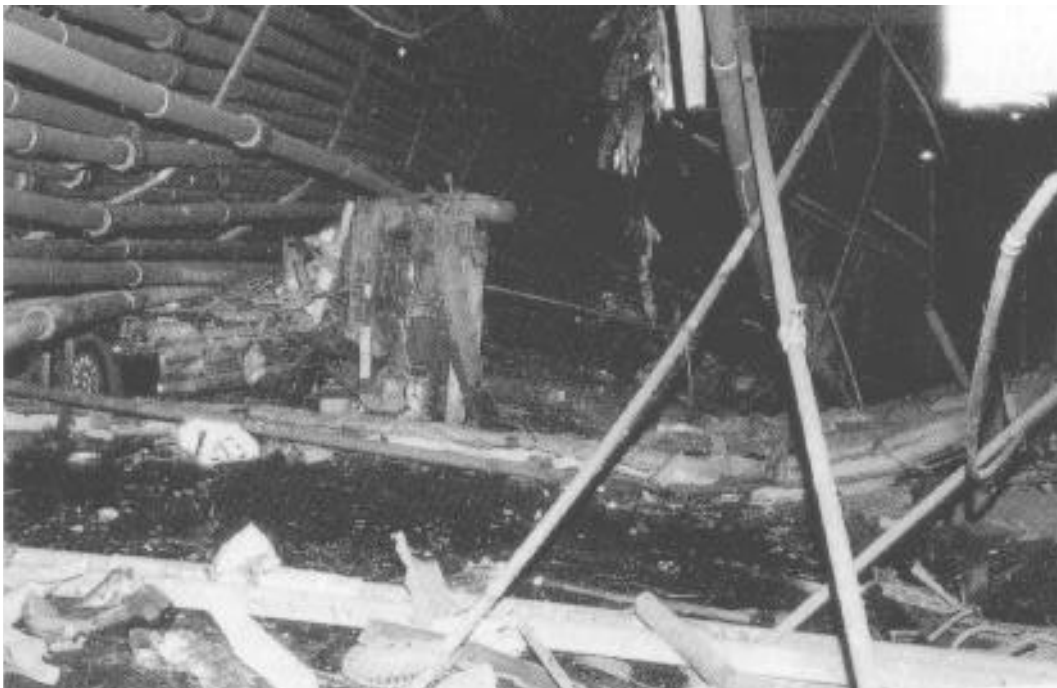
**Building systems in the vicinity of the blast were destroyed. Here, twisted electrical conduit has landed on top of what was once a car.**

**Damage/hazard assessment.** Lights were brought into the below-grade areas. Damage from the blast was extensive. The B-2 level surrounding ground zero was completely destroyed. Piping and conduit were snapped like twigs. Masonry walls and steel-reinforced concrete flooring were blown apart. Cars were strewn about like toys. Steel columns were shocked but held.

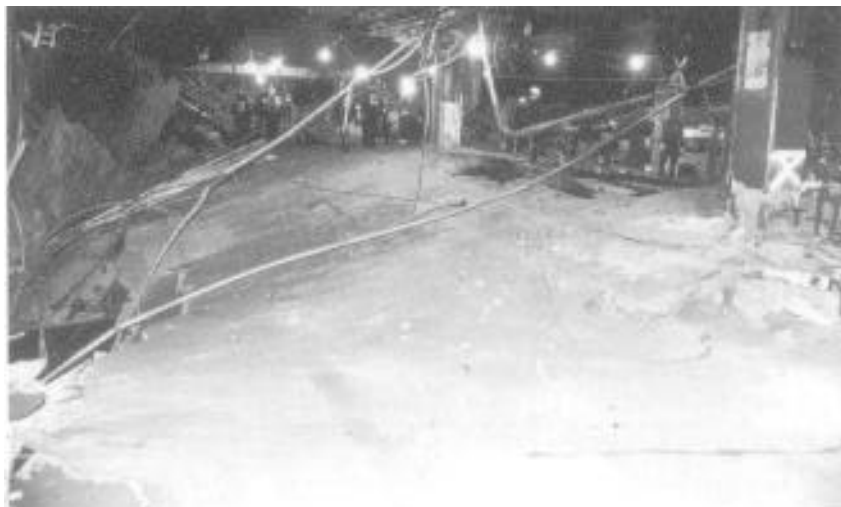
**The sloping, hanging steel-reinforced concrete floor at the perimeter of the crater was a major hazard for units operating on the crater fire, particularly in the heavy smoke condition.**

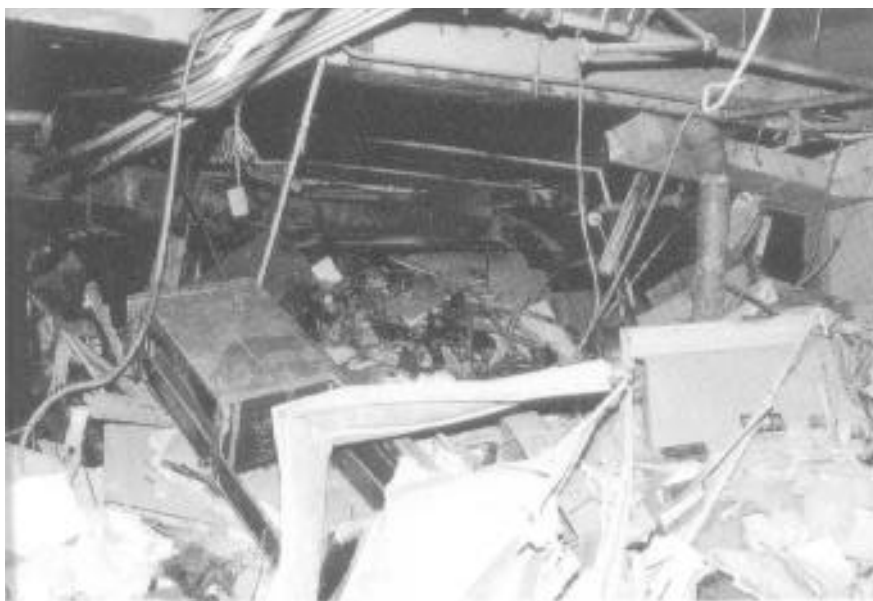
**This destroyed office area on the B-2 level is typical of the debris piles faced by searching firefighters.**

Port Authority personnel assisted by establishing a probable victim location in occupied work areas on the B-2 level under the Vista Hotel and Tower 1. The blast destroyed a dividing wall between the garage and this work area (demolished, it was later found, by a steel support beam hurled through it with the unimaginable force created by the blast). A search first was concentrated in this area, and four fatalities were located and removed by FDNY to a temporary morgue established in the Vista Hotel. Five of the six fatalities in this incident were removed within the first two hours. (One victim was found by FDNY on a driveway ramp early in the incident.) The sixth victim was located in rubble by police personnel during their investigation 17 days later.
