U.S. Fire Administration/Technical Report Series

The World Trade Center Bombing: Report and Analysis

New York City, New York

USFA-TR-076/February 1993

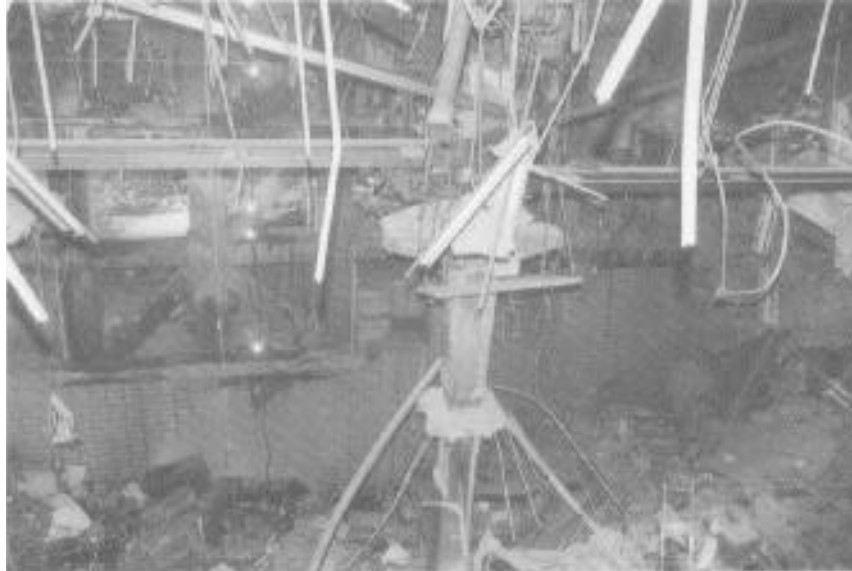
A view of the crater from the B-1 to B-5 levels. Noe the steel column. Horizontal supports were destroyed in some cases, but the columns did not give.

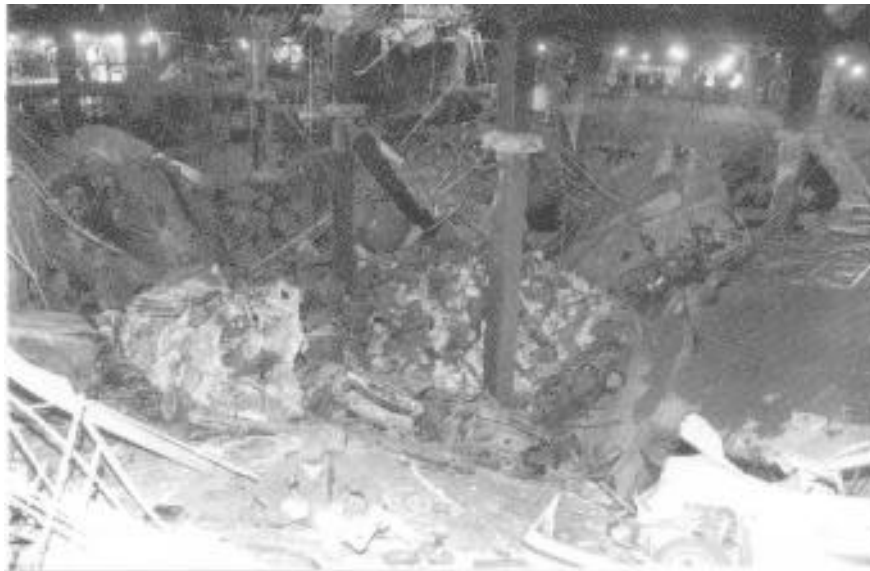
The crater, looking from the B-2 level down to B-5, taken during the investigation/restoration phase.

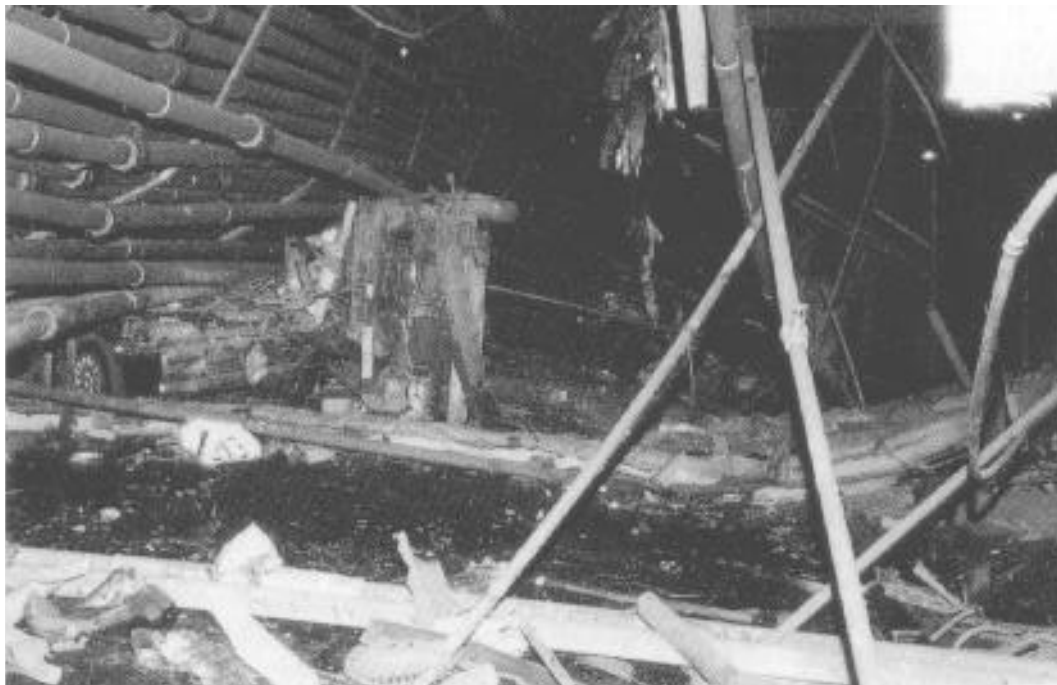
Building systems in the vicinity of the blast were destroyed. Here, twisted electrical conduit has landed on top of what was once a car.

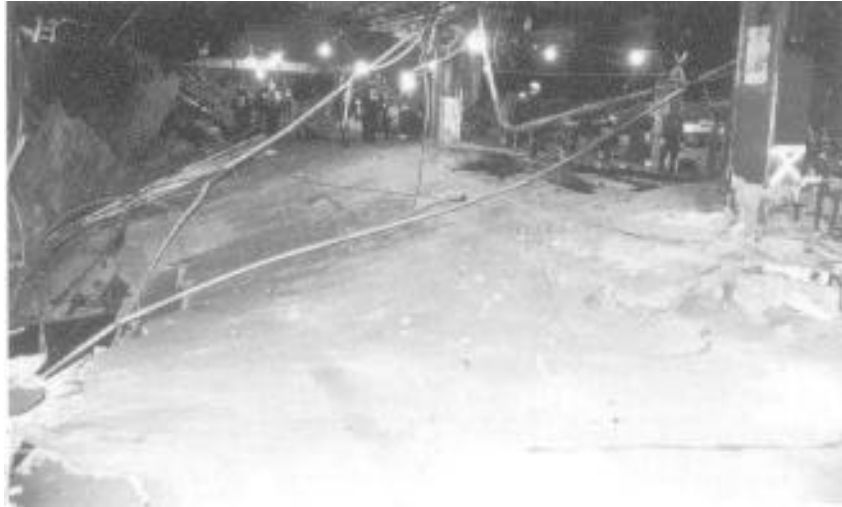
The sloping, hanging steel-reinforced concrete floor at the perimeter of the crater was a major hazard for units operating on the crater fire, particularly in the heavy smoke condition.

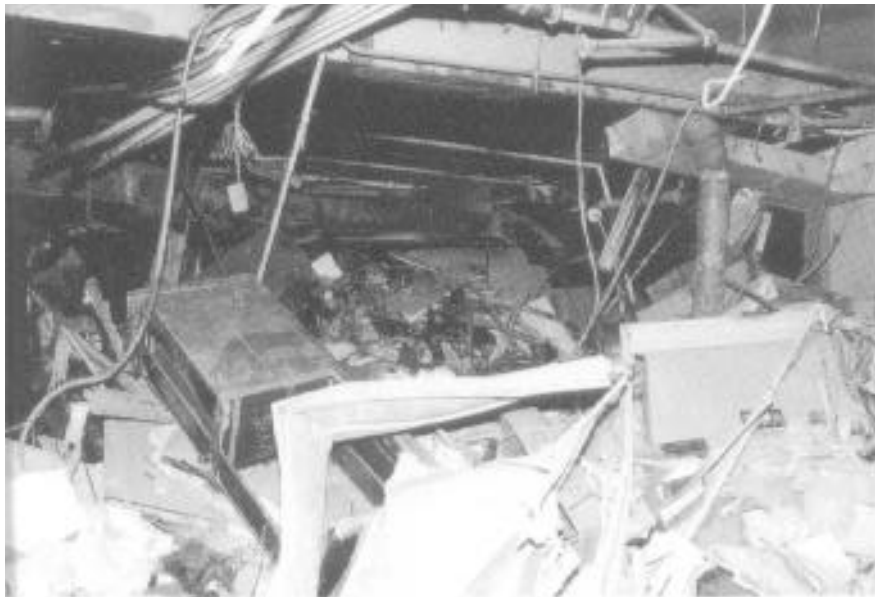
This destroyed office area on the B-2 level is typical of the debris piles faced by searching firefighters.

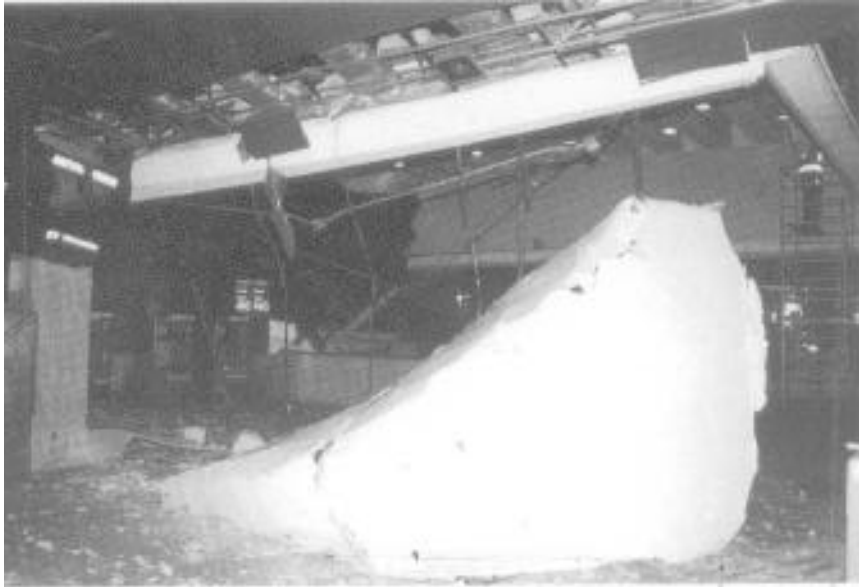
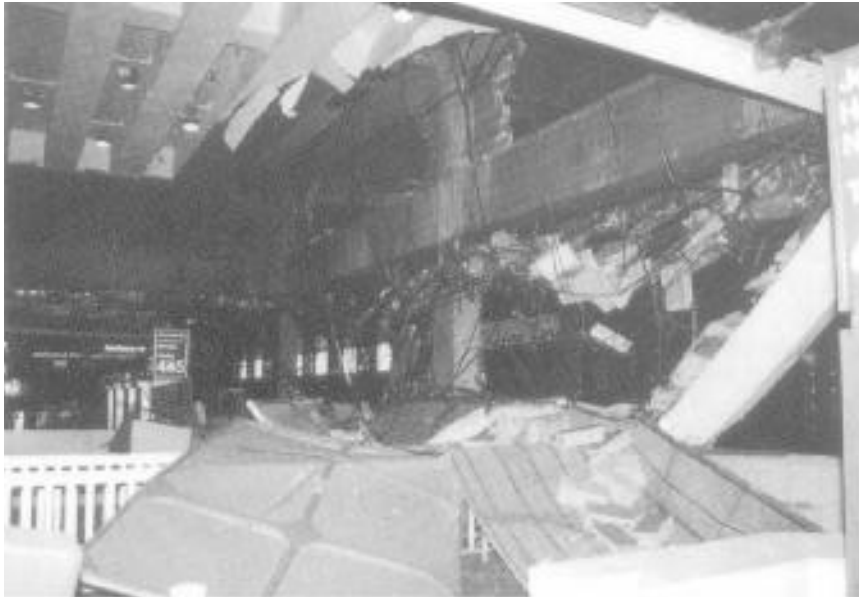
The explosion collapsed a portion of ceiling on the B-5 level onto a PATH train concourse.

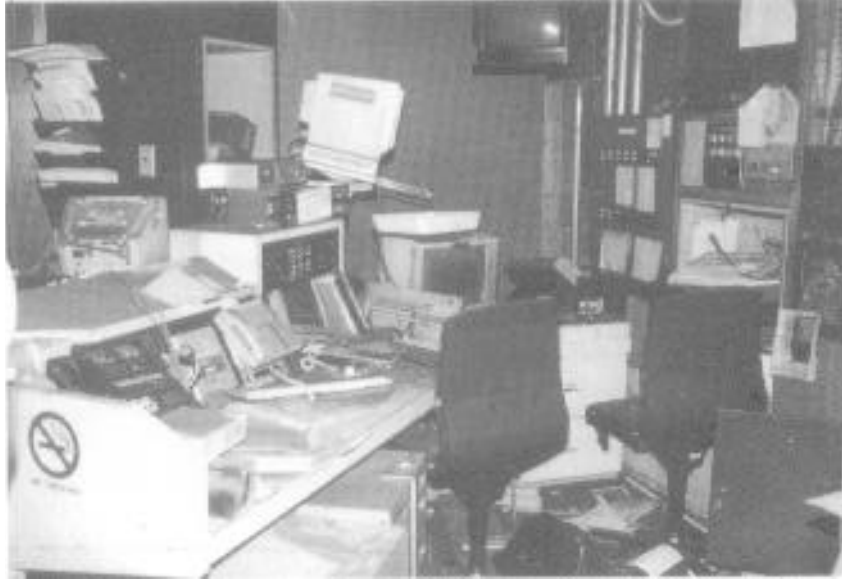
The Port Authority Command/Communications Center on the B-1 level, approximately 50 feet from the blast hole on that level, was damaged and communication with occupants in the towers was lost.

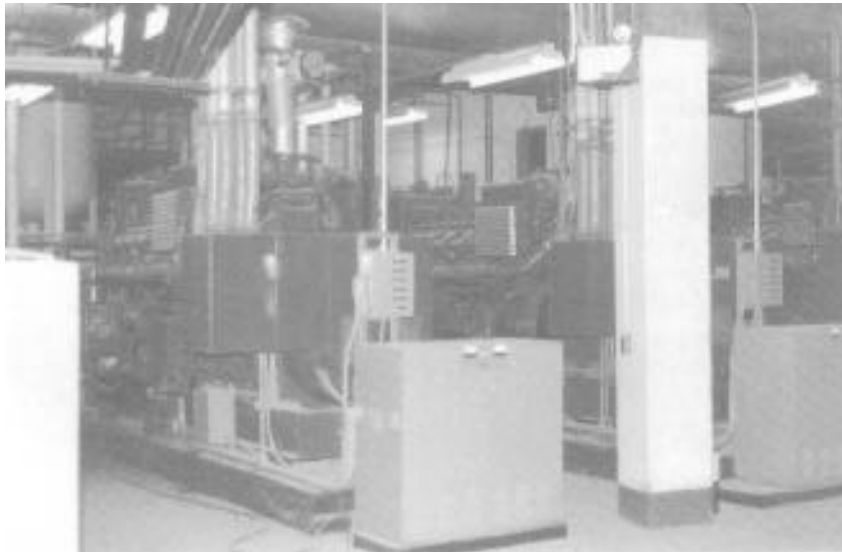
Emergency generators on the B-6 level. Cooling water lines for these unit were ruptured by the blast, shutting down all emergency power.

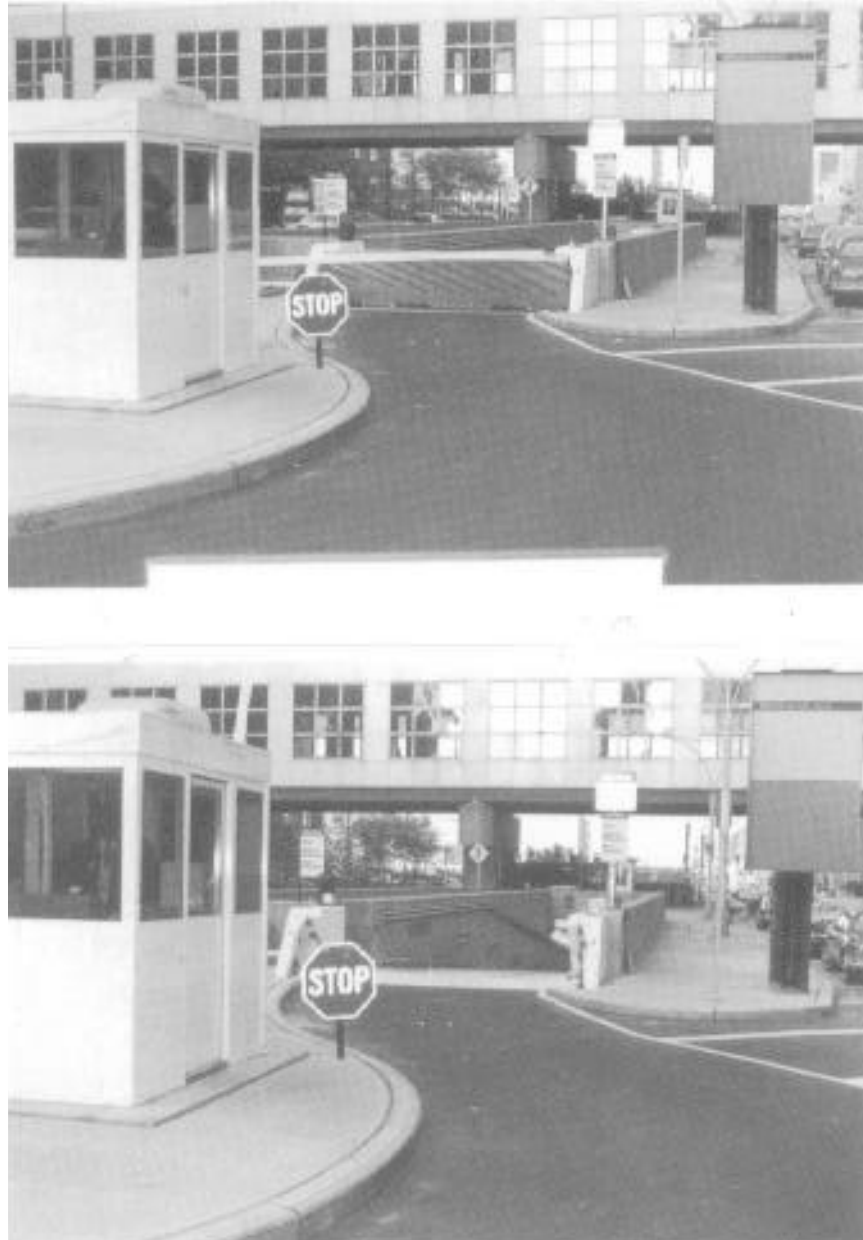
Controlling access to public buildings is a major concern for building management. After the incident, Port Authority, in addition to many security changes, installed substantial barriers to unauthorized vehicle access. The barrier, controlled by security personnel in the booth, folds down when the driver has been cleared to enter.
