# Seafloor Disturbance and Recovery Monitoring at the Block Island Wind Farm, Rhode Island - Summary Report (Year 6)

February 2022

CSA Ocean Sciences Inc. (CSA) has prepared this Seafloor Disturbance and Recovery Monitoring at the Block Island Wind Farm, Rhode Island - Summary Report (Year 6) to document the methods, data, observations, results, and major conclusions from seafloor disturbance and recovery monitoring survey conducted in and around the Block Island Wind Farm (BIWF) located off of Block Island, Rhode Island (**Figure 1**) during the summer of 2021. The results of this monitoring effort are compared to the previous BIWF seafloor monitoring results (Fugro 2019) to effectively evaluate disturbance and recovery since the previous survey which occurred in September 2018.

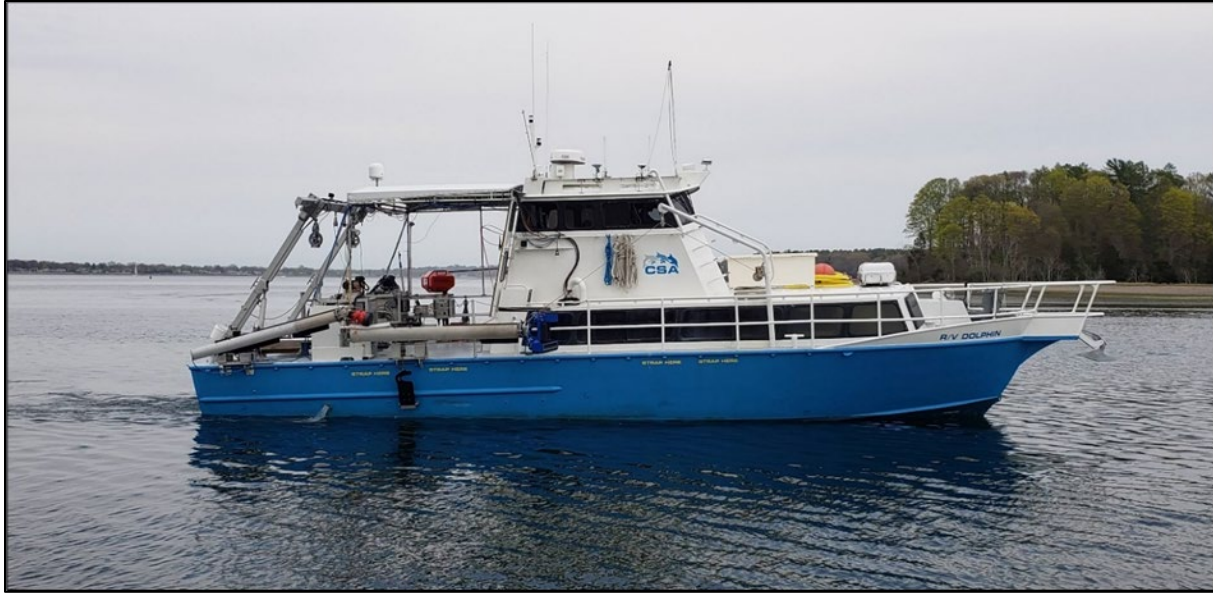
The survey was conducted from the R/V *Dolphin*, a 49 ft (15 m) aluminum multipurpose marine science platform specially configured to support geophysical survey operations (**Figure 2**). The vessel layout includes a large aft working deck, a raised wheelhouse with 360° viewing windows, and a structured multi-use service area below decks.

**Figure 2. The 49 ft (15 m) R/V *Dolphin* utilized during the Block Island Wind Farm Geophysical Survey with starboard side pole mount**
