# Implementing a Rapid Deployment Bridge Scour Monitoring System in Colorado, 2019

Scientific Investigations Report 2022–5023

By Mark F. Henneberg and Rodney J. Richards

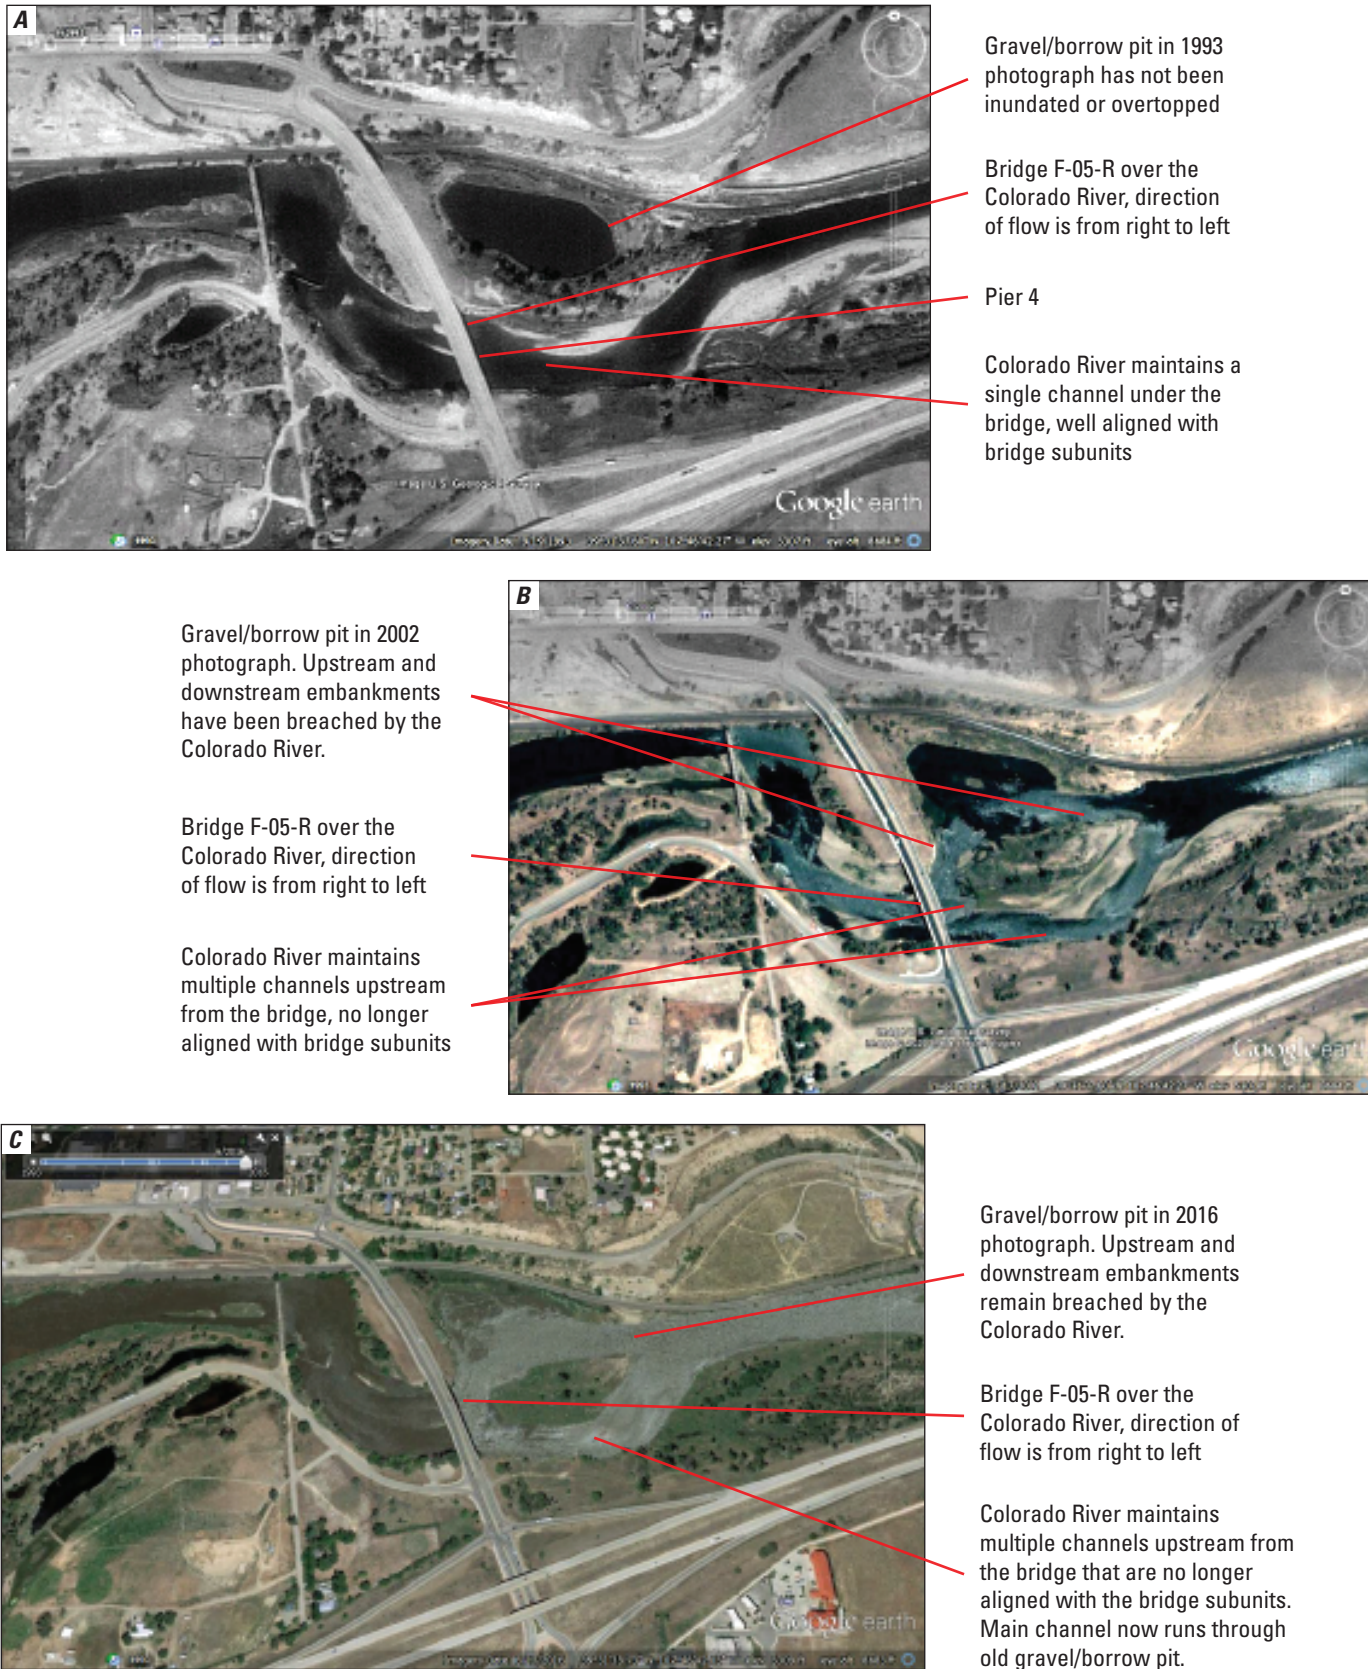
**Figure 5.** Satellite photographs of bridge F-05-R from *A*, 1993, *B*, 2002, and *C*, 2016 that illustrate channel alignment changes to the Colorado River near Rifle, Colorado. Base map data from Google, 2016 and U.S. Geological Survey, 1993, 2002.

with the bridge subunits exacerbate scour forces along the upstream right bank, right abutment, and piers 4 and 5 (CDOT, 2015a). A review of historical satellite photographs indicates that the embankment containing a gravel and (or) borrow pit adjacent to the upstream right riverbank (when oriented looking downstream) was overtopped by the Colorado River at some time between 1993 and 2002. The Colorado River subsequently rerouted itself through the inundated gravel pit, changing the course of the river and alignment with the bridge (fig. 5). The bridge is not aligned with the main thread of the river, and in its current configuration, the approach flow has an angle of attack of up to 30 degrees (CDOT, 2015a).

Pier 4, located mid-channel, is the subunit most directly affected by the river alignment change. Pier 4 is now subject to an attack angle of approximately 30 degrees, resulting in scour conditions around the upstream nose and along the right side of the pier (CDOT, 2015a). Because of these conditions, the team elected to place instrumentation on the upstream nose of pier 4 to monitor scour conditions in real-time.
