Carl Sandburg Home National Historic Site

The Swedish House

# Historic Structure Report

September 2005

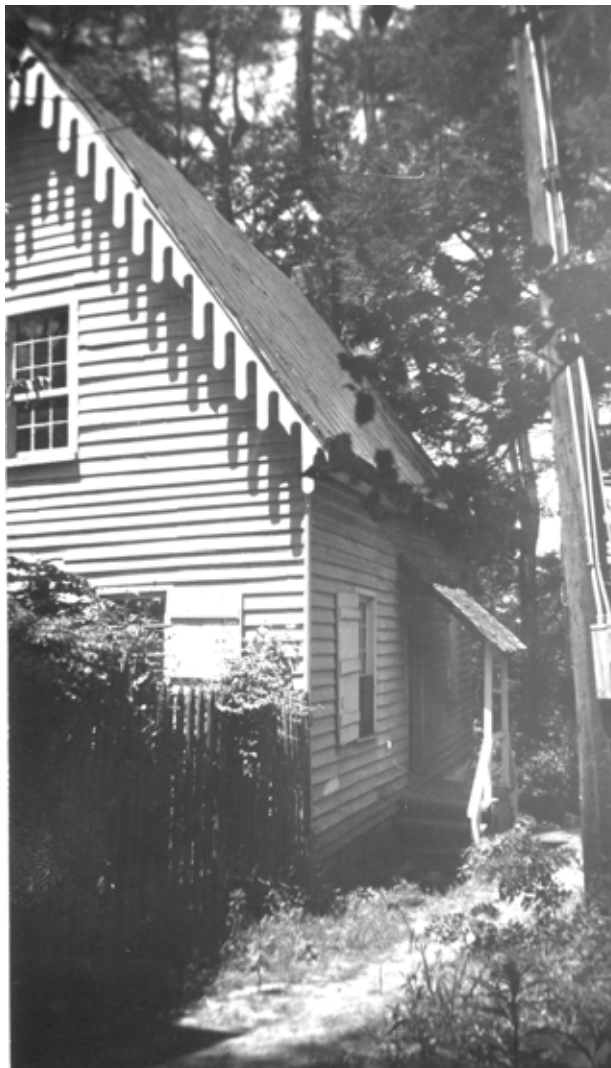
FIGURE 25. Earliest image of Swedish House, 1946, with early wooden steps and porch still intact. (CARL3000/17/1P Coll.)

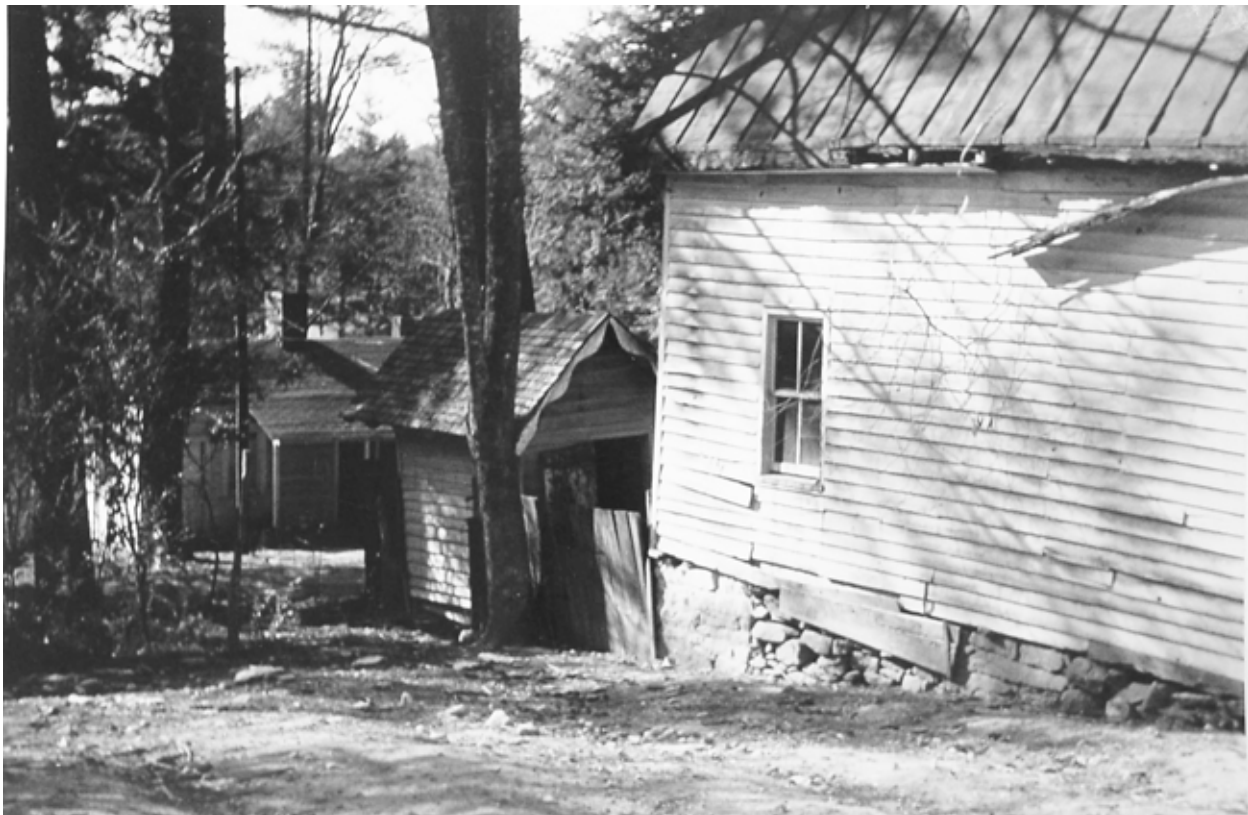
FIGURE 28. View of rear of Swedish House, c. 1964?, with antebellum privy and tenant house in background. (CARL 3000/17/4P)

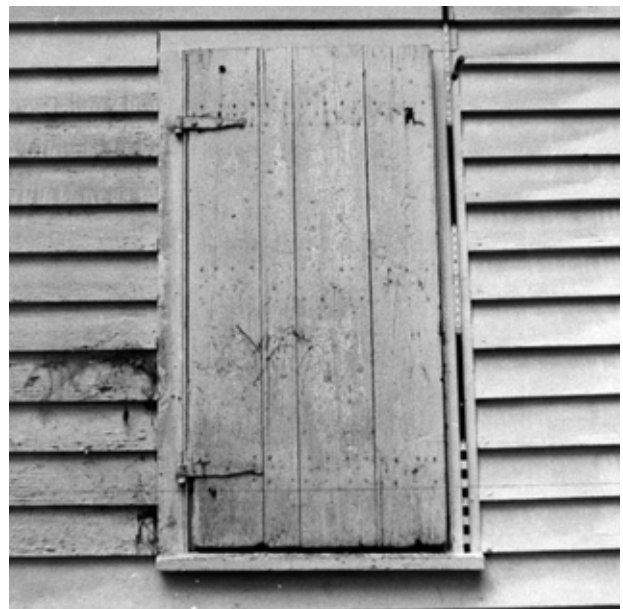
FIGURE 32. View of typical shutter, c. 1970. (CARL5026/2/3P)

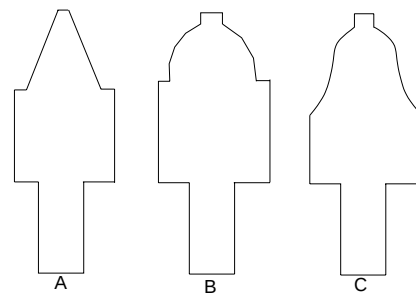
FIGURE 34. Muntin profiles in Swedish House, with Type A representing muntins in original sash and B and C muntins in later replacement sash.

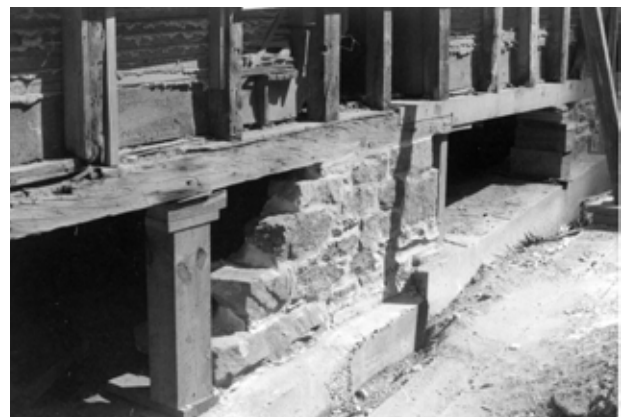
FIGURE 36. View of south foundation during repairs, 1977. (CARL4008/03/25P)

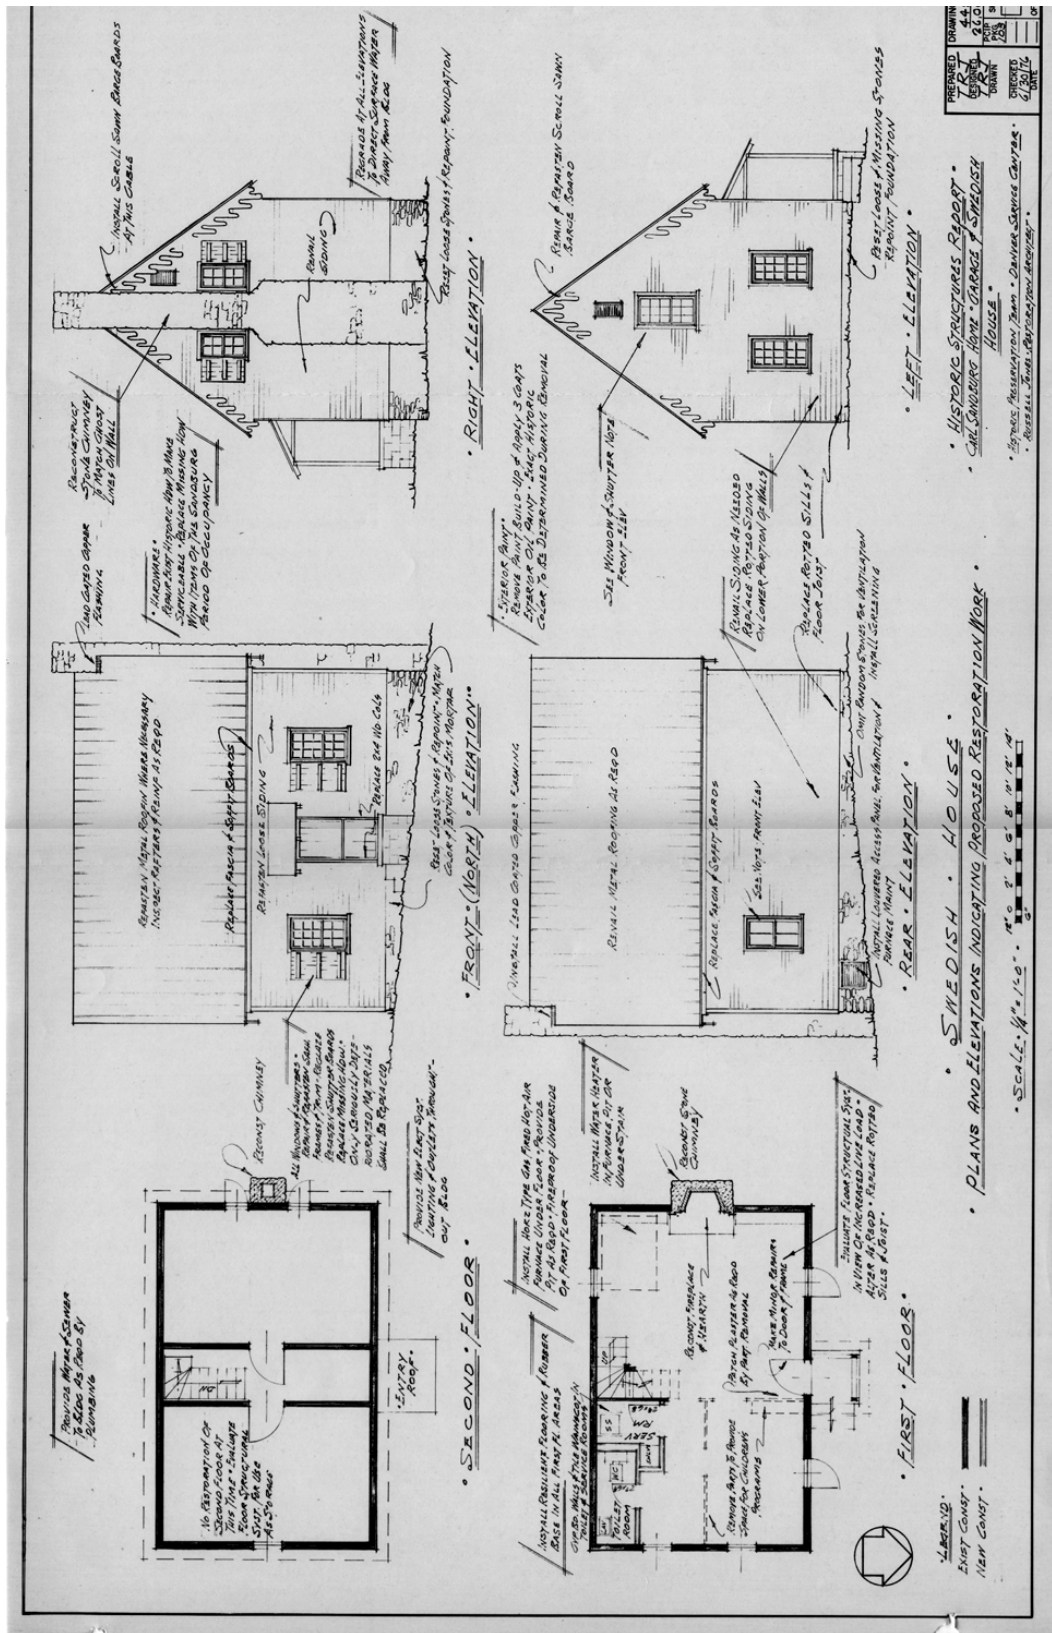
**FIGURE 38.** "Plans and Elevations Indicating Proposed Restoration Work," from Russell Jones' historic structure report on the Swedish House, 1976.

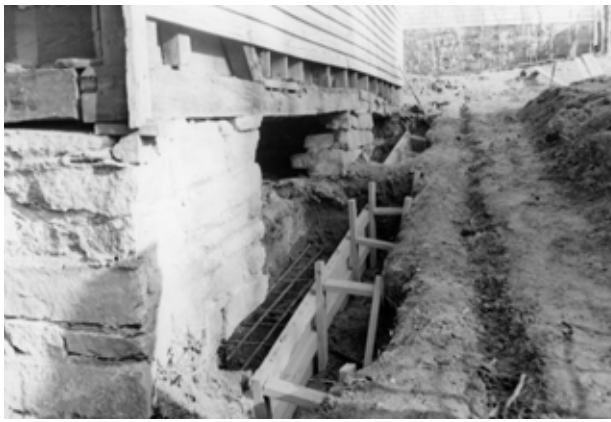
FIGURE 39. View of new footings, 1977. (CARL4008/03/15P)

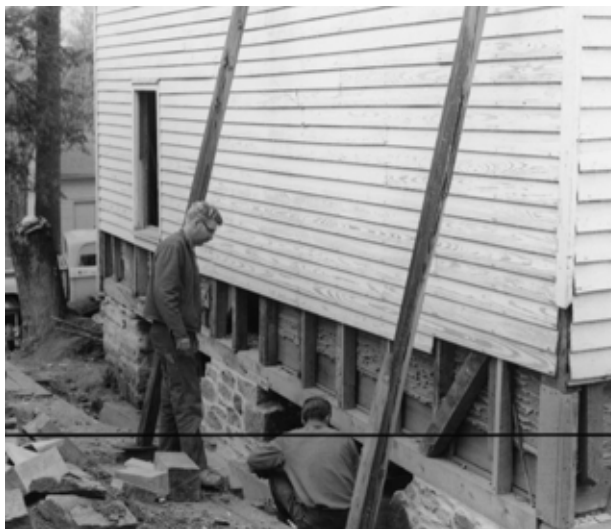
FIGURE 40. Glenn Barnwell, former maintenance employee, standing, inspecting foundation repairs at rear of house, 1977. (CARL4008/03/27P)

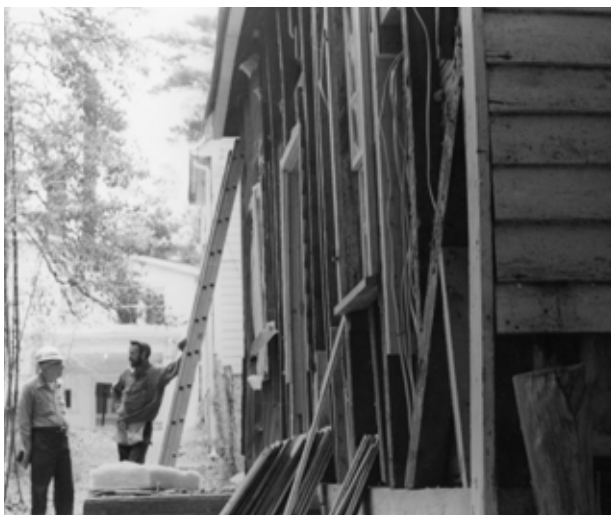
FIGURE 41. Chief of Maintenance Charlie Hamm, left, and Joe Moore, temporary carpenter, at front of house with siding removed, 1977. (CARL4008/03/38P)

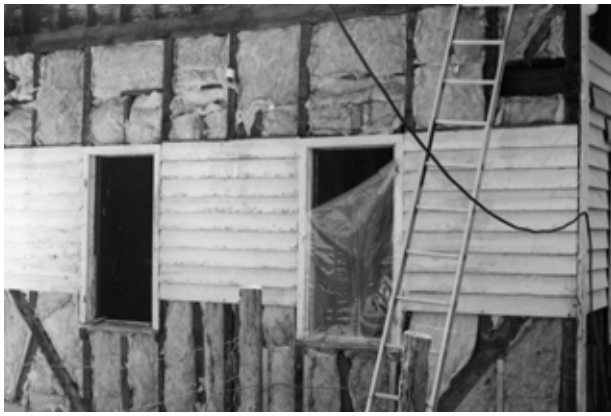
FIGURE 44. View of east end of house after installation of insulation. (CARL4008/03/39P)

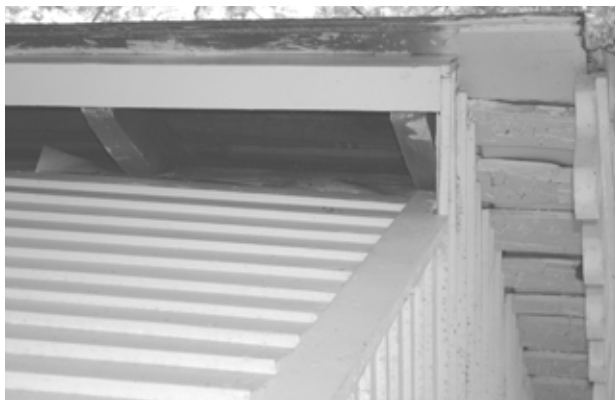
FIGURE 52. View of northwest corner of house, showing typical roof decking and exterior finishes. (T. Jones, NPS, 2004)

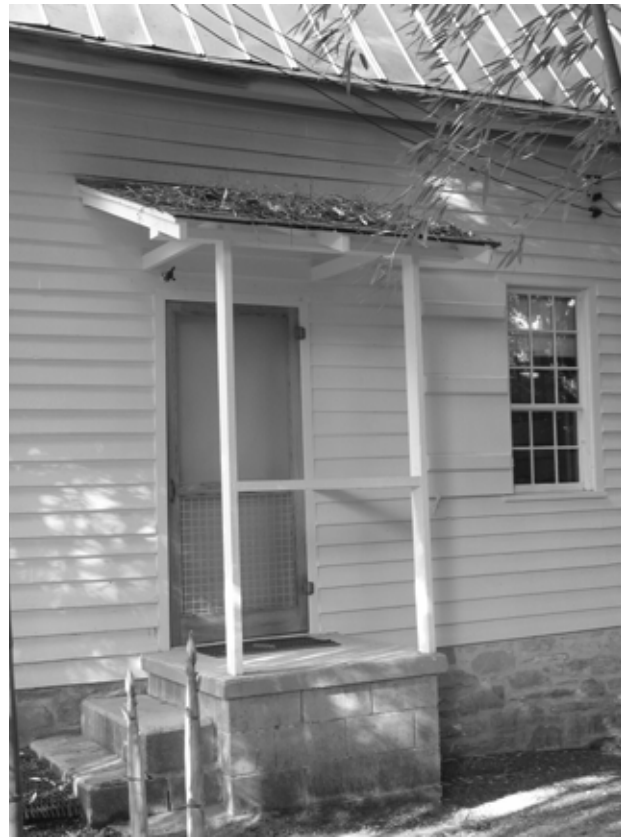
FIGURE 54. View of twentieth-century stoop and shed roof at front door. (T. Jones, NPS, 2004)

Historic photographs show that the small concrete stoop and single flight of concrete steps at the front door were constructed by the Sandburgs prior to 1964 to replace an earlier wooden stoop which had a flight of steps on both its east and west sides. The earlier steps had wooden railings, which were not reconstructed for the concrete steps. At the same time, the shed roof sheltering the stoop was replaced with the present roof, which has a much more shallow pitch than the earlier roof. The archaeological investigation in the 1970s found large stones beneath the existing stoop and suggested that these were an

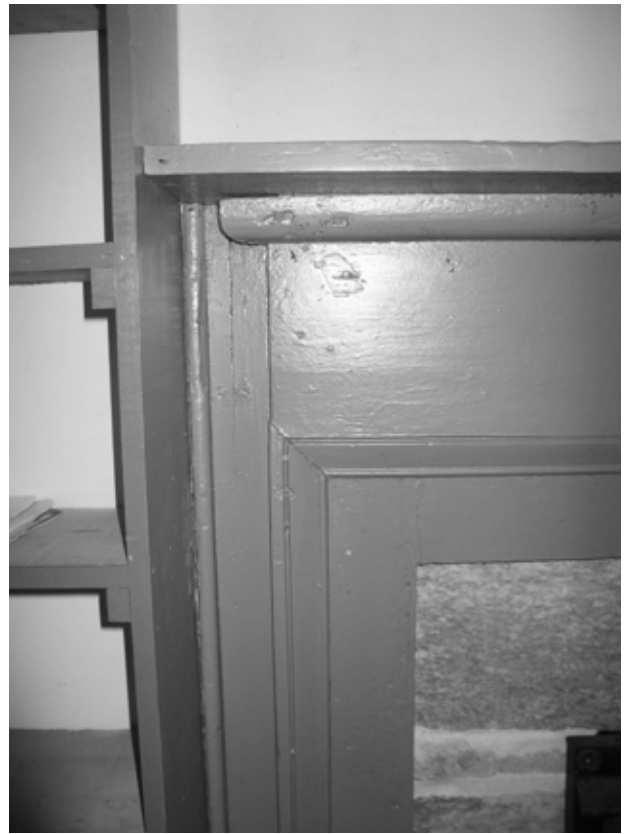
FIGURE 59. Detail view of mantel in Room 100. (T. Jones, NPS, 2004)

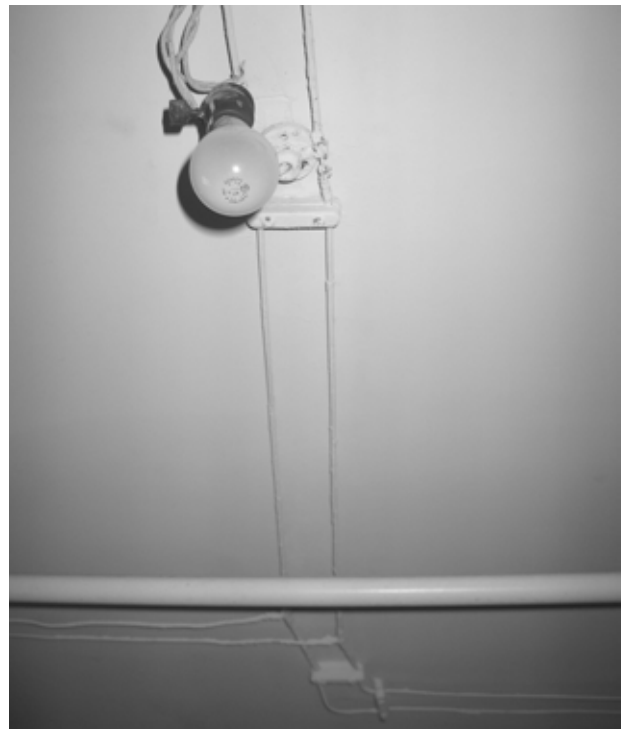
FIGURE 69. View of a portion of the knob-and-tube wiring system, which is no longer active. (T. Jones, NPS, 2004)
