# **CULTURAL LANDSCAPE REPORT FOR ELLIS ISLAND**

**SITE HISTORY, EXISTING CONDITIONS, AND ANALYSIS**

## **STATUE OF LIBERTY NATIONAL MONUMENT**

National Park Service  
Olmsted Center for Landscape Preservation  
Brookline, Massachusetts, May 2003

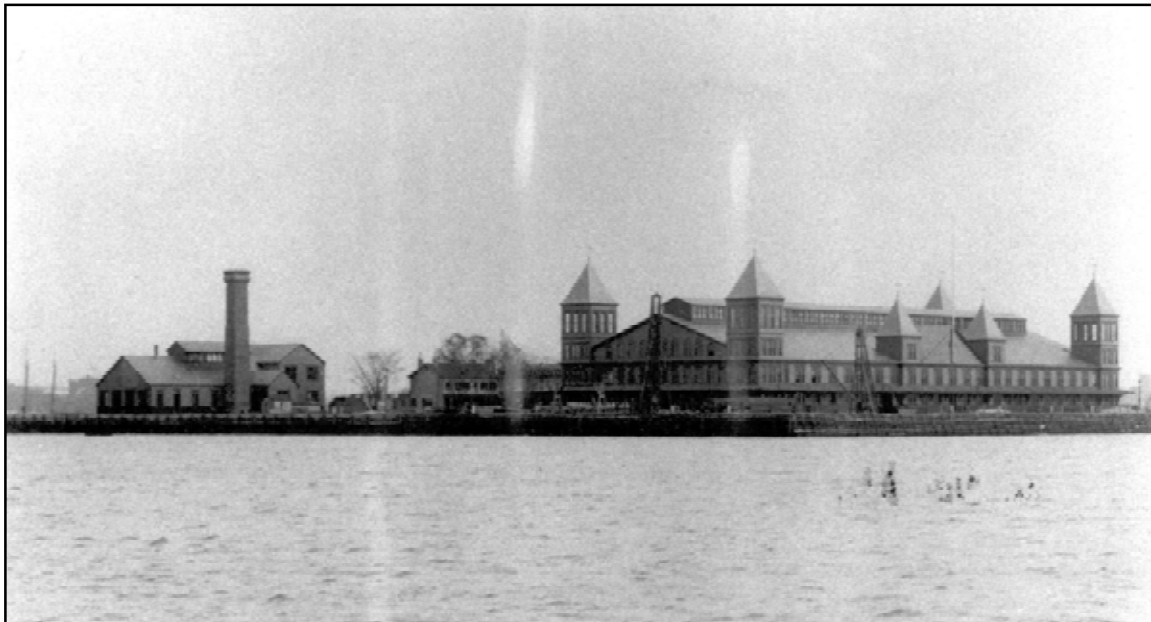
**Figure 2.2** The first immigration station on Ellis Island. The buildings from left to right are the tank and coal house, boiler house, surgeon's quarters, and main building. 1892. (National Archives and Records Administration, RG121-BCP-37D-5)

completed under Department of the Treasury contracts included the construction in 1897 of a new disinfecting house on the eastern side of the detention building, the installation of a covered passageway with a baggage run between the main building and ferry landing, and the addition of a landing dock on the south end of the island. In June 1897 construction on the facility ceased with the installation of underwater cables to New York City for telegraph and telephone service via Governors Island (Figures 2.1 – 2.2).<sup>28</sup>

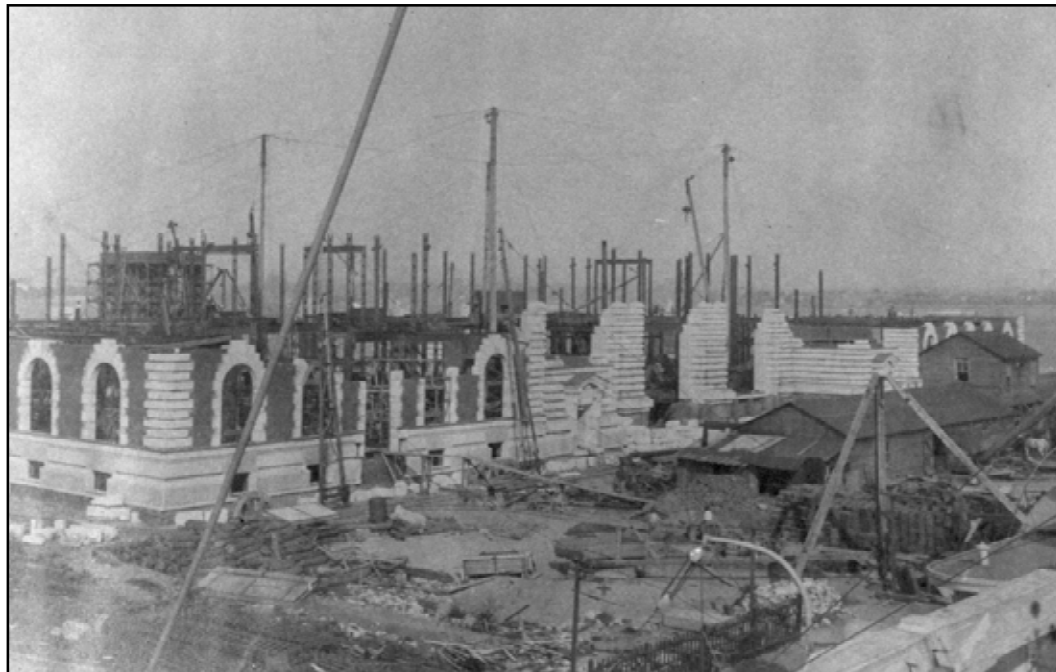
**Figure 3.2** Construction of the main immigration building. Notice the wooden fence remaining from the earlier building in the foreground. June 30, 1899. (National Archives and Records Administration, RG121-BCP-37D-6)

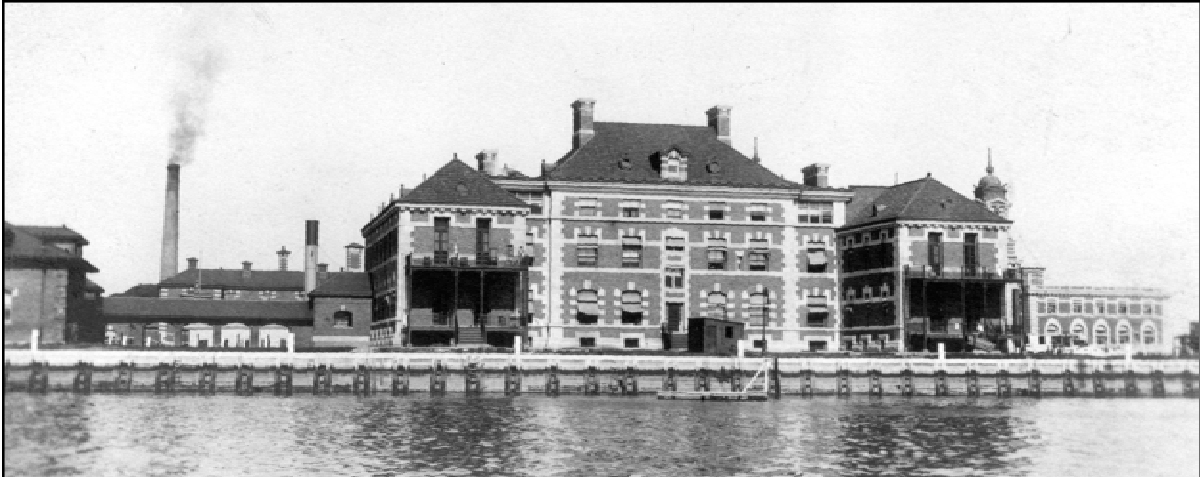
**Figure 3.7** The main hospital building on Island Two, viewed from the south side. Circa 1903. (William Williams Collection, Photography Collection, Miriam and Ira D. Wallach Division of Art, Prints and Photographs, The New York Public Library, Astor, Lenox and Tilden Foundations)

In early February 1898, the Department of the Treasury approved initial plans for the main hospital building on Island Two and work began on installing the pilings. However, construction was soon suspended due to a funding delay by Congress. Complete funding was not acquired until March 1899 when Congress appropriated \$150,000 for the main hospital building, \$9,500 for the surgeon's house, and \$33,340 for the hospital outbuilding. Boring and Tilton developed plans for the main hospital building, while the office of the supervising architect designed the surgeon's house and hospital outbuilding. The plans specified the use of piers on the ground and the avoidance of pilings. A small pump house was also included. After initial bids for the main hospital building came in over budget, Boring and Tilton redesigned the structure for cost savings, and Daniel A. Garber of New York City was awarded the contract on February 20, 1900. Garber finished the contract in April 1901, but only after much conflict between Garber and the authorities, culminating in the contractor having to address a number of construction inadequacies (Figure 3.7).<sup>24</sup>

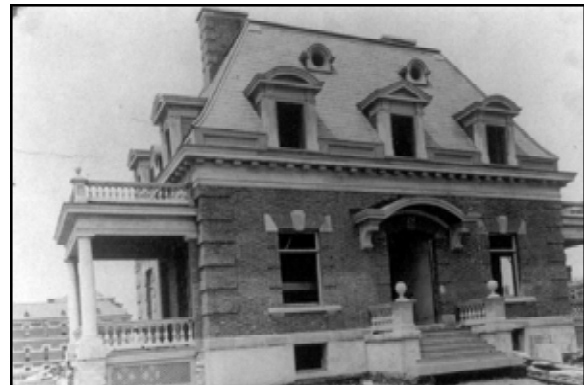
**Figure 3.8** The surgeon's house on Island Two, with the main hospital building in the left background. June 30, 1901. (National Archives and Records Administration, RG121-BCP-37D-1)

Attilio Pasquini of New York City. As with the main hospital building, initial bids for the projects came in over budget, and the office of the supervising architect altered the designs with cost-saving changes. The hospital outbuilding included a laundry, linen room, and autopsy room. The surgeon's house was designed and constructed with a basement; a parlor, kitchen, pantry, dining room, library, and hall on the first floor; and five bedrooms, hall, and bath on the second floor. Pasquini proceeded with construction, and after numerous minor change-orders, completed both buildings by late November 1901 (Figure 3.8).<sup>25</sup>

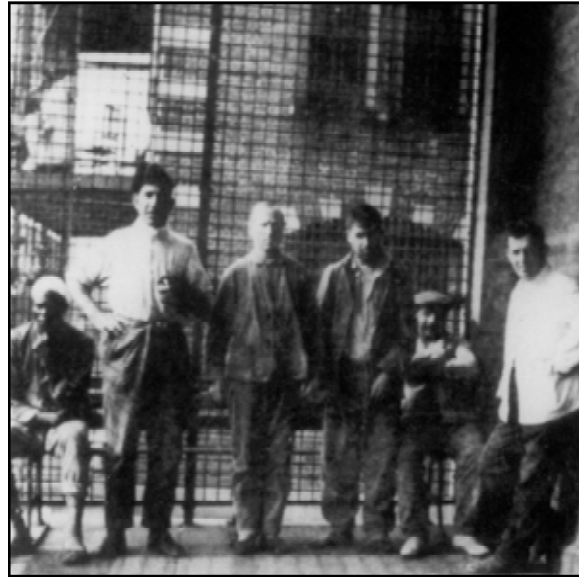
**Figure 3.9** This undated photo, labeled “The porch, men’s psycho ward” was probably taken on Island Two. It is not clear which building is actually in the photo, but this type of enclosed porch was typical of Island Two structures. The structure in the background may be a building originally constructed to house psychopathic patients. (National Archives and Records Administration, RG90-G-125-53[3])

Along with regular hospital patients, there was also an increase in the number of “insane aliens” requiring housing prior to deportation. This led to the construction of the psychopathic ward between the main hospital building and the hospital outbuilding on Island Two. William F. Holding of New York City completed the facility in November 1907. The two-story brick structure could house about twenty-five patients, and contained a small enclosed porch on the south side of the building (Figure 3.9).<sup>28</sup>

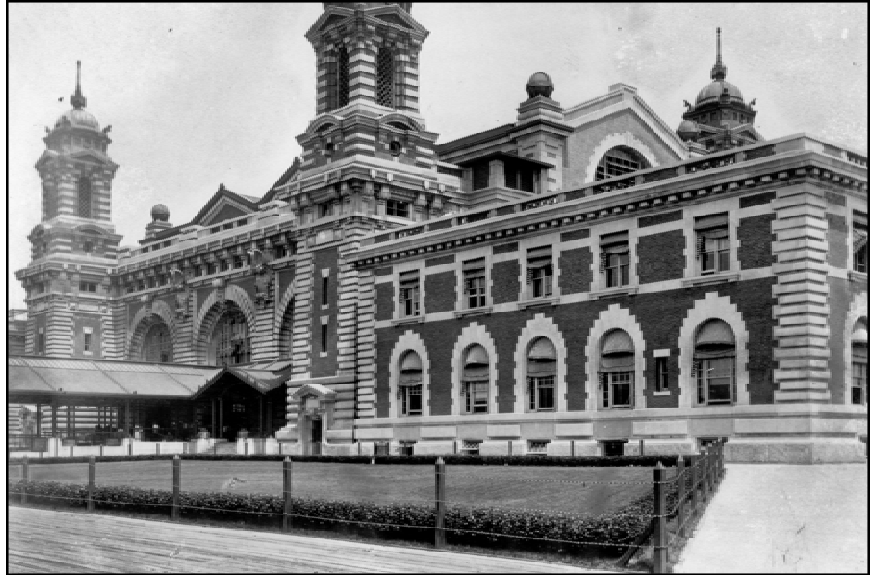
**Figure 3.13** In 1903 landscape features on the southeast end of Island One included a small flower bed, benches, flagstaff, and ornate lamp posts. (William Williams Collection, Photography Collection, Miriam and Ira D. Wallach Division of Art, Prints and Photographs, The New York Public Library, Astor, Lenox and Tilden Foundations)

Landscape improvements began with the removal of construction debris and the addition of approximately seven thousand cubic yards of loam. Work crews graded the island and planted lawns.<sup>33</sup> They installed scored concrete walks in front of the main immigration building and the kitchen and laundry building, extending along the southwest side of the main immigration building and connecting with rear doors. They added concrete around the powerhouse, the main hospital building, and the existing flagstaff, and installed a wider boardwalk along the edge of the ferry basin. They constructed small post and wire fences around the blocks of lawn in front of the main immigration building, placed benches under the portico and south of the main immigration building, and added ornamental light fixtures along the boardwalk. Gardeners added greenery and color to the island by planting *Ligustrum* hedges and filling beds and containers with flowers (Figures 3.11 – 3.14).<sup>34</sup>

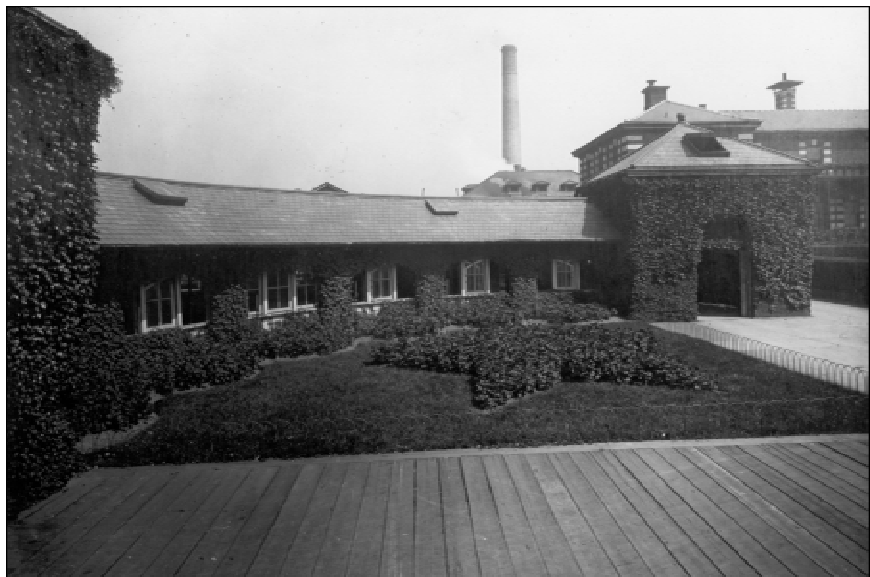
**Figure 4.4** In 1913 the star-shaped flower bed adjacent to the boardwalk at the northern end of the ferry basin continued to be used for annual plantings. A small wire hoop fence separated the lawn from the walks, replacing the earlier post and twisted-wire fencing, and ornamental vines climbed the adjacent walls. (William Williams Collection, #28878, Photography Collection, Miriam and Ira D. Wallach Division of Art, Prints and Photographs, The New York Public Library, Astor, Lenox and Tilden Foundations)

There were several of these beds scattered throughout the island, some dating to the initial 1902-1903 landscape improvements and others installed at later dates. Gardeners planted flowers and shrub roses along the entry path to the greenhouse, along with several climbing roses on five freestanding trellises. They used shrub roses between the baggage and dormitory building and the greenhouse in a small semicircular bed. They filled the existing star-shaped flower bed near the ferry house with begonias and protected the bed with a border of small wire hoops. Workers also installed a small pool, fountain, and flower bed in the lawn between the baggage and dormitory building and the powerhouse. Other ornamental vegetation present during this period included vines on the exterior walls of the kitchen and laundry building and the adjacent covered walkway, and numerous flower boxes and planters at several island locations (Figures 4.3 – 4.8).<sup>5</sup>

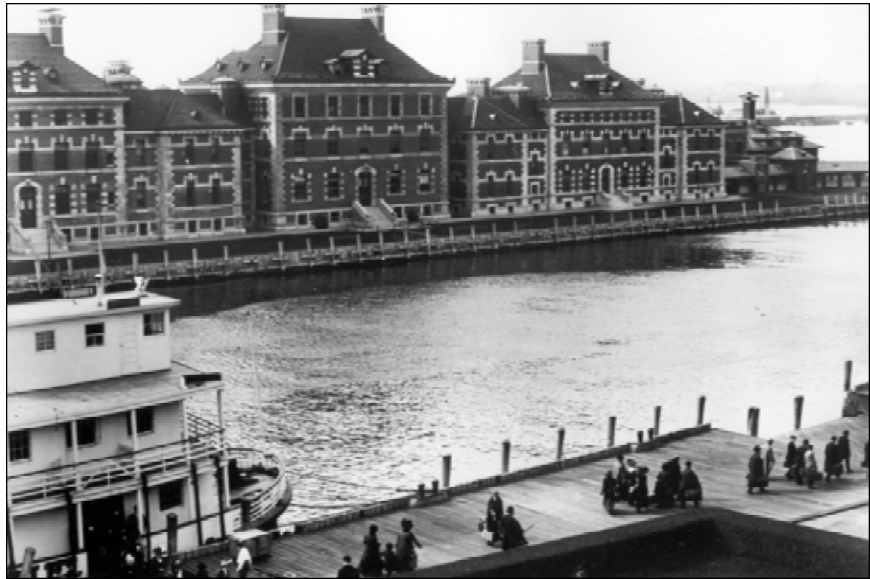
**Figure 4.11** Island Two is viewed from Island One in this circa 1913 photograph, showing (left to right) the new hospital extension, administration building, and the original main hospital building. The boardwalk, wooden cribwork seawall, and fender pilings along the ferry basin on Island One are shown in the foreground. (STLI Library, 19.5, #14)

began construction in June 1908, and work was nearly complete by the spring of 1909. Cold weather delayed the pouring of concrete sidewalks and stoops until late April, but by May all construction was finished (Figure 4.11).<sup>17</sup>

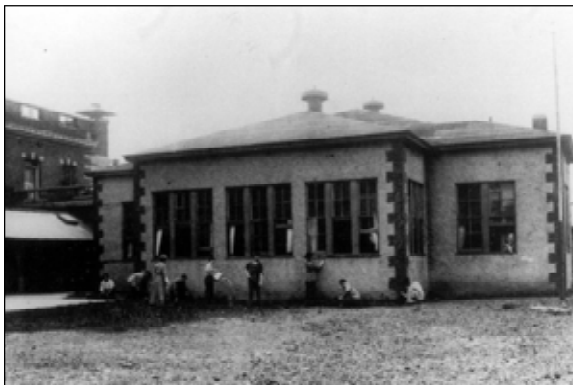
**Figure 4.12** Workers install plantings around the new American Red Cross recreation building on Island Two. Circa 1915. (National Archives and Records Administration, RG90-G-125-56)

Another addition to Island Two was the American Red Cross recreation building constructed around 1915. The small masonry structure was located on the northeast corner of the island near the ferry house and the hospital outbuilding. There is little documentation on the construction of this building, however, photographs show the installation of ornamental landscaping along the building's foundation (Figure 4.12).<sup>18</sup>

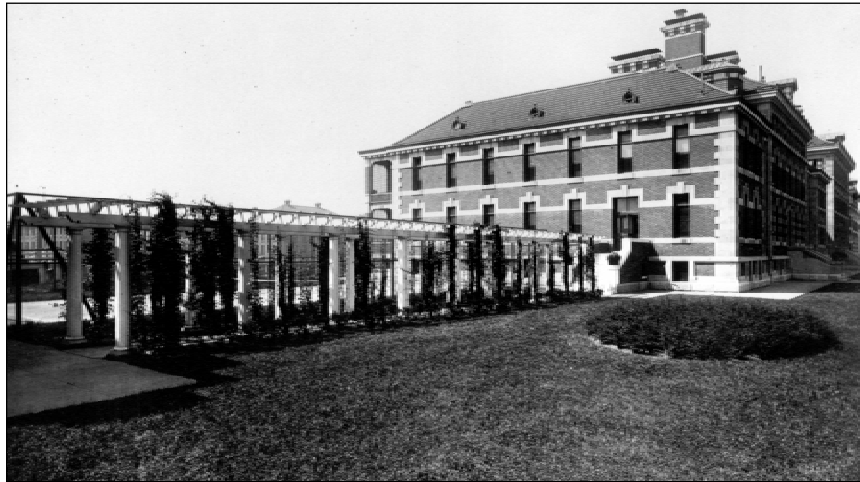
**Figure 4.14** This walk and pergola, constructed between the new hospital extension and the surgeon's house (out of photo to left), provided a perfect location for flowers and vines. Also shown are a circular flower bed and tennis courts behind the pergola on the southwest side of Island Two. Circa 1913. (William Williams Collection, #28877, Photography Collection, Miriam and Ira D. Wallach Division of Art, Prints and Photographs, The New York Public Library, Astor, Lenox and Tilden Foundations)

and exact date of these features is unknown, however, they first appear on 1913 maps and photographs. Vines and flowers enhanced both the pergola and a circular flower bed between the pergola and ferry basin (Figure 4.14).<sup>19</sup>

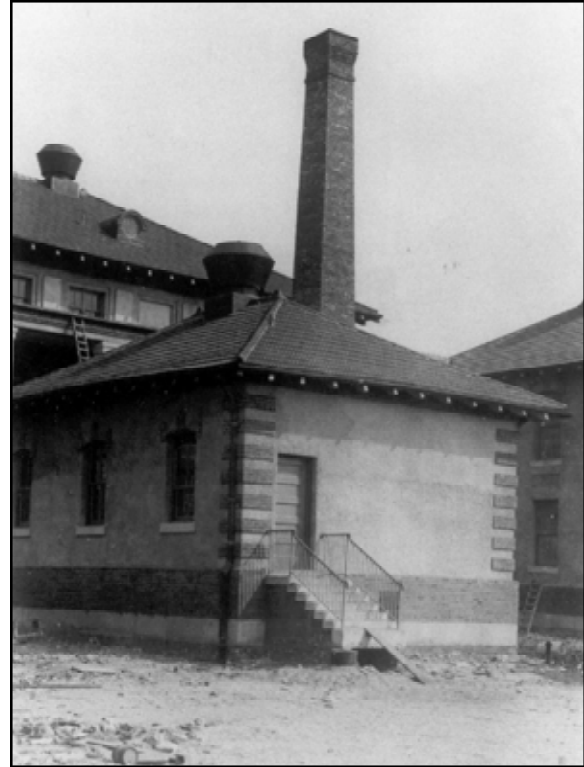
**Figure 4.16** Upon completion of the mortuary (animal house) on Island Three, there was still a considerable amount of fill needed to raise the island's grade to its planned elevation. Notice the distance between the bottom of the staircase and the rough grade prior to the addition of topsoil fill. October 14, 1907. (National Archives and Records Administration, RG121-BCP-38A-3)

As building construction concluded, the landscape surrounding the newly completed hospital was gradually improved. It is unknown whether this work was contracted out or performed by immigration employees. In 1908 workers filled around the first set of completed buildings on Island Three with soil taken from the excavations of the new hospital extension on Island Two. They graded the fill, added loam, and planted a lawn (Figure 4.16). Work crews completed additional grading and lawn renovations on Island Three in 1912. However, they did not install any trees or shrubs, nor did officials develop a comprehensive plan for the island's landscape. By 1913 an established lawn existed on the north side of the island, but areas on the south side remained rough and barren.

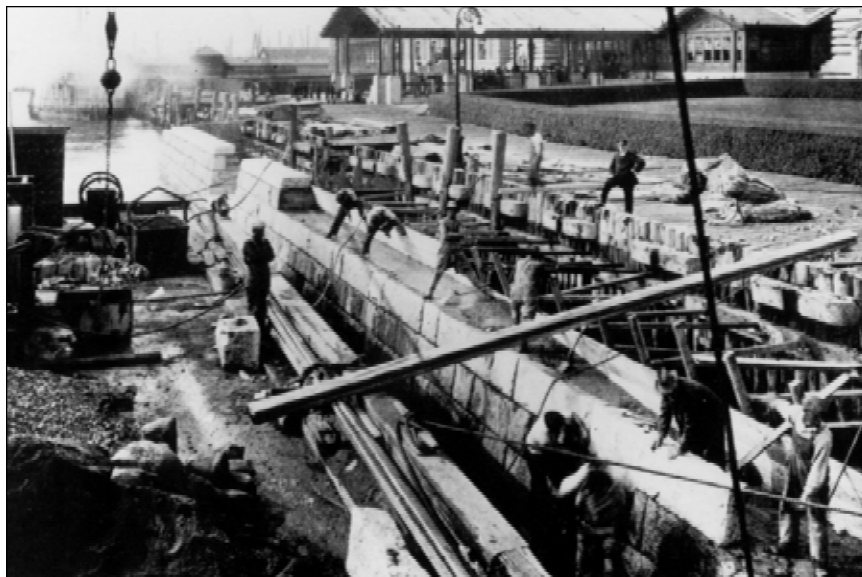
**Figure 4.17** In 1913 construction began on the new concrete and granite seawall on Island One. This image of construction on Contract #1 shows how the new seawall was placed outside the existing crib bulkhead, reducing the width of the ferry basin by about thirty feet when the north and south basin seawalls were completed. Circa 1913. (STLI Library, 26.7, #16)

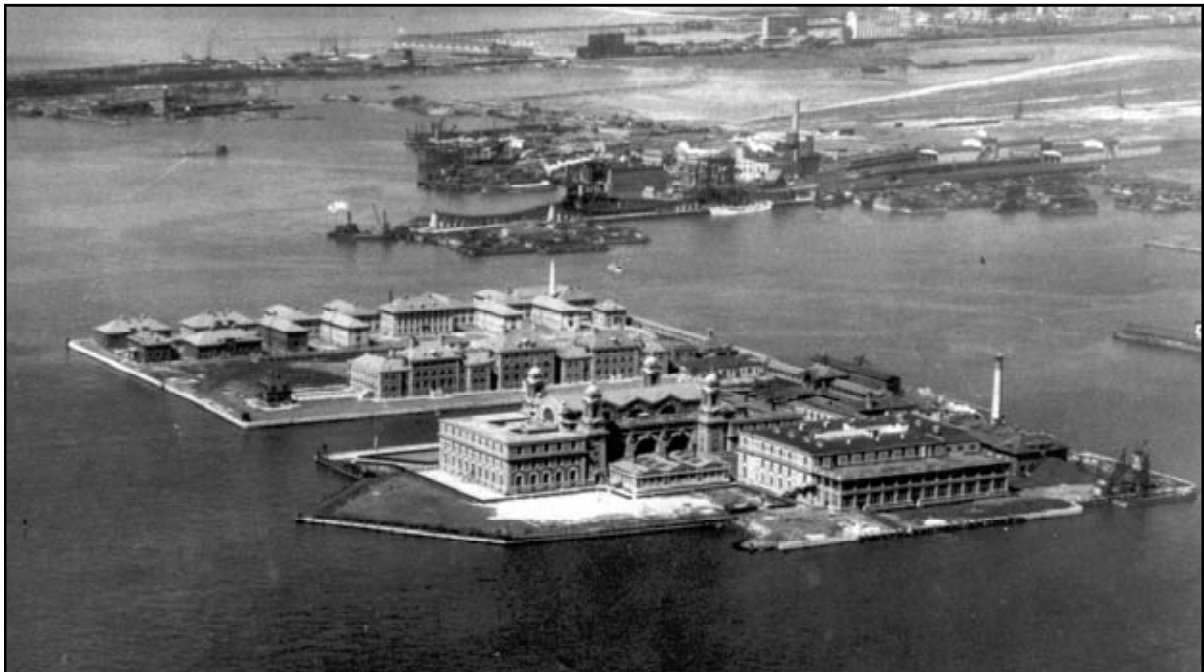
**Figure 4.18** Circa 1920 aerial photo of Ellis Island. (National Archives and Records Administration, RG18-AA-93-60)

The landscape of Ellis Island underwent many improvements during facility expansion from circa 1907 until the midteens. During the war years, from 1917 to 1919, it is unlikely that the landscape was improved upon or highly maintained. When the island reopened for immigration after the war, the landscape showed evidence of neglect. Postwar priorities for the Bureau of Immigration centered on reestablishing the immigration operations and maintaining the deteriorated facilities, leaving limited resources available for maintaining the ornamental landscape.<sup>31</sup> Figures 4.18 and 4.26 illustrate the circa 1920 landscape with an aerial photograph and period plan.

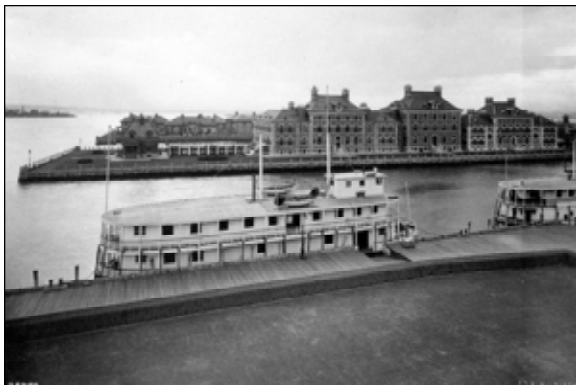
**Figure 4.19** The boardwalk along the ferry basin on Island One. Circa 1913. (William Williams Collection, #28939, Photography Collection, Miriam and Ira D. Wallach Division of Art, Prints and Photographs, The New York Public Library, Astor, Lenox and Tilden Foundations)

The circa 1915 replacement of the ferry basin boardwalk with a new concrete walk improved circulation on Island One. On Island Two, concrete aprons around the buildings and a perimeter cinder walk created new circulation routes. An enclosed central corridor and outside perimeter walks connecting all buildings provided circulation on Island Three. The addition of a dock extension on the northeast corner of the ferry basin, adjacent to the ferry ramp and extending out over the bulkhead, slightly altered the circulation pattern of incoming immigrants at the ferry house. This addition allowed immigrants to access the ferryboat directly from the basin-side walk on Island One without having to enter the ferry house. Water circulation routes remained consistent. Immigrant ferries arrived at the main ferry slip, while barge traffic landed at the powerhouse coal wharf and the coal wharf behind the ferry house (Figures 4.19 – 4.21).

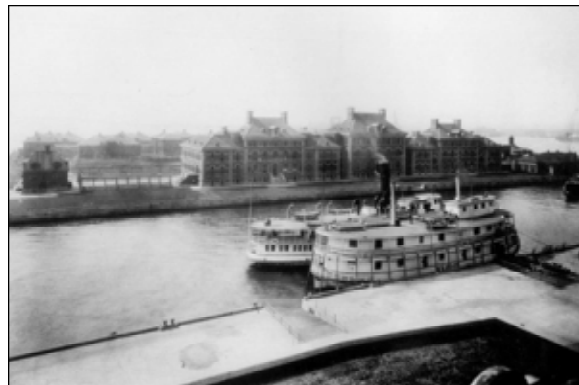
**Figure 4.20** This new concrete walk replaced the boardwalk along the ferry basin on Island One. Circa 1915. (STLI Library, 19.6, #29)

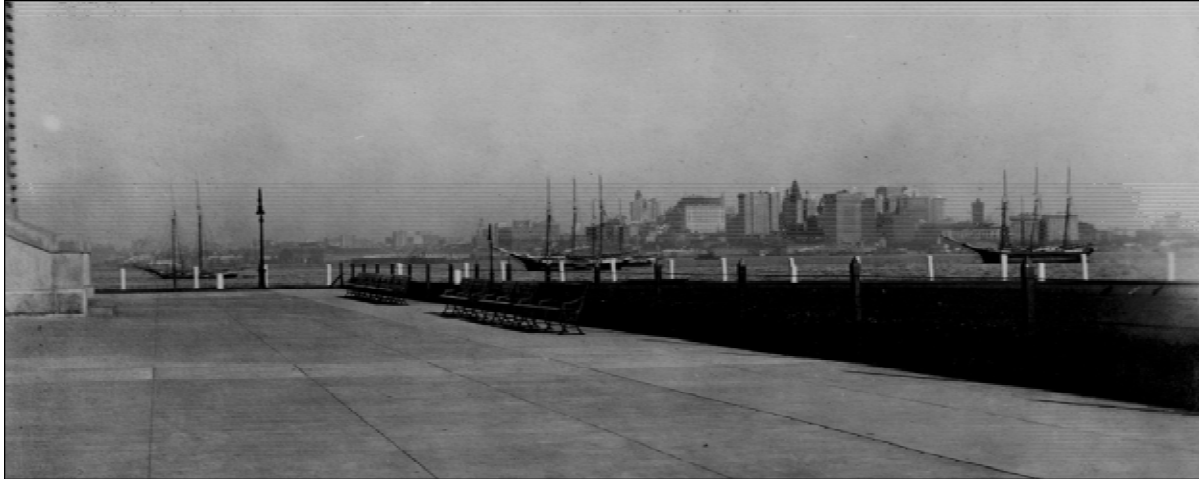
**Figure 4.23** Benches and lamp posts remained on the island from the earlier era, including these on the southeast side of the main immigration building. Circa 1913. (William Williams Papers, Manuscripts and Archives Division, The New York Public Library, Astor, Lenox and Tilden Foundations)

Many of the small-scale features present in earlier periods remained on the island, including the circa 1902 lamp posts, benches, planters, a fog bell, and the flagstaff. The post and wire fencing around the lawn on Island One had been removed by circa 1913. Some wooden picket fence sections assisted with crowd control on the main sidewalks. At several points along the seawall, including the edge of the ferry basin, large iron mooring cleats served as docking points for ferryboats and other vessels. Playground equipment occupied a small area in the recreation grounds on the northeast side of Island One (Figures 4.23 - 4.25).

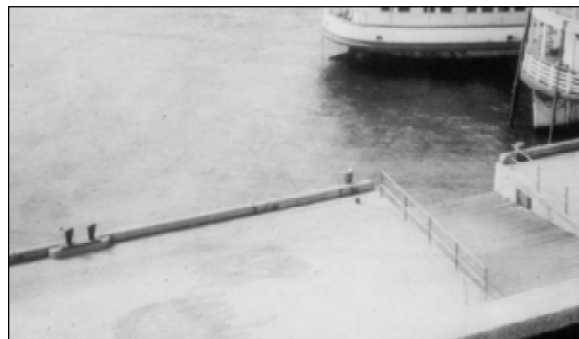
**Figure 4.25** Iron mooring cleats along the seawall, as shown in the lower left of the photo, assisted with docking ships. They were added to the landscape sometime between 1907 and 1913. Circa 1915. (STLI Library, 19.6, #29)

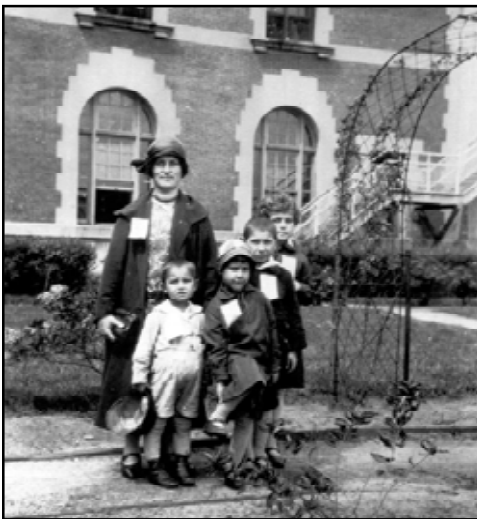
**Figure 5.2** A recently installed steel staircase is shown on the northeast side of the baggage and dormitory building, with immigrants standing next to a trellis on the greenhouse path. Circa 1920s. (STLI Library, 20.3, #5)

Various landscape and structural renovations, completed during the 1920s, improved both the flow through the buildings and the immigrant's experience on the island. In the main immigration building, individual beds with supplied bedding replaced old bunks in wire cages, improving the situation for overnight detainees. Rearrangement of the reception and examining rooms eliminated "unnecessary climbing of stairs and needless going to and fro," and allowed the "transfer station [to] be more businesslike."<sup>5</sup> In late 1924 the Hamilton & Chambers Company of New York City installed a steel staircase on the northeast side of the baggage and dormitory building. This provided access for the detainees from the open porch on the second story of the building to the recreation area below (Figure 5.2).<sup>6</sup>

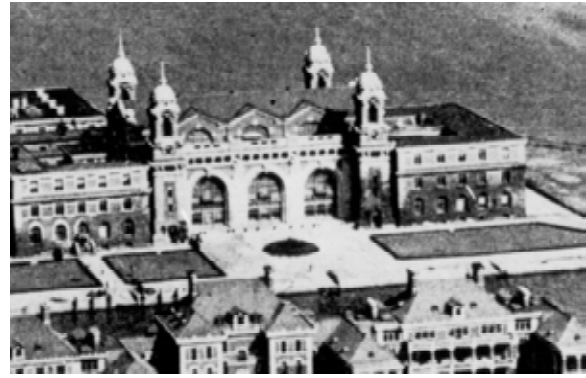
**Figure 5.6** One of the improvements initiated by Commissioner Corsi was the replacement of the entry portico in front of the main immigration building with a large circular planting bed. January 9, 1934. (STLI Library, 25.2, #8, copy also located at National Archives and Records Administration, RG90-G-90-16)

building.<sup>11</sup> In 1932 removal of the entry portico altered the main immigration building's entry, and installation of a paved plaza and a forty-foot diameter circular flower bed renovated the surrounding landscape (Figure 5.6). In that same year, the Quintine Realty Company of New York City installed a new steam heating system in the greenhouse to improve its operation.<sup>12</sup> As early as 1920, immigration officials proposed converting the generators in the powerhouse from coal to oil burners to save fuel and manpower costs. After the third proposal in 1931, Congress appropriated \$40,000 to complete the work. The R. H. Baker Company of New York City completed the changes by January 1933. Part of this contract included converting the original 75,000-gallon water tank into a standby oil storage tank, leaving the two large water towers to serve the island's freshwater needs.<sup>13</sup> The coal hoist and conveyor equipment near the powerhouse were removed soon after.<sup>14</sup> Another alteration occurred in October 1932 when contractors installed an additional incinerator in the same building as the existing incinerator, increasing the capacity of the facility.<sup>15</sup>

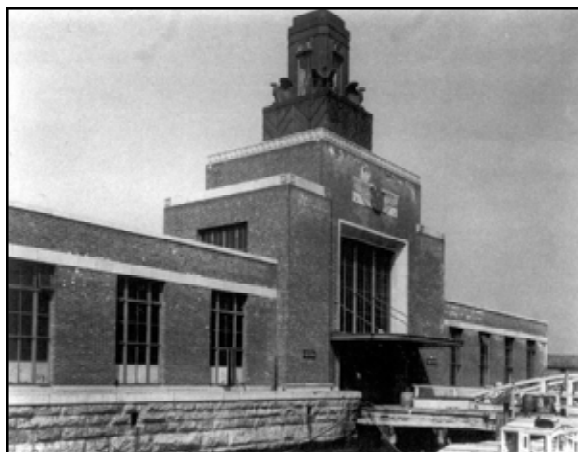
**Figure 5.8** New ferry building. Circa 1939. (National Archives and Records Administration, RG135-SA, Photo B)

One addition proposed by the committee was a new ferry terminal building. By 1934, the existing ferry house was "old and somewhat dilapidated" and, along with the wooden connecting passageways, needed replacement. The committee recommended replacing the structure with "a new fireproof ferry house and connecting passages." In October 1934 the Department of Labor awarded a \$133,000 contract to George F. Driscoll of Brooklyn for building construction. The building, consisting "of a high central pavilion surmounted by a copper-covered cupola and two one-story wings," was a fireproof masonry and steel construction designed with art deco influences. Driscoll constructed the building at the head of the ferry basin between Islands One and Two. The contractor finished both the new ferry building and covered walkways, including a new covered masonry walk replacing the 1918 covered wooden walk between Islands Two and Three, by January 1936 (Figures 5.8 - 5.9).<sup>20</sup>

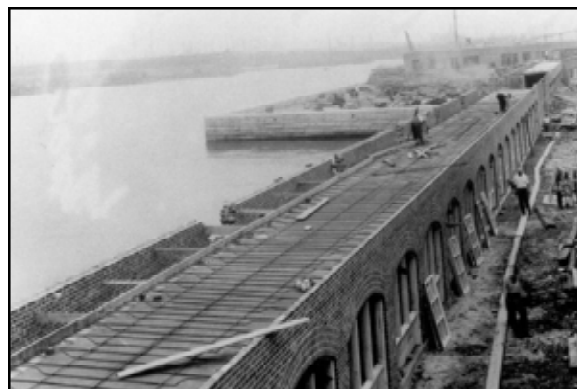
**Figure 5.9** Construction of the covered masonry walkway between Island Two and Island Three. July 26, 1935. (National Archives and Records Administration, RG121-BCP-38B-28)

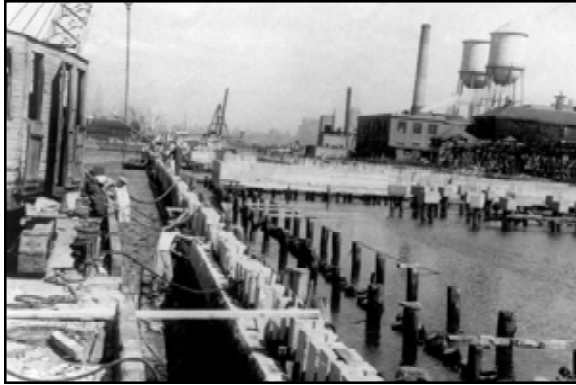
**Figure 5.10** A new seawall and pilings were added to accommodate construction of the new immigration building on the northwest side of the island. September 24, 1934. (National Archives and Records

aid in segregating the different classes of immigrants and detainees, was located on the northwest side of the new ferry building. Construction required the addition of a new section of seawall and landfill north of the new ferry building. Installation of the support pilings began in 1934, and Driscoll completed the structure in 1935-1936. The building's original plans reflected continued emphasis on immigrants' recreation needs. Chester H. Aldrich, consulting architect for the project, specified sun porches on the north and south ends of the building as well as a playground and gardens in the surrounding landscape. Even though these initial plans were never implemented, the newly filled ground around the building was used for recreation. Two tennis courts took the place of the proposed garden on the south end of the building (Figures 5.10 – 5.13).<sup>21</sup>

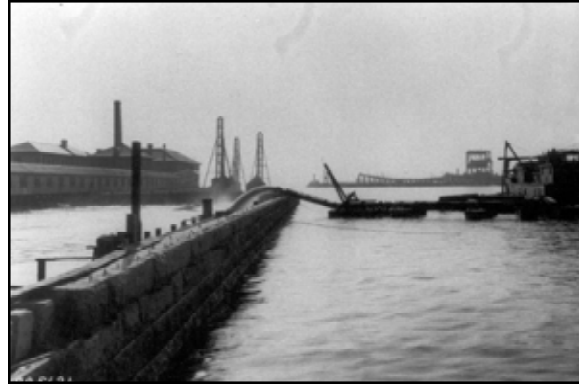
**Figure 5.11** After seawall completion, dredging and fill created a land area for the new immigration building. The old wooden covered walkway is shown in the background. October 24, 1934. (National Archives

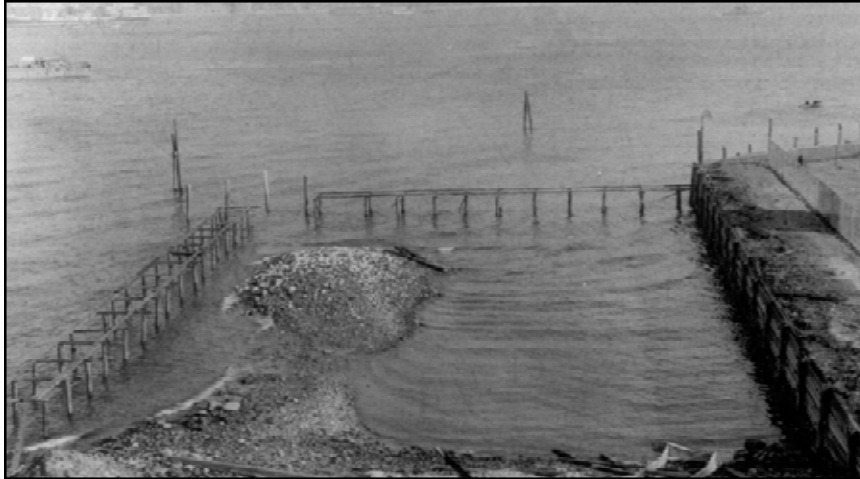
**Figure 5.14** This area northeast of the main immigration building adjacent to the recreation yard was the last section of landfill added to the island. Its addition increased the available space for immigrant recreation. It may have been constructed as part of Federal Project No. 61. April 2, 1934. (National Archives and Records Administration, RG121-BCP-38C-12)

Federal Project No. 61 was one of the landscape projects already under way when the committee issued its recommendations. This project included adding "2397 linear feet of granite facing concrete seawall to complete the enclosing of Ellis Island, as authorized by Congress 1911," installing "required fill and soil for the eastward extension of Island No. 1 if new sea wall is built," and removing "2 feet of present cinder fill between buildings of Is. No. 2 and replace with 18 inches of sub soil and 6 inches of top soil and plant with grass and shrubs. Also similar treatment for north side of Is. No. 1 and south side of Is. No. 3."<sup>24</sup> The proposed cost was \$549,000. In 1934 an updated cost estimate added repairs of the existing seawall, dredging in the ferry slip, and various landscaping for Islands Two and Three.<sup>25</sup> It is not clear whether Federal Project No. 61 was fully implemented as proposed, but numerous projects on all three islands throughout the mid- to late 1930s addressed items included in this proposal (Figure 5.14).

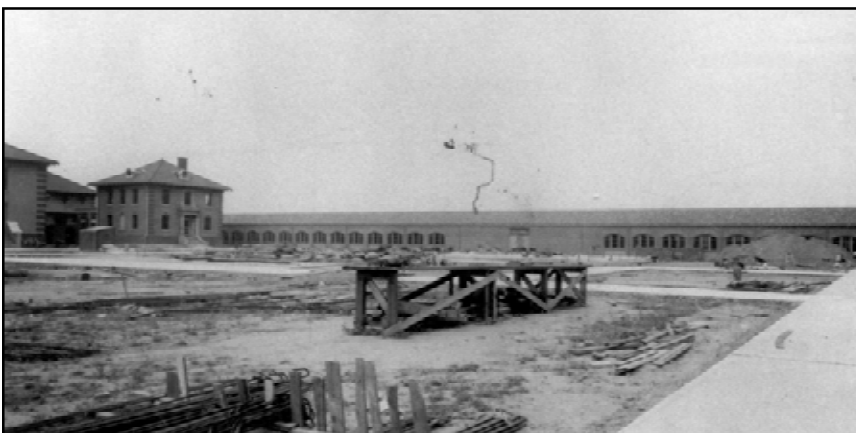
**Figure 5.19** Newly poured concrete walkways in the recreation area between Islands Two and Three. June 25, 1936. (National Archives and Records Administration, RG121-BCP-38B-26)

A new system of walkways also defined the recreation space between Islands Two and Three. Constructed in 1936, the walks followed the rectilinear grid pattern first shown in the committee's 1934 report (Figure 5.19). Lawn

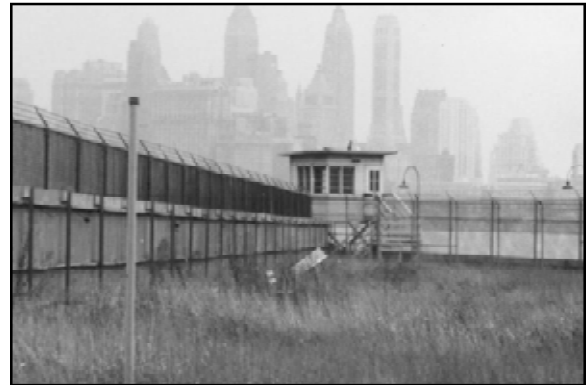
**Figure 5.27** Detail of guardhouse in the Island One recreation yard. (*Ellis Island, Recreation Area in Front of Main Building*, Shirley Burden, Circa 1958, Museum of the City of New York, 88.85.1.14)

Other extant structures included four guardhouses around the detainee recreation yard (Figure 5.27), a sand and gravel box and debris box adjacent to the greenhouse, and two water tanks and one oil tank southeast of the powerhouse on Island One. The ferry slip, along with the moored ferryboat *Ellis Island*, remained in the ferry basin. On Island Three a small greenhouse (circa 1950) was adjacent to wards 31-32, and a storage shed and small oil tank stood near the kitchen. The concrete and granite seawall, completed during this era, enclosed the entire island.

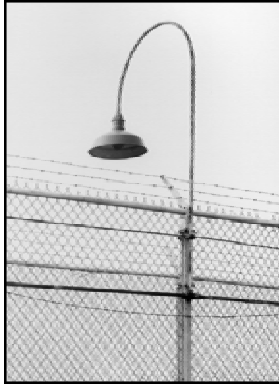
**Figure 5.29** Detail of crook-neck light post and chainlink fencing on Island One. (*Ellis Island, Untitled*, Shirley Burden, Circa 1958, Museum of the City of New York, 88.85.1.15)

Numerous small-scale features were extant in 1954. There were several circa 1945 crook-neck lights attached to the chainlink fence near the main immigration building (Figure 5.29).<sup>58</sup> In the recreation area between Islands Two and Three, circa 1935 Beaux Arts lamps with eight-foot octagonal posts were present (Figure 5.30). All circa 1902 lamp posts had been removed from the island. The fog bell occupied the eastern corner of Island Two, housed in a wooden tower constructed circa 1940, and a pilot light was located directly across the ferry basin on the corner of Island One (Figures 5.31 - 5.32). Several 1952 fire hydrants remained on Islands One and between Islands Two and Three. The circa 1920 iron mooring cleats lined both sides of the ferry basin and several other docking locations on the island. Several manhole covers were present. Some of these may have dated to construction of the original immigration station. Cast concrete downspout splash guards remained from the 1940s around several of the buildings on Islands Two and Three (Figure 5.33). Three flagstaves remained – on the southeast point of Island One, on the southeast end of Island Two, and east of the new ferry building.

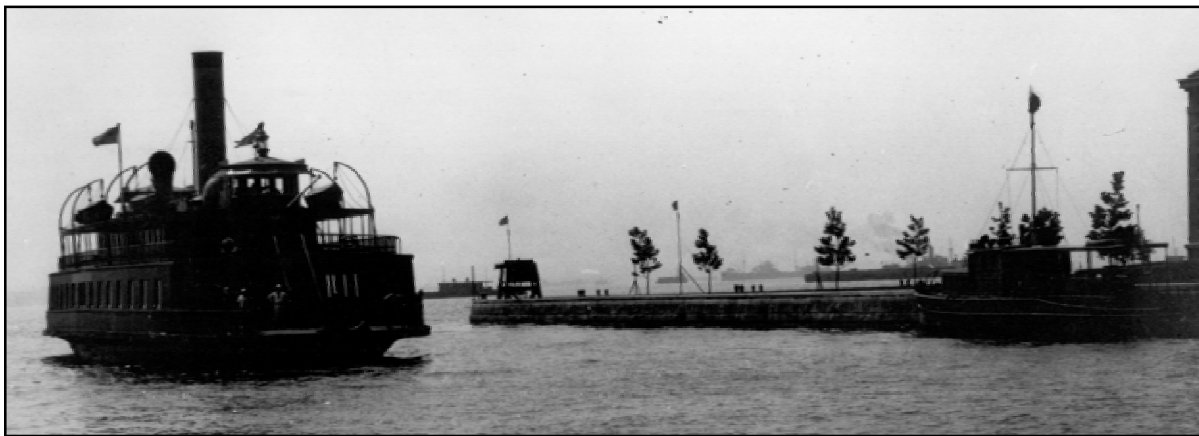
**Figure 5.32** A view of the southeast corner of Island Two from Island One shows the fog bell in its wooden tower, constructed here circa 1940. Also shown are young trees and iron mooring cleats along the seawall. Circa 1950. (STLI Library, 19.6, #25)

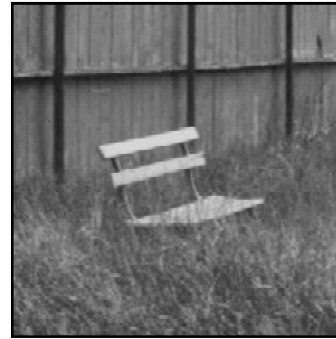
**Figure 5.34** Detail of cast-iron/wooden bench and wooden fencing in the recreation yard on Island One. (Ellis Island, Recreation Area in Front of Main Building, Shirley Burden, Circa 1958, Museum of the City of New York, 88.85.1.14)

Four bench styles were extant on the island. The first style, near the railroad ticket office in the recreation yard, was cast iron with one-inch-by-four-inch wooden slats and dated to circa 1904 (Figure 5.34). The second style, used on the north side of the baggage and dormitory building, had bent-steel supports on seven-foot centers and wooden slats. The third, west of the new immigration building, had perforated cast-iron supports and wooden slats. An example of the fourth bench style was located on the northwest corner of Island Two and consisted of simple steel supports and wooden slats. Wooden picnic tables were also scattered around the recreation yard on Island One (Figure 5.35).<sup>59</sup>

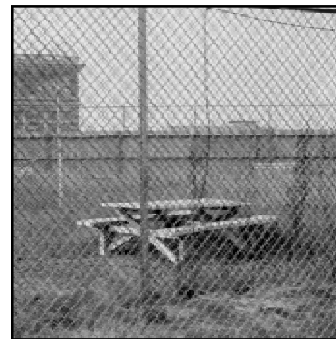
**Figure 5.35** Detail of wooden picnic table and chainlink fencing in the recreation yard on Island One. (Ellis Island, Untitled, Shirley Burden, Circa 1958, Museum of the City of New York, 88.85.1.15)

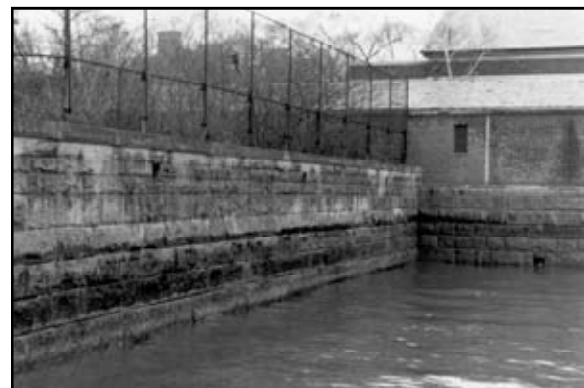
**Figure 5.36** The INS added this fence in the 1940s west of the new immigration building around the site of the former tennis courts. It remained in place until the 1970s. (BOSO Engineering Files, 1978)

Sections of chainlink fencing from the late 1940s stood at various island locations, including near the main immigration building, baggage and dormitory building, powerhouse, new immigration building, and around detainee recreation yards on

Islands One and Three (Figure 5.36). A wooden fence and the chainlink baseball backstop were also present in the recreation yard on Island One. An eight-foot-high brick wall, present between the bakery and carpentry shop and the seawall, was a circa 1937 feature used to separate detainee classes.<sup>60</sup>

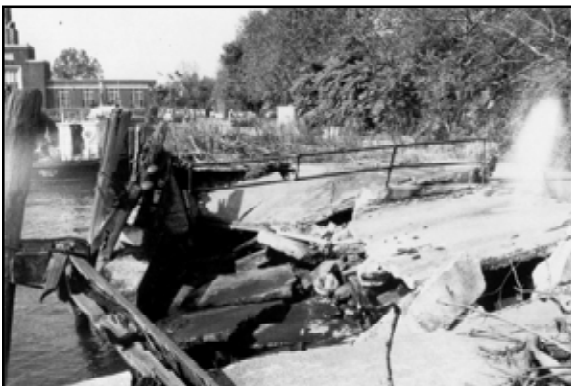
**Figure 6.5** During the early 1970s, much of the island remained in a derelict state, as illustrated by this deteriorated section of seawall and walkway along the north side of the ferry basin on Island One. October 1973. (STLI Library, 26.7, #2)

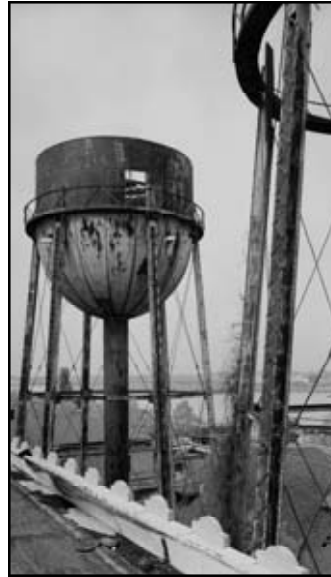
**Figure 6.12** The water towers on Island One prior to their demolition. The new ferry building is visible through the supports of the tower on the left. May 1985. (Library of Congress, Prints and Photographs Division, HABS, NY, 31-ELLIS, 1H-1 [Jack E. Boucher, NY-6086-H-1])

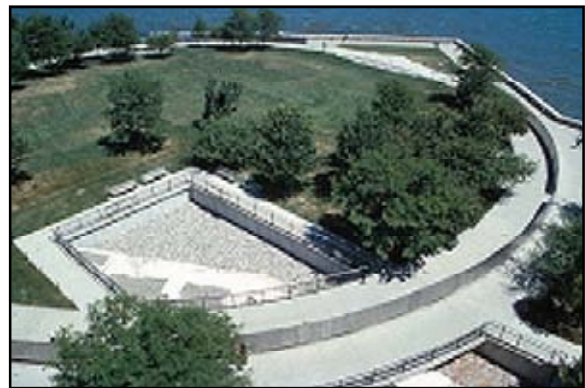
**Figure 6.14** The circular Wall of Honor and Fort Gibson excavation occupies the southeast corner of Island One adjacent to the main immigration building. 1999. ("Cultural Landscapes Inventory")

the top of the seawall. However, the horizontal panels became routinely covered with sea bird guano, making them hard to read and requiring frequent cleaning. In 1993 contractors removed these panels and began construction of a new Wall of Honor. They constructed phase one of this project as a circular wall of stainless-steel panels, located east of the outdoor concession area and main immigration building. Phase two added a row of linear panels nearby in 1998-2001.<sup>14</sup> During the construction of the Wall of Honor, NPS archeologists excavated in the area, uncovering some of the original Fort Gibson walls. Upon completion of the excavation, a section of the fort's wall remained exposed for interpretive purposes (Figures 6.14 - 6.15).

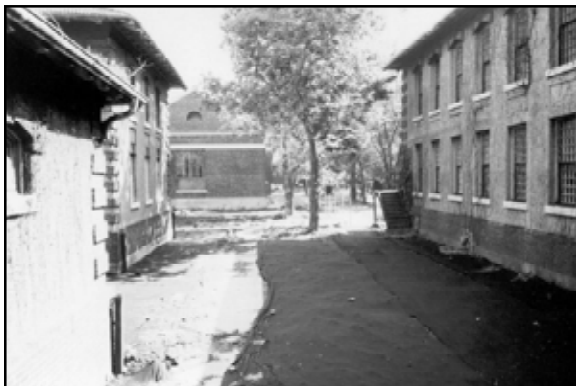
**Figure 6.17** After vegetation clearing, crews installed landscape fabric to deter vegetation from resprouting in the courtyard areas. This recently cleared space is between the nurses' quarters and wards 11 & 12 on Island Three. August 2002. (Photo by author)

stabilization on Islands Two and Three, the NPS supervised removal of nonhistoric vegetation during an extensive project completed by prisoners from the New Jersey prison system. The park sponsored additional clearing projects during the next two summers, and most overgrown vegetation was cleared from Islands Two and Three by fall 2002 (Figures 6.16 - 6.17).<sup>15</sup>

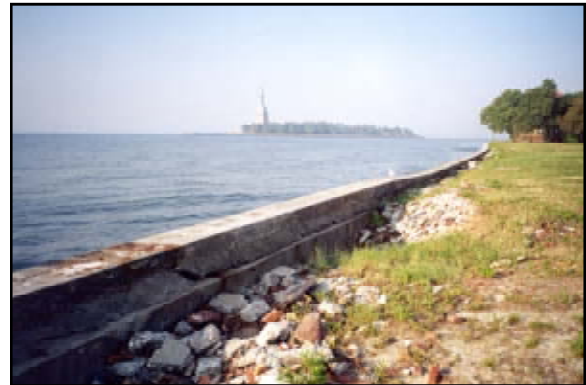
**Figure 6.18** Some sinkholes continue to exist along the seawall, including this section on the south side of Island Two. August 2002. (Photo by author)

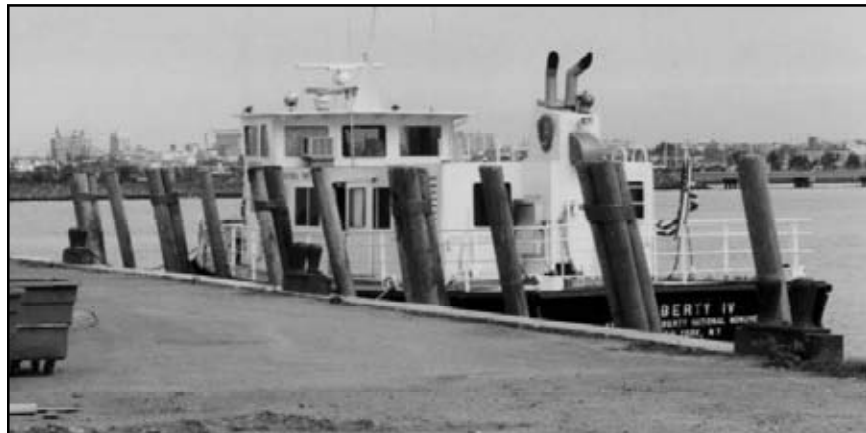
**Figure 6.20** Staff boat docking at the old coal wharf on Island One. 1999. ("Cultural Landscapes Inventory")

longer used. Visitors arrive by boat, landing at the seawall directly in front of the main immigration building and disembark onto one of the ferry ramps built into the sidewalk. Staff boats land in this location as well as at the old coal wharf adjacent to the powerhouse, and a small floating dock on the northwest corner of the ferry basin accommodates U. S. Park Police boats (Figures 6.20 - 6.21). The addition of the bridge to Liberty State Park and a gravel parking area between the new immigration building and the powerhouse added vehicular circulation to the island.

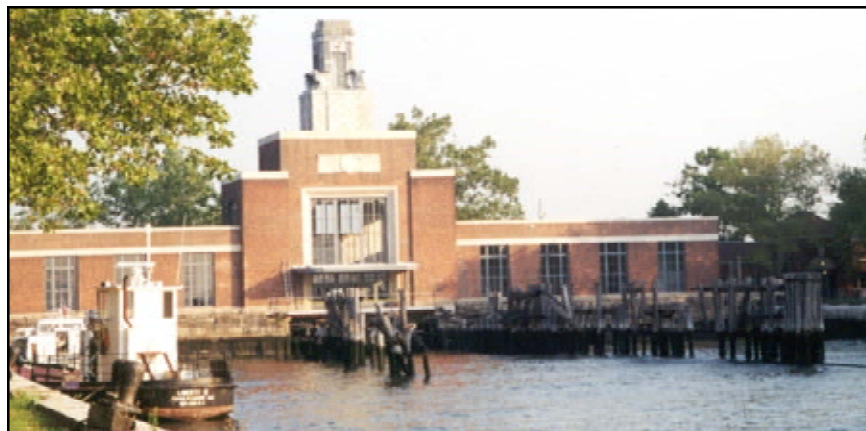
**Figure 6.21** Remains of the historic ferry slip and a small floating dock used by U. S. Park Police boats. August 2002. (Photo by author)

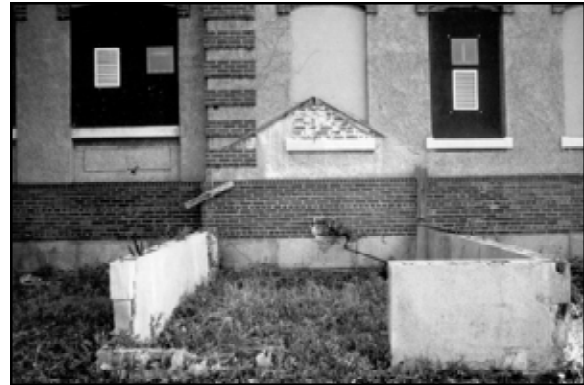
**Figure 6.22** Remains of the small greenhouse, including foundation walls and heating pipes, are extant adjacent to wards 31 & 32 on Island Three. August 2002. (Photo by author)

longer present, although remnants of this structure include foundations, plumbing, and stacks of clay flowerpots under a layer of rubble (Figure 6.22).

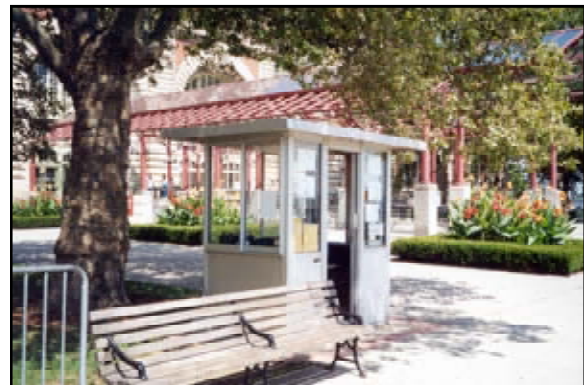
**Figure 6.24** This small NPS guardhouse is located along the main walkway at the entrance to the main immigration building. August 2002. (Photo by author)

Several other structures are also extant on the island, many of them nonhistoric additions. A reconstructed water tower is present between the baggage and dormitory building and the powerhouse (Figure 6.23). A small NPS guardhouse is located at the ferry landing near the main immigration building's portico (Figure 6.24), and a concession kiosk is located on the terrace at the south corner of the building. The Wall of Honor (1993, 2001), including both the circular and linear portions, occupies the entire southeastern corner of Island One. A metal maintenance building is located south of the recreation shelter and a utility area containing fuel tanks and HVAC units is located north of the powerhouse on Island One (Figure 6.25). Additionally, the historic ferry slip and the sunken ferryboat *Ellis Island* remain in the ferry basin, and a mostly rehabilitated granite seawall surrounds the island (Figure 6.26).

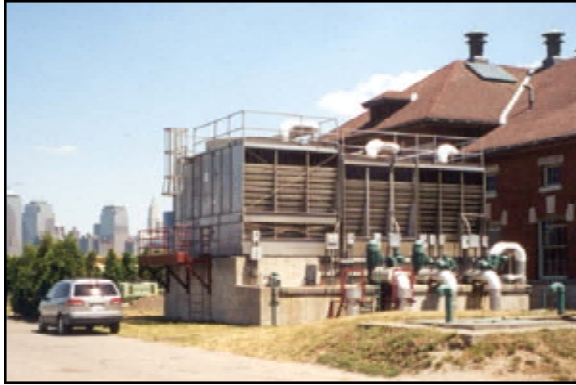
**Figure 6.25** A service area containing fuel tanks and HVAC units is located north of the powerhouse on Island One. August 2002. (Photo by author)

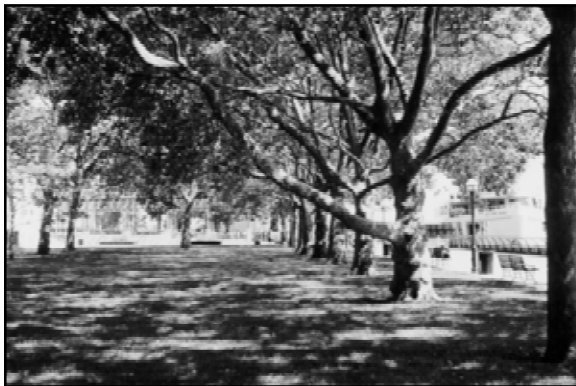
**Figure 6.27** The major vegetative features on Island One continue to be the historic trees and expanses of lawn adjacent to the main immigration building. 1999. (“Cultural Landscapes Inventory”)
