# **CULTURAL LANDSCAPE REPORT FOR ELLIS ISLAND**

**SITE HISTORY, EXISTING CONDITIONS, AND ANALYSIS**

## **STATUE OF LIBERTY NATIONAL MONUMENT**

National Park Service  
Olmsted Center for Landscape Preservation  
Brookline, Massachusetts, May 2003

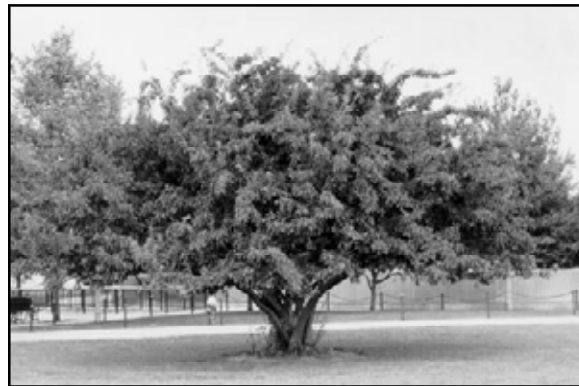
**Figure 6.28** This mature crabapple southeast of the main immigration building probably started as a volunteer tree along an old detention fence originally located in this area. 1999. (“Cultural Landscapes Inventory”)

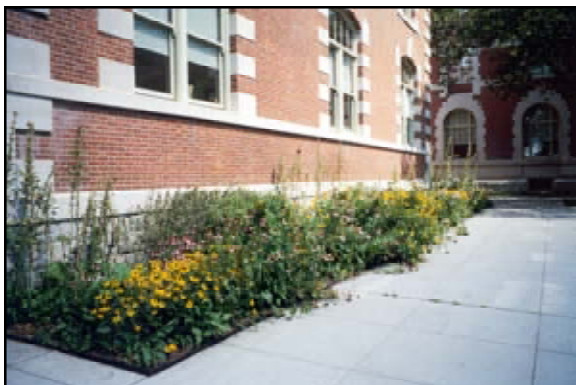
**Figure 6.29** Contemporary additions to the landscape include various flower beds planted for seasonal color, including this site adjacent to the kitchen and laundry building, and others incorporated into the walkway at the entry portico. August 2002. (Photo by author)

Trees are the predominant vegetation on the island, primarily the numerous historic *Platanus acerifolia* lining the ferry basin, which date to the 1939 planting plan. Nineteen of these trees are extant along the basin's north side, while fourteen trees are present on the basin's south side. The turfgrass on Island One was renovated during the island's rehabilitation phase during the 1980s and follows the 1939 layout, with slight modification for the new entry portico (Figure 6.27). Installation of the Wall of Honor created an additional circular lawn on the southeast corner of the island. A few trees are extant near the Wall of Honor dating to the historic period, including one large crabapple (Figure 6.28). These are probably volunteer species that grew along fence lines in the former detainee recreation yard. Contemporary additions include flower beds adjacent to the entry portico and in front of the kitchen and laundry building, approximately seventy-five new trees located in the Wall of Honor area, and evergreen screening used around the utility yard north of the powerhouse on Island One (Figures 6.29 - 6.30).

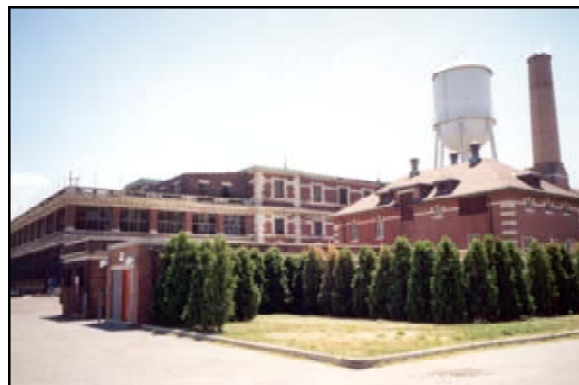
**Figure 6.30** Arborvitae hedges (*Thuja species*) are used to screen the fuel tanks and HVAC units in the utility area on Island One. August 2002. (Photo by author)

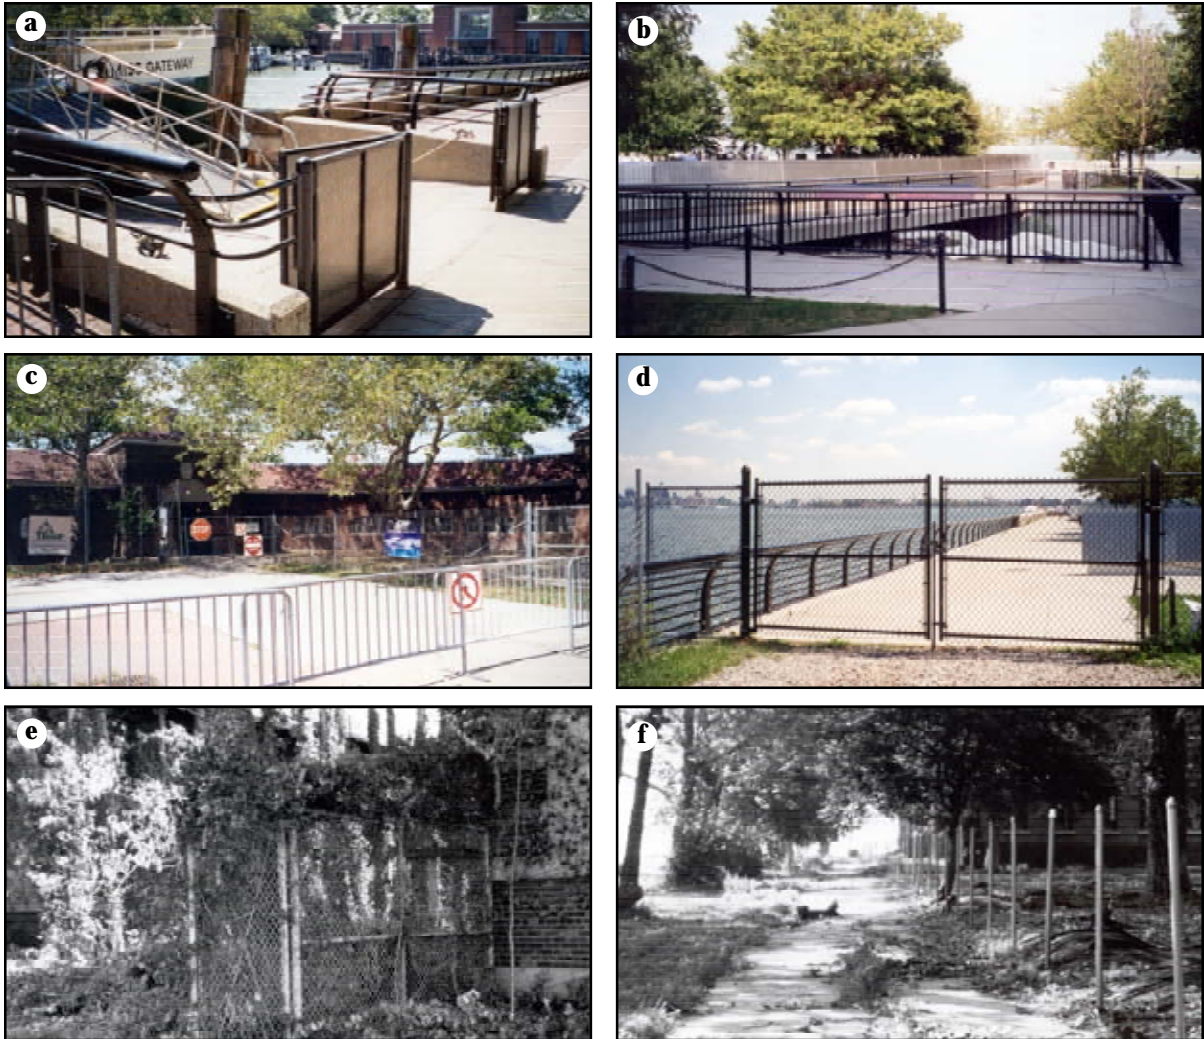
**Figure 6.34** Fence styles: **a)** iron railing along ferry basin and steel mesh gate at ferry ramp on Island One, **b)** iron railing at Fort Gibson site and post-and-chain fencing at Wall of Honor, **c)** portable iron rail fencing used for crowd control, chainlink fencing in background on Island One, **d)** chainlink fencing and gate, iron railing along seawall on northeast side of Island One, **e)** historic chainlink fencing on northwest side of Island Three, dating to early 1950s detention era, **f)** contemporary posts used for chainlink fencing to restrict access to Island Three, fence is down to facilitate recent vegetation clearing. August 2002. (Photos by author)

Both historic and contemporary small-scale features are present on all three islands. Historic features include iron mooring cleats along the seawall edge, fire hydrants, manhole covers, flagstaff bases, the fog bell, birdbath, utility trenches and pits, and remnant lighting and fencing. Contemporary features added to the landscape during island renovation include new lighting, seating, trash receptacles, fencing, railings, and signage. Selected extant small-scale features are shown in Figures 6.34 to 6.39.

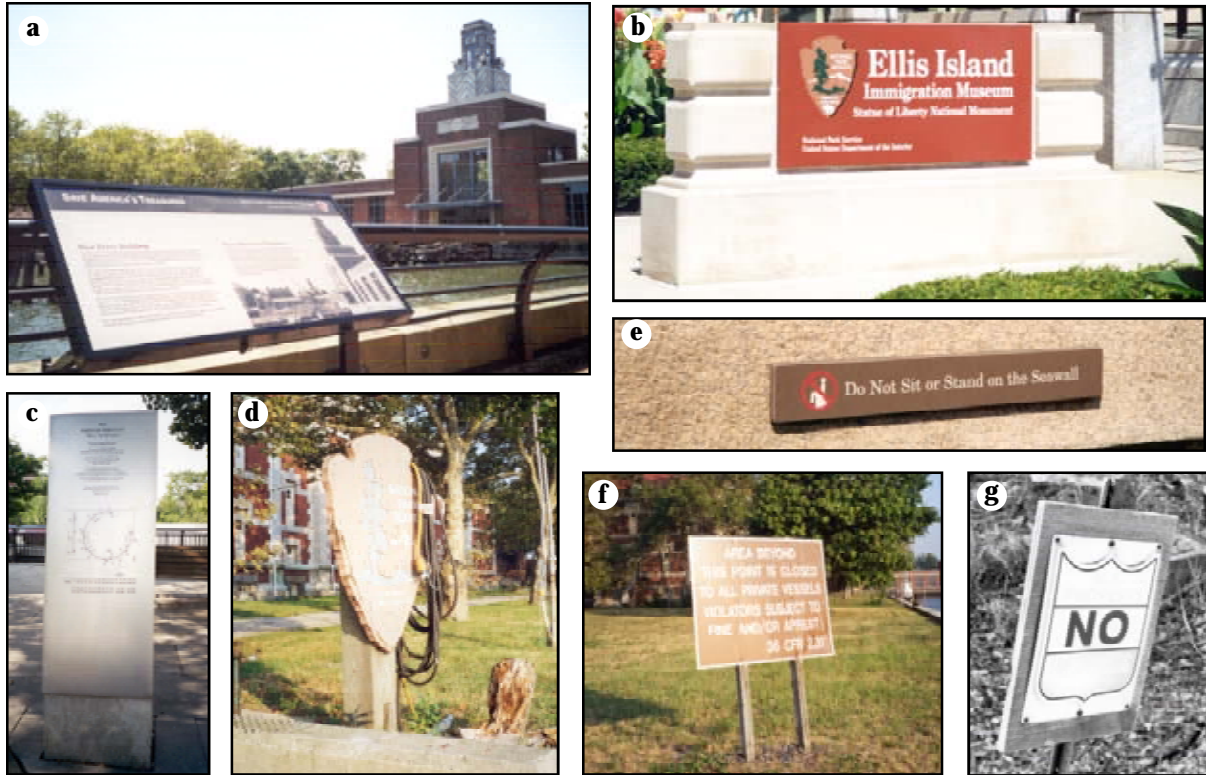
**Figure 6.37** Sign styles: **a)** interpretive sign at ferry basin on Island One, **b)** park identification sign at main entry to the immigration museum on Island One, **c)** orientation sign for the Wall of Honor, includes name locations and credits, **d)** NPS arrowhead sign along the ferry basin on Island Two, **e)** caution sign located on the seawall on Island One, **f)** large “No Trespass” sign at the southeastern corner of Island Two, **g)** small “No Trespass” sign along the western seawall on Island Three. August 2002. (Photos by author)

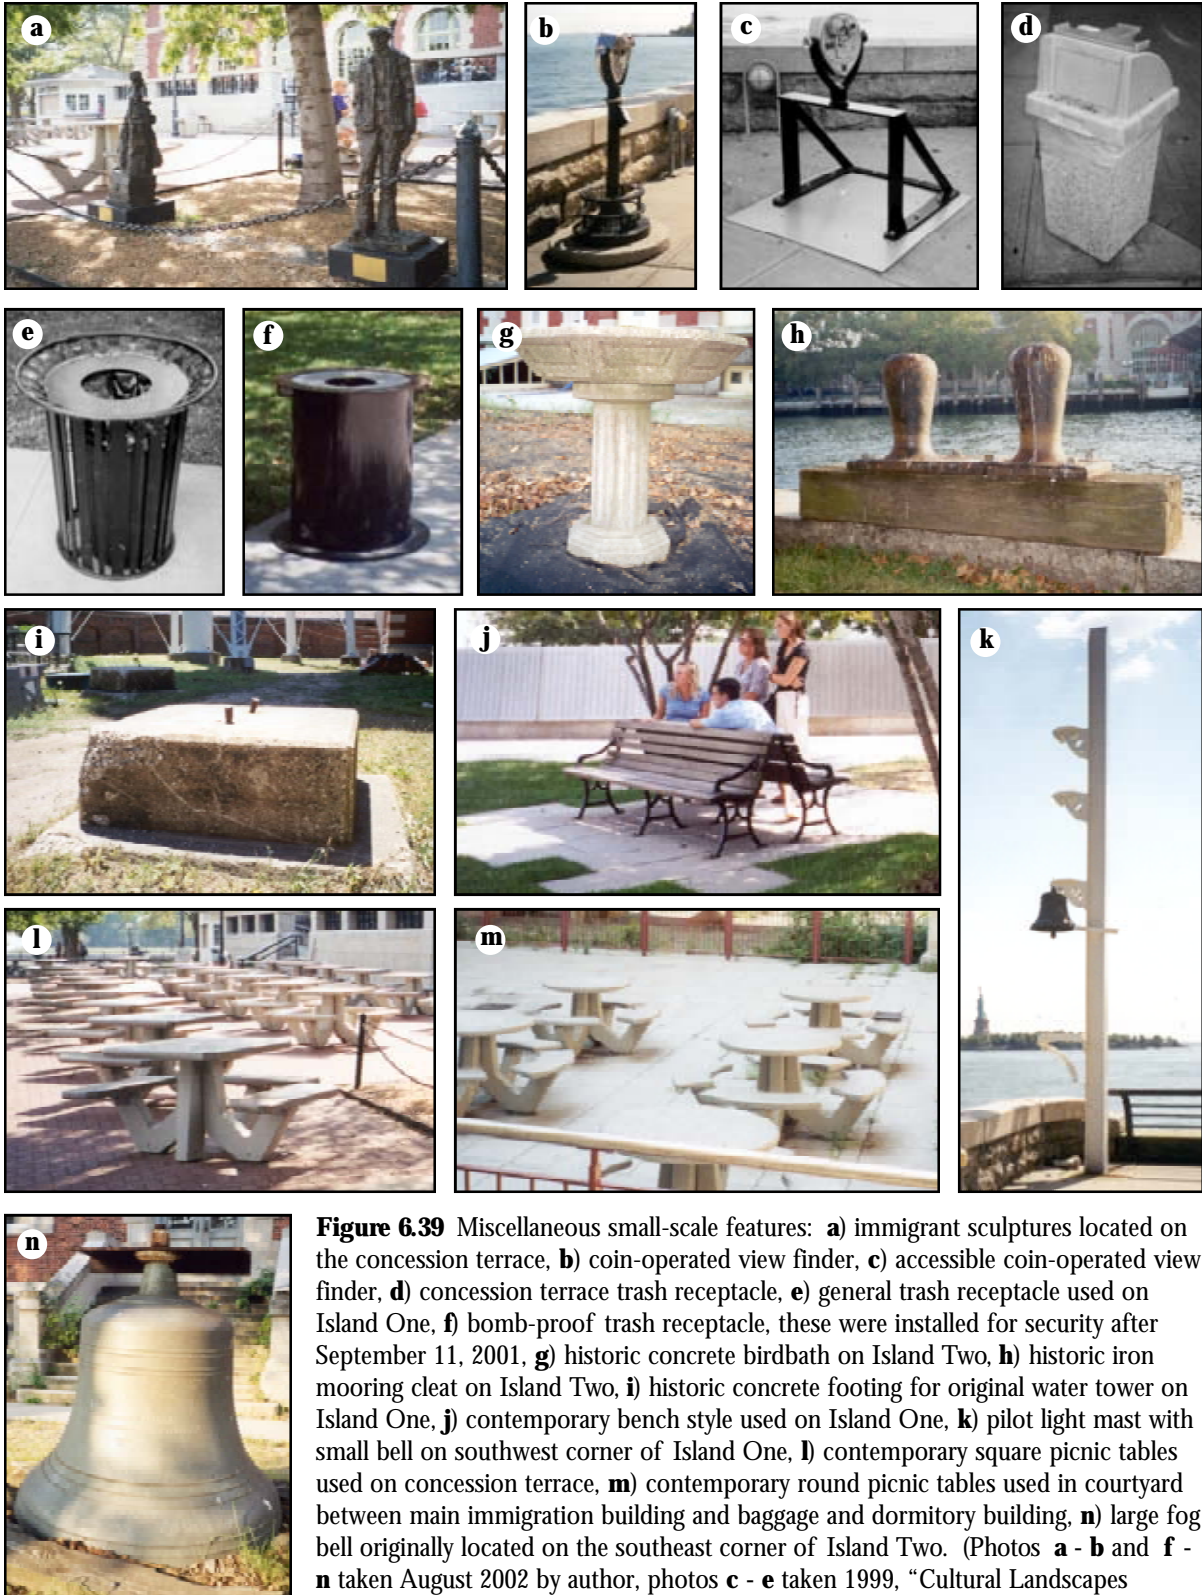
Figure 6.40

# Ellis Island 2002 Existing Conditions

From 1954 to the present, the Ellis Island landscape continued to evolve as it had throughout the preceding historic periods. The island's vegetation became wild and overgrown when the station was abandoned, but other features like walkways on Islands Two and Three remained relatively unchanged. With interest in island preservation and subsequent construction projects in the 1970s and 1980s, portions of the landscape on Island One were modified for new uses while Islands Two and Three remained untouched. During the past decade, the NPS has recognized the importance of landscape resources in overall island rehabilitation, and their planning efforts are more comprehensively addressing the island's cultural landscape. The landscape's current condition reflects this change in approach. The island's 2002 existing conditions are described below and graphically illustrated in Figure 6.40.
