# RIPARIAN AREA MANAGEMENT

TR 1737-12 1996 (Revised 1999)

*Using Aerial Photographs to Assess Proper  
Functioning Condition of Riparian-Wetland Areas*

U.S. Department of the Interior  
Bureau of Land Management

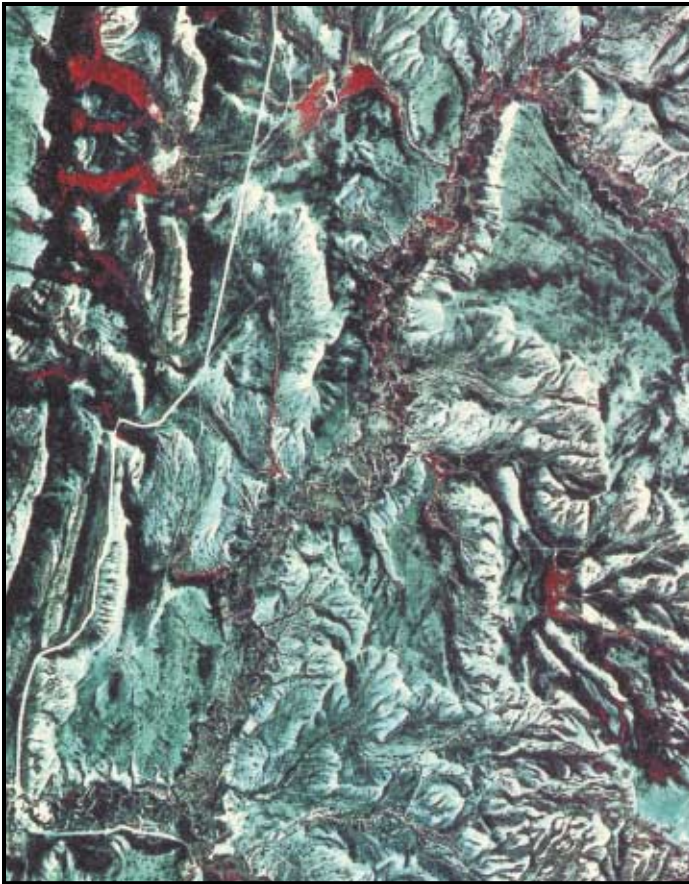
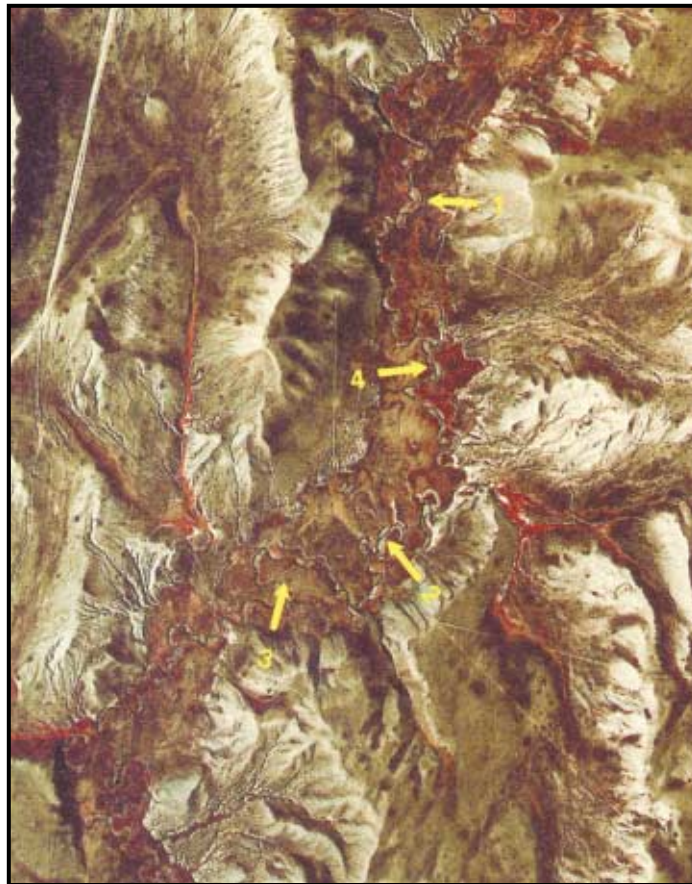
**Photo 1a** — July 1989

The presence of midchannel bars (arrow 4) suggests that the floodplain and channel characteristics are not adequate to dissipate energy. Deposition of materials also indicates the system is not in balance with its sediment load.

The color balance difference in the two photos should be noted. Color balance in CIR photography is difficult to control.

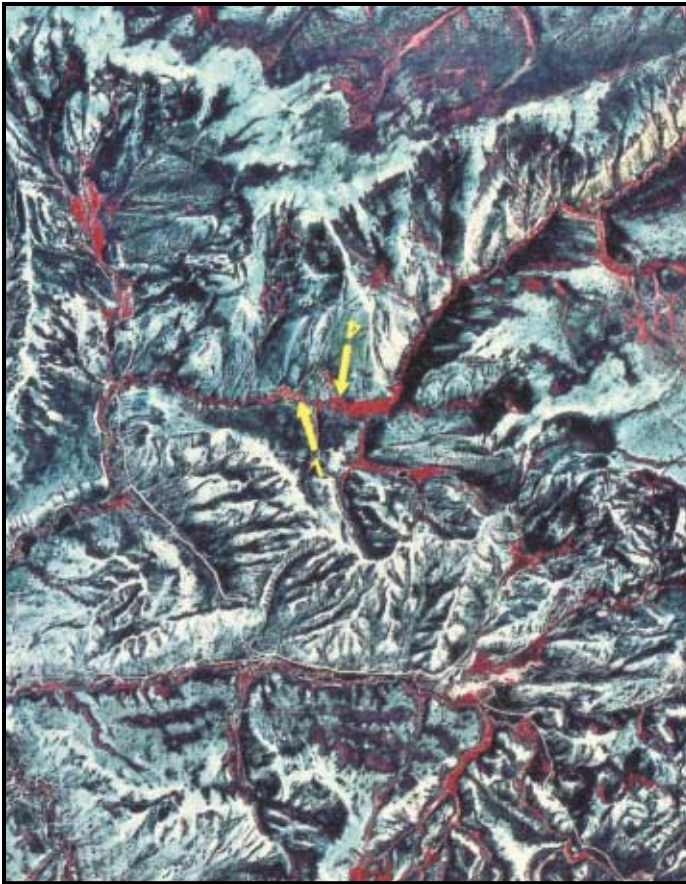
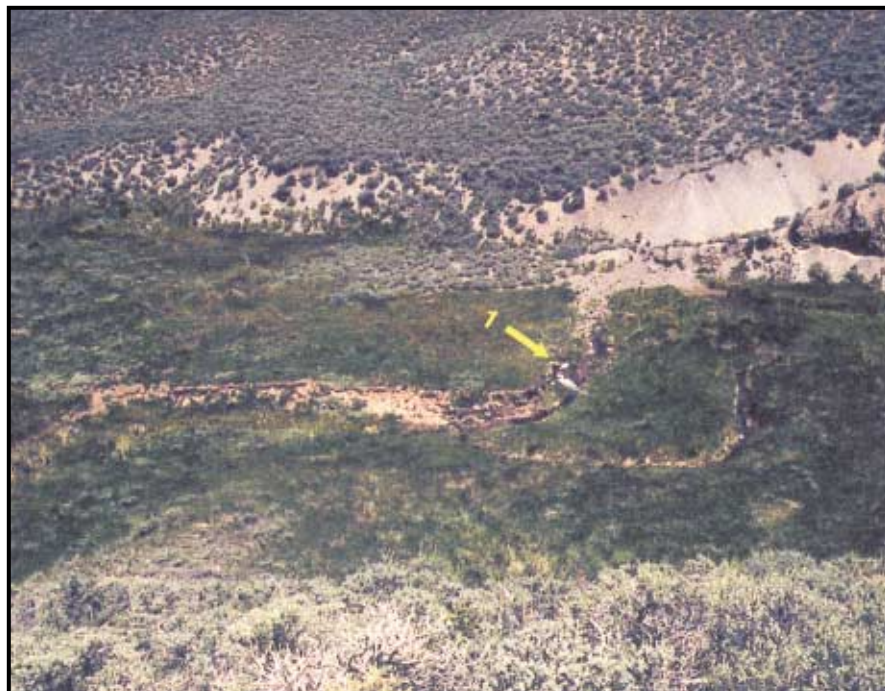
**Photo 2a — July 1989**

Photo 2a is a CIR photo of Littlefield Creek at a nominal scale of 1:40,000, photo 2b is a CIR photo at a nominal scale of 1:3,000, and photo 2c is a ground photo. All three photos focus on a headcut (arrow 1) that is slowly progressing upstream through a beaver complex.

This stream would be divided into two reaches, one above the headcut and one below, based on evidence in these photos. The disturbance caused by the headcut can be seen in all three photos.

Under stereo magnification, diverse age structure of vegetation (arrow 5) can be seen around the beaver ponds in aerial photos 2a and 2b. Variations in texture, height, and spectral reflectance are indicators of a diverse composition and age structure of vegetation. Some diversity can still be seen below the headcut (arrow 6). However, the mixed red, white, and blue-green signatures are indicators of upland species that have invaded the site due to lowering of its water table.

On a standard PFC checklist, items addressing vegetation above the headcut would be answered "Yes;" items addressing vegetation below the headcut would be answered "No."

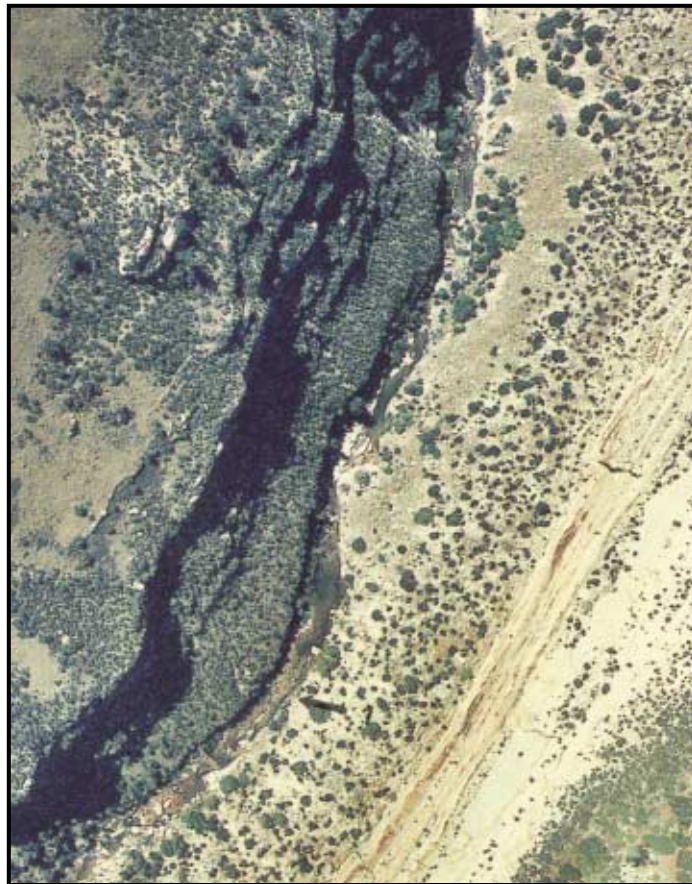
**Photo 3a** — July 1989

Photo 3a is a CIR photo of the Middle Fork Powder River at a nominal scale of 1:40,000. Photo 3b is a natural color photo of the same area at a nominal scale of 1:3,000. Photo 3c is a field photo taken from a ledge approximately 200 feet above the valley floor. This series of pictures shows how landform is important in determining the condition of a riparian-wetland area.

Under stereo magnification, unvegetated spots (arrow 1) can be seen in the channel in photo 3a. The slope of the valley bottom and the gradient of the stream suggest that these could be rock rather than sand, gravel, or soil bars; the other two photos confirm the presence of large rocks and possible bedrock in the channel.

Vegetation items on a PFC checklist could be answered "N/A" or "Yes" because vegetation plays a limited role in dissipating stream energy.

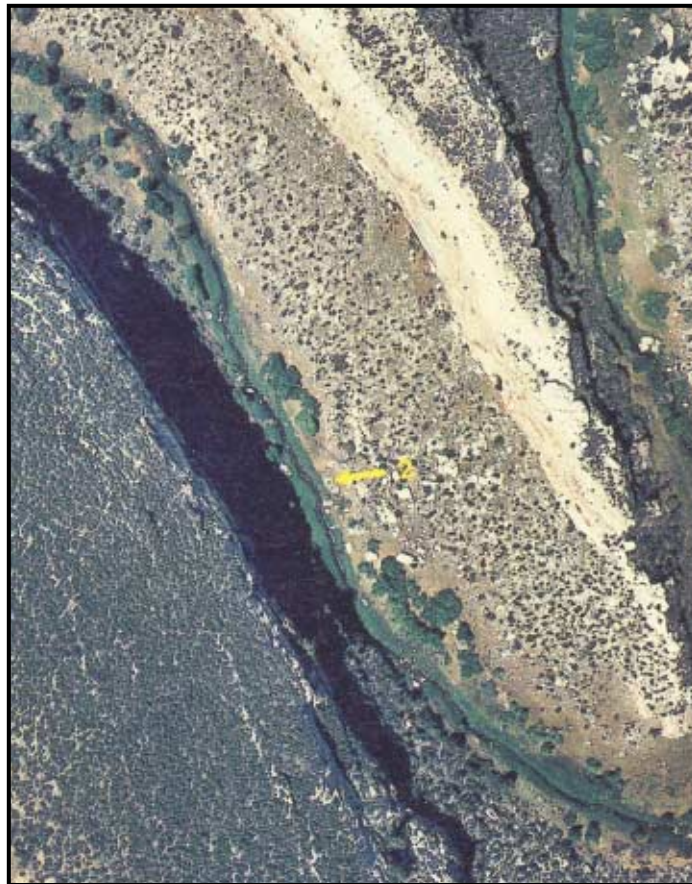
**Photo 4a** — June 1989

Photo 4a is a CIR photo of Buffalo Creek at a nominal scale of 1:40,000. Photo 4b is a natural color photo of the same area at a nominal scale of 1:3,000. Photo 4c is a ground photo.

Photo 4a shows a bright red signature throughout the valley floor due to a wet year (arrow 1). This would be interpreted as excellent riparian-wetland vegetation condition throughout the reach. However, an interpreter must compensate for photos that were taken while upland species are still actively growing. Photos 4b and 4c show that there is a high percentage of upland vegetation, especially grasses, growing on the streambanks (arrow 2). Upland plants do not count when deciding if there is adequate vegetation to protect streambanks. Vegetation items on a PFC checklist would be answered "No."
