Special Inspector General for Iraq Reconstruction

Lessons in Inspections of U.S.-funded Stabilization and Reconstruction Projects

December 2011

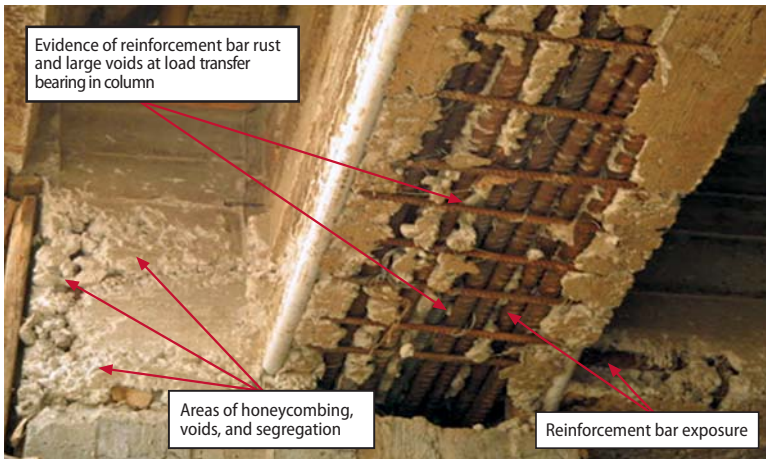
Project photographs and diagrams can help document the quality of construction and aid in the explanation of complex engineering terms. For example, SIGIR identified concrete quality as a significant issue with several Iraqi contractors and subcontractors, especially at the five Kirkuk primary healthcare centers and the Baghdad Police College project site. In addition to providing descriptions of construction terms, such as honeycombing, segregation, voids, and reinforcement bar

An example of SIGIR report illustrations: honeycombing, segregation, voids, and reinforcement bar exposure within the central laundry facility at the Baghdad Police College.

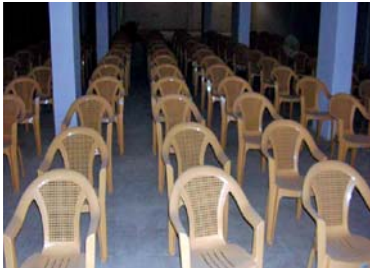
Plastic chairs provided to the Kerbala Library in place of metal, upholstered chairs required by the contract.

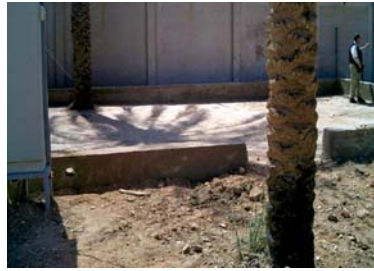
Empty site at the Babylon Police Academy where a 1-megawatt generator was required to be installed by the contractor.

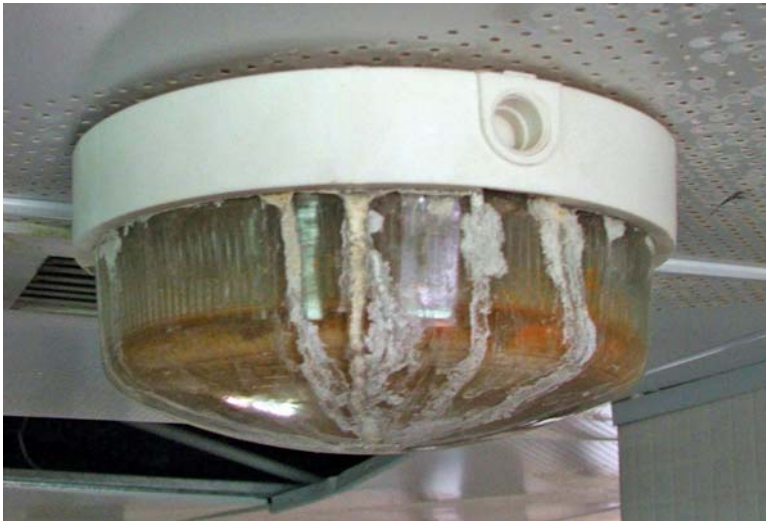
SIGIR found many instances in which contractors were rewarded—instead of penalized—for poor performance. For example, SIGIR’s assessments of the Baghdad Police College project identified myriad construction deficiencies by the contractor, Parsons Delaware, Inc., whose construction practices were so poor that water and other waste materials continually drained through the top floor down into second-floor and ground-floor rooms.

Urine-filled light fixture in cadet barracks bathroom at the Baghdad Police College.

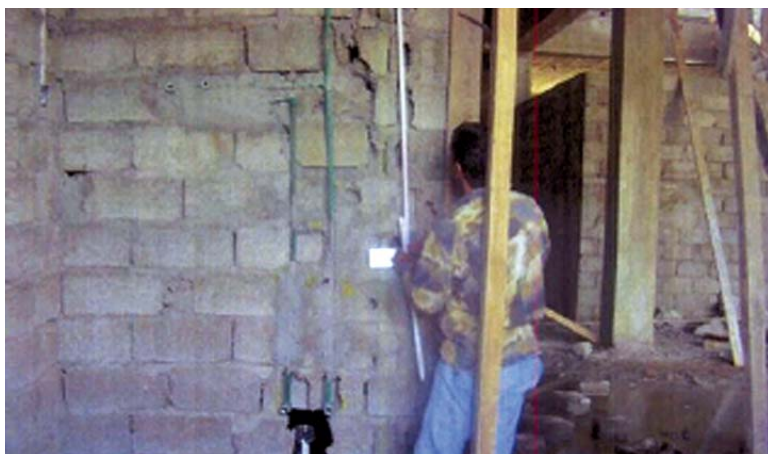
Example of poor block laying at primary healthcare center in Kirkuk. (USACE photo)

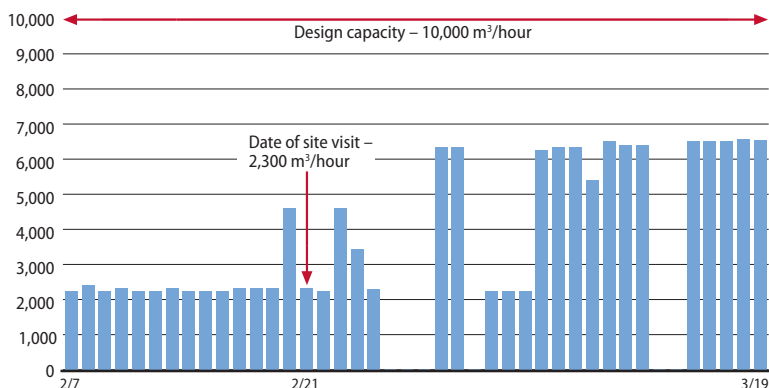
FIGURE 3
FINISHED WATER PRODUCED AT THE NASSIRIYA WATER TREATMENT PLANT,
2/7/2008–3/19/2008
 Cubic Meters per Hour

Note: The chart shows the average of the daily finished water output claimed on the daily process acceptance reports. For most days, output was measured at two-hour intervals, four times per day. SIGIR assumed output was constant during each two-hour interval throughout the day.

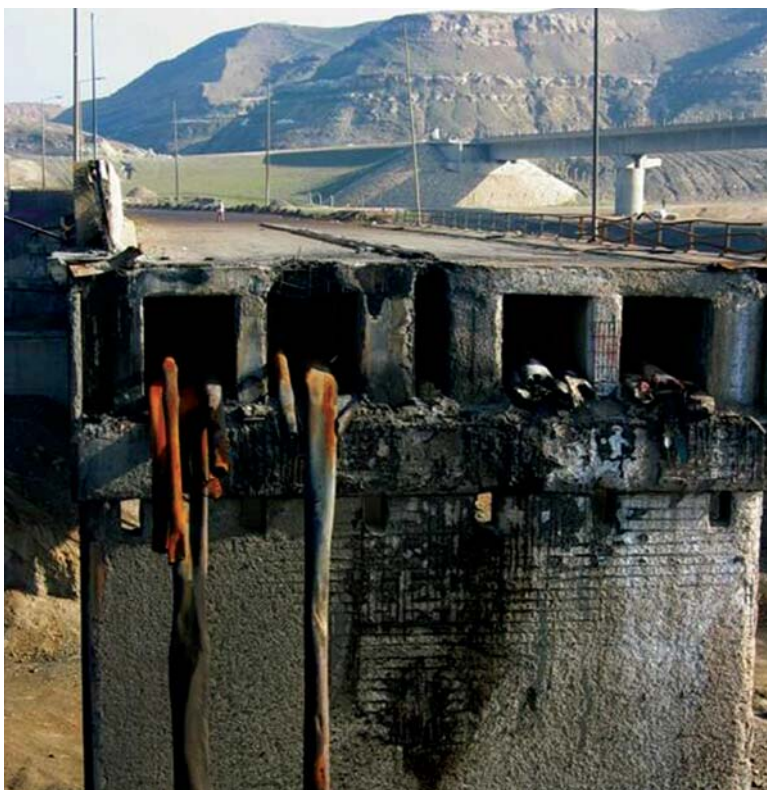
Cross section of al-Fatah bridge showing melted oil pipes. (USAID photo)

SIGIR believed the geological complexities that caused the project to fail were foreseeable. Important engineering studies and analyses, recommended by a geological consultant hired by KBR, were not performed. KBR and USACE ignored recommendations made by

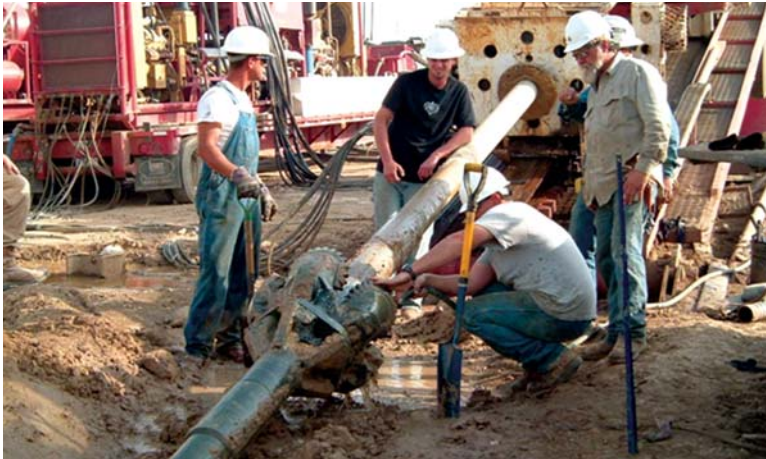
HDD rig with backreamer.

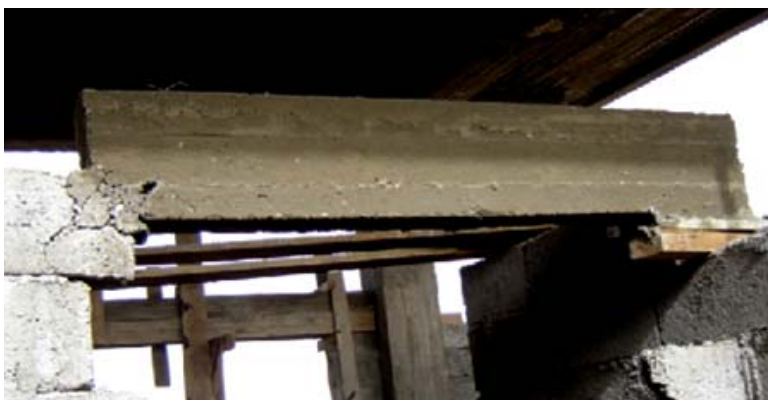
Improper support for a load-bearing lintel at a primary healthcare center during construction. (USACE photo)

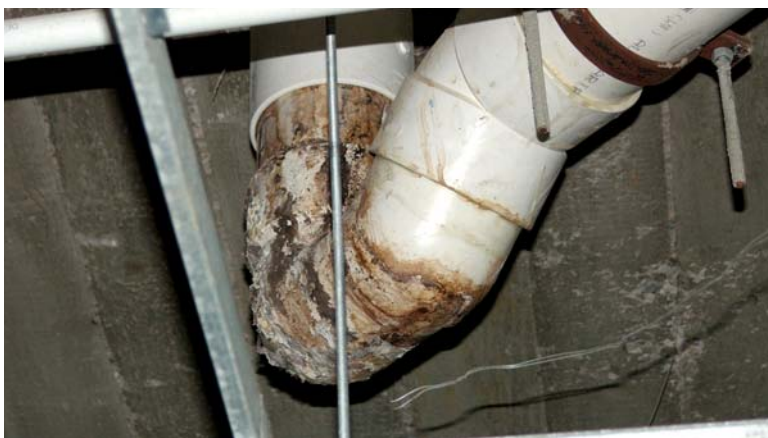
The seriousness of the plumbing problems identified during the initial visit prompted SIGIR to issue a Quick Reaction Report in Septem-

Effluent leaking from pipes at the newly constructed Baghdad Police College.

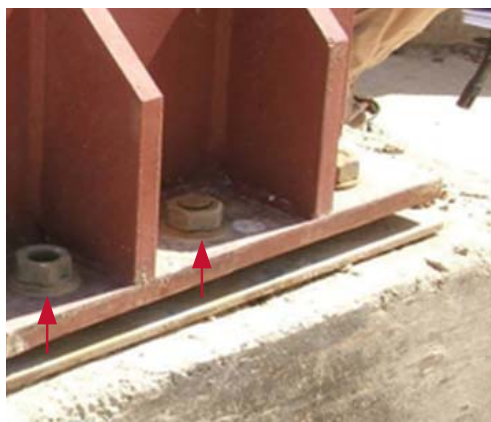
Contractor's design drawings required bolt threads extend beyond the nut and washer.

Example where one foundation bolt extends beyond the nut and another bolt does not.

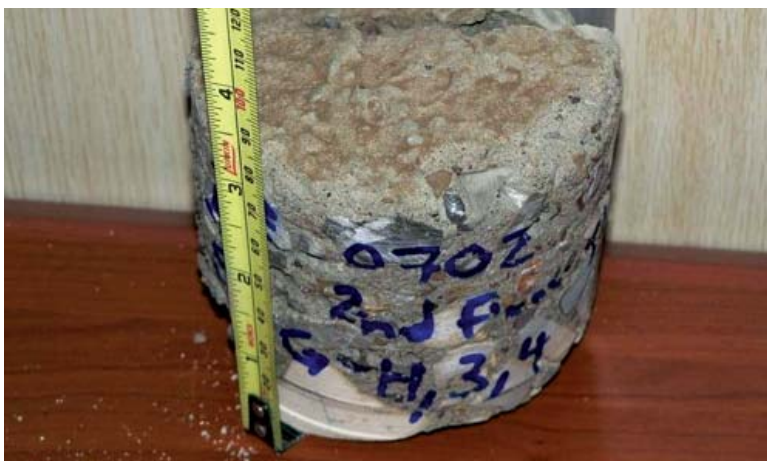
Measurement of a concrete core sample that did not meet contract specifications. (USACE photo)

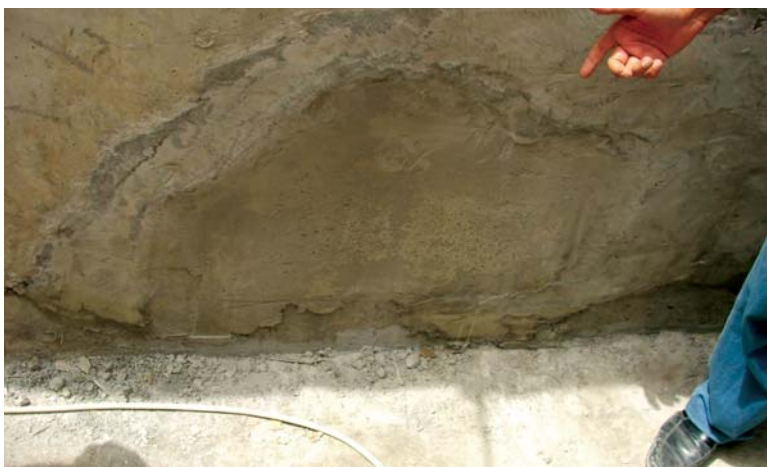
Because the work site was located in a dangerous area, SIGIR's inspectors only had time to inspect the wastewater treatment plant and Pump Station 1. At the treatment plant, they found no significant deficiencies; however, at Pump Station 1, they observed an area of inadequately

Unacceptable cement pour at a Falluja Waste Water Treatment System pump station.

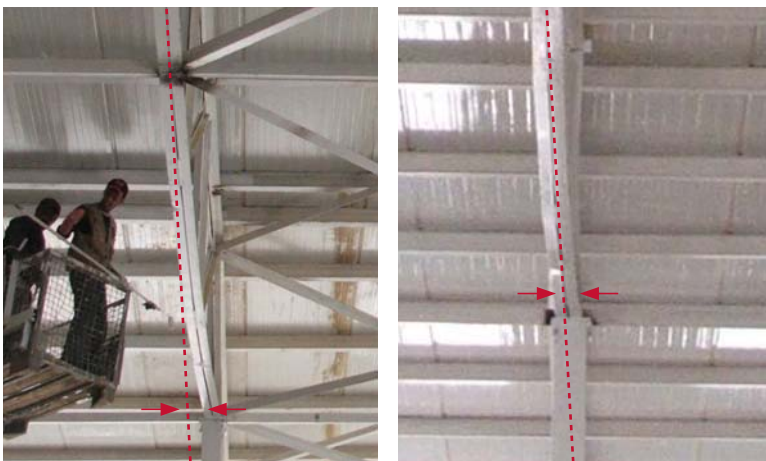
Deformation (lateral bow) in lower roof truss chords at the Abu Ghraib Dairy.

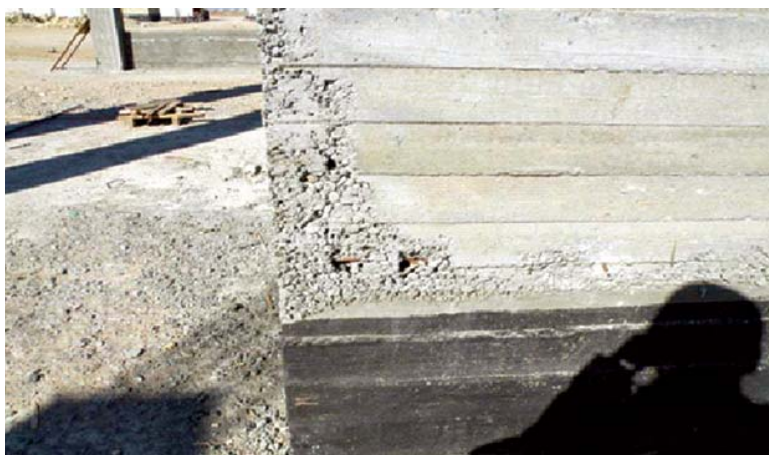
SIGIR inspected the construction site in January 2009 and found only a partial skeleton of the project completed—concrete formwork and preparation for concrete placement. SIGIR determined that the “26% complete” reported by various U.S. agencies was overly optimistic; the main hospital portion of this project, scheduled to be completed by March 2009, was more realistically about 10%–15% complete. SIGIR observed construction deficiencies, such as a poorly constructed security wall, areas of reinforcing steel with a coating of cement residue, a reinforcing configuration used in the construction of the reinforced concrete columns that varied from the configuration specified in the design drawings, and several examples of concrete honeycombing—ranging from slight to moderate to severe.

Unacceptable cement pour with honeycombing and exposed rebar at the Missan Surgical Hospital.

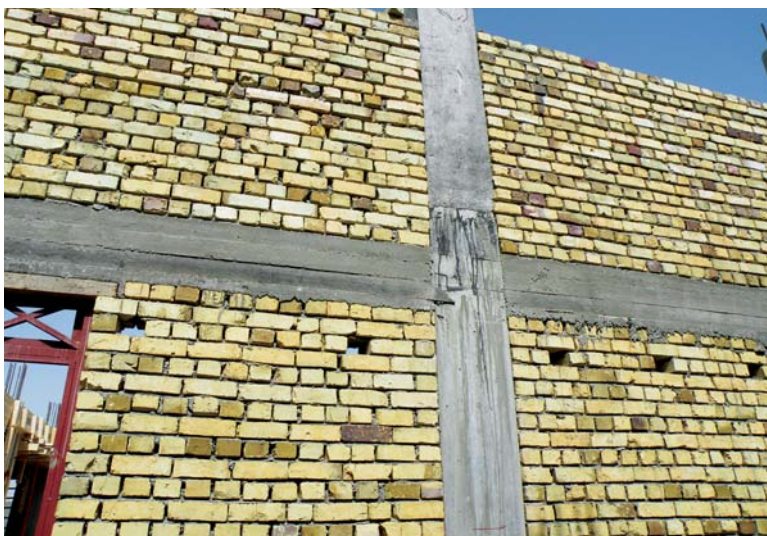
Basrah Modern Slaughterhouse under construction, showing upper-level concrete intermediate (cross) beams improperly supported by brick façade.
