Collection of Data with Unmanned Aerial Systems (UAS) for Bridge Inspection and Construction Inspection

PUBLICATION NO. FHWA-HRT-21-086

SEPTEMBER 2021

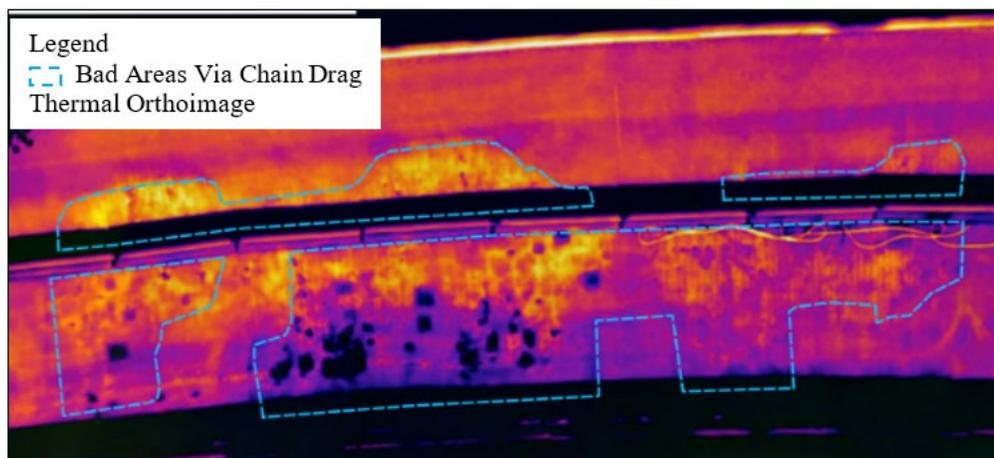
An example of an IR image that identifies bridge-deck delamination is shown in figure 4. The areas outlined in light blue dotted lines depict delaminated areas of unsound concrete located using traditional hand sounding and mapping. The yellow and orange areas highlighted using the IR imaging technology correspond well to the areas of interest identified using traditional mapping techniques. The bridge in this image is an active construction project. The dark areas in the center of the image are the result of the barriers placed by the construction team to divide the traffic lanes, creating shadows, and the other dark areas are deck patches on areas recently repaired by the contractor.

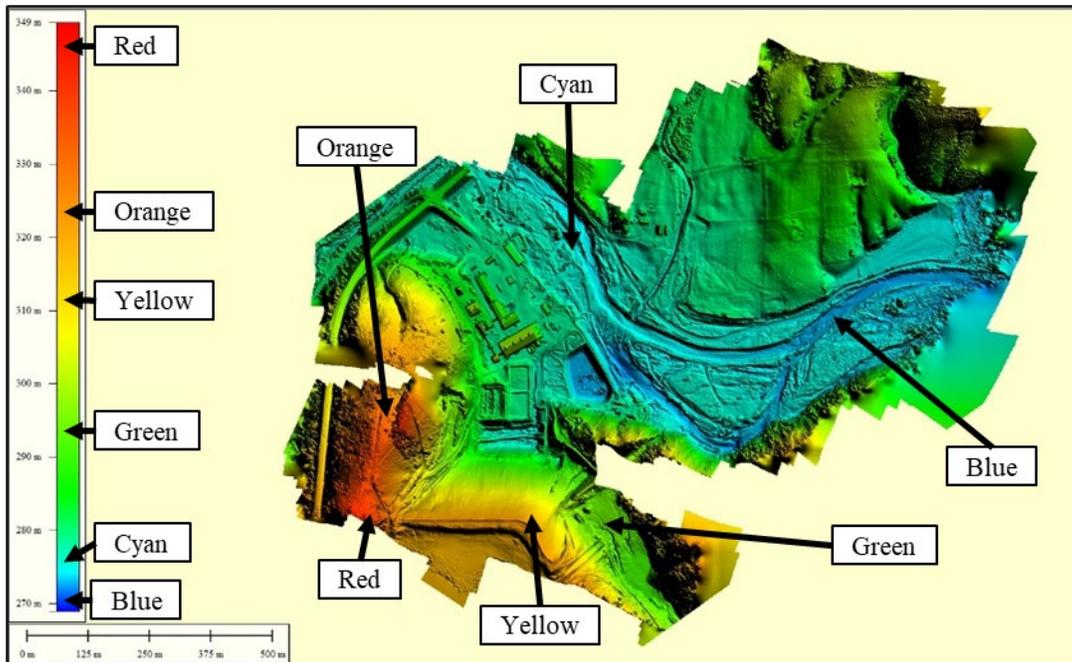
Unlike EO and IR cameras, which passively respond to inputs from the environment, LiDAR sensors actively emit pulses of light, up to hundreds of thousands of returns per second, to measure the distance between the sensor and a target object accurately. This measurement is achieved by calculating the time it takes for a pulse to hit a target and return to the sensor (USGS n.d.). The information can then be either used during the postprocessing phase to create 3D point-cloud models or processed further in digital elevation models (DEMs), as shown in figure 5. A LiDAR point cloud of a bridge is depicted in figure 6.

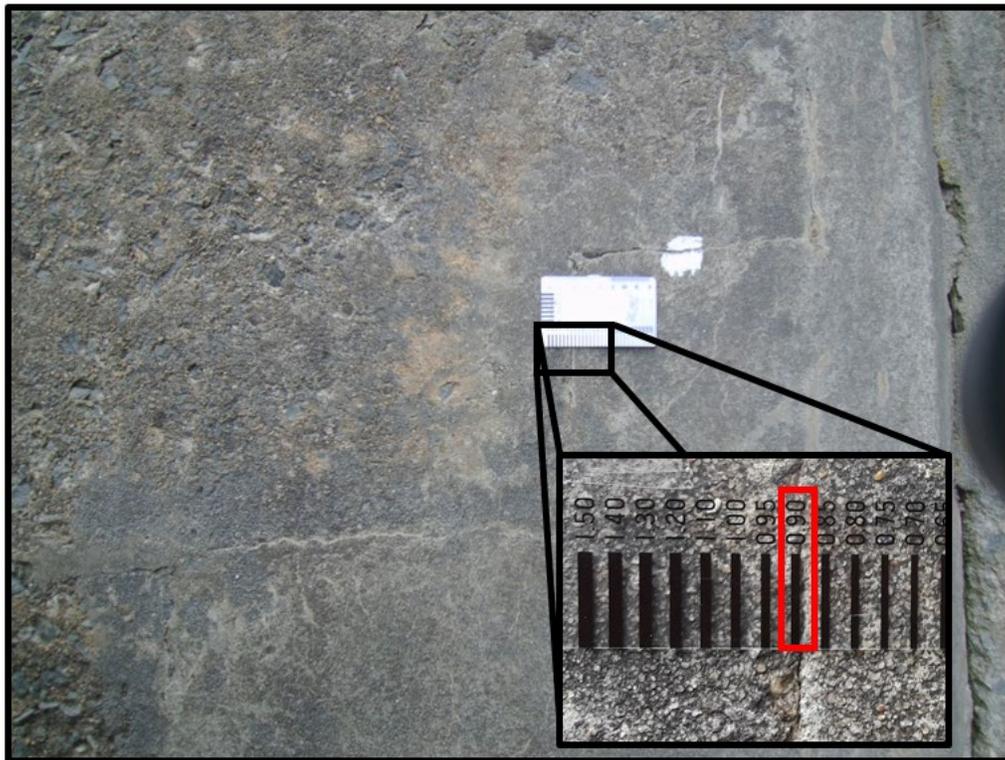
Figure 8. Photo. EO image with crack comparator.

Figure 8 presents another example of an EO image, this one taken in the field of a bridge component and utilizing a crack comparator card. The figure depicts a small crack on a patch of a concrete wing wall that appears as a thin white line at the bottom left of the comparator card. The crack is approximately 0.035 inches (0.90 mm) in width as measured by a crack comparator card overlaid. The image was taken using the same camera as figure 7 with the UAS camera hovering approximately 36 inches (0.914 m) away from the structure. No postprocessing was done to the image other than reducing the original 13- by 10-inch (33 by 25.4 cm) image to fit the page. The image was captured under ambient light conditions during the afternoon at the bridge location. The embedded close-up image was an additional image taken with a 13 MP handheld camera from approximately 6 inches (15.240 mm) away so that the measurements on the crack comparator could be seen for reference.

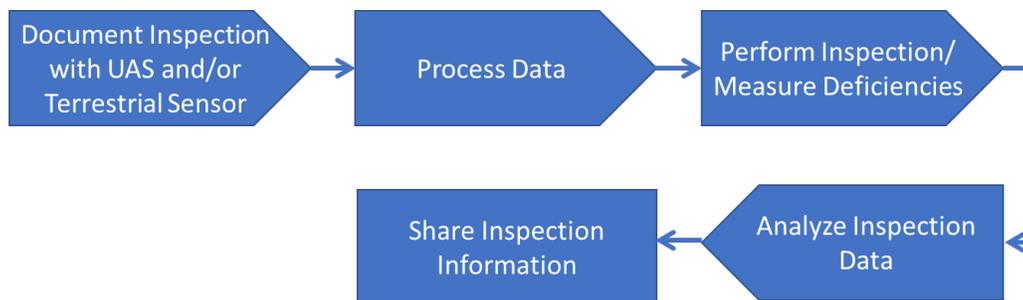
Figure 12 portrays a fly-then-inspect workflow used to fly the UAS and capture the imagery needed to create 3D models and other products that document the results of an inspection. The data are then used to create a dimensionally correct image, which is used by the bridge owner to view inspection results. The 3D model is especially useful for comparing bridge condition over several inspection cycles (Wells and Lovelace 2018).

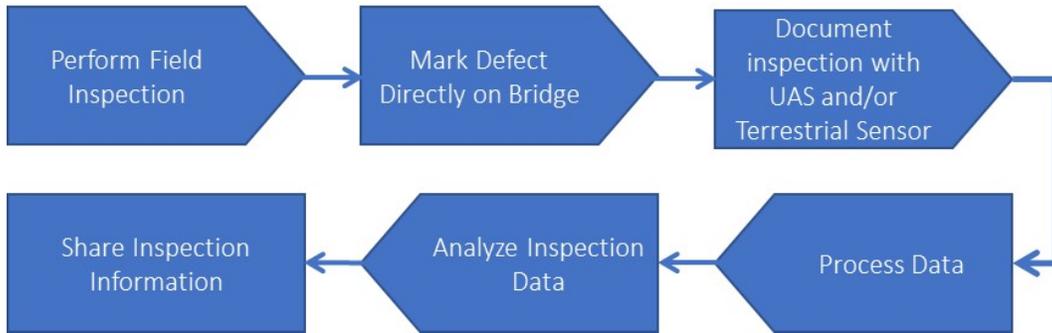
Figure 13 is a inspect-then-fly workflow used with traditional inspection processes that are supplemented with imagery captured by the UAS to document the inspection. This workflow can be used for creating photogrammetric models of bridges with imagery from UAS and terrestrial cameras. MnDOT has used this workflow to document the findings of an inspection where the defects were marked directly on the bridge. This method allows the user to create 3D and orthographic models and then capture measurements of deficiencies while in the office. These models are then available for comparison during future inspections (Wells and Lovelace 2018).

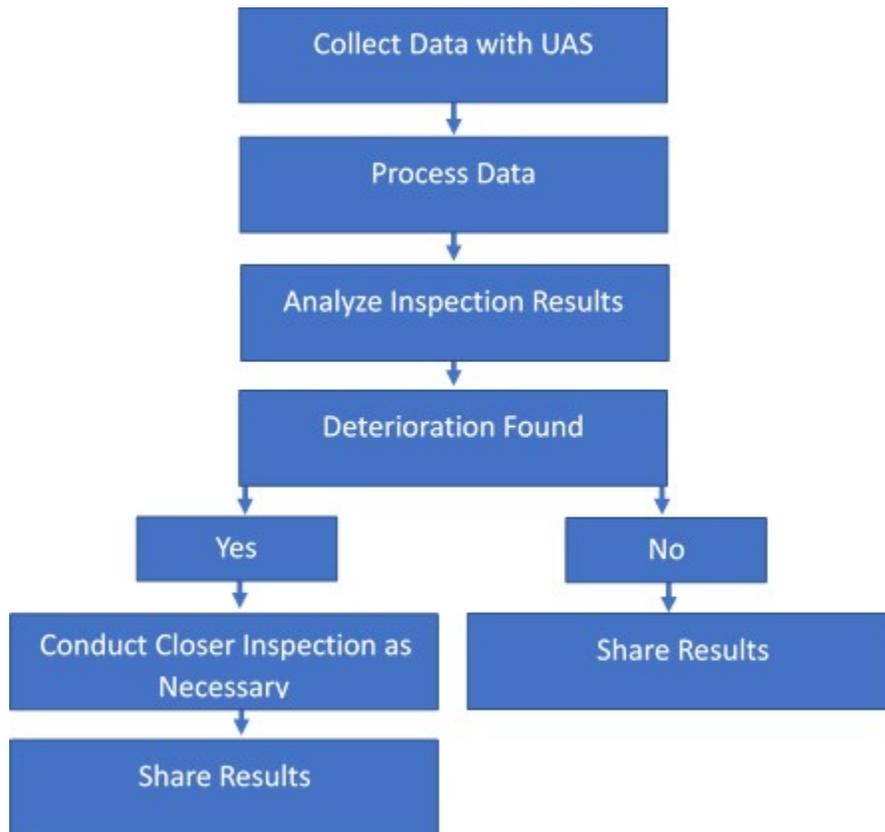
Figure 14 is a hybrid workflow that also serves as a decision tree. The purpose of this workflow is to ensure that, if a defect or deterioration is found while employing a UAS during a bridge inspection, the defect is examined in closer detail by using other means, such as a UBIT, ladder, etc. This workflow will correspond most closely with a quality NBIS inspection.

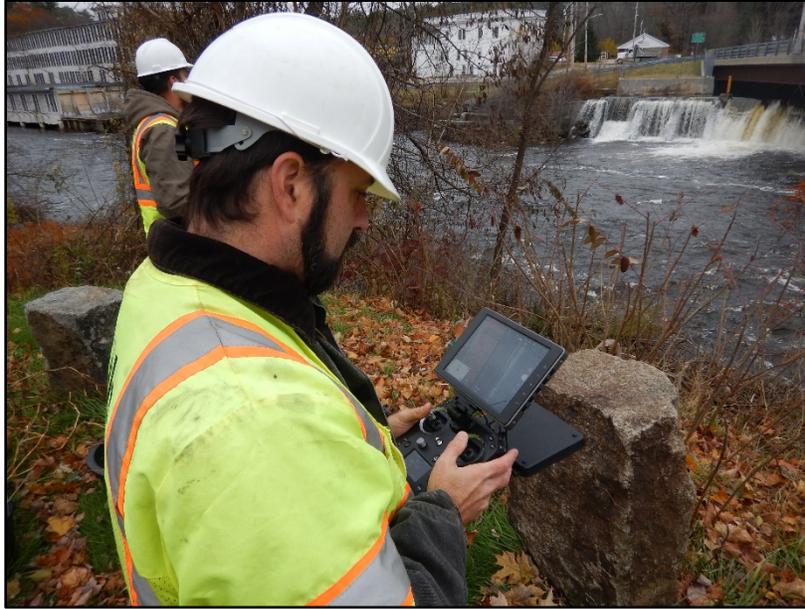
Figure 15. Photo. Dual control UAS operation.

Figure 15 depicts a bridge inspector working in coordination with a UAS pilot. Using dual controls, the inspector can focus on capturing the needed images of the bridge structure while the pilot concentrates on safely flying the platform.

The dual-control inspection team comprises a UAS pilot and a sensor operator who perform their tasks using separate controllers. The sensor operator in this scenario is the bridge inspector. The UAS pilot controls the UAS position during flight, ensuring the safety of the platform and the surroundings and getting the UAS in position to attain the desired images and video. There are two video feeds from the UAS in this setup: a “first person view” (FPV) camera for the UAS pilot and a second high-resolution camera capable of viewing the live feed and capturing inspection video and photos for the bridge inspector. The bridge inspector directs the onboard camera and can, while the platform is in flight, adjust the gimbal angle, the zoom (if equipped with variable focal length lens), and multiple camera settings to achieve the highest quality inspection imagery possible.

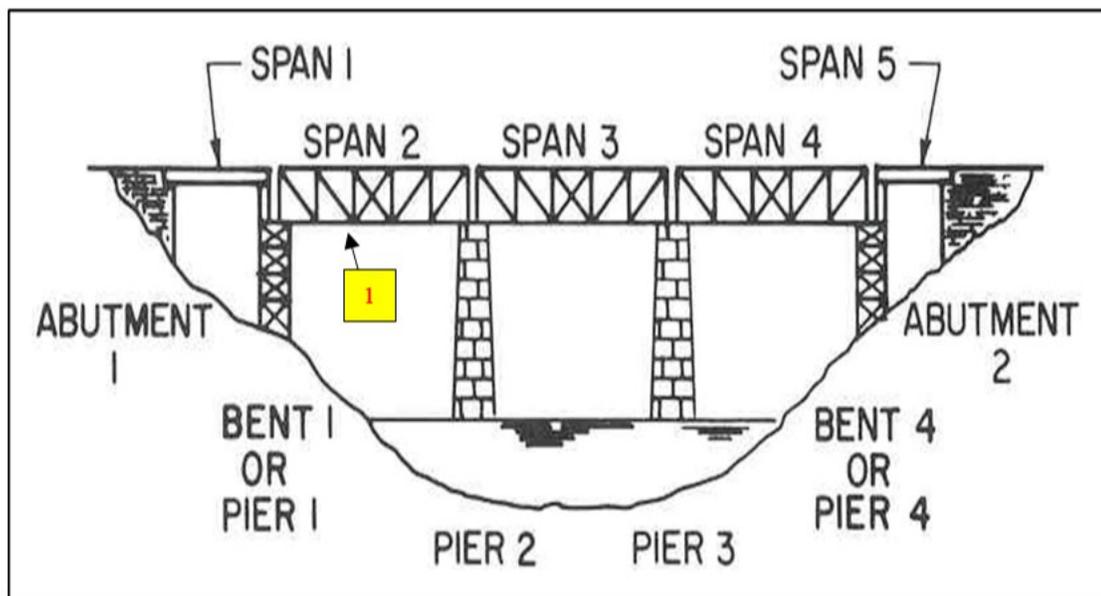
Image 1; Span 2; L1 outboard gusset plate connection to member U2, missing rivet.

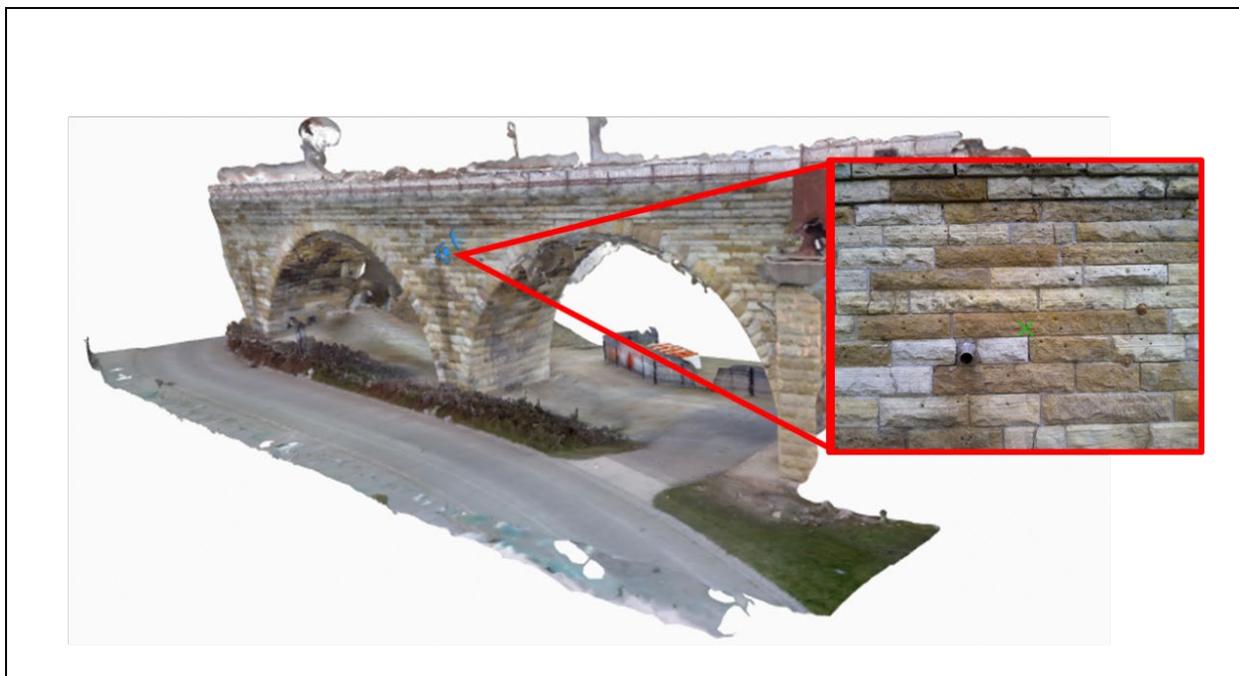
Figure 18 shows an example of MnDOT's use of imagery cataloging via a selectable 3D model (Wells and Lovelace 2018). To use it, the inspector clicks on a particular point in the model and views images that contain that point on the structure. The image can then be inspected for defects. This type of software can reduce the need for a manual photolog since the photogrammetry software will locate the image on the structure.

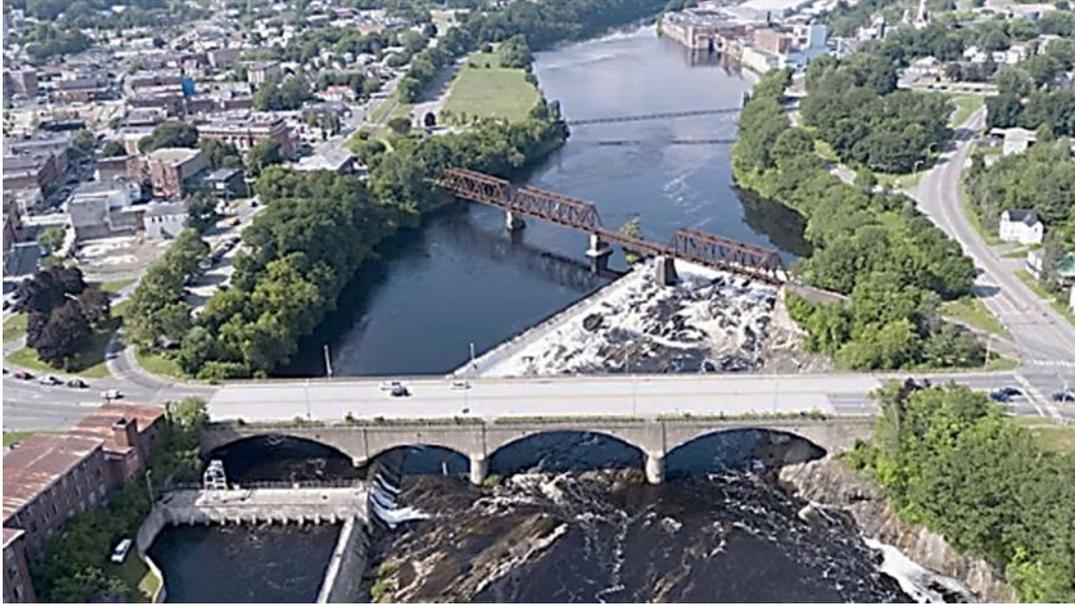
Figure 19. Photo. UAS aerial view of the Ticonic Bridge.

The Ticonic Bridge is a wide bridge situated over complex terrain, both natural and artificial, making it challenging to inspect (figure 19). It is a multispan bridge comprising three adjacent bridge types. The two-steel, welded-plate and build-up riveted-girder bridge has cast-in-place concrete decks. The adjacent historic, soil-filled-spandrel, arched-rail bridge was used in the past to support rail loads but currently only supports a pedestrian sidewalk. The bridge has five traffic lanes, two westbound and three eastbound, along with the sidewalk, and spans the Kennebec River.

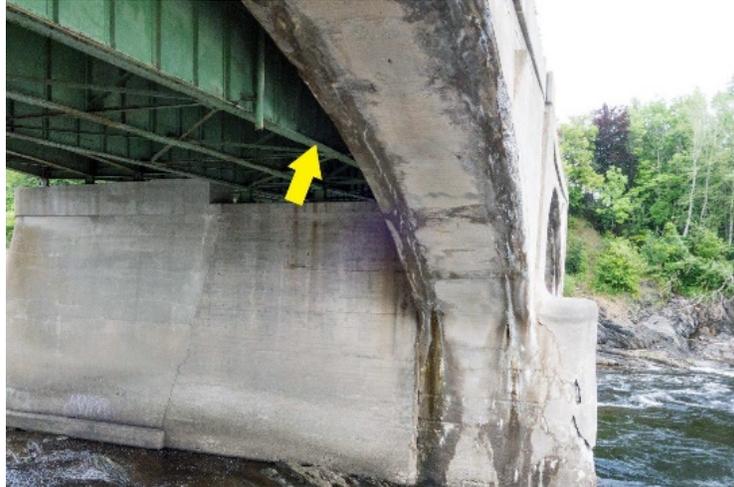
Figure 21. Photo. Key area of interest for UAS imaging.

Most of the flying was done at midday, and the high-sun conditions created some flight challenges for the inspection team. On several occasions, the bright sky in the frame of the image caused the camera's auto focus to struggle and required the team to make multiple changes to the aperture setting to obtain quality images. The team positioned the UAS so that consistent lighting filled the frame and adjusted the camera settings for each flight to optimize the lighting conditions anticipated for the next area of the bridge to be imaged. The sensors used required the aperture (or ISO settings) to be adjusted manually between flights. Today's newer technologies are more advanced, so the camera operator can adjust settings from the controller while the platform is in flight. The primary area of interest for imaging by the UAS was very dark (figure 21). This area between the historic, soil-filled concrete arch and adjacent steel structure was approximately 8-ft deep (measured vertically). Several flights were needed to refine the camera settings enough to obtain quality images.

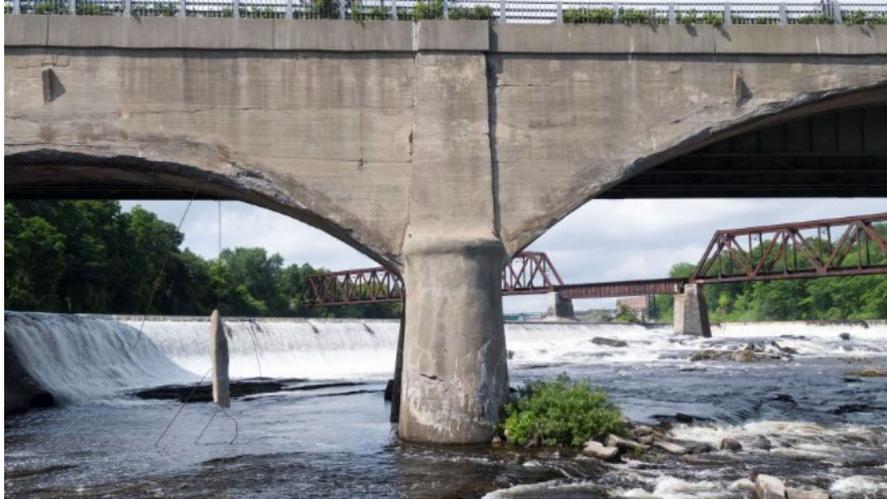
Figure 22. Photo. UAS-captured downstream view of pier and spalled concrete hanging from span.

While standing in a single spot on the bank of the river, the pilot and inspector could view the bridge from a distance to get an overall view of the condition of the piers and spans and the underside of the bridge deck where the UBIT could not reach (figure 22 and figure 23, respectively).

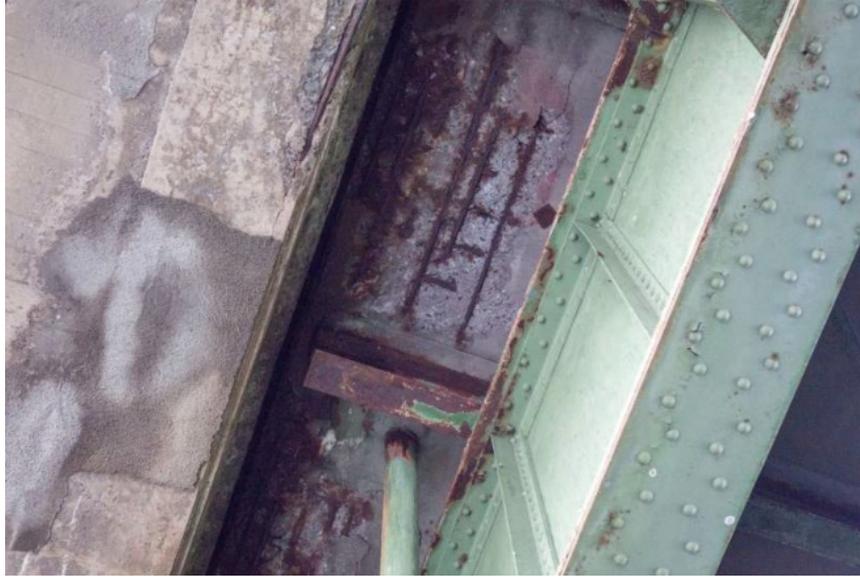
Figure 24. Photo. Image of the underside of concrete arch between the steel girders using an upward facing camera on the UAS.

Positioning the UAS below the bridge deck was more challenging for the pilot due to the loss of GPS signals to the platform, but the ability to image the spaces between the concrete arches and the steel girders using the top-mounted, upward-facing camera gave the inspector unique views of the bridge that had not been adequately imaged previously using other access methods (figure 24).

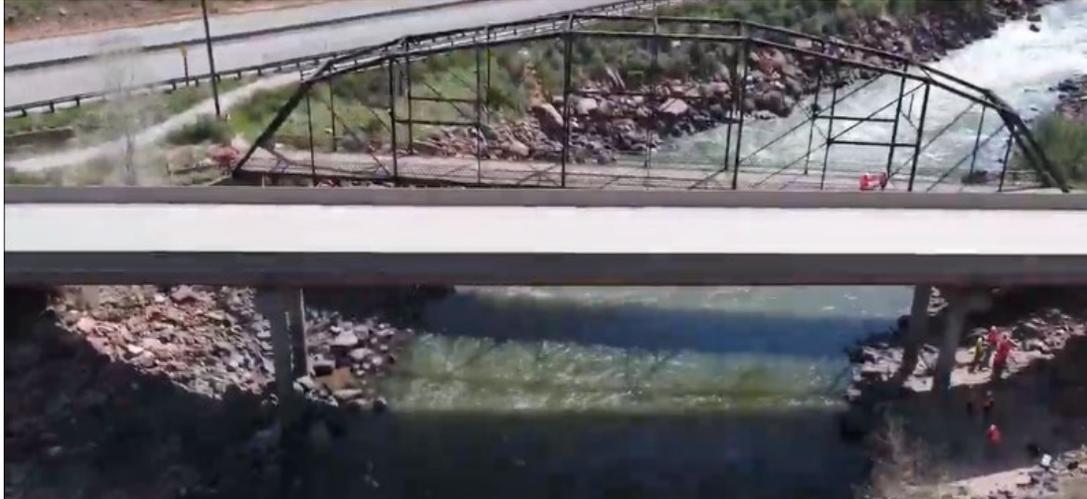
Figure 26. Photo. Glenwood Springs Bridge from the UAS.

The bridge is located on Route 134 approximately 5.5 mi to the west of Glenwood Springs, CO, and is situated over the Colorado River connecting the north and south banks with I-70. It features a footpath to the north, a rail line to the south, and a footbridge to the east. Figure 25 shows the geography of the surrounding area. The bridge has a concrete deck and is a three-span, steel-girder bridge. It is approximately 248 ft long and is supported by two piers (figure 26).

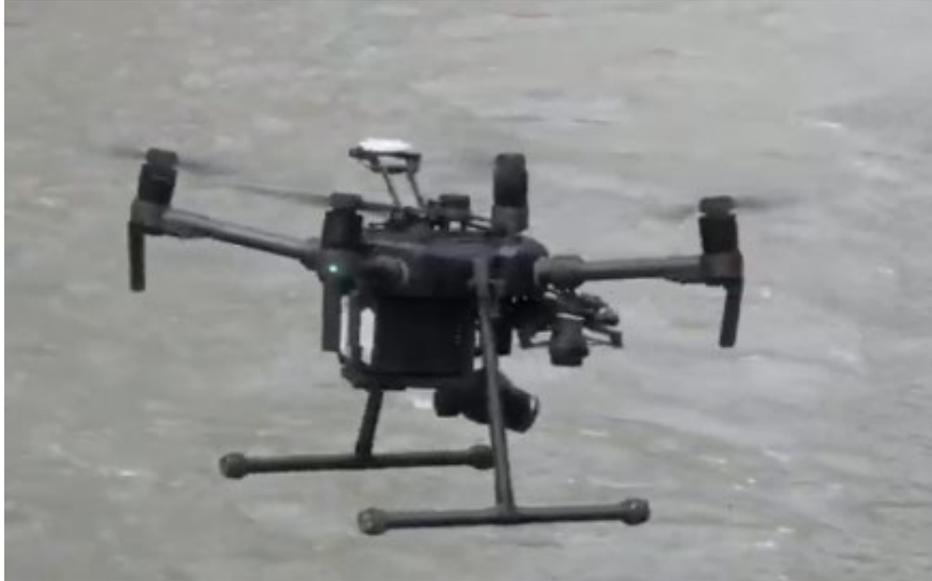
Figure 27. Photo. Inspection UAS used during the proof-of-concept study.

The platform employed for this proof-of-concept study was a COTS quad-rotor system (figure 27). The system was purposely built for infrastructure inspections, with mounts for gimbals on the top and bottom of the platform.

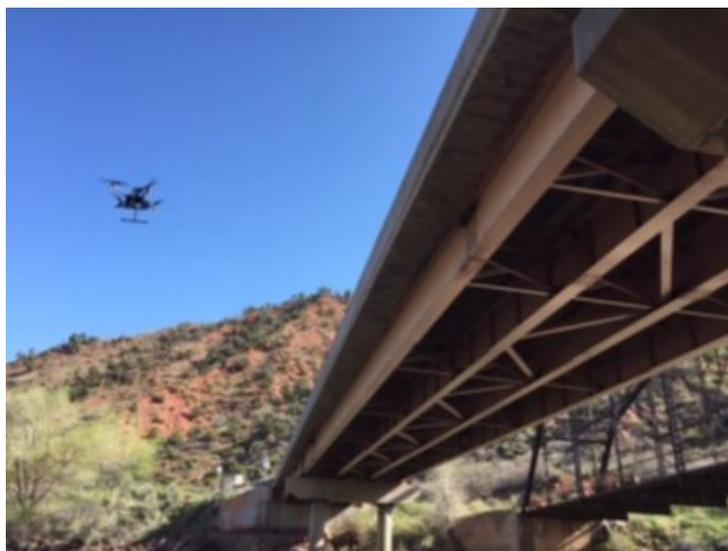
Figure 29. Photo. Glenwood Springs Bridge UAS operational environment.

The Glenwood Springs Bridge presented environmental challenges to operating the UAS and capturing quality imagery (figure 29). The bridge is in a valley that can funnel winds across and under the structure, and high, gusty winds were experienced during the flights. Winds compounded the flying challenges resulting from the loss of GPS signals under the bridge deck and the extensive level of imagery overlap required by the project scope.

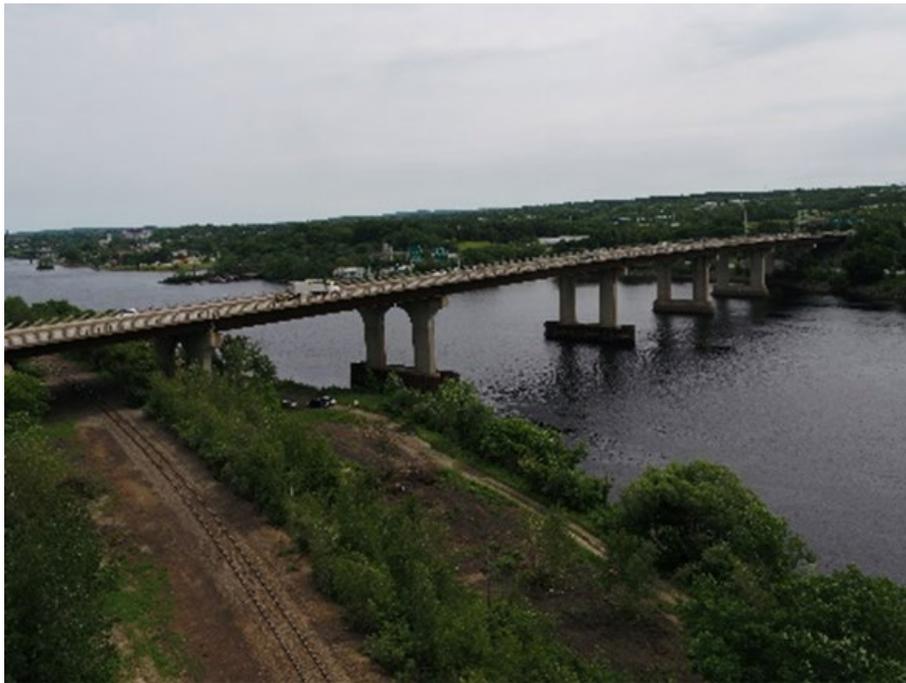
Figure 34. Photo. Veterans Remembrance Bridge.

The Veterans Remembrance Bridge in Bangor is a highway bridge of girder construction built in 1986 that spans the Penobscot River (figure 34). The flights were conducted to simulate a portion of a routine inspection. In addition to the inspection and demonstration images, several images were collected to identify components that were in need of rehabilitation. Of particular interest during the inspection were the pier bearings on the east side of the bridge.

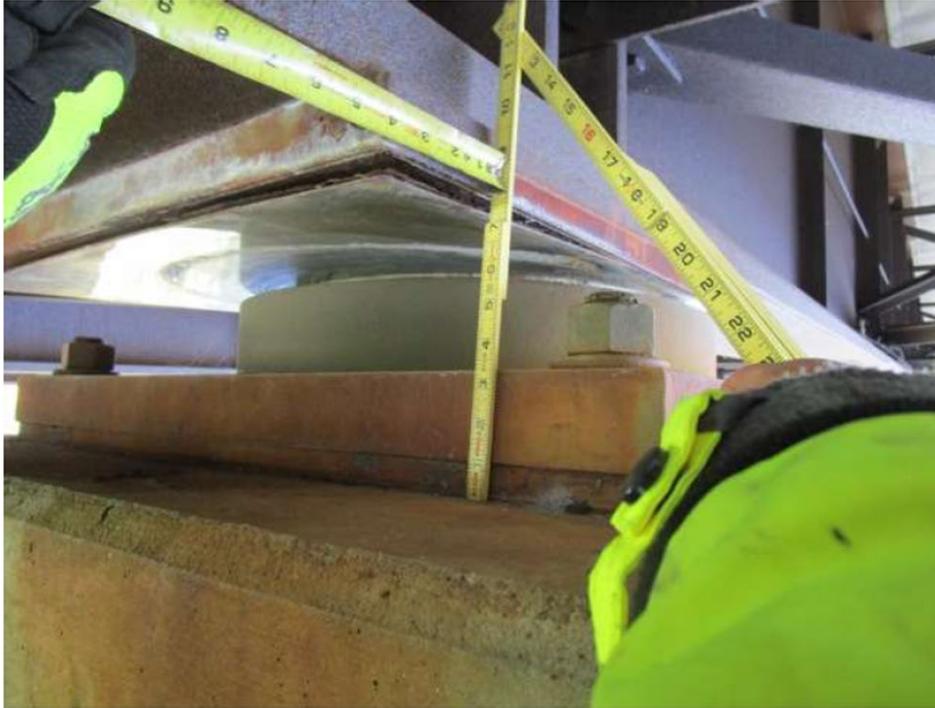
Figure 35. Photo. Inspector measuring bearing shift.

During the previous MaineDOT routine inspection using traditional techniques, the inspection team determined that a bearing on pier 7 had shifted. The inspector at the time was able get measurements of the defect by accessing the area using the staging located on the east side of the pier. Figure 35 shows the inspector measuring the defect by hand, which required the use of a walkway located under the bridge to access the staging.

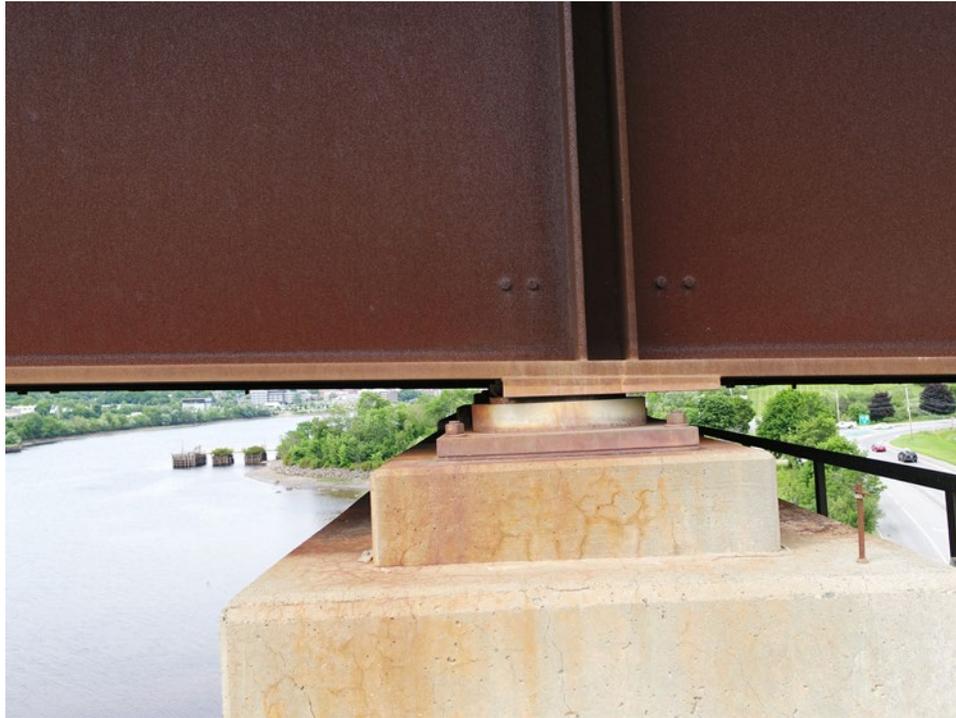
Figure 36. Photo. UAS image showing bearing out of alignment.

During the field test, the inspection team identified multiple defects during the course of the inspection with UAS. The team used the UAS to examine the same bearing shift defect for comparison purposes. Figure 36 shows the original UAS image that was captured, and the displacement of the bearing on pier 7 can be clearly seen. This image was collected with no interruption to traffic, and the team was located safely away from hazards.

While the pier 7 bearing shift is an example of how a UAS can be used to obtain images of defects without increased risk to personnel, the process would still require the inspector to

compare the measurements to the theoretical position so that an engineering assessment could be made.

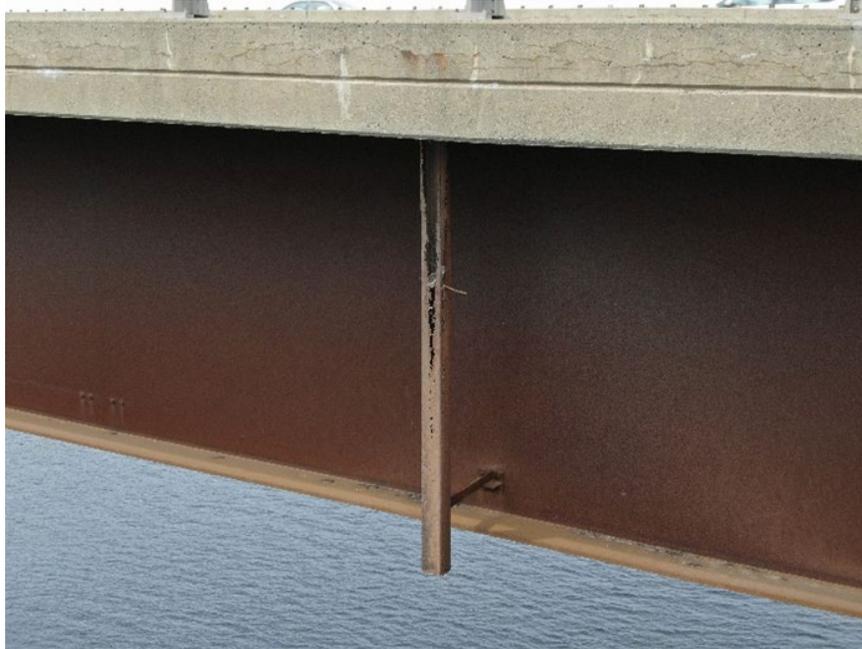
Figure 38 is a downspout with significant decay.

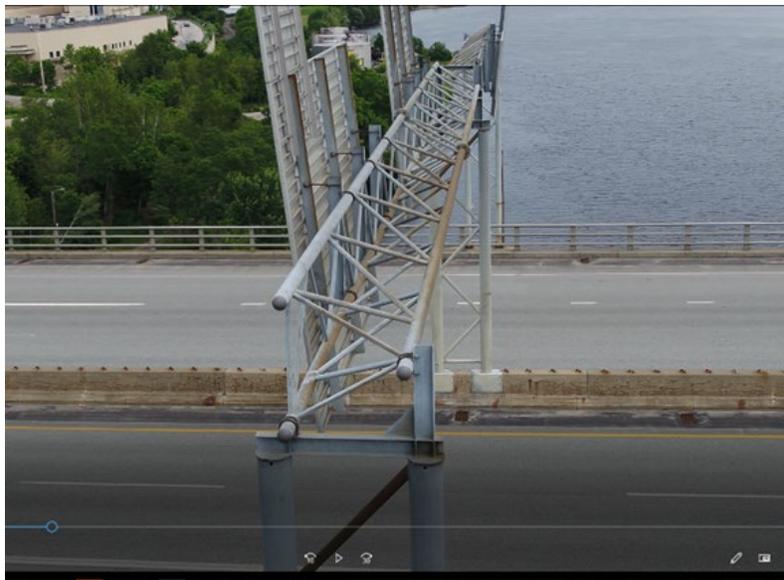
Figure 39 is an image snapshot from the 4K video captured by the UAS showing corrosion on a bridge sign structure.

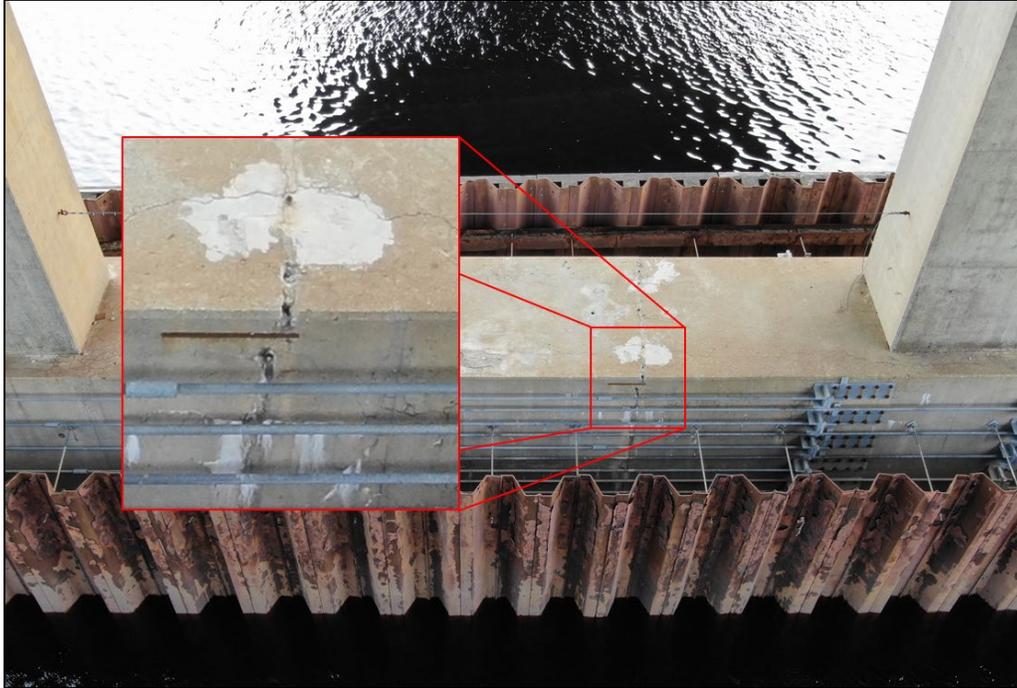
Figure 40 is an image taken by a UAS showing cracking on the foundation of pier 3 that would normally require boat access to inspect.

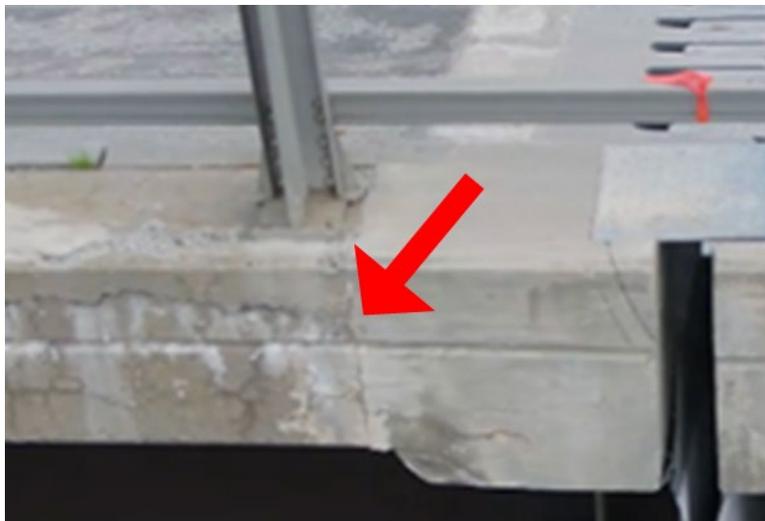
Figure 41 is a snapshot from a 4K video showing joint, curb, and fascia degradation.

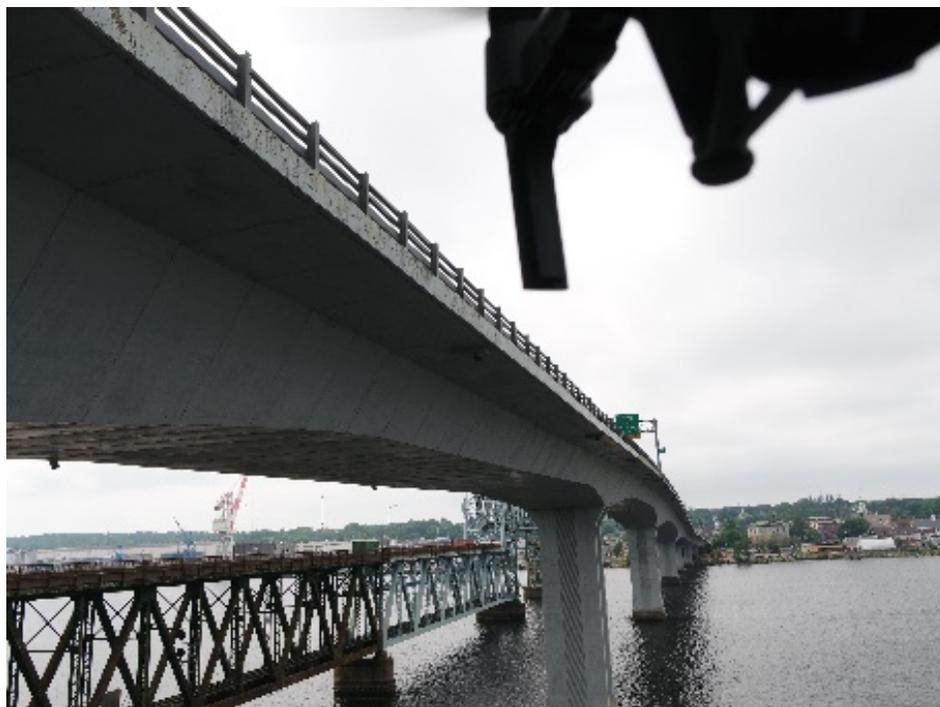
Figure 42. Photo. UAS image of the Sagadahoc Bridge.

The Sagadahoc Bridge is four-lane prestressed concrete segmental box girder bridge located on Route 1 between Bath and Woolwich, ME (figure 42). The bridge carries a high volume of daily traffic over the Kennebec River. The research team's inspection team leader had conducted a traditional routine inspection on this bridge earlier in the year.

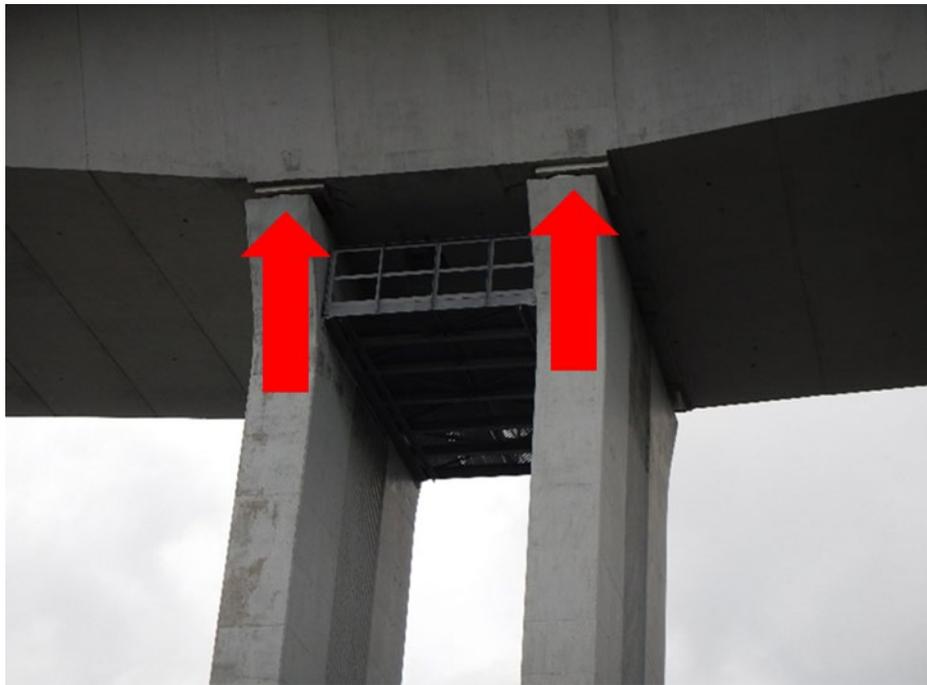
Figure 43. Photo. Image of Sagadahoc Bridge piers 8 and 9 bearings captured by UAS.

During the previous (traditional) routine inspection, the team employed a boat to observe and access key bridge components. While inspecting the bridge from the boat, the team noticed that the bearings at piers 8 and 9 were off center, as indicated by the red arrows in the image (figure 43). Due to difficulty in accessing the bearings, as well as concerns about safety, the team did not measure the bearing offset at that time.

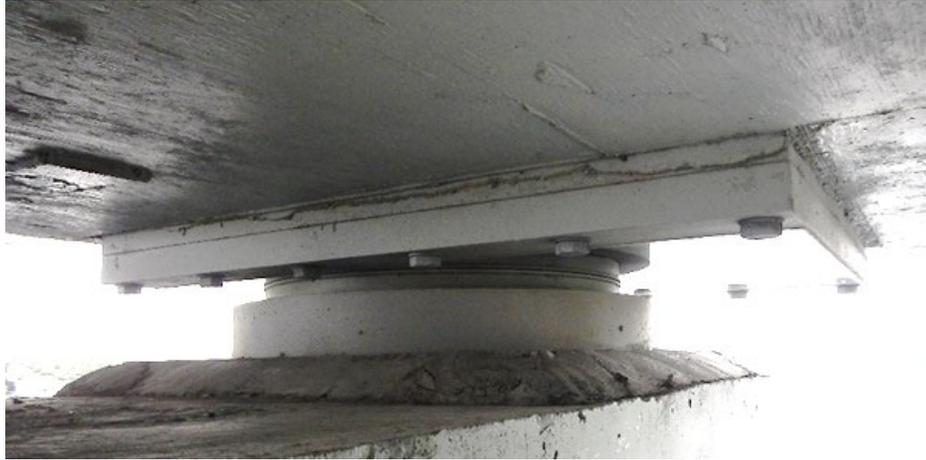
Figure 44. Photo. Image of bearing taken with handheld camera from the staging on the underside of the bridge.

The inspection team conducting the routine inspection had limited access to bearings on piers 8 and 9 from a built-in work platform. To fully access the bearings shown in figure 44 to obtain measurements, the inspector would have needed to either free climb to the top of the piers, exposing the inspector to increased risk, or use a UBIT, which would have required interrupting traffic flow.

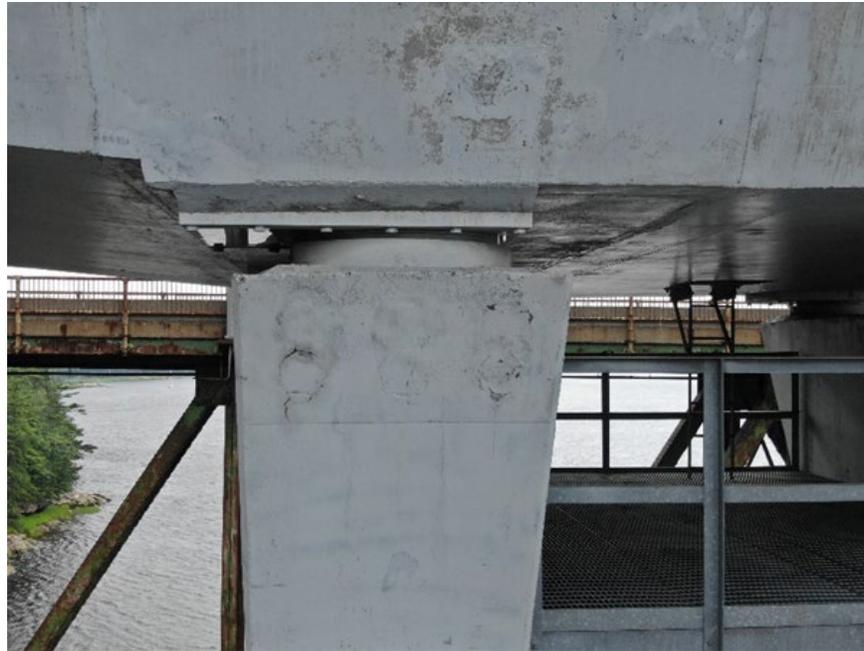
Figure 45. Photo. Raw image of the pier 8 bearing.

Because the magnitude of the bearing shift was not measured during the routine inspection, the research team flew directly to pier 8 during the UAS test flights and worked with camera settings to achieve a usable image for approximating the bearing offset. Figure 45 is the raw image taken with the UAS.

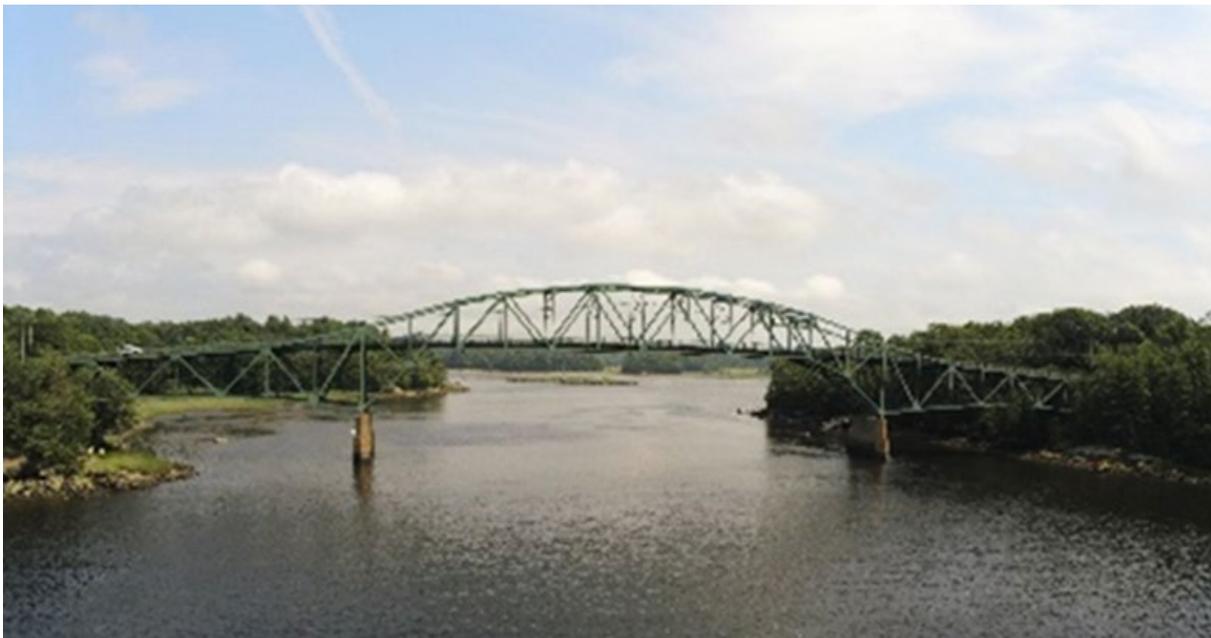
Figure 48. Photo. UAS image of the Max L. Wilder Memorial Bridge.

The Max L. Wilder Memorial Bridge was built in 1950 and spans the Sasonoa River in Arrowsic (figure 48). The structure type is a steel-cantilever (arched), rivet-connected, polygonal-warren, through-truss bridge. The UAS test flights were flown prior to a scheduled fracture critical inspection to determine if a COTS UAS EO camera was sufficient to capture defects that would otherwise have to be located using standard industry practices for a fracture critical inspection. The focus of the inspection on this bridge was a previously installed repair to arrest developing cracks on several of the members.

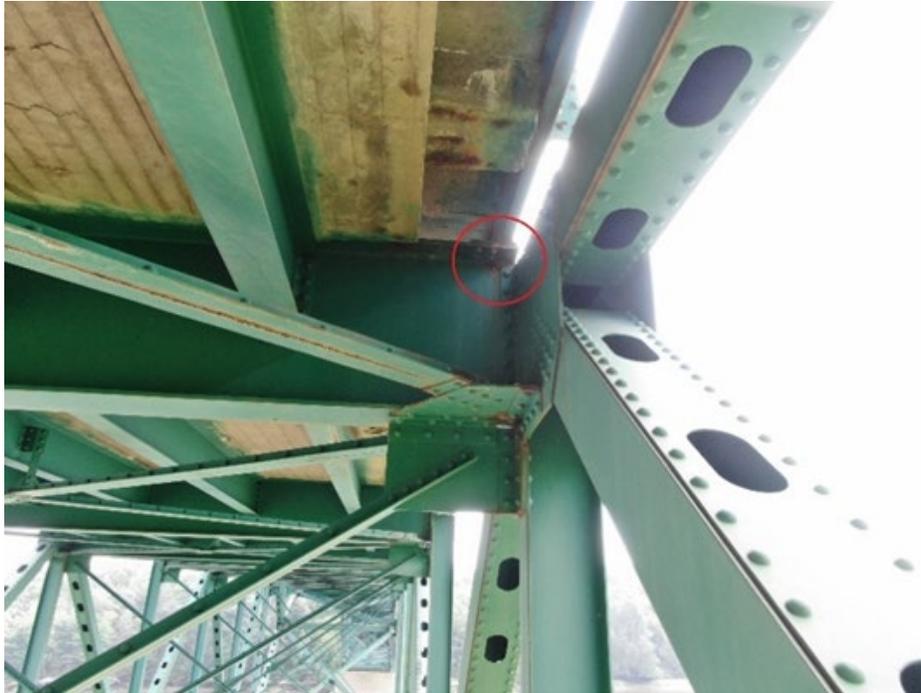
The inspection team leader for the UAS flights later joined the MaineDOT team to assist with the bridge's scheduled fracture critical inspection. The previous fracture critical inspections identified several fatigue cracks at the end of the floor beams that required preventative maintenance to halt the progression of the cracks. The area shown in figure 49 is an image of the fatigue crack location taken from a UBIT. This specific location was difficult to access and required the inspector to leave the bucket of the UBIT and to climb to further inspect the area located within the red circle in figure 49.

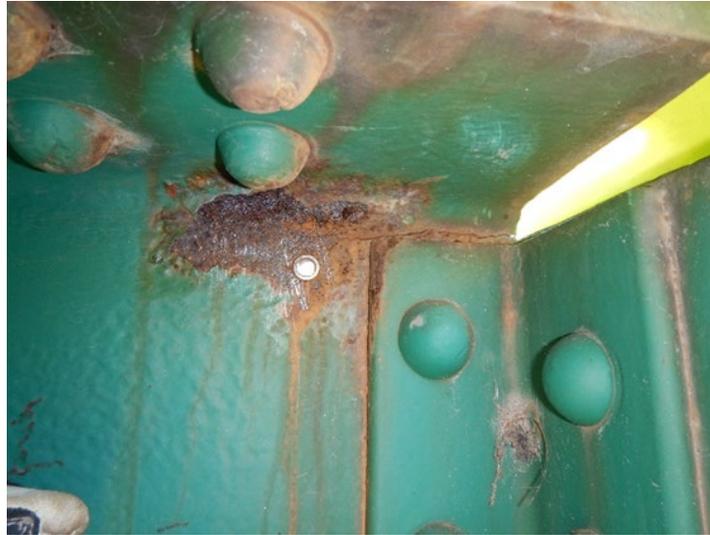
Figure 50. Photo. Photo captured by an inspector at 18 inches.

Figure 50 shows the detail that was captured by an inspector that was within 18 inches of the defect with a handheld camera. One issue that the inspector had to account for when collecting this image was light infiltration into the space where the two components were connected. To prevent light infiltration, a piece of paper was placed on the outside of the connection point to block out the excess light.

Using traditional access methods, the inspector was able to clean the surrounding area to accurately determine the extent of the defect and the effectiveness of the previous repair.

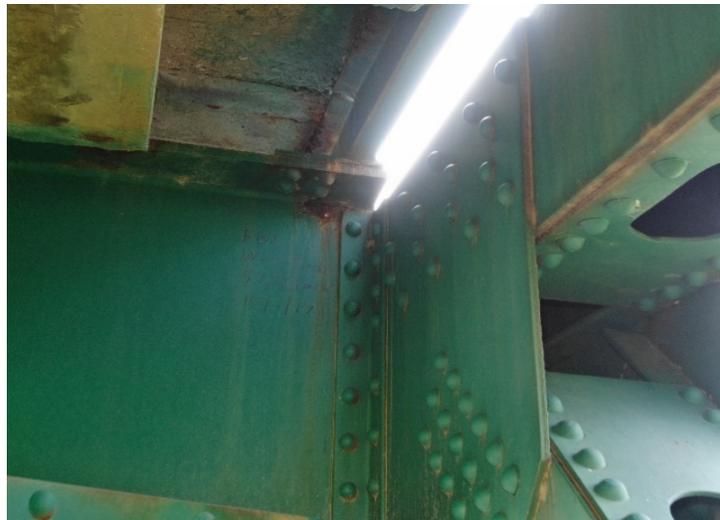
For the inspection with the UAS, a 12-MP camera was used. Figure 51 shows the image without any postprocessing, and it provides a rough approximation of what the image looked like on the UAS controller display.

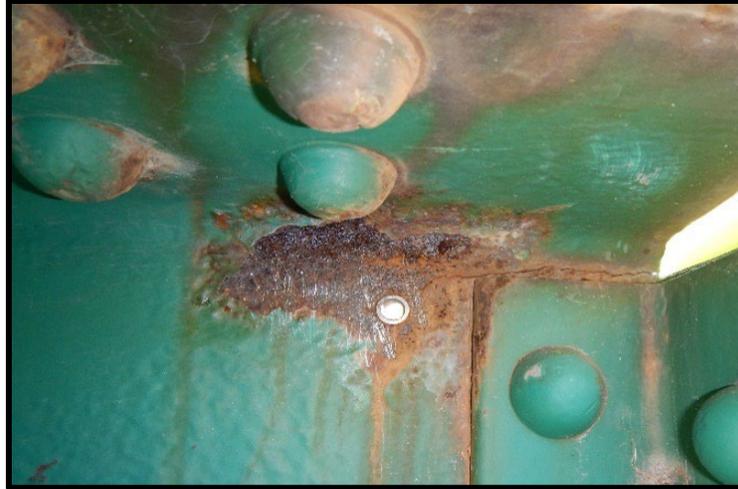
Figure 52. Photo. Inspector's photo.

Figure 52 and figure 53 provide a comparison of the quality of the defect images captured during the two inspections. Figure 52 was obtained by the inspector within arm's length of the defect, while figure 53 is an image of the same defect that was captured with a UAS at approximately 5 ft. The image in figure 53 was enlarged approximately seven times to show a scale similar to that achieved by the inspector. As can be seen, the lighting is very poor, and the enlargement does not provide the detail needed to assess the defect.

When the UAS was employed to inspect this bridge, the intent was to determine whether it could provide suitable images to aid in the inspection of fracture critical members. As a result of several different factors, the inspector determined that, for this particular bridge, the UAS did not provide the quality of imagery needed to make an assessment of the defect, but that it was useful for assisting in locating areas that required a hands-on inspection.

One issue that reduced the efficacy of the UAS was the interference experienced with the indoor stabilization, which in turn impacted the ability of the pilot to maneuver the UAS closer than 5 ft from the defect. Another significant issue, relating directly to the overall usefulness of UAS for fracture critical inspection, was the lack of tools or instruments that could contact the surface of the bridge to clean, measure, and otherwise conduct a more detailed inspection of the defect.
