Collection of Data with Unmanned Aerial Systems (UAS) for Bridge Inspection and Construction Inspection

PUBLICATION NO. FHWA-HRT-21-086

SEPTEMBER 2021

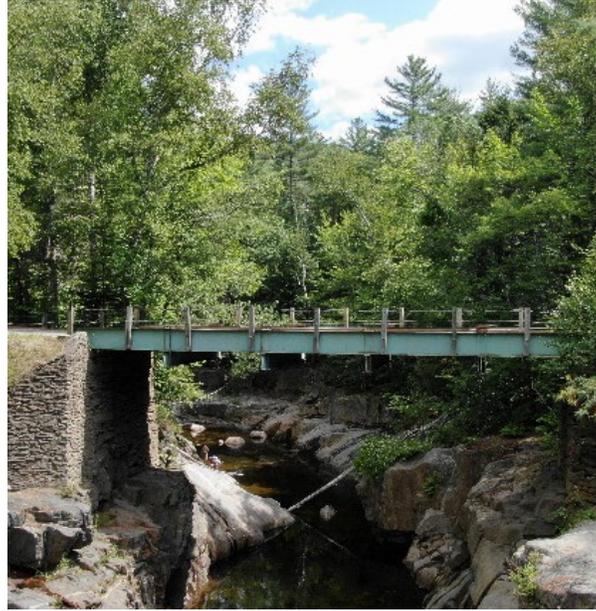
Figure 54. Photo. Coos Canyon Bridge.

The final bridge flown was the Coos Canyon Bridge in Maine (figure 54). It is a single-span, steel through-girder and floor beam system with timber stringers, deck, and wearing surfaces and stone masonry abutments and wings. This bridge also requires fracture critical inspections. The surrounding terrain is very challenging for inspection teams; thus, examining the results using a UAS gave the research team an additional variable to explore.

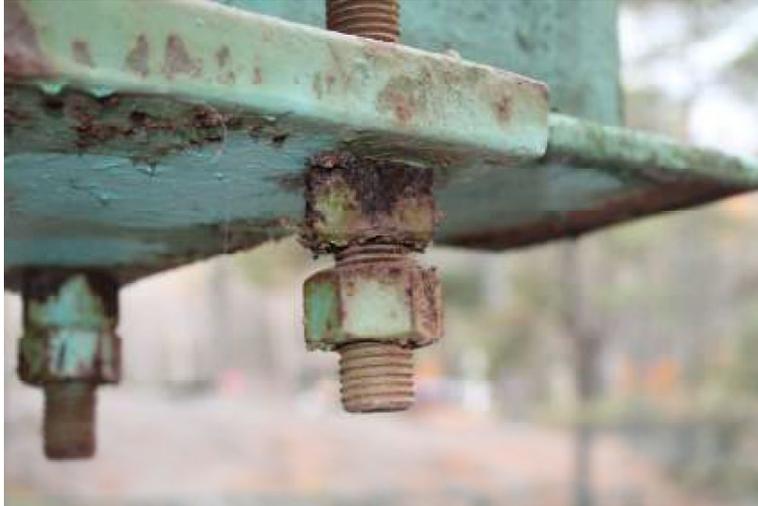
Figure 55. Photo. Image of locking nut taken by inspector using handheld camera.

Using the UBIT, the inspector captured close-up images of defects. Because the inspector was close to the defects, precise measurements could be extracted from the images as well as the physical structure. In figure 55, a locking nut that had backed away from its original position can be seen, and the measurement of how far it had backed off can be obtained.

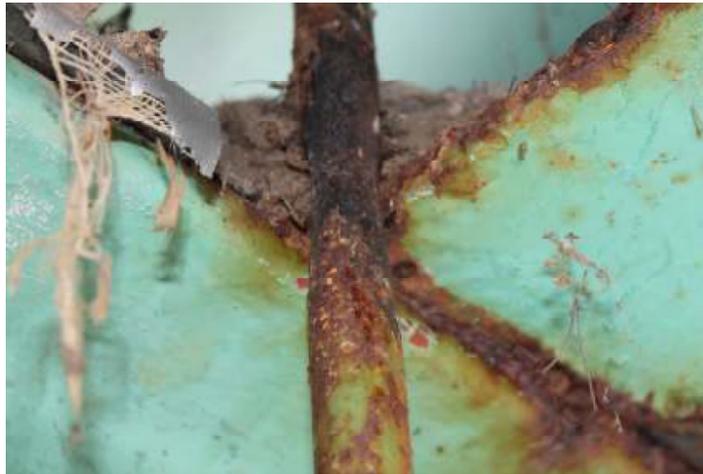
Figure 56. Photo. Image of steel hanger rod taken by inspector using handheld camera.

Figure 56 was also taken by the inspector with a handheld camera from the UBIT. The image clearly shows section loss on the hanger rod.

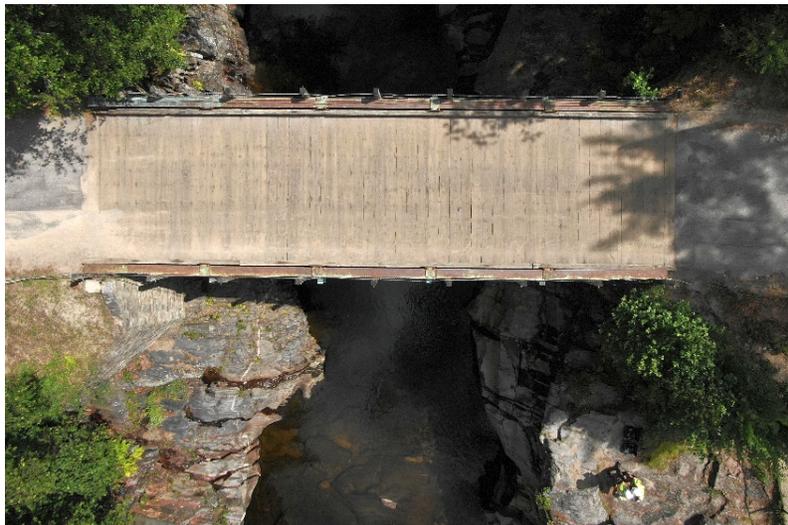
The inspection included an overhead image (figure 58) of the bridge deck for establishing the overall condition. The length of the bridge was short enough the entire surface could be captured in one image.

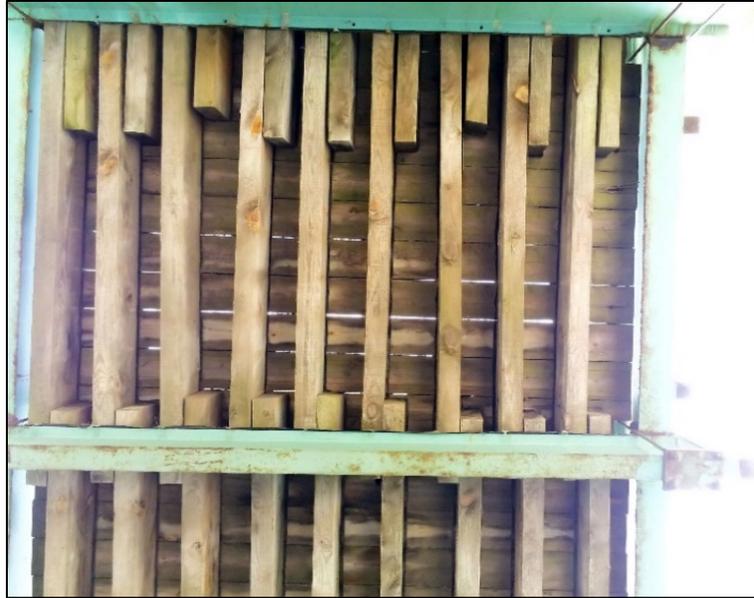
Figure 59 shows the underside of the bridge taken from a UAS and looking straight up, as opposed to from an oblique angle. This perspective allowed the inspector to see cracking and end checking on the floor beams. To obtain similar images during a traditional inspection, the inspector would need to enter the water, which would be unsafe at this location.

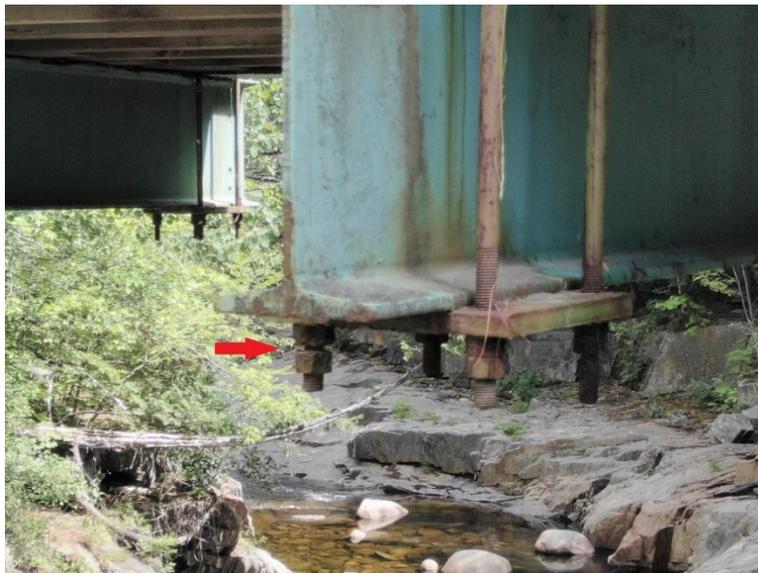
As the pilot flew the along the bridge, the inspector was able to identify defects that had only been noted during previous inspections using a UBIT, demonstrating the usefulness of a UAS for inspections. Figure 60 shows a locking nut that has backed off or was not tightened at the hanger rod connection, as indicated by the red arrow, which is the same defect identified during the traditional inspection, as shown in figure 55.

Figure 60. Photo. UAS image of backed off nut on hanger rod.

Figure 61 shows an image of the same defect shown in figure 60, but it has been enlarged during postprocessing to allow the inspector to approximate the distance that the nut has backed off.

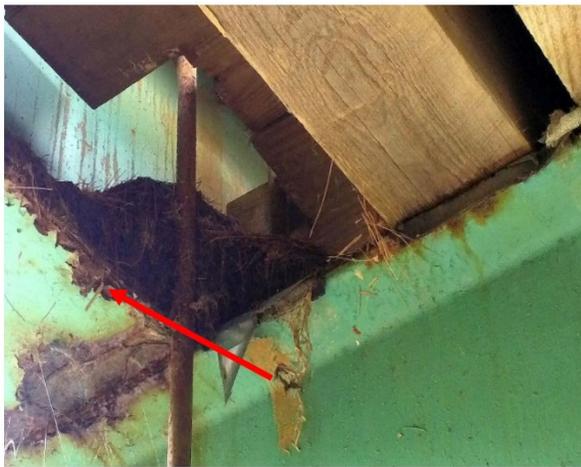
Figure 62 shows side-by-side images of the same section-loss defect. The image on the left was taken with no zoom, and the image on the right was taken at 2× zoom. The images are usable for noting that section loss is present, although the amount cannot be quantified.

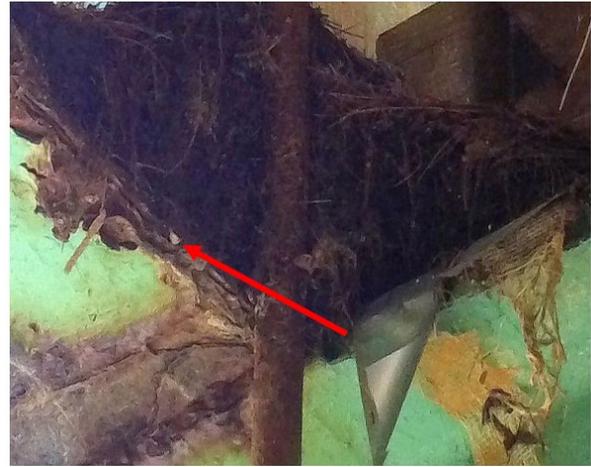
B. Zoomed photo showing section loss.

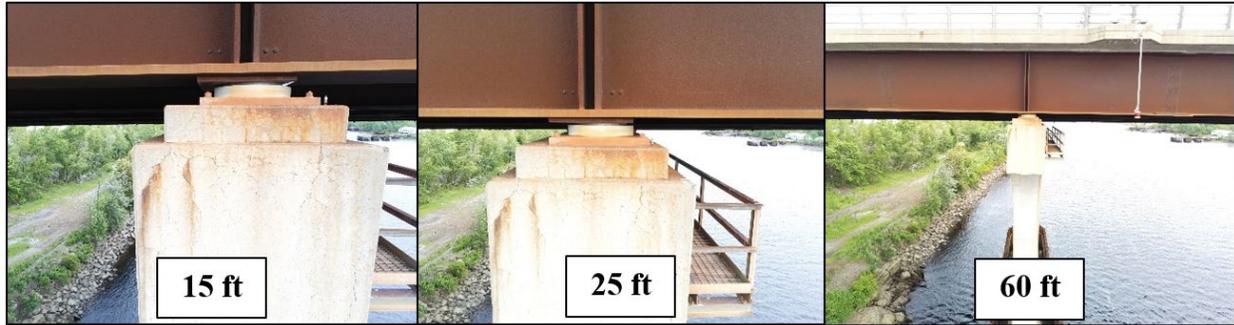
The standoff distances determined to provide usable results without compromising the safety of the platform under a bridge were 6 to 8 ft horizontally and 3 to 4 ft vertically. When flying around the outside of the structure, the minimum safe distance had only a horizontal component, which was 6 to 8 ft. During the flight, these distances were estimated as the systems flown lacked the capability to measure true distances from the structure. The distance can be increased to provide an additional safety margin if the camera is equipped with either a digital or optical zoom capability. The images in figure 63 show what an object looks like when taken from varying distances.

Figure 63. Photos. UAS images taken at varying distances from the bridge structure.

The images taken at 15 and 25 ft were immediately usable for evaluating the position of the bearing plate. The image taken at 60 ft was unusable while the UAS was flying but was usable once the image was placed on a computer display and enlarged.

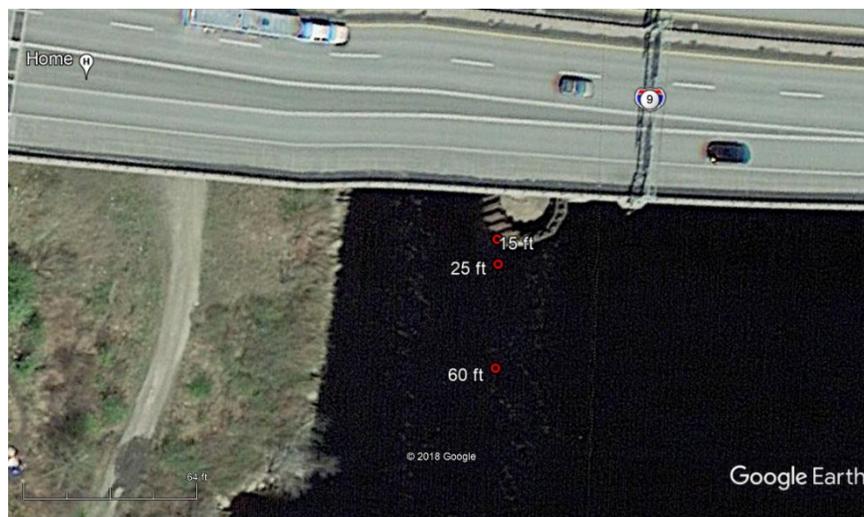
The distances in these images were initially estimated in the field and then verified using KML shape files and a measuring tool (figure 64). The red dots represent the UAS position relative to the bridge at the time the image was captured.

Figure 64. Image. Standoff distance determination using shape files.

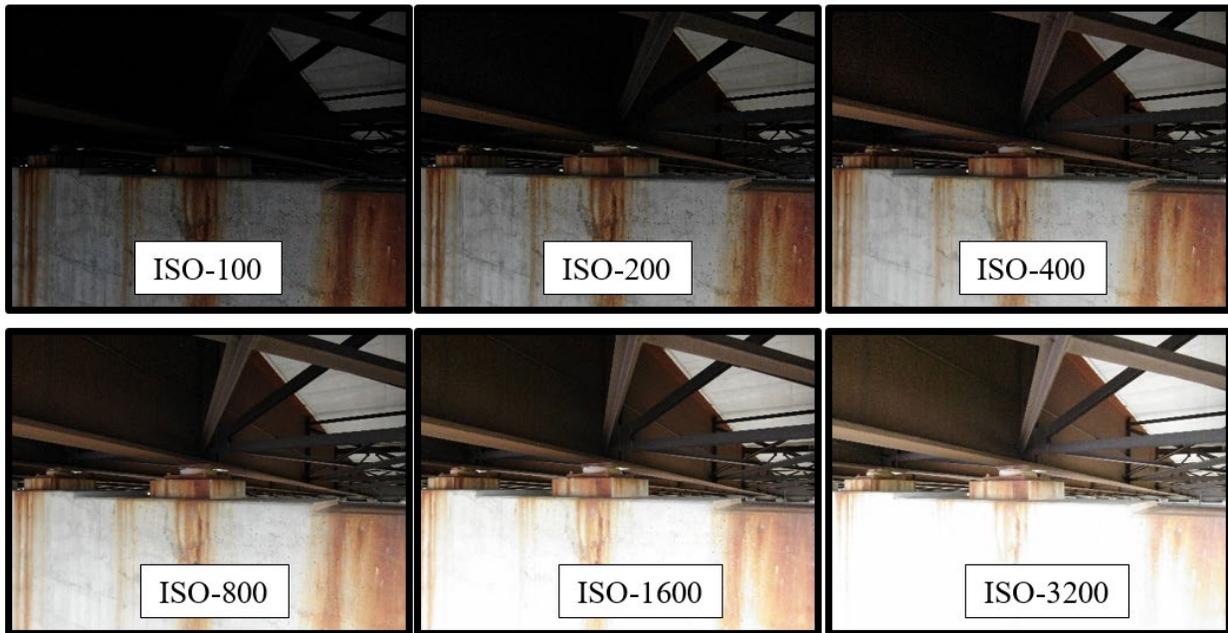
Lighting intensity at the field-test locations was not measured due to the lack of a light meter that could deliver the information remotely. Instead, the images were evaluated by the inspector for usability, and settings were adjusted until the image was usable. The settings were then further adjusted until the image was no longer useable to determine the effect of changing the ISO on image quality (figure 65). In addition to the ISO setting, external lighting was employed to determine its effectiveness in obtaining a usable image.

Figure 65. Photo. Images of the underside of a bridge deck taken with different ISO settings.

The major focus in the field tests was on ISO setting, since this is what controls the sensor's sensitivity to light. In most cases, a minor adjustment to the ISO was sufficient for the inspector to obtain usable imagery with which to evaluate the structure for defects while in flight.

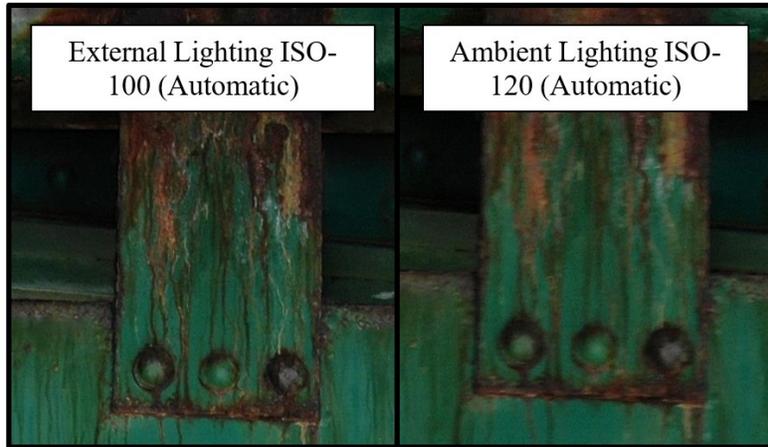
Even though ISO was the primary focus in the field, due to the seemingly limited availability of external lighting on COTS UAS, one system that was employed was equipped with an external lighting source. The external lighting was employed to determine its effectiveness in a field setting. The use of external lighting resulted in an image that was sharper and allowed the inspector to see with greater clarity the surface details on the member being inspected (figure 66).

Figure 66. Comparison of images taken with and without external lighting.

In figure 66, the image on the left was taken with the UAS’s external lighting on, and the image on the right was taken with no external lighting. In this case, the ISO was set to automatic. The camera adjusted the ISO to 100 with the external lighting on and to 120 with the external lighting off.

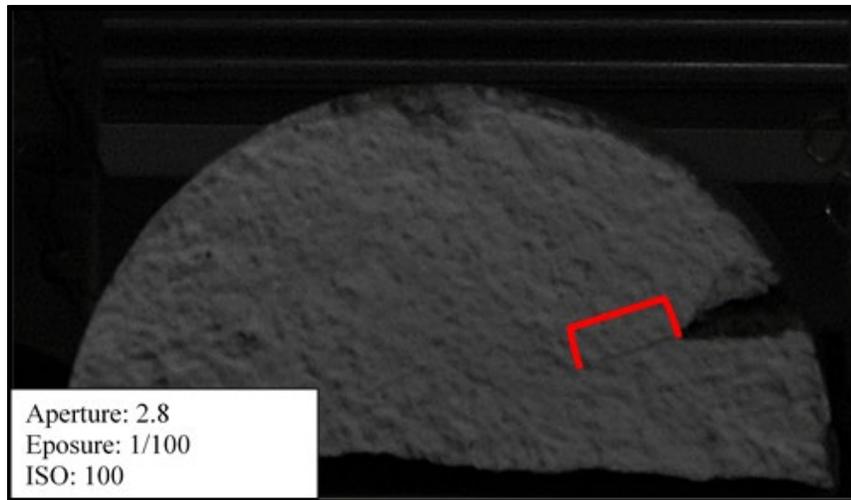
Figure 69 shows an underexposed image. The crack in the image is inside the red bracket and can be seen, but it lacks sharpness, making the crack less visible.

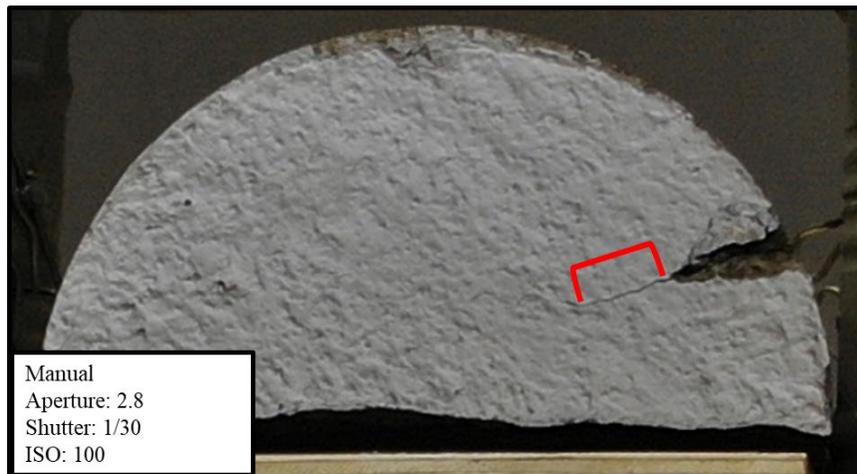
Figure 70. Photo. Image of concrete defect taken with automatic settings.

Figure 70 was taken using automatic camera settings, and figure 71 is an image that resulted from changing the shutter speed manually. The manual settings were matched as closely as possible to the automatic settings.

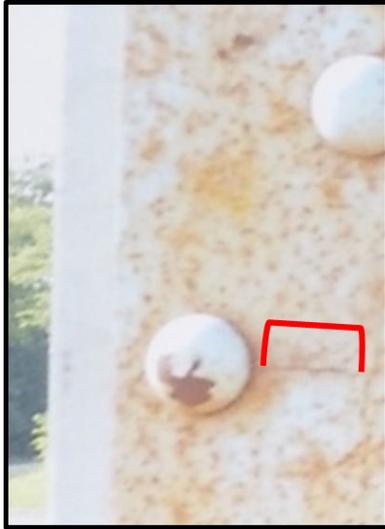
Motion blur is typically a result of movement of the camera and an improper shutter speed. A significant factor for capturing quality imagery with a UAS is stability. Instability in the platform will cause motion blur in the image. Instability can be a result of winds exceeding the UAS's operating limits or unstable GPS without a secondary stabilization system, as was the case in the images in figure 72, which shows side-by-side images of a riveted structural member. Figure 72-A is without motion blur, while figure 72-B is affected by motion blur.

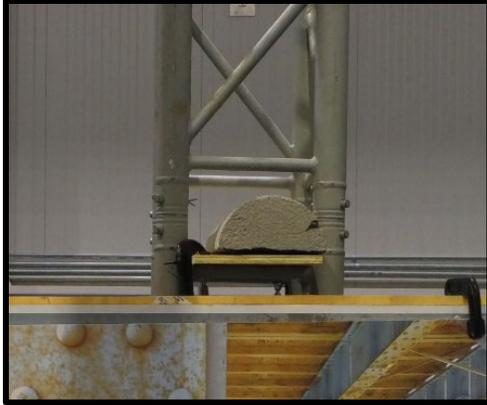
The effect of zoom was tested to determine variances in image quality when taken at different distances from the bridge element using the zoom function. The goal was to achieve an image quality that was roughly the equivalent of being within 1 ft of the structure. To determine these equivalent distances, images were captured at 5, 10 and 15 ft, both without zoom and with maximum zoom. Two of the three cameras that were used could magnify the image up to 2× or 3× magnification. The images in figure 73 were taken from 5 ft without zoom (figure 73-A) and 15 ft with 3× digital zoom (figure 73-B). The images taken at maximum zoom were taken using a digital zoom and therefore may have resulted in a loss of resolution when magnified.

A. Photo at 5 ft with 0× zoom.

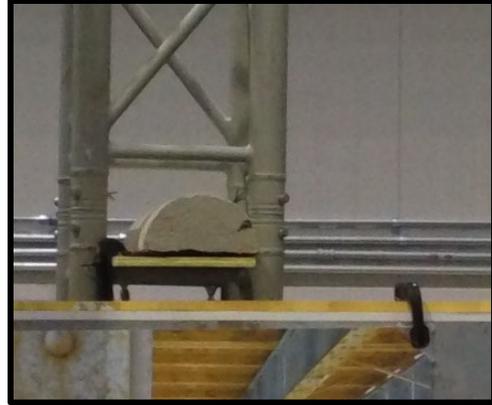
B. Photo at 15 ft with 3× zoom.

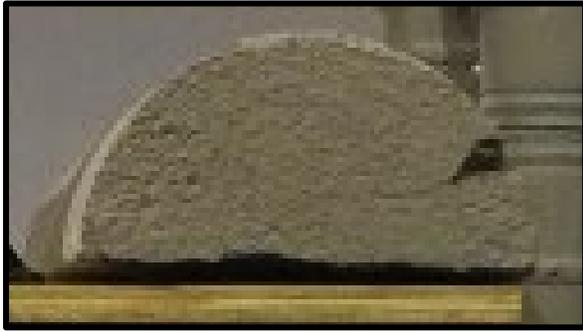
Even though the images presented in figure 73 cannot fully display the quality of the images as seen in person, it initially appeared that an image taken using 3× digital zoom at 15 ft provides nearly the same resolution as an image taken at 5 ft with no zoom. The difference in resolution, however, became clear during postprocessing. Figure 74 shows the same defect images enlarged four times from the original size.

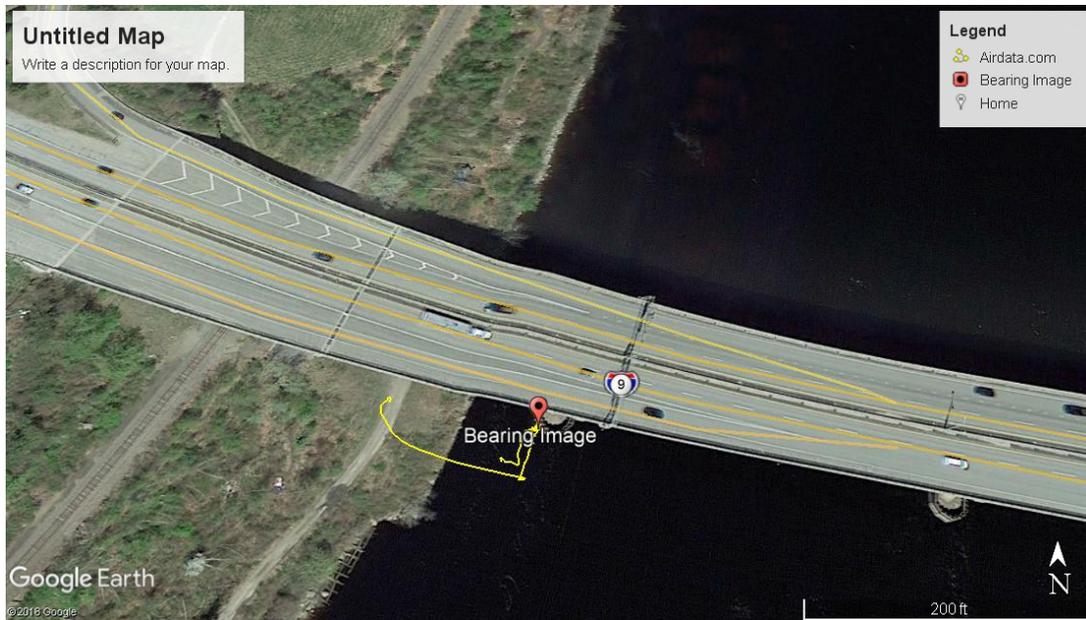
A possible use for this technique may be marking defect locations on a fracture critical bridge to ensure that each is cataloged in a flight plan for subsequent inspections. Figure 75 is an example of a map showing a flight path that was recorded using GPS and marked with the location where images were taken.

Figure 75. Photo. Example of a map image with flight path and image location.

The yellow line in figure 75 is the UAS flight path overlaid on the map image, and the red marker with the black dot in the center is the location where the image was taken.

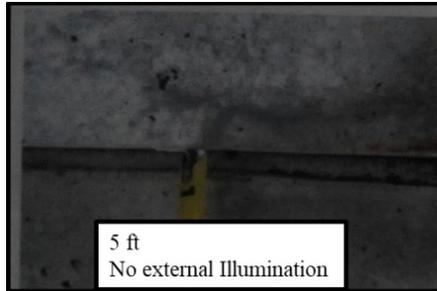
In some instances, the available light under a bridge is insufficient to adequately capture the images needed. Overcoming poor lighting conditions can be achieved by using external lighting if the UAS has the capability. The images in figure 76 were taken without external lighting at 5, 10, and 15 ft at a lighting intensity of approximately 50 lx.

A. Photo taken at 5 ft with no external illumination.

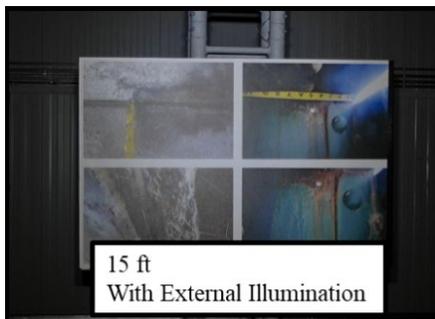
The images in figure 77 were taken with external lighting enabled on the UAS. The image quality improved overall when the external light source was used, particularly at closer ranges. The test images suggest that external lighting beyond a range of 15 ft is of little value.

C. Photo taken at 15 ft with external illumination.

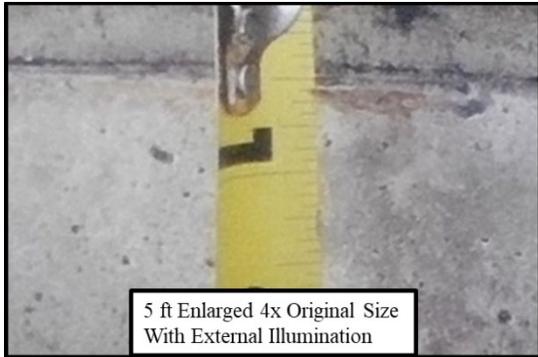
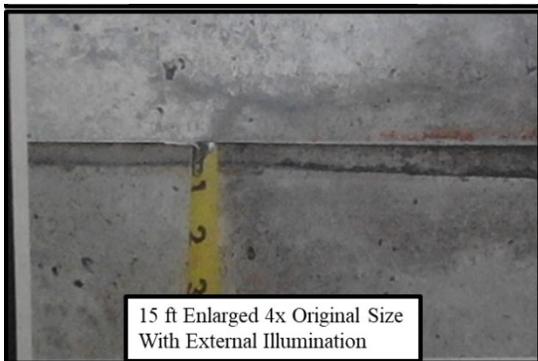
The postprocessed images in figure 78 are enlarged to four times their original size and show the difference in image quality and detail between images captured with and without an external lighting source.

A. Photo from 5 ft, magnified 4×, with external illumination.

C. Photo from 15 ft, magnified 4×, with external illumination.

Figure 78-A and figure 78-C were captured using external lighting. The biggest difference is the level of fine detail that can be achieved. The distance at which the external lighting improved the quality of the imagery was only tested out to 15 ft due to laboratory constraints.

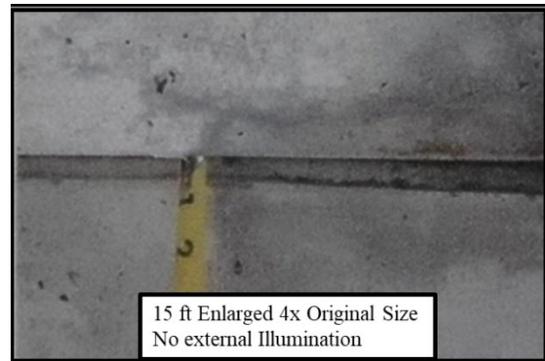
D. Photo from 15 ft, magnified 4×, with no external illumination

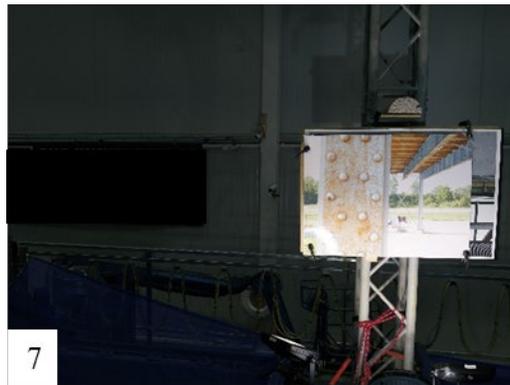
Figure 85. Photo. Image 7, fracture critical member and cracked concrete sample taken at 5 ft.

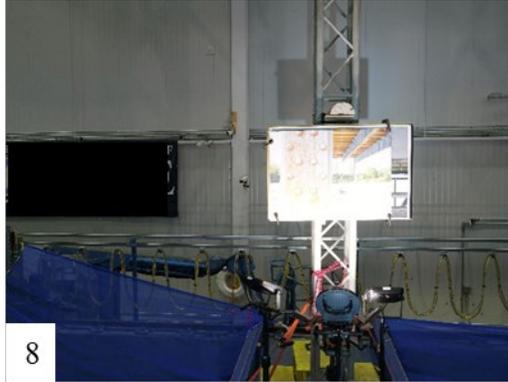
Figure 86. Photo. Image 8, fracture critical member and cracked concrete sample taken at 10 ft.

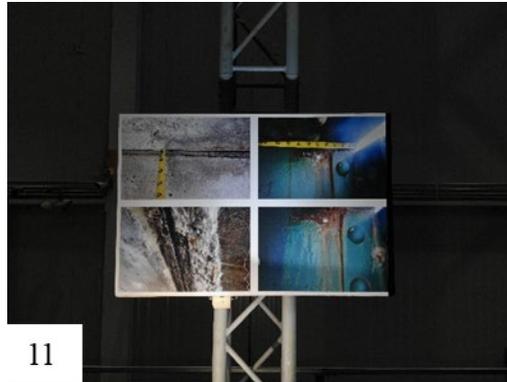
Figure 89. Photo. Image 11, composite of various defects taken at 5 ft.

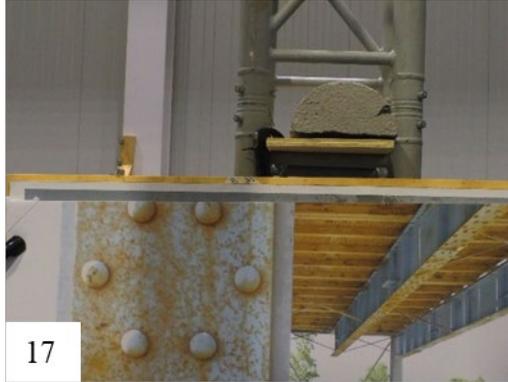
Figure 95. Photo. Image 17, fracture critical member and cracked concrete sample taken at 5 ft.

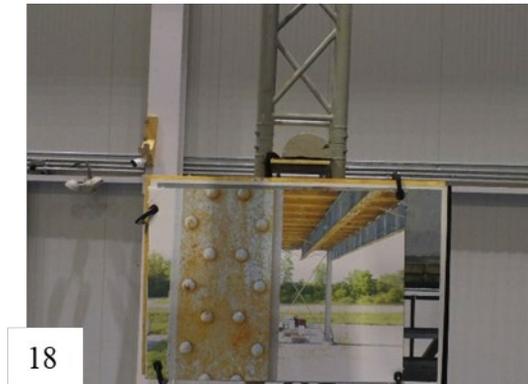
Figure 96. Photo. Image 18, fracture critical member and cracked concrete sample taken at 10 ft.

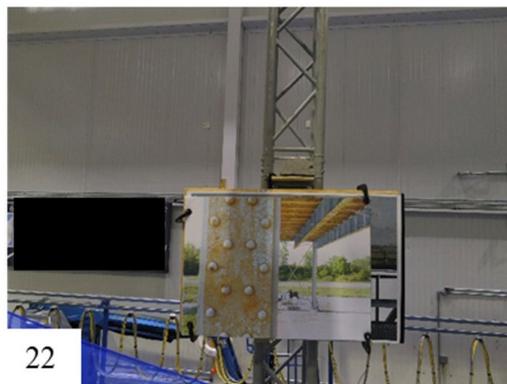
Figure 100. Photo. Image 22, fracture critical member and cracked concrete sample taken at 5 ft.

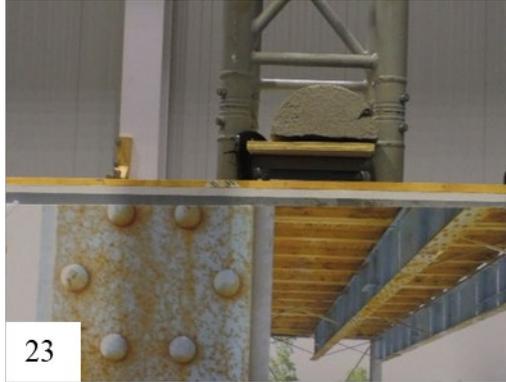
Figure 101. Photo. Image 23, fracture critical member and cracked concrete sample taken at 5 ft.

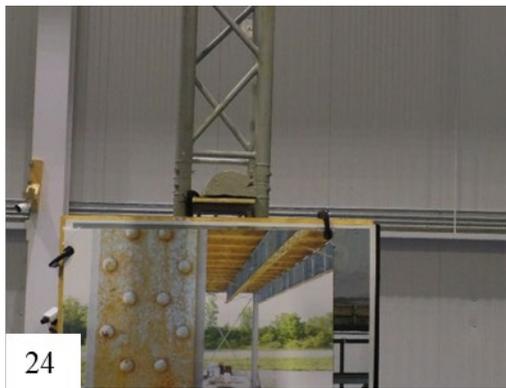
Figure 102. Photo. Image 24, fracture critical member and cracked concrete sample taken at 10 ft.

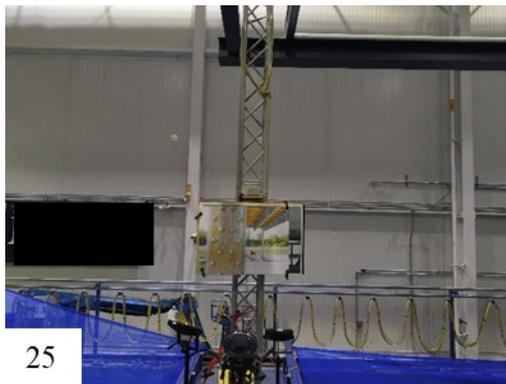
Figure 103. Photo. Image 25, fracture critical member and cracked concrete sample taken at 10 ft.
