# Current and Innovative Solutions to Roadside Revegetation Using Native Plants

**A DOMESTIC SCAN REPORT**

| 1. Report No.<br>FHWA-WFL/TD-11-001 | | 2. Government Accession No. | | 3. Recipient's Catalog No. | |

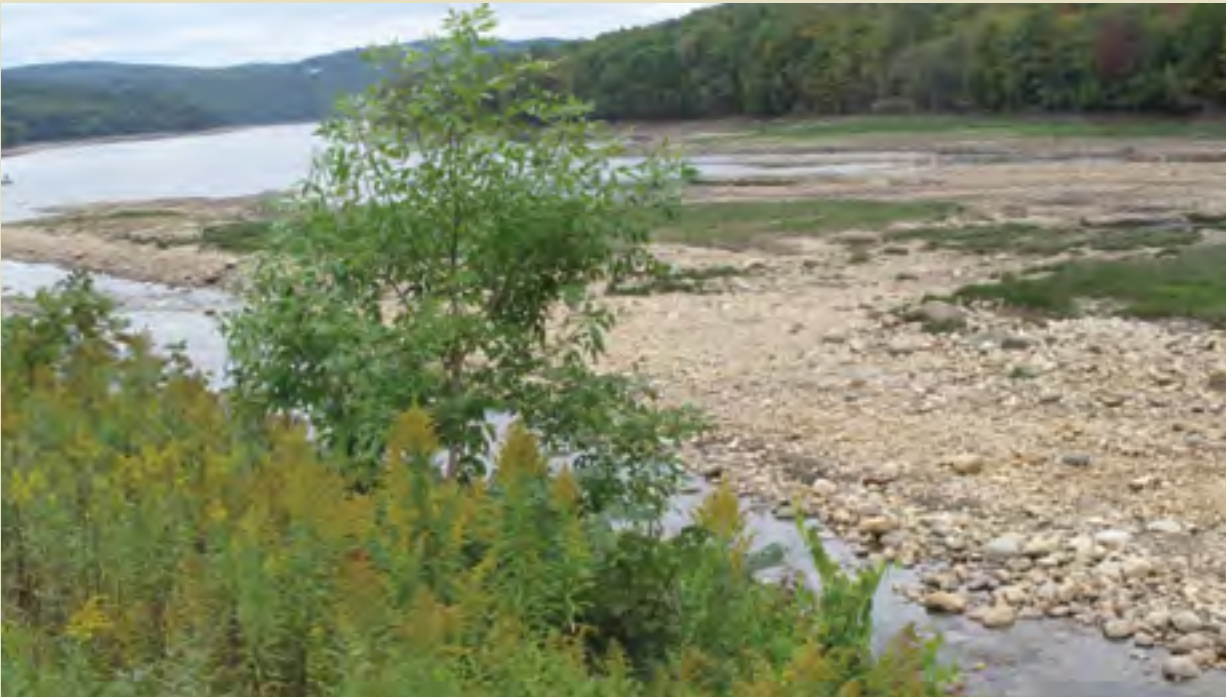
**Figure 3.** Planting pocket showing tree planting, with Harriman Reservoir in background

Planting pockets demonstrated that trees and shrubs can be established on a buried riprap slope if they are given additional room to expand their root systems. Since this project is less than five years old, the long term success of these plants remains to be seen; however, at the time of observation, there is no indication that they will fail. The decision to use this particular method will roadway engineer review to confirm that excavating from embankment riprap will not compromise the integrity of the erosion protection.

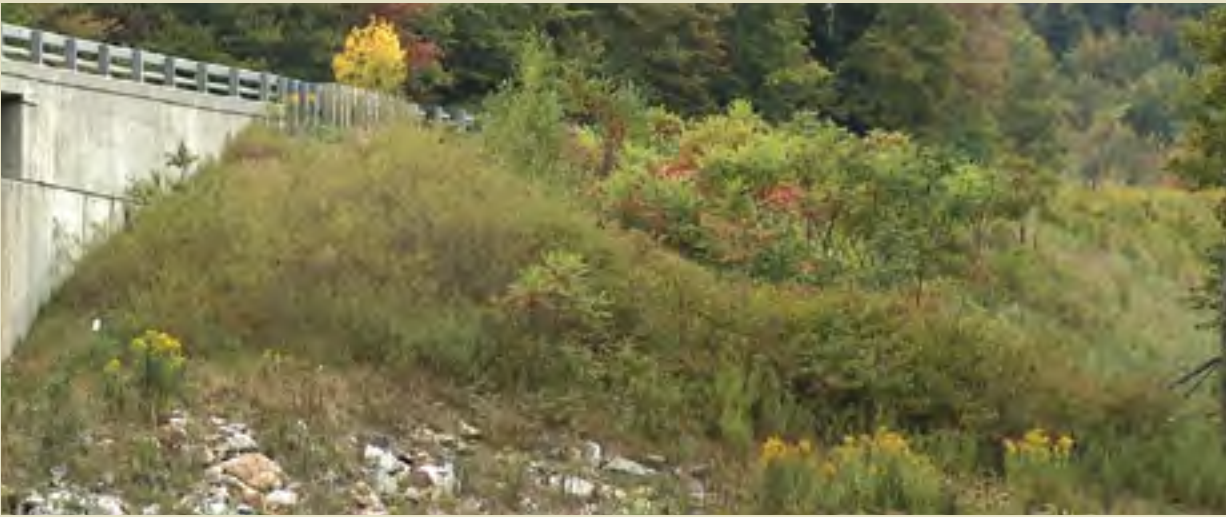
**Embankment Plantings** – Not all slopes required riprap protection as described above. Much of the roadside area did require planting on steep slopes; however, much of this landscape required only additional topsoil over the sub-soil (Figure 4). This technique facilitated planting of trees and shrubs in larger groups rather than the limitations imposed by planting pockets.

Although embankment plantings are not an innovative technique, these areas established quite successfully and provide large masses of native vegetation that contribute to the overall project objectives. The vegetation in these areas also includes the same native grasses, forbs, shrubs, and trees that were installed in the planting pockets, but the vegetation was installed in areas exceeding 100 feet in length and twenty feet in width.

**Figure 4.** Embankment planting on Route 9 near Wilmington, VT

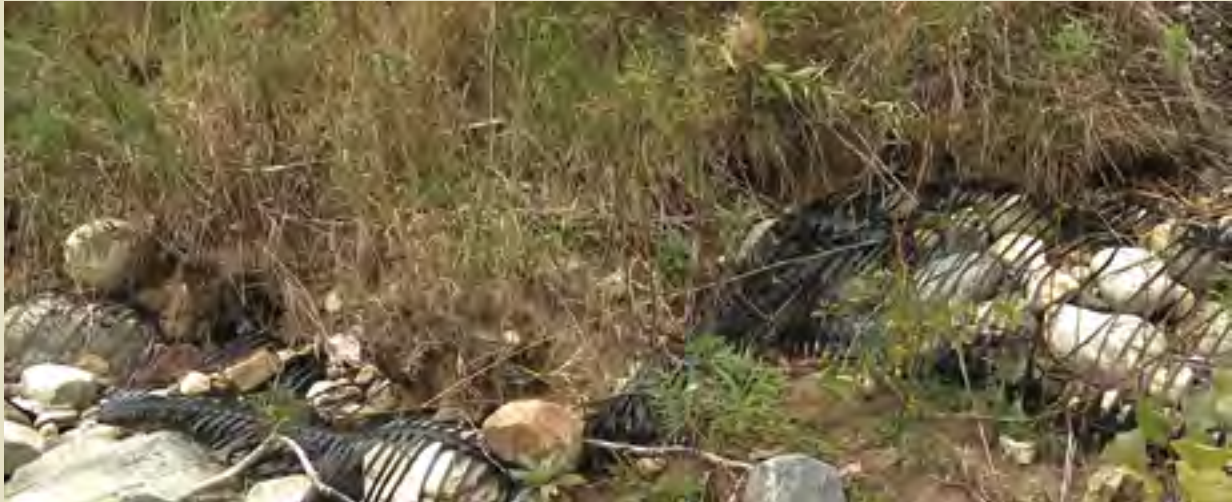
**Geogrid Sub-Base Stabilization Plantings** – A third planting technique was required for steep slopes created during road construction, when the sub-base of the road was built up in lifts of approximately 18”. Instead of using riprap to stabilize the slopes, the engineers developed a method where the soil lifts were wrapped and contained in a geogrid material (Figure 5). However, the geogrid not only created a stabilizing structure for the embankment soil, but also created a barrier for root growth. Therefore, the landscape architect developed a specialized planting plan for these areas that only included grasses, forbs, and shrubs. Trees were not used because of the potential damage to both the geogrid material and to the tree roots themselves.

*Figure 5. Geogrid sub-base stabilization planting near Wilmington, VT*

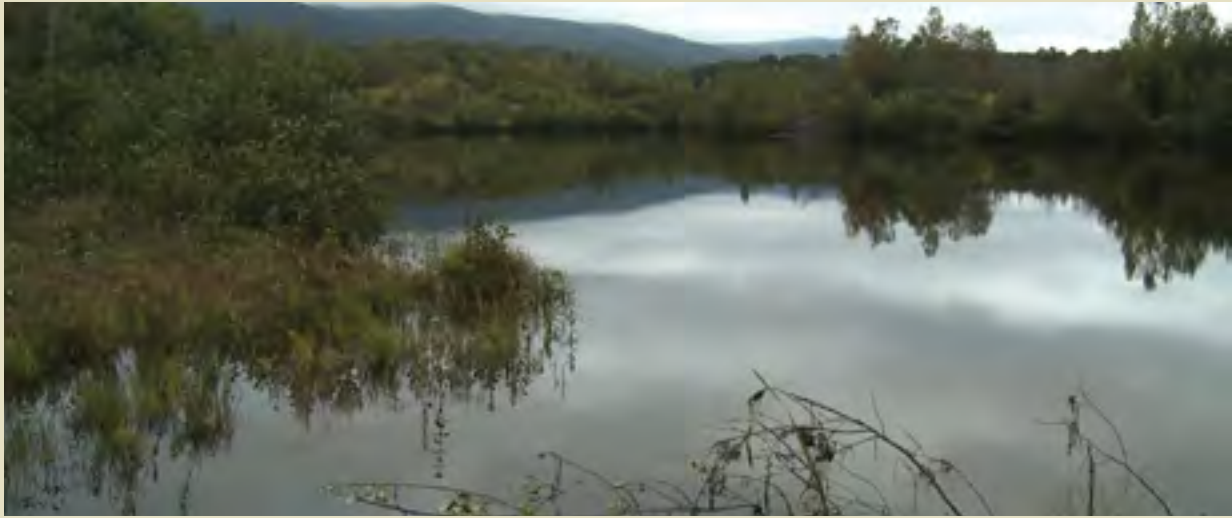
**Wetland Mitigation** – Another component to this project observed by the expert panel included a wetland mitigation site (Figure 6). This site was constructed under requirements set forth by the US Army Corps of Engineers for impacts to existing wetlands that occurred during construction of the road. Due to the lack of adequate on-site mitigation, all of the wetland mitigation was conducted at an off-site location that was approximately 15-miles from the town of Wilmington. The site was approximately 10-acres and located in abandoned gravel mine.

*Figure 6. Wetland mitigation site near Wilmington, VT*

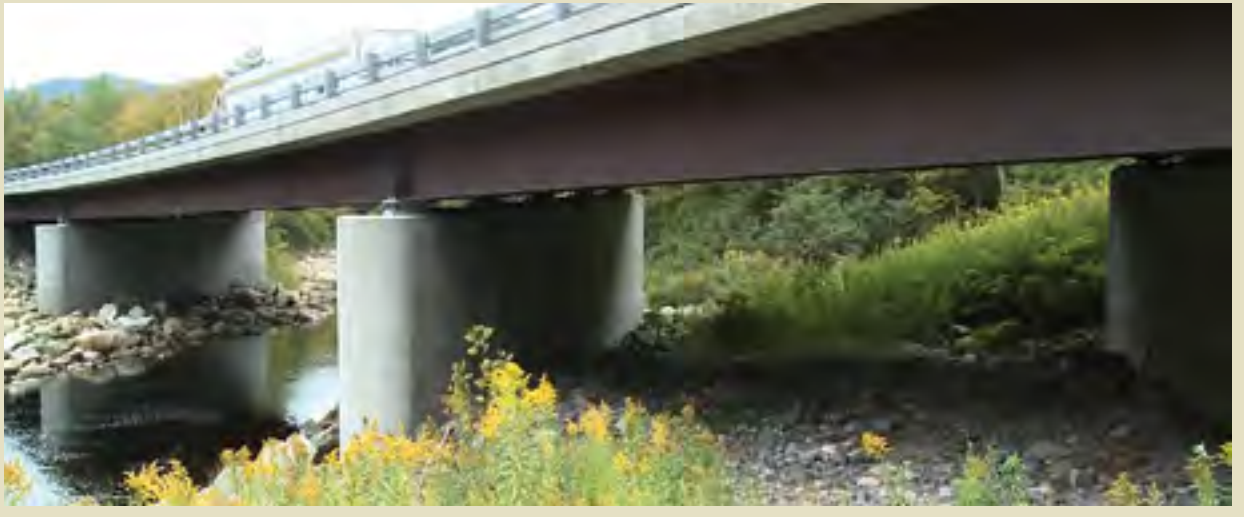
**Wildlife Underpass Crossings** – There are many incidents involving wildlife and traffic encounters in this area, so designers worked closely with staff from the Vermont Department of Fish and Wildlife to provide for animal passage under the bridges. These pathways were called “Critter Crossings” and were specially designed to allow animals, both large and small, the opportunity to pass under the bridges on stable footing (Figure 7). While this technique didn’t have a significant impact on the revegetation process, it is worth noting as a technique to improve safety for both humans and wildlife along State and Federal highways.

*Figure 7. Critter crossing underpass near Wilmington, VT*

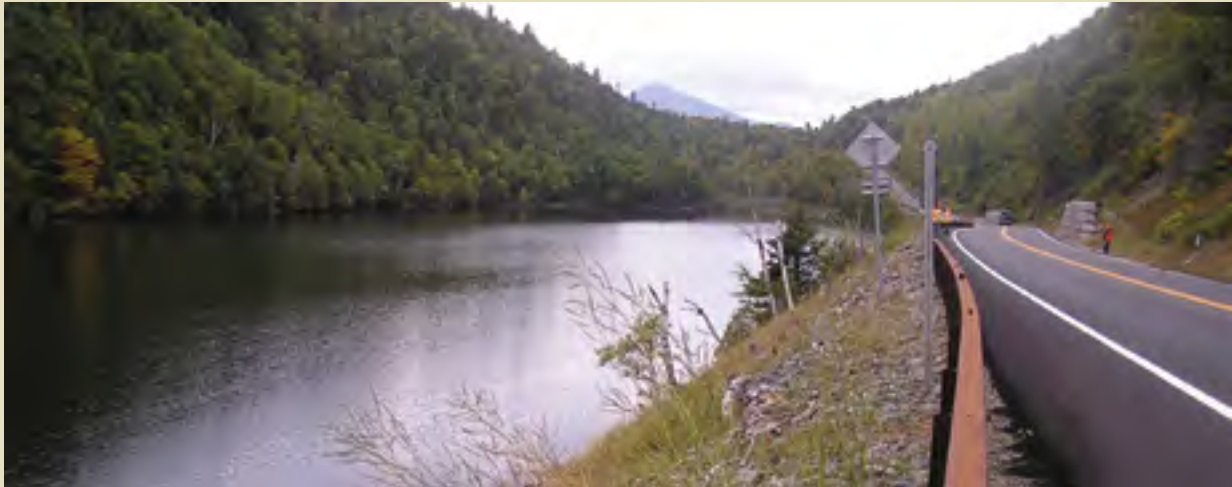
The landscape that lies between the roadway and the lakeshore is very narrow and steep with poor topsoil (Figure 9). There is evidence of soil erosion caused by stormwater runoff that flowed off of the road and into the lake. Additionally, the sand and salt used to control the ice have washed off the road, smothering the bases of trees, shrubs, and grasses at this site. One species in particular was noticed to be experiencing a higher than normal (and unexplained) mortality rate - the white birch (*Betula papyrifera*).

Figure 9. Route 73 at Cascades Lakes Pass showing steep slopes with rocky soils

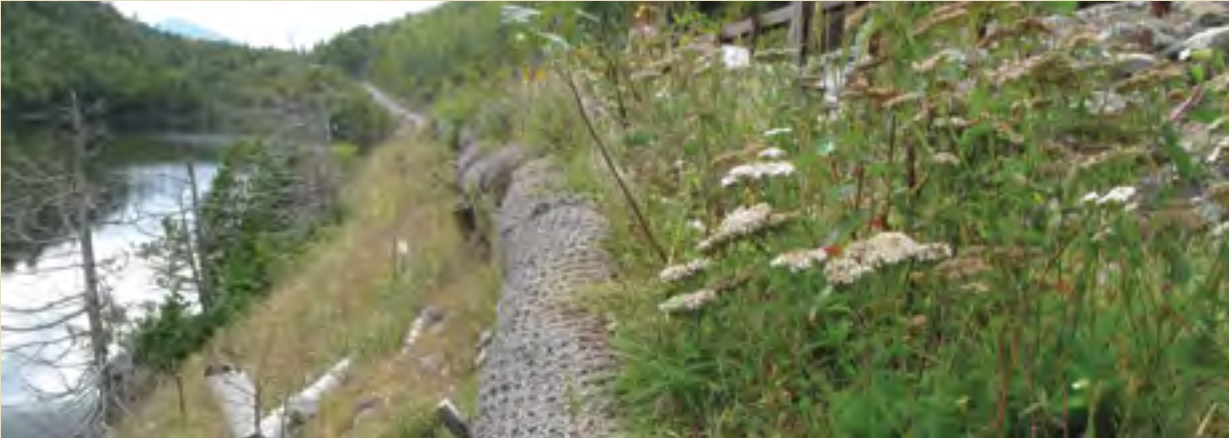
**Coir Log Planting Bench** – Several of the planting locations were on very steep grades with extremely poor topsoil. Revegetation would have been nearly impossible without the use of a method to create more favorable planting conditions on these extreme slopes. Additionally, the area was located in a narrow area that was wedged between the highway and the lakeshore. Working the site with heavy equipment and attempting to install plants on near vertical slopes would have been impractical; therefore, coir logs were installed by hand and then topsoil was placed behind them to create a planting bench (Figure 10). This method created a stable planting area with good water holding capacity on an otherwise harsh site.

Figure 10. Coir log planting along Route 73 with Cascade Lakes in the background

After two complete growing seasons the results are mostly successful. The coir logs have created hospitable conditions for plant materials on the upslope side and along with the imported topsoil have effectively held water. The planting benches also support good growth of the trees, shrubs, grasses, and forbs that were installed by the crew. Following is a list of species that were planted from container plantings:

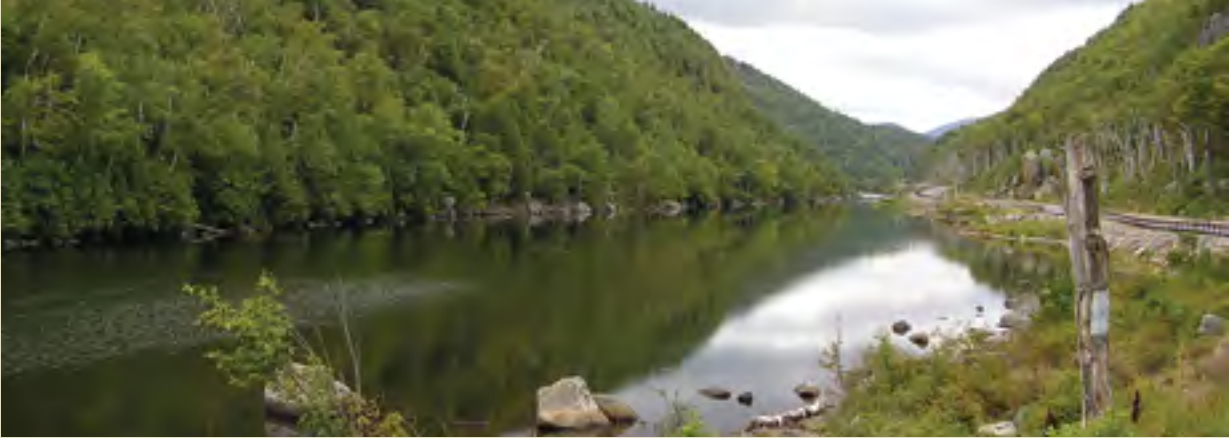
**Living Snow Fence** – The snow and ice that accumulates on the road in winter creates a very dangerous situation for drivers and presents a constant challenge for the maintenance crews. Wind blows through the valley and across the frozen lake, depositing drifting snow and ice across the roads. One of the study recommendations was to install a living snow fence created by planting native evergreen trees (Figure 11). Although the plants that were installed are only approximately 3’ in height, it is anticipated that eventually the plants will reach sufficient height to provide a barrier and prevent excess snow and ice from accumulating on the roads.

White spruce (*Picea glauca*) trees were planted due to their ability to withstand wind, heat, cold, drought, and crowding. In addition, these species are salt tolerant and are native to the Adirondacks.

Figure 11. Living snow fence area at Cascade Lakes Pass; small spruce trees planted for the eventual snow fence

One documented problem is that three of the white spruce did not survive or appear to be extremely stressed. The NYSDOT replaced these species with additional tamarack (*Larix laricina*), which will function similarly to the white spruce. Subsequent to the site visit, NYSDOT determined that most of the white spruce did not survive—likely a result of the wet planting conditions near the lake—and they have been replaced with tamarack.

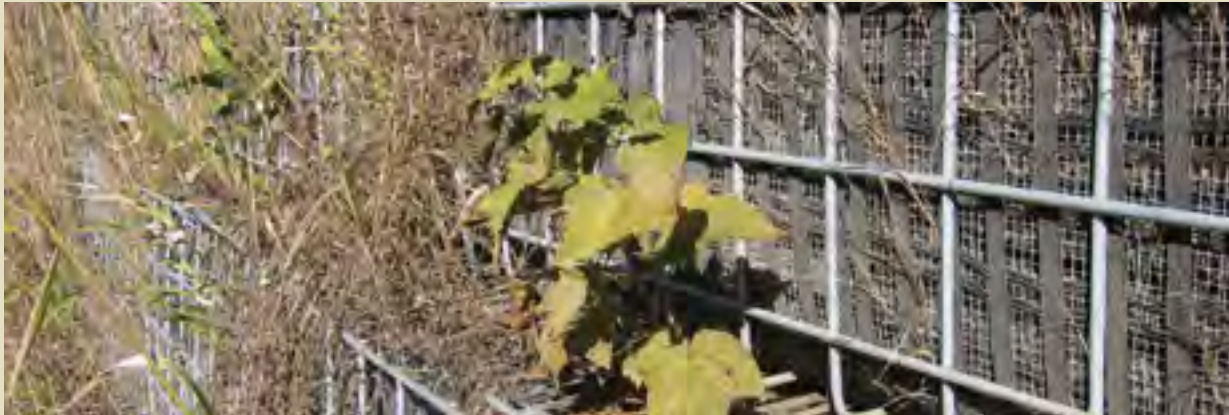
Figure 13. Mechanically Stabilized Earth Retaining Wall planting

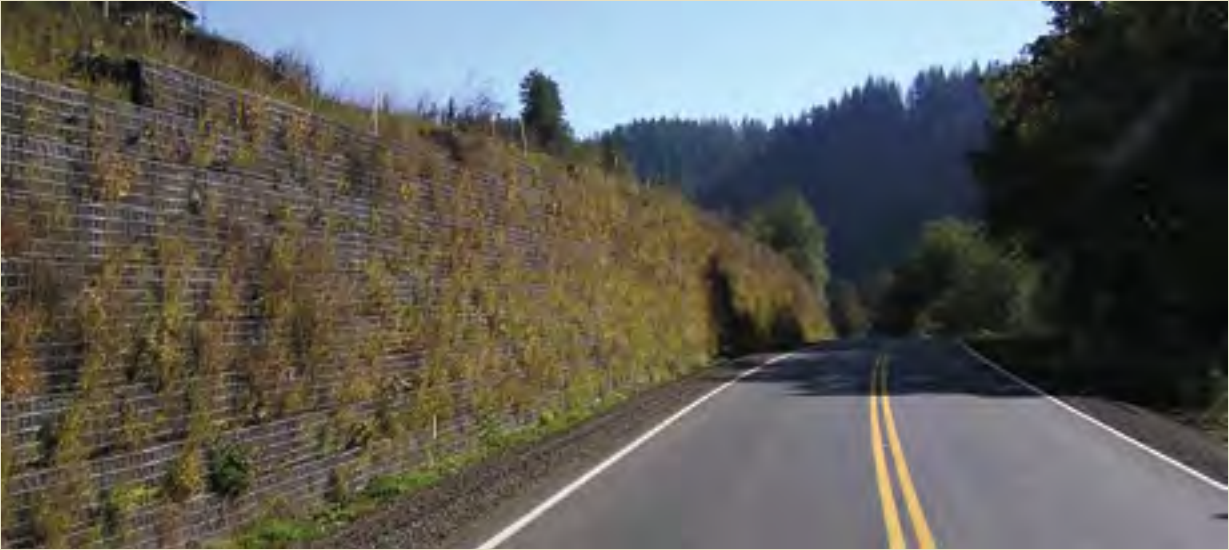
The MSE wall is a modular wall that uses welded wire material and geogrid fabrics in combination with both structural soils and topsoil to create a modular system (Figure 13). The topsoil is placed on the inside face of the walls to a depth of approximately 12 inches to ensure the face of the wall and the stepped ledges are capable of supporting plant materials. Container plants and grasses were installed by hand to create the vegetative screening along the wall structure.

**Figure 14.** Vegetated mechanically stabilized earth wall on Blaine Road

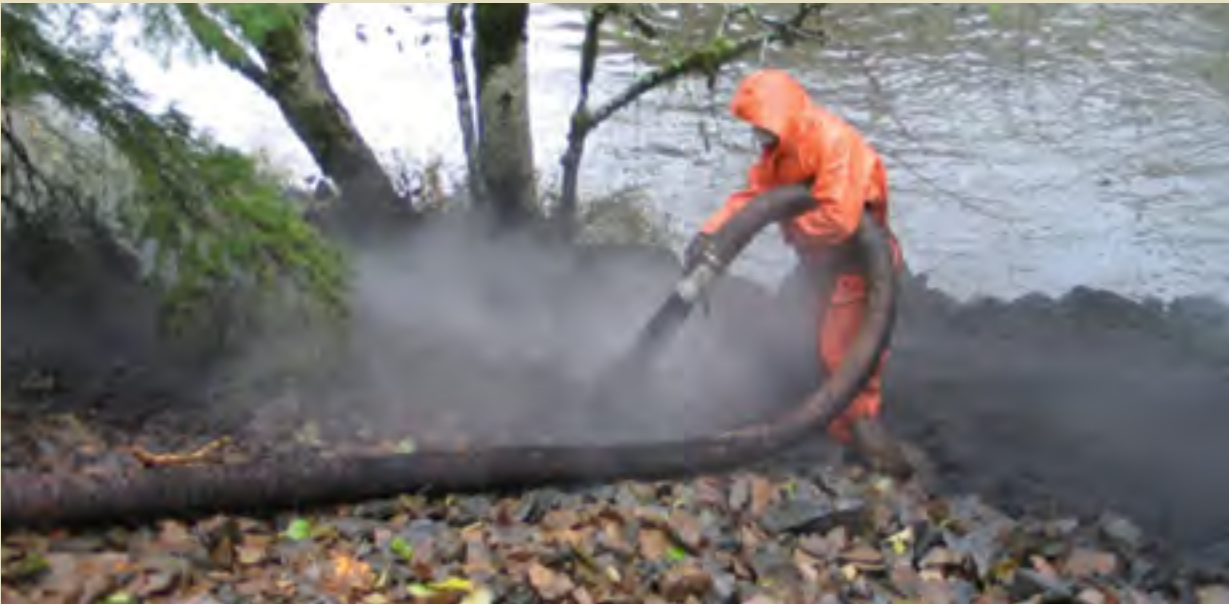
**Vegetated Riprap Areas** – Because of the strict revegetation standards set forth by the regulatory agencies pertaining to riprap areas around the culverts, an innovative approach had to be developed that would allow plants the opportunity to properly establish (Figure 14). Riprap was installed to prevent soil erosion in steep areas and along drainage culverts, but the shortage of adequate topsoil for cover over the riprap was a constraint. Further, some of the sites that were on very steep slopes would have present complications in the installation of topsoil, even if adequate topsoil were available.

The project team determined that a blown-in-place compost material could be applied that would provide plants with a favorable growing medium over the riprap. The consistency and relative ease of application made this a good choice to fill the voids and to build up a five- to ten-inch layer above the rock material. Not only was the ease of application a plus for the project, but the material itself is a very nutrient-rich compost that is made out of recycled organics containing beneficial bacteria, mycorrhizal fungi, and a binding agent to prevent wind and water erosion. The compost was blown in place through a low impact, pneumatic method and was mixed with the native grass seed mix in one application process.

**Figure 15.** Application of compost over rip rap

The compost with tackifier was stable through several very intense rainstorms and held the soil even without the use of a surface erosion fabric. Moisture in compost remained relatively high during August without supplemental irrigation.

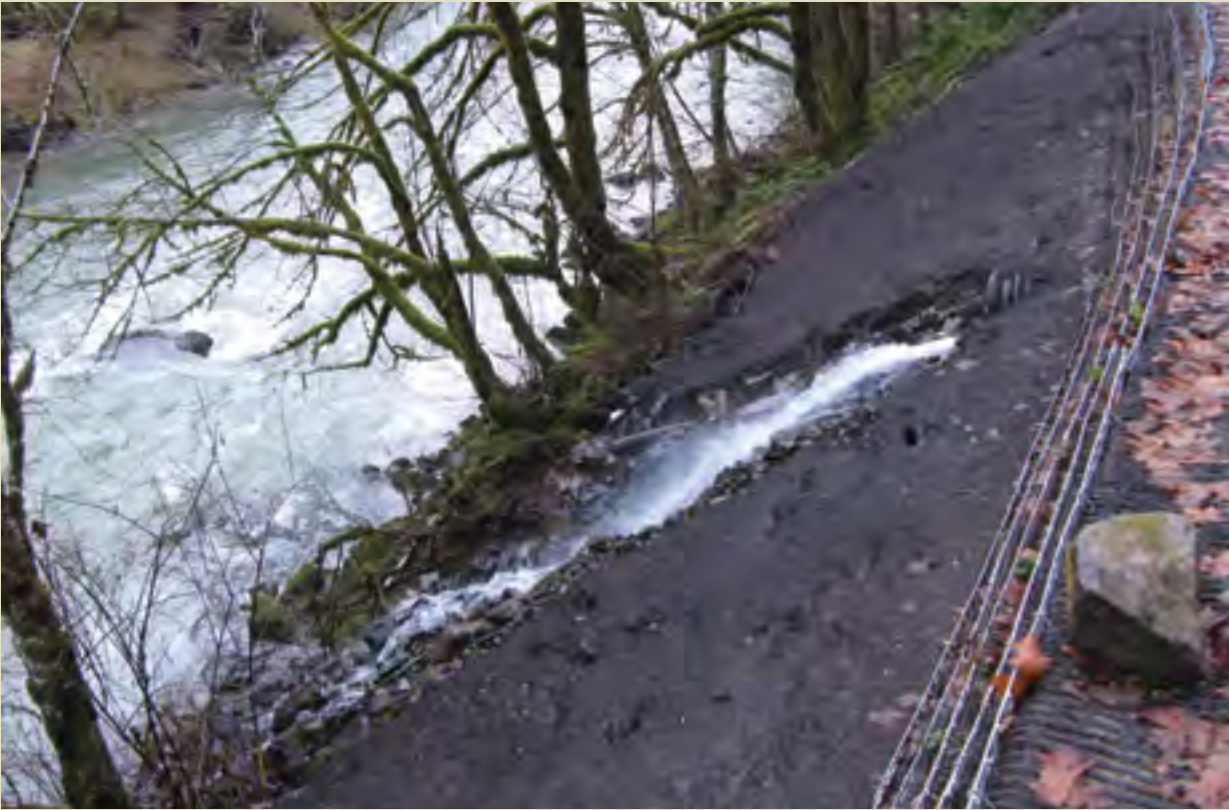
In January of 2009, approximately 2,800 tree and shrub materials were planted by hand to meet the desired future condition of twelve native shrub or tree species per 100 square feet (Figure 15). This plant material was able to survive even during the drier summer months because the compost held an ideal moisture level throughout the year (Figures 16 and 17).

**Figure 16.** Compost over riprap at culvert prior to plantings

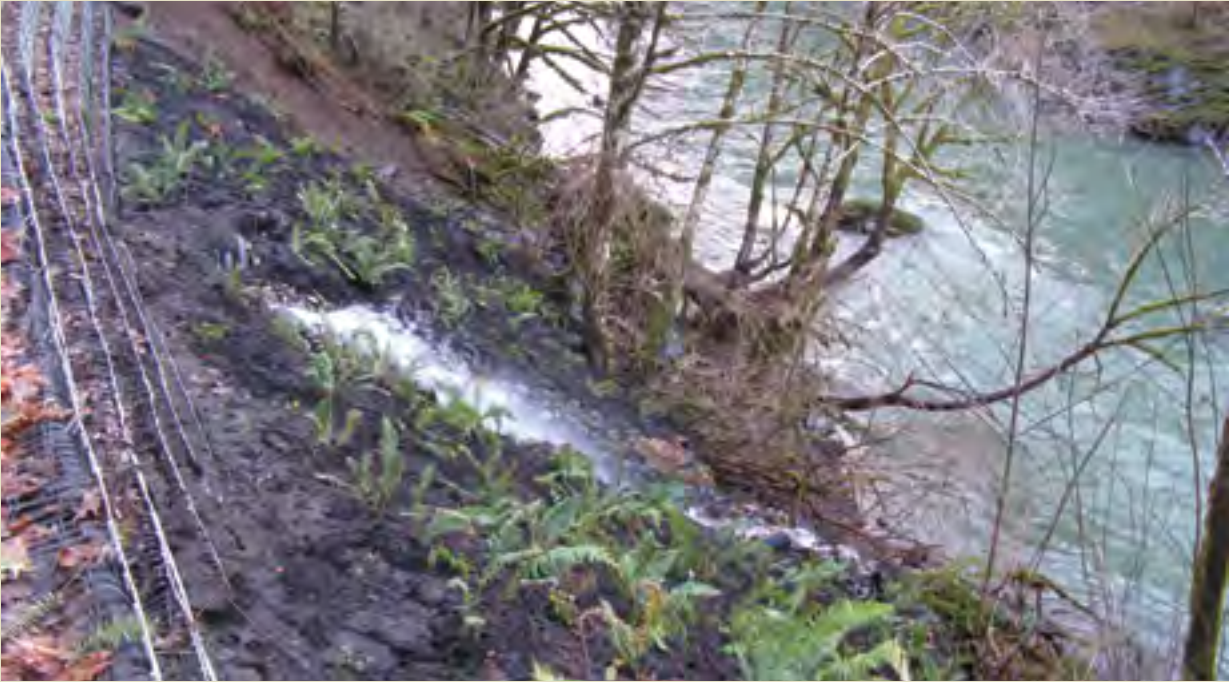
**Figure 17.** Compost over riprap at culvert after planting

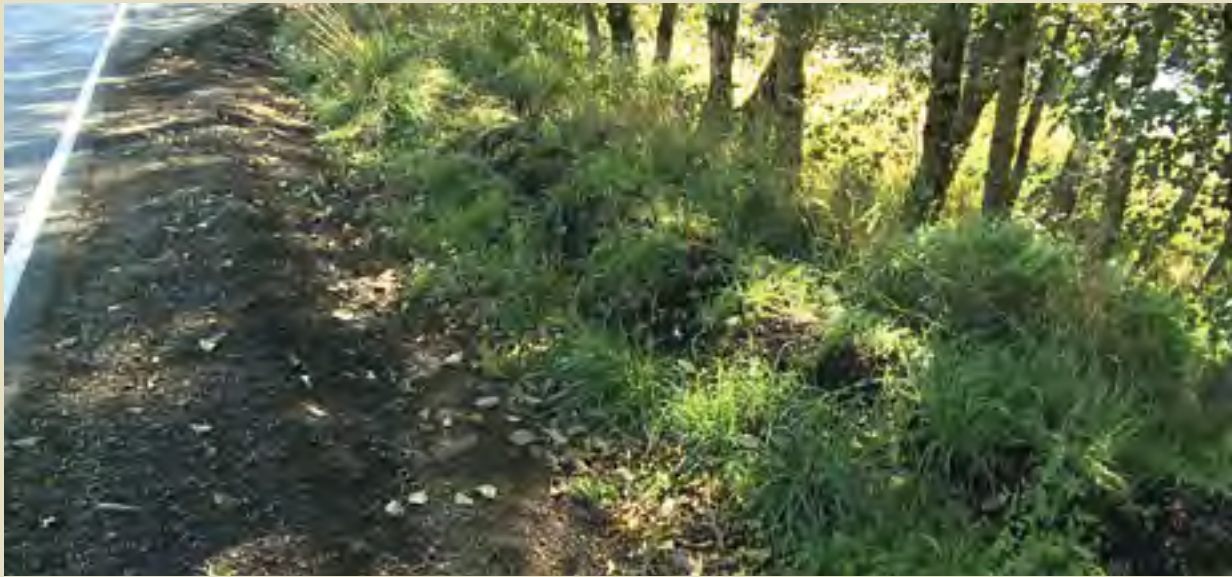
**Compost Berm.** As an alternative to using a silt fence, project managers decided to install a compost berm between the construction zone and the adjacent Nestucca River as a means to prevent sediment runoff. Due to the rocky soils, the use of a silt fence would have caused unnecessary damage to the landscape during installation (Figure 18). However, the compost berm was a reliable option without causing harm to the riparian zone. In addition, the berm itself was planted with a native seed mix that ultimately provided visual screening of the BMP when the grasses began to establish.

Figure 18. Compost berm

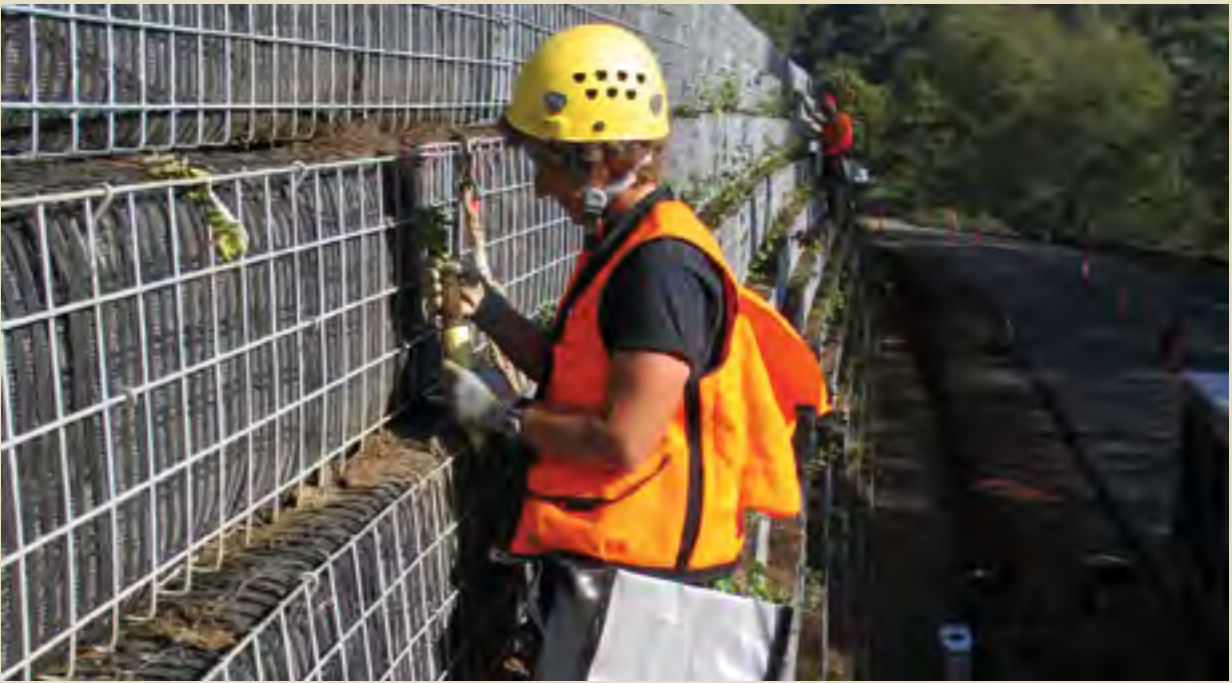
Figure 19. Plant installation on Mechanically Stabilized Earth Wall

When ledges on which people can stand are built into the MSE wall, it is much easier to install plants. Oftentimes, these walls are designed and constructed without any ledge and it makes it extremely difficult to install plants. Further, plants must be installed at an angle, which makes establishment difficult (Figure 19).

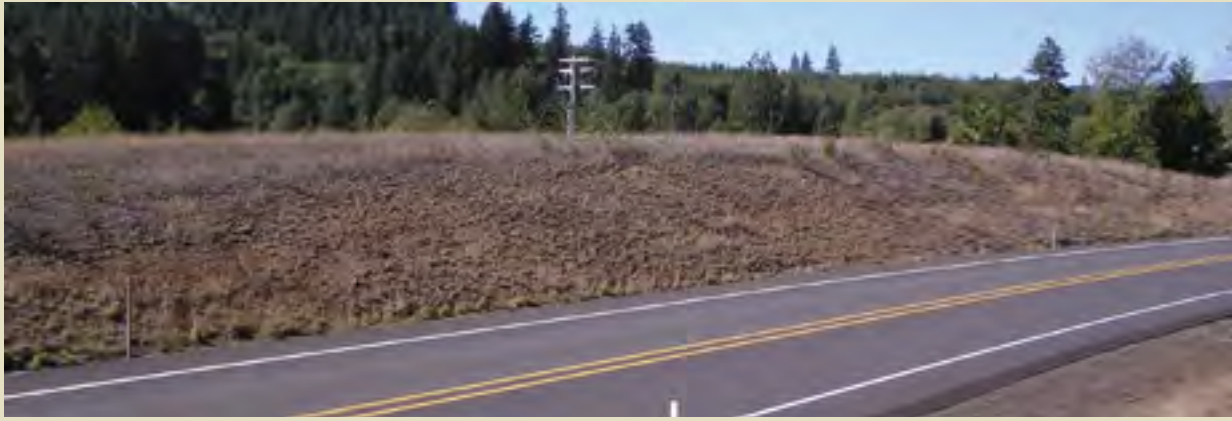
**Figure 21.** Example of hydroseeding without using blown in place mulch on Sandlake Road

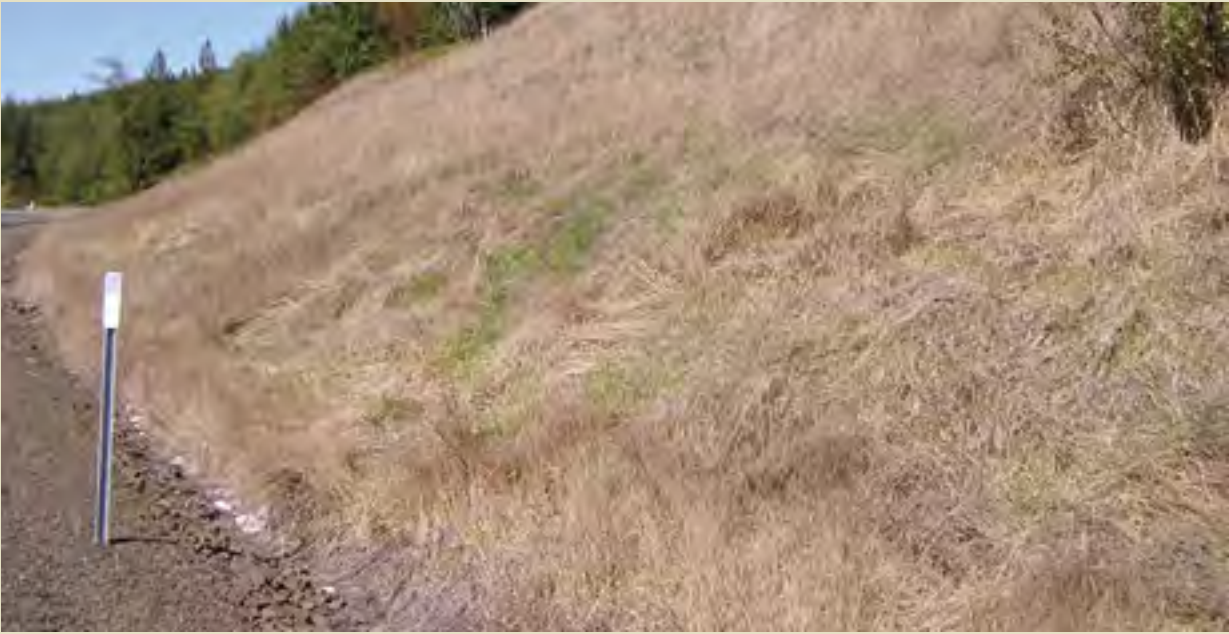
The lower quarter of the slope with the compost demonstrated a very dense stand of grasses that was very different than the top three quarters of the slope. It had the appearance of seed that may have washed down the slope and settled in the lower regions, but upon further exploration, it was determined that there is most likely a seep in the cut slope that provides additional moisture to the bottom quarter of the slope.

**Figure 22.** Example of seeding on steep slope and using blow-in-place compost on Sandlake Road

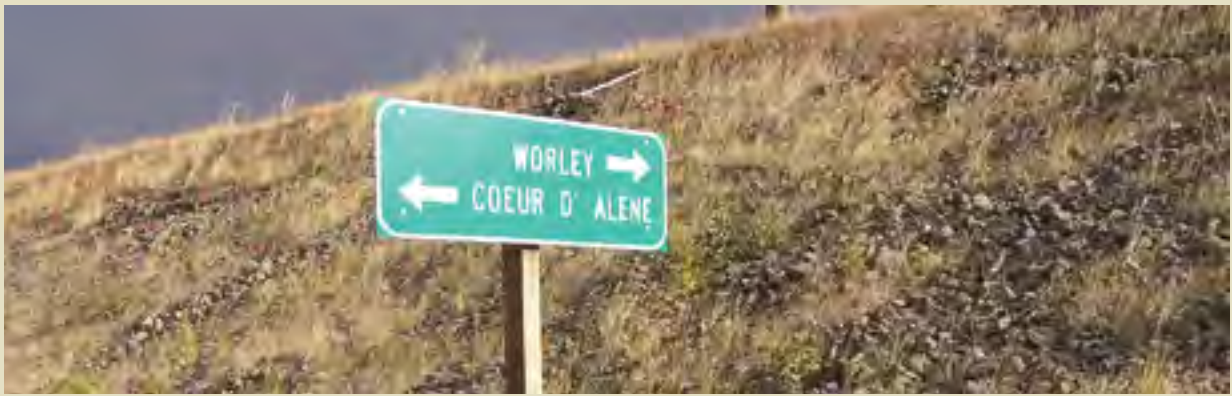
Figure 24. North facing slope with rock mulch and vegetation on Setter’s Road

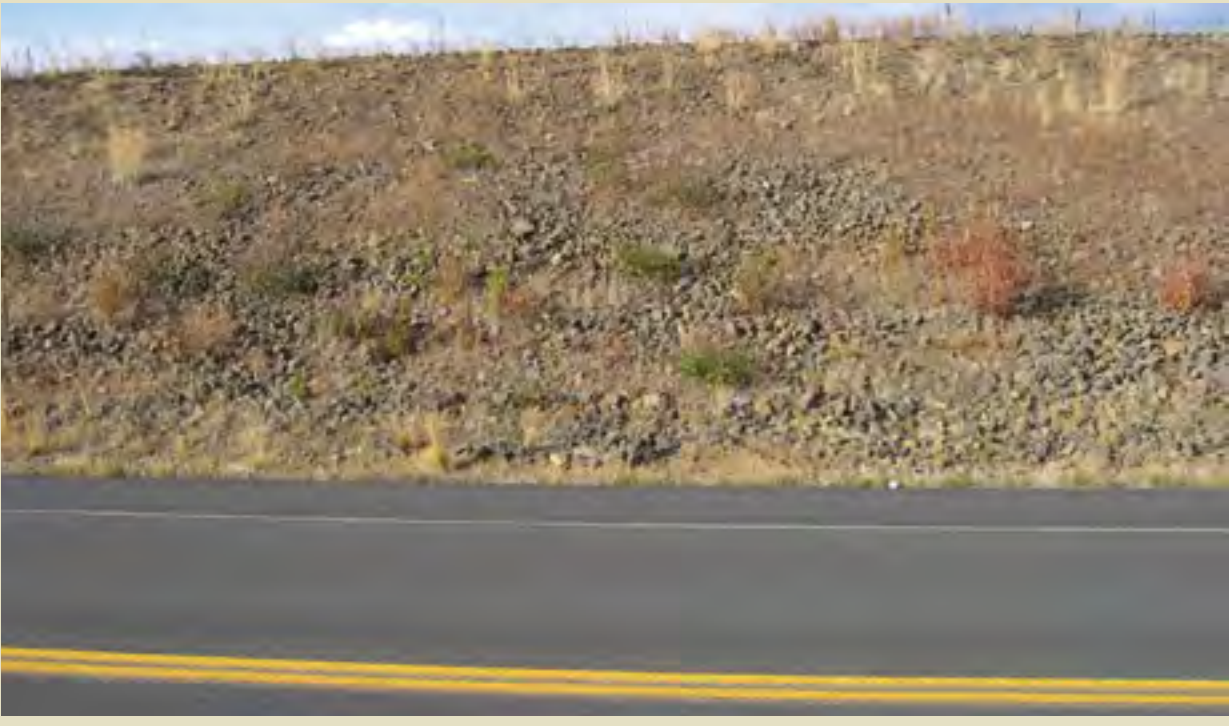
Figure 25. Cut slope on Setter’s Road three years after revegetation efforts

At the time of the site visit, the project was a little over three years old and there were many specimens of shrubs that were at least 4 feet in height and many more that were beginning to emerge (Figure 25). In addition, there were volunteer species of shrubs and perennial grasses that had begun to establish.

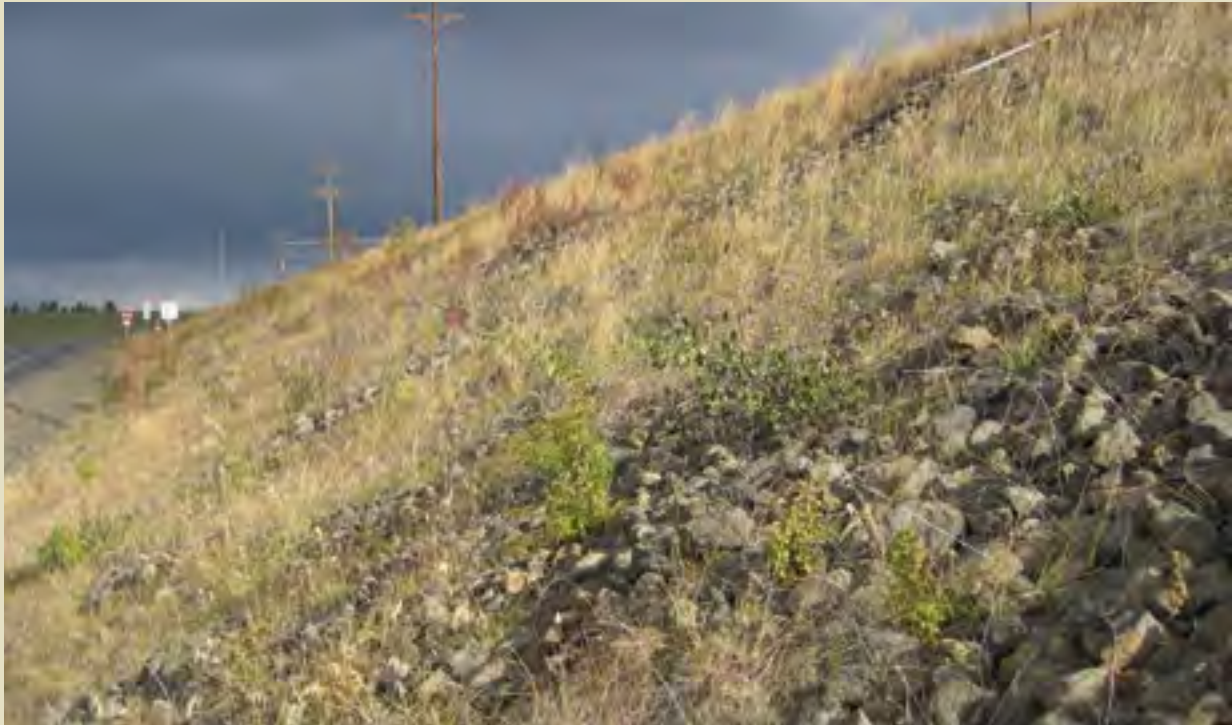
Figure 26. Setters Road rock mulch and revegetation

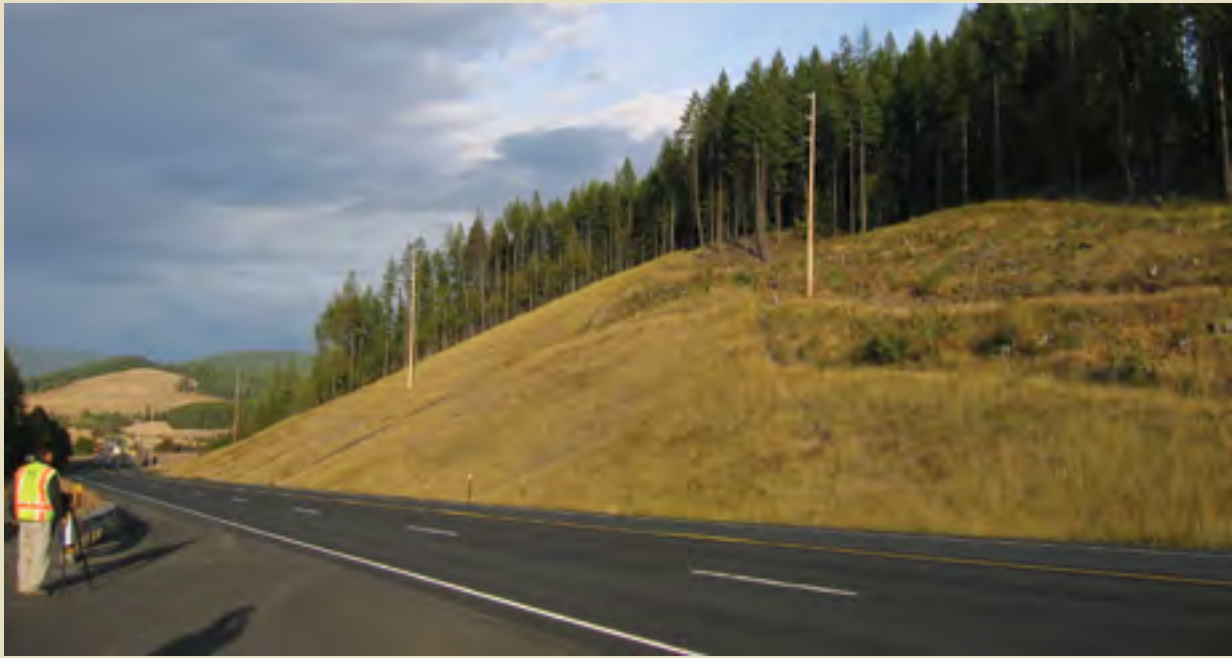
**Figure 28.** An example of a successful revegetated cut slope along US-95

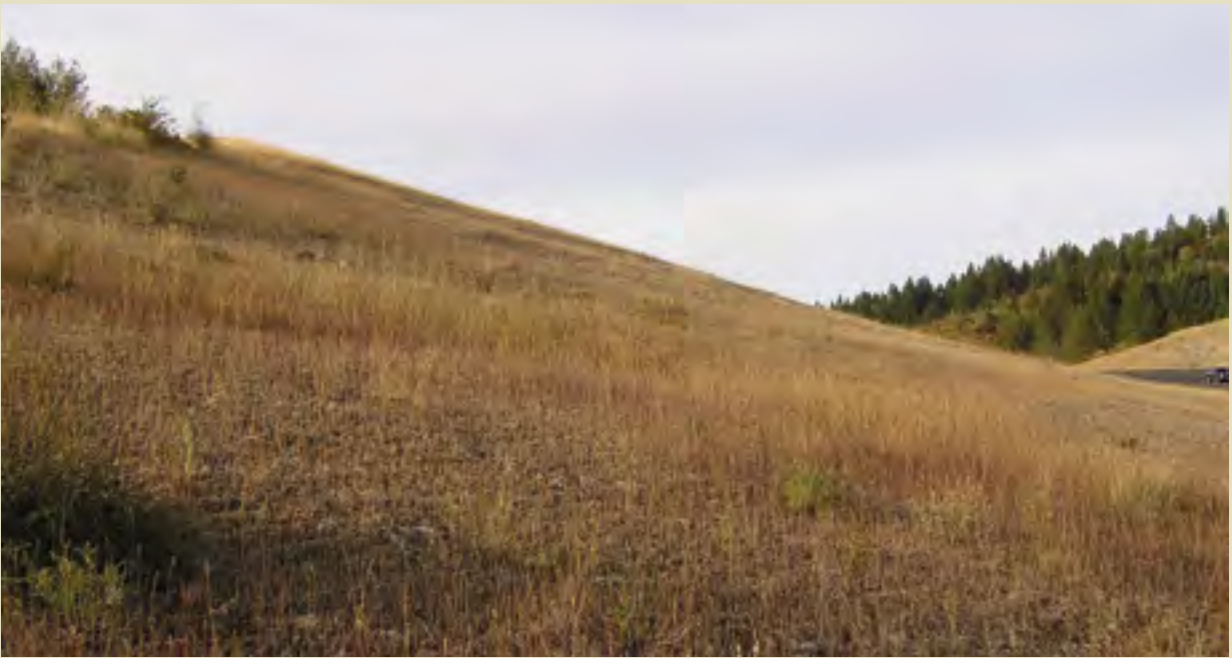
**Figure 29.** Revegetated cut slope on US-95

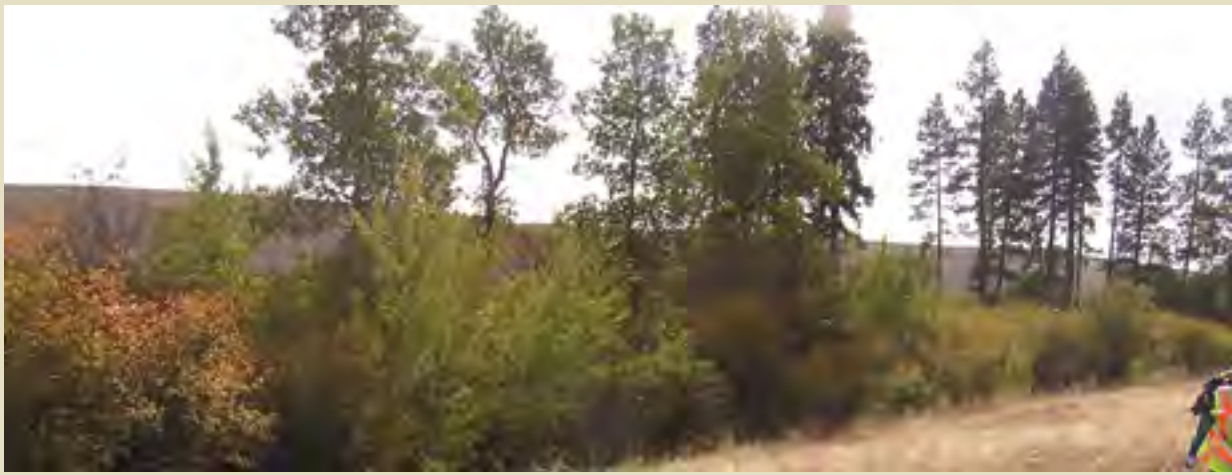
Figure 31. Native Plant Research Project transects

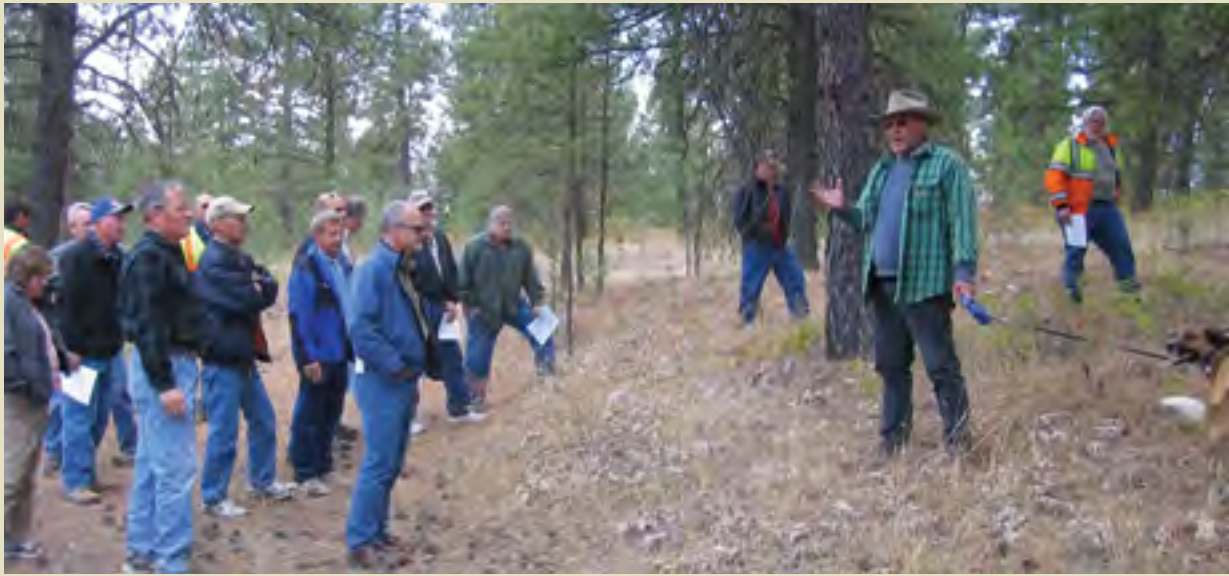
Figure 32. Native Plant Research Project reference site
