DOT/FAA/AM-08/4  
Office of Aerospace Medicine  
Washington, DC 20591

# **Field Evaluation of Whole Airliner Decontamination Technologies – Wide-Body Aircraft With Dual-Use Application for Railcars**

Final Report

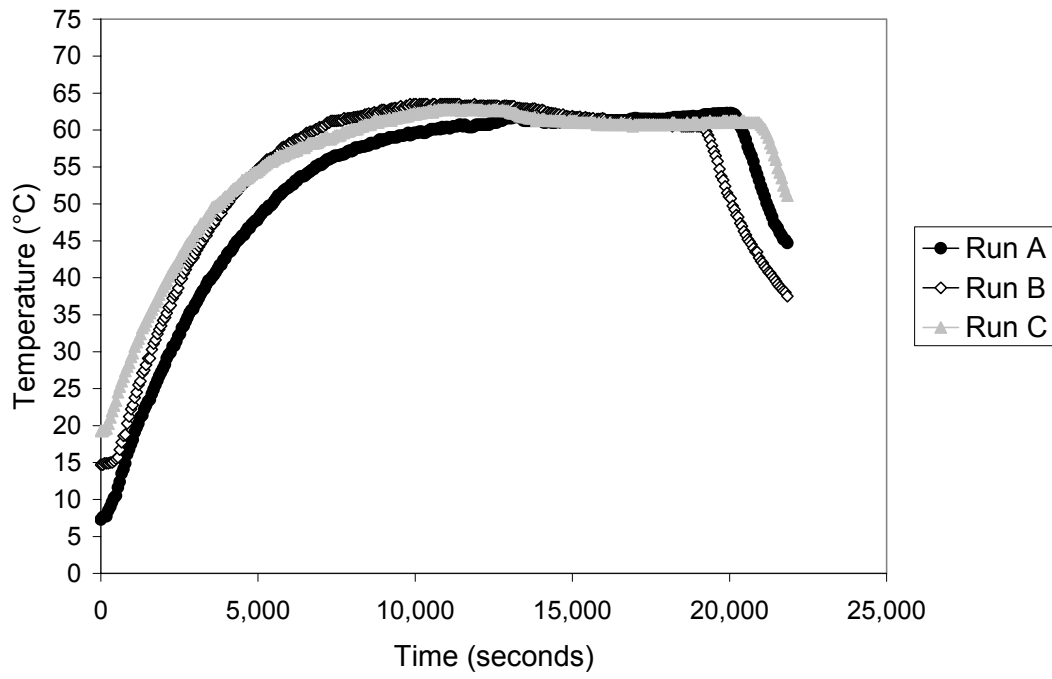
**Figure 1.** Profile from an armrest towards the rear of the cabin

It proved possible to heat the majority of the 747 cabin to close to 60°C and hold fairly near to this temperature for an extended period with the use of two thermal decontamination units (Figure 1). However, in some cases regions, it was not possible to hold at 60°C for 2 hours, as stipulated in the protocol (Figure 2). Surface temperatures in other locations (e.g. adjacent to the inlet) were found to exceed 65°C, with a maximum temperature of 71°C being observed where the incoming air stream impinged on the cabin (Figure 3). The two thermal decontamination units appeared to be well matched to the thermal mass of the 747, whereas a single unit had a rather larger heating capability than that required for a DC-9.

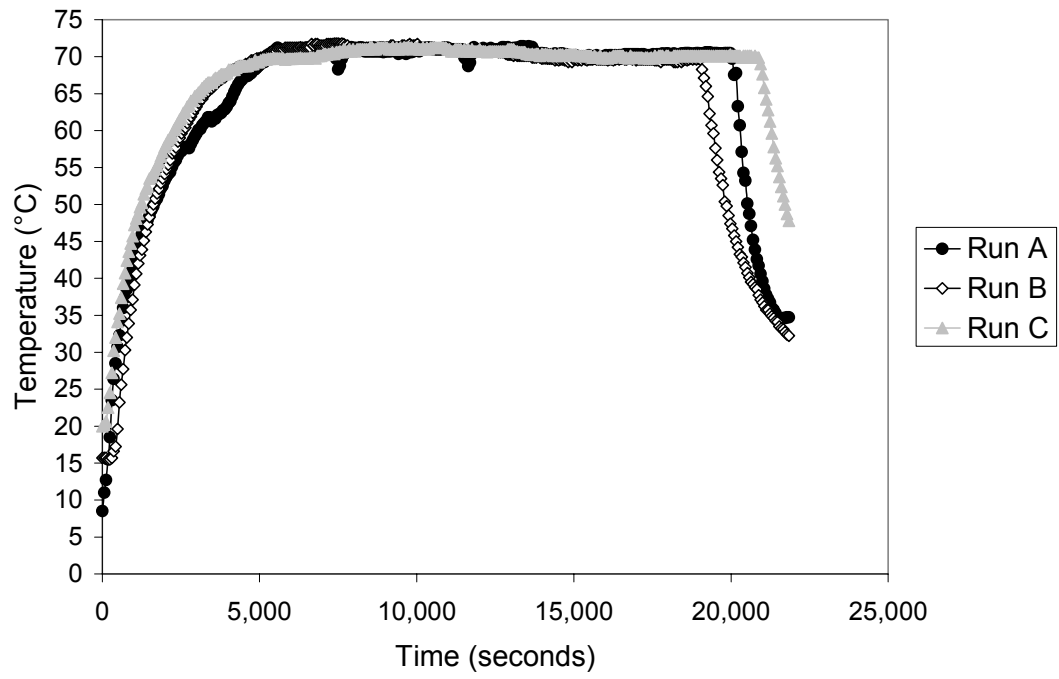
**Figure 3.** Profile from an overhead area adjacent to inlet

Most of the cabin was efficiently heated, without resort to an air distribution system within the cabin. However, one location, adjacent to one of the cabin service areas (galleys and lavatories), was found to have insufficient airflow, so an extension trunk was used to deliver air to this location (Thomas, 2007). It is possible that, with further optimization of the air delivery system, the extension trunk could be eliminated.

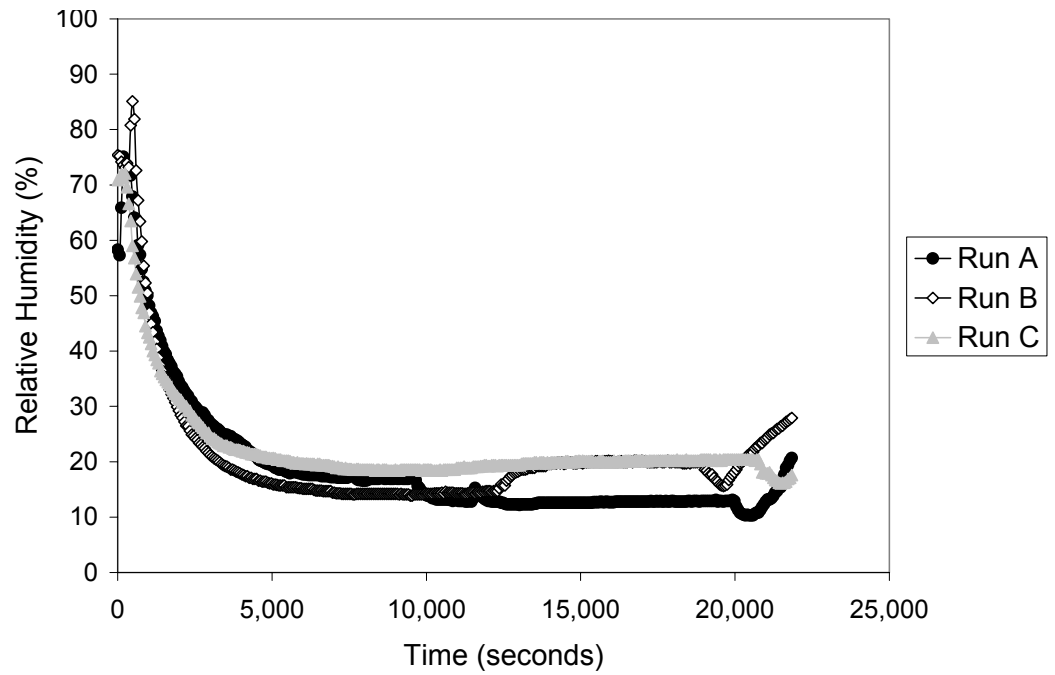
**Figure 4.** Relative humidity profile from the rear of the cabin

Using the 100 kW steam generator, it was not found possible to bring the cabin RH to above 20% (Figures 4 and 5).
