DOT/FAA/AM-02/19

# **General Aviation Pilot Performance Following Unannounced In-Flight Loss of Vacuum System and Associated Instruments in Simulated Instrument Meteorological Conditions**

Final Report

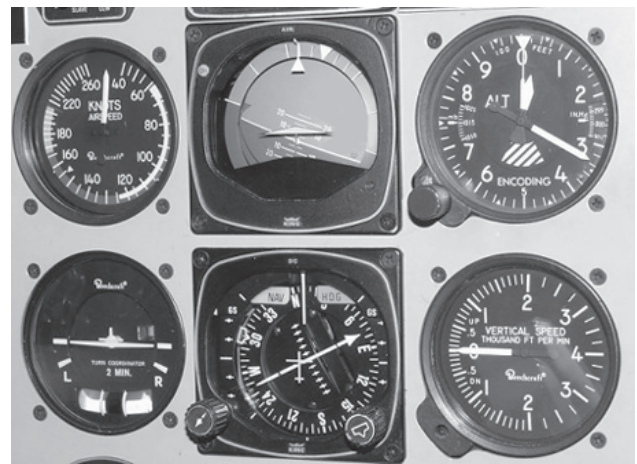
**Figure 2.** Bonanza instrument panel.

*Aircraft.* The two aircraft used were a simple (Piper Archer PA-28) (see Figure 1) and a complex (Beechcraft Bonanza A36; see Figure 2) airplane. Each was equipped with all Federal Aviation Regulation - FAR - required items for a single-pilot IFR flight. Polarized material was placed across the lower portion of the windscreen and left side window of each aircraft (see Figure 3) so that approximately the lower two-fifths of the windscreen was covered. The Francis hood used to simulate IMC (see inset, Figure 3) contained the same polarized material in the eye openings, oriented 90° to

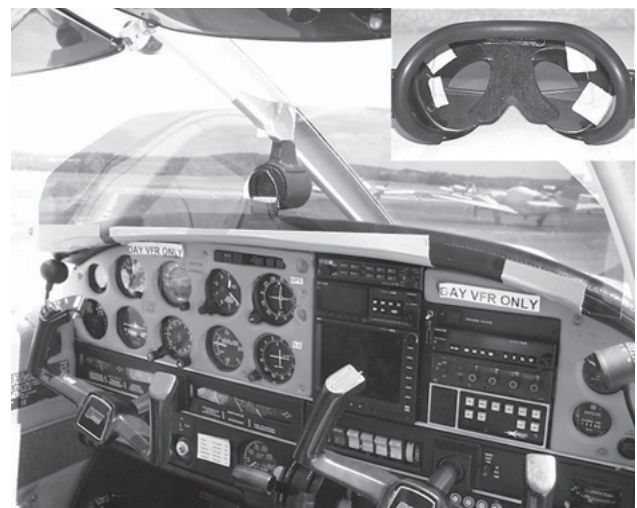
**Figure 3.** Polaroid material across windscreen of Piper Archer with (inset) Francis hood.

the windshield material. This arrangement allowed the pilots to see inside the cockpit, but eliminated the outside view immediately above the glare shield.
