NUREG-2240

# Flood Penetration Seal Testing Protocol Research

Office of Nuclear Regulatory Research

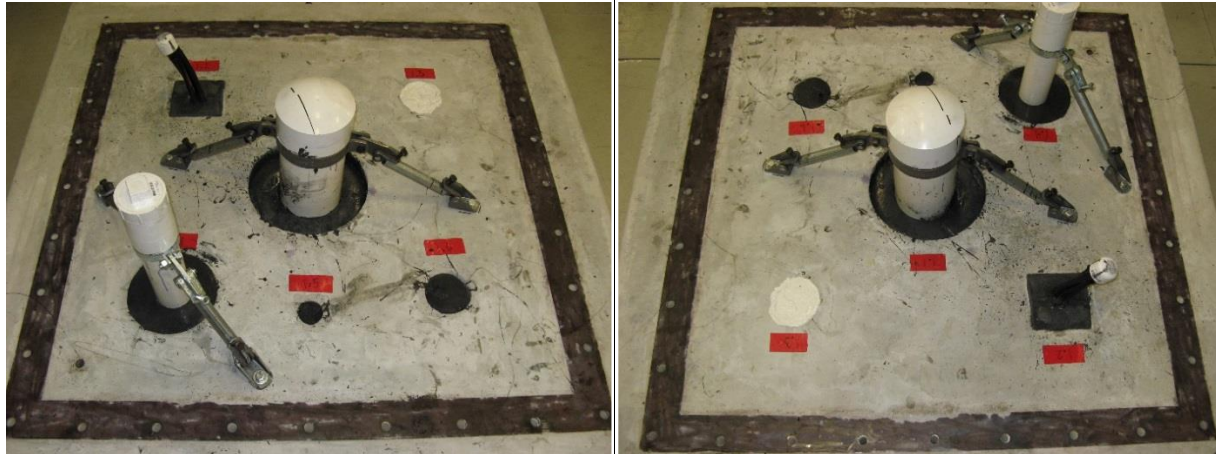
**Figure 4-10 Photos of Test Deck 1 After Seal Assembly Installation**

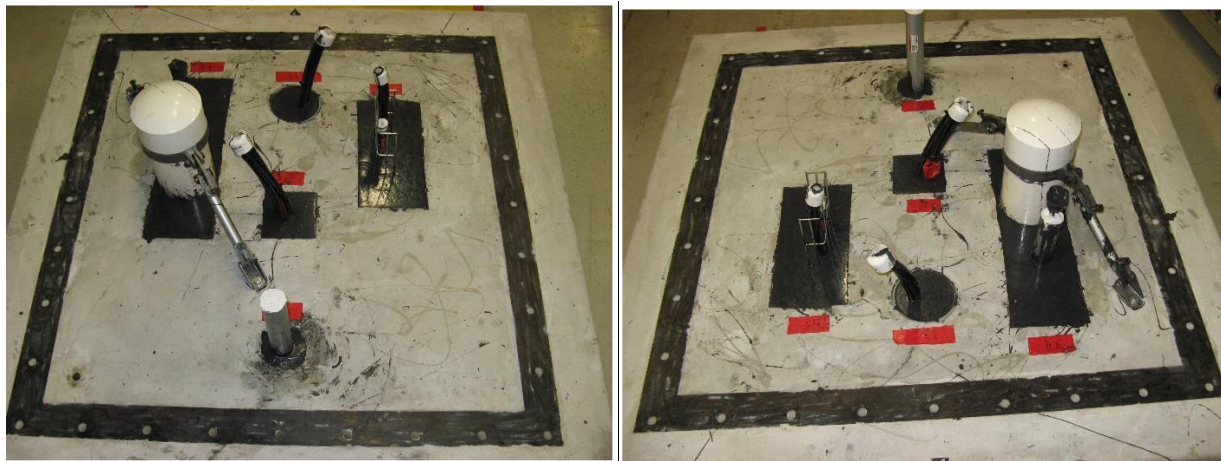
**Figure 4-16 Photos of Test Deck 3 After Seal Assembly Installation**

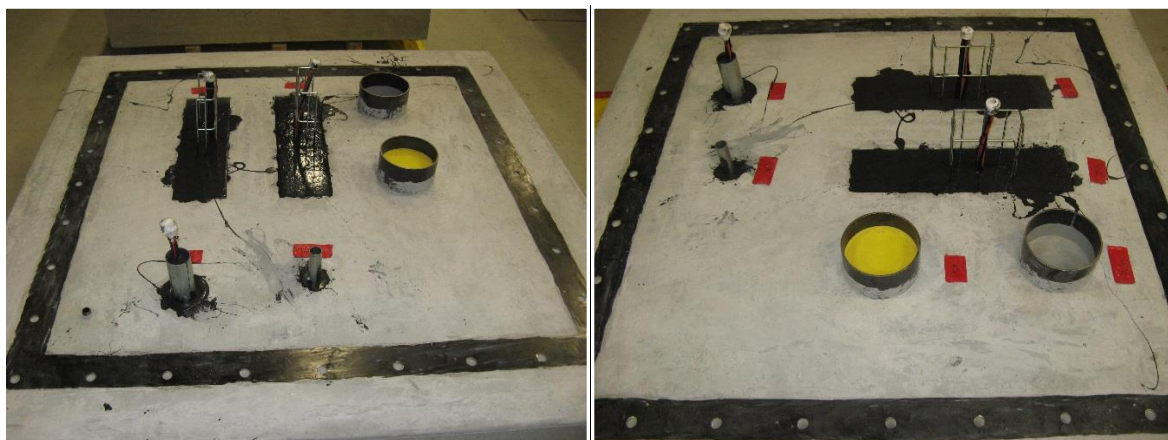
**Figure 4-18 Photos of Test Deck 4 After Seal Assembly Installation**

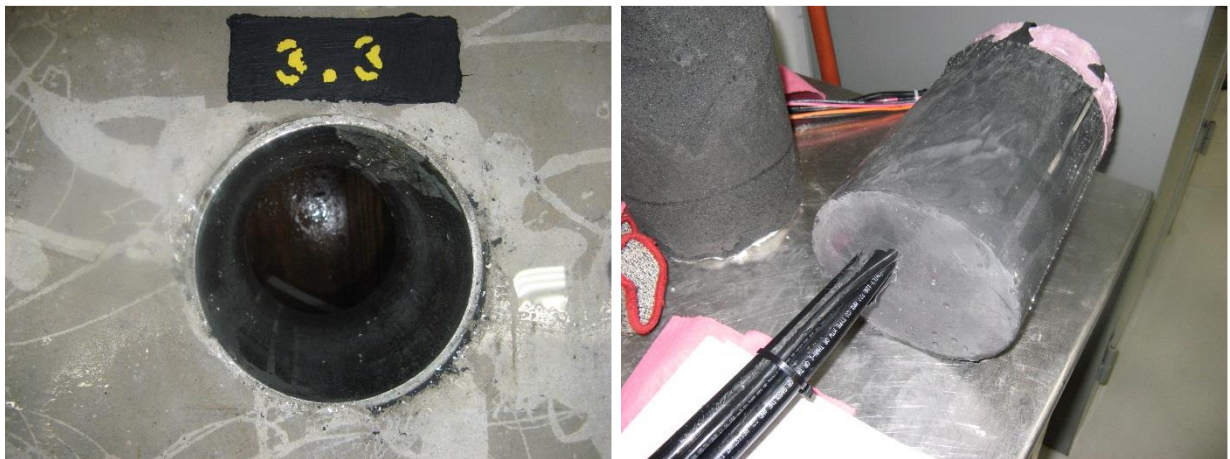
Following the termination of the test, visual inspections were conducted on Test Deck 3 (Figure 5-24). The seal in Penetration 3.3 was found to be completely dislodged from its installed position and pushed down into the leakage collection system. No damage or other notable discrepancies with the other five penetrations were observed.

**Figure 5-24 Empty Steel Sleeve for Ejected Penetration 3.3 (Left Photo) and Ejected Seal Material and Penetrants for Penetration 3.3 (Right Photo)**
