## CHAPTER 13

# *A Conservator's Perspective*

BERNARD RABIN

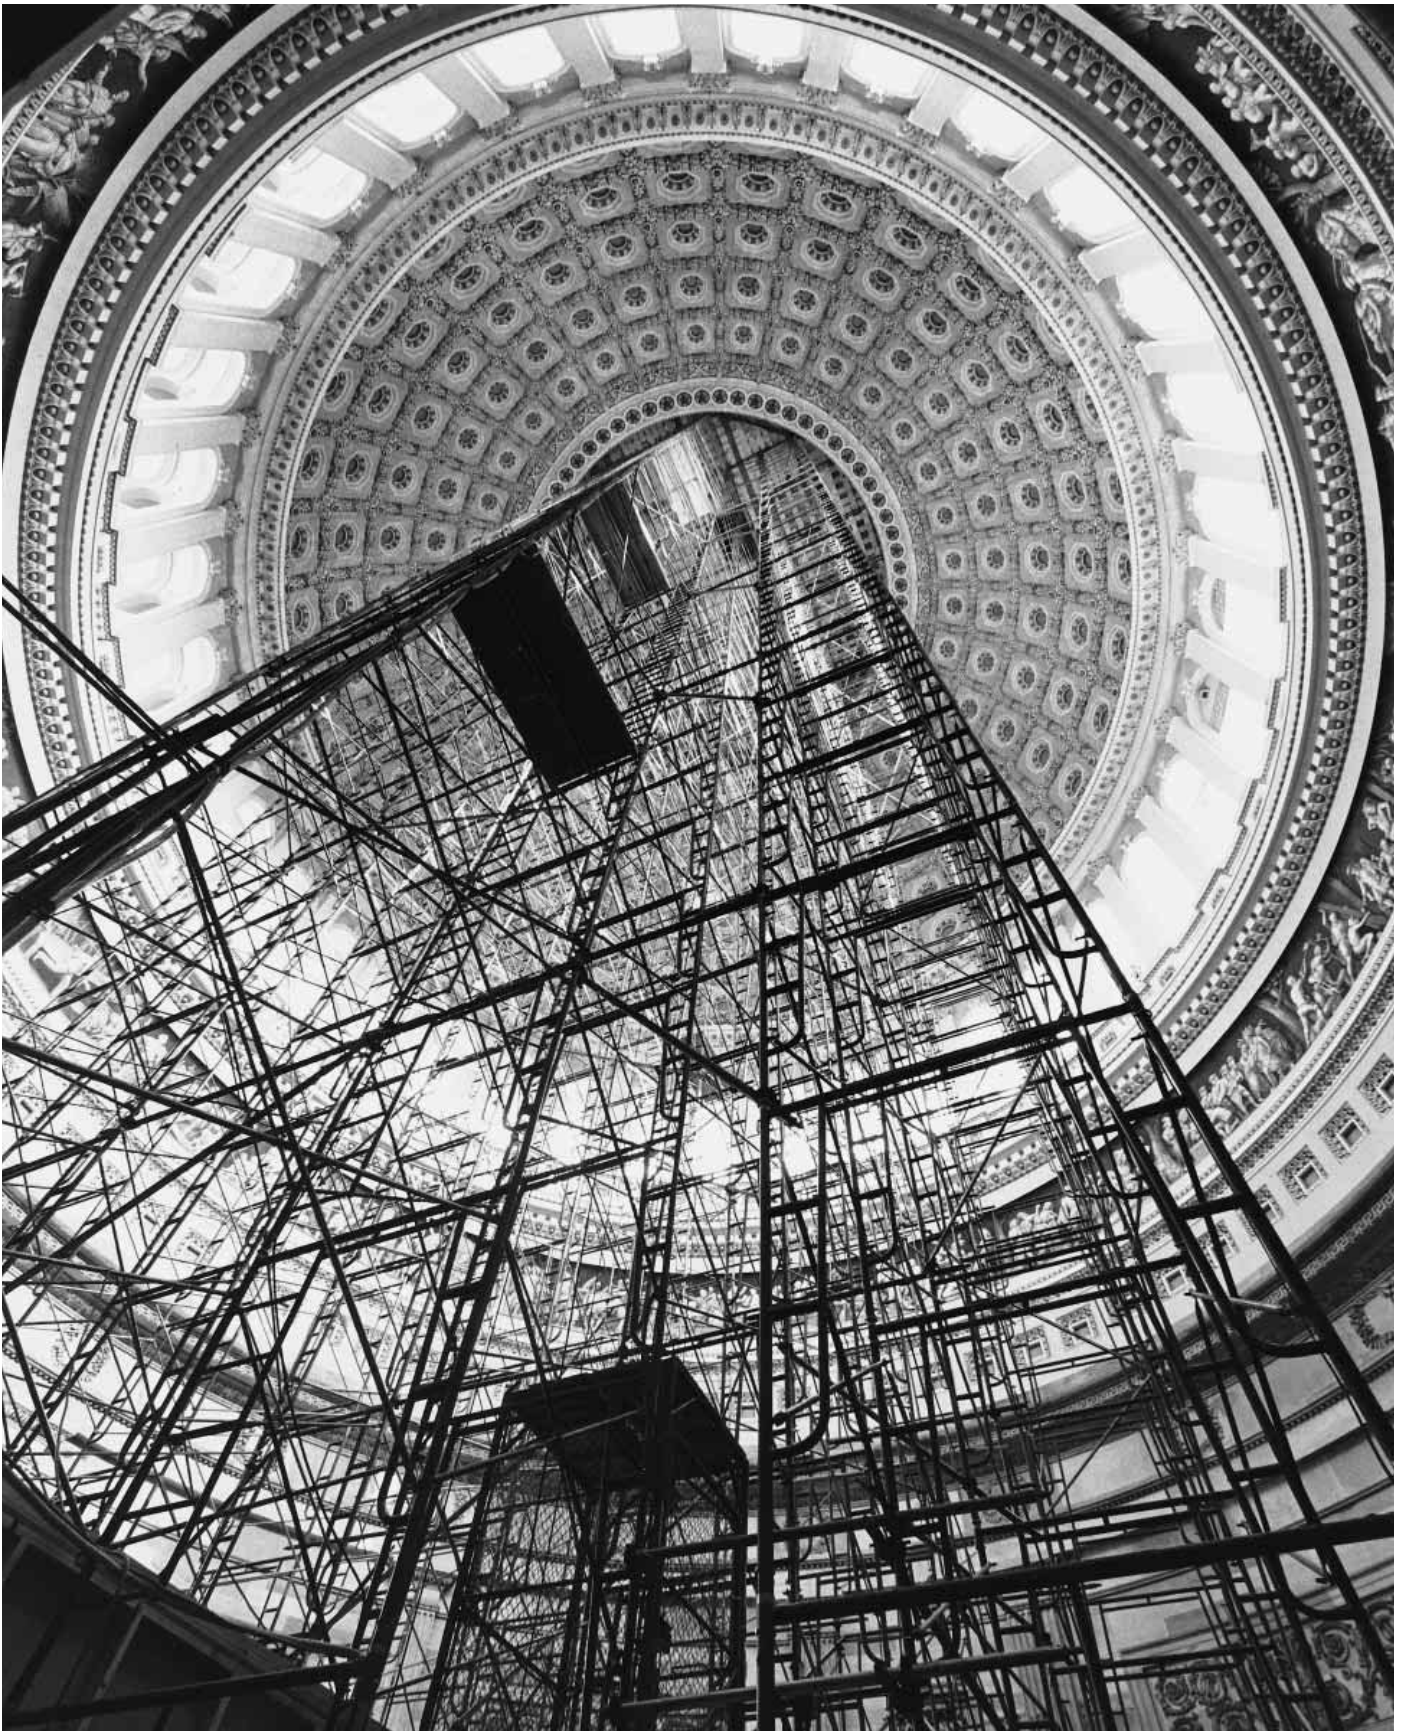
**Fig. 13–3.** Scaffold constructed for the restoration of the canopy. *The 150-foot-high structure supporting a wooden floor at the base of the fresco filled much of the Rotunda for a year.*

In planning for the treatment of the canopy, it was not possible to reach the curved surface to inspect it closely or to conduct tests ahead of time; I was able to make some rudimentary spot cleaning tests only at the lowest edge of the fresco by using a pole from a ladder on the balcony. Therefore, I approached the canopy with trepidation, not knowing the problems that we would find. Because a space frame across the balcony would not have provided complete access to the fresco and was more costly, a carefully designed scaffold was built from the floor of the Rotunda, its weight transferred to the massive columns in the crypt below (fig. 13-3). A passage was left through the scaffold for access across the Rotunda. I requested a small elevator for transportation of equipment, supplies, and personnel, particularly for myself in light of the fact that I was past retirement age. (At one point, the plans for the elevator were nearly scuttled when the Architect of the Capitol discovered that the previous restorer, Allyn Cox, had walked up.) The ride took at least eight minutes; my youthful crew often found they could beat it by walking up the stairs, between the inner and outer domes.

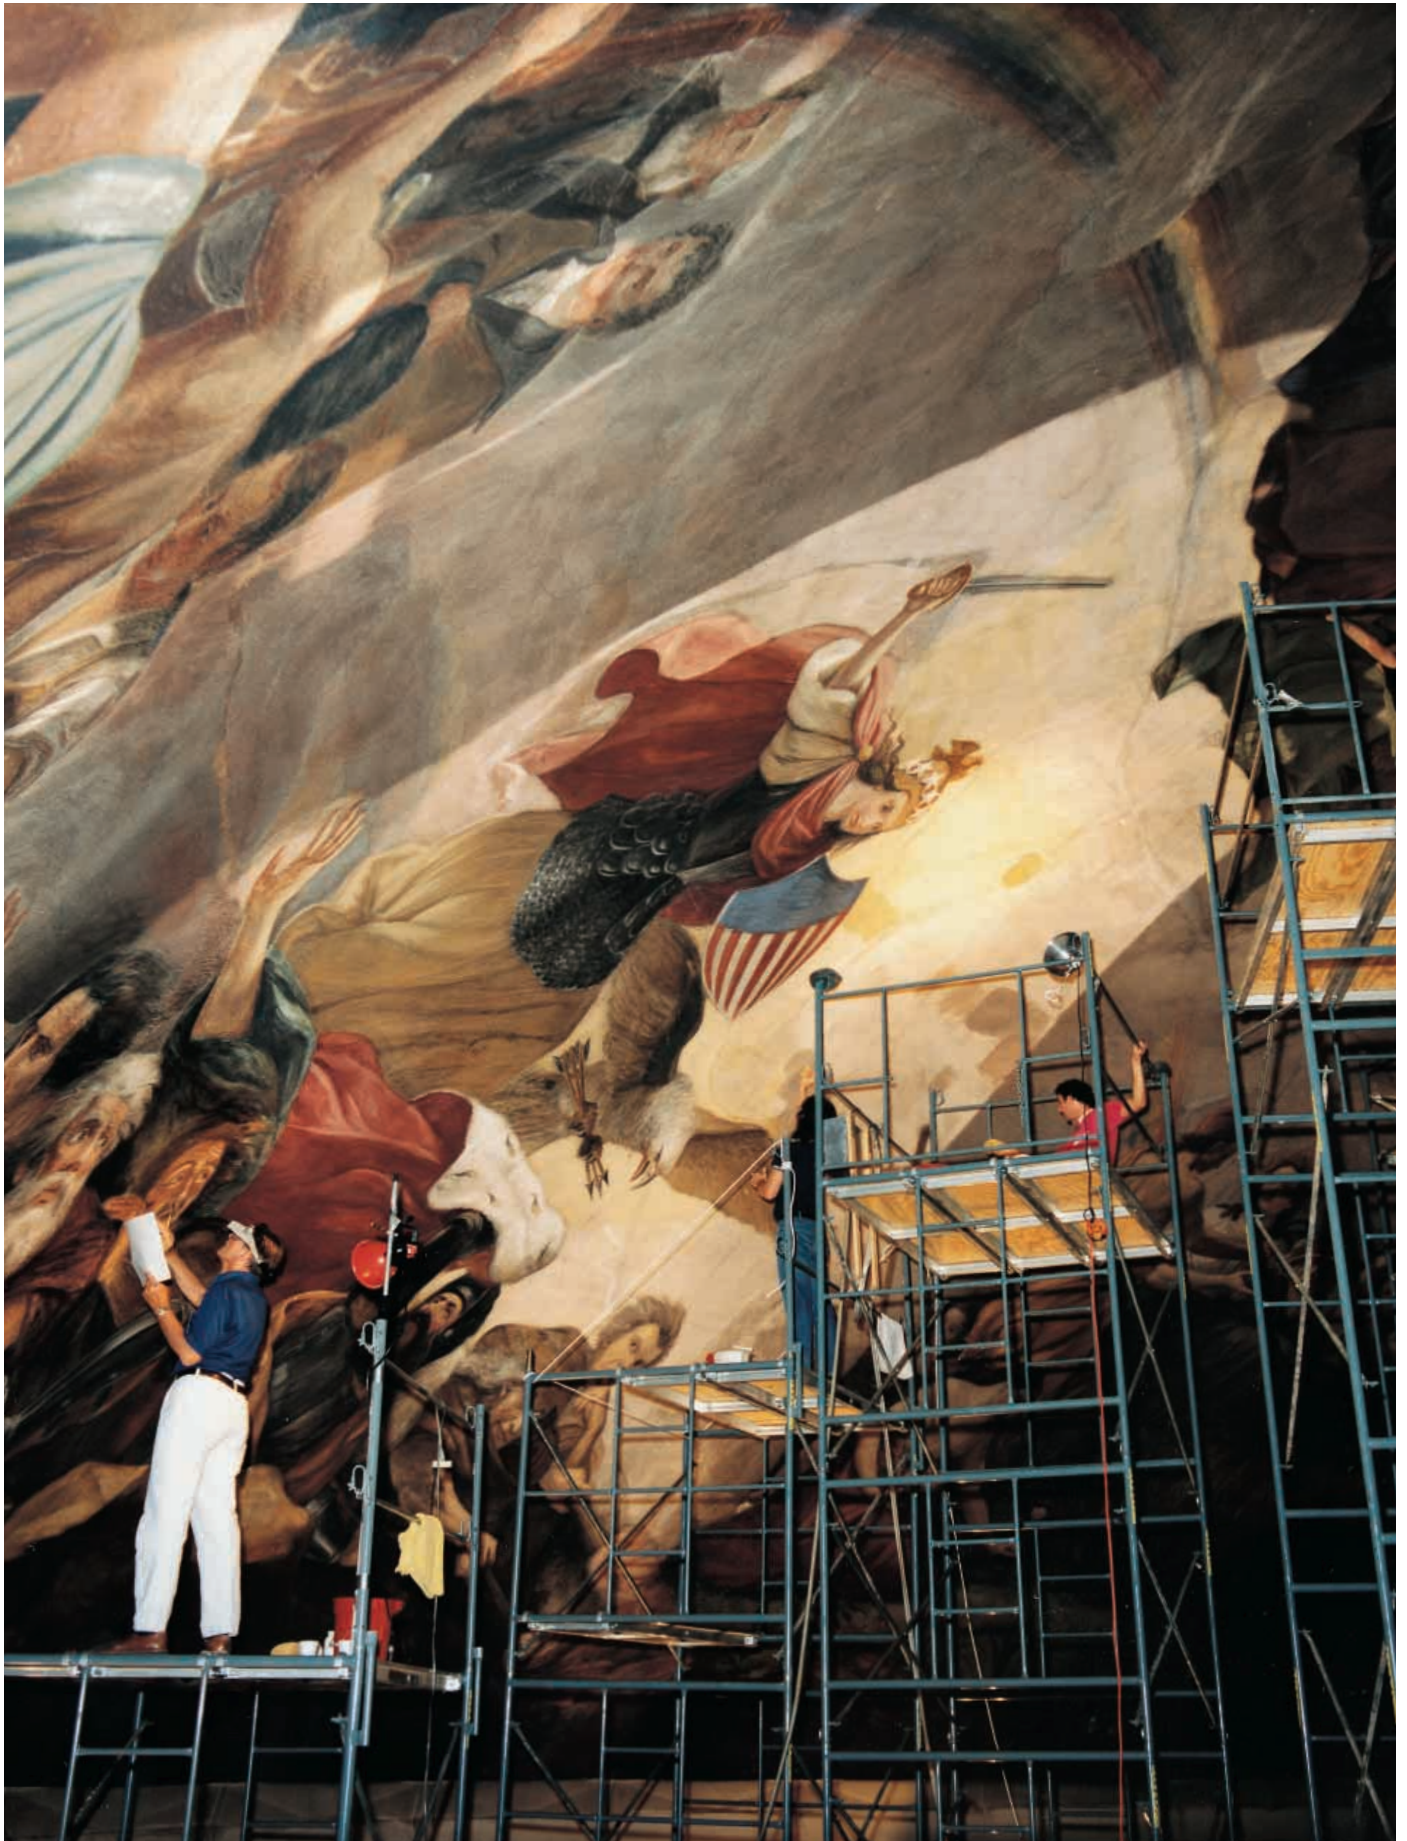
**Fig. 13-4. Rolling scaffolds atop the fixed scaffold.** *The conservators could reach all parts of the curved canopy from the platforms at varying heights.*

On the platform at the top of the fixed scaffold, smaller rolling scaffolds were provided to enable my team, which consisted of Larry Keck, Constance S. Silver, Perry Hurt, and Todd Overturf, to reach all levels of the concave canopy (fig. 13-4). Because there is no plumbing at the top of the dome, special pumps and drains were designed so that the murals could be cleaned with water.
