## CHAPTER 14

# Conserving the Rotunda Frescoes

BERNARD RABIN AND CONSTANCE S. SILVER

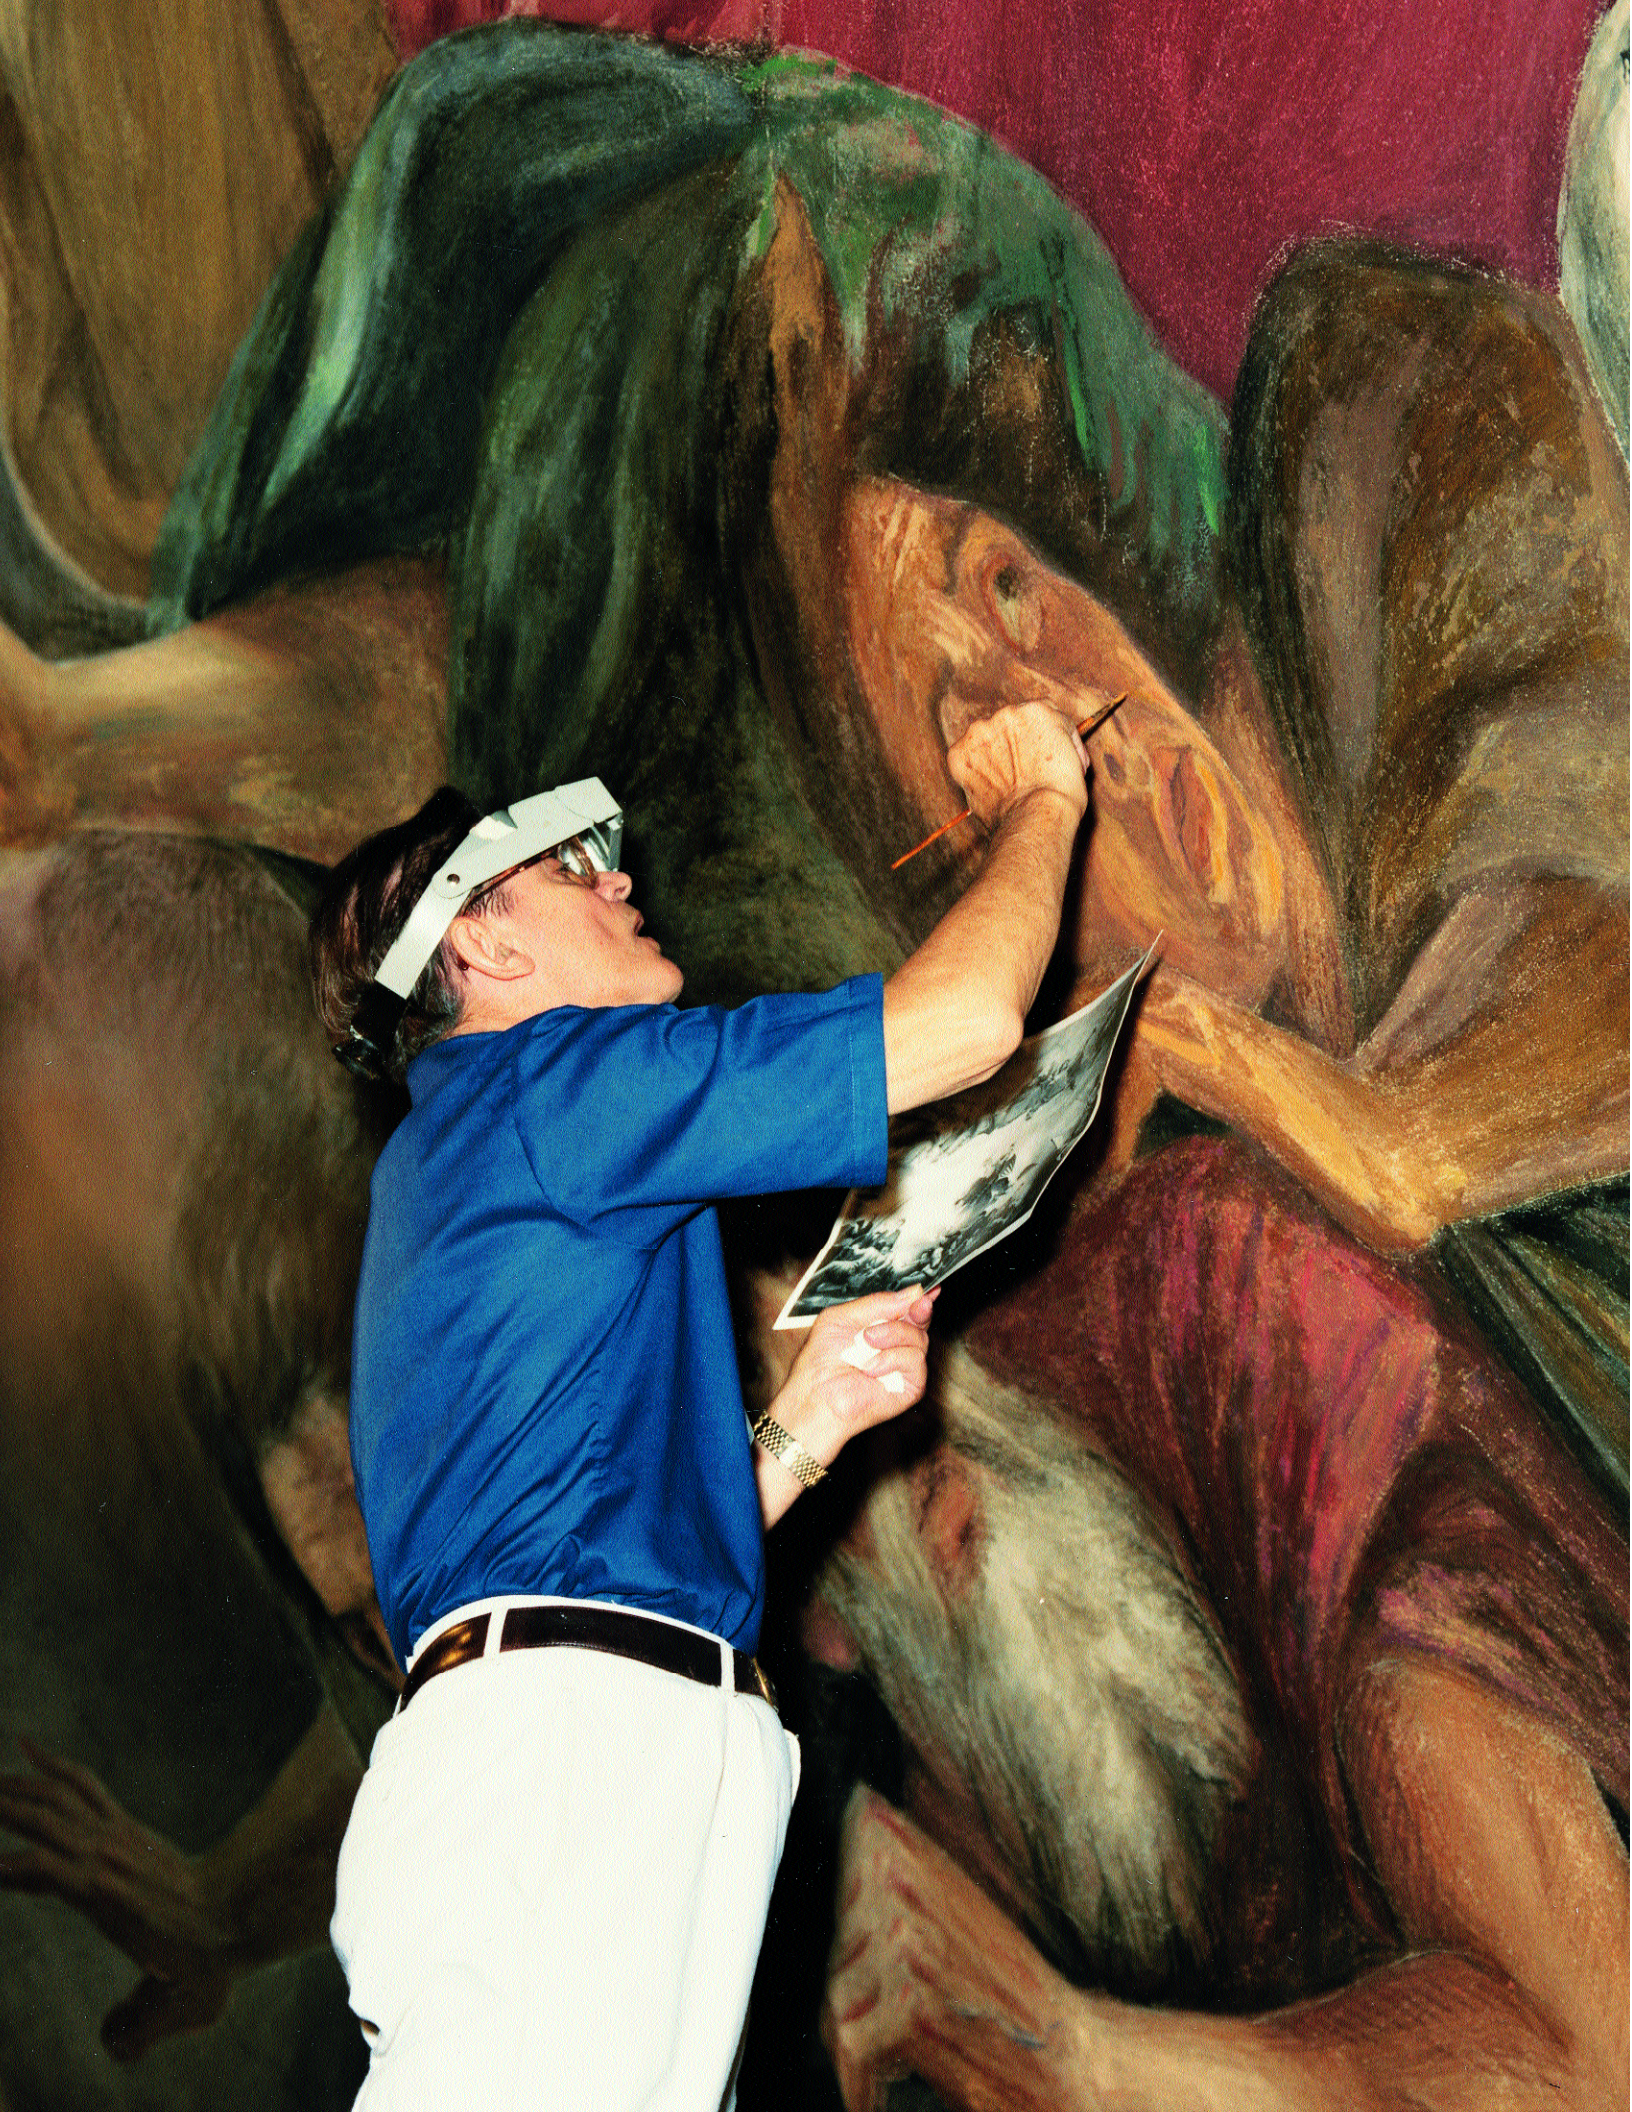
**Fig. 14–1. Bernard Rabin inpainting losses.** *The conservators used archival photographs to guide the reconstruction of damaged forms. The water-based paint they used can be easily removed if so desired in the future.*

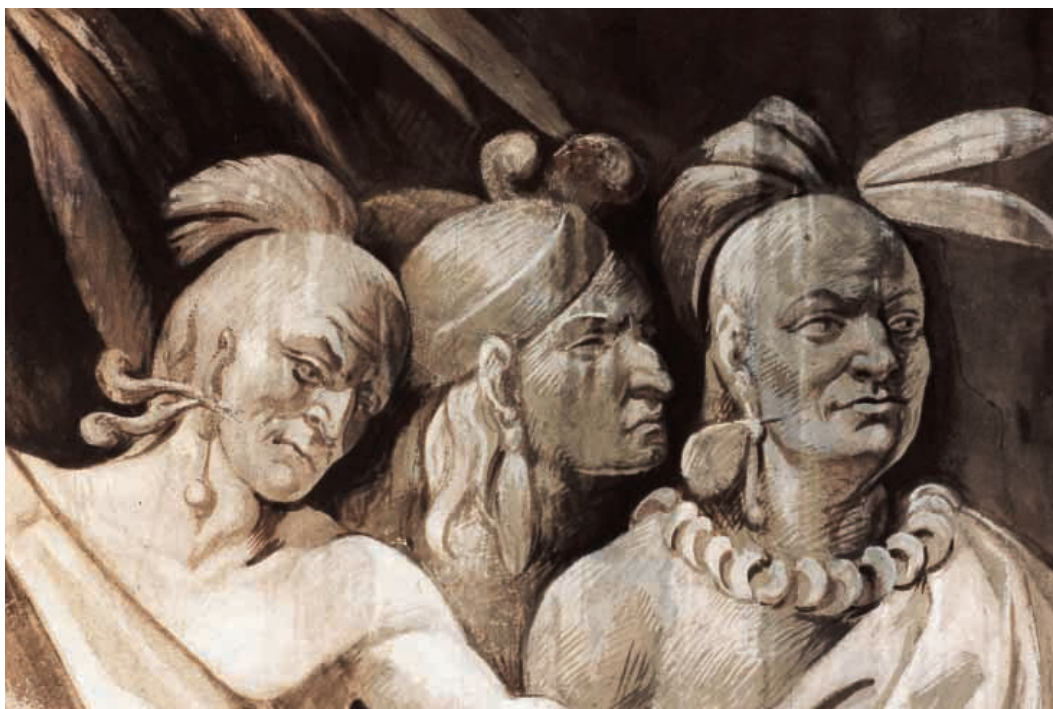
**Fig. 14-4.** Group of Native Americans in “Oglethorpe and the Indians” shown before conservation. *In badly damaged areas, Allyn Cox used his imagination to reconstruct forms.*

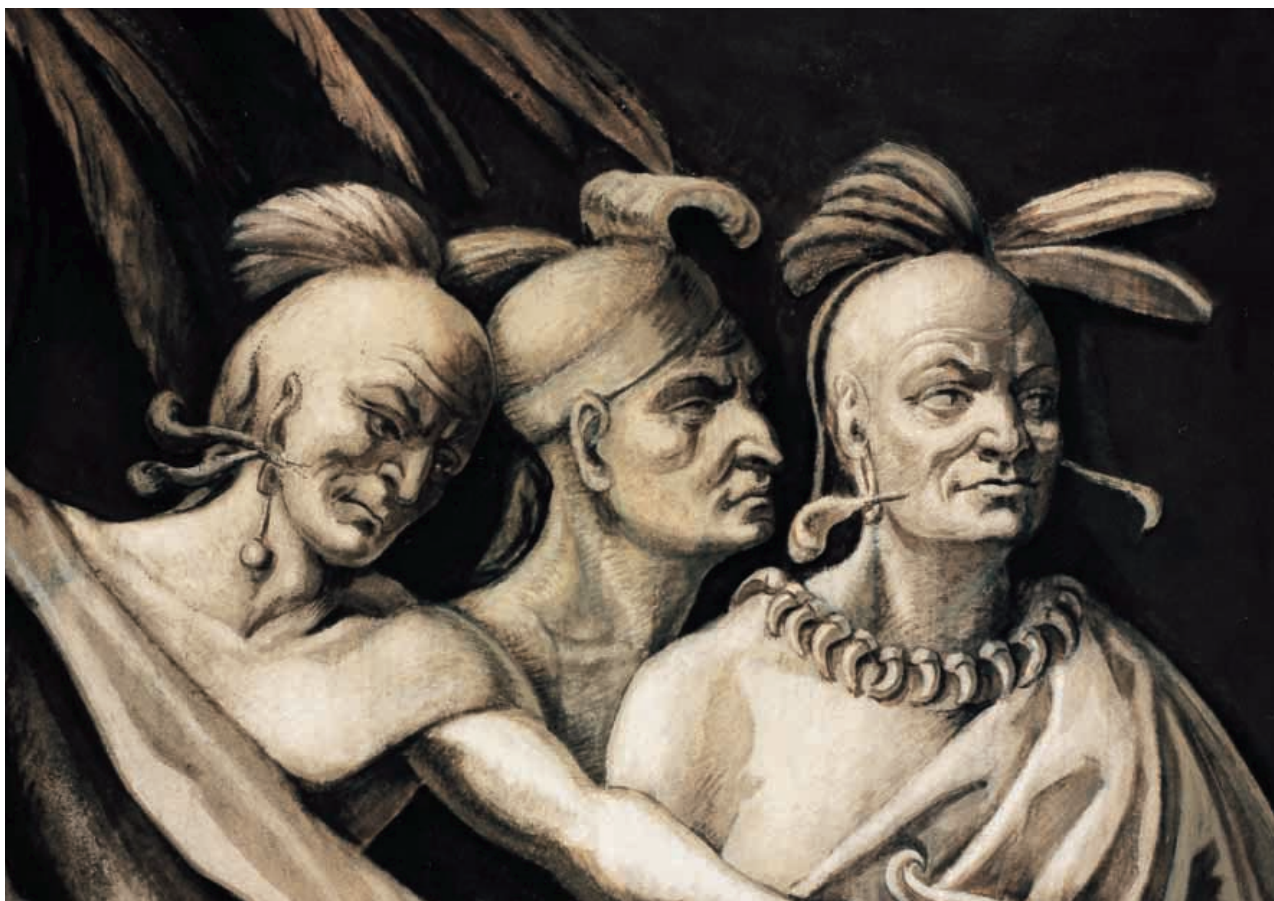
**Fig. 14-5.** Group of Native Americans in “Oglethorpe and the Indians” shown after conservation. *The professional conservators consulted historic photographs of the frieze for accuracy.*

Extensive reconstruction was required only at scene 10 (see fig. 14-3). Here Cox had reconstructed some damaged areas by extrapolating from the fragmentary forms that remained (fig. 14-4). By consulting archival photographs, we were able to restore more correctly Brumidi's original details (fig. 14-5).

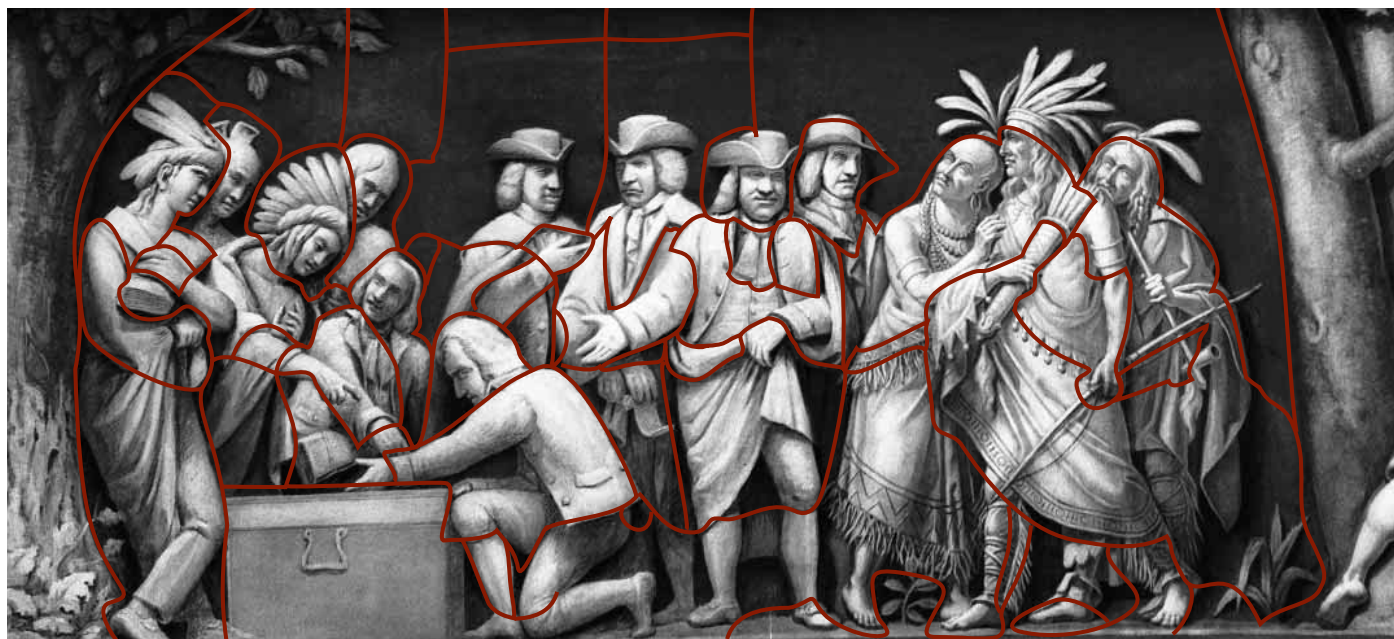
**Fig. 14–7. Diagram of the *giornate* in “William Penn and the Indians.”** The number and configuration of the sections of plaster on which Brumidi painted each day were recorded as part of the conservation treatment. In this section, Brumidi’s small sections to the left contrast with Costaggini’s larger ones to the right.

Costaggini also relied heavily on a variety of transfer technique—incisions, *puntini*, and *spolvero*—to ensure the precise and somewhat rigid execution of a myriad of details. Thus his *giornate* tend to be rather large and predictable, most probably laid out in precise relationship to the cartoons (fig. 14–7).

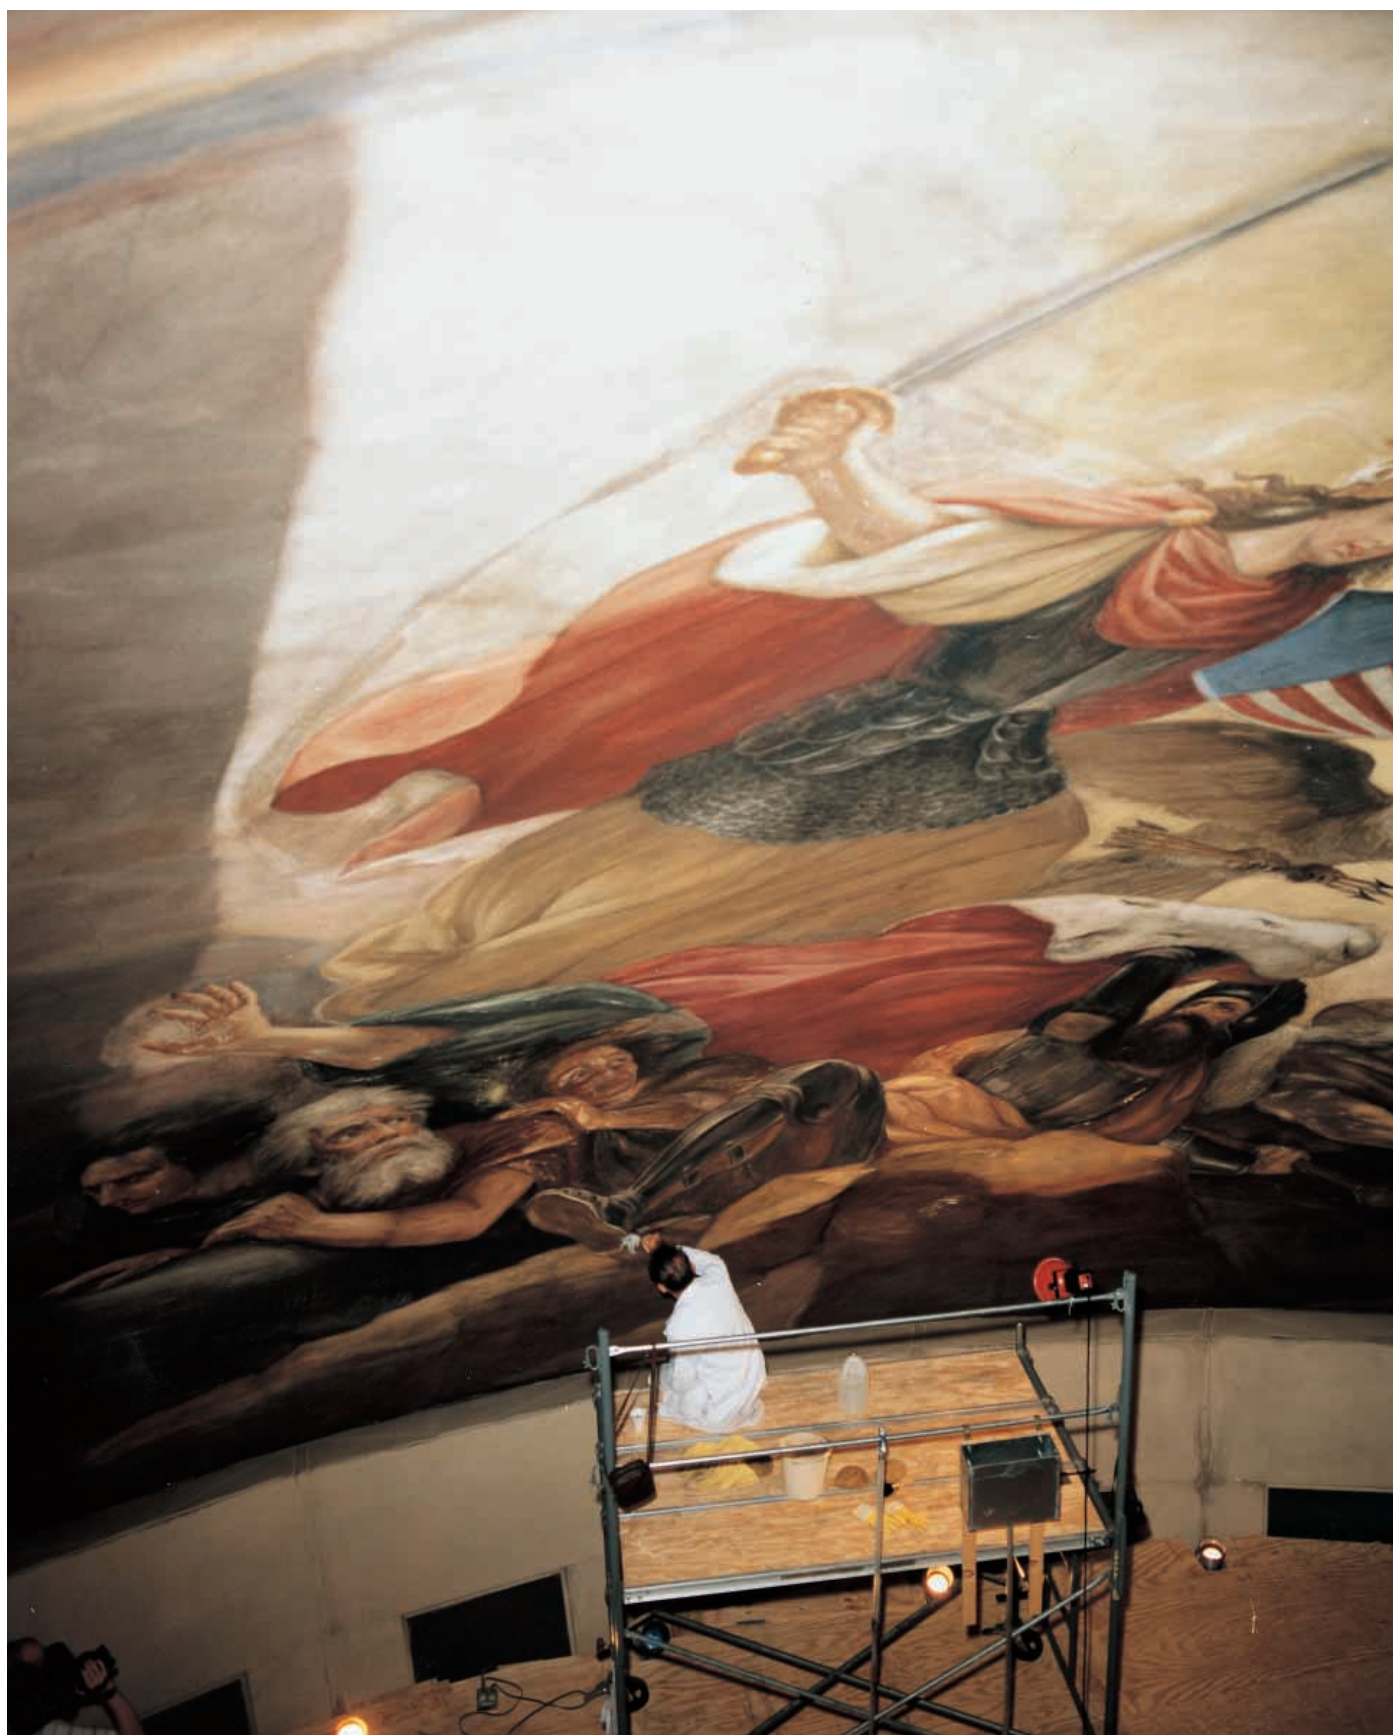
**Fig. 14–8.** First area on the canopy cleaned. *Bernard Rabin is dwarfed by Freedom, whose vibrant colors were uncovered beneath heavy layers of grime.*

The first step was to carry out cleaning tests. The amount of grime darkening the fresco was even greater than we expected. Even with the first simple water cleaning, the sky changed from dark gray to yellow white (fig. 14–8). As on the frieze, we found a layer of tenacious grime from the burning of the coal-gas jets that illuminated the dome for forty years.

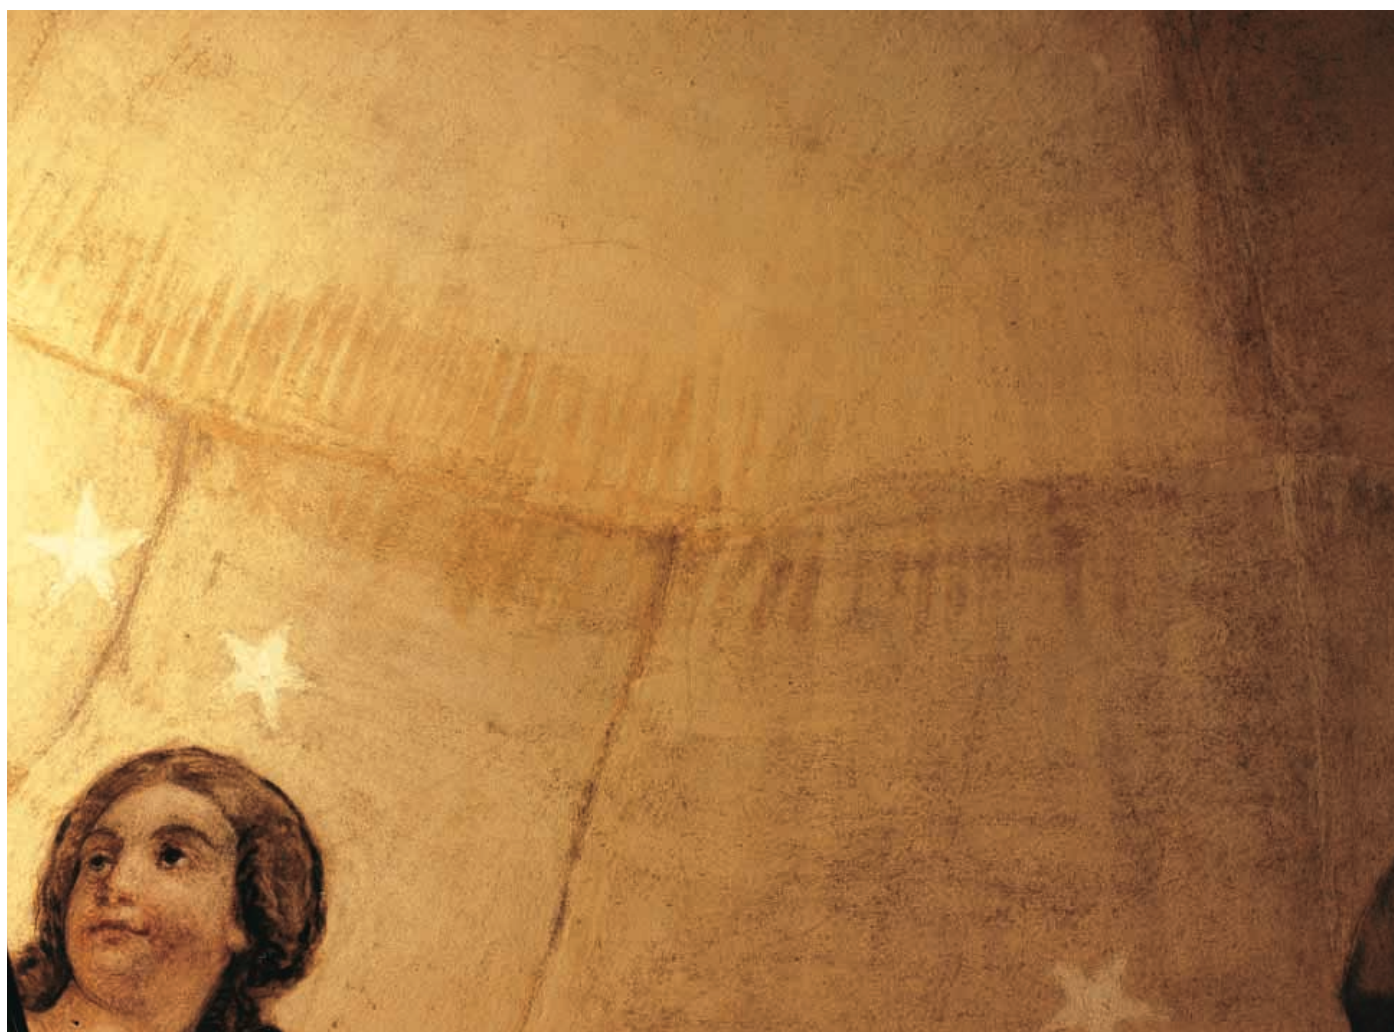
**Fig. 14–10. Brumidi’s hatch marks.** *The artist tried to reduce the prominence of some of the joins by scratching lines across them in the plaster.* Photo: Rabin & Krueger.

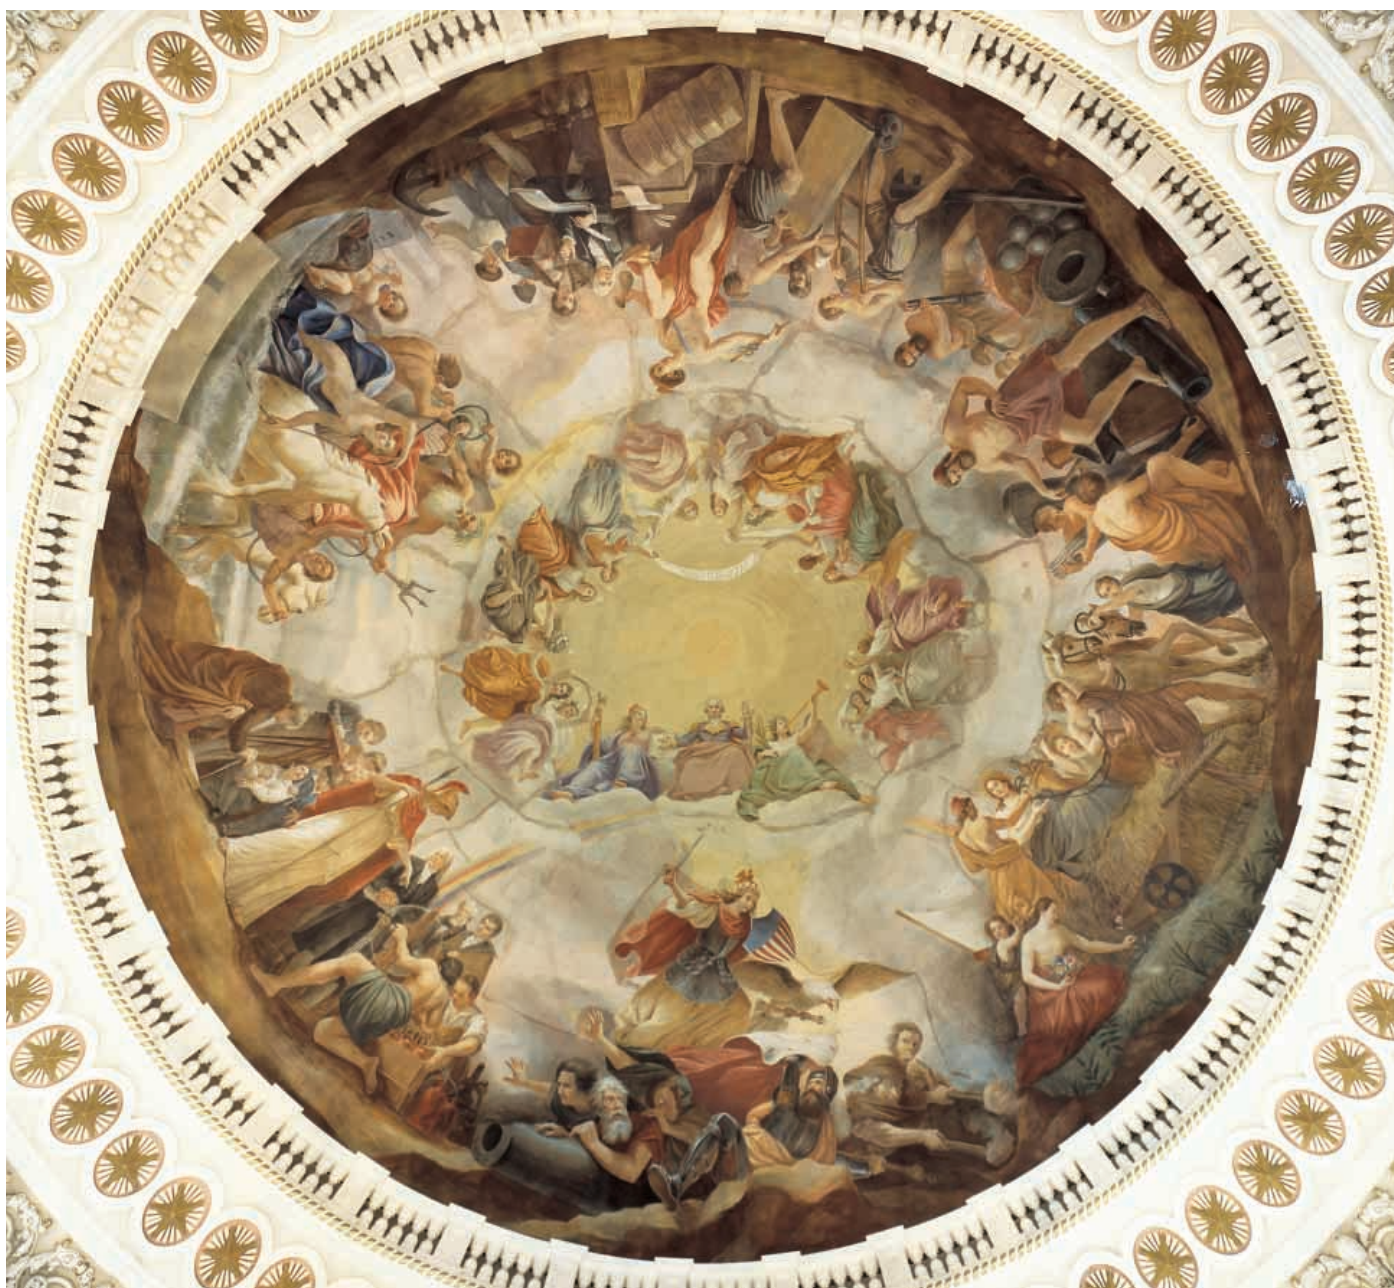
**Fig. 14–12. *The Apotheosis* before conservation.** By 1987, the forms and colors were dulled by grime, and the paint applied between the *giornate* in 1959 had darkened and become extremely disfiguring.

trusive. High-magnification examination of samples taken from the dark joins between the *giornate* provided further confirmation. They showed four distinct layers: the *intonaco*, Brumidi's frescoed pigment layer, Brumidi's retouching, and Cox's 1959 overpaint.<sup>10</sup>

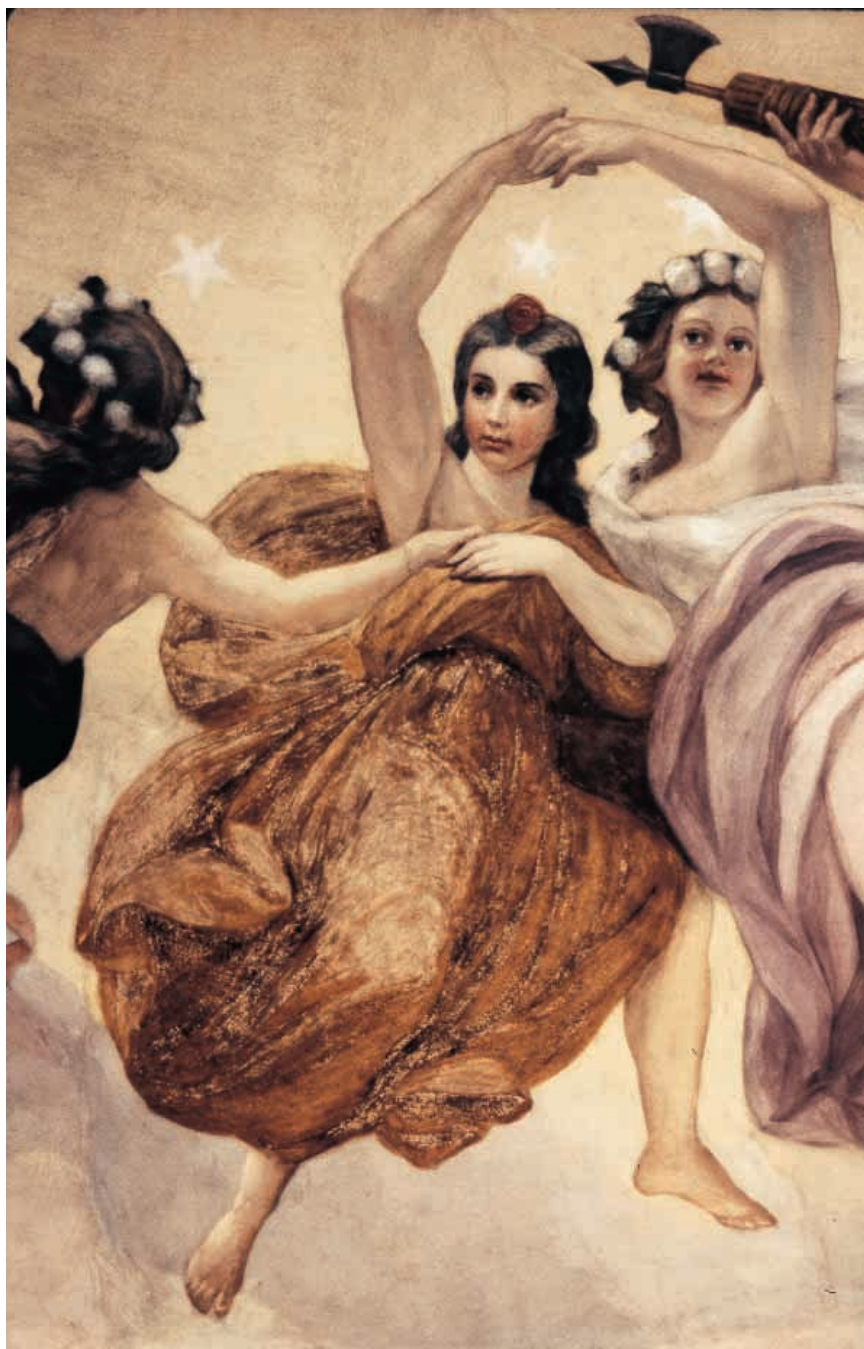
**Fig. 14–13. Area where loose plaster had been brushed off.** The conservators found numerous areas, especially in the brown and green drapery, where little original pigment remained, leaving white plaster. Photo: Rubin & Krueger.

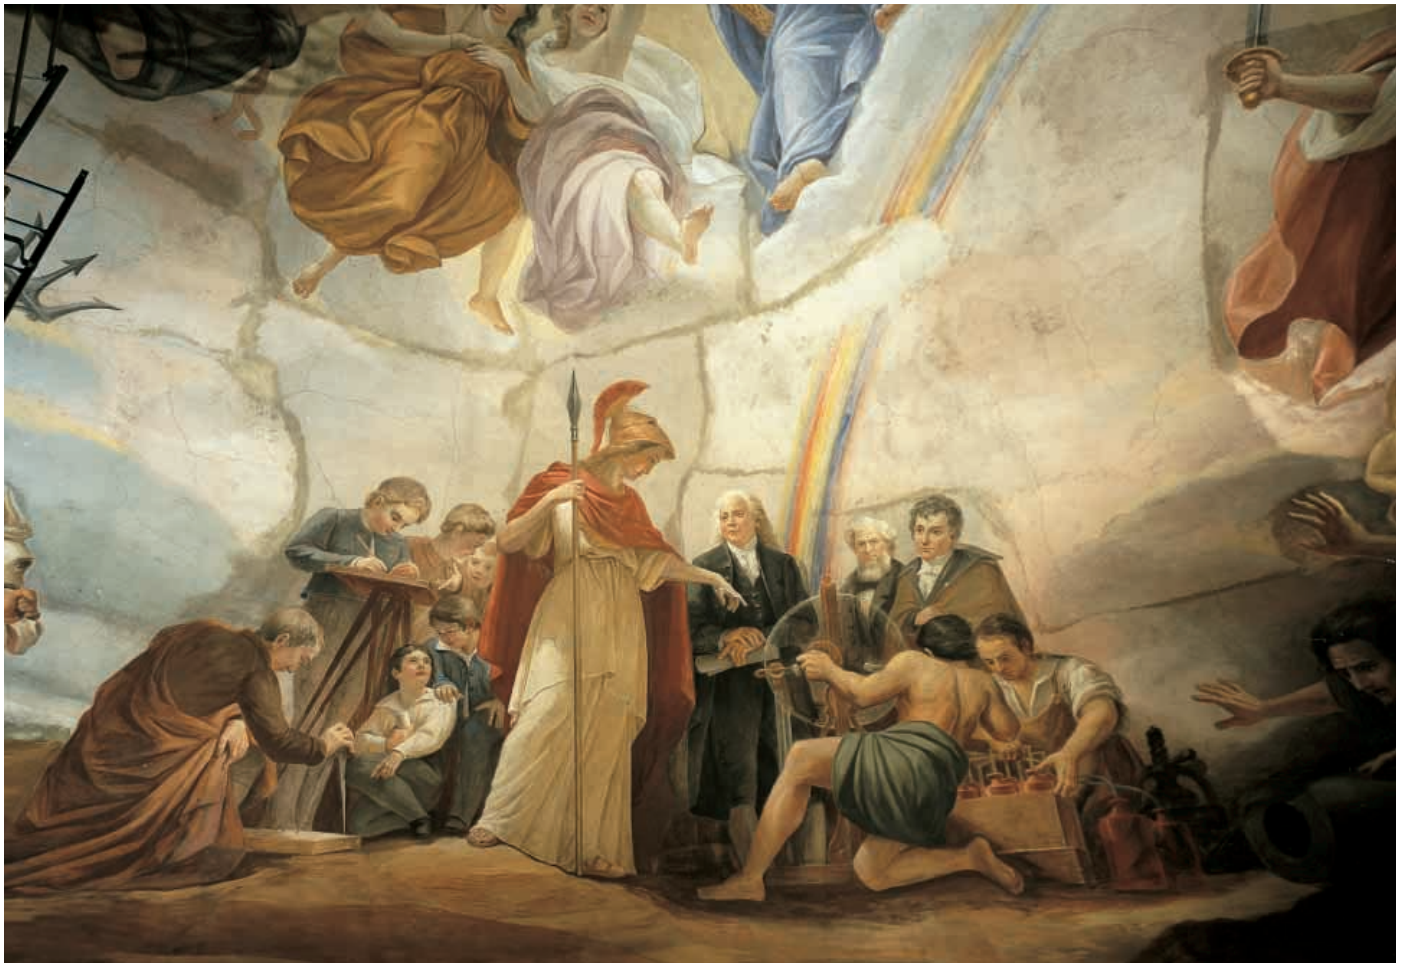
**Fig. 14–15. “Science” before conservation.** *The legibility, three-dimensionality, and beauty of each scene were marred by dark grime, the darkened overpaint outlining the giornate, and stiffly repainted drapery.*

As the cleaning progressed, we no longer saw dark gray skies and muddy colors (fig. 14–15). The fresco became luminous and bright, section by section, layer by layer (fig. 14–16). Even after inpainting damaged areas, the lines between the *giornate* remained aesthetically distracting. However, extensive overpainting of an artist’s original work, even to cover up his original mistakes and difficulties, is not an ethical solution. Working with Architect of the Capitol George White and Curator Barbara Wolanin, we arrived at a balanced approach. Mr. White suggested we retain the physical evidence of the *giornate*

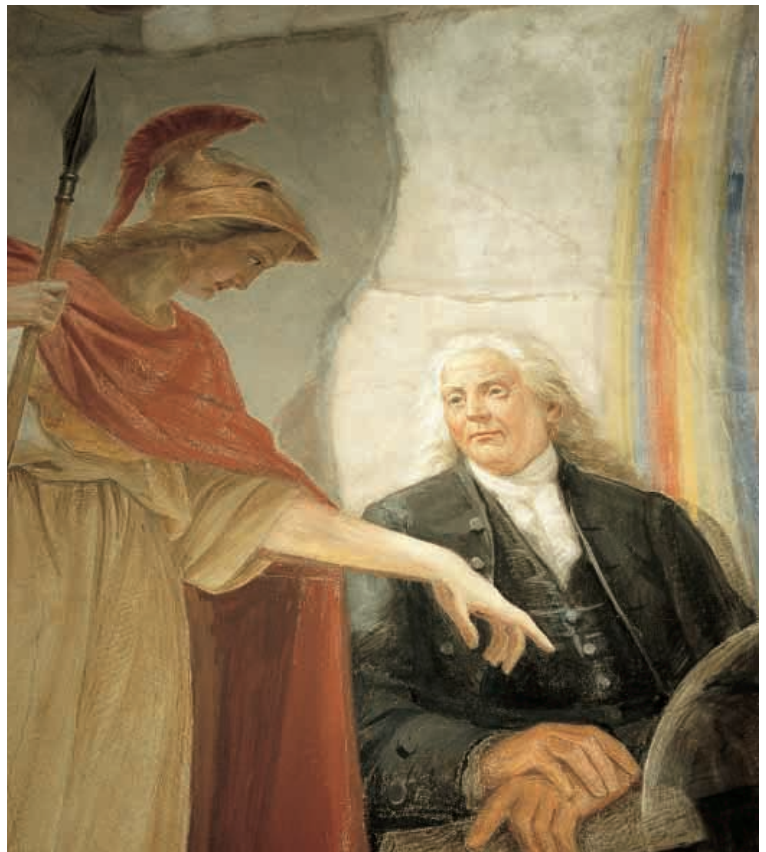
**Fig. 14–16. “Science” during conservation.** *Cleaning, mainly with water, revealed Brumidi’s vibrant colors, especially in the delicately painted rainbow. The contrast with the uncleaned areas, at left, was striking.*

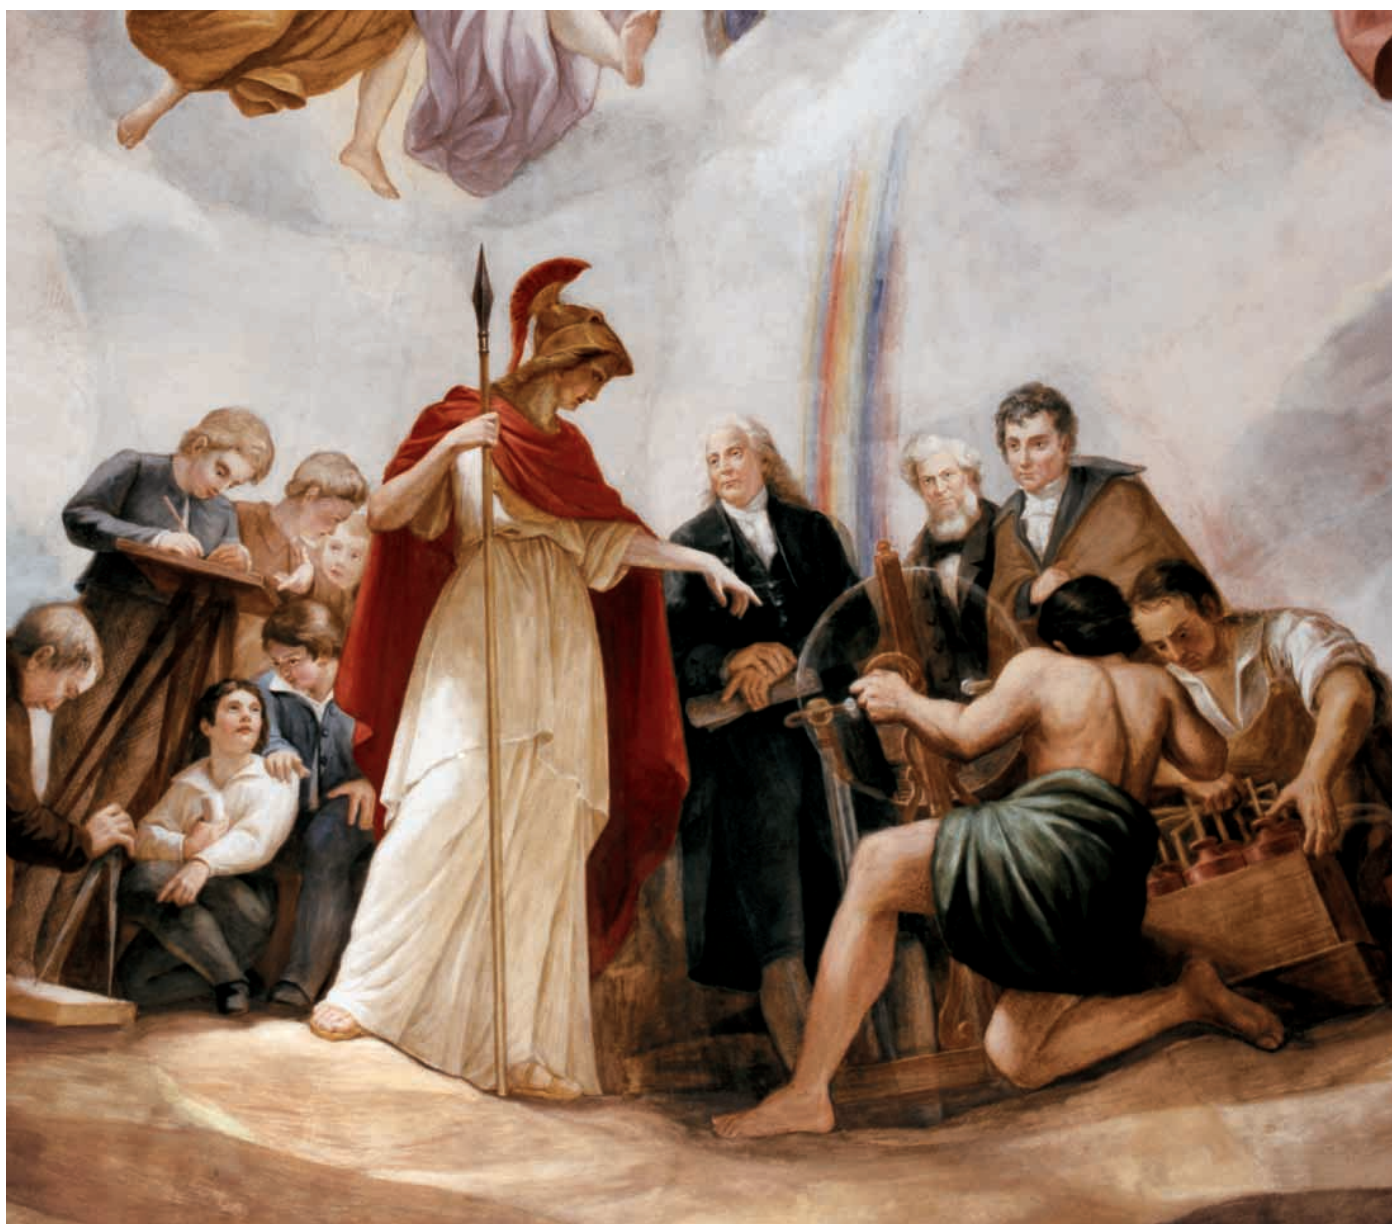
**Fig. 14–17. “Science” after conservation.** *The figures seemed to come alive after treatment, when the entire fresco regained its clarity and harmony.*

while reducing the amount of contrast. To achieve this end, the joins in the light sky areas were slightly blanché and blended with chalk. As a result, the fresco can be read as a whole, as Brumidi intended (fig. 14–17).

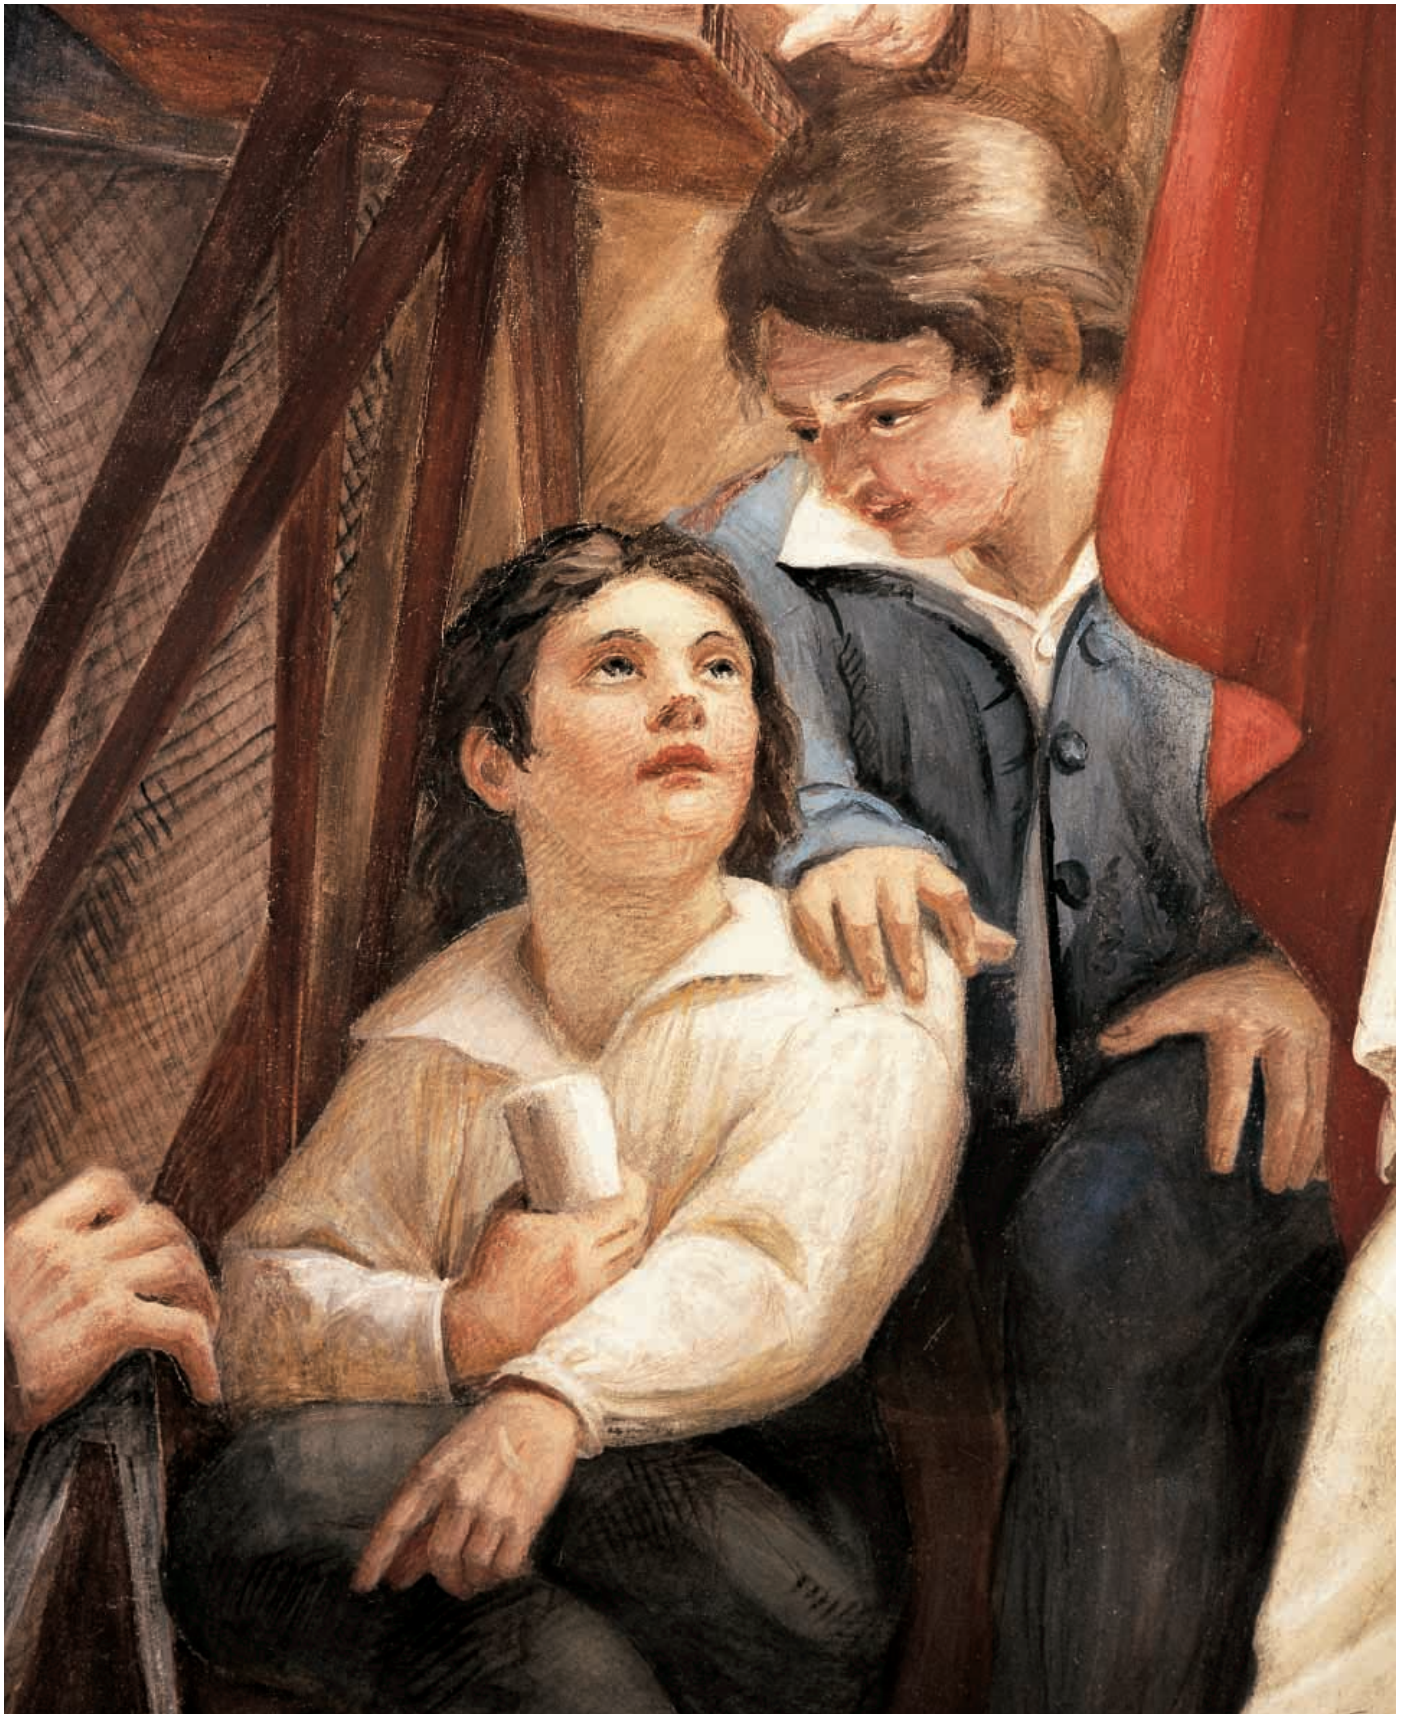
**Fig. 14–18.** Detail of “Science.” *A close-up view of the cleaned fresco leads to an appreciation of the varied types of hatched strokes Brumidi used to enhance the sense of space and three-dimensional forms.*

Until the scaffold was removed and the fresco viewed under normal light conditions, we could not be sure that the retouched and repaired areas would be invisible. To our gratification, our treatment was successful, and we were thrilled to see the integrity of the composition was restored, from the grandeur of the entire composition (see frontispiece) to the mastery evident in the individual bold brush strokes (fig. 14–18).
