HURRICANE KATRINA: WHY DID THE LEVEES FAIL?

COMMITTEE ON HOMELAND SECURITY AND GOVERNMENTAL AFFAIRS UNITED STATES SENATE

NOVEMBER 2, 2005

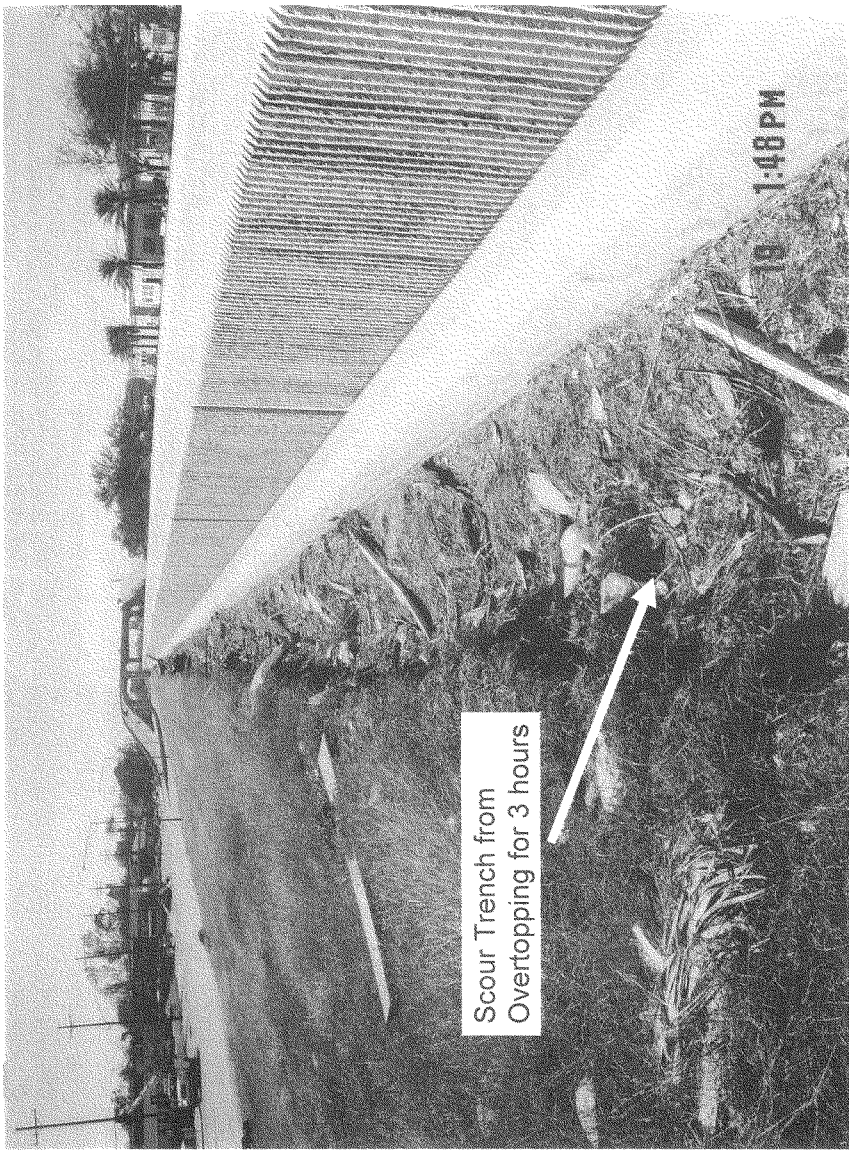
Scour Trench from
Overtopping for 3 hours
1:48 PM

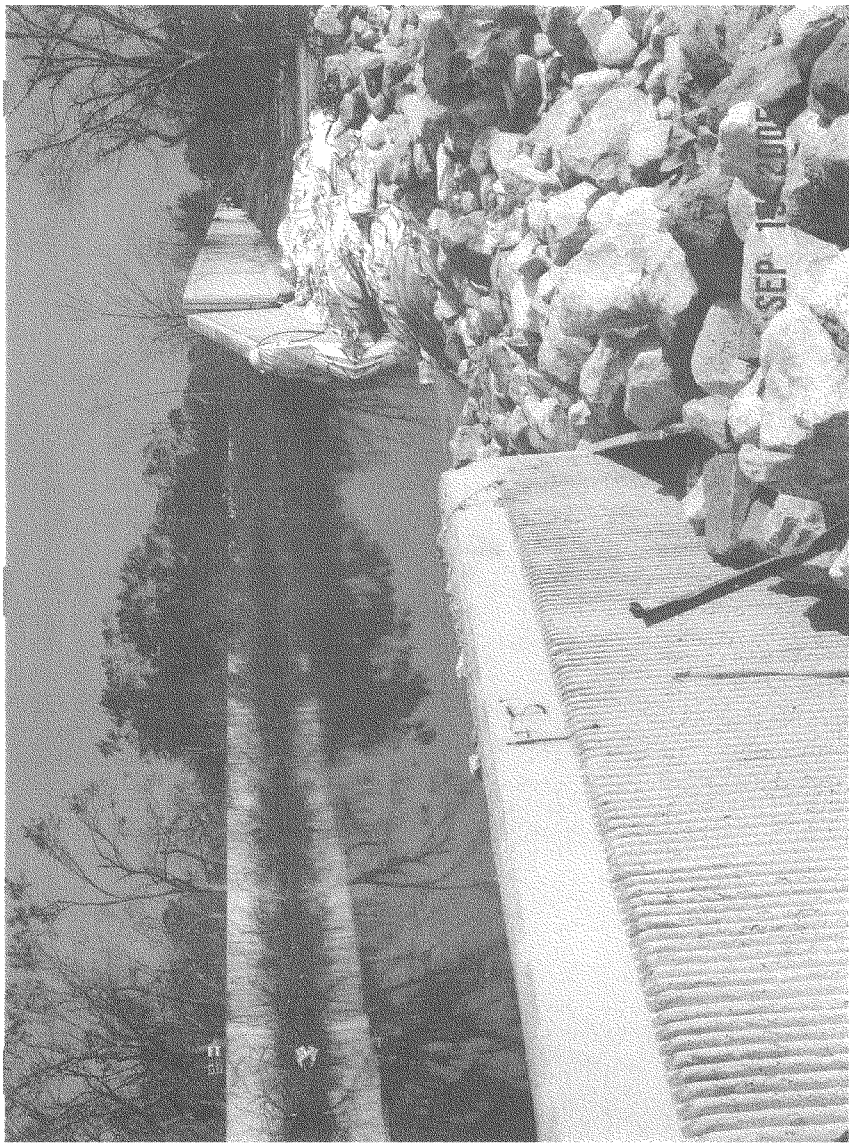
Mirabeau Break on London Ave.
LOTS OF SAND!
10. 06. 2005.

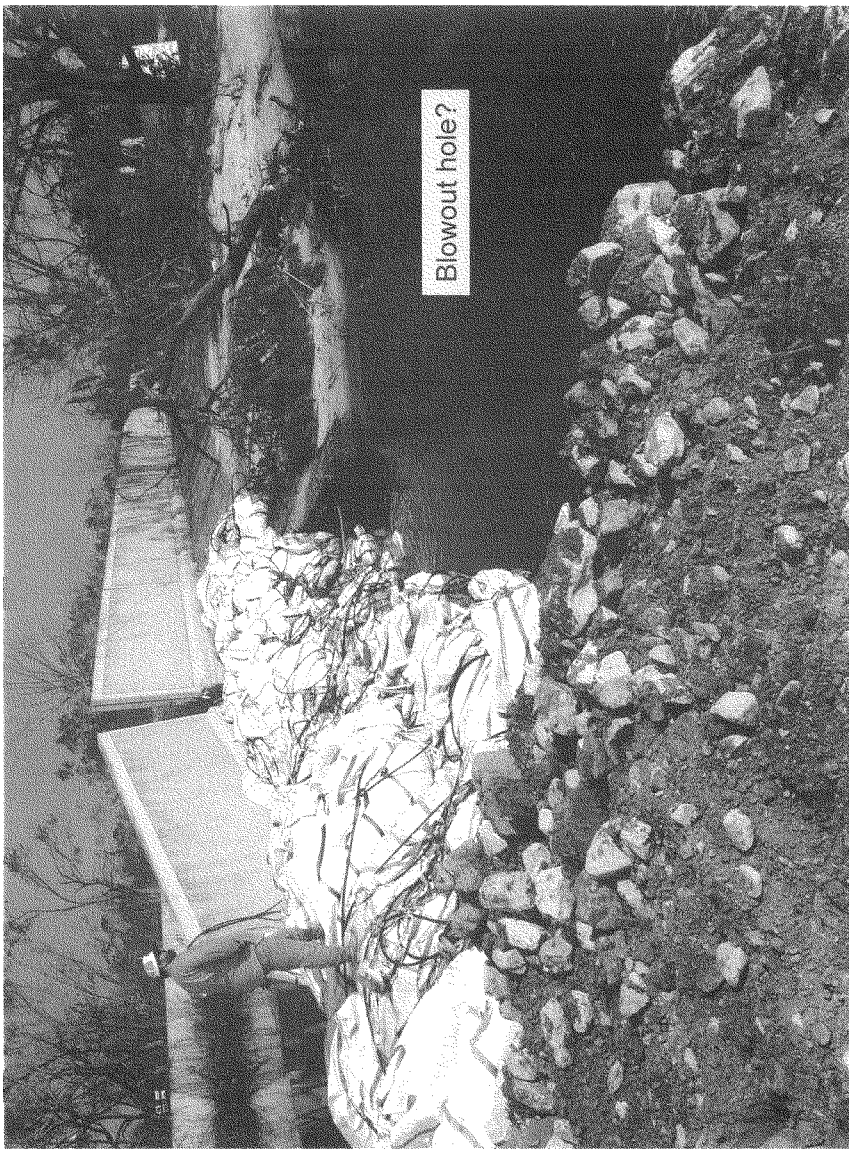
Blowout hole?

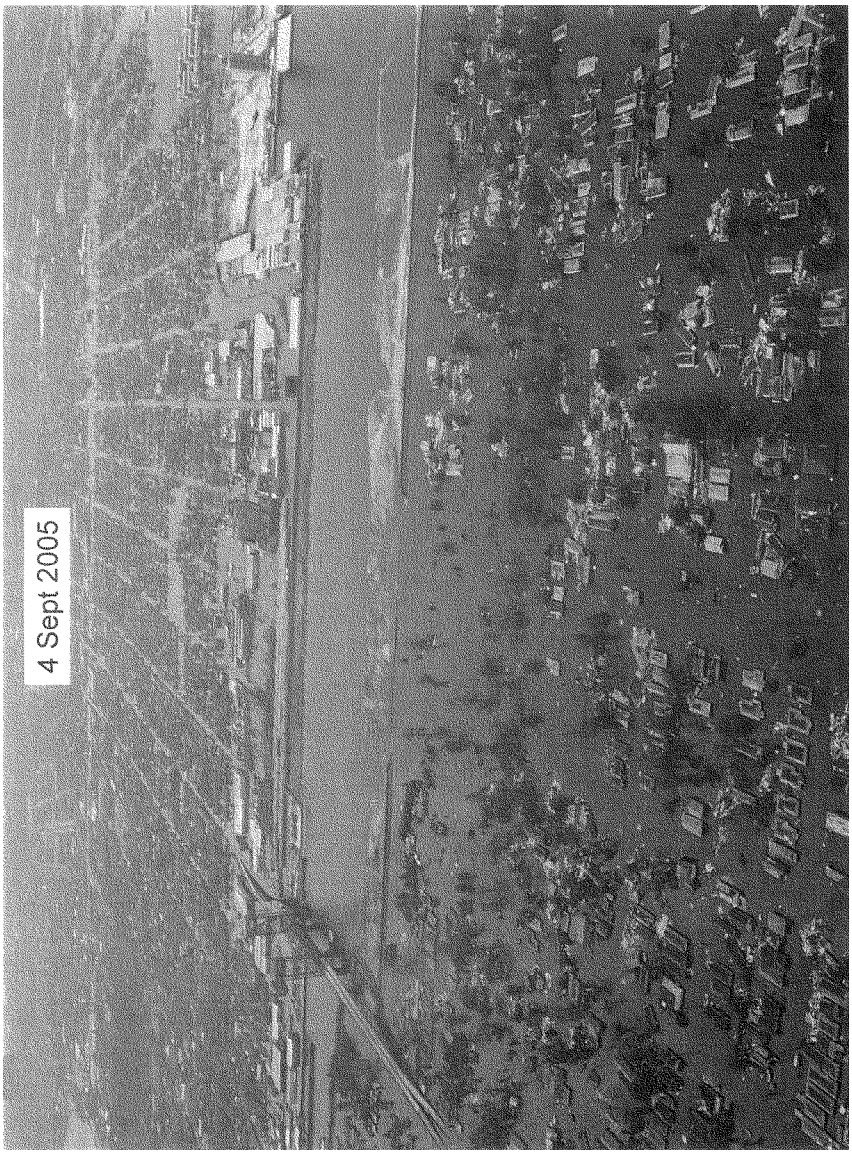
Levee Failure on East Side of Industrial Canal
09.02.2005

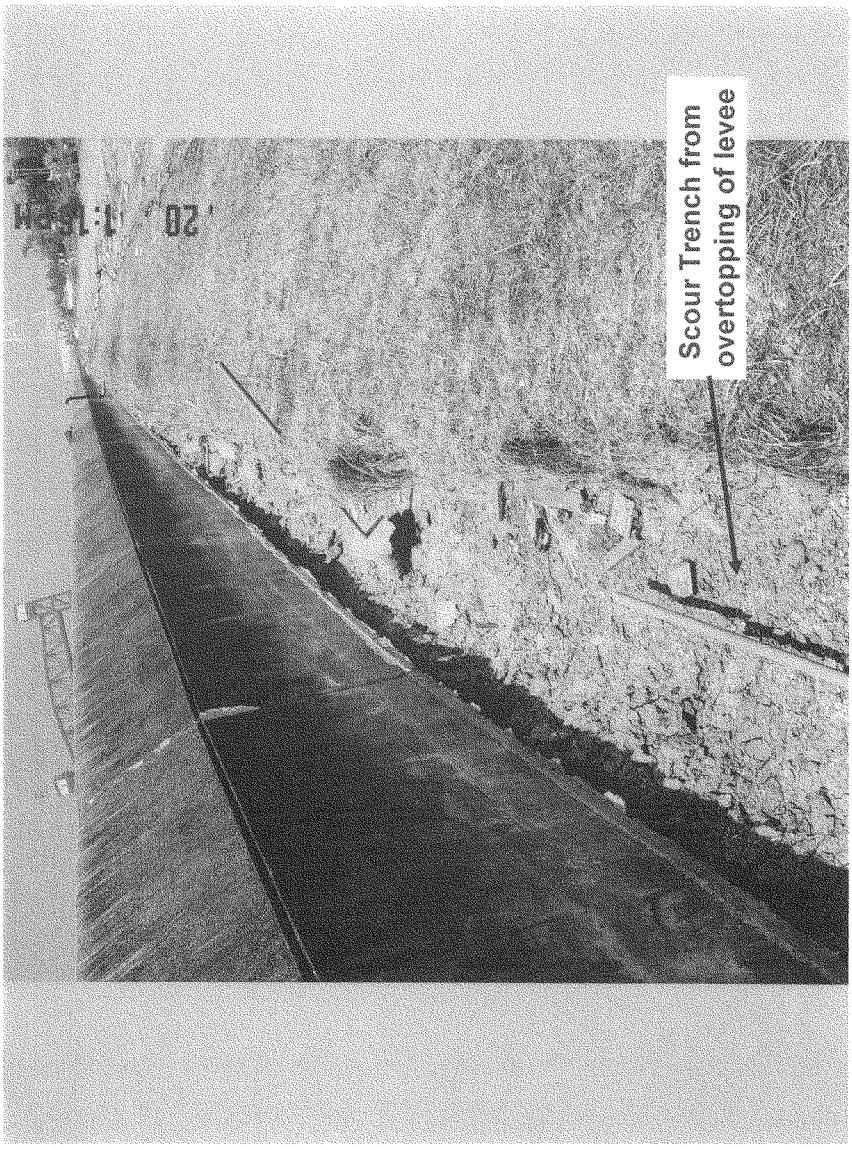
Scour Trench from
overtopping of levee

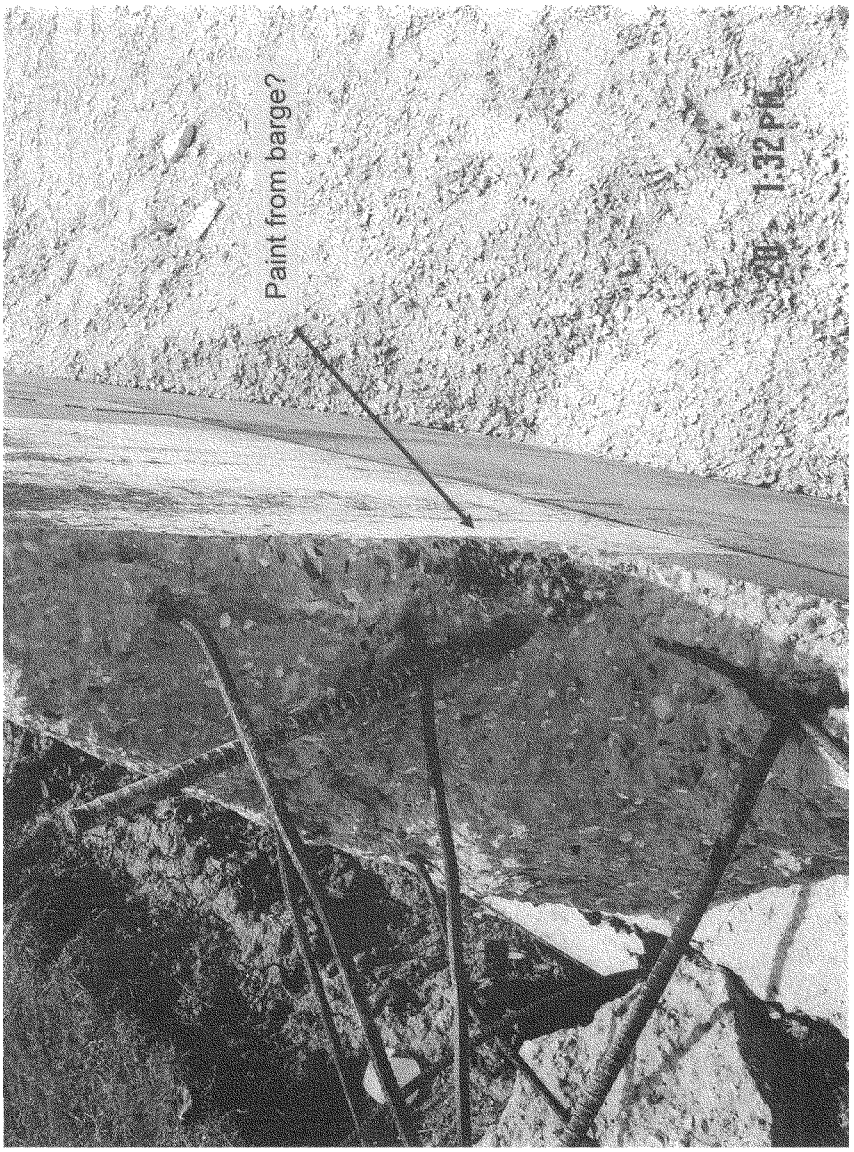
Paint from barge?
Sep 1, 32 PM

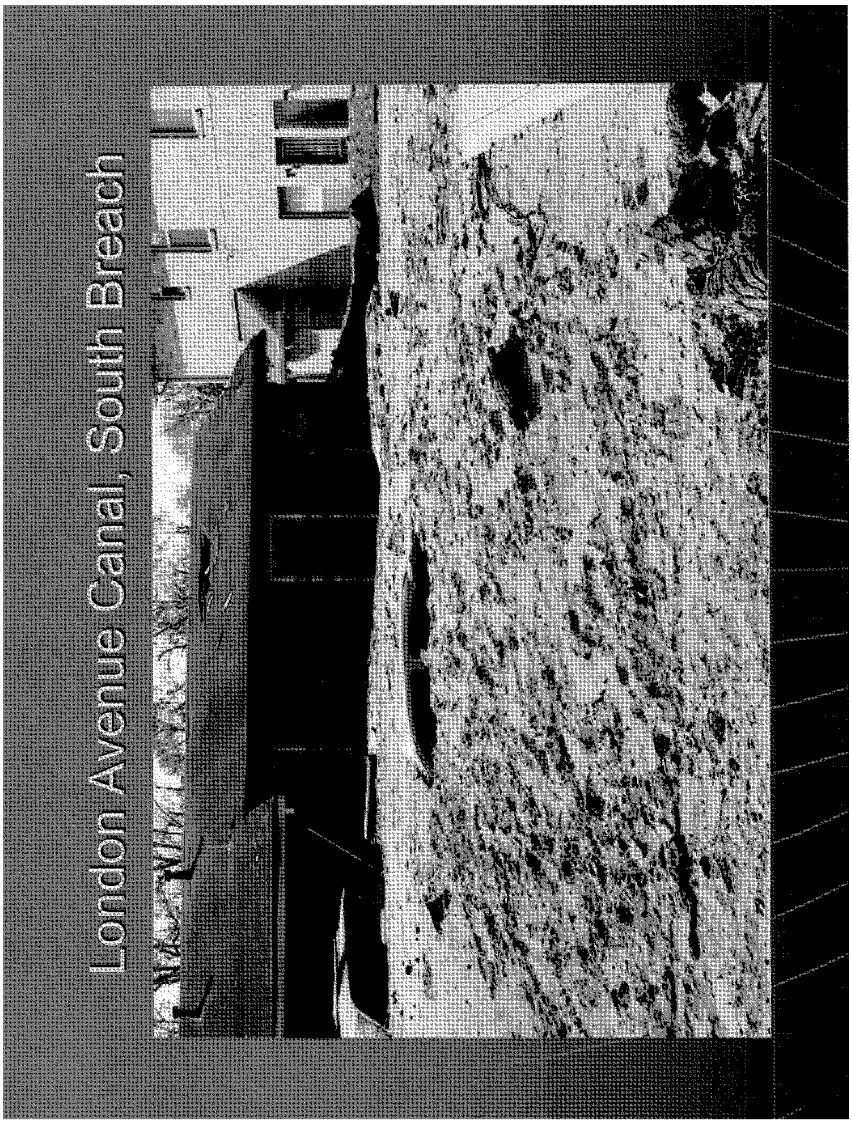
London Avenue Canal, South Breach

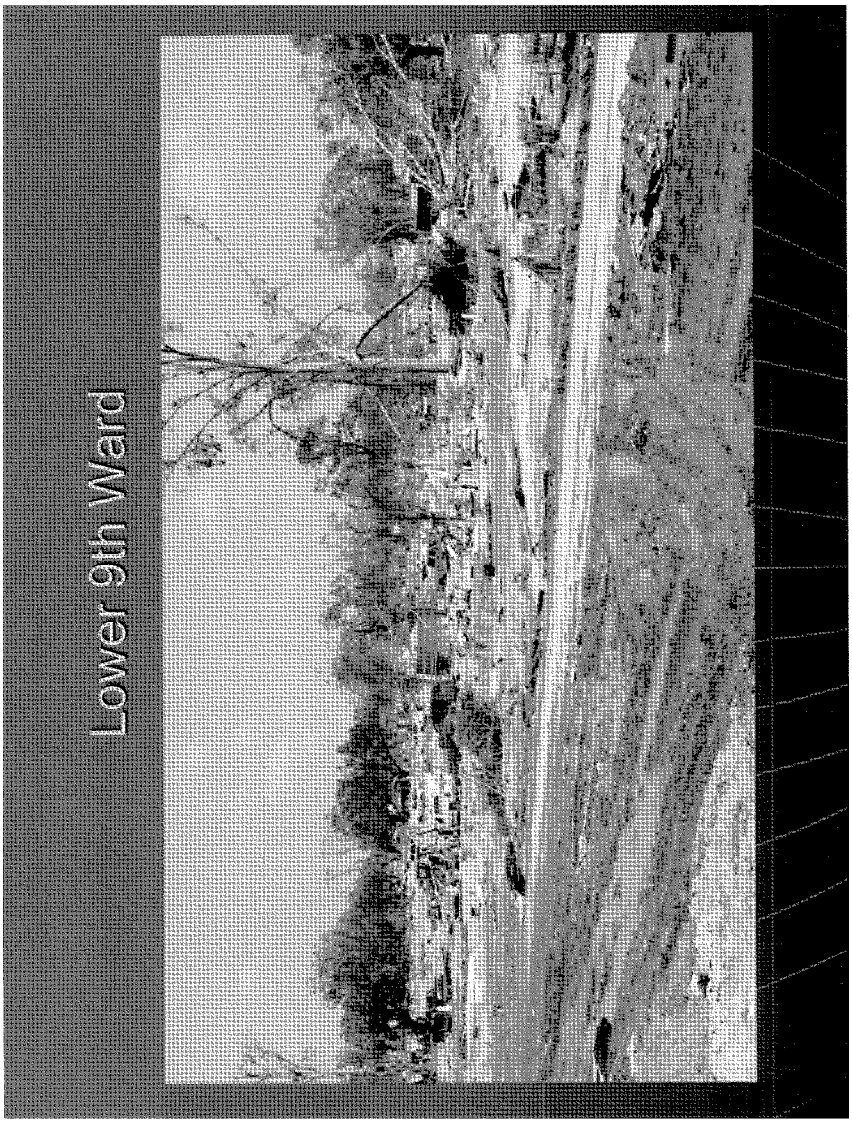
Lower 9th Ward

Inner Harbor Navigation Channel
Back Scour at Lower 9th Ward

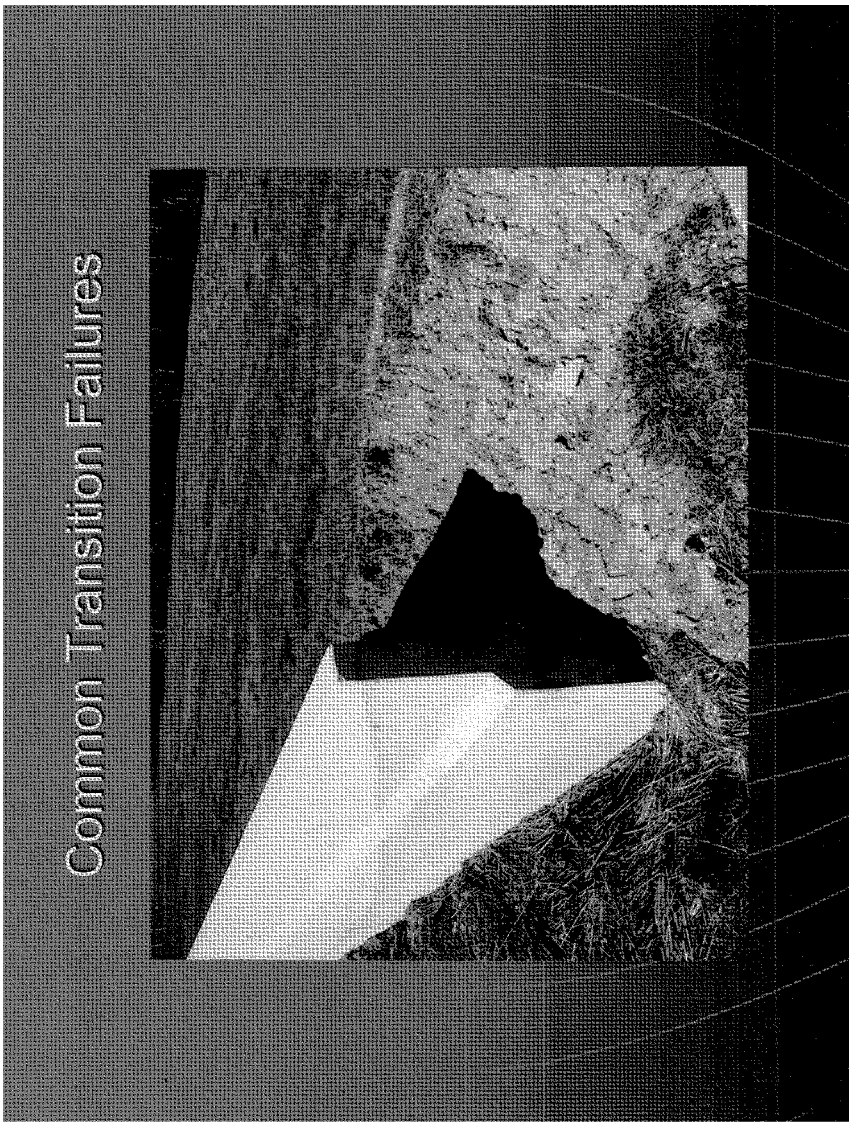
Common Transition Failures

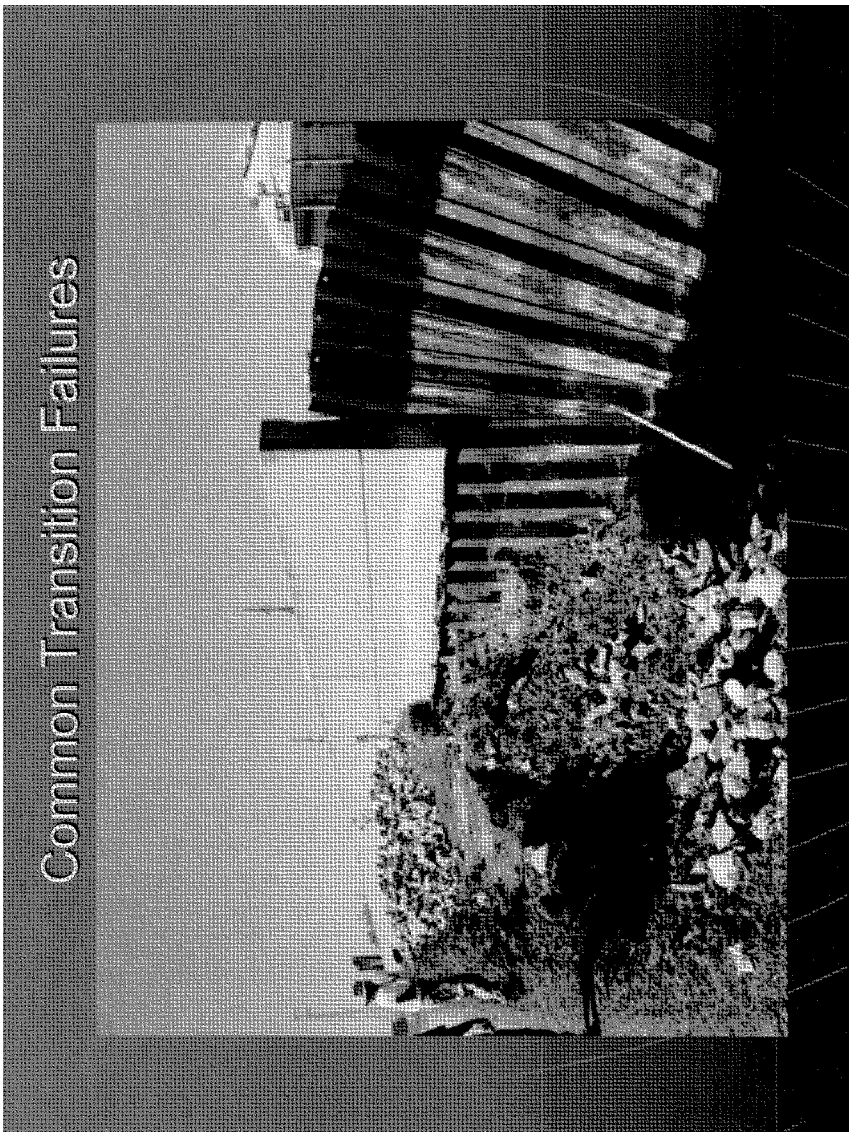
Common Transition Failures

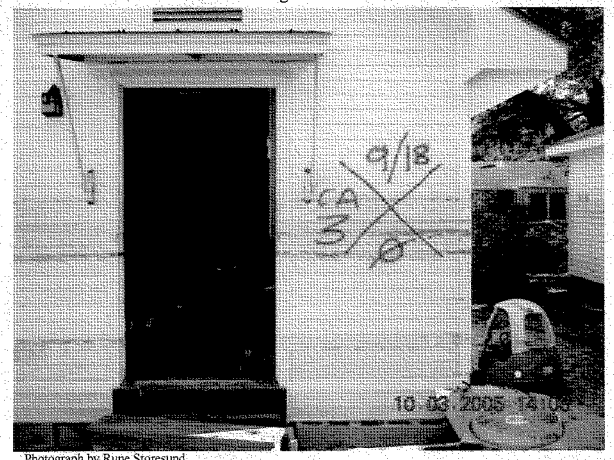
Figure 1.8: High water marks remain on structures after temporary levee repairs have been completed and flood waters have been pumped out.

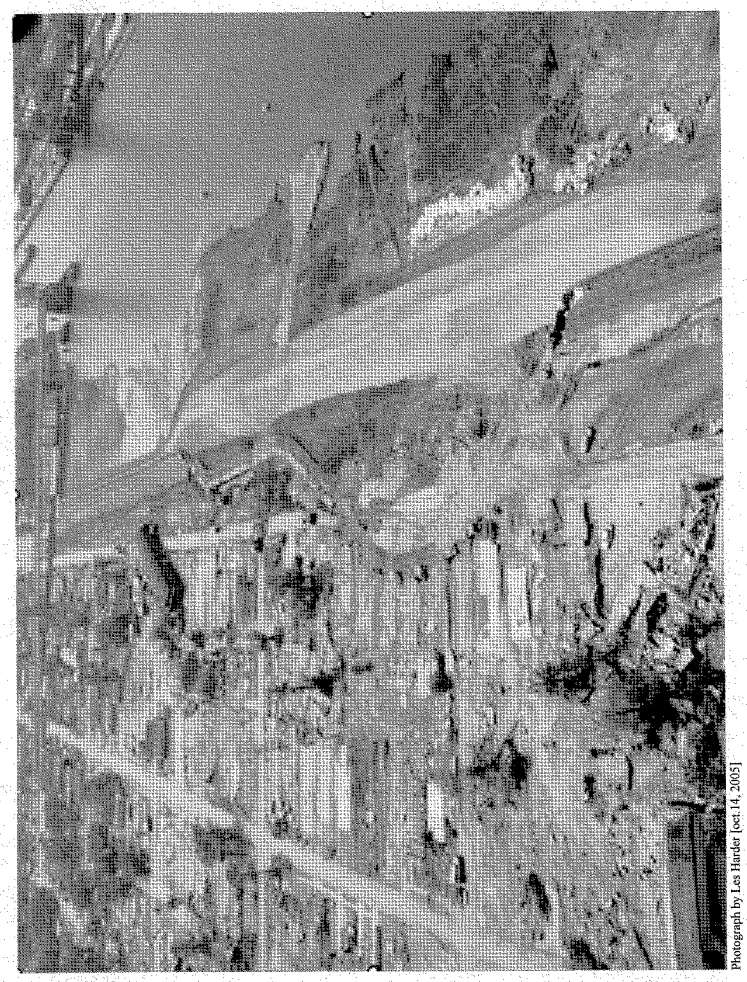
Figure 1.9: Oblique view of the (south) levee break at the Inner Harbor Navigation Canal into the lower Ninth Ward.

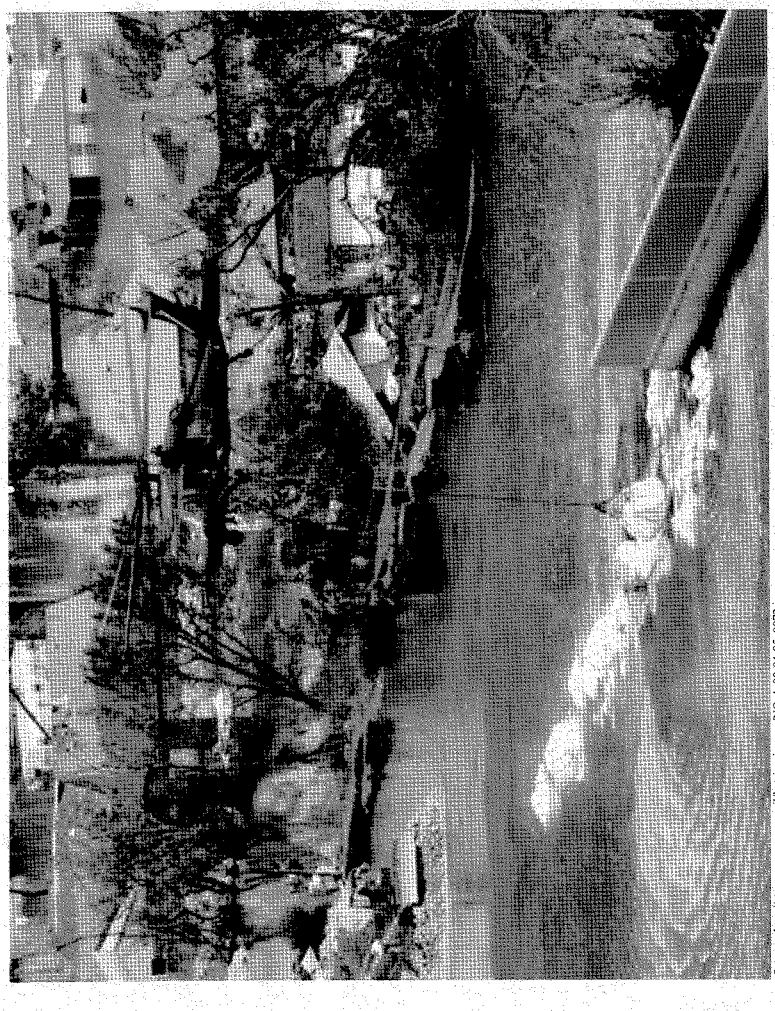
Figure 2.3(a): The 17th Street Canal breach during initial breach closure.

Figure 2.3(a) shows the major breach at the east side of the 17th Street Canal as it is being "plugged" with large sandbags being delivered by military helicopters in the wake of Hurricane Katrina. This photo is taken looking to the northeast. Figure 2.3(b) shows the same figure, but this time highlighting key features for discussion. The line of grassy soil units in the center of the photo are the inboard half of the southern end of the original levee embankment, and the chain link fence is remnants of the fence that passed along the inboard lip of the crest road, separating the crest from adjacent homeowner's back yards. The southern end of the embankment has translated to the east, traveling laterally up to about 45 feet away from its original position. The northern end of the breached embankment section was largely eroded by scour after the breach opened.

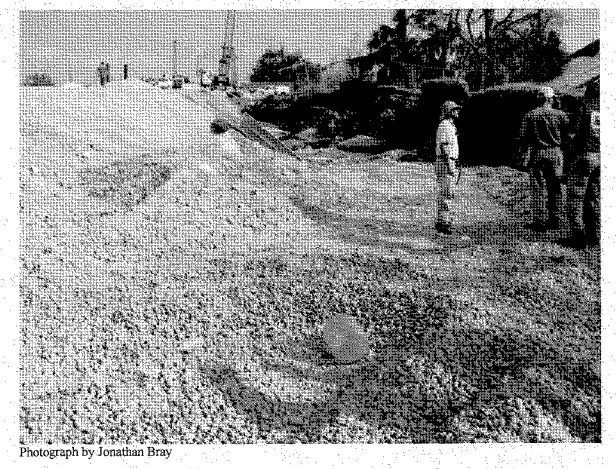
Figure 2.4: View of the 17th Street breach section from the south.

Figure 2.4 shows a second view of some of the details at this site. The relatively intact southern embankment sections translated laterally approximately 45 feet, and without significant rotation, as the trees and chain link fence remained vertical throughout this displacement. The laterally translating wedge of embankment (and possibly also some foundation) soil "plowed" into soft soils at the inboard toe, causing them to bulge upwards, heaving the largely collapsed shed and pushing it into the house.

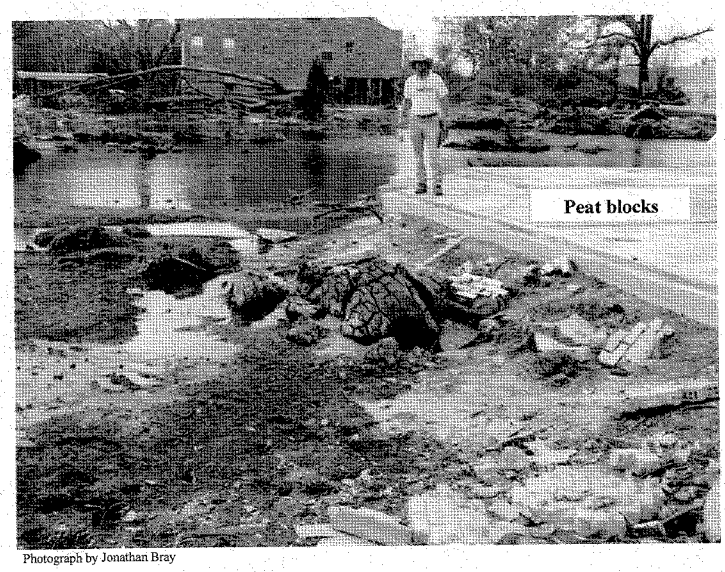
Figure 2.5: View from crest of emergency embankment closure section at the 17th Street Canal breach, looking south across the floodwater scoured zone.

Figure 2.5 shows a view looking east across the zone through which the principal floodwaters flowed. Clearly evident in this photo are large blocks of peat scoured from the eroding foundation by the floodwaters.

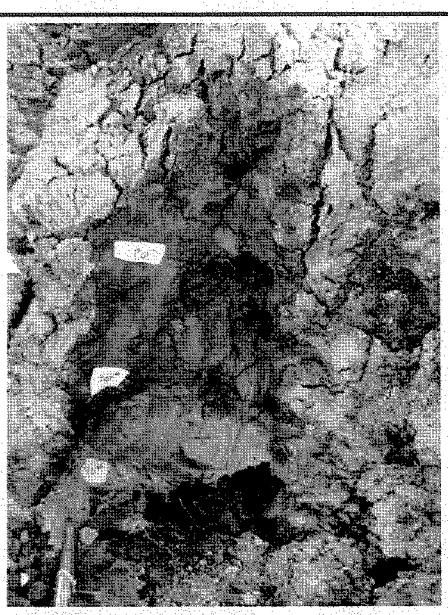
Figure 2.8: Location at which clay seam interbedded within the peat at the toe of the translated levee embankment was sampled.

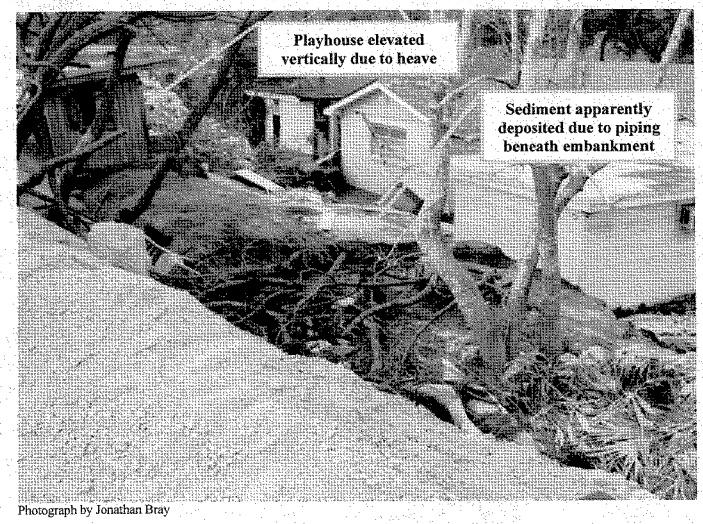
Figure 2.15: The breach section at the west side of the London Avenue Canal (North).

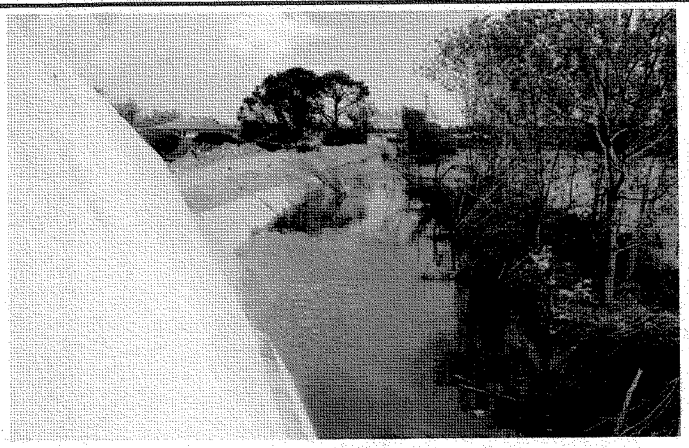
Figure 2.16: Conditions at the inboard toe of the London Avenue Canal (North) breach section.

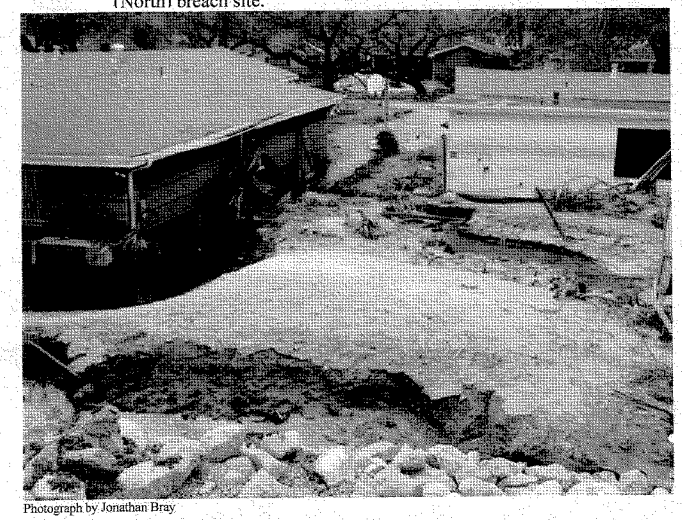
Figure 2.17: The toppled floodwall/sheetpile walls at the London Avenue Canal (North) breach site.

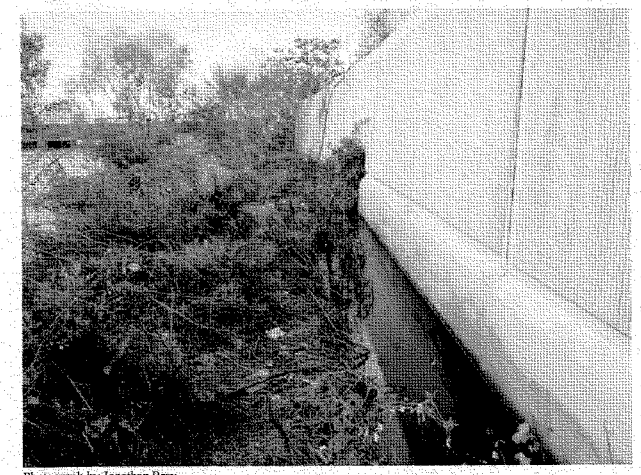
Figure 2.18: Sediment from the London Avenue Canal was deposited inboard of the levee break. High water marks (from long-term ponding) are visible on the exteriors of the residential homes.

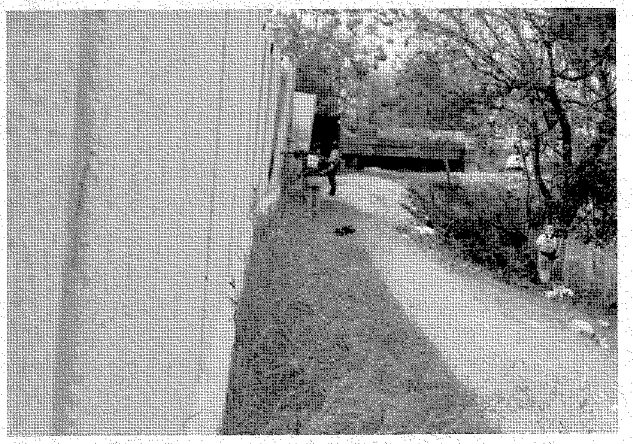
Figure 2.19: Gap at the base of the floodwall on the canal side of the East Bank "distressed" section.

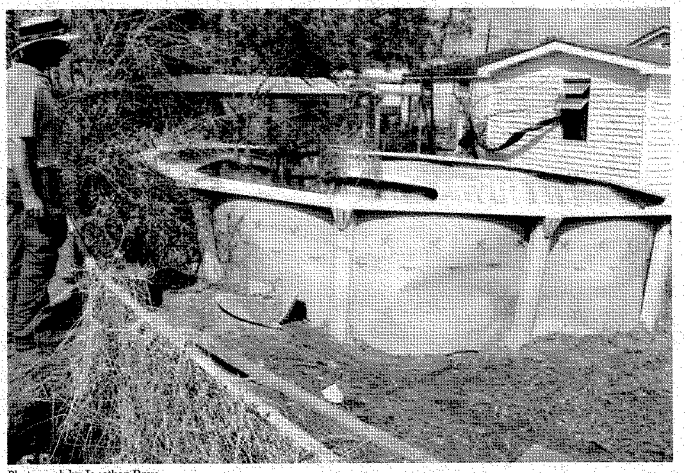
Figure 2.21: Closeup view of sinkholes at the inboard toe of the floodwall, at the location of the engineer wearing a red shirt in Figure 2.20.

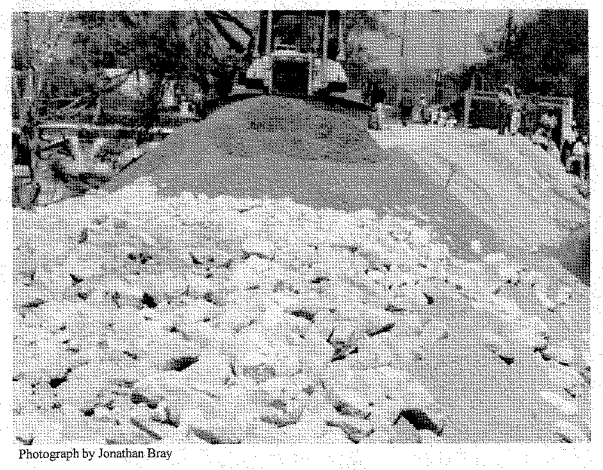
Figure 2.22: View of conditions at the inboard toe, immediately inboard of the locations shown previously in Figures 2.21 and 2.22. Note the bulged and hummocky ground, the laterally displaced chain link fence, and the piping boil ejecta.

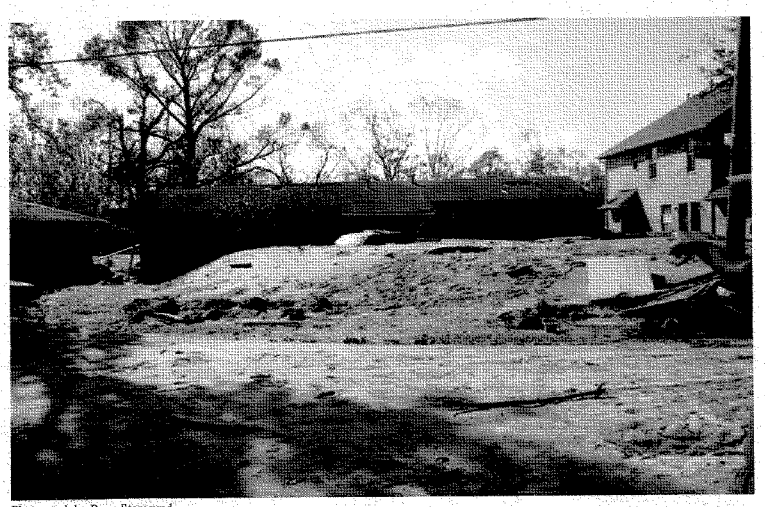
Figure 2.25: View of the crest of the temporary embankment closure section at the London Avenue Canal (South) breach.

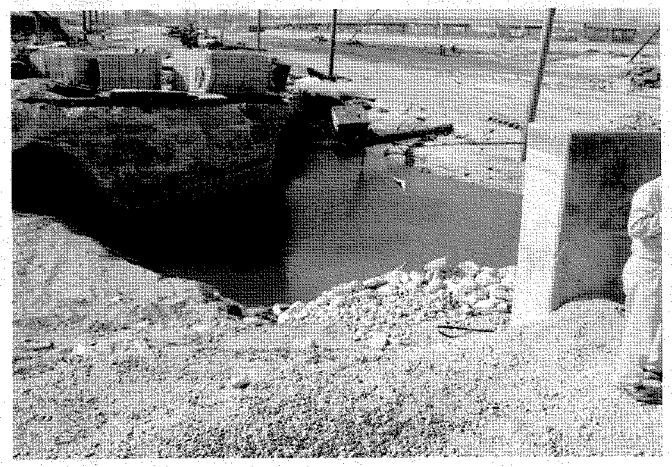
Figure 2.28: Erosion at the inboard toe of concrete floodwalls at Location "A" along the west side of the INHC, adjacent to the breached section shown previously in Figure 2.27.

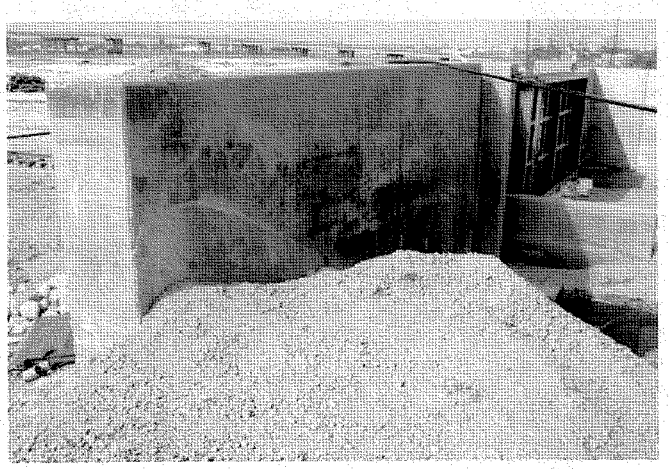
Figure 2.29: Erosion at a "transition" between a concrete floodgate wall and the adjacent earthen embankment section.

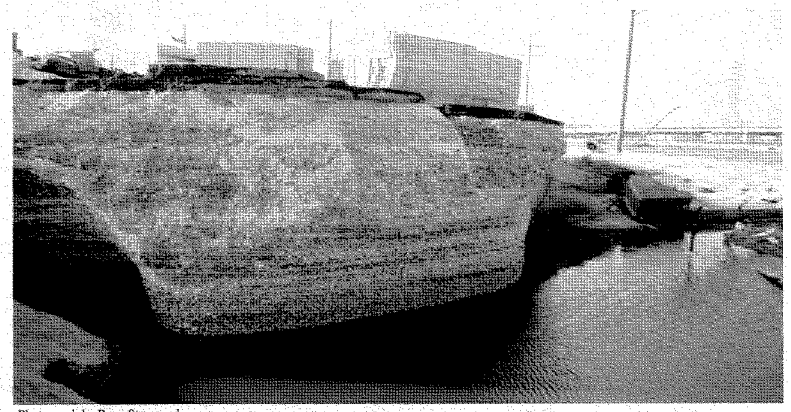
Figure 2.30: View of the structural wall and floodgate structure from Figure 2.29.

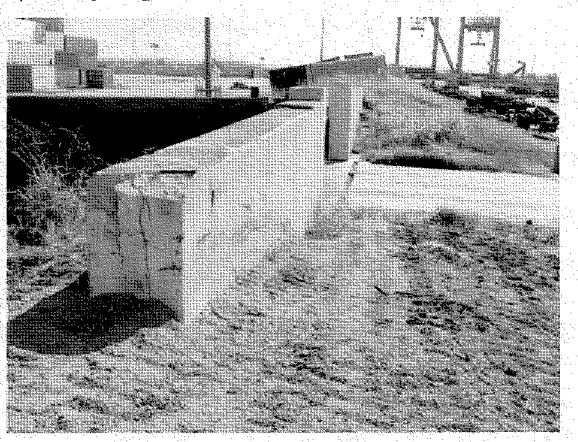
Figure 2.31: Close-up view of sandy "shell" fill at the scoured edge of the breach shown previously in Figure 2.29.

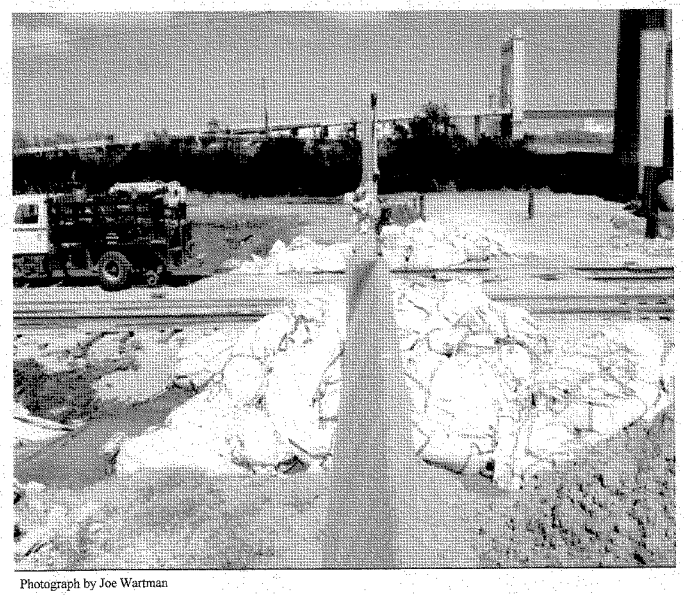
Figure 2.34: A complex "transition" involving several overlapping operations and penetrations through the flood protection levees immediately south of the I-10 bridge across the IHNC.

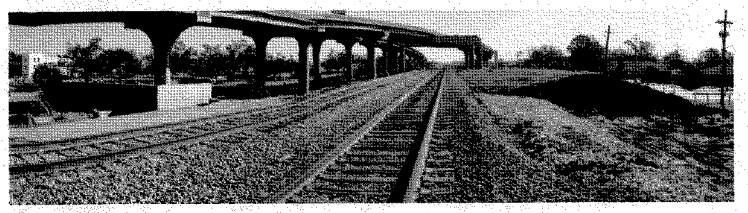
The Lakefront Airport is located at the northwest corner of the New Orleans East polder on Lake Pontchartrain near the entrance to the IHNC. Evidence of surge/wave overtopping was observed here along with a breach at a complex transition that combined levee sections of varying floodwall/levee heights and materials. Figure 3.2 shows a panorama

of this distressed transitional area. The problems observed here were: 1) a concrete floodwall higher than adjacent roadway over an earthen material adjacent to; 2) railroad tracks laid over highly pervious ballast, with tracks at approximately the same elevation as the top of the floodwall, adjacent to; 3) an earthen embankment levee. The breach that occurred at this location was, in fact, two breaches. One was a scour of the roadway section next to the higher concrete wall, while the other occurred through the embankment levee immediately south of the railroad embankment. It is difficult to assess the role the pervious ballast beneath the tracks played, if any, to the problems observed at this site.

Figure 3.2: Complex transition near Lakefront Airport consisting of various flood protection heights, differing materials and junctures between various jurisdictional organizations. These types of complex transitions were found to be associated with several of the levee flood protection problems.

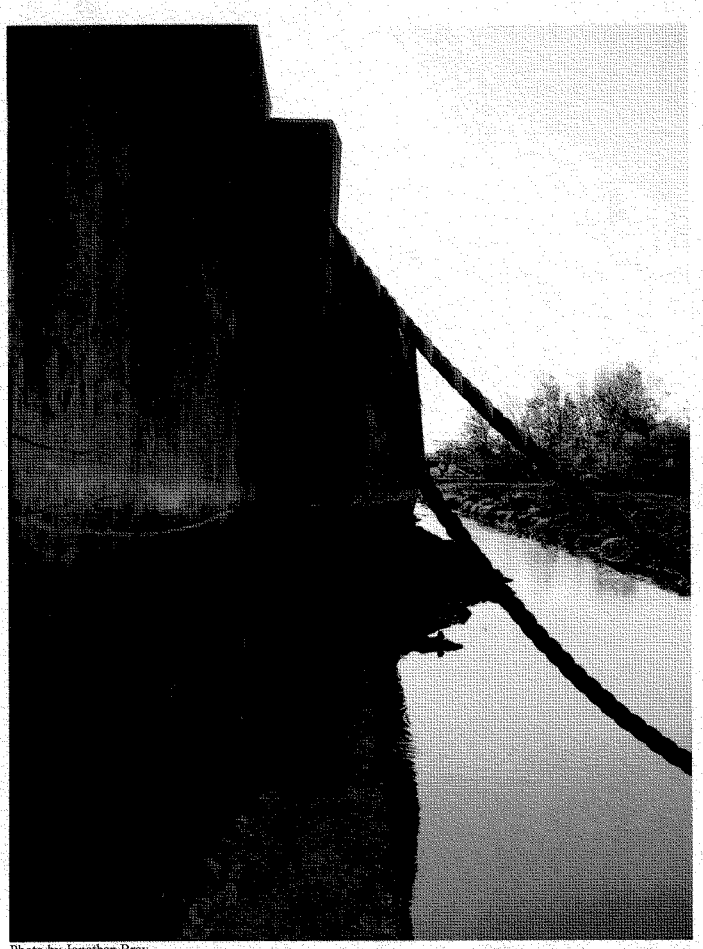
Figure 3.9: The lone surviving structure at Little Woods appears unscathed, except for the lack of stairs.

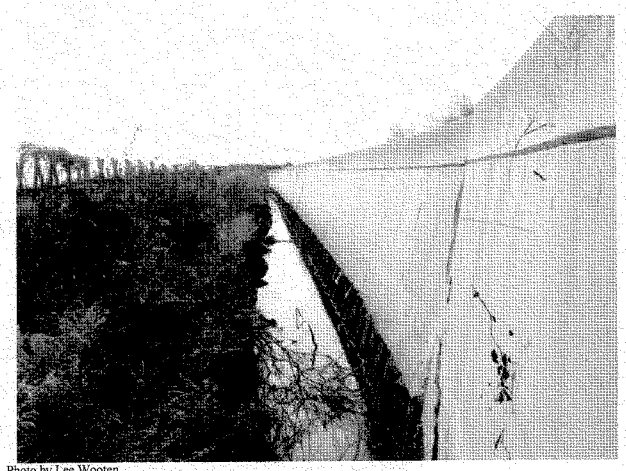
Figure 3.11: Severely distressed I-wall after overtopping from the water side along the IWW/MRGO.

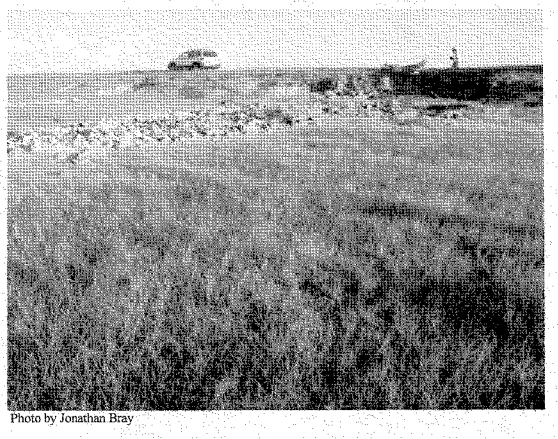
Figure 3.14: Aerial view of the failed wall section shown in Figure 3.14

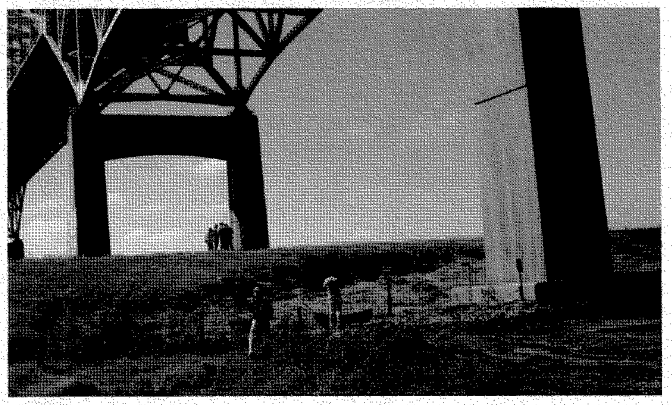
Figure 3.16: Virtually unscathed earth embankment levee on the eastern edge of the protected area of New Orleans East

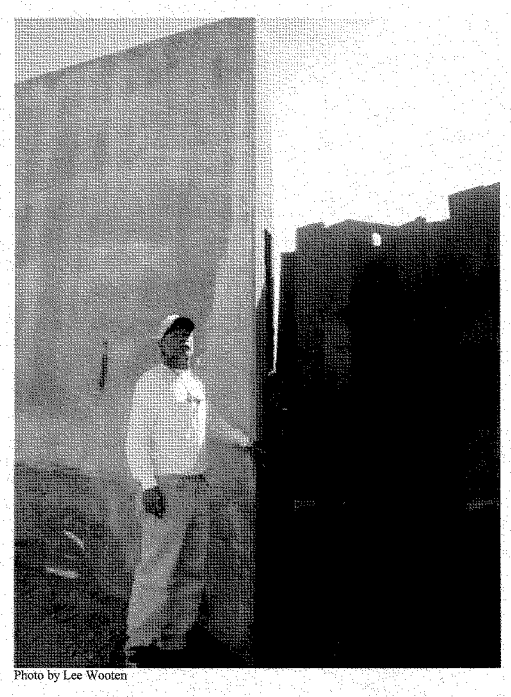
The earth levee along the north bank of the Intracoastal Waterway under the Route 47 Bridge stands as an example of satisfactory performance despite hydraulic conditions that far exceeded the design criteria. Figure 3.17 shows the erosion damage on the landside slope of the levee due to the overtopping. Figure 3.18, taken from the Entergy Michoud Generating Plant, shows the area in Figure 3.17 under storm conditions. Given the ferocity of the storm as evidenced in Figure 3.18, the relatively modest damage to the earth levee represents satisfactory performance.

Figure 3.18: Same view of the overtopped earth embankment as seen in Figure 3.18 taken during the storm surge.

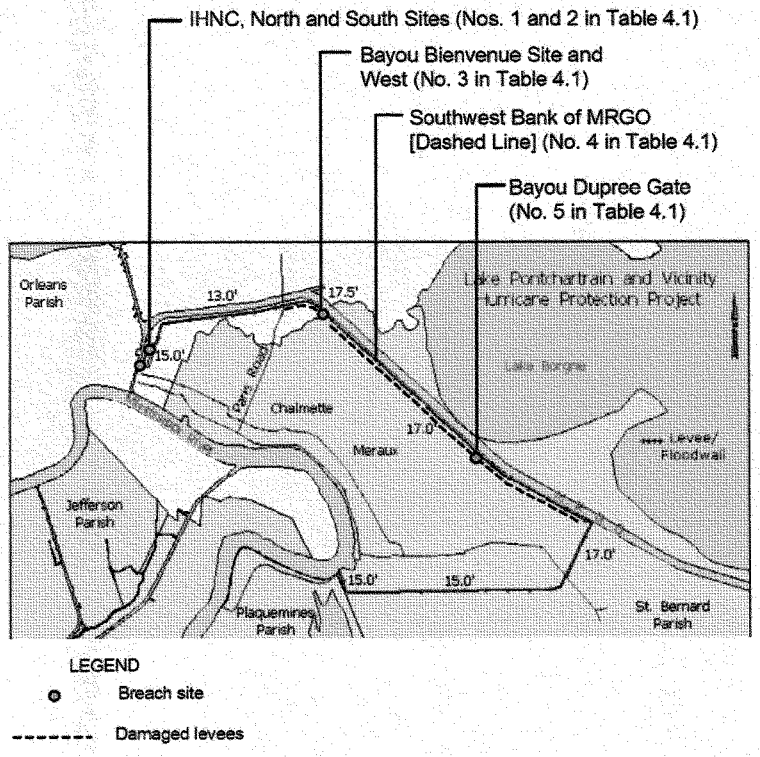
Figure 4.1: Overview map of the Lower Ninth Ward/St. Bernard Parish Polder showing the locations of damage to the primary levee system. Sites nos. 1 through 4 are summarized in Table 4.1. The elevations shown correspond to the top of the levee system at each location (after USACE).

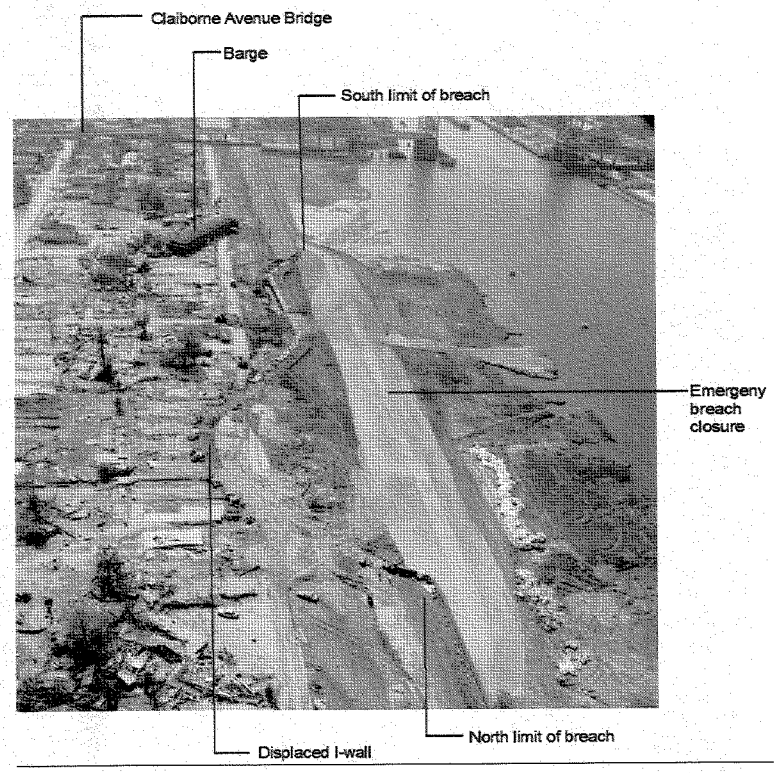
Figures 4.2 and 4.3 show aerial views of an approximately 900 feet long levee breach located 850 feet north of the Claiborne Avenue Bridge. The breach initially resulted from the Hurricane Katrina storm surge in the IHNC. An emergency repair was made shortly after the breach occurred. This repaired portion of the breach was later re-breached on September 24 by a storm surge caused by Hurricane Rita, which flooded the Lower Ninth Ward for a second time. This second flooding incident was reportedly much less severe than that caused by Hurricane Katrina (floodwaters reached a depth of about 3 feet), and as such, it is likely that it caused relatively little, if any, additional damage to the levee system at this location.

In this area, the earthen portion of the levee was almost completely destroyed and the I-wall was overturned toward the landside and dragged inland by as much as 190 feet. As shown in Figure 4.2, the displaced I-wall assumed a sinuous shape that reached its maximum distance along the northern extent of the breach. It is worth noting that the sheet pile remained interlocked, hence the displacement resulted from elongation of the sheet pile portion of the I-wall structure. The unbreached portions of the I-wall system located immediately north and south of the failure were tilted landward, reaching their maximum inclination of approximately 3 degrees near the breach and gradually tapered to close to vertical at further distances from the breach. Scour trenches at the landside toe of the floodwall (protected side) were found along the entire length of the intact I-wall section. The scour trenches were typically about 5 feet wide at the top and extended to depths of approximately 4 feet. The scour trenches were generally wide and U-shaped near the breach and gradually became narrower, V-shaped and incised with at further distances from the breach (Figure 4.4).

Figure 4.2: Aerial view of the south breach at the Lower Ninth Ward (L. Harder, October 14, 2005).

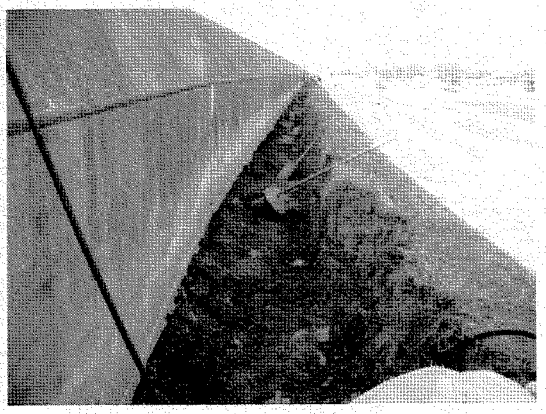
Figure 4.4: North view from the end of the south breach of Lower Ninth Ward. Note how the scour trench becomes progressively wider as it approaches the breach (J. Wartman, October 4, 2005).
