HURRICANE KATRINA: WHY DID THE LEVEES FAIL?

COMMITTEE ON HOMELAND SECURITY AND GOVERNMENTAL AFFAIRS UNITED STATES SENATE

NOVEMBER 2, 2005

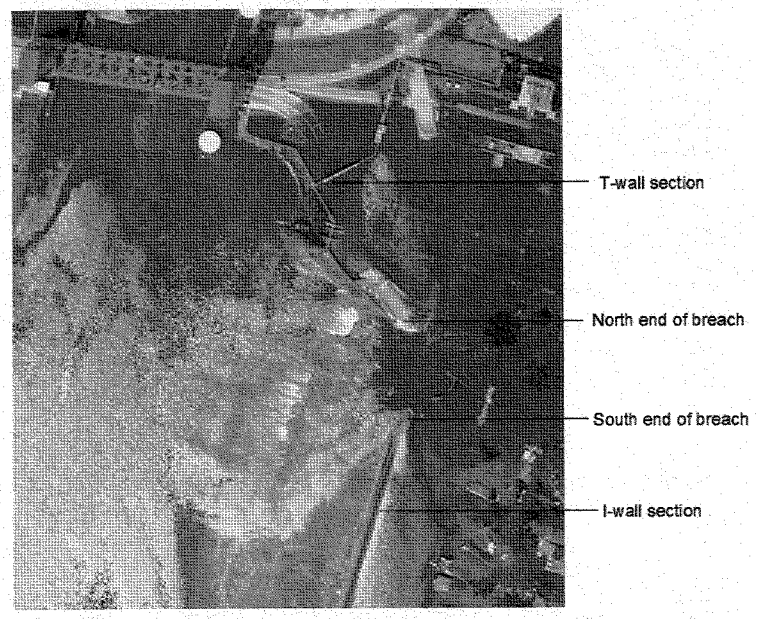
Figure 4.7: Airborne digital imagery of the north breach at the Lower Ninth Ward. Water is shown flowing back into the IHNC (courtesy NOAA, August 31, 2005).

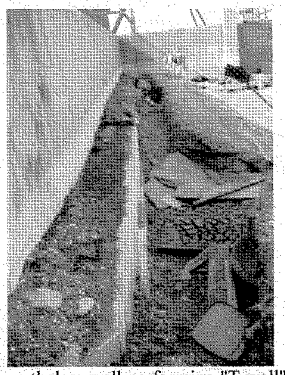
The unbreached portions of the I-wall system located immediately south of the failure were tilted inward (landward). The tilted I-walls reached their maximum inclination of approximately 3 degrees near the breach and gradually tapered to close to vertical at further distances to the south. Scour trenches at the landside toe of the floodwall (protected side) were found along the entire length of the intact I-wall section. The scour trenches were typically about 5 feet wide at the top and extended to depths of approximately 3 to 4 feet. As with the south breach, the scour trenches were wide and u-shaped near the breached area and gradually became narrower, v-shaped and incised at greater distances. Scour was also noted along the landside of the T-wall levee sections (Figure 4.8).

Figure 4.8: A scoured, but nevertheless well-performing "T-wall" levee section located near the north breach of the Lower Ninth Ward (J. Wartman, October 4, 2005).

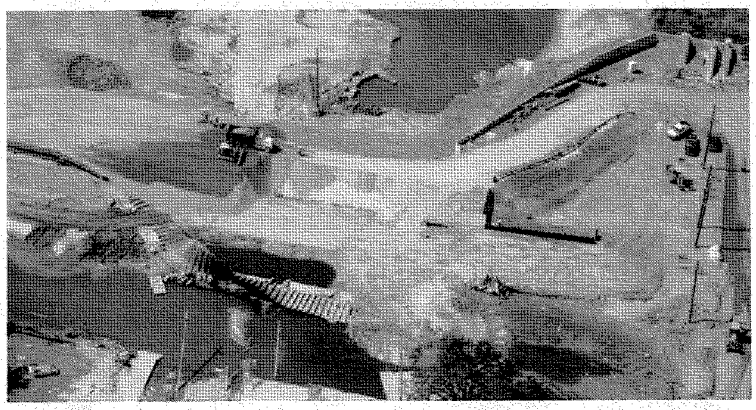
Figure 4.9 shows an aerial view of a 210 foot long levee breach located approximately 500 feet south of Florida Avenue. The breach initially resulted from the Hurricane Katrina storm surge in the IHNC. An emergency repair was made soon after. It is reported that unlike the south breach location, the north breach emergency repair was not overtopped in Hurricane Rita The earthen portion of the I-wall levee system was almost completely destroyed and the I-wall was overturned and dragged inland by as much as 70 feet while remaining fully interlocked. In the most extreme case, the I-wall came to rest upside down, with the concrete portion at the bottom, and the toe of the sheeting pointing upward (Figure 4.10). The sheet pile separated from the concrete wall at the north end of the site by splitting the webbed section rather than tearing the interlock.

Figure 4.9: Aerial view of the north breach of the Lower Ninth Ward (L. Harder, October 14, 2005).

Figures 4.9 and 4.11 show the emergency repair, consisting of a core of large sandbags overlain by embankment fill. The sandbags were airlifted into place, while the stone was placed from land. Owing to the presence of standing water on the landside during a visit on October 4, it was not possible to determine if seepage was occurring through the repaired section.

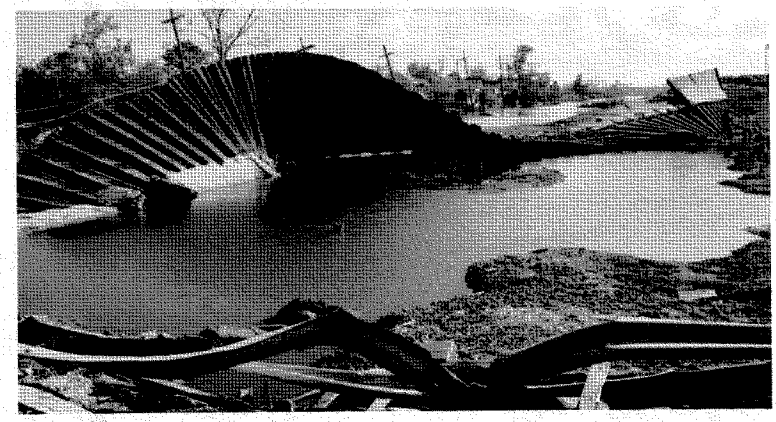
Figure 4.10: Overturned I-wall system at north breach of Lower Ninth Ward (J. Wartman, October 4, 2005).

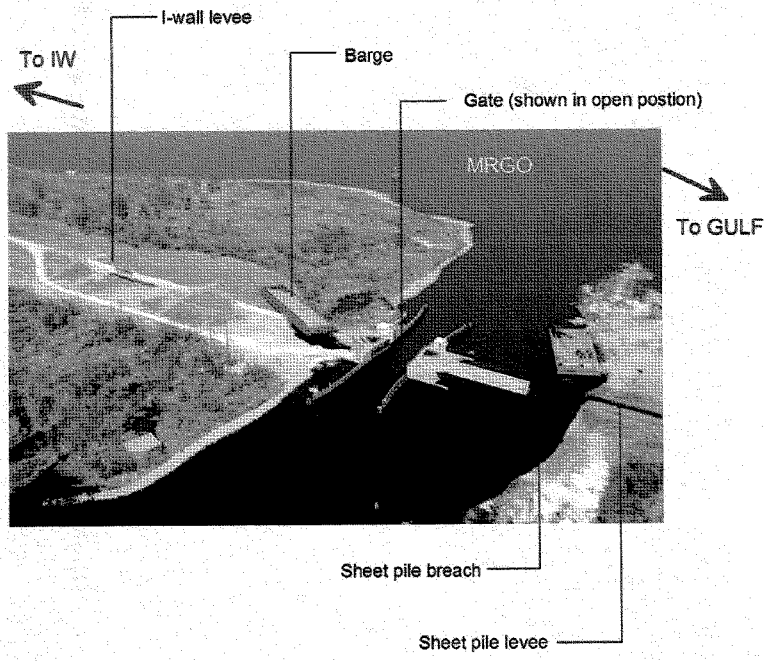
The flood protection system at the Bayou Bienvenue gate site is a complex levee-gate transition involving several different levee sections located as shown in Figure 4.12. These include (from northwest to southeast) an earthen levee, transitioning to an I-wall, transitioning to a gate structure, transition to a sheet pile section, which finally transitions again to an earthen levee along the MRGO.

Figure 4.12: Northwest facing aerial view of the Bayou Bienvenue Gate structure (L. Harder, October 14, 2005).

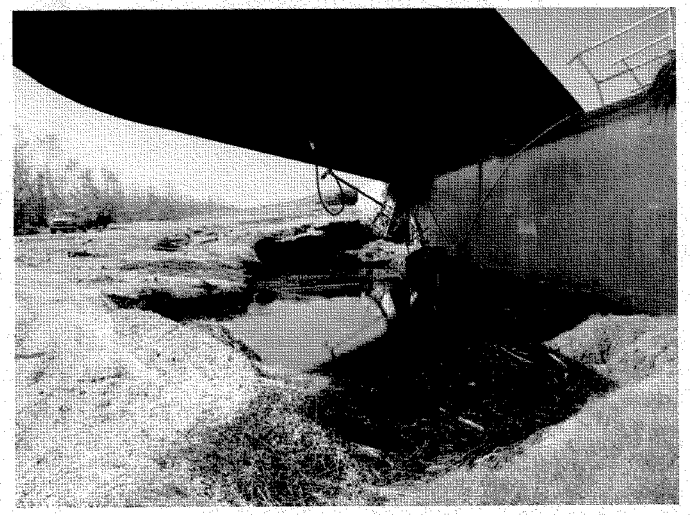
Figure 4.13: Sheet pile breach at the Bayou Bienvenue Gate (J. Wartman, October 5, 2005).

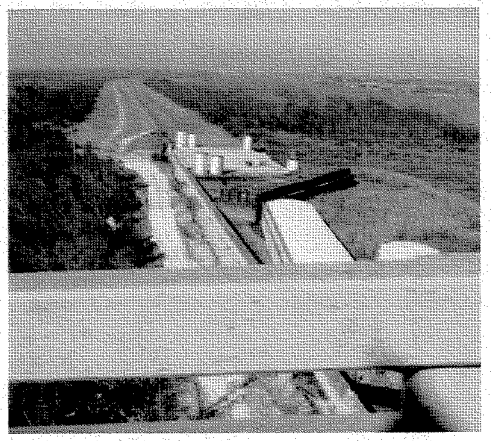
Figure 4.15: Scour near Bayou Bienvenue Gate site (L. Wooten, October 5, 2005).

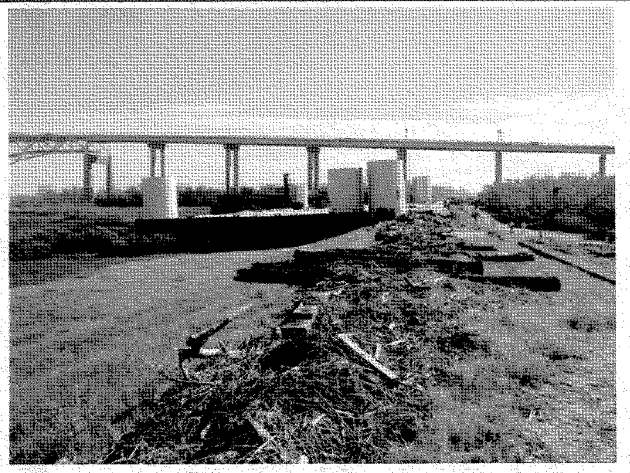
Figure 4.17: Debris line near levee crest just west of the Rt. 47 Bridge south abutment (L. Wooten, October 5, 2005).

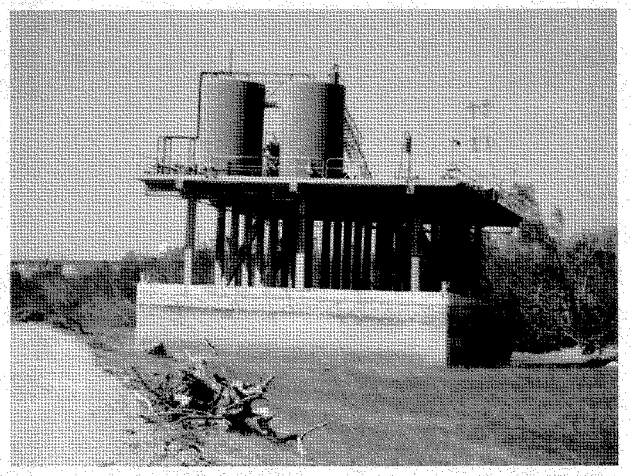
Figure 4.18: Various barges and other floating structures made contact with the earth levees without causing significant damage. Photo shows a gas processing barge (F. Silva, October 1, 2005).

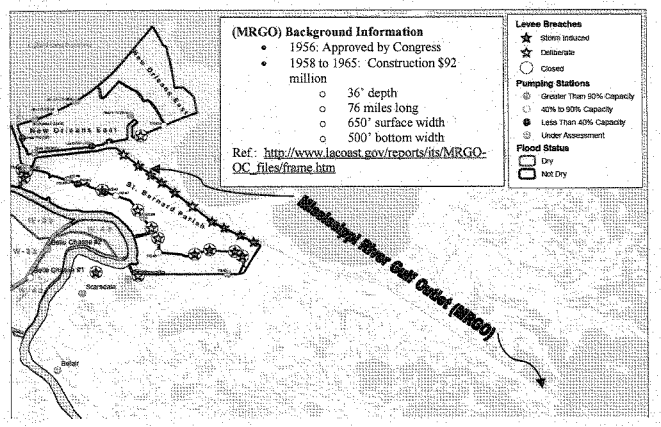
Figure 4.19: Mississippi River Gulf Outlet [MRGO] (USACE). The two yellow stars (i.e., deliberate breaches) along MRGO seem to correspond to locations of gate structures where storm-induced breaches occurred. These yellow stars markers are likely errors in the original map that should have been designated using blue star markers.

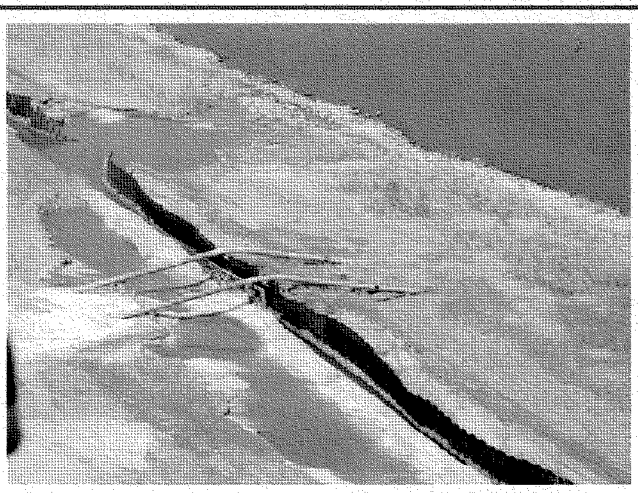
Figure 4.20: Failure of earth levee with steel sheetpile barrier on the southeast bank of the MRGO. Note severe erosion and scour (L. Wooten, October 6, 2005).

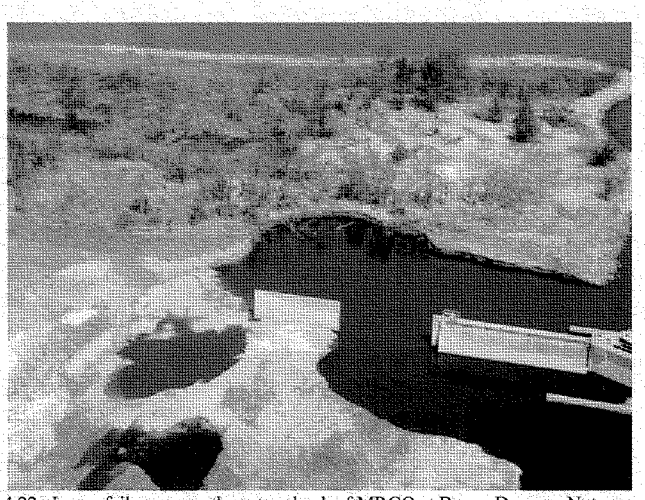
Figure 4.21: Levee failure on southwestern bank of MRGO between Bayou Bienvenue (where barge is aground on I-wall) and Bayou Dupree. Note severe erosion and scouring (L. Harder, October 14, 2005).

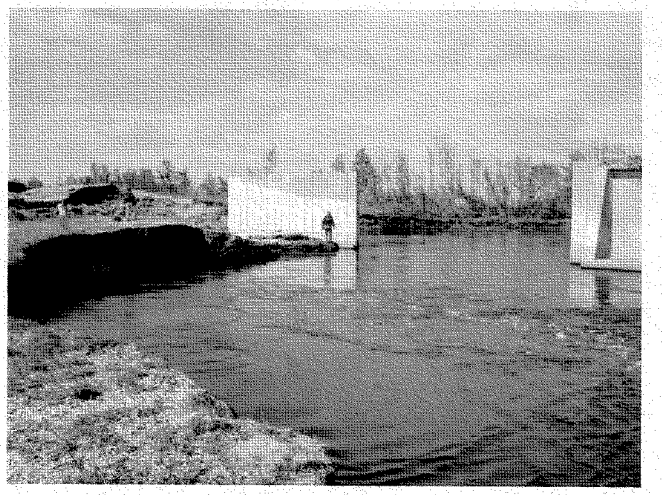
Figure 4.22: Levee failure on southwestern bank of MRGO at Bayou Dupree. Note concrete sheetpile and levee transition washouts (L. Harder, October 14, 2005).

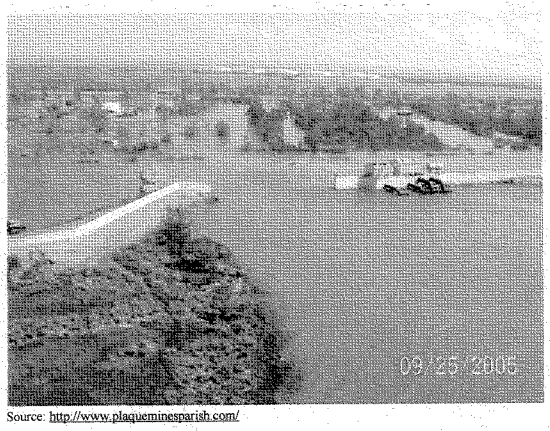
Figure 5.1: Aerial photograph of inundated portion of Myrtle Grove along western side of the Mississippi River (September 25, 2005)

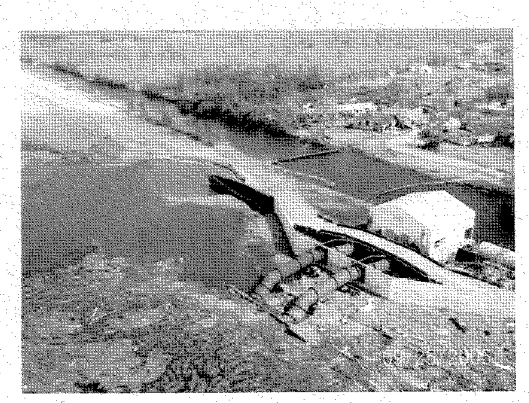
Figure 5.2: Aerial photograph of levee breach of hurricane (back) levee along western side of the Mississippi River near the community of Sunrise (September 25, 2005)

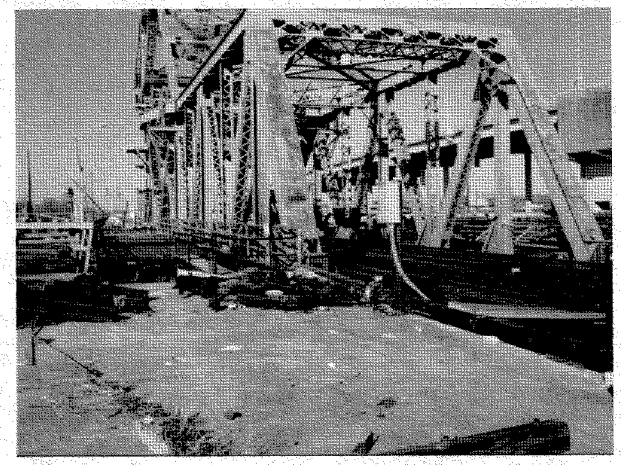
Figure 6.1: A railroad bridge adjacent to the Lake Pontchartrain frontage road.

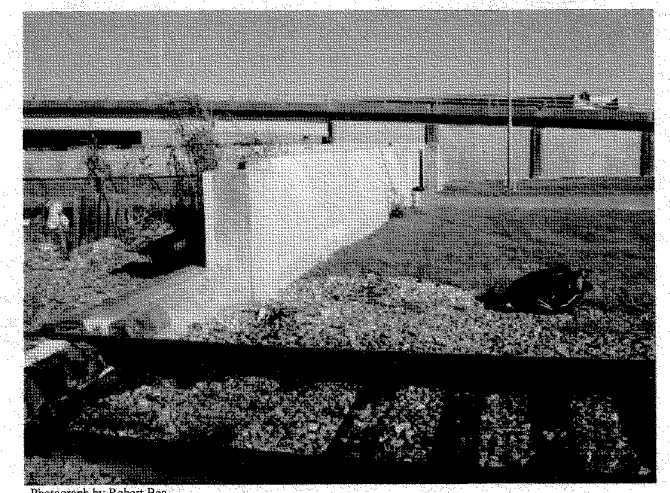
Figure 6.2: Lack of a floodgate at the railroad line crossing resulted in scour around the railroad tracks. No overtopping was observed the floodgate across the adjacent roadway.

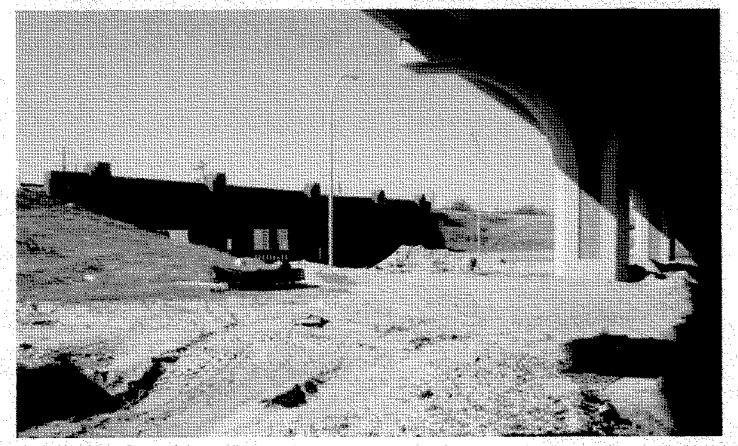
Figure 6.3: Lack of a flood gate beneath the railroad over-crossing facilitated the flooding of residential neighborhoods.

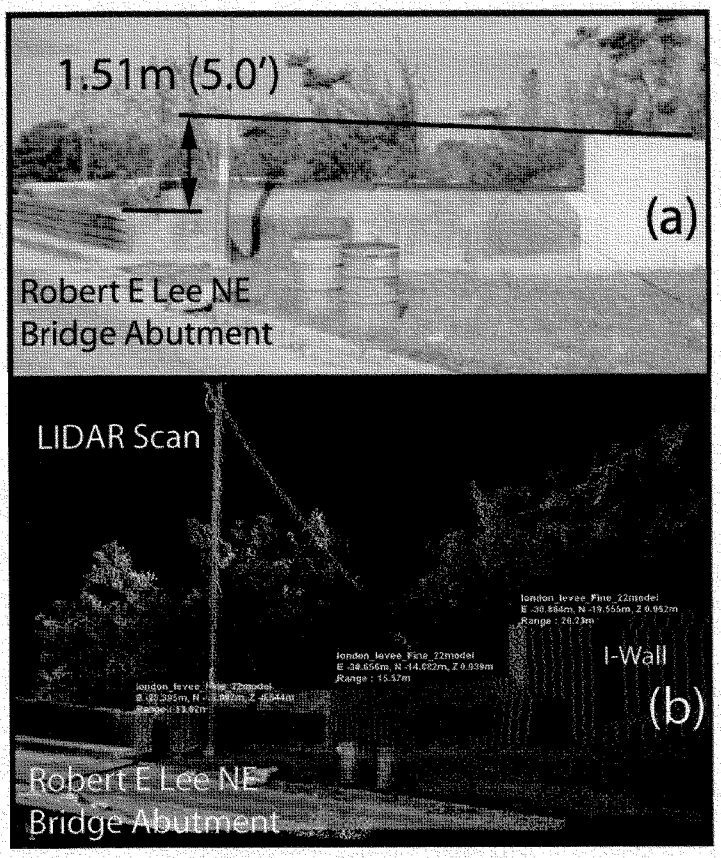
The London Canal levee failure (west side) and distressed wall (east side) are both immediately south of the bridge crossing at Robert E. Lee Boulevard. A significant gap in height between the lower un-walled bridge abutment and I-wall prevents water from overtopping these levees. The height gap differs slightly between the walls located north and south of the bridge, due either to differing design heights or differential settlement following construction. At the distressed I-wall section on the southeast corner of the bridge, LIDAR surveys and visual inspection indicated the gap at this location was approximately 1.7 meters (5.6 feet). Therefore, water rising in the canal would overtop the bridge abutment and begin to flood the surrounding community when the water level was 1.7 meters (5.6 feet) below the top of the I-wall. Figure 7.15 shows this considerable wall gap, as well as moderate scour at the southeast edge of the bridge abutment (Figure 7.15a). On the northeast corner of the bridge abutment near the north levee wall, LIDAR surveys indicate the gap at this location to be approximately 1.51 meters (5.0 feet). Figure 7.16 and 7.17 show this gap, as well as a scour trench at the base of the northeast abutment (Figure 7.17a).

Figure 7.15: Photograph of the southeast abutment of the London Avenue Canal bridge at Robert E. Lee Blvd (a), and LIDAR scan of the same location (b). New soil and rock apparently fills scour and sink hole erosion beneath the abutment. The relative height gap between the bridge abutment and the flood wall is 1.72 meters (5.6 feet).

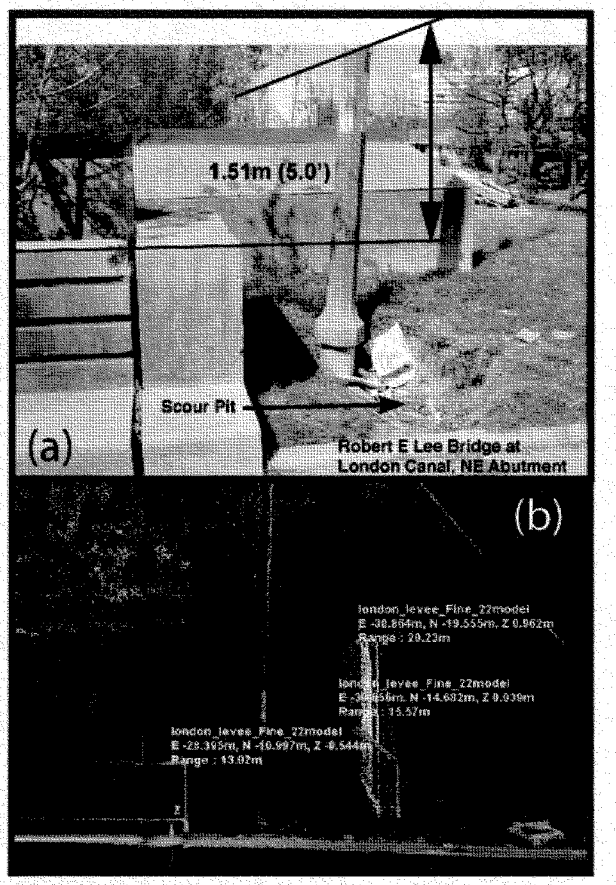
Figure 7.16: The northeast abutment of the London Avenue Canal bridge on Robert E. Lee Blvd. in photograph taken from the lower portion of the bridge approach-fill embankment (a), and corresponding LIDAR scan (b). The wall gap here is 1.51 meters (5.0 feet).

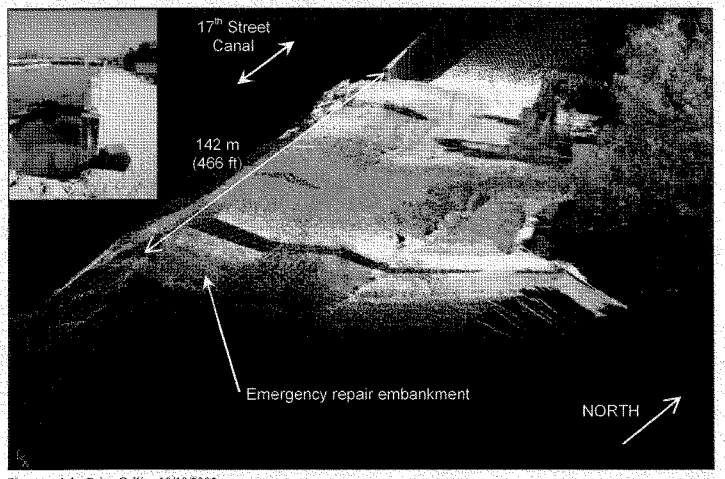
Measurement of displacement along the 17th Street Canal breach can be made by identifying the blocks of ground formerly within the intact levee that slid eastward toward the landside of the levee. Figure 7.18 is an overview image of a portion of the 17th Street point cloud data set consisting of 11 individual scans. In this image, the bridge crossing over the canal at Robert E. Lee Blvd. (also called the Hammond Highway.) is toward the upper left (north). A dense cluster of points is visible at the levee breach in the center of the image as are the houses in the affected area. Close in to the levee breach in Figure 7.19, the remaining I-wall can be seen in alignment with the crest of the replacement structure. Here, a total breach repair width of 142 meters (466 feet) as measured between intact I-wall sections has been calculated directly from the LIDAR data set. A cross section taken through this area is shown in Figure 7.20. A multi-section view is shown, consisting of a section of the intact southern I-wall overlain over the failed section of the levee. The geometry of the emergency repair embankment is clearly visible. The sections also show the magnitude of the

Figure 7.18: Overview oblique image of the 17th Street Canal area in the vicinity of the breach. The Robert E. Lee Blvd. Bridge is to the north (upper left) and the breach area is to the upper right (east). Houses within the neighborhood breach area and the scour pond were imaged from the new levee and Bellaire Drive.
