[Docket No. 94–CE–28–AD; Amendment 39–9472; AD 95–26–13]

Airworthiness Directives; The New Piper Aircraft, Inc. (Formerly Piper Aircraft Corporation) PA28 and PA32 Series Airplanes

95–26–13 The New Piper Aircraft, Inc.: Amendment 39–9472; Docket No. 94–CE–28–AD; Supersedes AD 76–25–06, Amendment 39–2788.

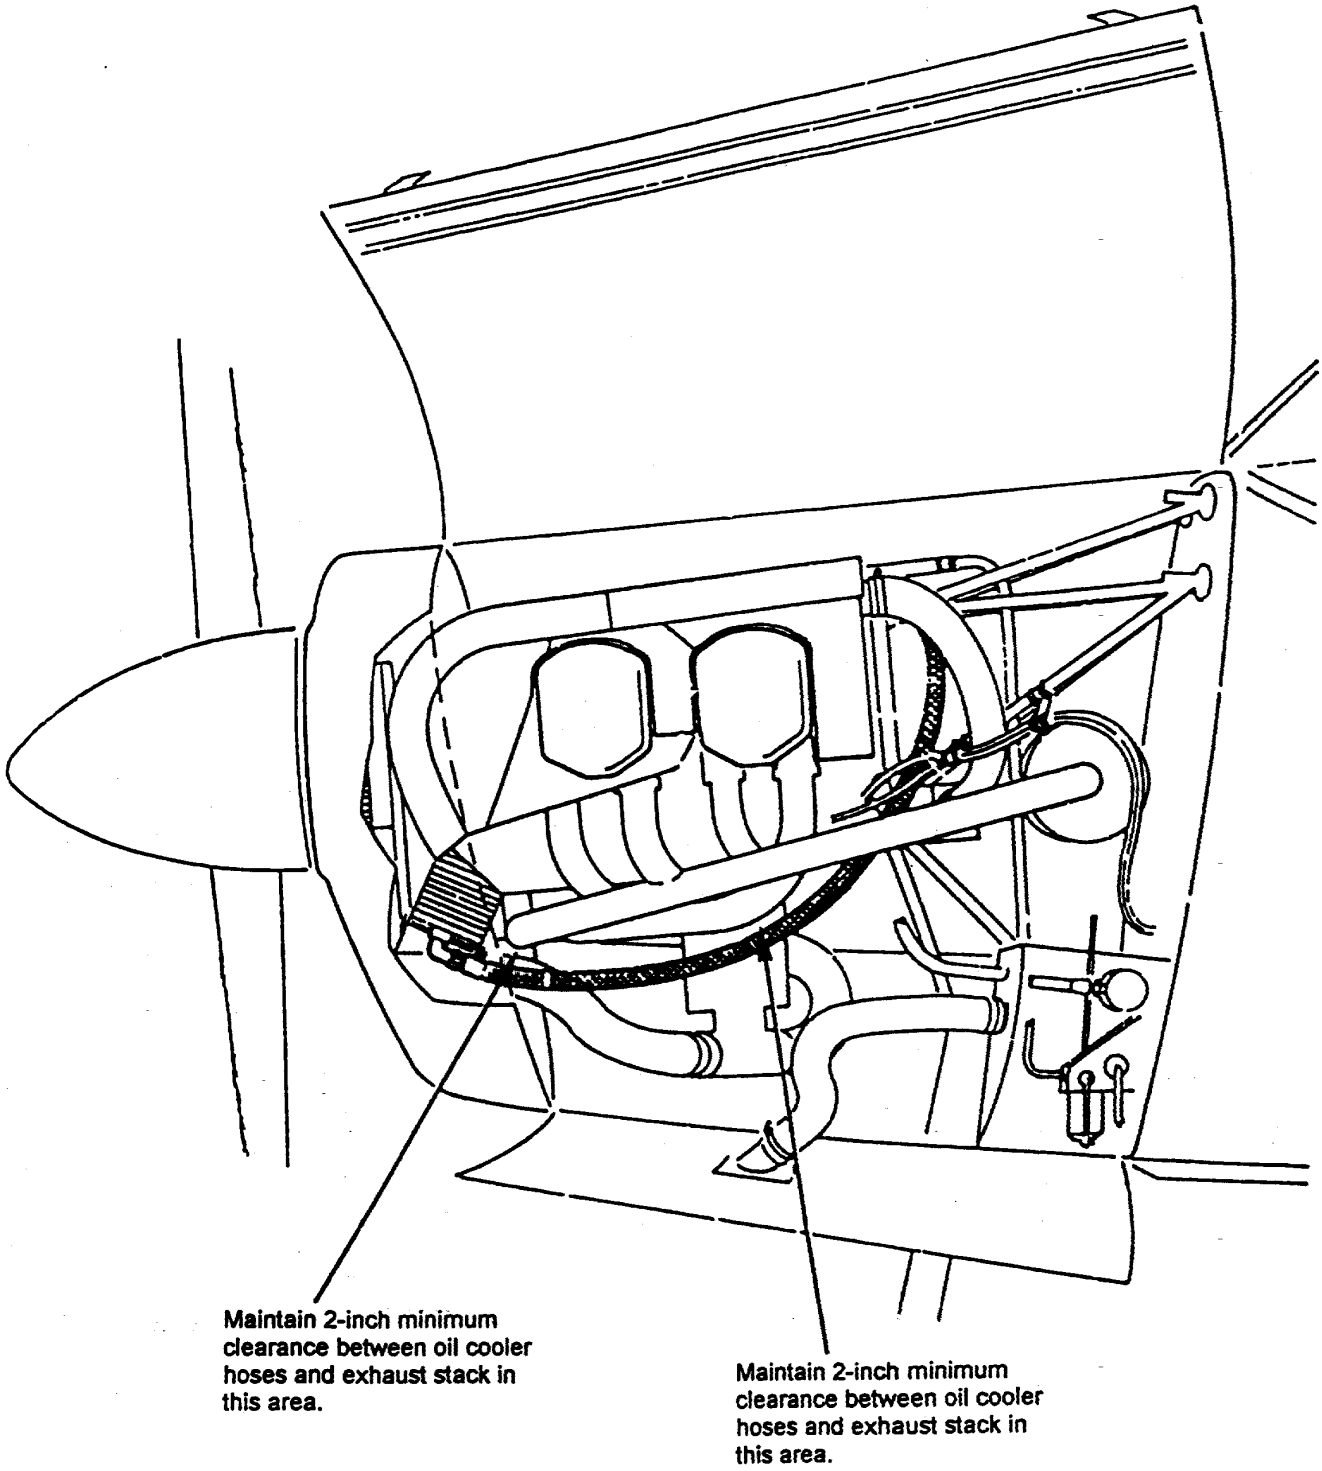
(i) The hose passes underneath and behind the electrical ground cable and in front of the lower of the two engine mount struts when the hose is routed to the rear of the engine; and

(ii) The hose is tied to the engine mount strut and a clearance of at least 2 inches exists between the oil hose and exhaust stack.

Note 2: Figure 1 of this AD relates to the conditions specified in paragraphs (a)(2)(i) and (a)(2)(ii) of this AD.

(2) On airplanes that have any oil cooler hose assembly mounted in the front of the airplane, ensure that the following exists, and, prior to further flight, adjust accordingly:
