Denial of Petition for a Defect Investigation

Petition Analysis DP96-011: Petition for Defect Investigation Concerning Rollover Propensity of MY 1995-96 Isuzu Trooper and 1996 Acura SLX Vehicles

June 1997

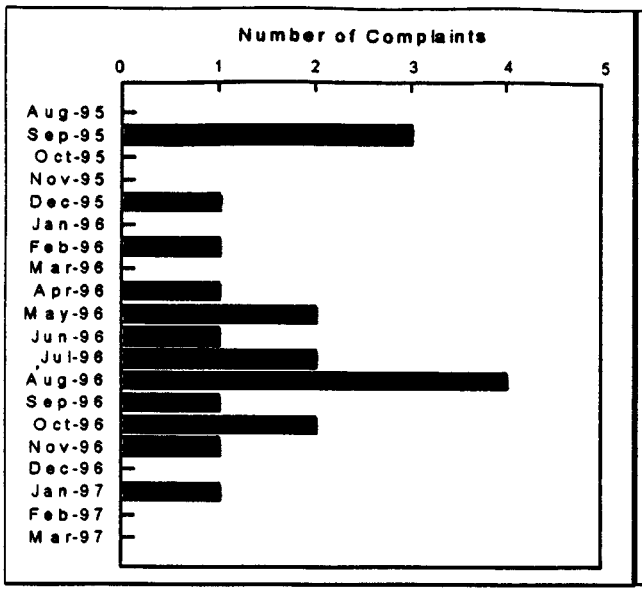
The complaints are fairly evenly distributed by failure date (the date of the alleged incident). Failure and complaint date data are presented in Figures 1 and 2.

Figure 1. Failure Date Analysis, Subject Vehicles.

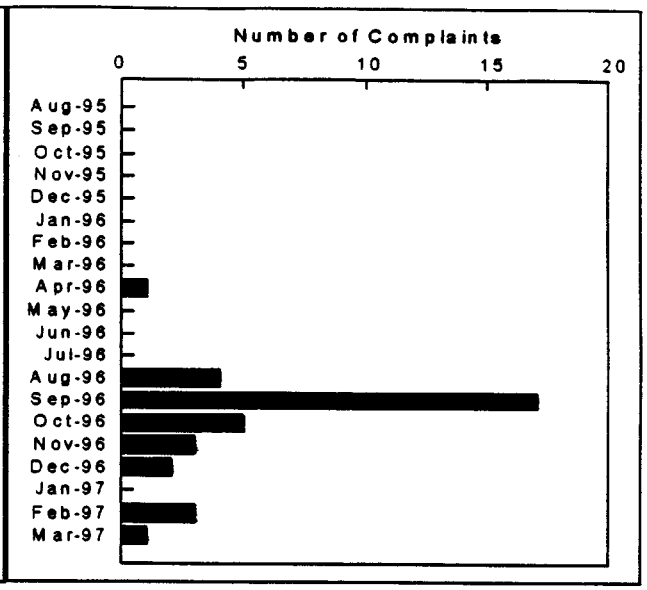
Figure 2. Complaint Date Analysis, Subject Vehicles.

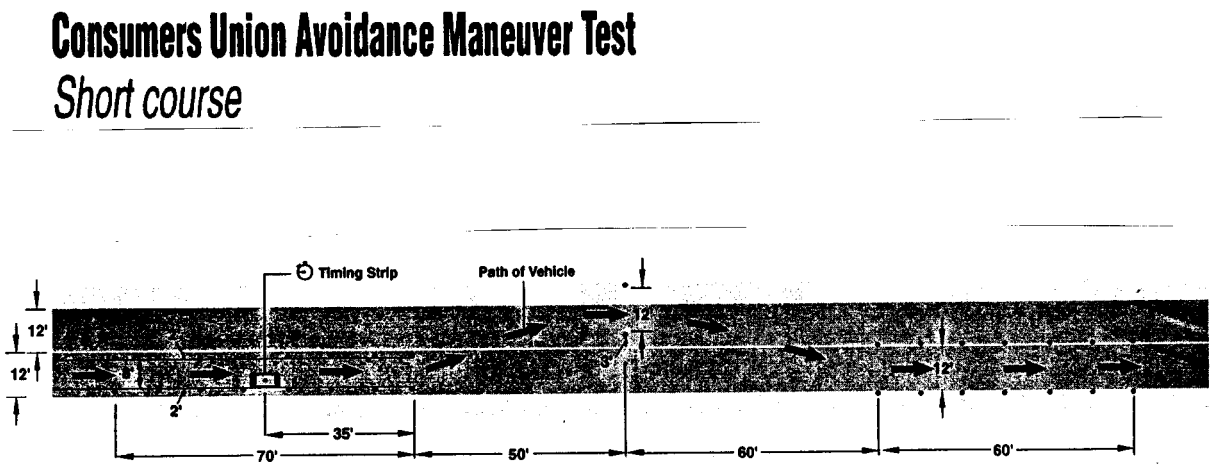
Figure 3. CU Short Course (from CU submission).

The CU short course is depicted in Figure 3. This course requires two lane changes. It consists of a 70-foot-long, 8-foot-wide entrance lane that is centered in the 12-foot-wide first (right) lane, a 50-foot-long area to make the first lane change, a set of gate cones at this 50-foot mark that are 12 feet apart, (with the right cone three feet over into the second (left) lane), a 60-foot-long area to make the second lane change (back to the original (right) lane), and a 12-foot-wide exit lane. CU drivers steer the vehicles through this course at successively higher entry speeds until the vehicle either plows out, slides out, or tips up. The vehicle's brakes are not applied, and the throttle is released as the vehicle passes the timing strip which measures the vehicle speed, located 35 feet before the end of the entrance lane (see Figure 3 for reference).

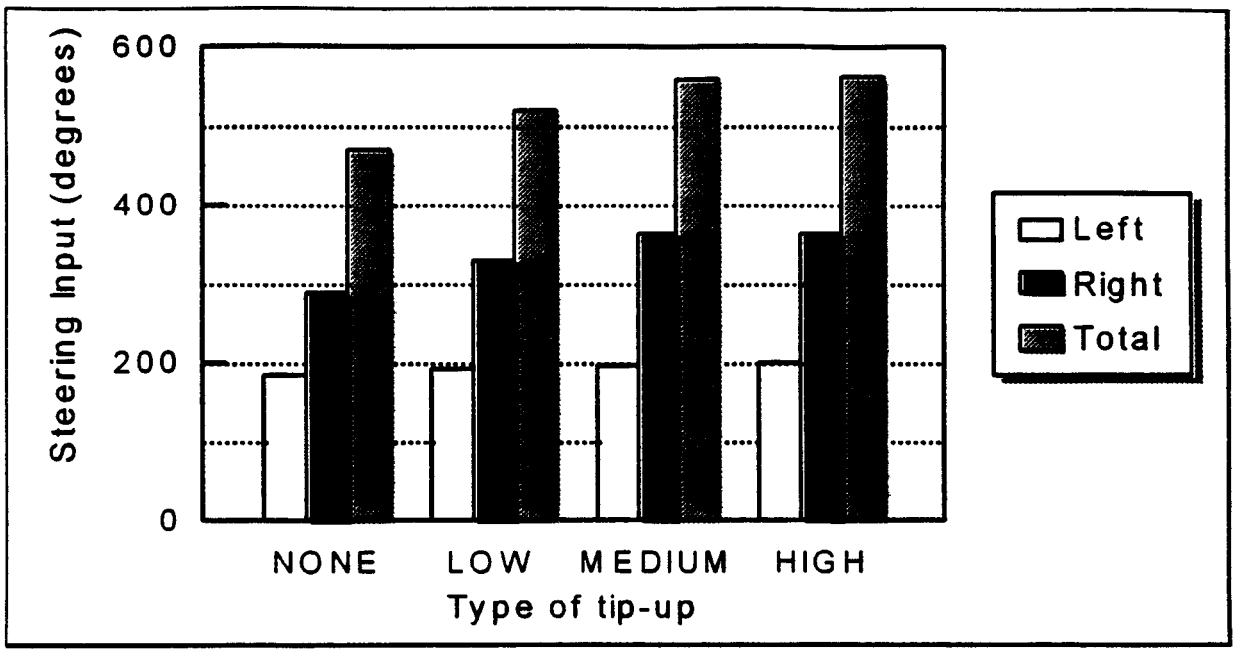
Figure 4. Average Steer Input for CU Tests of Subject Vehicles by Tip-up Result (November 25, 1996 submission).

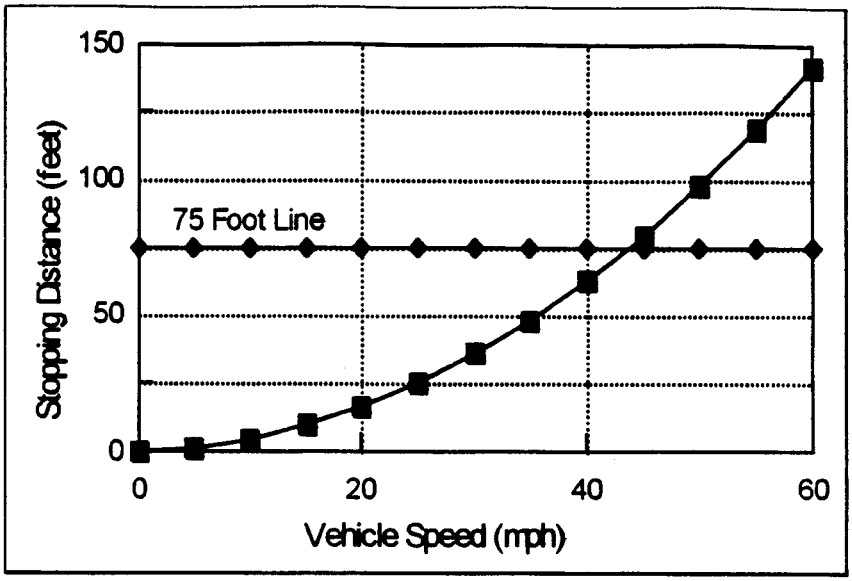
Stopping distance for a typical vehicle with typical brakes on a dry road with coefficient of friction of 0.85 is shown in Figure 5. (These distances will vary with surface conditions.) Vehicles traveling up to 45 mph can stop before they reach an obstacle that is 75 feet away. Vehicles can stop in 60 to 70 feet from speeds typical of the entrance speed used by CU in its short course tests. Thus, a driver who applies the brakes at the point when the CU test drivers began to turn could safely stop before reaching the obstacle, without attempting to turn.

Figure 5. Stopping Distance vs. Vehicle Speed.

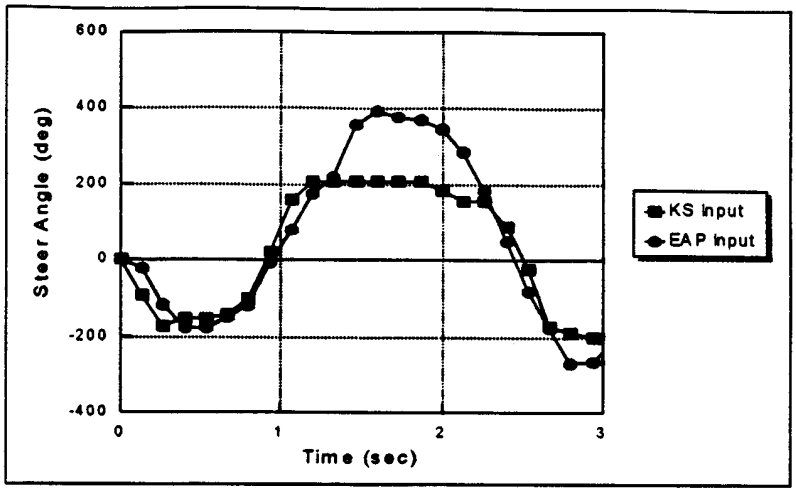
CU used three different drivers for these tests: KS, EAP, and ROS. The CU drivers have apparently developed different strategies for driving vehicles through the short course. For example, data from the two tests that CU evaluated in its December 23, 1996 submission, are plotted in Figure 6.[11] KS (marked with squares) steered sooner than EAP (marked with dots), while EAP used more steering input than KS. The KS steering input resulted in an non-tip-up, clean run, while the EAP steering input resulted in a high tip-up, non-clean run.

Figure 6. Clean Run Driving Profile for KS and High Tip-Up Run Driving Profile for EAP.

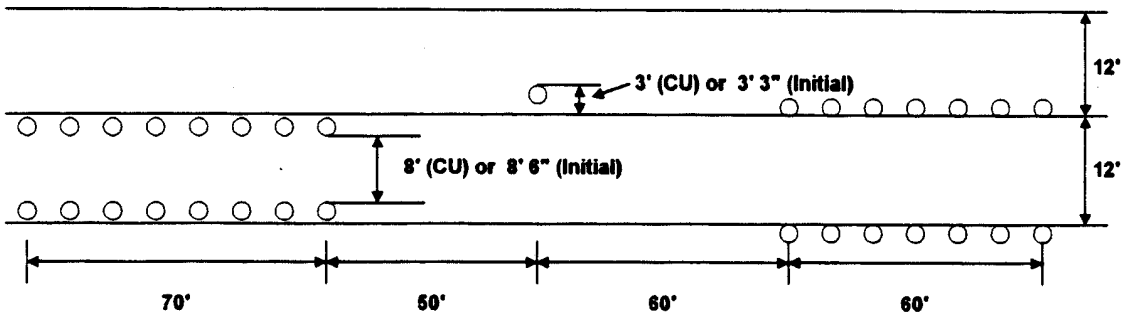
Initial testing conducted at TRC was based on an improperly labeled drawing of the CU short course.[15] The centers of the entrance lane cones were nine feet apart, while the inside bases of the left and right side cones should have been eight feet apart. In addition, the right gate cone was centered three feet into the second lane, while the inside base of that cone should have been three feet into the lane. A comparison of the CU short course and the course originally used at TRC is

given in Figure 7. Since the original TRC course was set up on cone centers, the diameter of the cones affect the inside base distances. The cone size used in this TRC testing resulted in an inside base distance of eight feet six inches, as compared to the CU short course distance of eight feet, and an inside base gate cone distance of three feet three inches, as compared to the CU short course distance of three feet.[16] All short course testing at the UTQG facility was on a course identical to the CU short course.

Figure 7. Differences between CU Short Course and Initial TRC Course.

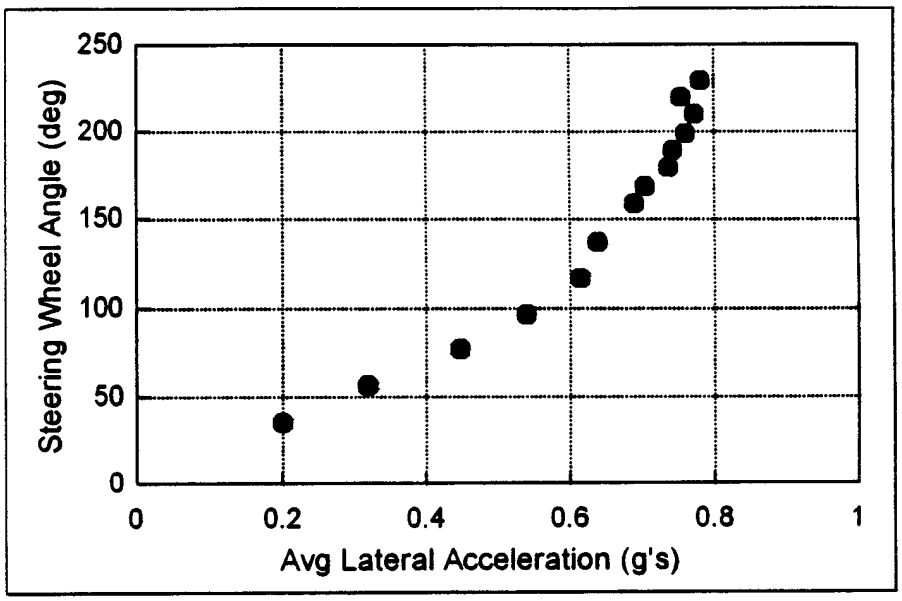
Testing was conducted at 40 mph to steer angles of 230 degrees, which resulted in lateral acceleration levels of nearly 0.8 g, a very high lateral acceleration. The results of these tests are plotted in Figure 8. These data indicate that the vehicle exhibits understeer throughout the range of testing; that is, for each percentage increase in the steering wheel angle, there is an even smaller percentage increase in lateral acceleration.

Figure 8. Steering Wheel Angle vs. Lateral Acceleration, 40 mph, 1996 Acura SLX w/o Outriggers.
