General
Technical
Report
FPL–GTR–177

Condition Assessment of Main Structural Members of Steam Schooner WAPAMA

Xiping Wang
James P. Wacker
Robert J. Ross
Brian K. Brashaw

June 2008

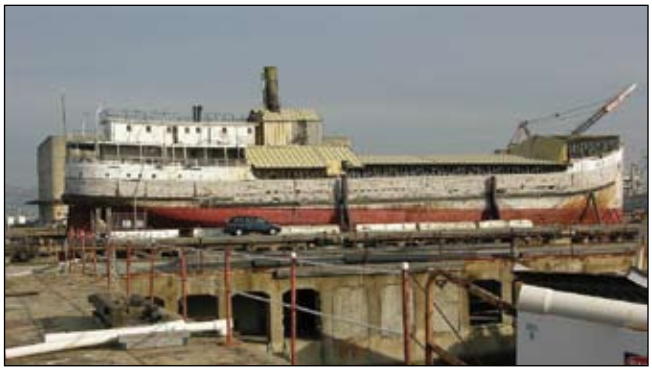
Figure 2. A recent photo of the WAPAMA placed on Barge 214 at Richmond Reserve Shipyard in Richmond, California.

In 1980, the vessel could no longer remain afloat due to severe deterioration and was hauled out of water and placed on Barge 214, berthed at Pacific Drydock Co., Alameda. Since that time, the WAPAMA has remained on the barge and received limited maintenance. Currently, the vessel resides on Barge 214 in a flooded graving dock at the Richmond Reserve Shipyard in Richmond, California, and is unsafe for public access (Fig. 2).

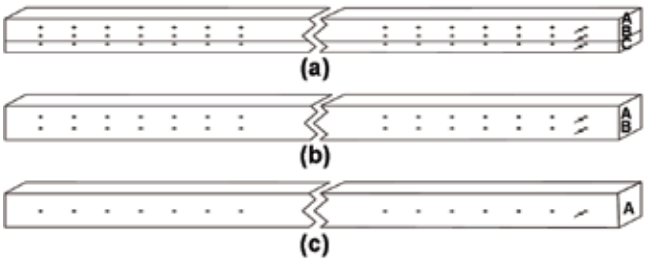
Figure 3. Scanning diagram of longitudinal strength members: (a) keelsons; (b) keel; (c) main deck stringer.

The rider keelson and main keelson (above the top surface of the assistant keelsons) in the cargo hold were stress wave scanned along three lines (Fig. 3a). Lines A and B were on the rider keelson, and line C was on the main keelson. The portion of the keelsons tested is between frames 7 and 48. The keelsons beyond this portion were not tested due to lack of access or difficult access.

in Figure 3b. For the convenience of quickly establishing a scan pattern, we set frame 79 (where the iron tie plate ends) as the starting point and scanning was proceeded along two lines (A and B) from aft to fore. Stress wave transmission time data were collected between the keel blocks and at 6-ft intervals. Figure 8 shows the distribution of stress wave transmission time and the mapping of physical conditions of the keel.

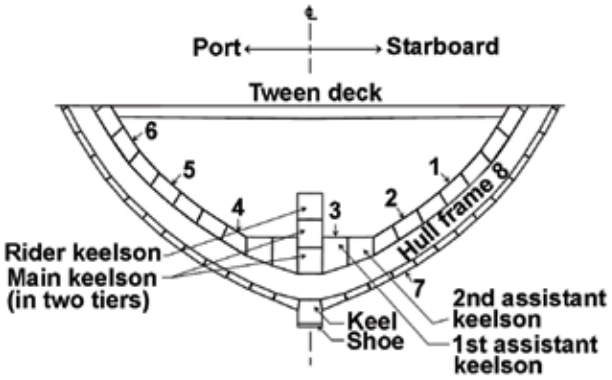
Figure 4. Schematic of drilling locations for the cross section at frame 8.

A total of seven micro-drilling resistance measurements were collected from the hull assembly at frame 8 (Fig. 4). Safety concerns limited our access to the smaller area underneath the tween deck, therefore no data were collected from tween deck beams. From the interior of the vessel, five micro-drilling locations penetrated downward through ceiling planks and a portion of the hull frame. One additional micro-drilling location penetrated into the first assistant keelson (starboard). From the exterior of the vessel, one micro-drilling location on the starboard side penetrated upward through strake planks and a portion of the hull frame. The thickness of the interior ceiling and/or exterior strake planking varied and resulted in different penetration levels into the main frame members.

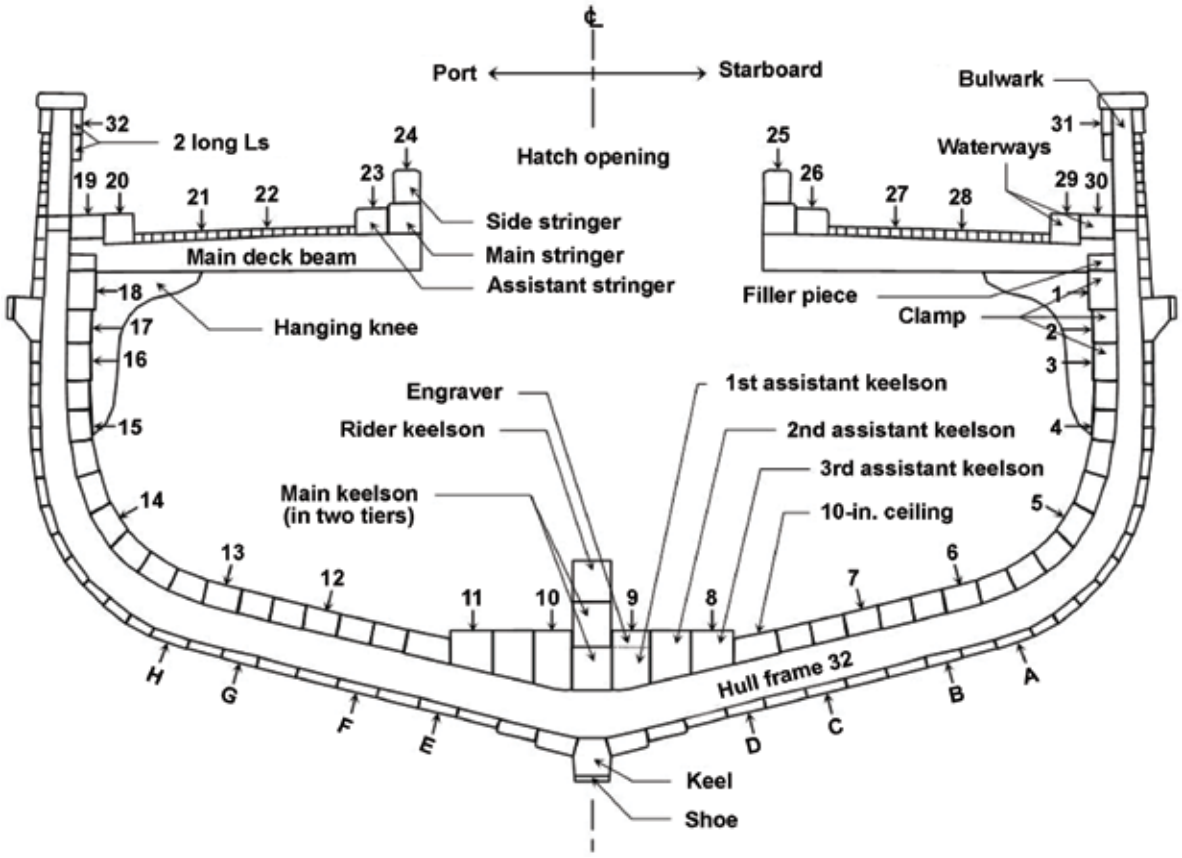
Figure 5. Schematic of drilling locations for the cross section at frame 32.

A total of 40 micro-drilling resistance measurements were collected from the hull assembly at frame 32 (Fig. 5): 18 from the interior portion of the hull assembly penetrated into clamps, ceiling planks, and assistant keelson members; 14 from topside of the main deck penetrated into bulwarks, waterways, decking, stringers, and assistance stringers; and 8 from the outer hull portions that were accessible from the barge deck.

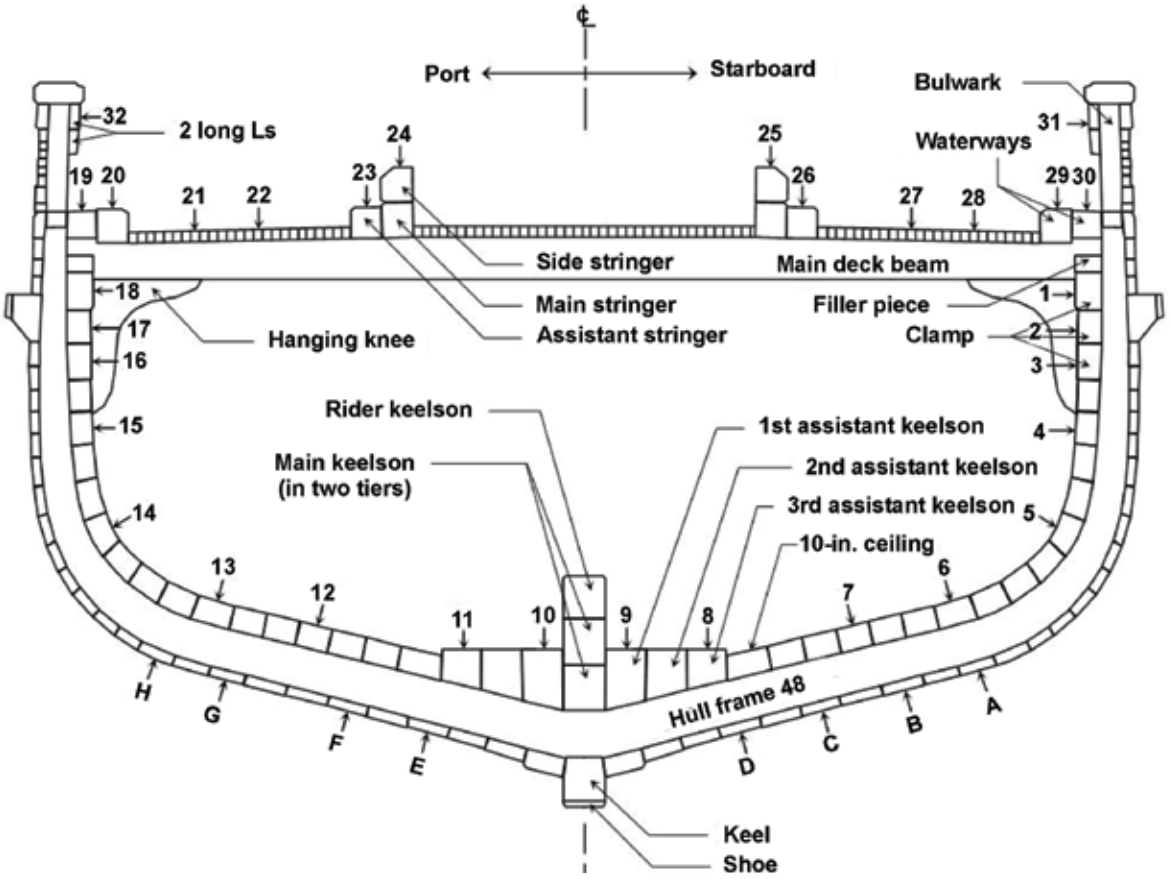
Figure 6. Schematic of drilling locations for the cross section at frame 48.

A total of 40 micro-drilling resistance measurements were collected from the hull assembly at frame 48 (Fig. 6): 18 from the interior portion of the hull assembly penetrated into clamps, ceiling planks, and assistant keelson members; 14 from topside of the main deck penetrated into bulwarks, waterways, decking, stringers, and assistance stringers; and 8 from the outer hull portions that were accessible from the barge deck.

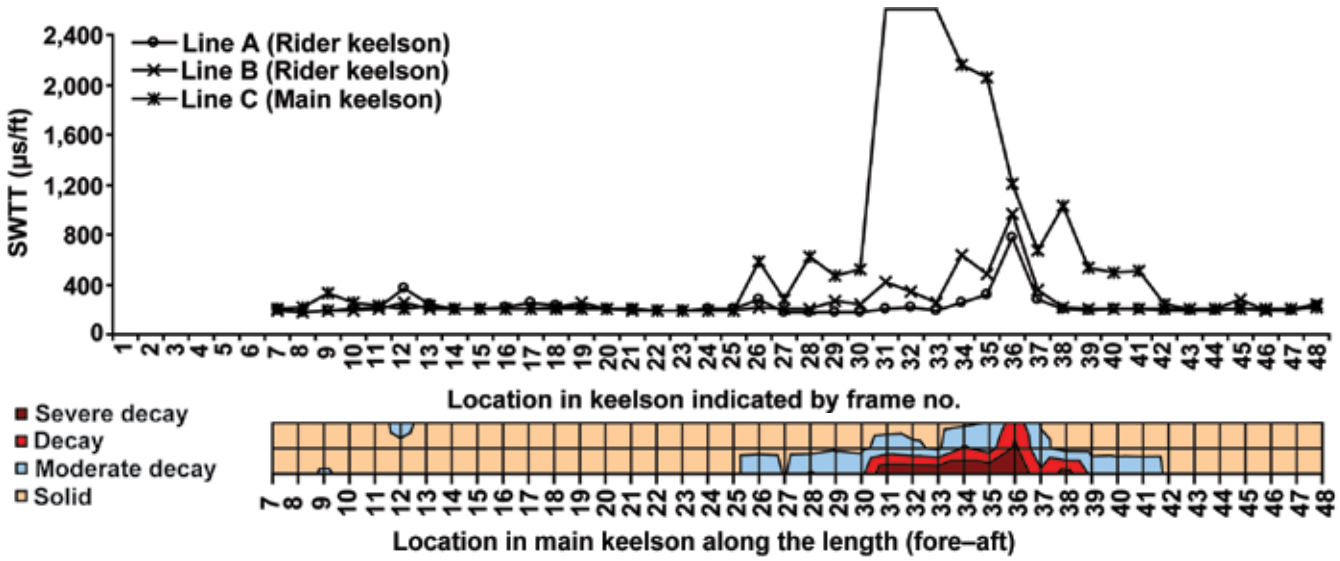
Figure 7. Distribution of stress wave transmission time (SWTT) and mapping of physical conditions of the keelsons.

Figure 7 illustrates the distribution of stress wave transmission times (SWTTs) (in µs/ft) along the length and the mapping of physical conditions of the rider keelson and main keelson. The physical conditions of each test location were rated into four categories by comparing the measured SWTT with the reference SWTT and color-coded as follows:

- Solid: <300 µs/ft
- Moderate decay: 300–600 µs/ft
- Decay: 600–900 µs/ft
- Severe decay: >900 µs/ft

The deterioration of the keelsons is concentrated between frames 25 and 42, and most severe decay occurred on the main keelson timber between frames 30 and 39. This is also confirmed by micro-drilling resistance tests. Rainwater likely entered this area through the hatch over the years due to failed weather protection and water remained trapped. Water damage in the untested portion of the main keelson between frames 30 and 39 and even beyond could also be significant. Deterioration could be further extended and advanced with the current outdated weather protection.

No significant deterioration was found between frames 7 and 25 according to stress wave scanning results. The tween deck, which extends from frame 11 to the forward end of the hatch at frame 26, has apparently protected the keelsons from direct exposure to rainwater dripping from above (through main decking). The micro-drilling resistance test revealed isolated internal rot (5.5–9.5 in.) at the location of frame 12. A similar condition at frame 11 was reported in a 1986 survey report (Tri-Coastal Marine, Inc. 1986).

Repair or replacement of the temporary roof shelter over the main deck is recommended. The current weather protection over the main deck is clearly ineffective in preventing intrusion of rainwater, as evidenced by water seepage from the underside vents in the outer hull. Moisture is saturating several key structural components on the main deck and in the cargo hold. An effective roof will prevent further decay until restoration work is initiated.

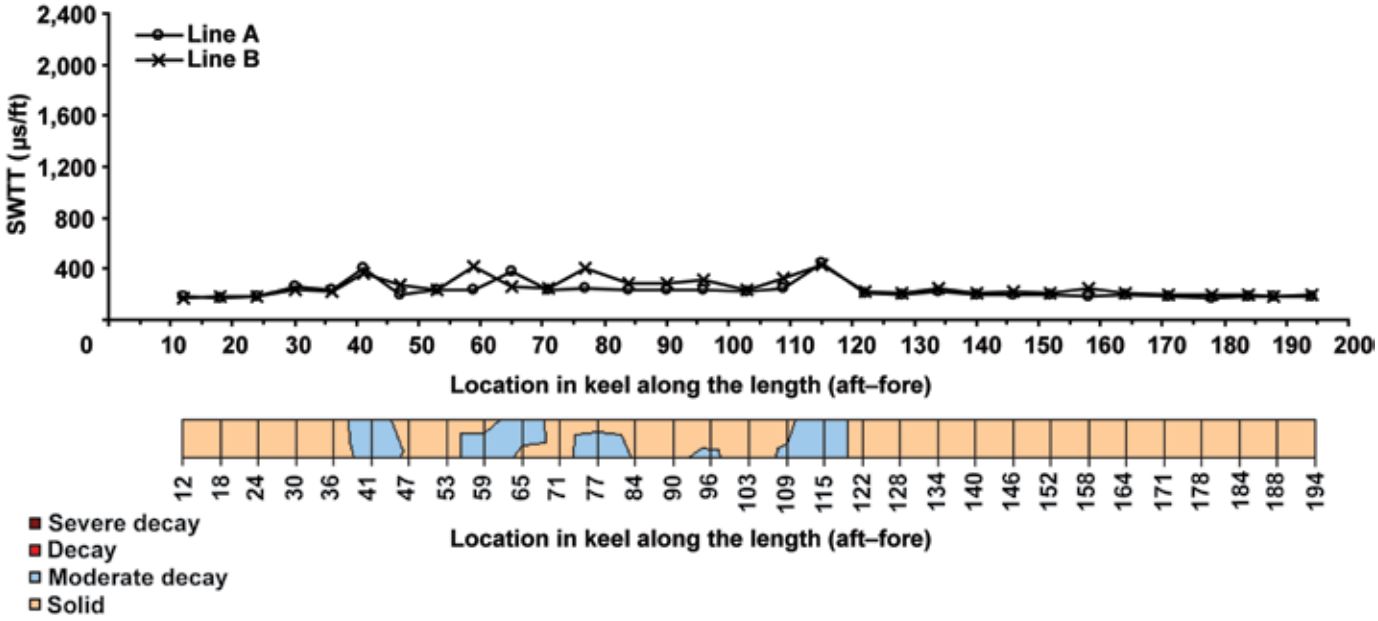
Figure 8. Distribution of stress wave transmission time (SWTT) and mapping of physical conditions of the keel.

Moderate deterioration was found at several areas of the keel, as indicated in the mapping. Although no severe decay is present in the keel, the hogging in the mid-section of the ship has caused significant mechanical damage (shear failure) to the keel as evidenced by cracks or splits along the grain. This is confirmed by a previous report that the keel was broken when the ship was placed on Barge 214 (Tri-Coastal Marine, Inc. 1986).

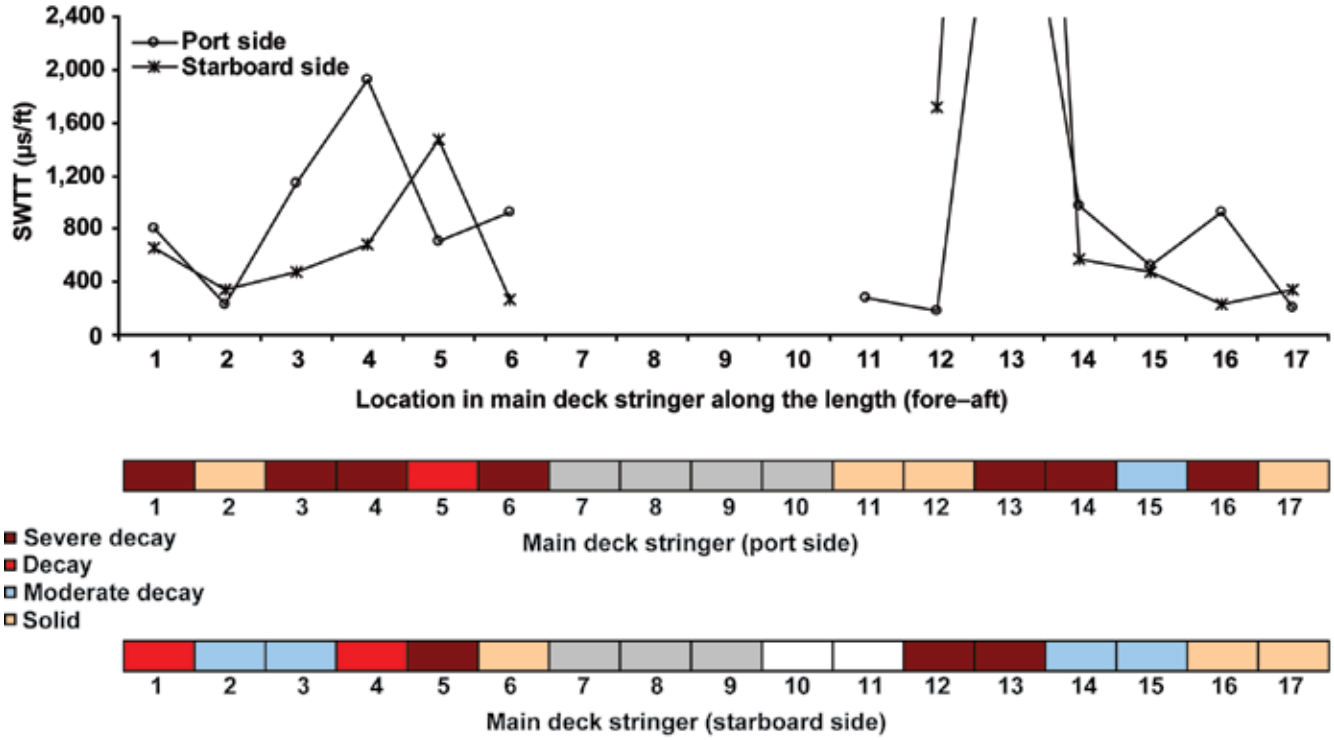
Figure 9. Stress wave transmission time (SWTT) and physical conditions of the main deck stringers.

The main deck stringers have lost most integrity due to severe deterioration. Visual signs of rot, splits, and checks are present in most portions of these members. To quantify the levels of deterioration, stress wave scanning was carried out on two side stringers with a less extensive interval (5 ft) and along the centerline of the member.

Figure 9 shows the distribution of stress wave transmission time along the length and the mapping of physical conditions of the main deck stringers.

The main deck stringers were spot-checked with stress-wave timing and micro-drilling resistance testing. Severe deterioration was confirmed in both side stringers and assistant stringers. Overall, the main deck stringers have lost nearly all structural integrity.

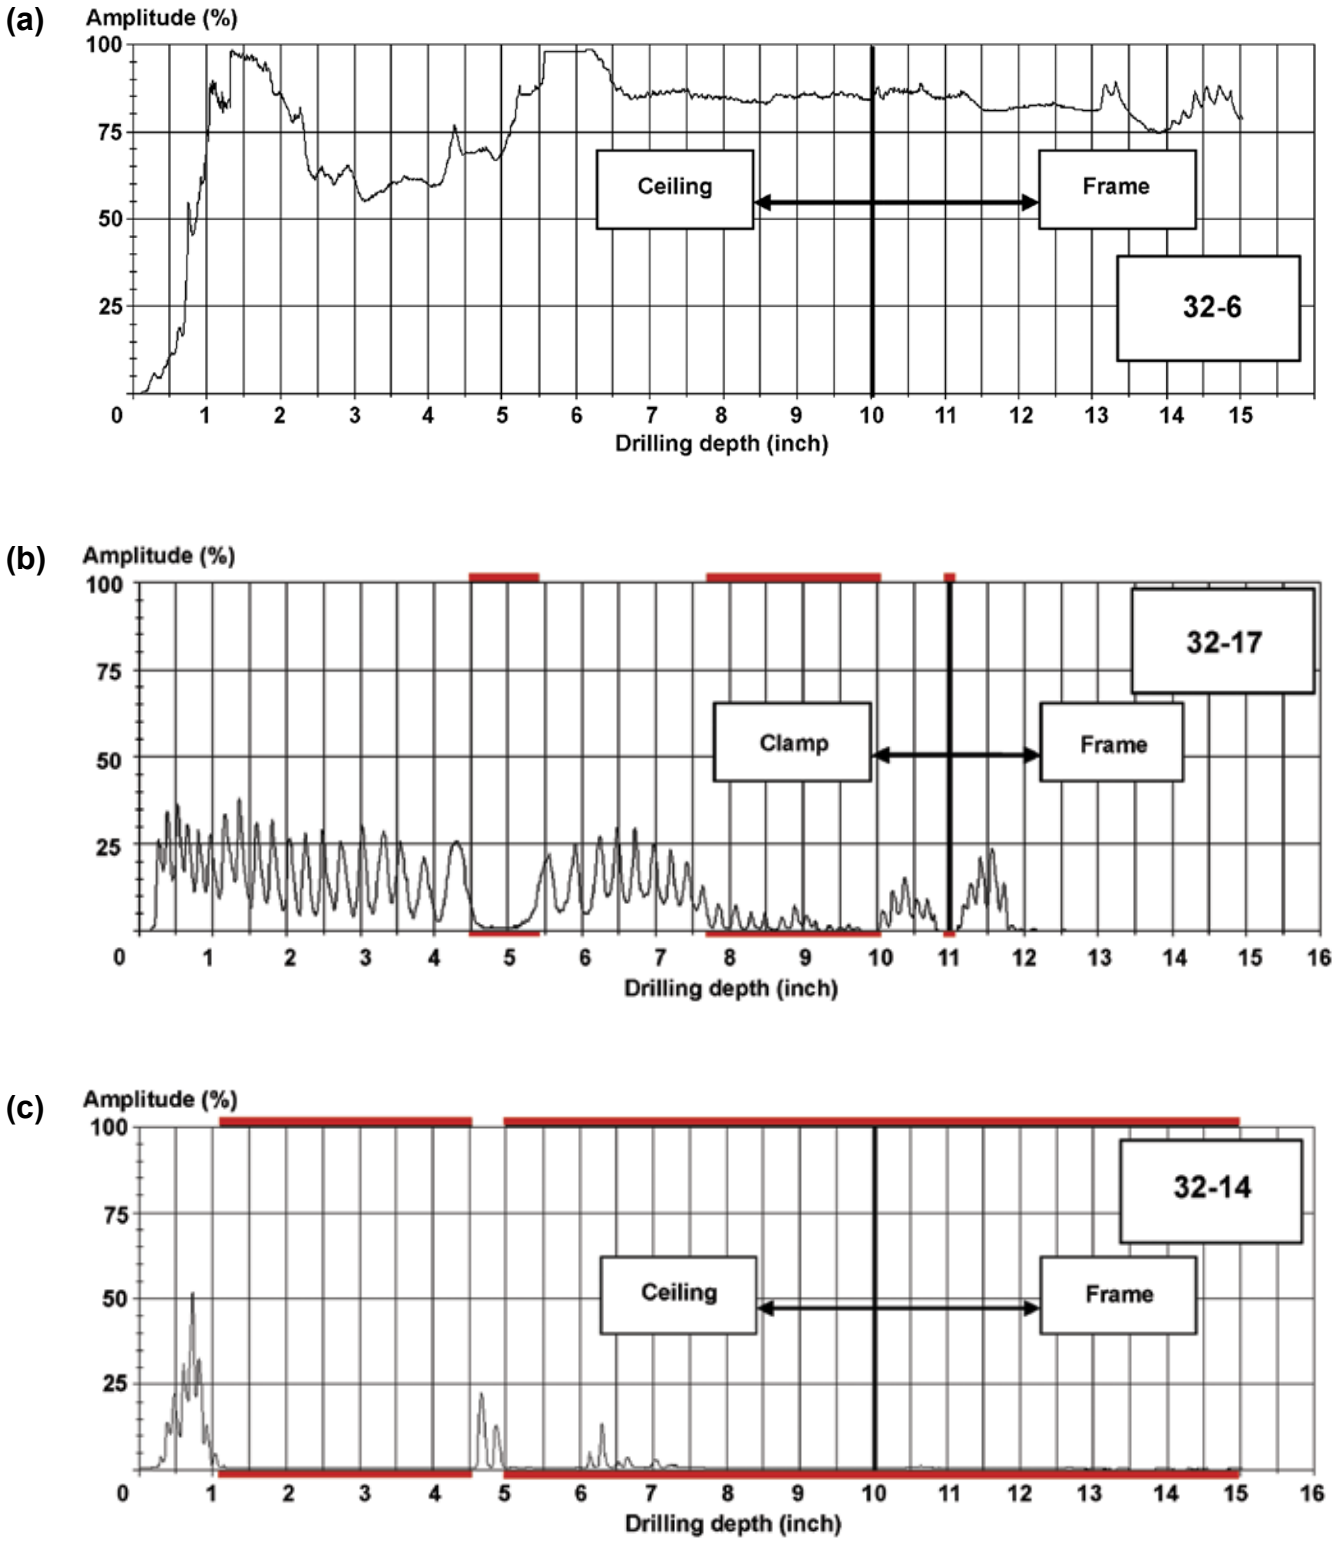
Figure 10. Typical results from micro-drilling resistance tests: (a) sound wood; (b) moderate deterioration; (c) severe deterioration.

Typical results from micro-drilling resistance tests showing sound wood, moderate deterioration, and severe deterioration are shown in Figure 10. Comprehensive results of all micro-drilling resistance tests are reported by NRRI (2006).

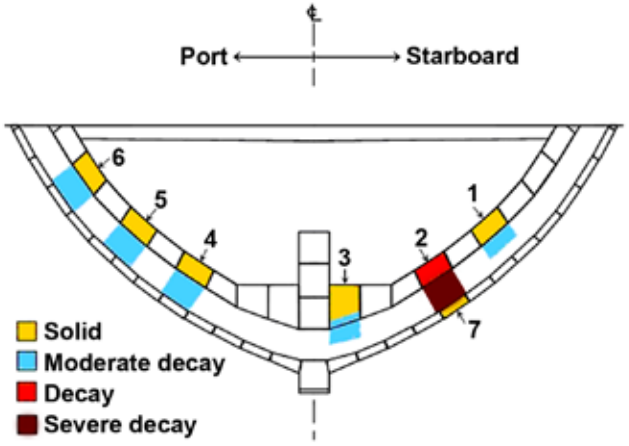
Figure 11. Mapping of physical conditions of the cross section at frame 8 (micro-drilling resistance interpretation).

A schematic summary of micro-drilling resistance data collected at hull frame 8 is provided in Figure 11. Severe decay was detected at two of seven (29%) drilling locations at this section. Most of the ceiling planks and the first assistance keelson (starboard) are in good condition, with decay present only in the ceiling plank at drill location 2. Moderate decay was detected in the inside upper portions of the hull frame drill locations, with severe decay present at drill location 2. There were visual indicators of water seepage through overhead tween and main decks, which probably caused this deterioration since the WAPAMA was lifted onto Barge 214.

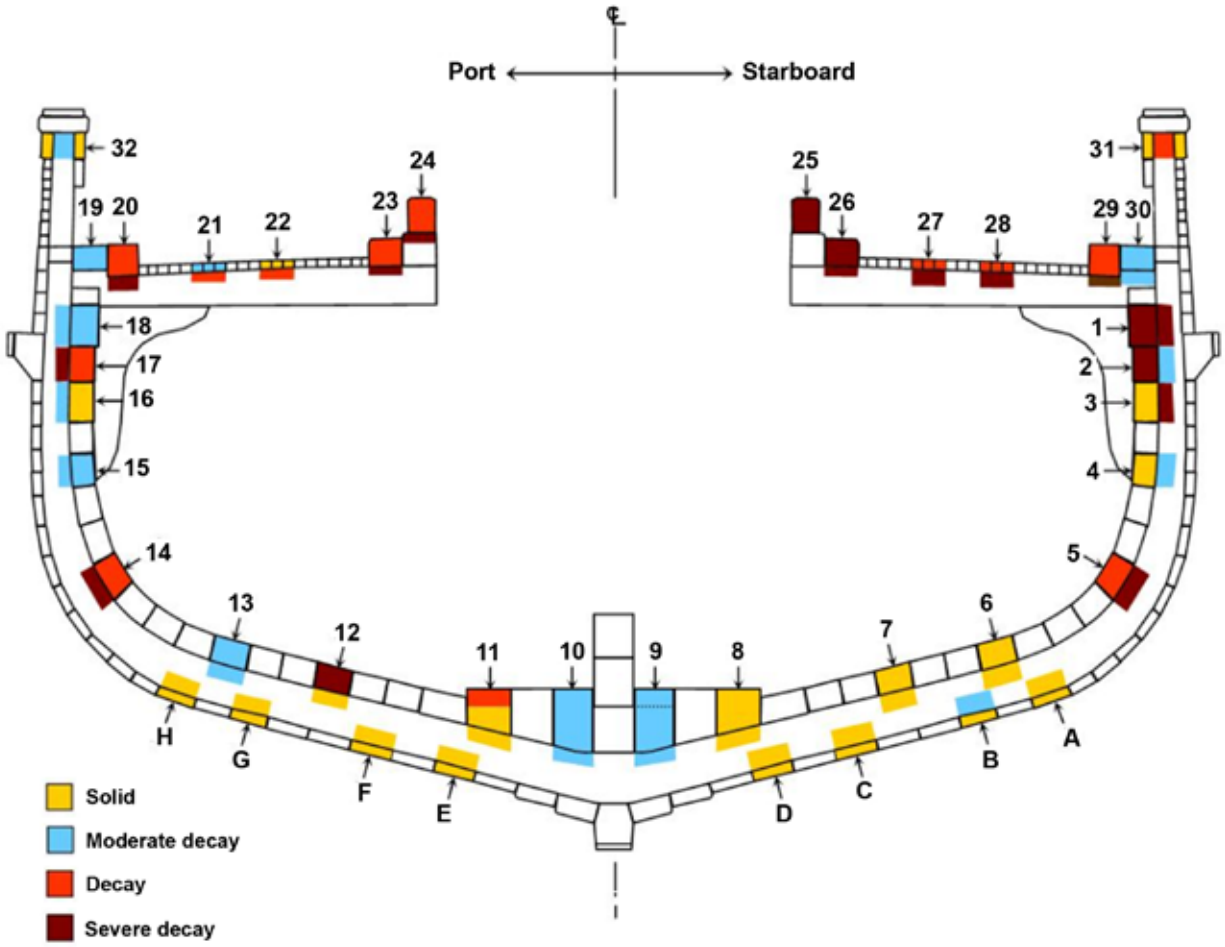
Figure 12. Mapping of physical conditions of the cross-section at frame 32 (micro-drilling resistance interpretation).

A schematic summary of micro-drilling resistance data collected at hull frame 32 is provided in Figure 12. Severe decay was detected at 15 (38%) of the drilling locations, with most of these areas located in the members at the main deck level (stringers and main deck beams) or near the main deck level (clamps, hull frame). Deterioration of the lower hull members and keelsons was mostly moderate. Deterioration ranging from decay to severe decay was detected at nearly all drilling locations drilled downward from topside main deck. The outer waterways 19 and 30 and portside main deck planks (21 and 22) showed signs of moderate decay. Deterioration ranging from decay to severe decay was detected in clamps 1, 2, and 17, ceiling planks 5, 12, and 14, the 3rd assistant keelson portside (11), and the inside upper portion of the hull frame 1, 3, 5, 14, and 17. Drillings upward into the outer hull detected mostly sound wood with only moderate decay present in the outer lower hull frame B.

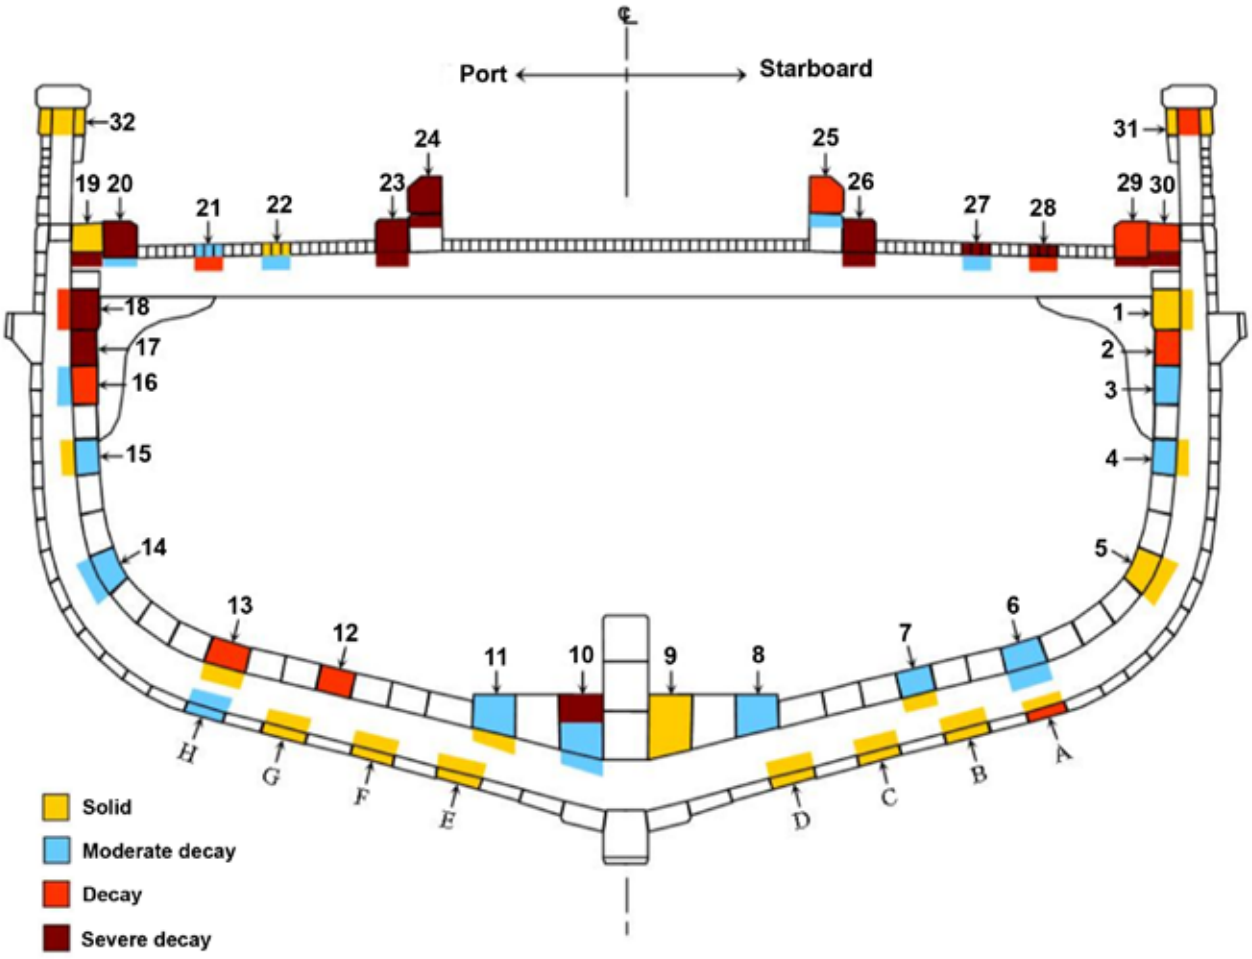
Figure 13. Mapping of physical conditions of the cross-section at frame 48 (micro-drilling resistance interpretation).

A schematic summary of micro-drilling resistance data collected at hull frame 48 is provided in Figure 13. Severe decay was detected at 12 (30%) of the drilling locations, with most of these areas located in the members at the main deck level (waterways, stringers, main deck planks, and main deck beams) or near the main deck level (clamps). Deterioration of the lower hull members and keelsons was mostly moderate. Deterioration ranging from decay to severe decay was detected at nearly all drilling locations drilled downward from topside main deck, except main deck plank 22. Deterioration ranging from decay to severe decay was also detected in clamps 2, 16, 17, and 18, the 1st assistant keelson portside (10), ceiling planks 12 and 13, and the inside upper portion of the hull frame 18. Drillings upward into the outer hull detected mostly sound wood, with deterioration noted only in outer hull plank A and in outer hull plank/hull frame H.

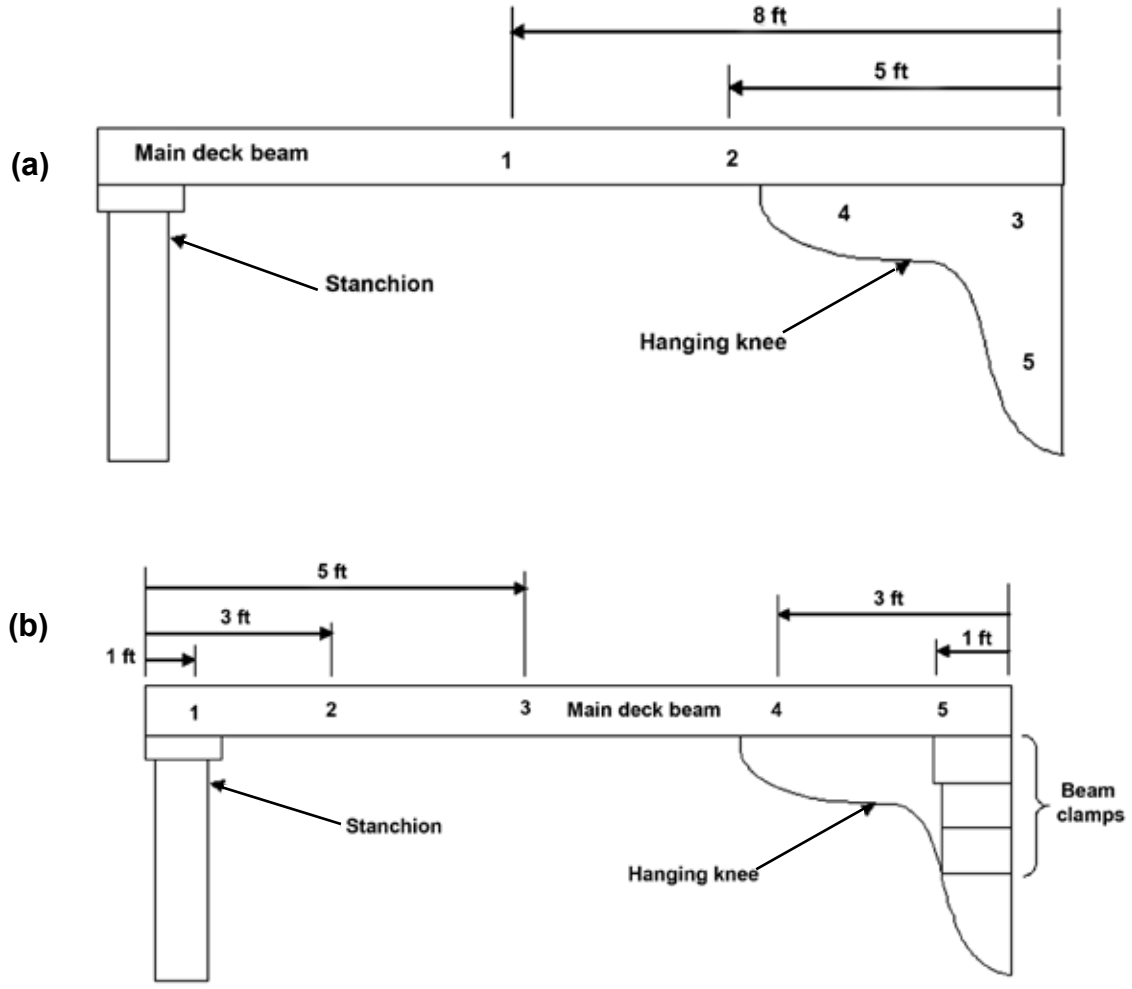
Figure 14. Stress wave testing locations for portside main deck beams: (a) main deck beams and hanging knees above tween deck; (b) main deck beams at rear cargo hold.

Stress wave transmission data were collected from the main deck beams at two areas on the ship's portside (Fig. 14). Five test locations were in the main deck beams above the tween deck, including some at the hanging knees (Fig. 14a). An additional five test locations were in the rear cargo hold between the main hatch and the cabin deck (Fig. 14b). A summary of the condition of the main deck beams is provided in Table 2 and Figure 15.

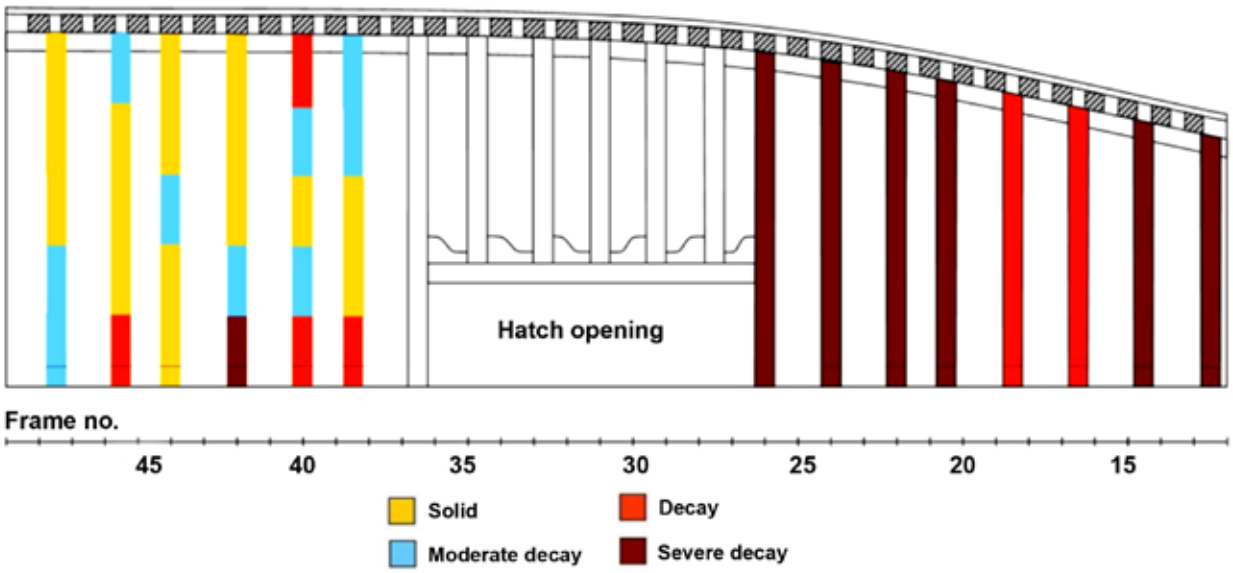
Figure 15. Mapping of physical conditions of portside main deck beams (plan view).

Stress wave transmission data confirmed that the main deck beams above the tween deck are in an advanced state of deterioration. Decay and severe decay were detected at all beams, as indicated by the stress wave transmission times in Table 2. Beams located at or near hull frames 13, 15, 20, 22, 24, and 26 have almost lost their entire strength and are considered having zero load capacity. In addition, severe deterioration was found in the hanging knees at frames 15 and 26, which raises serious concerns on the rest of the hanging knees that have not been tested.

The condition of the main deck beams at rear cargo hold varied. Decay to severe decay is present at the beam ends over the stanchion for most beams. The exception is the deck beam located near hull frame 44, which is sound. At the beam ends near the outer hull frame, only the beam at hull frame 40 shows decay, the beams near frames 38 and 46 shows moderate decay, and the beams near 42, 44, and 48 are generally sound. The condition of the main deck beams away from their supports is mostly sound, with moderate deterioration detected at some beams. The main deck beam in the best condition is at hull frame 44. Severe deterioration was present only at the end support (over the stanchion) at hull frame 42.

The main deck beams at the portside of the vessel were spot-checked with stress wave timing. Severe deterioration was found in nearly all main deck beams above the tween deck. Test results indicate that these beams have lost entire structural integrity and have potential to collapse in the near future, which poses a significant safety hazard. The main deck beams at the rear cargo hold area are mostly sound, with moderate to severe decay found at the end support areas.

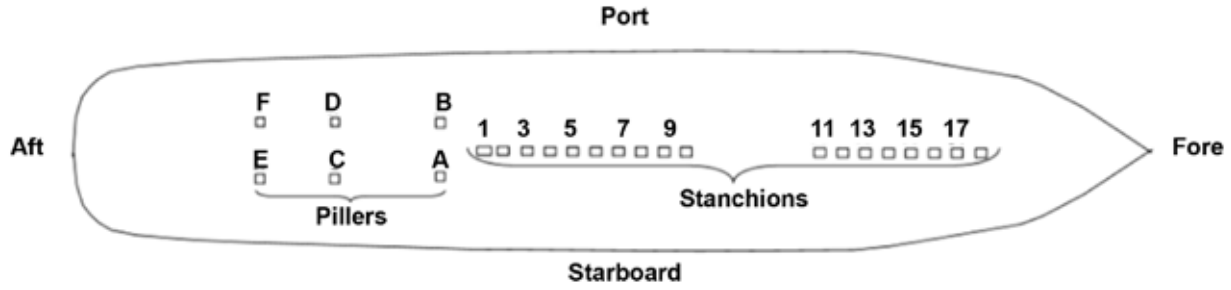
Figure 16. Location of pillars and stanchions on the ship (plan view).

Deterioration is present in most pillars, but varies at different levels (lower, middle, and upper). Pillars A and B show moderate deterioration in the lower level, decay in the middle level, and are sound in the upper level. Pillars C and D have areas of moderate deterioration and decay in the lower and/or middle level, whereas pillars E and F are found in sound condition in the lower level. Because pillars E and F could be accessed and tested only at one level of the ship, results are not conclusive for the entire members.

The hold stanchions were first visually assessed for deterioration, and then a subset of the members was spot-checked with stress wave transmission testing. The hold stanchions tested were numbers 1–3, 5, 7–10, 13–15, 17, and 20 (Fig. 16). Hold stanchions 1, 2, and 3 were found to have moderate decay, with stress wave transmission times ranging from 326 to 584 µs/ft. The remaining hold stanchions were found to be solid, with stress wave transmission times ranging from 179 to 200 µs/ft.
