AN INTERIM REPORT ON BOILING TESTS
OF
INSULATIONS FOR UNDERGROUND HEAT DISTRIBUTION SYSTEMS

Selden D. Cole and Paul R. Achenbach

NBS REPORT
6205

October 28, 1958

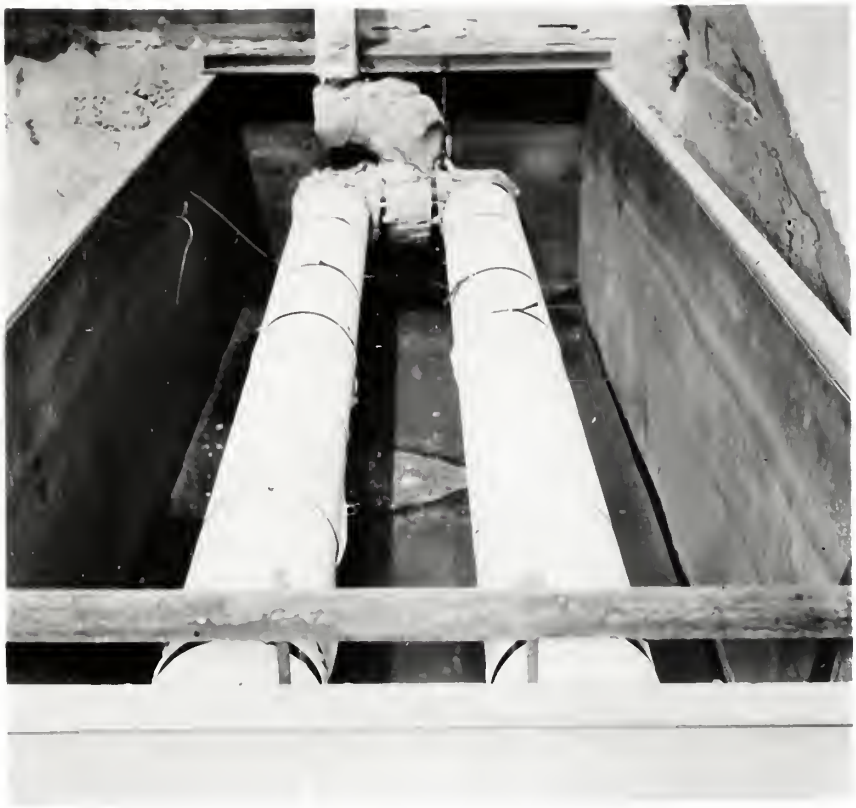
Figure 1

Amount fallen from pipe: Top half of 1st section fell off. Bottom half dropped down and resting on straps. 2nd section intact.

Reference to photographs: Fig 1 shows initial appearance; right specimen.
Fig 3 shows 1st section gone after 72 hours; right specimen.
Swelled appearance of 2nd section is primarily the stretched fabric covering.

Amount fallen from pipe: Parts of 2nd section. See Fig 3; left specimen. 1st section intact.

Cracks and ruptures: Insulation cut by wires on 2nd section and broken into pieces. Top half of 2nd section dislocated. See Fig 3; left specimen.

Reference to photographs: Fig 1 shows initial appearance; left specimen.
Fig 3 shows rupture of 2nd section as it appeared after 72 hr of boiling; left specimen.

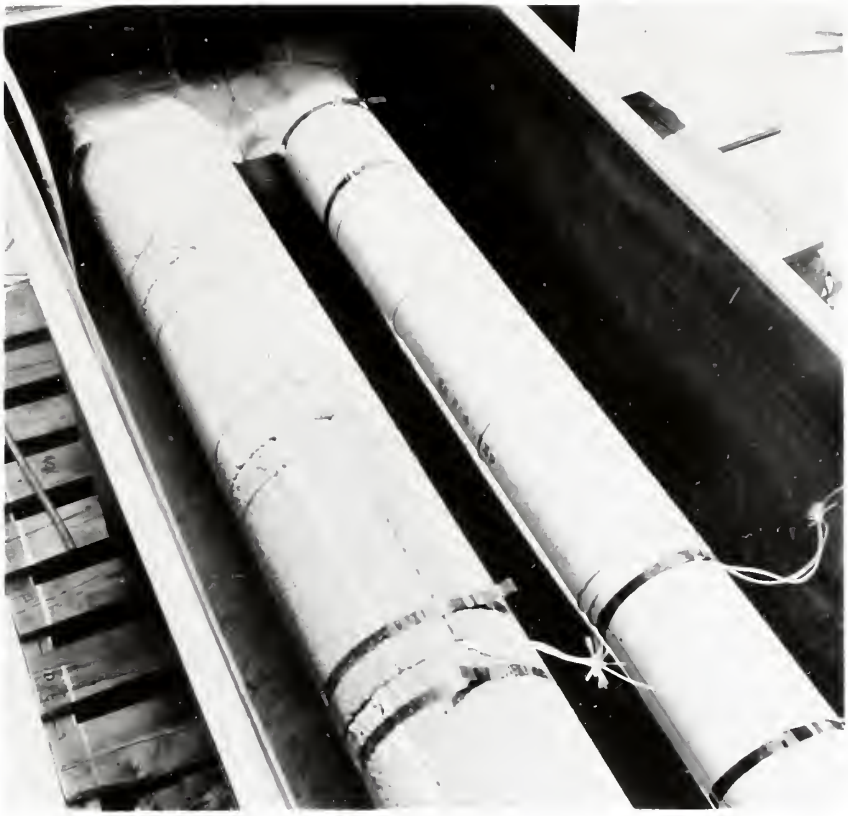
Figure 2

Eccentricity: 4th section cut by wire bands. Lower half dropped slightly from slack in wires.

Cracks and ruptures: Vibration of fourth section caused wires to cut into insulation, but it was not severed. See Fig 4; left specimen.

Reference to photographs: Fig 2 shows initial appearance; left specimen.
Fig 4 shows appearance after 72 hr boiling. Dislocation of 4th section from cutting by wires shown in left specimen.

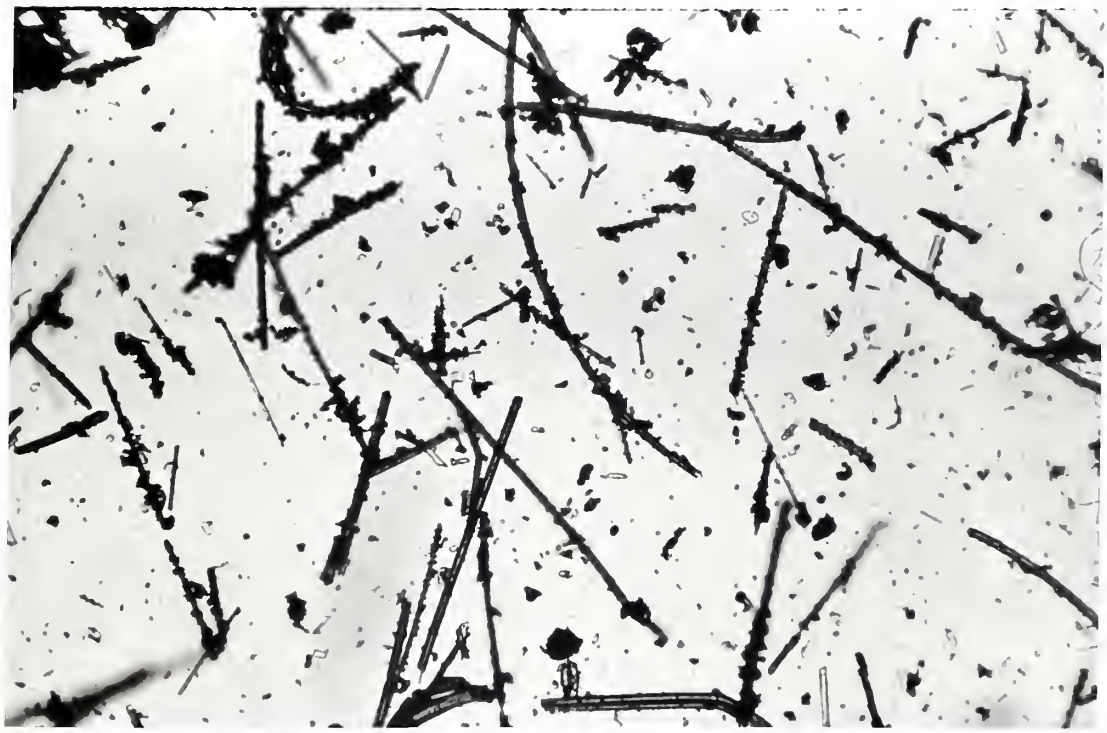
Figure 16a

Microscopic Examinations of Insulation: Samples of insulation were taken from the specimen at several locations after the test for microscopic examination. Microphotographs were taken of the glass fibers before and after boiling. Fig 16a shows the smooth, transparent, cylindrical appearance of the fibers when new. Fig 16b shows the appearance of the material near the surface of the envelope after boiling. It was broken into many short pieces, and appeared brown to the naked eye (perhaps the effect of the boiling water and steam on the oil treatment of the original material). Fig 16a and 16b are about 400 to 1 magnifications.

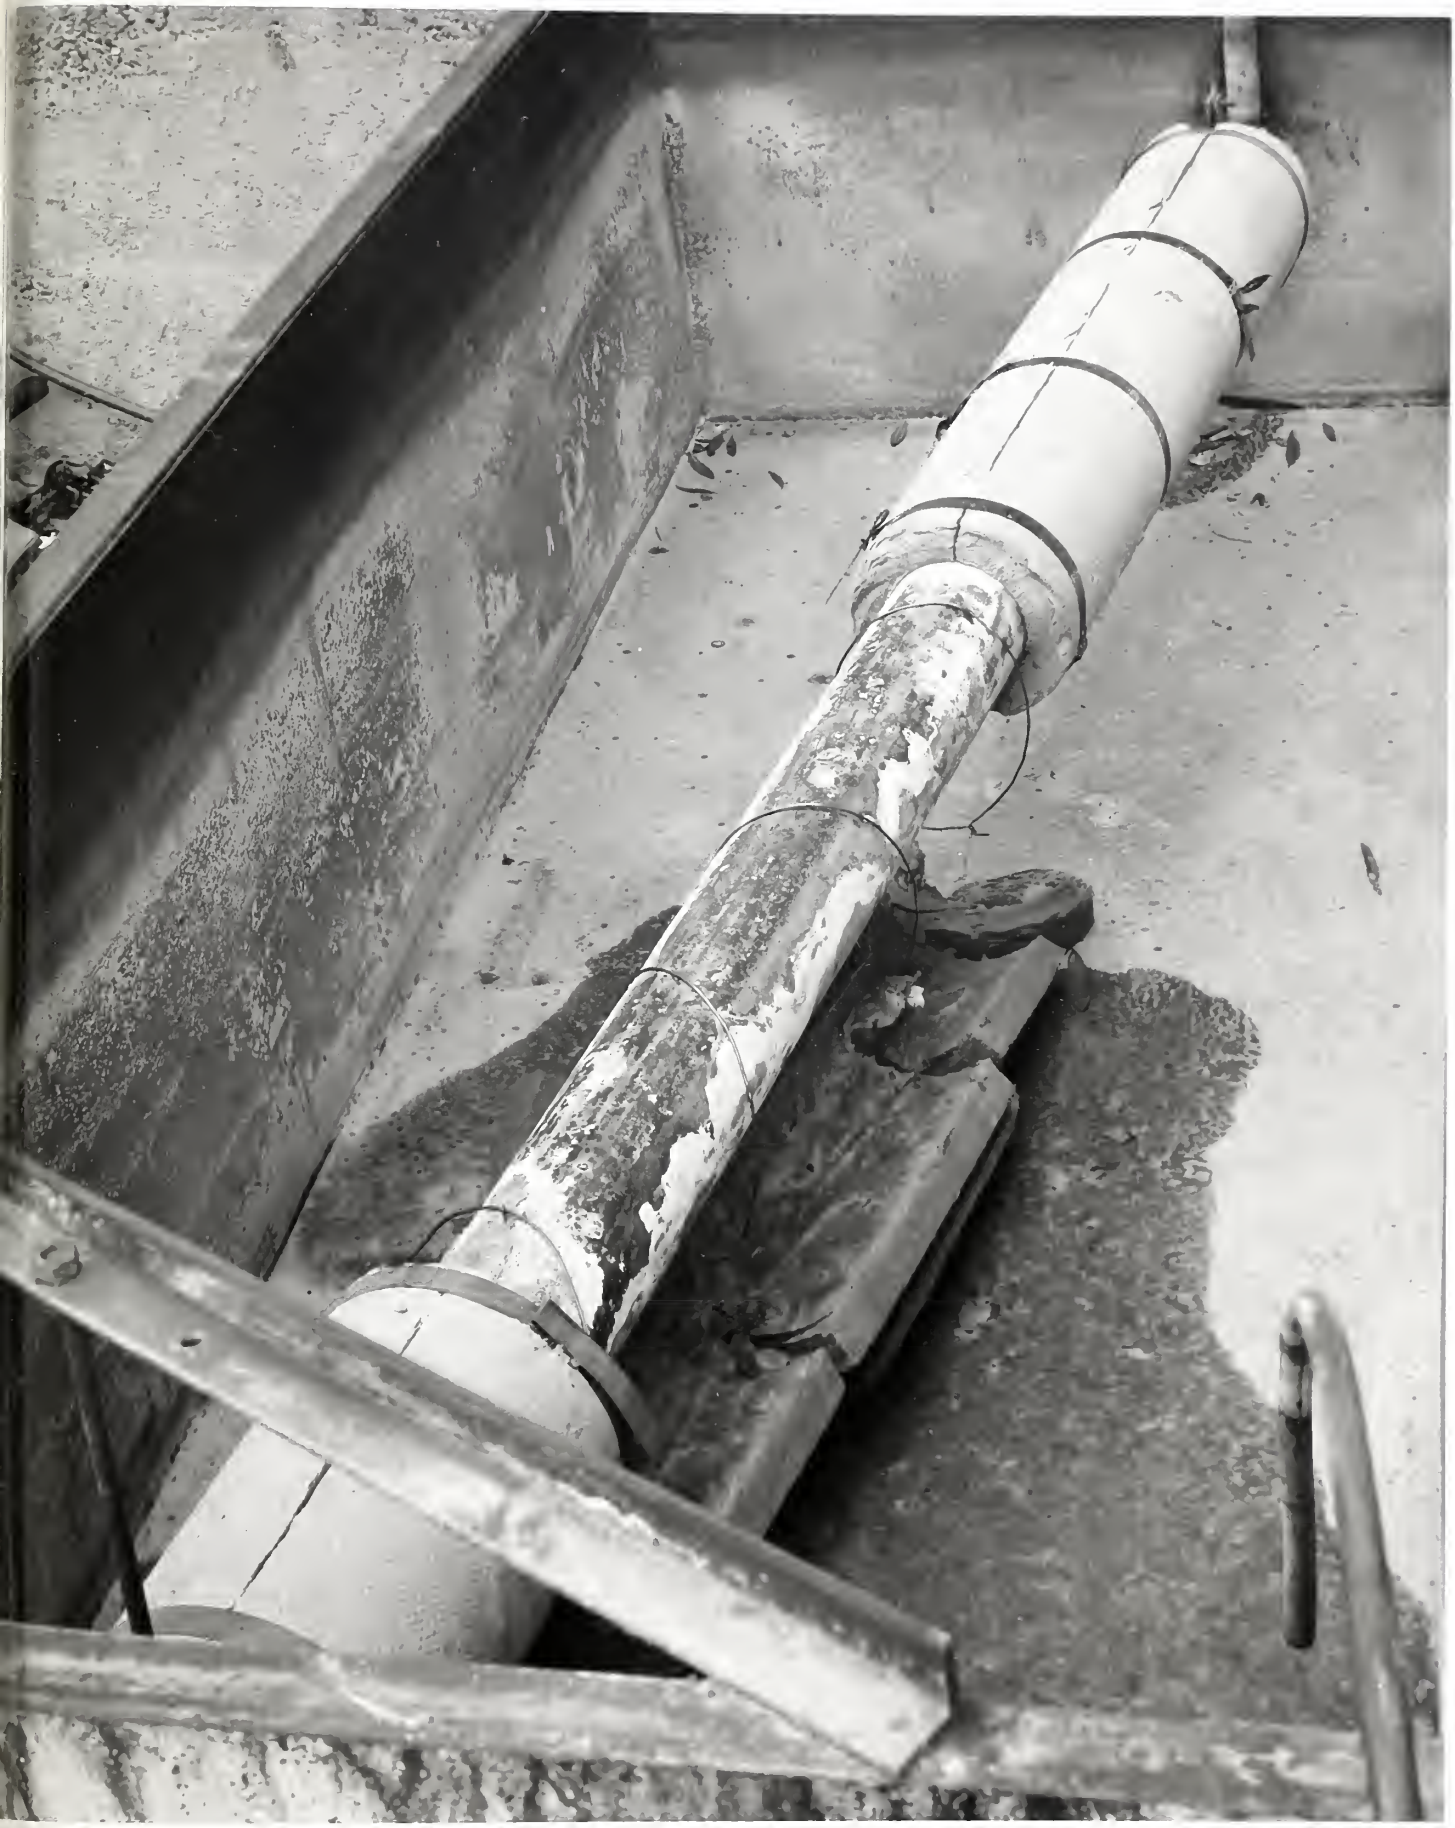
Figure 18

Amount fallen from pipe: After 72 hrs.
1st section, none.
2nd section, top half off pipe, part of bottom half.hanging by wires. Replaced with a new length.
3rd section, none

Other damage: After 144 hrs; 1st section; right side off pipe; part of left side hanging at bottom by straps.
After 72 hrs; replaced 2nd section; joints tight; joints show slight erosion at surface.
After 144 hrs; 3rd section; longitudinal joint tight.

Reference to photographs: Fig 18 shows the appearance of the insulation after 72 hours boiling. The first section, secured with straps, shows slight erosion and fraying. The second section, secured with wires, had separated from the pipe and a part had fallen into the bottom of the tank.
