Fire Resistance of Walls of Gravel-Aggregate Concrete Masonry Units

United States Department of Commerce
National Bureau of Standards
Building Materials and Structures Report BMS120

Building Materials and Structures Report 120

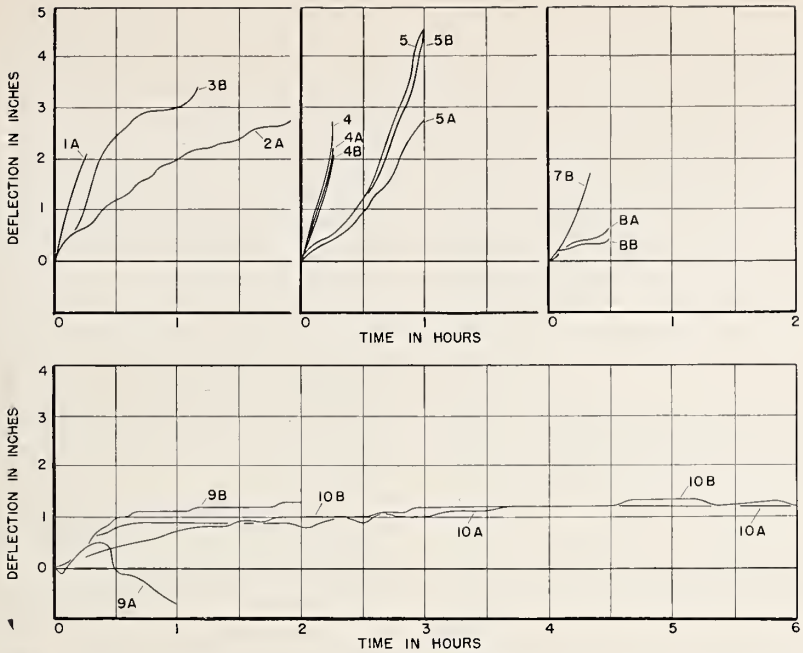
FIGURE 5. *Lateral deflections at centers of gravel-aggregate concrete masonry test walls.*

The fire endurance of the wall was limited by its failure under load at 1 hr 16 min. The deflection and temperature curves are given in figures 5 and 9.

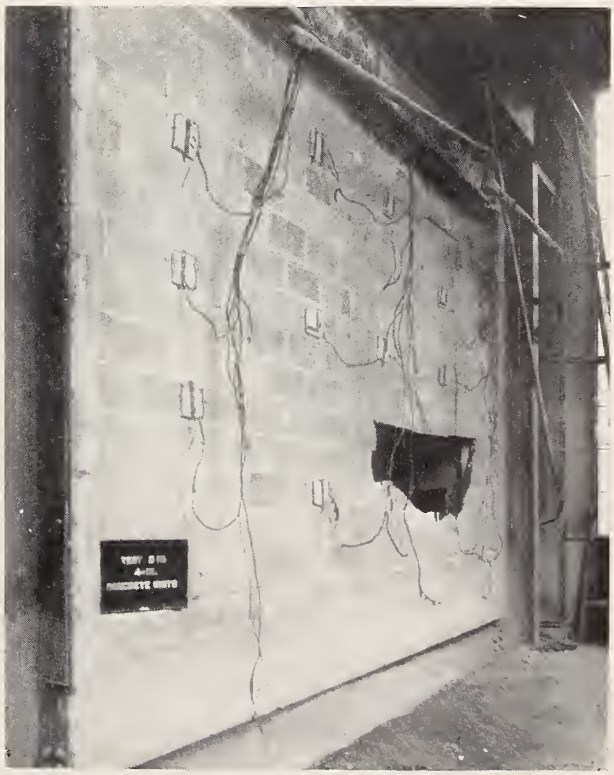
FIGURE 6. *Unexposed side of 4-in. unplastered nonload-bearing wall 1 after fire-endurance test.*

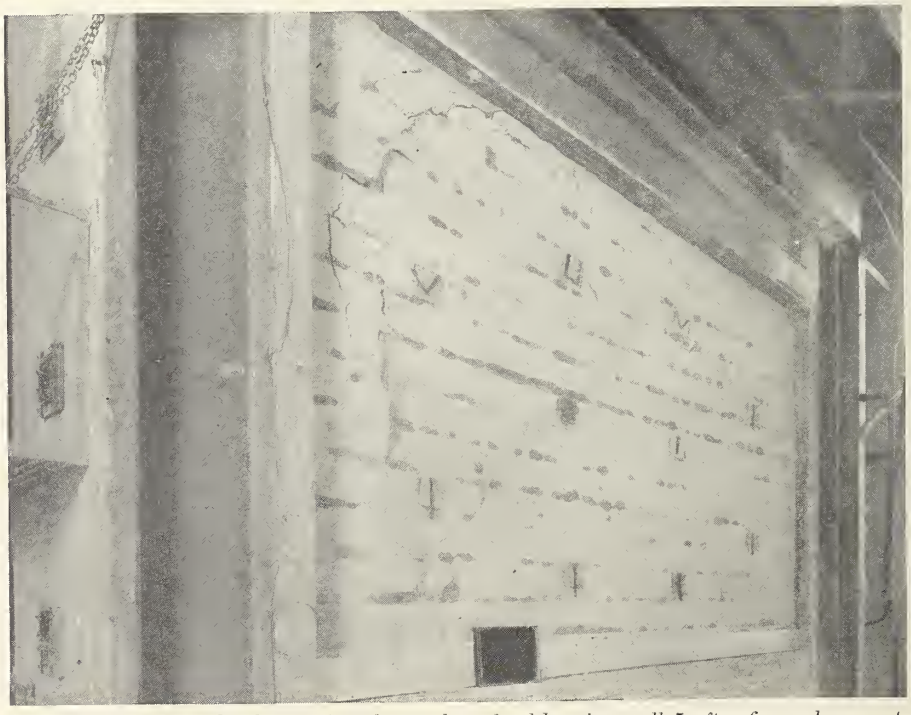
Horizontal cracks extending the length of the test partition, 3½, 5½, and 9½ ft from the lower edge of the unexposed side plaster, appeared at 5, 10, and 19 min, respectively. At 16 min, wet spots outlining the mortar joints, began to show in the unexposed plaster. At 25 min, steam was issuing at cracks. At 35 min, some of the plaster near the middle of the unexposed side loosened but did not fall. At 58½ min, due to the restraint, some of the units at midheight and near one end of the partition failed by crushing. This condition is shown in figures 7 and 8.

The fire endurance of the partition was limited by its structural failure at 58½ min. The deflection and temperature curves are given in figures 5 and 11.

FIGURE 7. *Exposed side of 4-in. plastered nonload-bearing wall 5 after fire-endurance test.*

FIGURE 8. *Unexposed side of 4-in. plastered nonload-bearing wall 5 after fire-endurance test.*

The 4-in. plastered nonload-bearing wall 5, built of units made with siliceous aggregates, failed near one end at 58½ min by the crushing of individual units. This fire endurance can be increased from 58½ min to 59½ min by correcting for the high severity of the fire exposure.[7] With this correction and the usual tolerance allowance, this wall would be considered as having a fire endurance of 1 hr and be required to meet the hose-stream test requirements. Although the deflection at the center of the wall was approximately 5 in. just before failure occurred, it was only 1.2 in. at 30 min, which is the fire exposure required when a duplicate specimen is used for the hose-stream test. The margin of stability thereby shown, taken together with the general experience with hose-stream tests applied to masonry partitions, indicates that the hose-stream requirements probably would have been met after a 30-min fire exposure, although in the absence of a test this cannot be assured.
