NATIONAL BUREAU OF STANDARDS REPORT

10 017

Examination of

M513/M514 FUSE SLEEVES

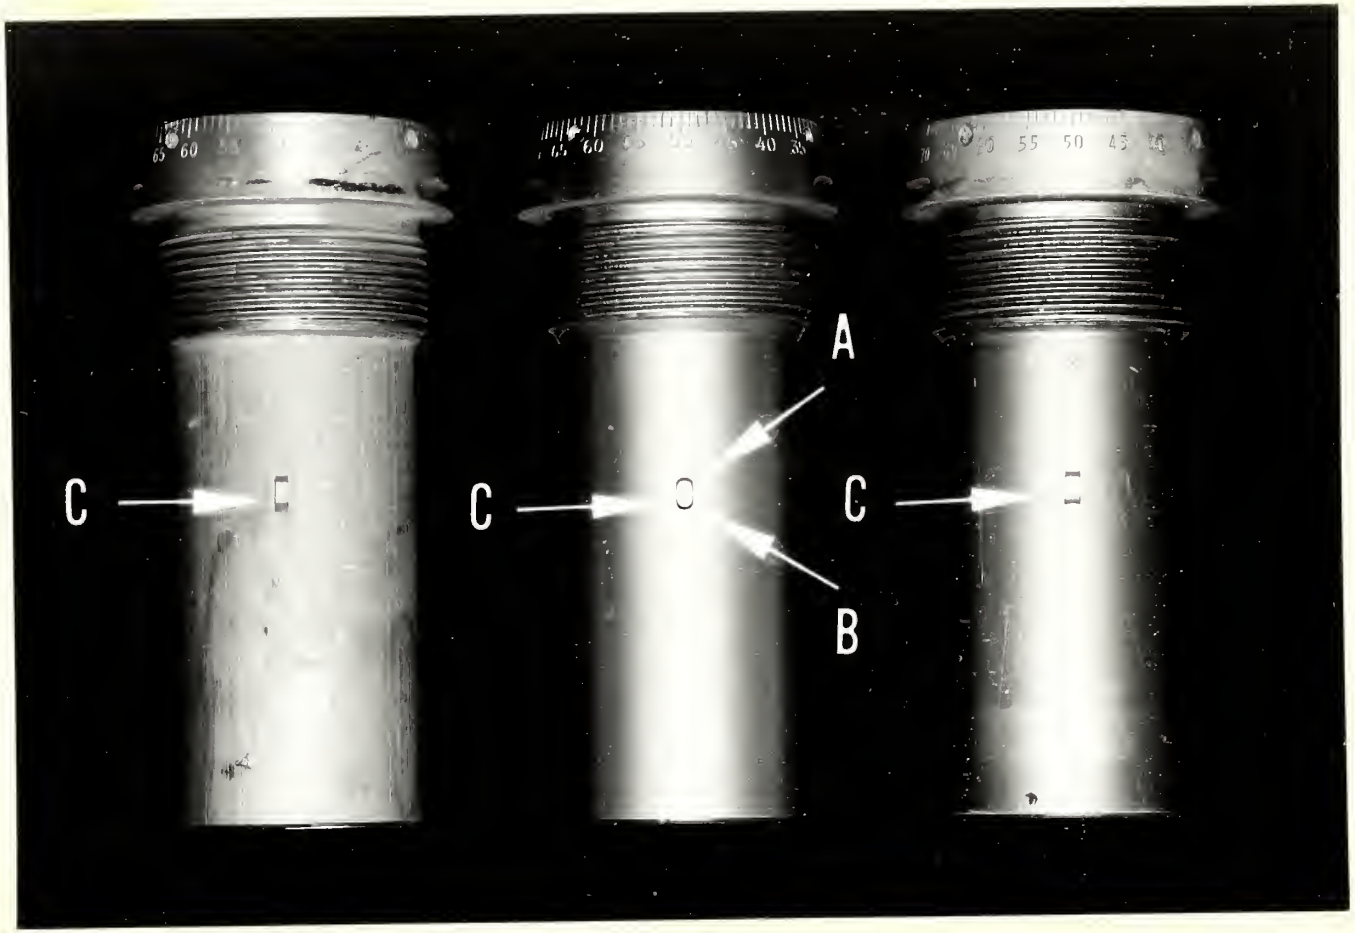
In figure 1, 16 of 33 fuse sleeves of type N fracture during tension testing occurred through the area marked by arrow (B), whereas in the other 17 N's fracture occurred at the position indicated by arrow (A). The failure at these two different areas indicated by arrows (B) and (A) in figure 1, could be attributed to the fact that underside of the semi-perforation, figure 4, did not have as sharp a radii as the top of the semi-perforations. The radii that existed at the top of N, figure 4, were apparently equal. Therefore, if cracks were present on the underside of the semi-perforation type N, the fracture would occur through the

Figure 1. Fuse sleeves in the as received condition. Sleeve on left is type ΔHP, in the middle, type N, and on the right, type ZW. The arrows (C) indicate the item, the semi-perforation, which was investigated on each of the fuse sleeves submitted. Arrow (A) indicates the area through which 53 fuse sleeves, type ΔHP, N and NB, failed during tensile testing. Arrow (B) indicates the area through which 16 of 33 type N fuse sleeves failed during tensile tests.

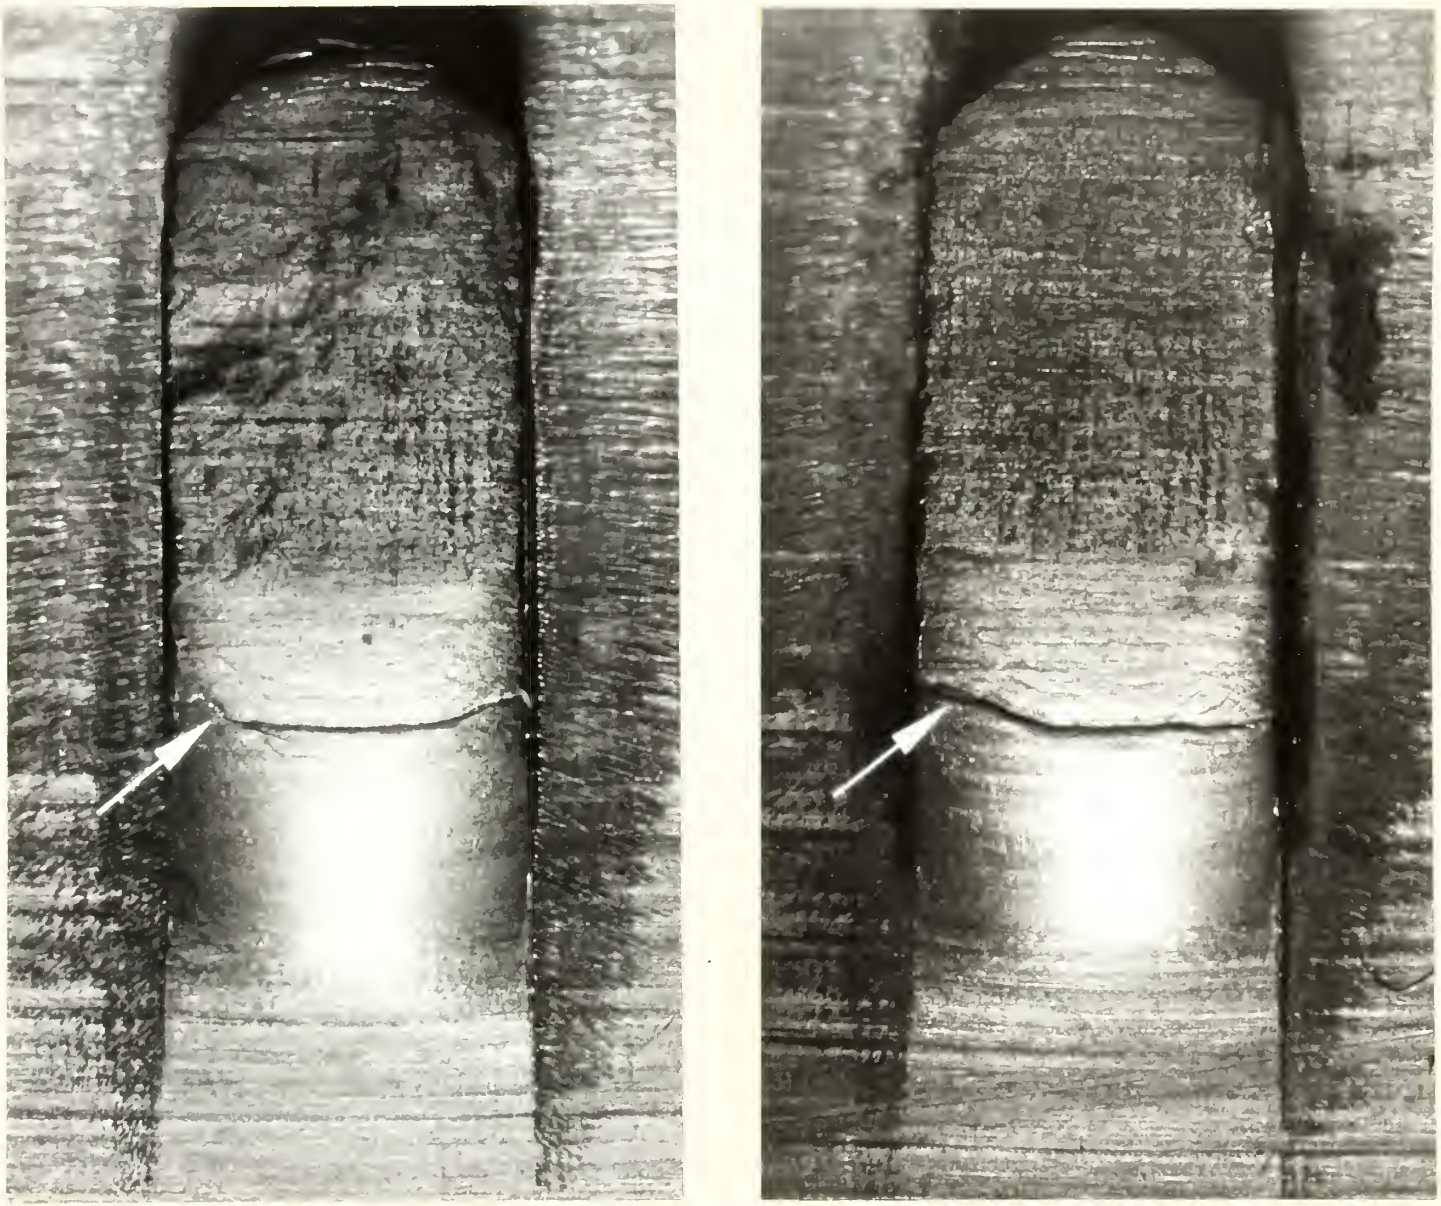
Metallographic Examination: Fuse sleeves 24 to 32 were given a metallographic examination. The sleeves were cut to reveal sections through the semi-perforations. Cracks, as indicated by the arrows in figures 2 and 3, were observed on the underside of the semi-perforations. In figure 3, the crack appears to have opened more after firing. The fuse sleeves were then sectioned longitudinally through the center of the semi-perforation. Photomicrographs of the sectioned semi-perforations are shown in figures 4 to 8. In figure 4, cracks as indicated by arrows (A), were observed on the underside of the semi-perforations in both the fired and unfired conditions. In figures 5 and 6, cracks, as indicated by arrow (A), were observed on the underside of the fuse sleeves where a sharp radius is present. However, in figure 7, the more generous radii as shown by arrows (A) and (B) in the type ZW semi-perforation appear to have been produced by the manufacturers' processing. Cracks were not found in this fuse sleeve.

Figure 3. Photographs of underside of semi-perforation of type N. Photograph on left is of the unfired condition, on the right, of the fired condition. Arrows indicate cracks. Unetched, X 20.

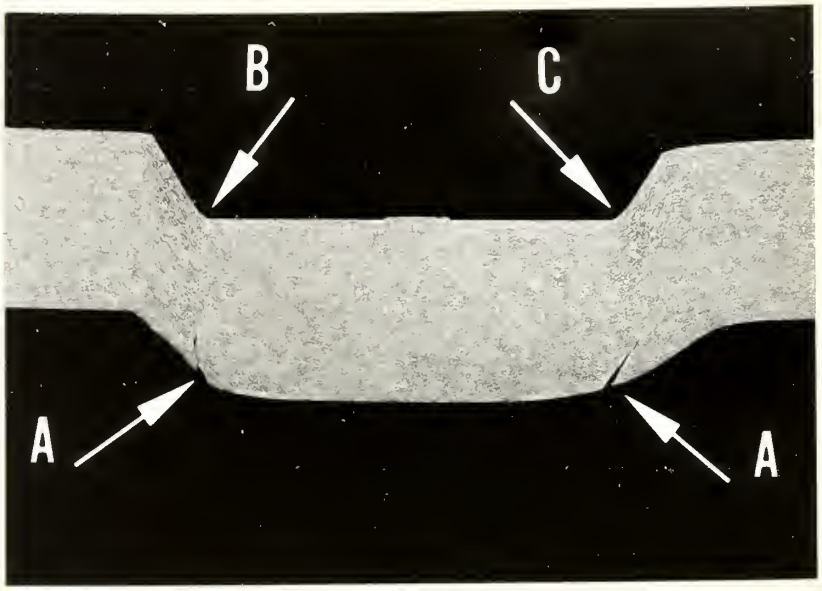
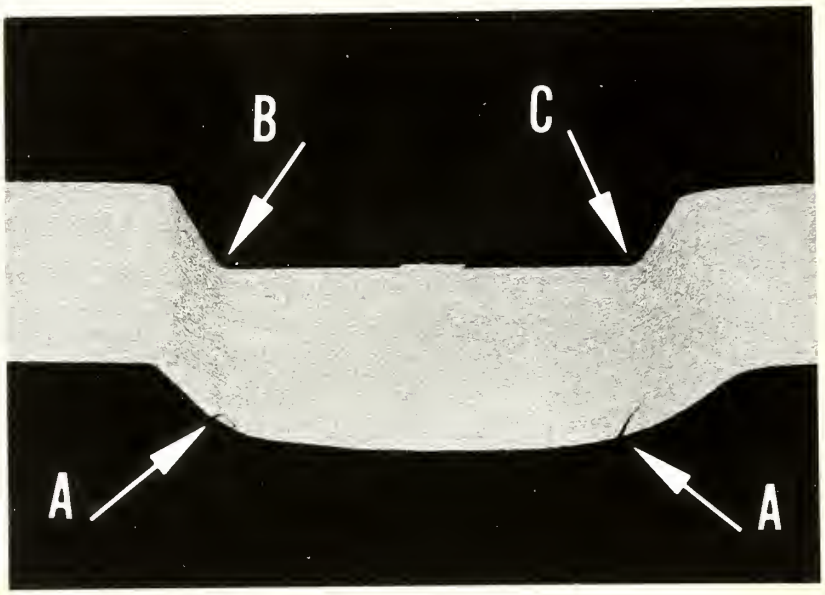
In the metallographic examination of fuse sleeves 24,25,26, and 27 (ΔHP's) and 32 (NB), cracks were observed, figures 5 and 6, only at the sharp radii on the underside of the semi-perforations. However, in the fuse sleeves, 28 and 29 (N's), which were metallographically examined, figure 4, the sharp radii existed at the top of the semi-perforation. The areas of sharp radii in type N were crack free, but cracks were observed on the underside of the semi-perforation on the smooth radii indicated by arrows (A) in figure 4.

Figure 4. Longitudinal sections of fuse sleeves type N, not tensile tested. Photograph (1) is of the fired condition, and (2) of the unfired condition. Arrows (A) indicate location of cracks observed on the underside of the fuse sleeves. Arrows (B) and (C) are locations of sharp radius. Sixteen type N fuse sleeves failed through area (C) and seventeen failed through area (B) during tensile tests. Etched, Keller's, X 12.

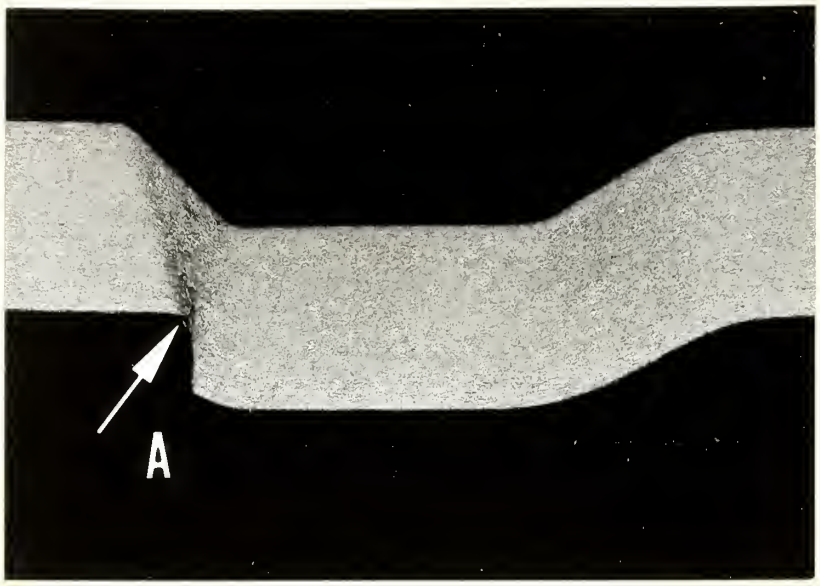
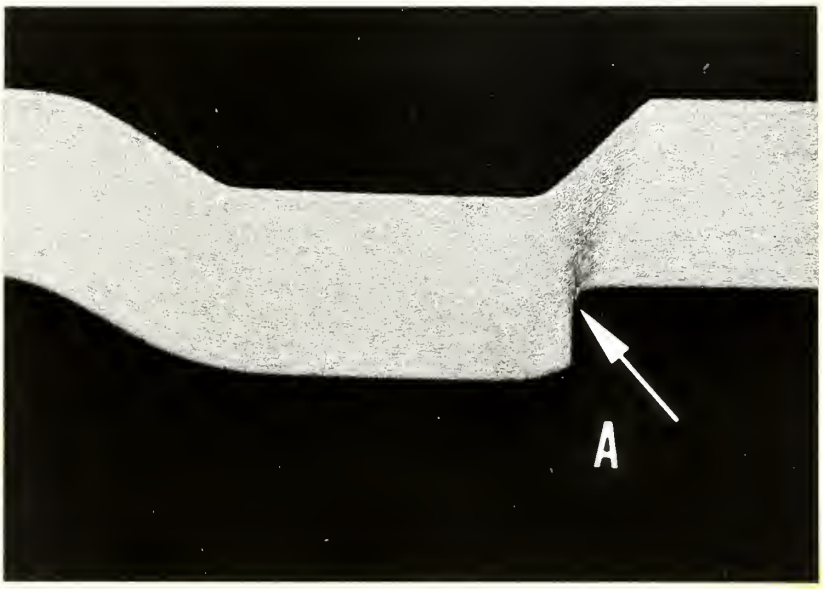
Figure 5. Longitudinal sections of fuse sleeve type ΔHP, not tensile tested. Photograph (1) is of the fired condition, and (2) of the unfired condition. Arrow (A) indicates area through which failure occurred during tensile tests, and area of a crack and sharp radius. Etched, Keller's, X 12.

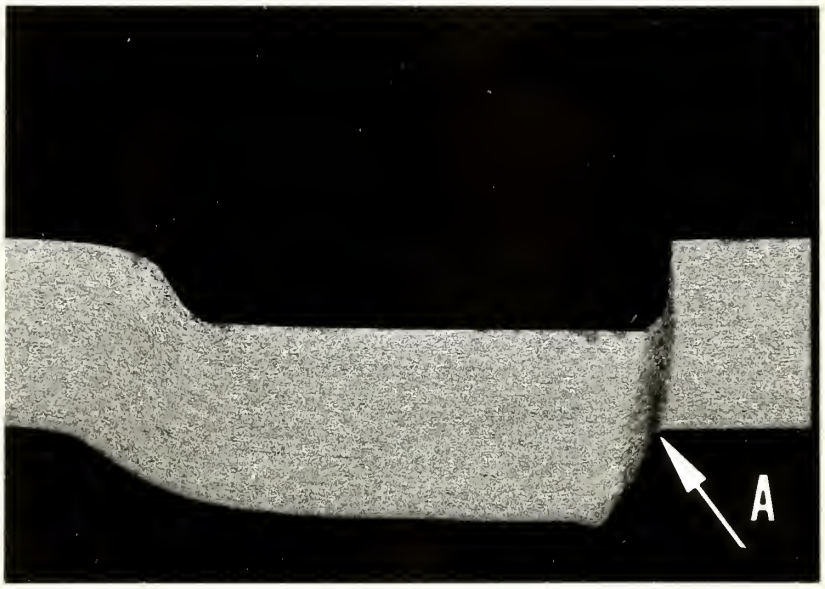
sharp radius adjacent to the larger of the pre-existing cracks. In fuse sleeves type ΔHP and NB, which were tested in tension, fracture occurred only through the area indicated by the arrow (A) figures 1, 5 and 6. This area of fracture initiation has sharp radii and apparently had initial cracks present such as those shown in figures 5 and 6, by arrow (A). The presence of a sharp radius and a crack are stress concentrators, and during tensile tests, failure would tend to occur through this area of the semi-perforation. Due to these stress concentrators, the breaking loads obtained on types ΔHP, NB, and N should be lower than those of a fuse sleeve which did not have a sharp radius and a crack present, such as in type ZW, figure 7.

Figure 6. Longitudinal sections of unfired fuse sleeve of type NB, not tensile tested. Arrow (A) indicates area through which failure occurred during tensile test and area of a crack and a sharp radius. Etched, Keller's, X 12.

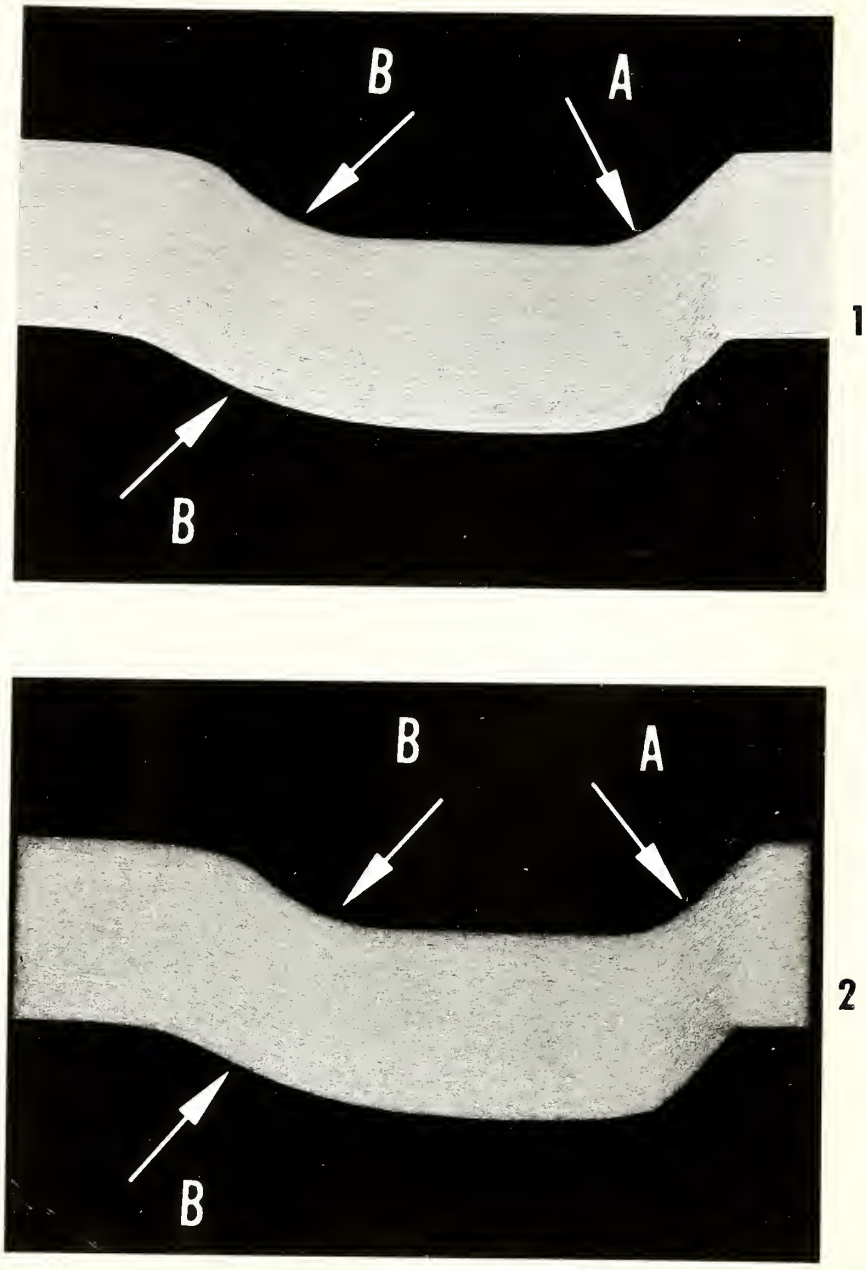
Figure 7. Longitudinal sections of fuse sleeve type ZW, not tensile tested. Photograph (1) is of the fired condition and (2) of the unfired condition. Arrows (A) and (B) indicate areas of smooth radius. Arrow (A) also indicates area through which fracture occurred during tensile tests. Etched, Keller's, X 12.

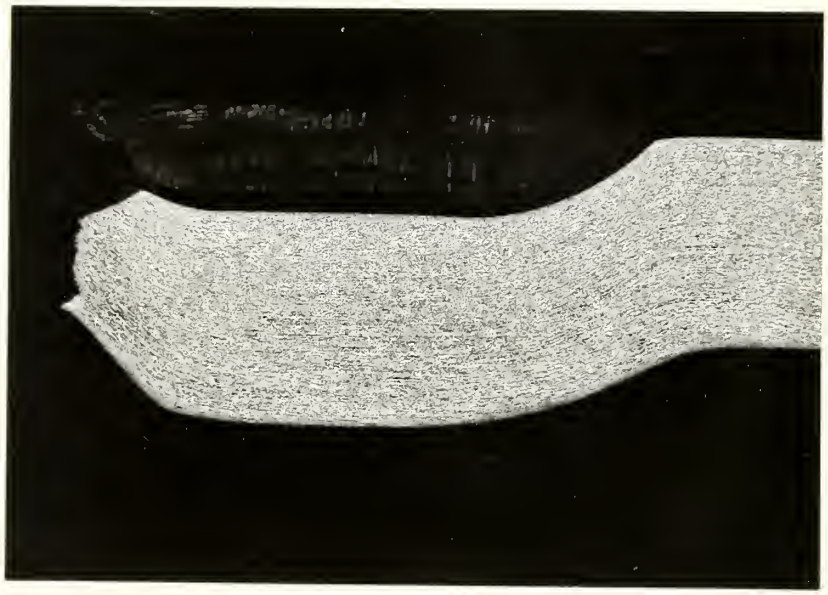
Figure 8 is a photomicrograph of type ZW which had been pulled in tension and then longitudinally sectioned. No cracks were observed, however HDL investigators are reported to have observed cracks in this particular fuse sleeve. It is possible that a prior existing crack may have initiated the main fracture and hence would no longer be visible.

Figure 8. Longitudinal section of fuse sleeve of type ZW after the fuse sleeve was tensile tested. Note absence of cracks on both the top and underside of the semi-perforation. Etched, Keller's, X 12.
