NBSIR 75-641

Performance of Mobile Homes Data Acquisition and Analysis Methodology

February 1975

Interim Report

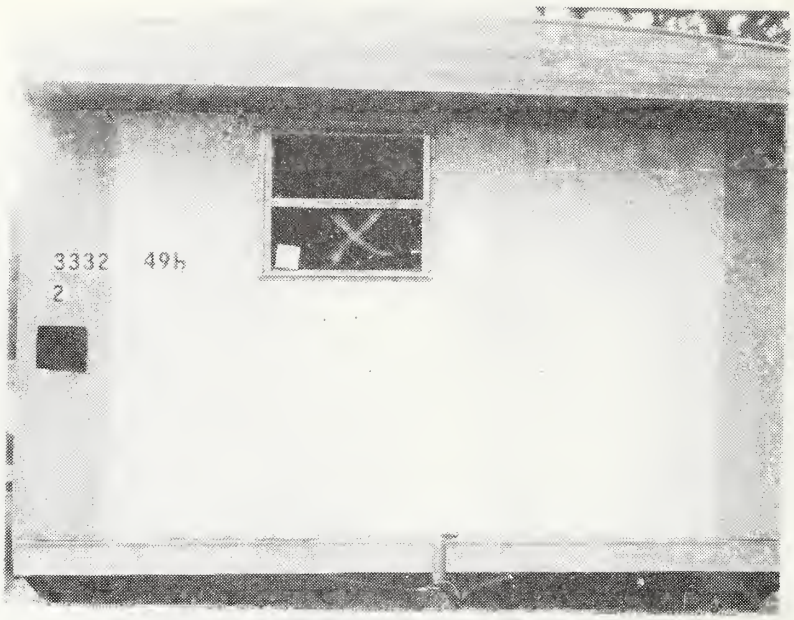
Figure 1 - Front of Mobile Home

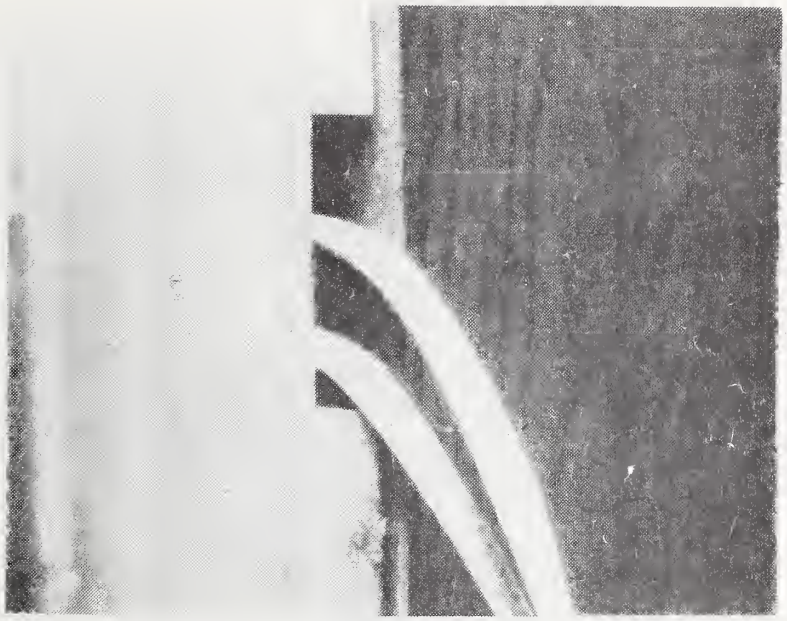
Figure 2 - Light Fixture in Area of Water Damage Pulled Loose from Ceiling

Figure 3 - Electrical Wiring Passing Through Stud Unprotected

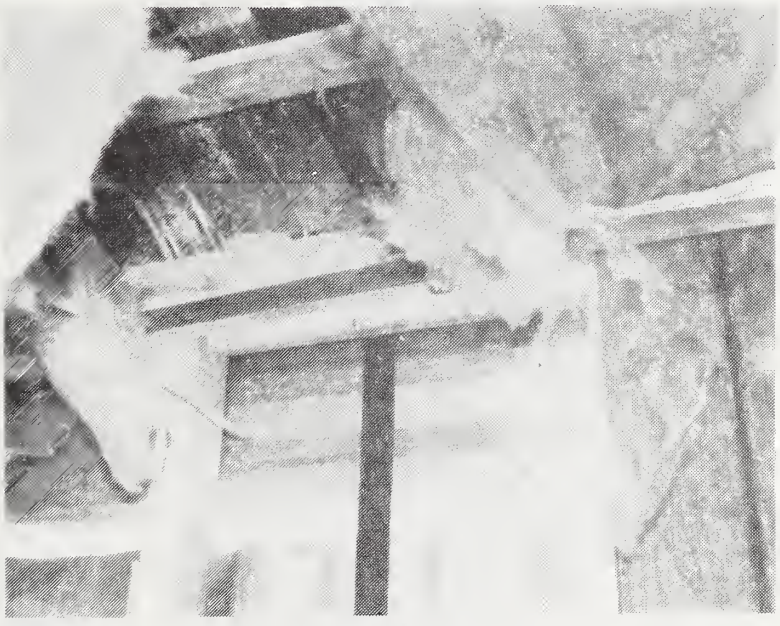
Figure 4 - Hurricane Strap in Exposed Roof and Wall Construction
