NATIONAL BUREAU OF STANDARDS REPORT

7387

Test of the Mobilization Structure
Under Sustained Uniformly Distributed Load

Bureau of Yards and Docks
Department of the Navy

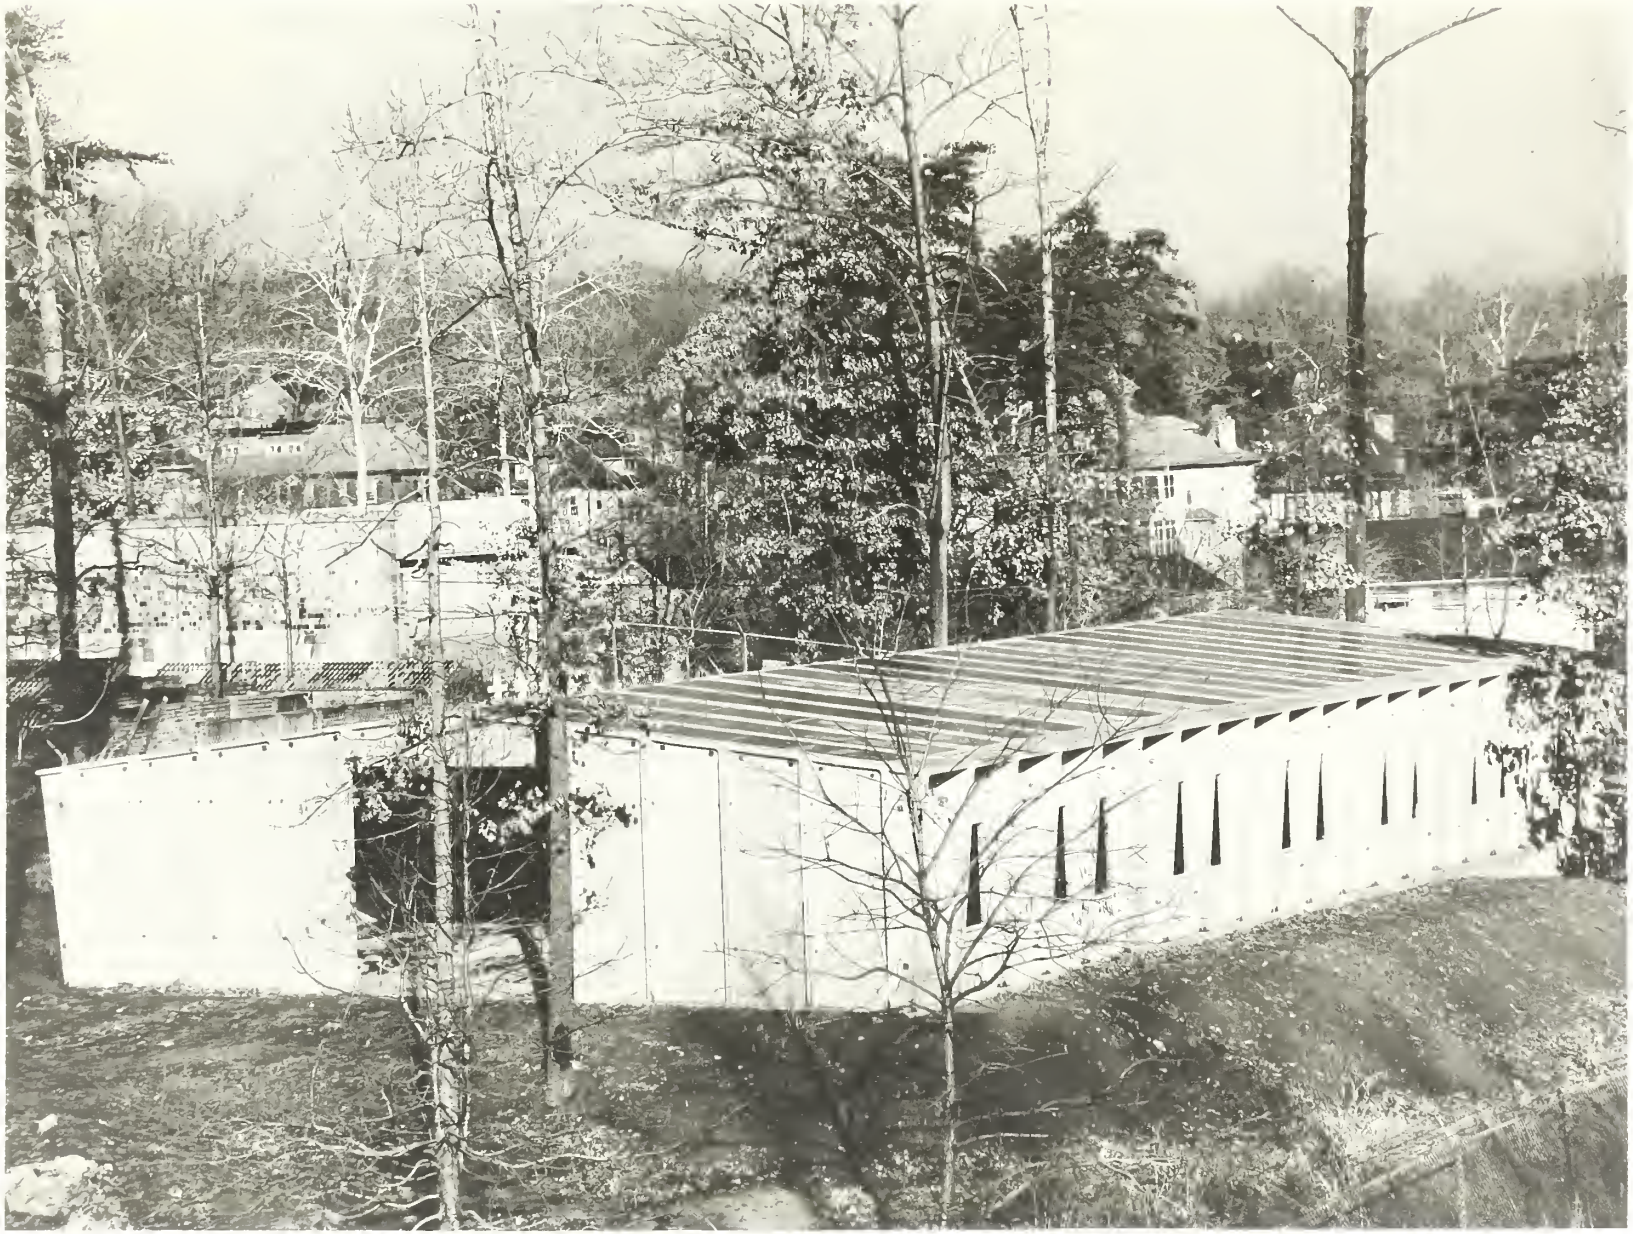
This system of moving the panels proved successful in that no panels were lost through breakage or severe damage. However, two objectionable features resulted from the use of this system. Cracks developed across the webs of each roof panel between opposite pairs of inserts. These cracks indicate that a plane of weakness was created by the insert cavities. After erection of the building was completed the insert cavities were filled with dry grout. These grout plugs appeared sound prior to the winter season, but after a number of cycles of freezing and thawing the bond between the panels and the plugs was destroyed to such an extent that the plugs could be simply lifted out of the cavities. These results indicate that the panels must be adequately reinforced in the vicinity of the embedded inserts, and that greater care must be taken in grouting the insert cavities. In the future, the insert cavities will receive a coating of epoxy/Thiokol adhesive prior to grouting, a system which proved to be successful in grouting welded joints of precast concrete panels - (See NBS Report 6682).

Another problem brought about by the use of the bolt system is that each bolt exposed to weathering is a source of water leakage during rainy weather. The bolts at the knee joints in particular exhibited a tendency to permit the passage of water. The reason for this is that water running off the roof follows the contour of the upper wall section and passes through the bolt holes. The same problem is evident at the bolted connections between wall panels but with less severity than was observed at the knee joints. The elimination of exposed bolts would, of course, be the ideal solution to the problem and future design considerations should be directed towards this end.

FIG. I. MOBILIZATION STRUCTURE

FIG. 3. ROOF PANEL BEING SWUNG INTO POSITION

FIG. 4. BOLTING ROOF PANELS TOGETHER AT RIDGE JOINT

FIG. 5. BOLTING ROOF TO SIDE WALL PANELS AT KNEE JOINT

FIG. 6. WELDING ROOF TO SIDE WALL PANELS AT KNEE JOINT

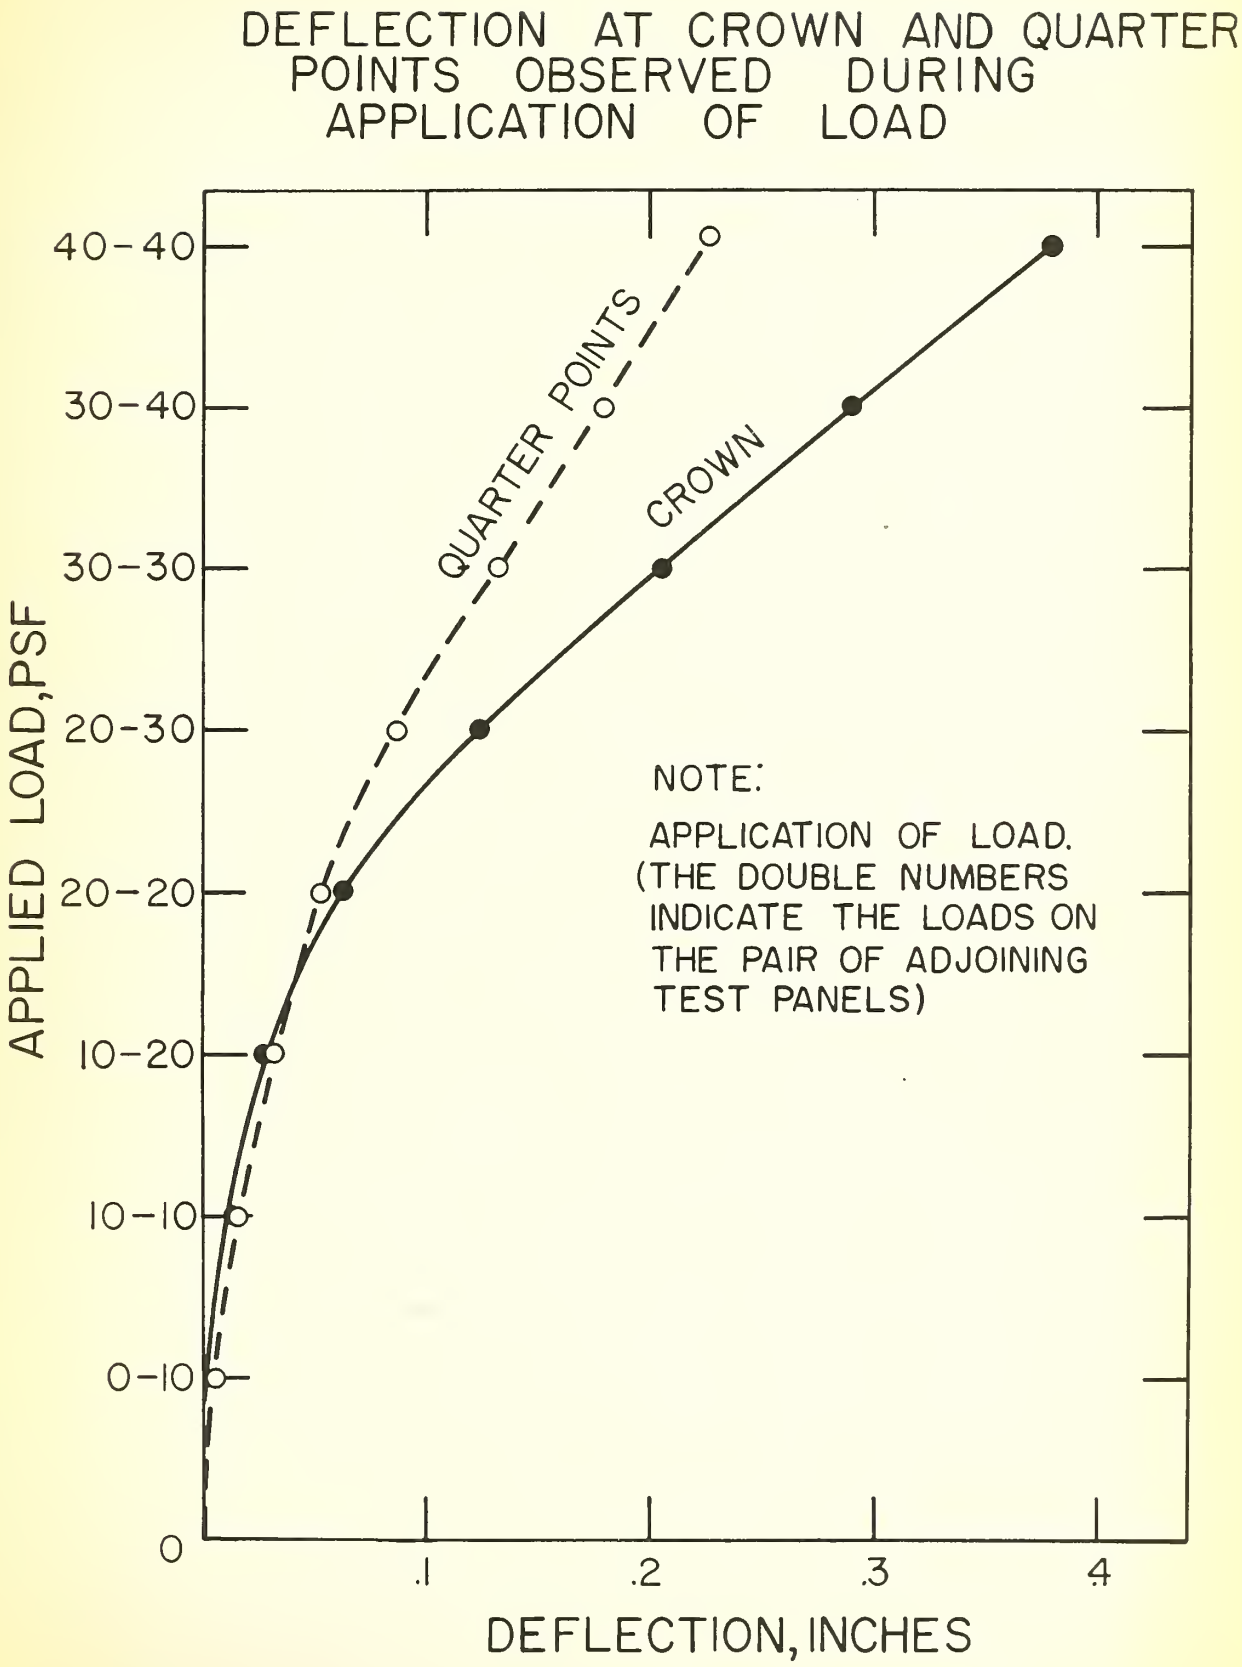
FIG. 7

The differential deflections anticipated as a result of alternate bent loading did not materialize. Figure 7 indicates the deflection vs. applied load at the crown and quarter points. The applied load notation refers to the amount of load applied to each bent (i.e., 0-10 means 0 psf on the north bent and 10 psf on the south bent). Although these curves represent the average deflection across the profile of each station, the load-deflection curves were essentially identical for individual bents.

Side wall movements did not become significant until the entire live load was applied. Measurements made at the kneee joints (8 ft above the floor level) indicated an average outward movement of .045 in. at maximum load. Measurements made 2 in. above the floor indicated an average outward movement of .002 in. at maximum load.

1. The instantaneous deflections at maximum load of the crown, quarter points and knee joints were .380, .236, and .045 in. respectively with no differential deflections observed due to alternate bent loading.

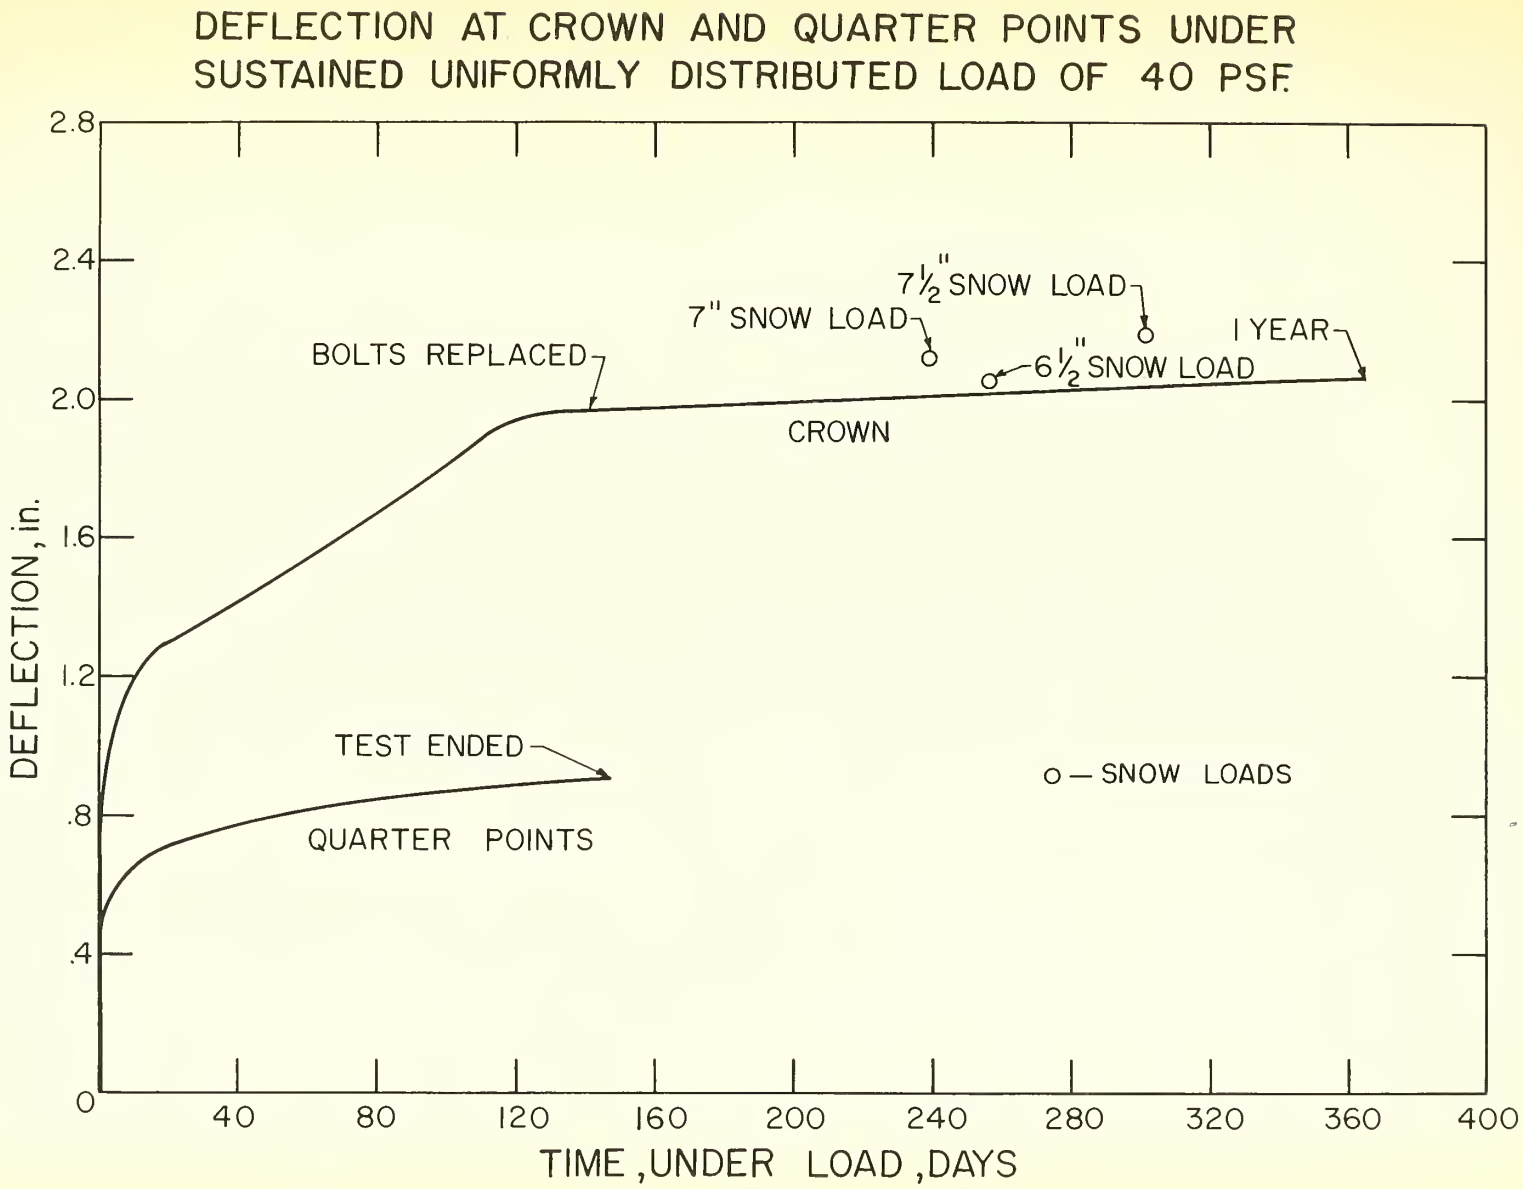
FIG. 8

Figure 8 is a graphic presentation of the deflection at the crown and quarter points plotted against the duration of sustained load. The deflection at the crown increased at a rapid rate for the first 20 days. The rate of increase became essentially linear for the next 100 days. From the 120 day period until the structure was under test for a year the deflection at the crown increased at a rate of approximately .01 in. per month, with a total one year deflection of 2.07 in.

The quarter point deflection measured just after application of the 40 psf load was .23 in. This initial deflection doubled after one day and increased to .92 in. after 148 days. As previously mentioned, mechanical difficulties necessitated the elimination of these gages after 148 days.

The deflections observed at times when the structure was subjected to various snow loads are indicated on figures 8 through 10. The deflection observed during the first snow load of 7 in. shows an expected increase in deflection at the crown accompanied by lateral movement of the side walls. The second snow load of 6.5 in. was preceded by heavy rainfall and a sudden freeze. This unusual moisture condition in the panels and formation of ice in the open joint between the test bents and the rest of the structure resulted in erratic movements at all gage stations. The third snow load of 7.5 in. was preceded by dry weather and the observed deflections conformed to those normally expected. The snow loadings did not appear to produce any lasting effects as deflection recovery occurrred after each thaw.

2. The equilibrium deflection at the crown was reached 5 months after application of the 40 psf test load and was approximately 2 in.

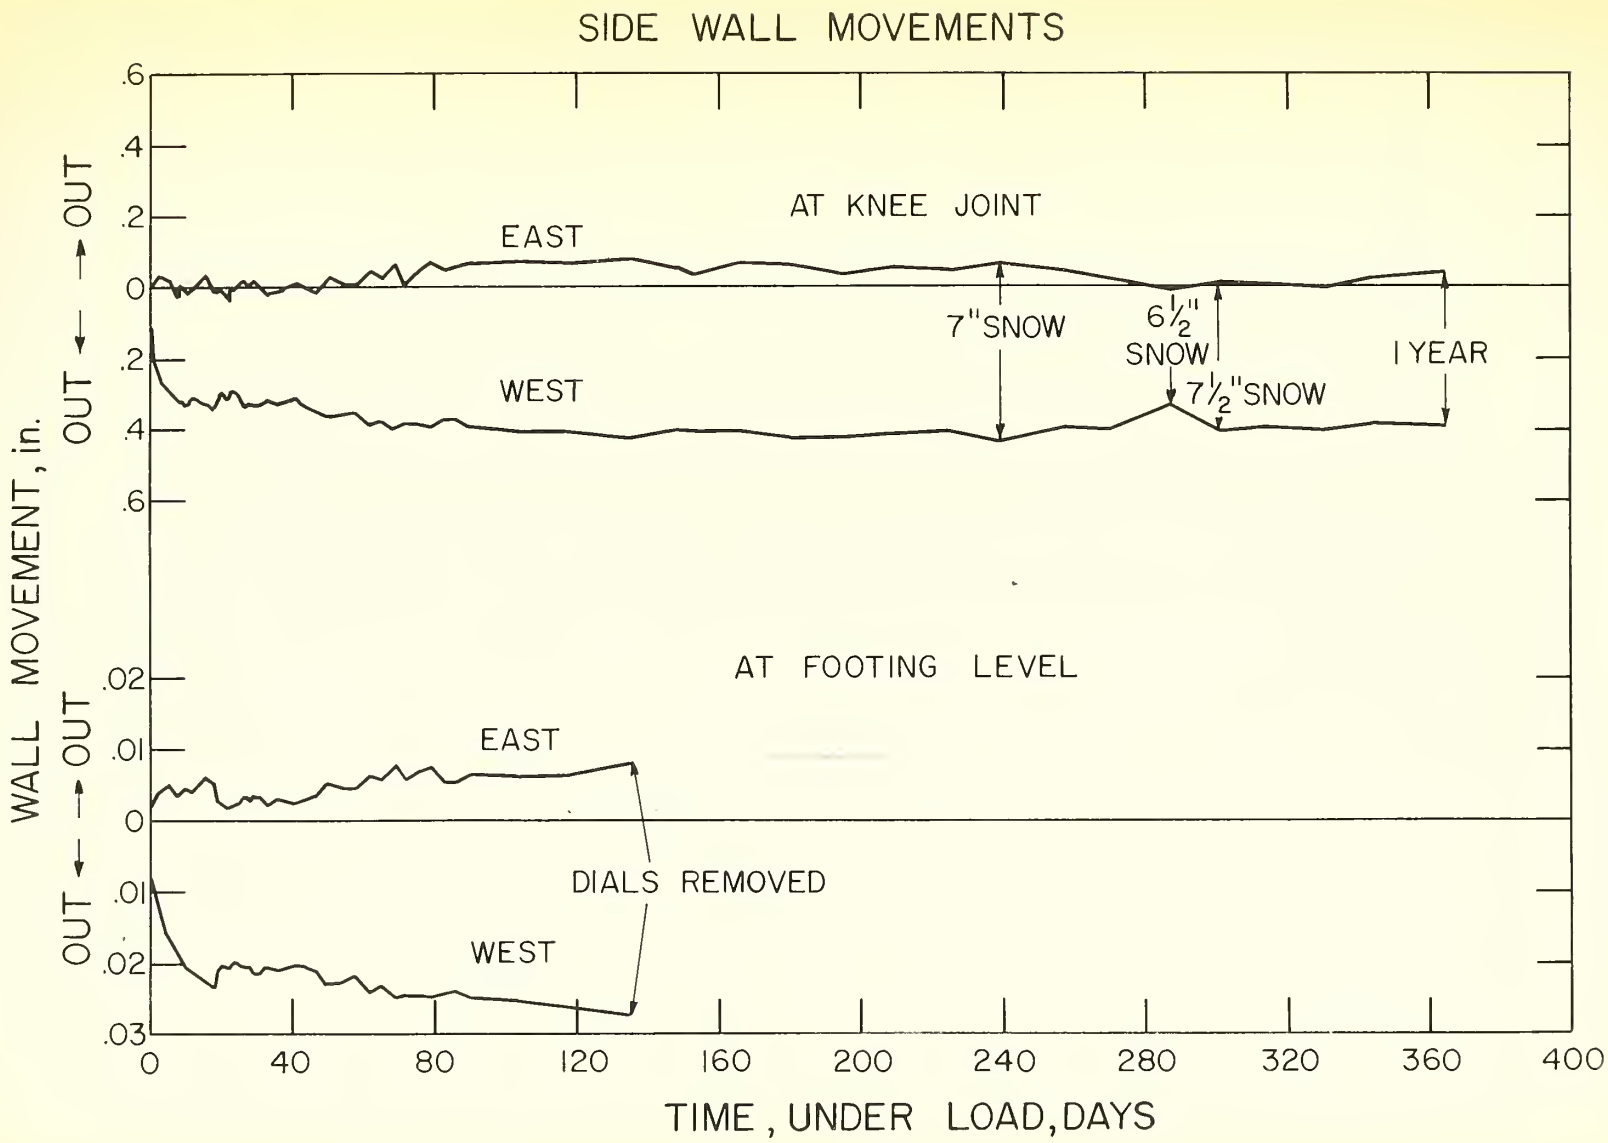
FIG. 9

Side wall movements at the knee joints and footings are shown in figure 9. Very little lateral movement was observed at the knee joint in the east side wall, the maximum being .08 in. 135 days after the beginning of the test. The west side wall stabilized to an average outward movement of .4 in. approximately 3 months after the beginning of the test. Side wall movements measured at the footings followed the displacement pattern observed at the knee joints.

3. Side wall movements were only significantly large at the west wall which attained a maximum stable deflection of 0.4 in. 3 months after initiation of the test.

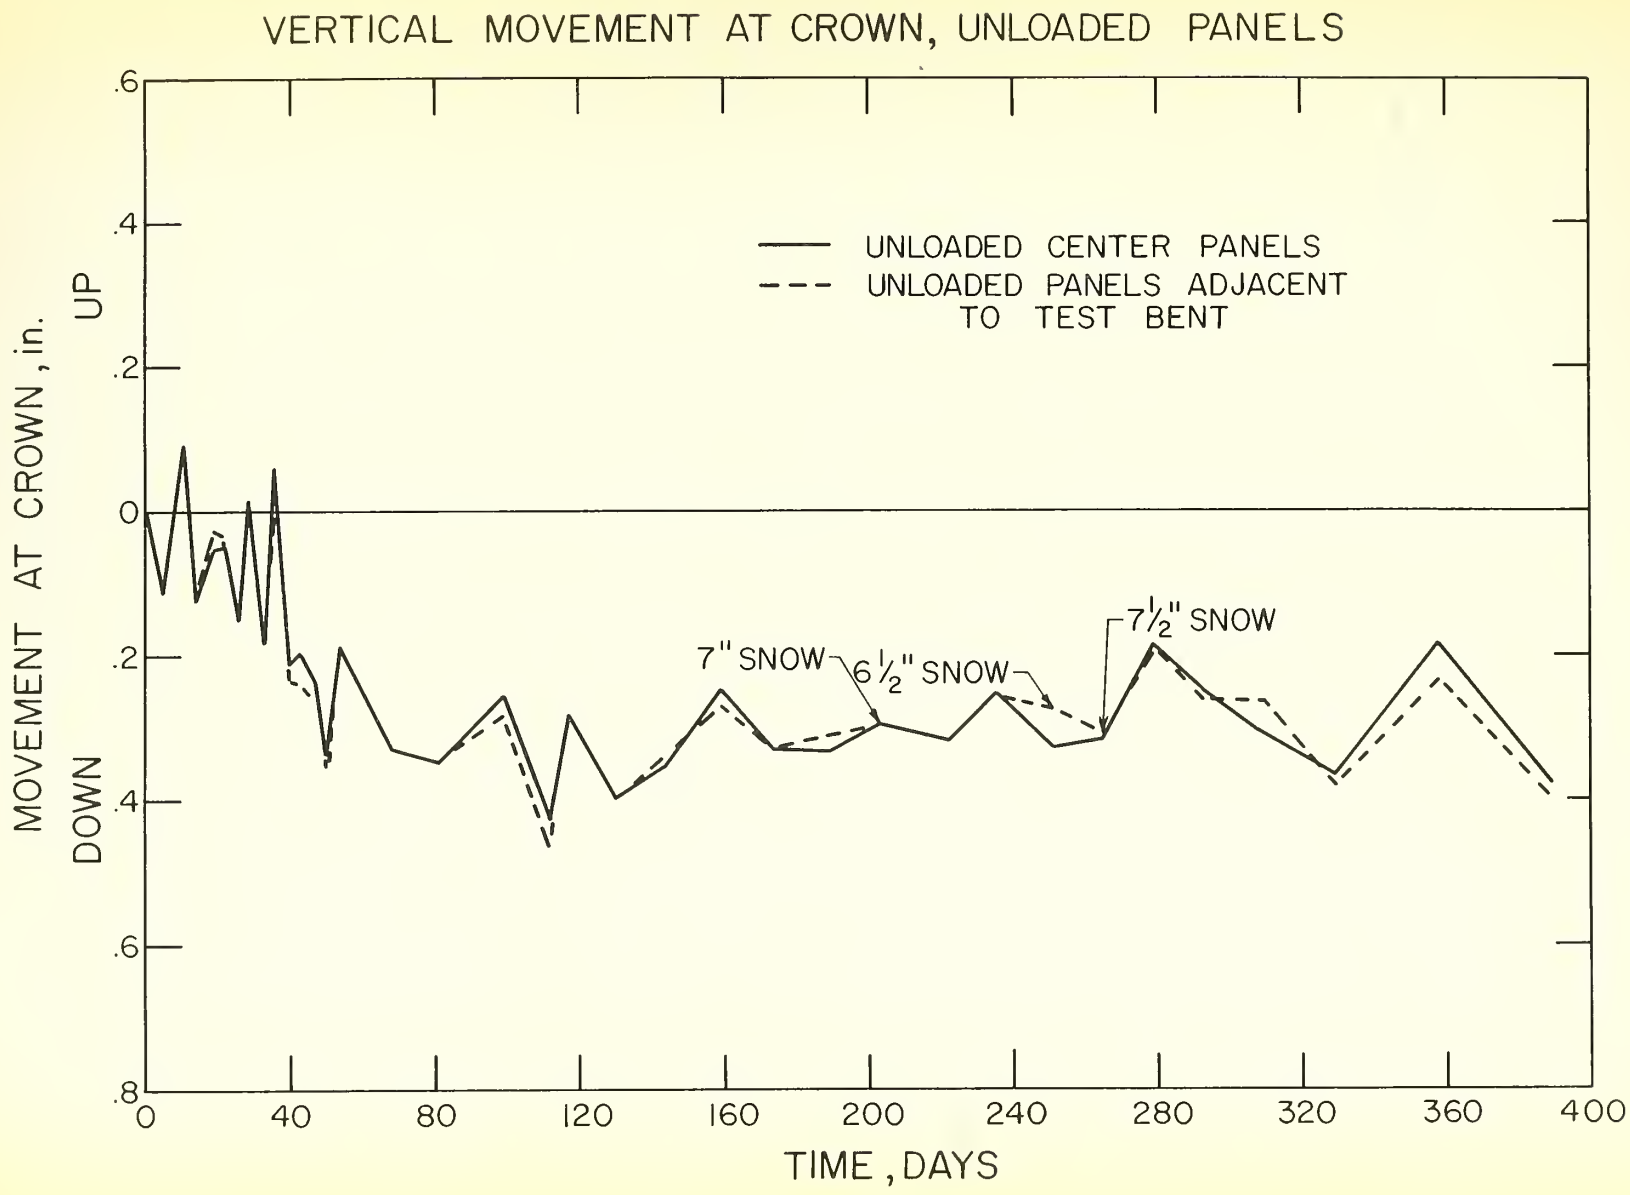
FIG. 10

A comparison of movements at the crown of panels adjacent to the test bent and panels near the center of the structure is made in figure 10. The gages near the center of the structure were placed in service approximately a month after the test began so that the comparison of deflections could only be made from that time on. Movement of the panels adjacent to the test bents agreed very closely with those observed near the center of the structure. This agreement indicates that the entire roof section acts as a unit when subjected to environmental changes.

4. Deflection measurements taken of unloaded panels at various locations within the structure show that the entire roof system acts as a unit when subjected to environmental changes.
