NBS PROJECT		NBS REPORT
1001-10-4811	October 28, 1955	4396

TESTS OF PRESTRESSED CELLULAR SLABS
(Slab Nos. 1, 2, 3, and 4)

M. Chi and D. Watstein

Bureau of Yards and Docks
Department of the Naby

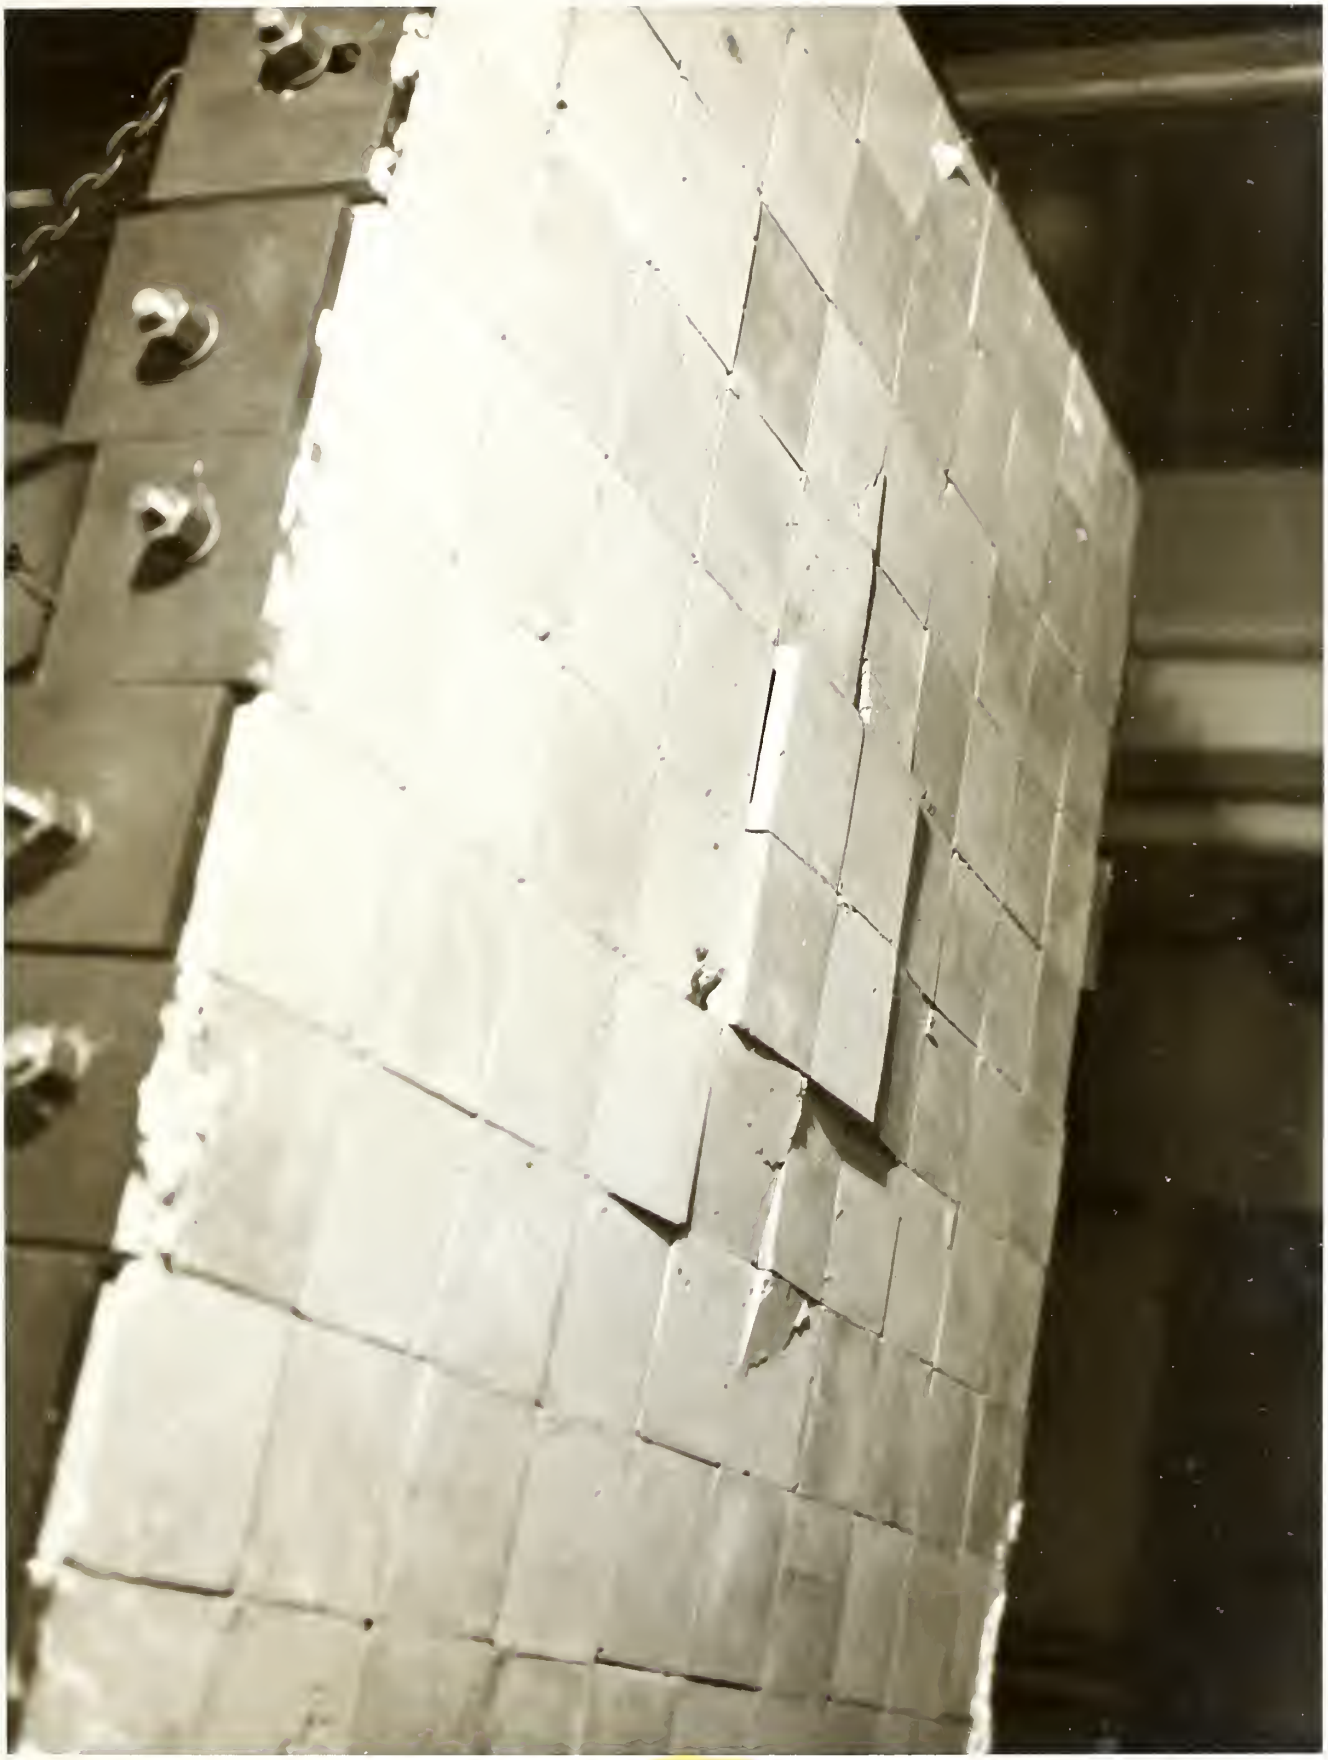
In Slab No. 1 the four cells under the loading block were pushed down about 3/4 in. The cells adjacent to them had crushed corners. This can be attributed to the failure of frictional forces between the cells to resist the shear. Figure 7 showing bottom view of slab, clearly illustrates this type of failure.

In Slab No. 2 the four cells directly under the loading block along with two rows of cells surrounding them were pushed down. There was some slipping between cells but the bottom surface formed essentially a convex surface. Cracks were irregular and did not form any definite pattern on the surface. The cells adjacent to the loading block and having a web parallel to its edge developed horizontal cracks near the top shell of the unit; for cells further away from the loading block, the horizontal cracks developed near the bottom shells. Webs of cells perpendicular to the edge of the loading block had diagonal cracks. Cells one foot or more away from the loading block appeared undamaged except for the presence of some horizontal hair cracks in the webs. The top surface of the slab remained intact but the loading block was forced into the slab about 1/4 inch. (See figures 8 and 9).

The failure of the slabs was primarily caused by punching shear around the periphery of the loaded area. The failure in every case was accompanied by the loaded area being "punched" out. This is strikingly demonstrated in figure 7 where the central group of four ungrouted cells is shown displaced about 3/4 in. below the adjoining cells and a similar view of the top is shown in figure 8. The displacement of the central loaded area is not quite as severe for the grouted slab as can be seen in figure 12.

Fig. 7. Bottom of slab No. 1 after failure.

Fig. 8. Top of slab No. 2 after failure.

Fig. 9. Bottom of slab No. 2 after failure.

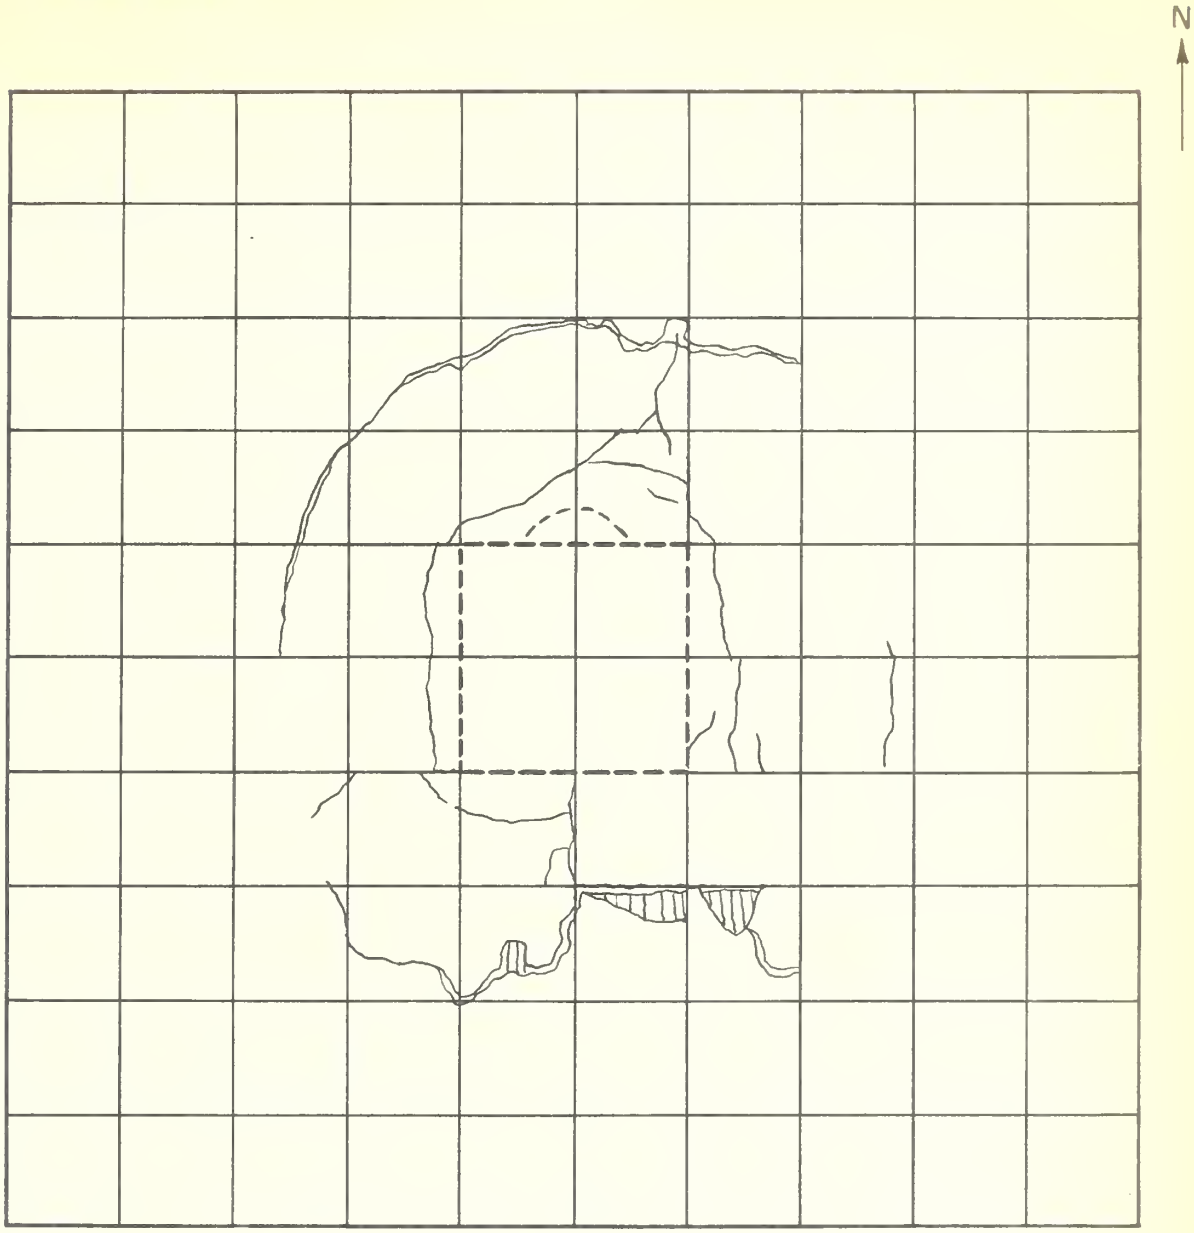
FIGURE 10. CIRCULAR CRACK PATTERN IN BOTTOM OF SLAB NO. 4.

In Slabs Nos. 3 and 4 a circular crack approximately 3 ft in diameter appeared at the bottom surface. Figure 10 shows the crack pattern observed in Slab No. 4. As in Slabs Nos. 1 and 2, the loading block was pushed approximately 1/4 in. into the slab. The top shells of the cells adjacent to the loading block cracked slightly. There was a circular hair crack in the top surface of Slab No. 3 with a diameter of approximately 3 ft. (See figure 11). No similar crack was observed in Slab No. 4. On the other hand, a hair crack approximately 14 in. in diameter was observed in the bottom face of Slab No. 4, but not in Slab No. 3. Cracks in the webs of cells were essentially similar to those in Slab No. 2. Typical diagonal crack patterns in sections of a slab are shown in figures 12 and 13; diagonal cracks in individual units are shown in figure 14.

BOTTOM VIEW OF SLAB NO. 4

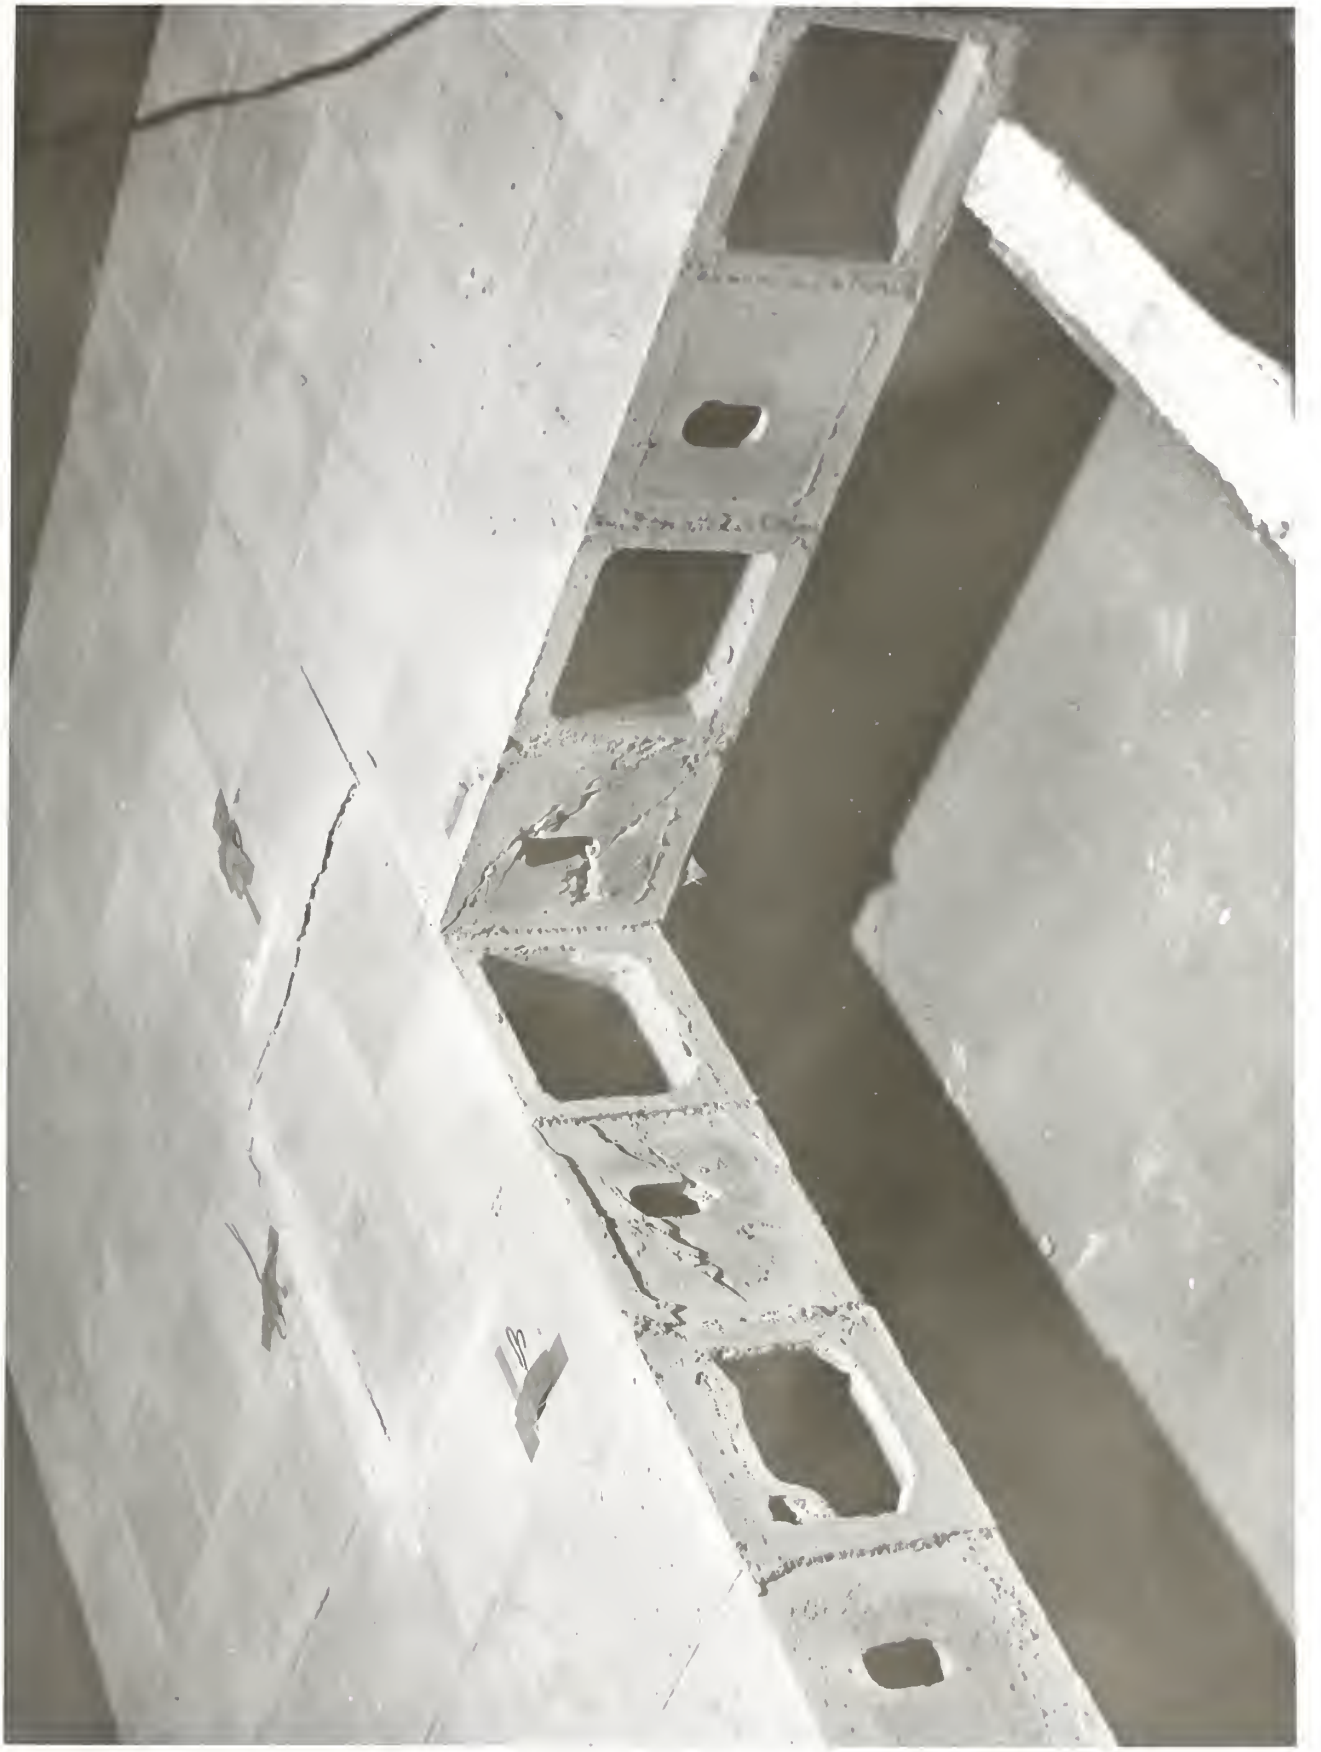
From the data given in section 5.1, it is evident that prestressed grouted slabs do not exhibit any sharply defined transition from uncracked to cracked slabs at the point where the initial prestress at the bottom fibers is reduced to zero. There is, rather, a gradual transition as evidenced by both the load-deflection and load-strain relationships in figures 4, 5, and 6. In Slabs Nos. 3 and 4 there was a gradual increase in the center deflection up to a load of about 30,000 lb, or about 85 percent of the load carrying capacity. As the loads approached the maximum values, cracking progressed over the tension face of the slab and deflections increased rapidly. It is probable that at this stage of loading the cracking around the elliptical holes in the cells was extensive. Examination of the cells after test revealed the presence of diagonal tension cracks extending into two or three rows of blocks adjacent to the loading block. This is illustrated in figures 12 and 13.

Fig. 12. Crack pattern in cross section of a slab.

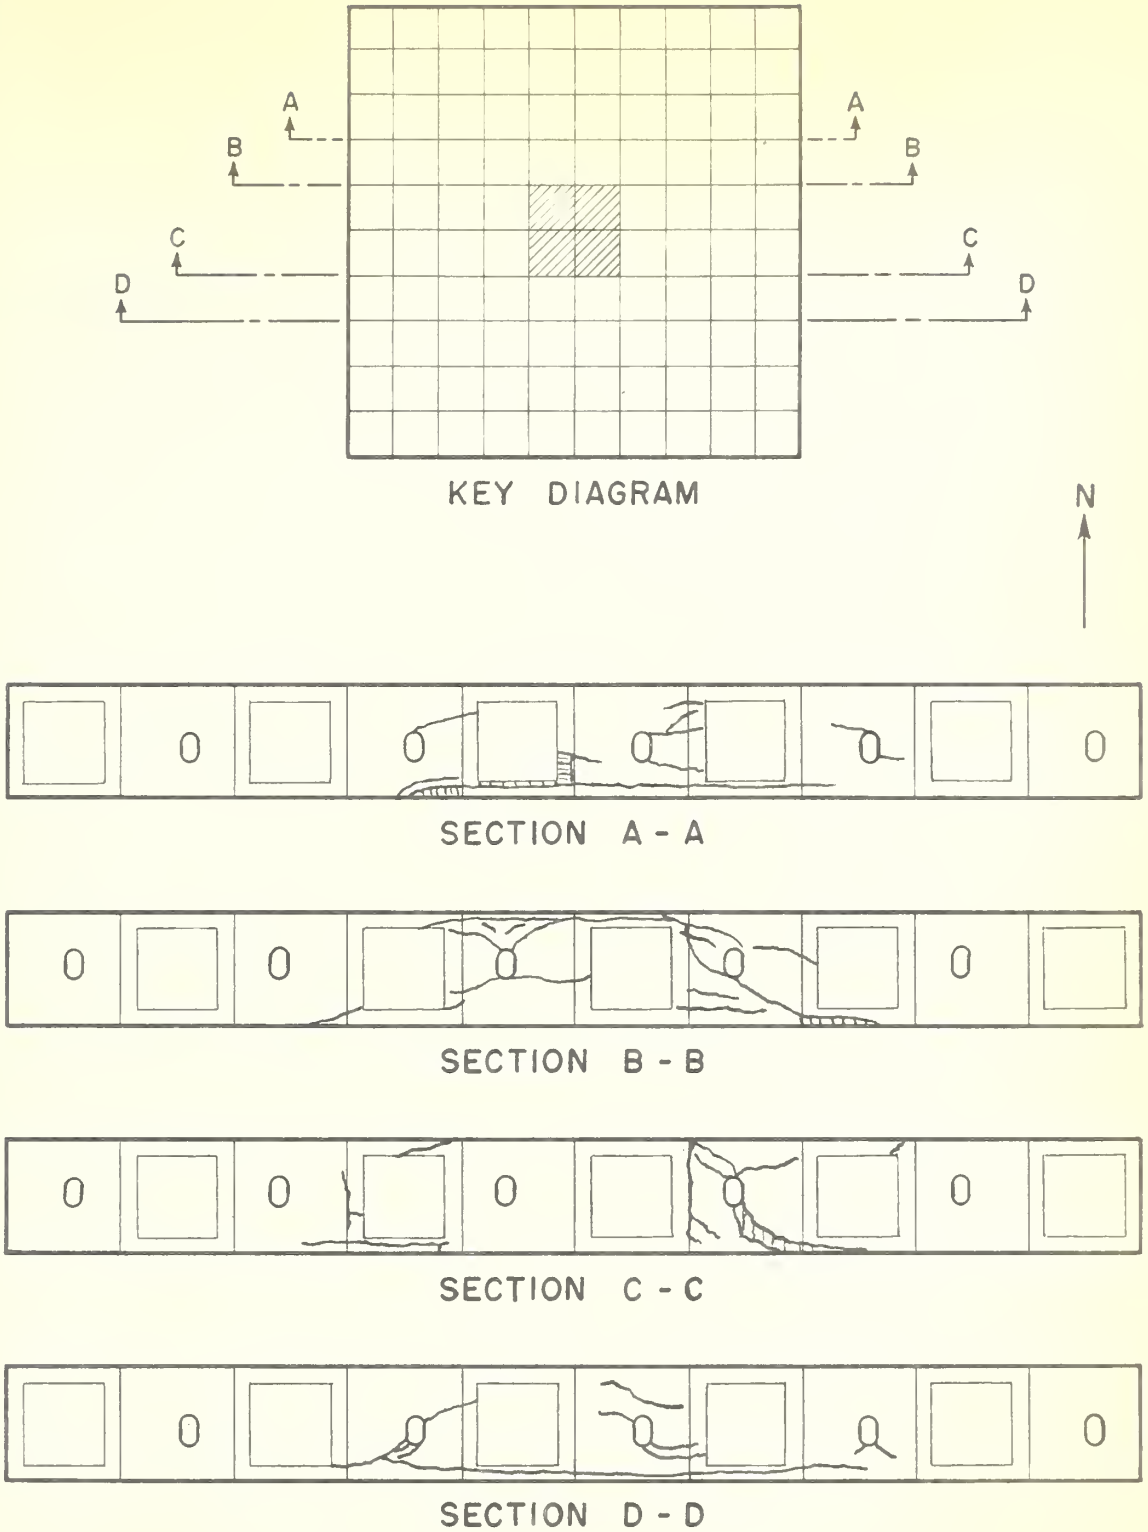
FIGURE 13. CRACK PATTERN IN SECTIONS OF SLAB AT VARIOUS DISTANCES FROM THE LOADED AREA.
