Long-Term Performance of Corrosion Inhibitors Used in Repair of Reinforced Concrete Bridge Components

Publication No. FHWA-RD-01-097

U.S. Department of Transportation
Federal Highway Administration
Research and Development
6300 Georgetown Pike
McLean, VA 22101-2296

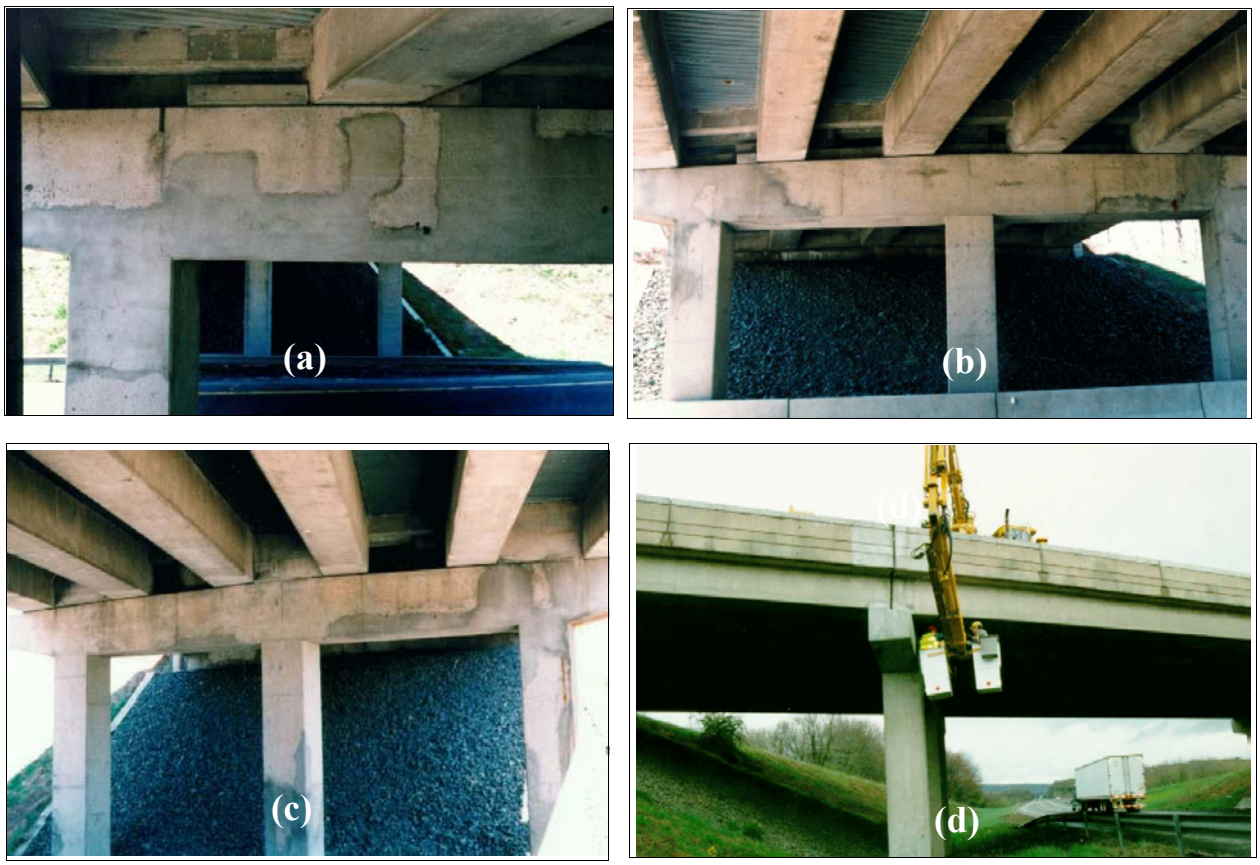
Figure 3-2. General views of piers:
(a) pier 1, (b) pier 2, (c) pier 3, and (d) field evaluation in progress.

During the first visit, the concrete surface of the three pier caps did not have spalls. All patched areas on the three pier caps were cracked. Detailed mapping of the cracks was not performed. Cracks generally occurred along patch perimeters and the crack pattern within patched areas was typical of drying shrinkage cracking. Cracking was not observed in the original concrete areas. Visual observations of the three piers during the second visit did not show much change compared to the first evaluation. During the third visit, approximately 2.5 m of new cracks were documented in the patch areas of pier 3 (treated with Cortec 2000). These cracks did not appear to be caused by drying shrinkage. Outside the survey area of pier 3, corrosion products were visible in the original concrete. The shrinkage cracks on the other two piers remained the same. Spalls were not visible on any of the three pier caps.

All patches on the control pier and the treated piers were experiencing shrinkage cracking. By the third evaluation, additional cracks had developed in the patches treated with Cortec inhibitor. Rust staining that originated in a crack at the patch concrete interface of a patch treated with the Cortec inhibitor was noted in the third evaluation. Hollow-sounding areas were observed on the patch of the pier treated with DCI inhibitor and they increased with time.

Piers 1, 2, and 3 were selected for SHRP C-103 field trial installation of shotcrete/corrosion-inhibitor repair systems. Areas of unsound concrete were delineated and removed to a depth of 19 millimeters (mm) below the reinforcing steel level with pneumatic hammers before repairs were begun. The exposed steel was sandblasted to near-white metal prior to application of the shotcrete and inhibitor treatment. In all patch repair areas, a wire mesh was tied to the reinforcing steel mat.

Pier 1 was used as the control. The repair cavities on this pier were backfilled with a standard shotcrete mix without any inhibitor treatment.

Pier 2 was repaired with shotcrete admixed with DCI inhibitor added at a rate of 1.9 liters (L) per bag of cement (approximately 4.99 L/m^3 of concrete). In addition, four spray applications of Postrite (a 15-percent calcium-nitrite solution) were applied to the repair cavities with exposed steel prior to backfilling with inhibitor-treated shotcrete. The surface of the repair cavity for each application was sprayed until it was saturated. The second application was done

Pier 3 was repaired with shotcrete treated with Cortec MCI 2000 inhibitor. The MCI 2000 admixture was added at a rate of 0.18 L per bag of cement (approximately 1.2 L/m^3 of concrete).
