DOT/FAA/AR-05/16

Contaminated Billet Study

September 2005

Final Report

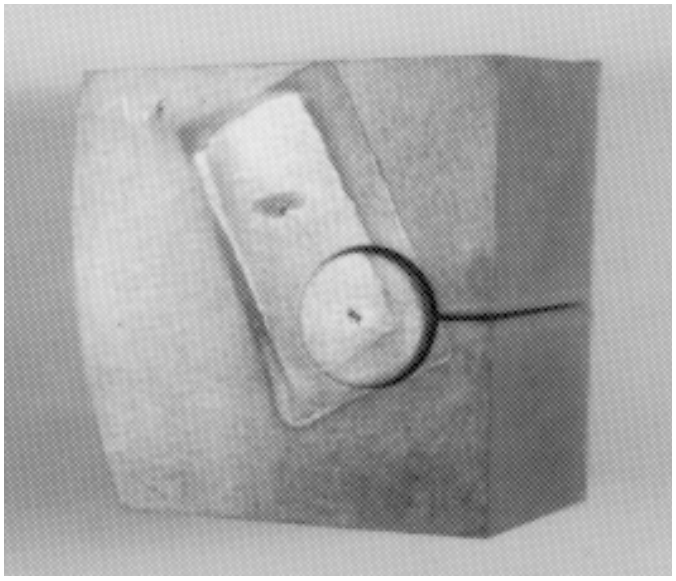
FIGURE 3. PHOTOMACROGRAPH DOCUMENTS REMOVAL OF INDICATION FROM BILLET SAMPLE
(Note the two indications visible in this sample were taken from B3W1. The indications were located at 0.875″ and 1.15″ from the billet surface.)

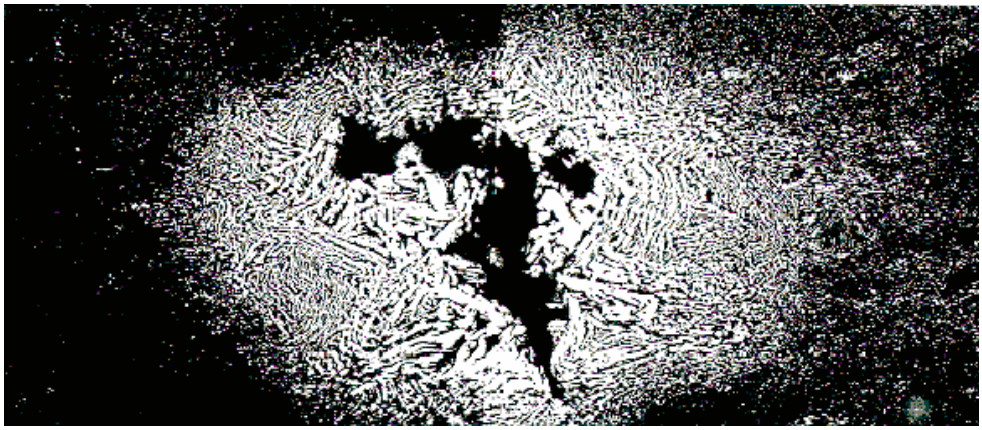
FIGURE 4. CYLINDRICAL SLUG TAKEN FROM BILLET B3W1 WAS CROSS-SECTIONED APPROXIMATELY 0.3″ BELOW THE PLANE OF THE PHOTOMACROGRAPH SHOWN IN FIGURE 3
(The 25X magnification photomicrograph shown here maintains orientation between top and bottom views with the billet center shown to the right.)

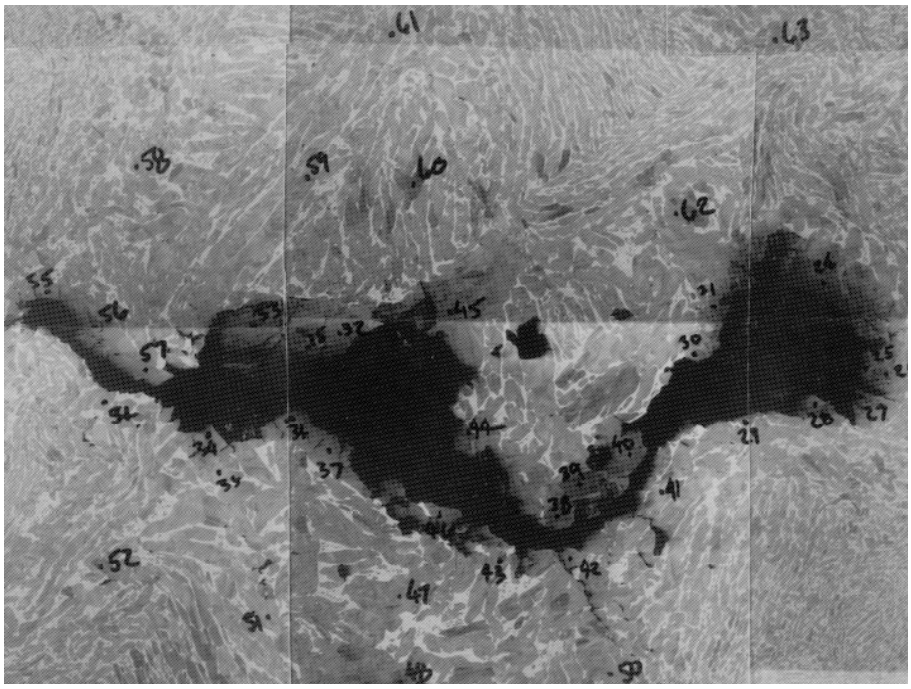
FIGURE 5. ELECTRON MICROPROBE BACKSCATTERED ELECTRON IMAGE OF DEFECT TAKEN FROM BILLET B3W1
(Numbers indicate location of microprobe measurements. Billet center is to right of image.)

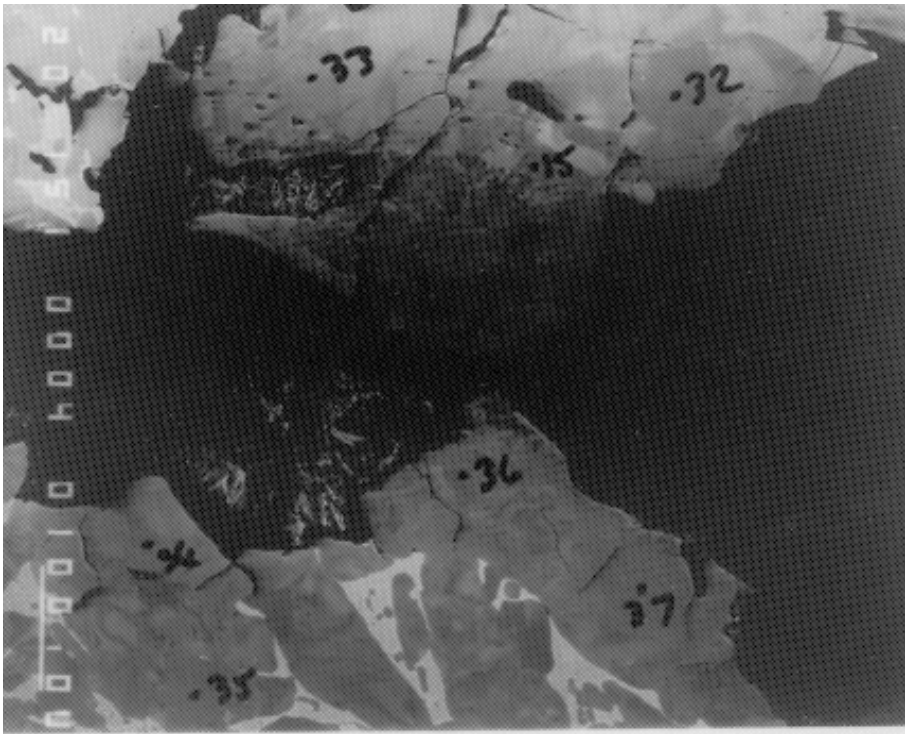
FIGURE 6. MICROPROBE RESULTS IN MEDIUM NITROGEN
(Range from 3.0% nitrogen at point 32 to 6.4% at point 33.)

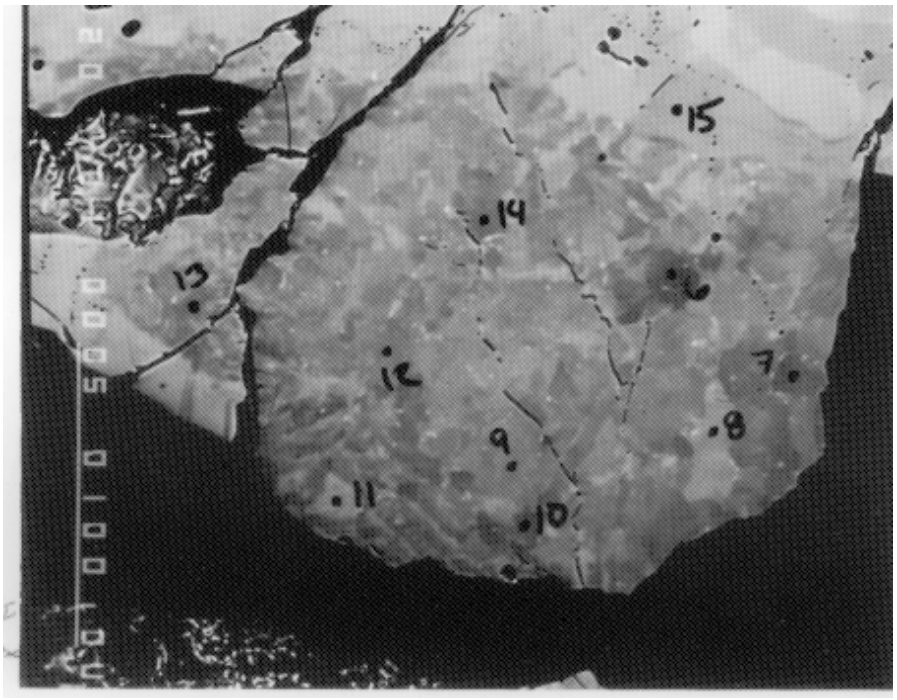
FIGURE 7. ELECTRON MICROPROBE SHOWS AREAS OF HIGHEST NITROGEN CONTENT
(The range of nitrogen content is from 7.4% N at point 15 up to 12.6% at point 8. The average nitrogen content in this area is 11.2%. Also note cracking in this area of the sample. The original micrograph was at 400X magnification.)

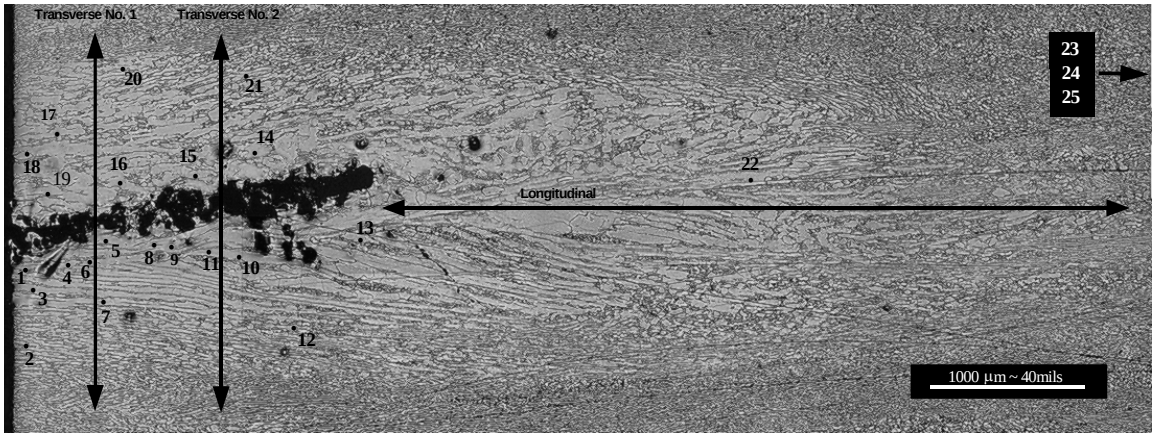
FIGURE 14. MICROPROBE MEASUREMENT POINTS FOR PRACTICE DEFECT

Figure 14 shows the location of 25 point scans and 3 line scans completed on the practice defect. The results for the 25 points are tabulated in table 2. The results for the nitrogen line scans are shown in figures 15 (transverse scan) and 16 (longitudinal scan). Figure 17 provides the results for the oxygen scans. The scans show that the variation in nitrogen concentration was much more prominent transversely across the defect (see figure 15) than parallel to (in the plane of) the defect (see figure 16). This is consistent with the metallographic appearance and indicates that both the defect and the surrounding diffusion zone are flattened and elongated. In the diffusion zone there were no points where the composition changed abruptly. Note that within 10 mils of the defect center, the nitrogen concentration has dropped to less than 1 percent nitrogen. The ETC team was interested in understanding the concentration profile that determines whether there are significant ultrasonic impedance differences that will impact the inspection response. Based on the microprobe results and the need to understand the concentration profile, the decision was made to confine future microprobe analyses to line scans.

Optical image of defect. Numbers and arrows indicate approximate locations of point analyses and line scans.

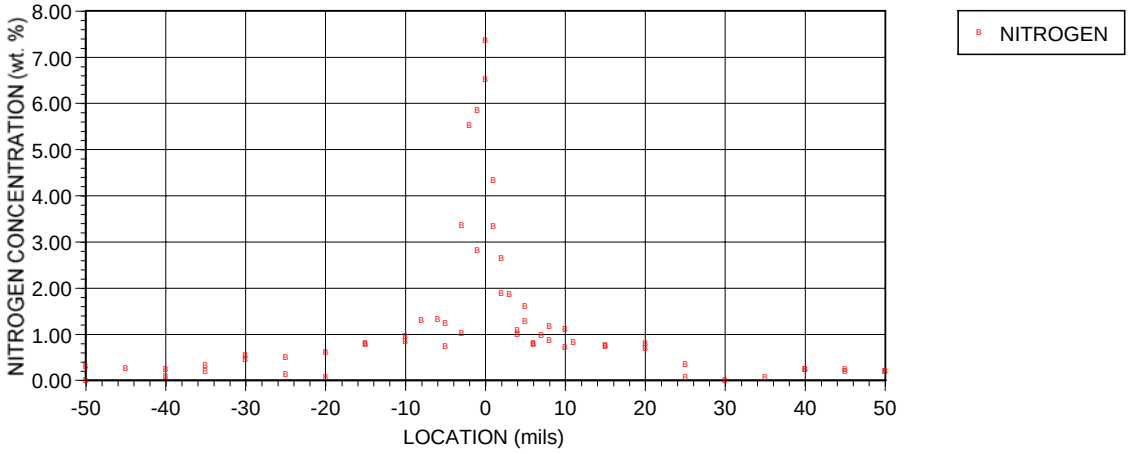
FIGURE 15. RESULTS FOR NITROGEN SCAN PERPENDICULAR (TRANSVERSE 1) TO THE LONG AXIS OF THE DEFECT WITH ZERO LOCATED AT THE DEFECT CORE
(The location of the scan is provided in figure 14.)

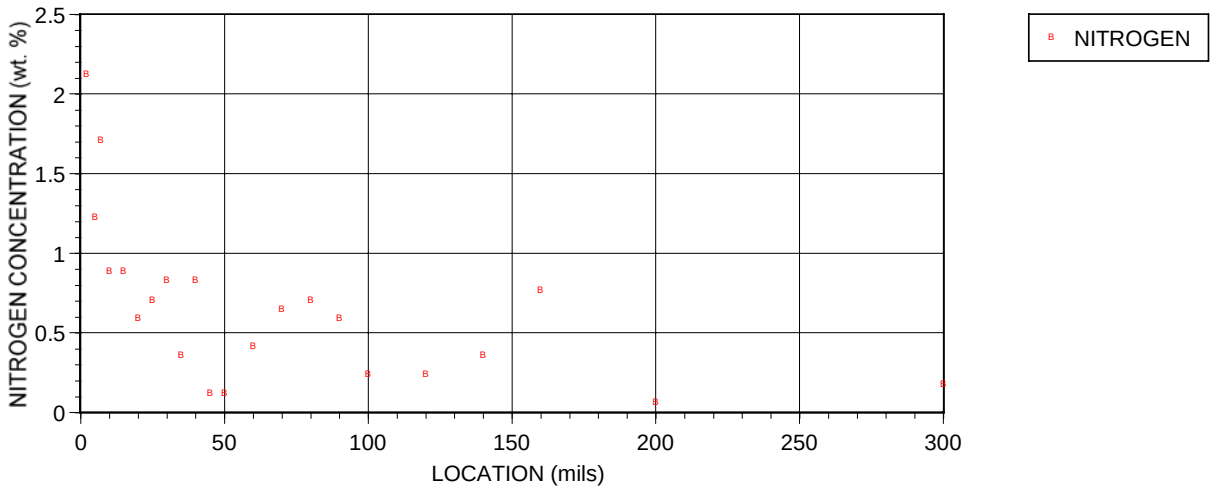
FIGURE 16. RESULTS FOR NITROGEN SCAN PARALLEL TO THE LONG AXIS OF THE DEFECT WITH ZERO LOCATED AT THE END OF THE DEFECT CORE
(The location of the scan is provided in figure 14.)

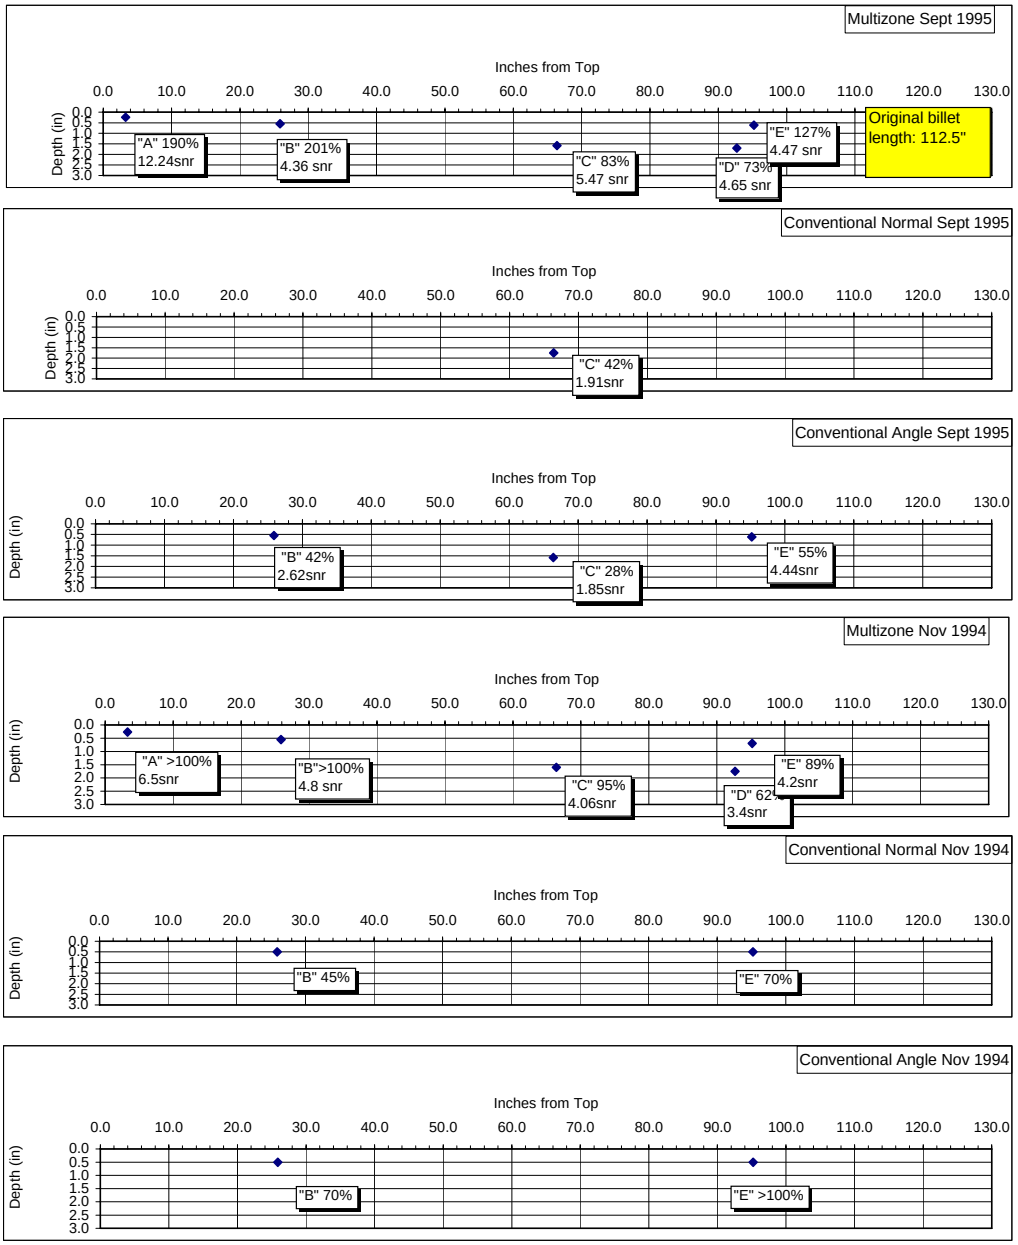
September 1995 Inspection			November 1994 Inspection		
Stamped I.D.	Inches from top	Multizone Depth	Conv. Normal Depth	Conv. Angle Depth	Multizone Depth	Conv. Normal Depth	Conv. Angle Depth
A	3.3	0.2			0.3		
B	25.9	0.6		0.6	0.6	0.5	0.5
C	66.4	1.6	1.8	1.6	1.6		
D	92.7	1.7			1.8		
E	95.2	0.6		0.6	0.7	0.5	0.5

Additional indication reported on Nov 1994
Multizone, 12" from top, 0.94" deep,
amplitude 53%, 2.11 SNR (not rejectable)

FIGURE 20. EXAMPLE OF INSPECTION RESULTS FOR BILLET B1AW1
(Results for all 12 billets are provided in appendix C.)

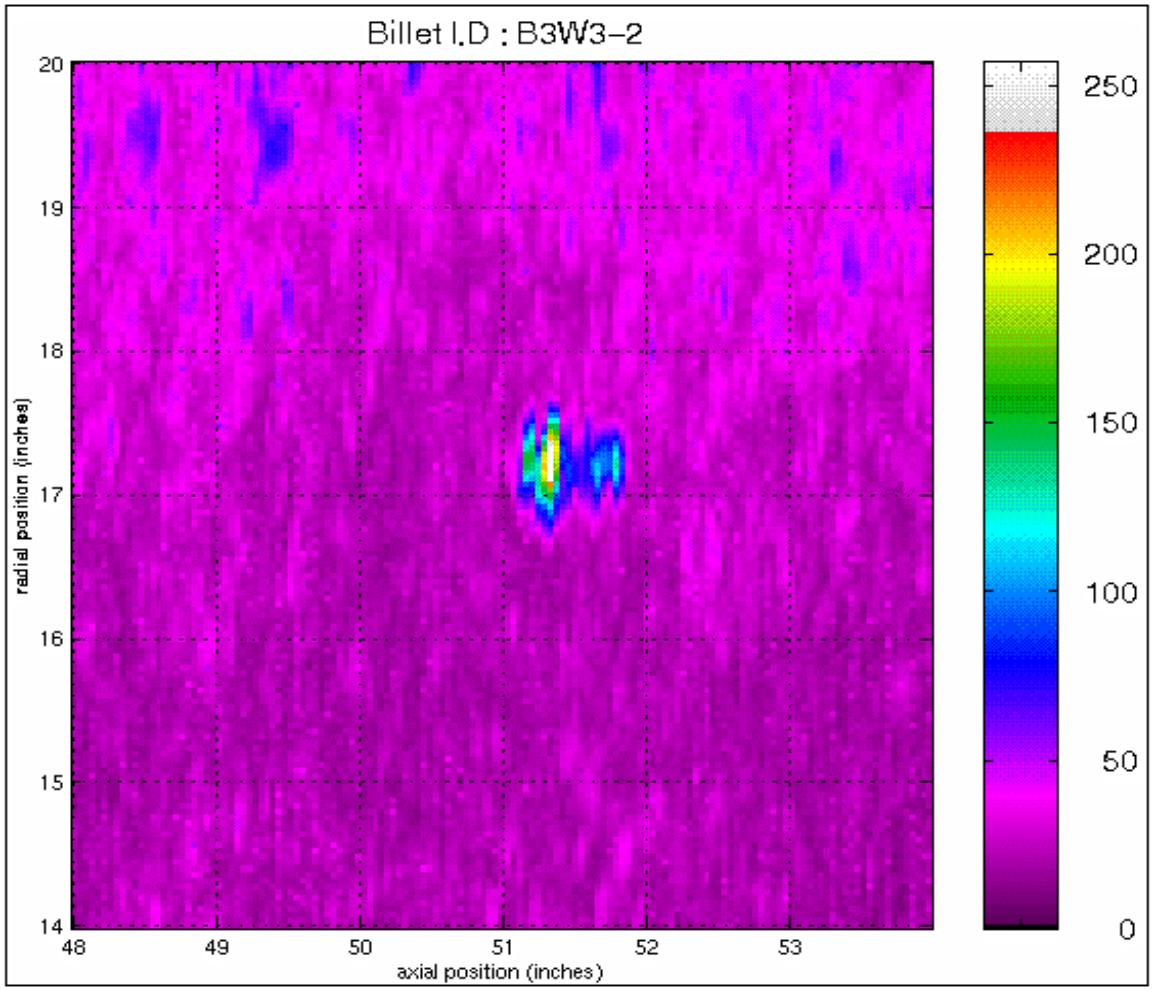
Billet ID: B3We-B

C-scan images were also generated for each of the indications and estimates made of the indication size. An example of the C-scan results is shown in figure 21. The billet ID and indication ID are listed (e.g., B3W3-B) along with the zone in which the indication was found. Inches from top indicates the axial location of the defect within the billet. The amplitude, SNR, and depth are tabulated from the billet maps (see figure 20). The axial and circumferential lengths were estimated using the indication sizes from the C-scan images. The estimates of the axial length were straight-forward. The estimates of the circumferential length were based on the formula $x = 2\pi r\theta$, where θ was the circumferential extent of the image in pixels divided by the total number of pixels in a 360° revolution. No correction was made for the effects of beam size.

FIGURE 21. EXAMPLE OF C-SCAN USED IN SELECTION OF DEFECTS FOR FURTHER CHARACTERIZATION
(The complete set of defects used in the metallographic studies is provided in appendix D.)

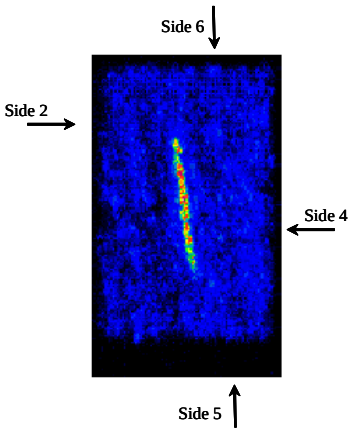
FIGURE 29. ULTRASONIC CHARACTERIZATION FOR B3W3 INDICATION B

The first of the indications came from billet B3W3. Indication B was sectioned from the billet at the axial position of 51.0″. Initial characterization and sectioning was completed at GE with the results shown in figure 29. The sample was then shipped to ISU for detailed ultrasonic characterization. The results are shown for side 4 in figure 30. After completion of the ultrasonic measurements in the 1″ cube, the samples were shipped to Pratt & Whitney for sectioning, capture of the digital micrographs, and microprobe analysis. For indication B3W3-B, 21 sections were required to polish through the indication. The results for several of the slices are shown in figure 31. Four sections were selected as representative of the defect. The first section shows the initial occurrence of diffusion zone and serves as the section from which other sections are measured. In the third section, taken at 15 mils, the occurrence of voiding is noted with more expansive voiding present in the 60-mil section. The last section occurred at 95 mils and shows the last remnants of diffusion zone for this sample. Note that for the 60-mil section, over 35 micrographs were taken and digitally pasted to generate the montage shown in figure 31. In some of the more extended defects, the number of micrographs required to fully capture the defect in a given section plane exceeded 120, generating copious amounts of metallographic data.

Side	Depth	Axial Length	Amplitude %	Sensitivity, dB
1	0.444″	0.8″	66	60
2	0.496″	0.8″	93	60
3	0.453″	0.8″	76	60
4	0.399″	0.8″	96	60
5	0.460″	0.8″	73	74
6	0.435″	0.8″	79	72

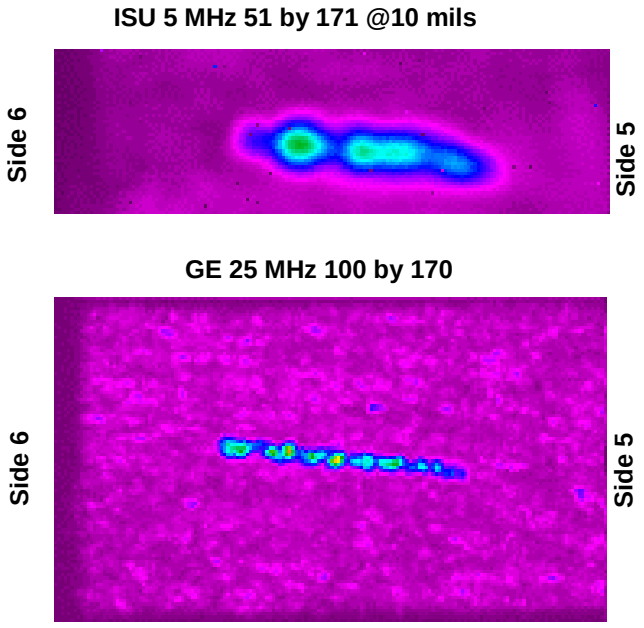
FIGURE 30. ULTRASONIC CHARACTERIZATION AT CUBE STATE PRIOR TO METALLOGRAPHIC SECTIONING OF B3W3 INDICATION B
(Results are shown for side 2 at 5 MHz (top) and 25 MHz (bottom).)

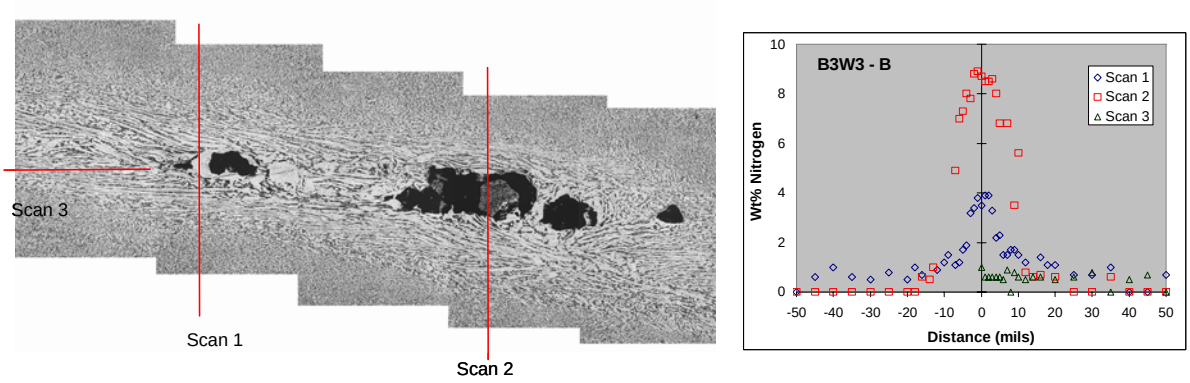
FIGURE 32. MICROPROBE RESULTS FOR SECTION 5
(APPROXIMATELY 20 mils) IN DEFECT B3W3-B
(Three scans were made, as shown on the micrograph. The results are plotted for nitrogen concentration as a function of distance from the core. Note that the longitudinal scan (scan 3) extended away from the indication with nitrogen levels at nominal levels out to 400 mils (data not plotted past 50 mils).)

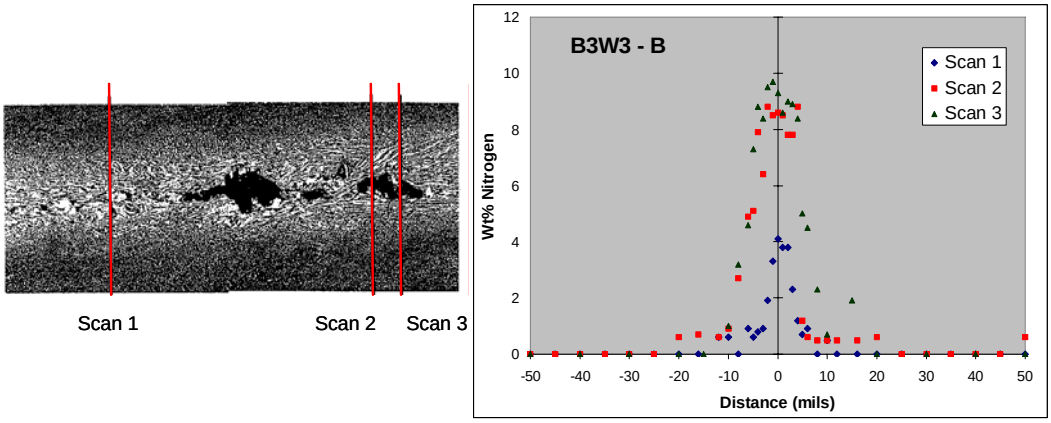
FIGURE 33. MICROPROBE RESULTS FOR SECTION 11 (APPROXIMATELY 65 mils) IN DEFECT B3W3-B
(Three scans were made, as shown on the micrograph. The results are plotted for nitrogen concentration as a function of distance from the center of the core.)

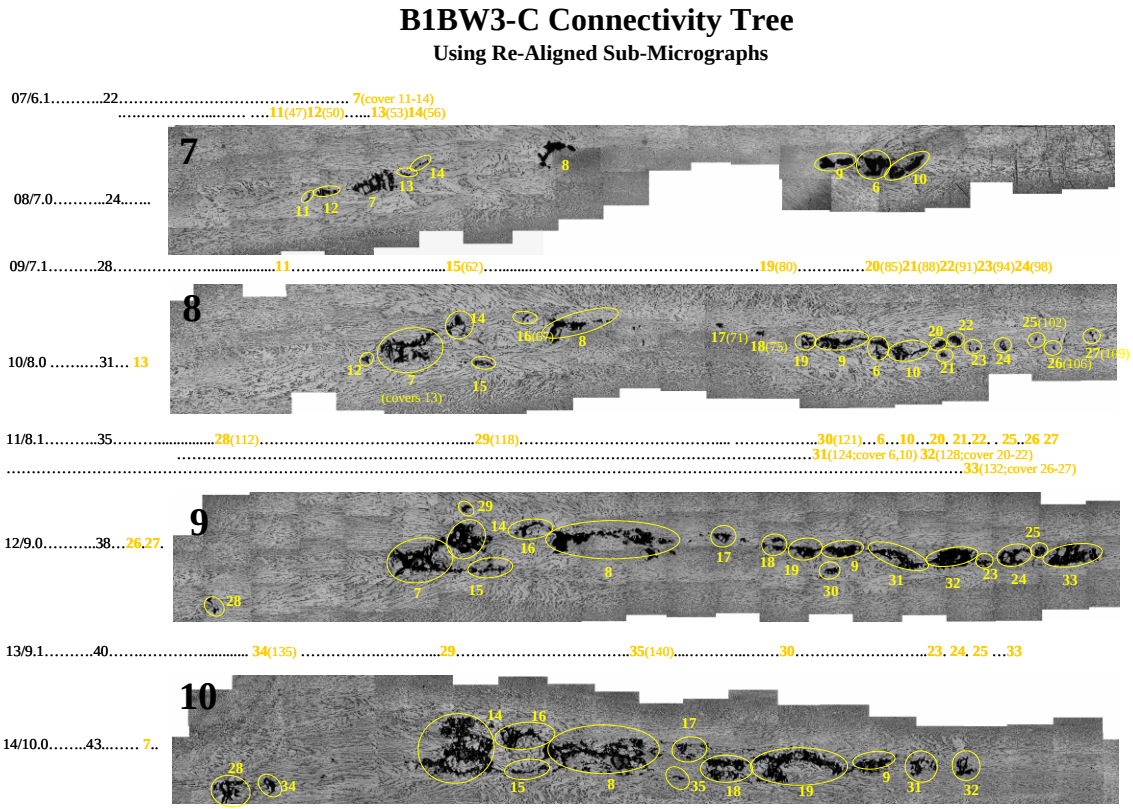
FIGURE 37. EXAMPLE OF MORE COMPLICATED VOID CONNECTIONS
(Results are shown for slices 7 through 10 of indication B1BW3-C. Numbers used to track voids between slices are shown in yellow.)

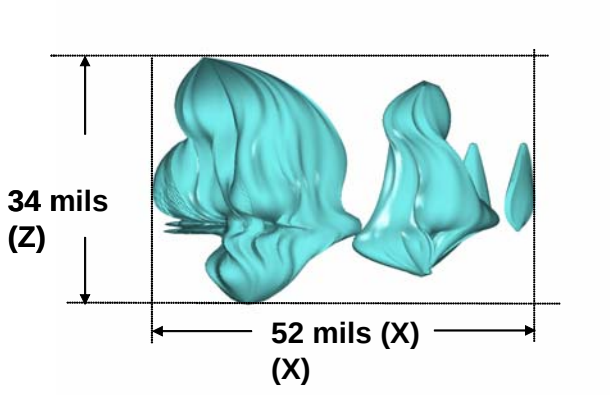
FIGURE 40. ACTUAL DIMENSIONS OF DEFECT B1AW2-X
(The dimension in Y direction is 18 mils.)

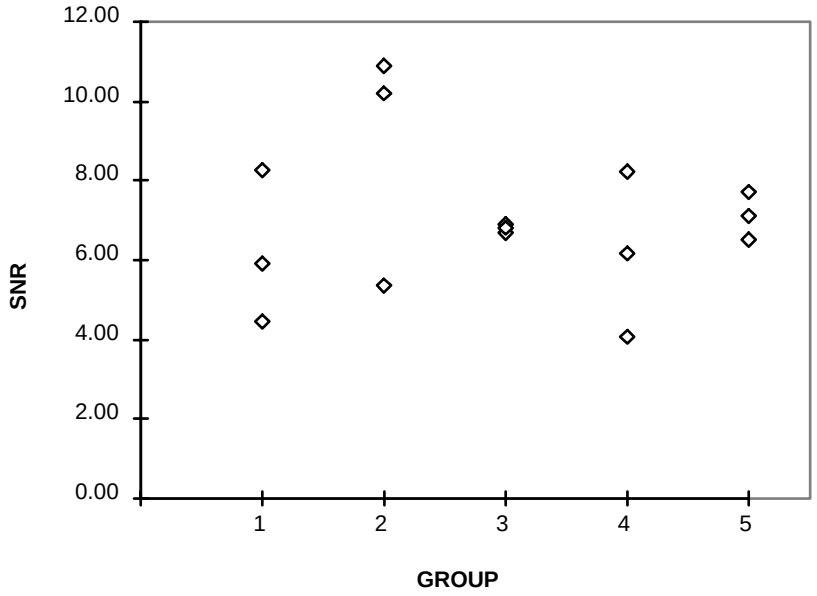
Typical results for a single indication are shown in figure 65. Indication B1BW1A-B was selected and the results were plotted. Each group represents three operators and the same location and using the same transducers.

FIGURE 65. REPRODUCIBILITY RESULTS FOR INDICATION B1BW1A-B FROM FIELD STUDIES

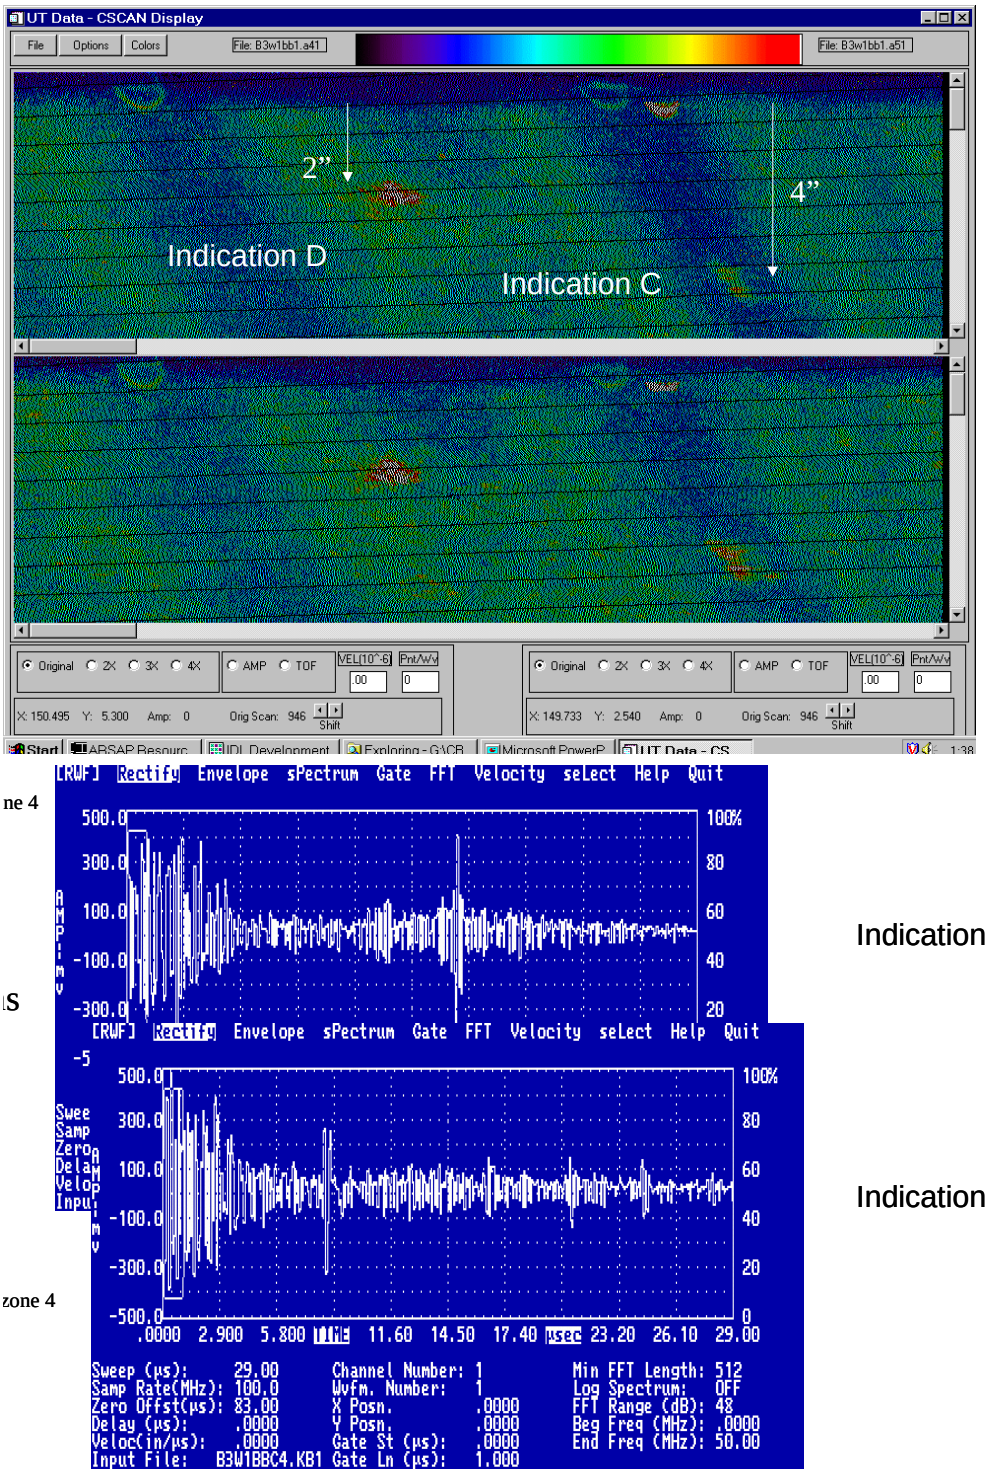
FIGURE 69. C-SCAN OF INDICATIONS D AND C FROM BILLET SEGMENT B3W1BB ALSO DETECTED IN PRIOR INSPECTIONS
(Note that both indications were detected in zones 4 and 5.
Waveforms from zone 4 are also shown for both indications (lower).)

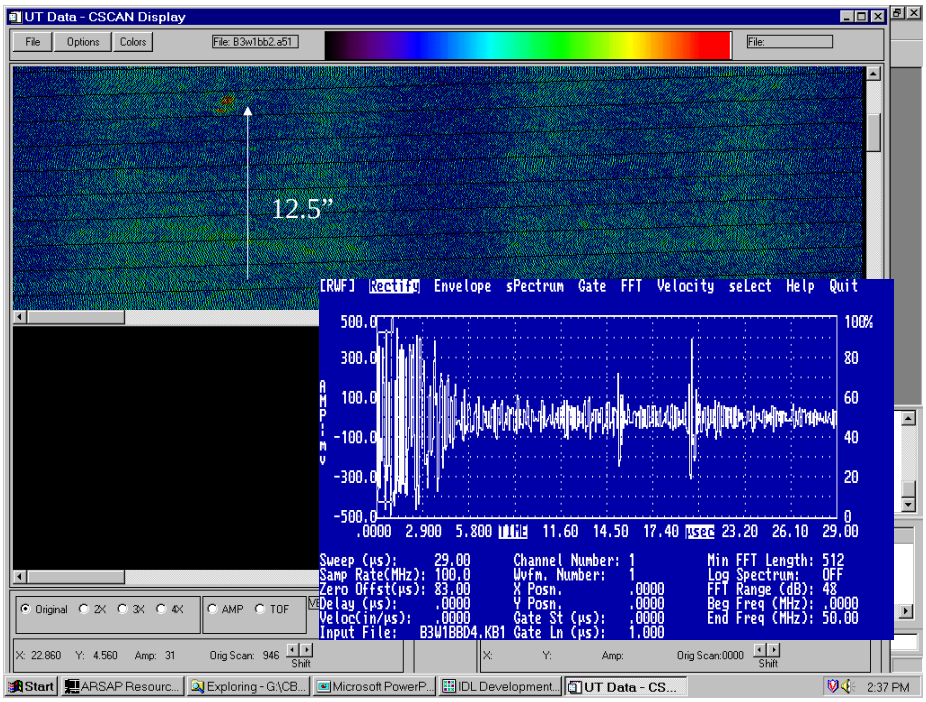
FIGURE 70. C-SCAN AND WAVEFORM RESULTS FOR INDICATION B OF BILLET SEGMENT B3W1BB

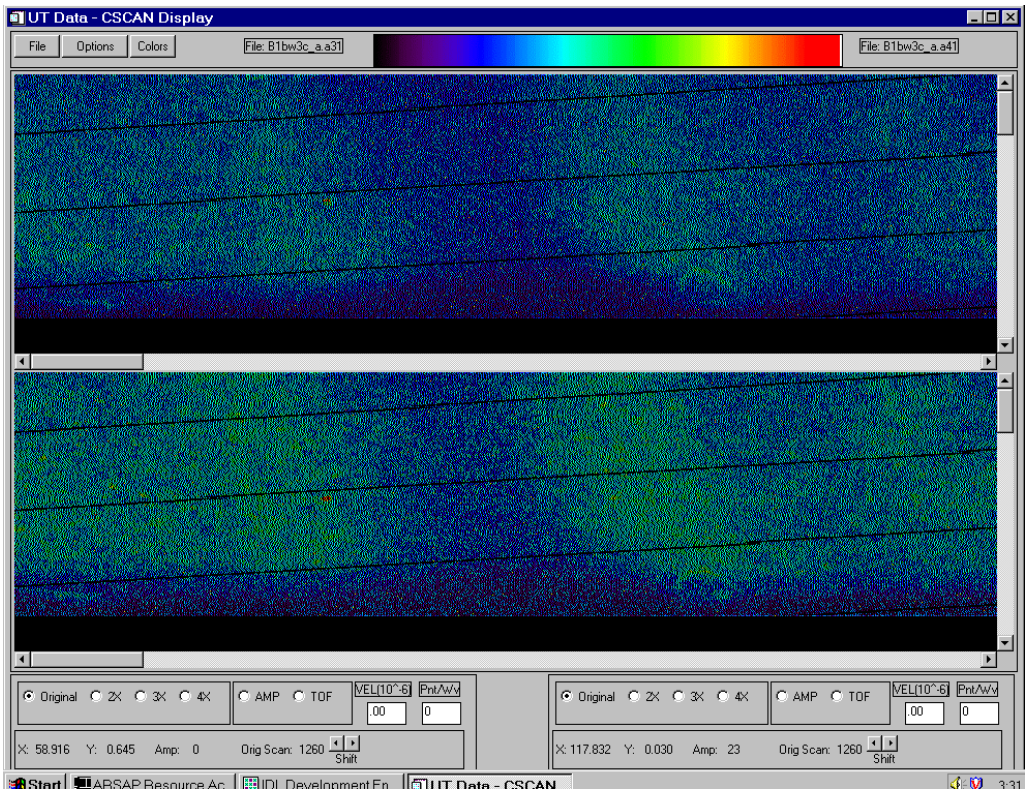
B1BW3CB; indication at ~1.2″ depth; ~95% of #2 FBH

As indicated in table 20, only one new indication was identified. The indication was found in billet segment B1BW3CB with an amplitude of 95% of a #2 FBH. Figure 71 shows the C-scan and waveform results taken with the phased array setup. After completion of the high-sensitivity phased array inspection (7.5 MHz), the sample was shipped to the GE Quality Technology Center (QTC) for multizone inspection. The GE-QTC staff reinspected the mult using production multizone probes and probes fabricated by Corporate Research and Development. A 34% amplitude was reported (based on 80% calibration for a #2 FBH), which is not rejectable. An offset of 0.1″ was used both axially and circumferentially. The axial offset resulted in no change. The circumferential offset increased the amplitude to 60%, which is below the reject threshold. These results are indicative of the variability that is present in billet inspection and point to the importance of flaw morphology and inspection setup to the detection of flaws. The sample was also inspected with a higher-frequency (10 MHz) phased array probe. The results from the inspection are shown in figure 72. Given the strong ultrasonic response from multiple inspections, the decision was made to destructively characterize the indication.

FIGURE 71. C-SCAN AND WAVEFORM RESULTS FOR NEW INDICATION FOUND IN BILLET SEGMENT B1BW3CB

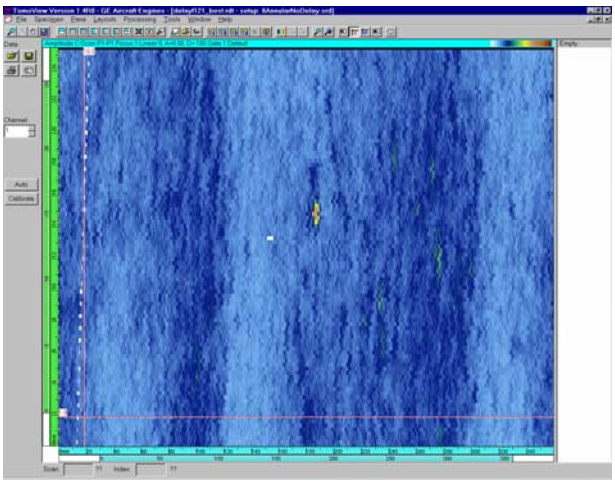
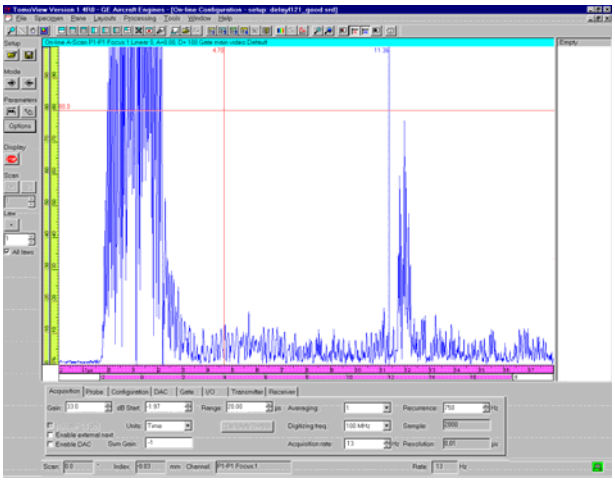
10 MHz phased array inspection results

FIGURE 72. C-SCAN AND WAVEFORM RESULTS FOR NEW INDICATION FOUND IN BILLET SEGMENT B1BW3CB USING 10-MHz PHASED ARRAY INSPECTION

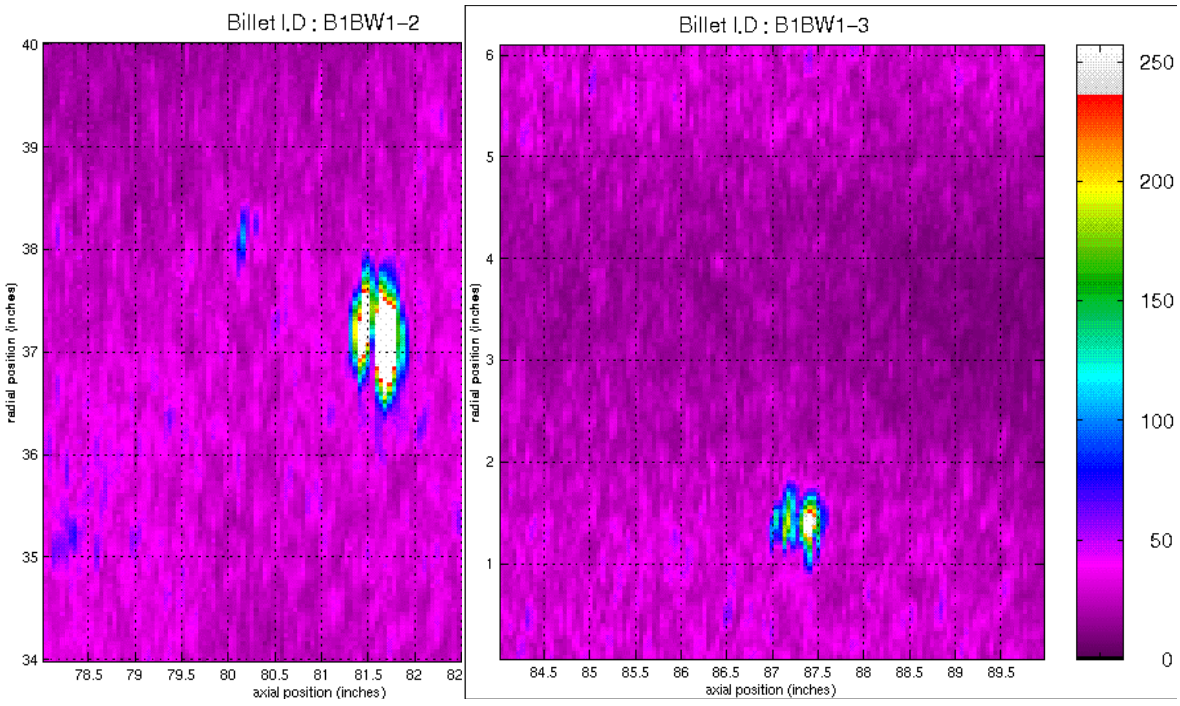
Among the samples that are included in the library is the hot isostatic press (HIP)-to-heal sample. In an effort to evaluate the effect or reducing and eliminating the cracks and voids normally associated with hard alpha inclusions on detectability of hard alpha, an indication was selected and a mult removed from the billet. Indication B1BW1-G was selected, and a 16″ section was removed. The details of the inspection are provided in table 22, and the results are shown in figure 73. The indication was detected using all three methods during the field inspection. After sectioning, the mult was inspected using the multizone system at GE prior to and after the HIPping process. No indications were found after the HIPping process. These results point to the enhanced detectability of hard alpha in the presence of cracks and voiding. The sample also provides an excellent resource for the evaluation of future inspection improvements.

Inspection location	MZ Amplitude and SNR	Conventional Normal Amplitude and SNR	Conventional Angle and SNR
Field inspection	213% - 8.3 SNR	100% - 2.9 SNR	80% - 3.4 SNR
Laboratory inspection	125% - 7.4 SNR		
After HIPping	No indication detected

FIGURE 73. C-SCAN RESULTS FOR INDICATION B1BW1-G USED IN HIP-TO-HEAL SAMPLE
(Note: the indication was detectable in zones 2 and 3 during the original field inspection.)

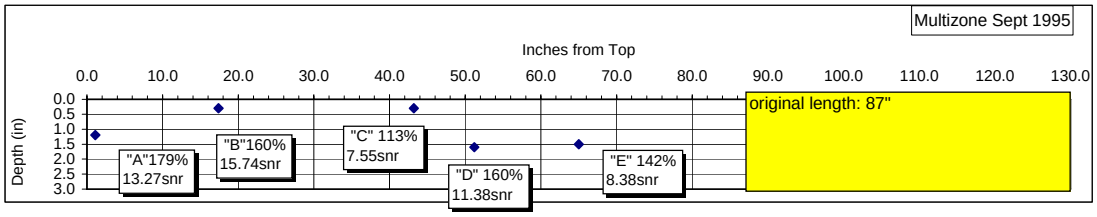
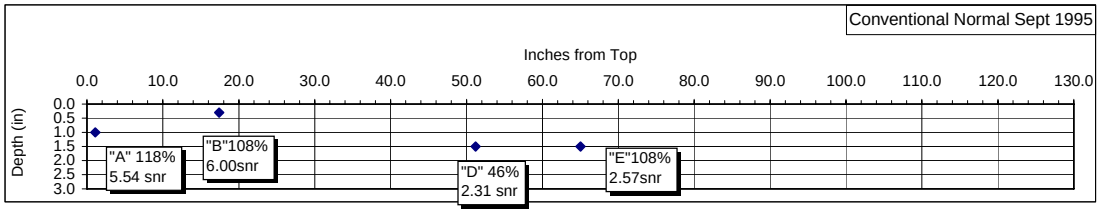
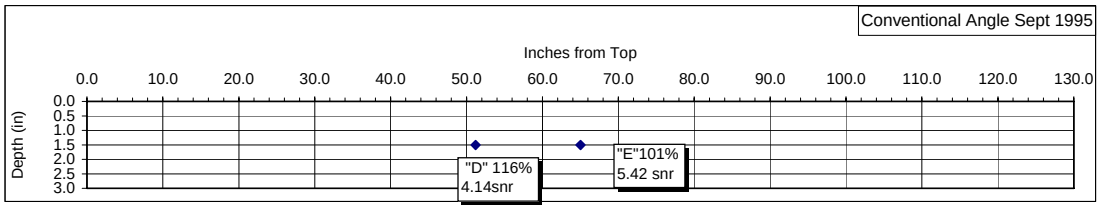
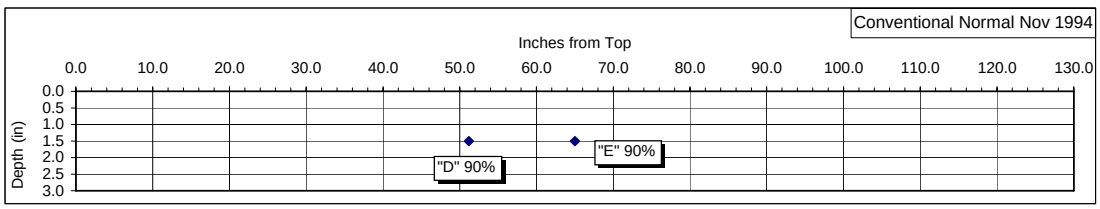
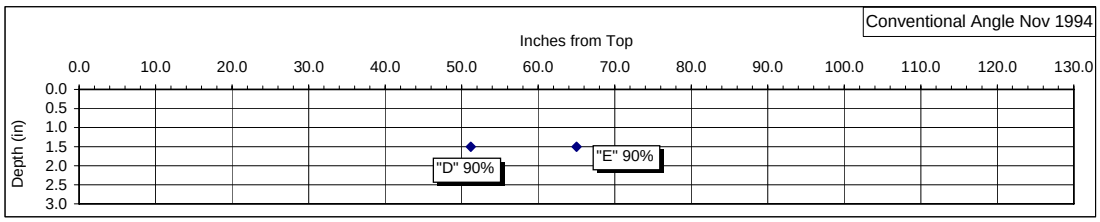
B1BW2B

September 1995 Inspection			November 1994 Inspection		
Stamped I.D.	Inches from top	Multizone Depth	Conv. Normal Depth	Conv. Angle Depth	Multizone Depth	Conv. Normal Depth	Conv. Angle Depth
A	1.1	1.2	1.0		NOT TESTED		
B	17.4	0.3	0.3				
C	43.2	0.3					
D	51.2	1.6	1.5	1.5		1.5	1.5
E	65.0	1.5	1.5	1.5		1.5	1.5

0 TO 14.5" SECTION REMOVED BETWEEN INSPECTIONS

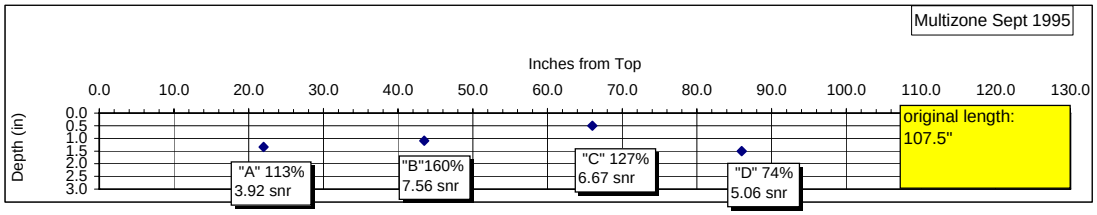
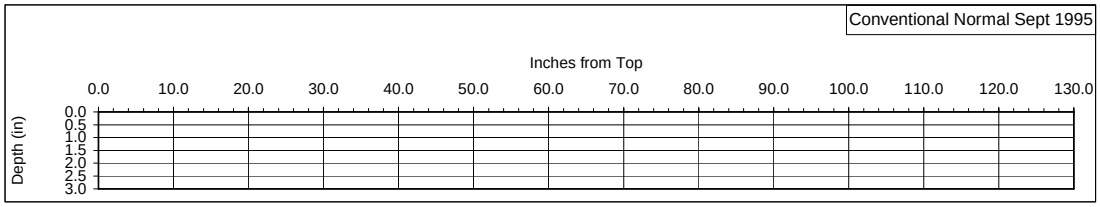
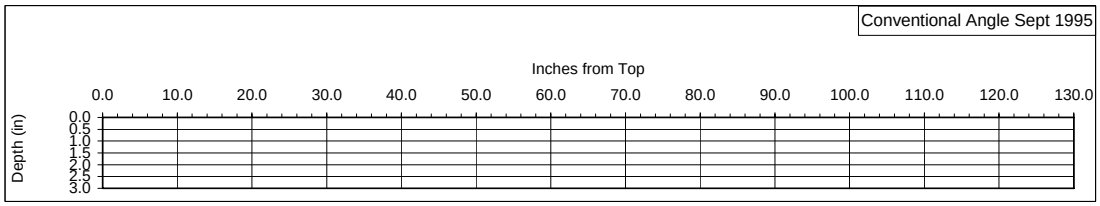
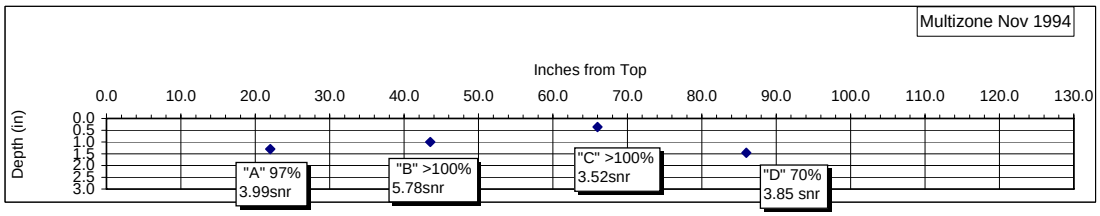
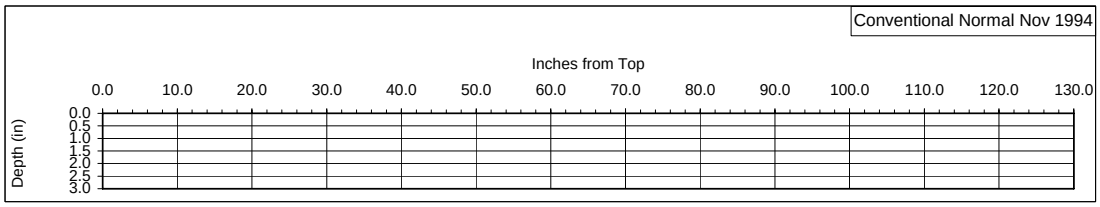
B1BW3

September 1995 Inspection			November 1994 Inspection		
Stamped I.D.	Inches from top	Multizone Depth	Conv. Normal Depth	Conv. Angle Depth	Multizone Depth	Conv. Normal Depth	Conv. Angle Depth
A	22.0	1.3			1.3		
B	43.5	1.1			1.0		
C	66.0	0.5			0.4		
D	86.0	1.5			1.5

Addtional Multizone 31% amplitude, 1.85 snr reported in Nov '95 test.

2 indications 19% & 30%, long & shear not marked to cut. No other conv. ind. See RMI11/9/94 report

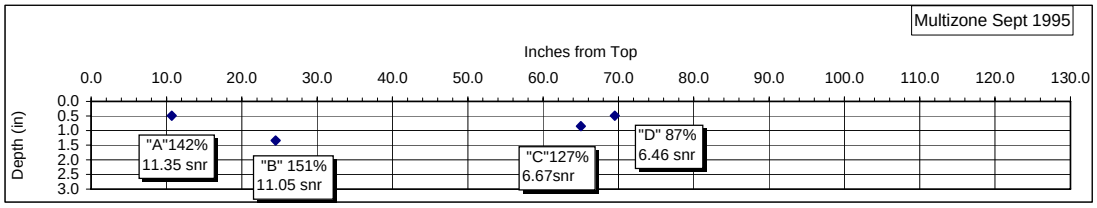
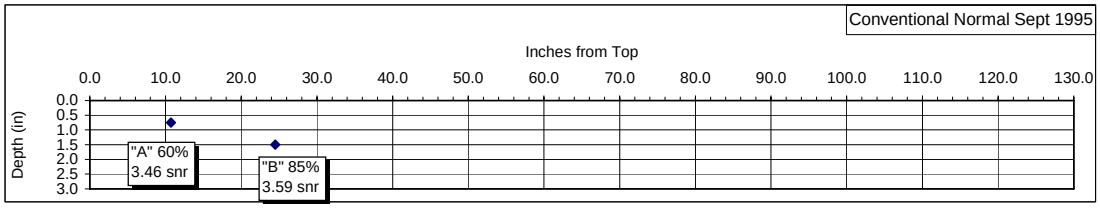
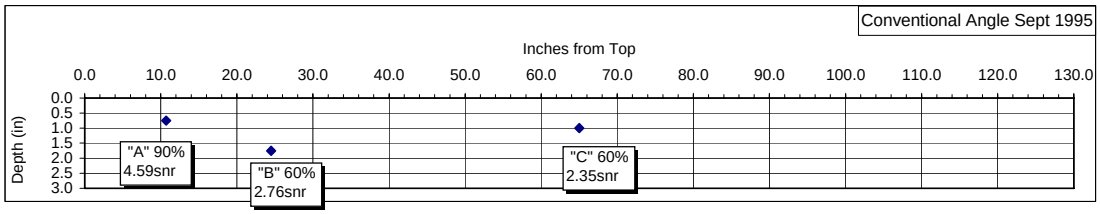
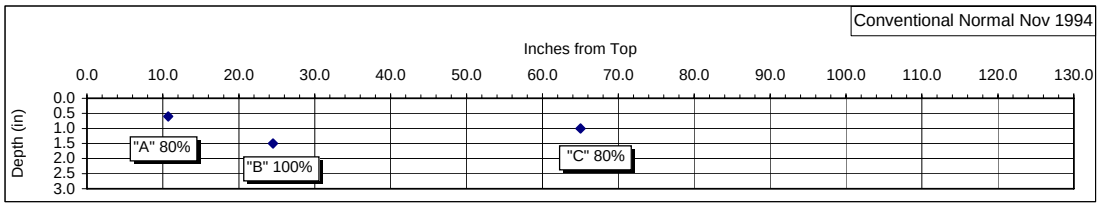
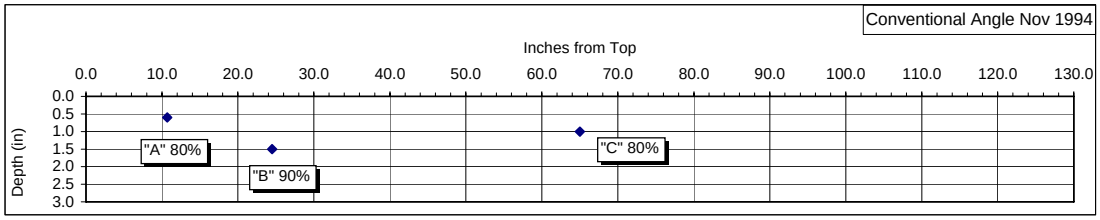
B2W1

September 1995 Inspection			November 1994 Inspection		
Stamped I.D.	Inches from top	Multizone Depth	Conv. Normal Depth	Conv. Angle Depth	Multizone Depth	Conv. Normal Depth	Conv. Angle Depth
A	10.7	0.5	0.8	0.8	NOT TESTED	0.6	0.6
B	24.5	1.3	1.5	1.8		1.5	1.5
C	65.0	0.9		1.0		1.0	1.0
D	69.5	0.5

original length: 133"

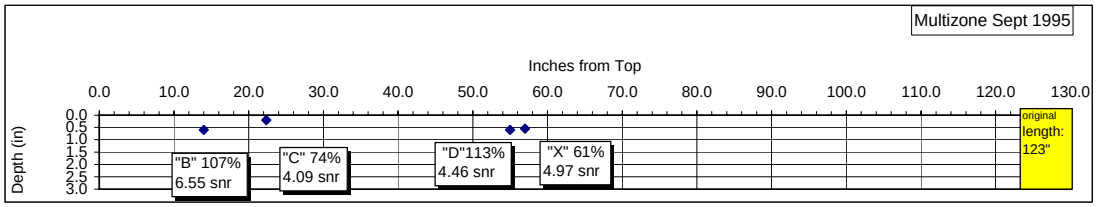
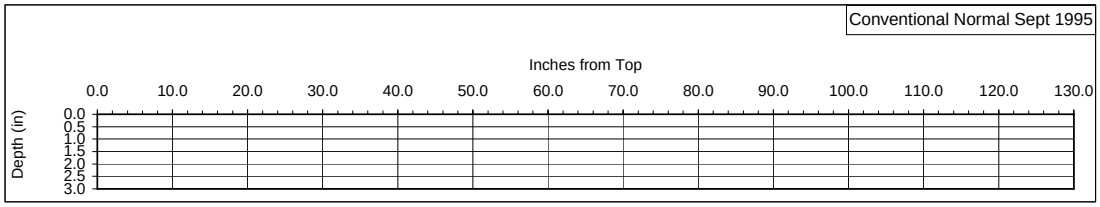
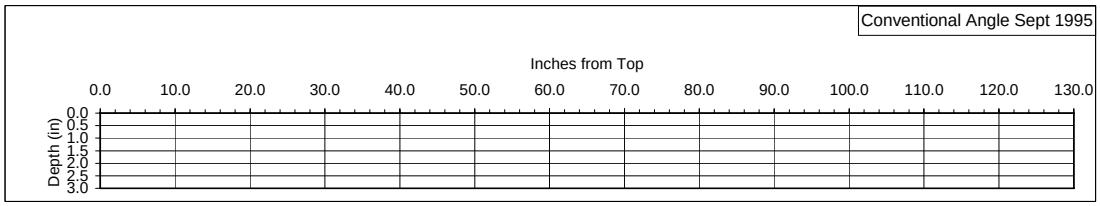
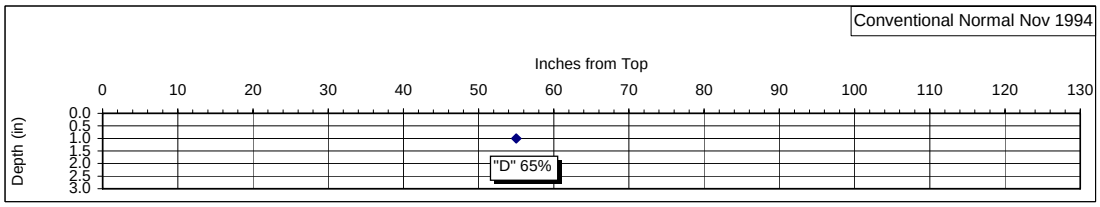
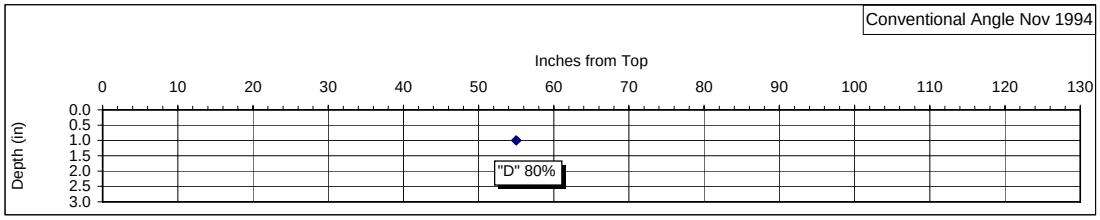
B2W2

September 1995 Inspection			November 1994 Inspection		
Stamped I.D.	Inches from top	Multizone Depth	Conv. Normal Depth	Conv. Angle Depth	Multizone Depth	Conv. Normal Depth	Conv. Angle Depth
A	Visible end burst - indications marked "A"						
B	14.0	0.6			Not tested		
C	22.4	0.2					
D	55.0	0.6				1.0	1.0
(X)	57	0.55
