DOT/FAA/AR-05/16

Contaminated Billet Study

September 2005

Final Report

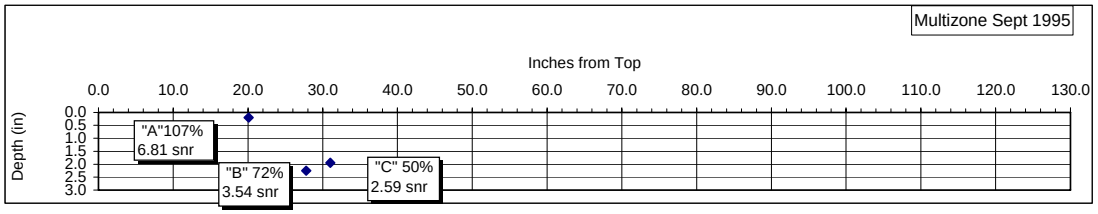
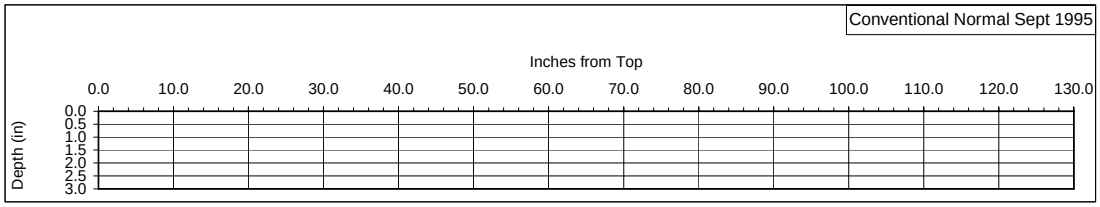
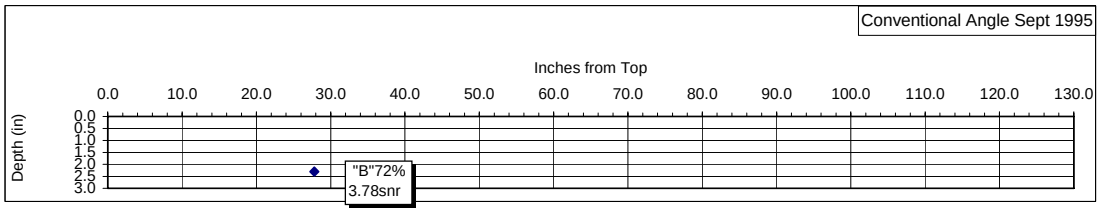
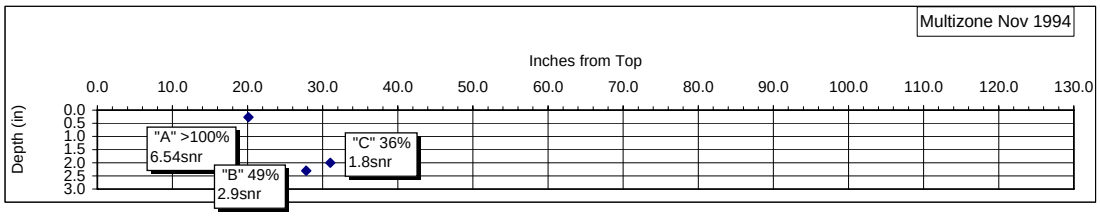
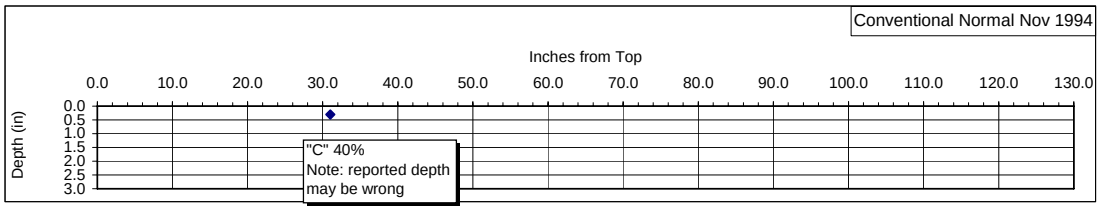
B2W3

September 1995 Inspection			November 1994 Inspection		
Stamped I.D.	Inches from top	Multizone Depth	Conv. Normal Depth	Conv. Angle Depth	Multizone Depth	Conv. Normal Depth	Conv. Angle Depth
A	20.1	0.2			0.3		
B	27.8	2.3		2.3	2.3		
C	31.0	2.0			2.0	0.3	0.3

Note: indication B mis-reported as C Nov 94, C not reported.
Billet map shows corrections determined from raw data

original length: 131"

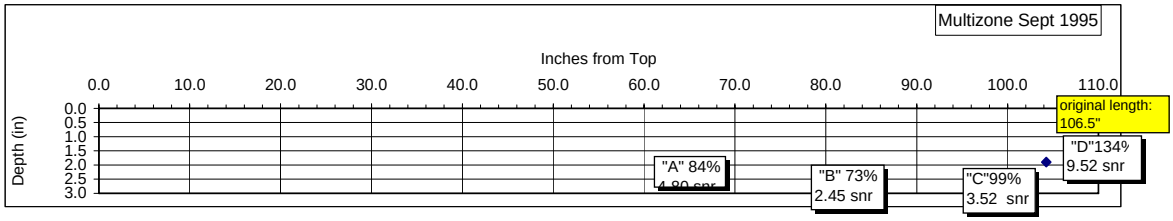
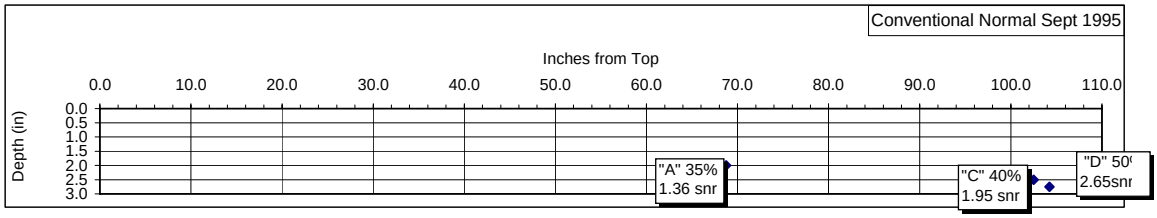
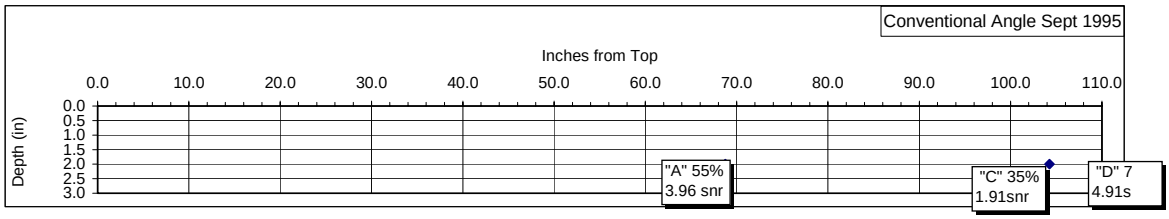
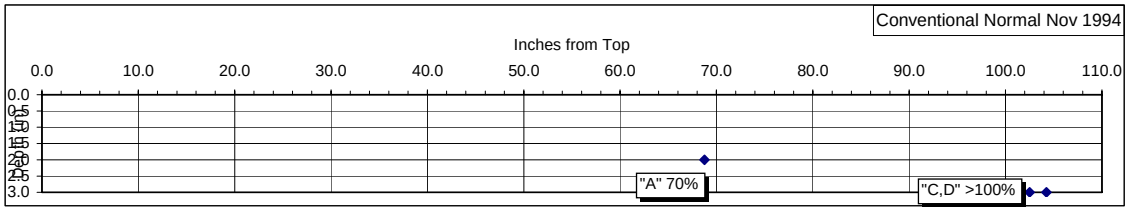
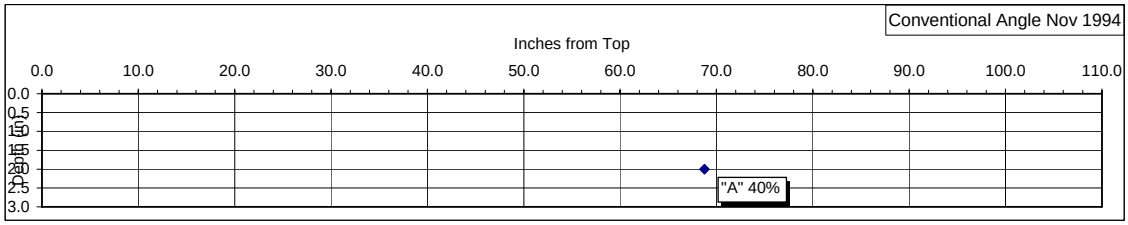
B3W1B

September 1995 Inspection			November 1994 Inspection		
Stamped I.D.	Inches from top	Multizone Depth	Conv. Normal Depth	Conv. Angle Depth	Multizone Depth	Conv. Normal Depth	Conv. Angle Depth
A	68.8	2.0	2.0	2.0	Test not run	2.0	2.0
B	84.8	2.2					
C	102.5	2.3	2.5	2.3		3.0	
D	104.3	1.9	2.8	2.0		3.0

0 - 11.5" section removed between tests

C,D reported as same ind. conv./norm

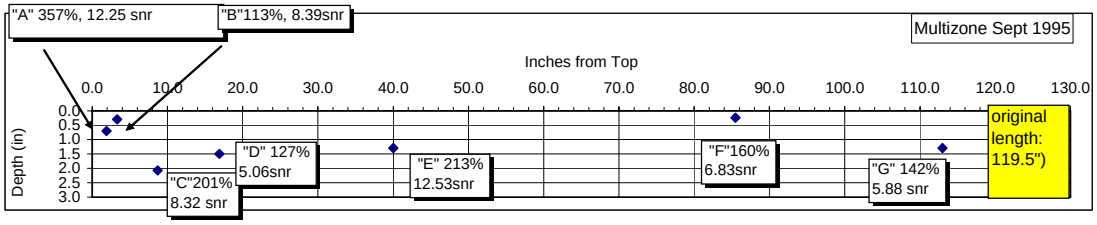
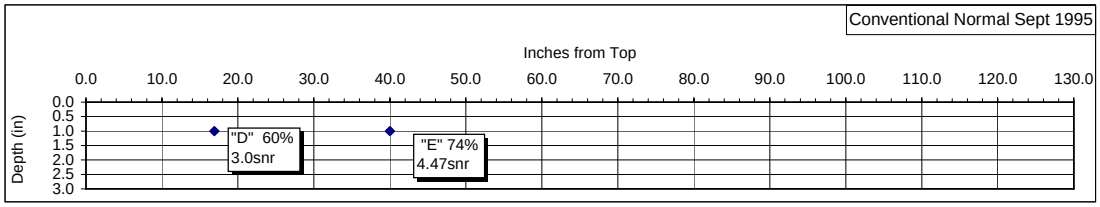
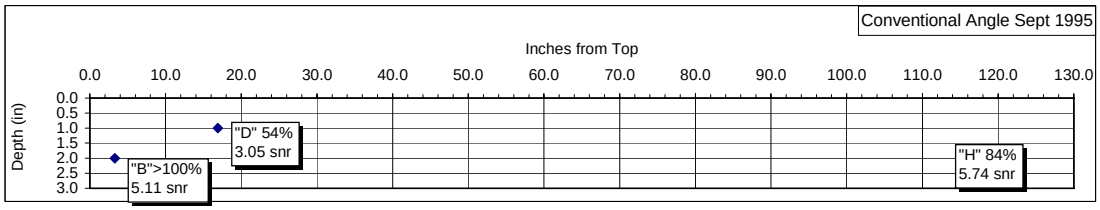
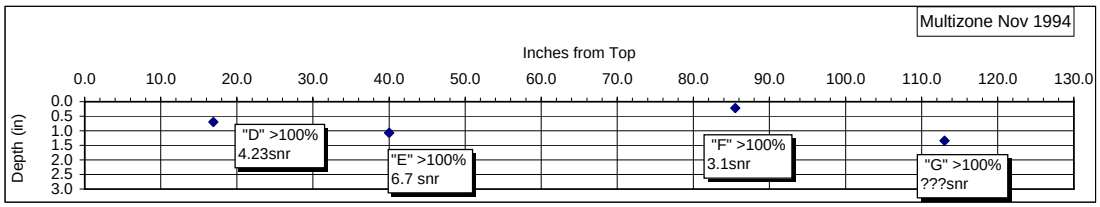
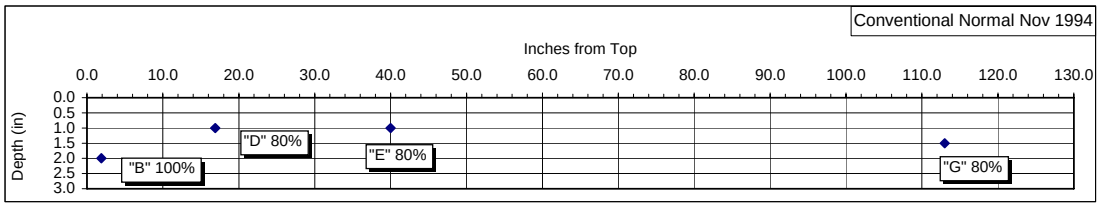
B3W2

September 1995 Inspection			November 1994 Inspection		
Stamped I.D.	Inches from top	Multizone Depth	Conv. Normal Depth	Conv. Angle Depth	Multizone Depth	Conv. Normal Depth	Conv. Angle Depth
A	1.9	0.7				2.0	2.0
B	3.3	0.3		2.0			
C	8.7	2.1					
D	16.9	1.5	1.0	1.0	0.7	1.0	1.0
E	40.0	1.3	1.0		1.1	1.0	1.0
F	85.5	0.2			0.2		
G	113.0	1.3			1.3	1.5	1.5

"A","B","C" are in region 0 - 5.5" marked "no test, visible hole" on 12/5/94 RMI report. "C" appears at 3.5" from end on C-scan inconsistent with RMI report). Additional MZ indication at 5", 56%, SNR 2.3 (not rejectable) on RMI

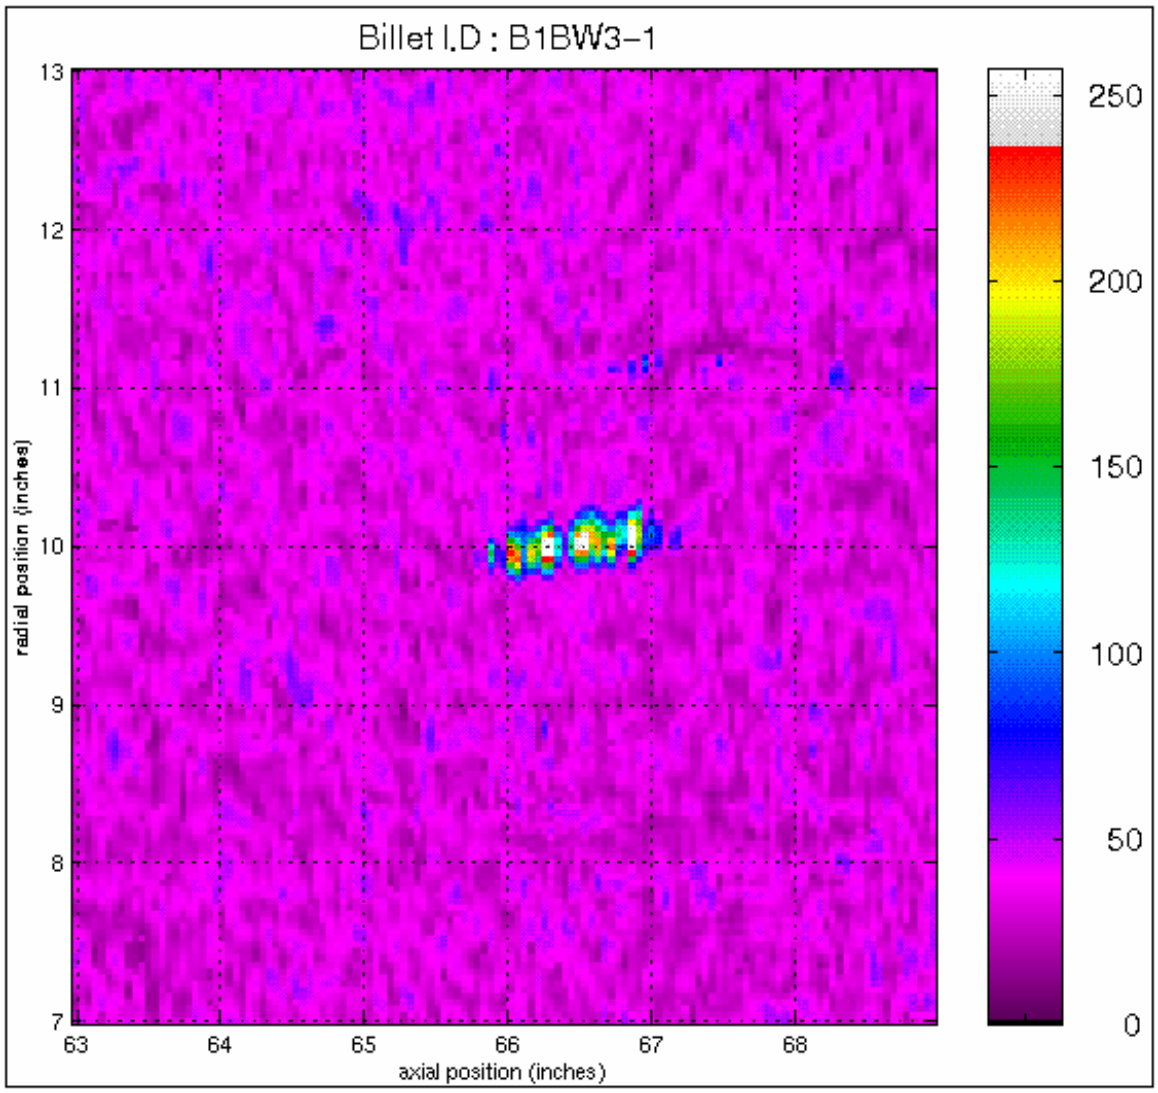
Billet ID: B1BW3 - C

Inches from top: 51

Amplitude (%)	S/N	depth (in)	axial length (in)	radial length (in)
Multizone	**120**	**5.74**	**0.8**	**0.7152**	**0.2160**
Conv. Longitudinal	**50**	**2.39**	**1.0**		
Conv. Angle	**60%**	**4.37**	**1.0**

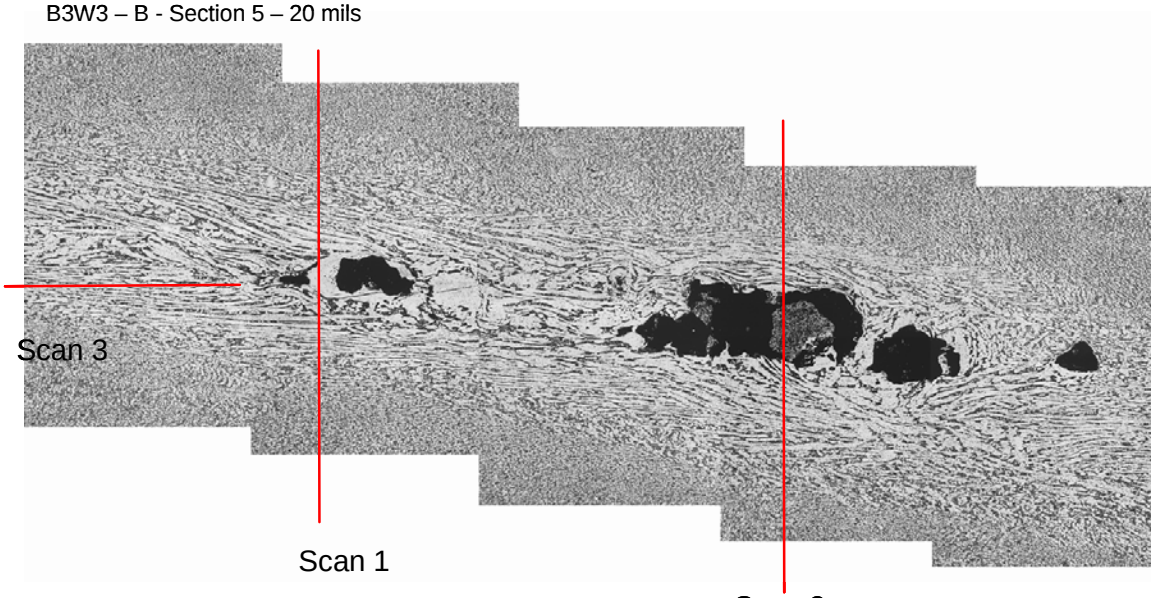
B3W3 – B - Section 5 – 20 mils

B3W3 - INDICATION B - TRANSVERSE PROFILE No. 1
ELECTRON MICROPROBE COMPOSITION MEASUREMENTS
Scanned perpendicular to long axis of defect with "zero" located at defect core.

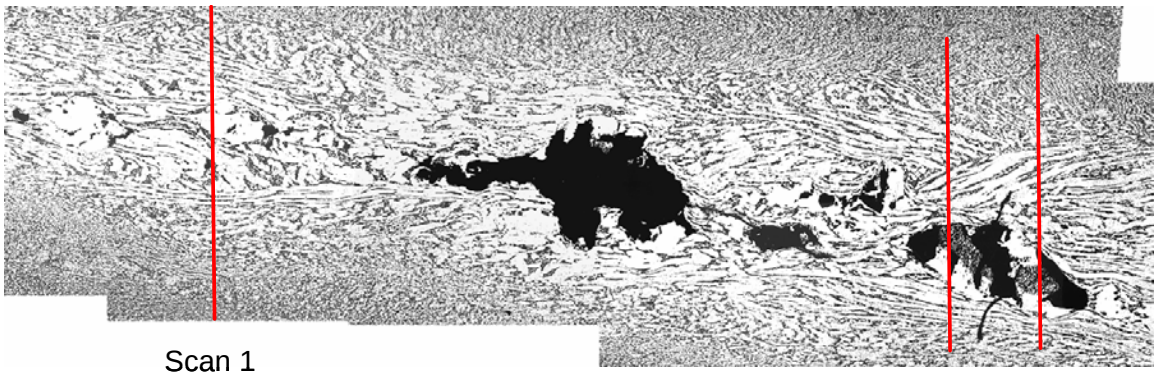
B3W3 – B - Section 11 – 45 mils

DEFECT B3W3-B - METALLOGRAPHIC SECTION No. 11 -
TRANSVERSE PROFILE No. 1
ELECTRON MICROPROBE COMPOSITION MEASUREMENTS
Scanned perpendicular to long axis of defect with "zero" located at defect core.

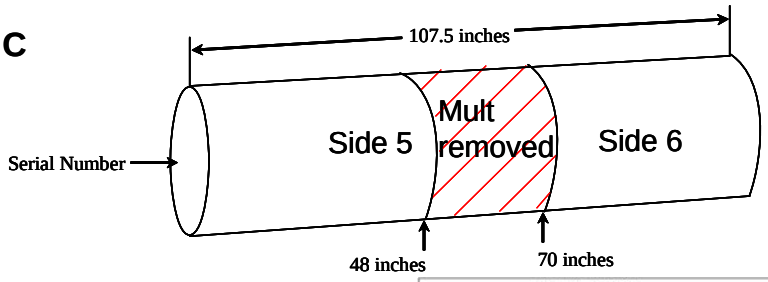
Indication: B1BW3 – C

Original billet length: 107.5”

Amplitude (%)	S/N	depth (in)	axial length (in)	radial length (in)
Multizone	127%	6.67	0.5	1.4474	0.2301
Conv. Longitudinal	%				
Conv. Angle	%

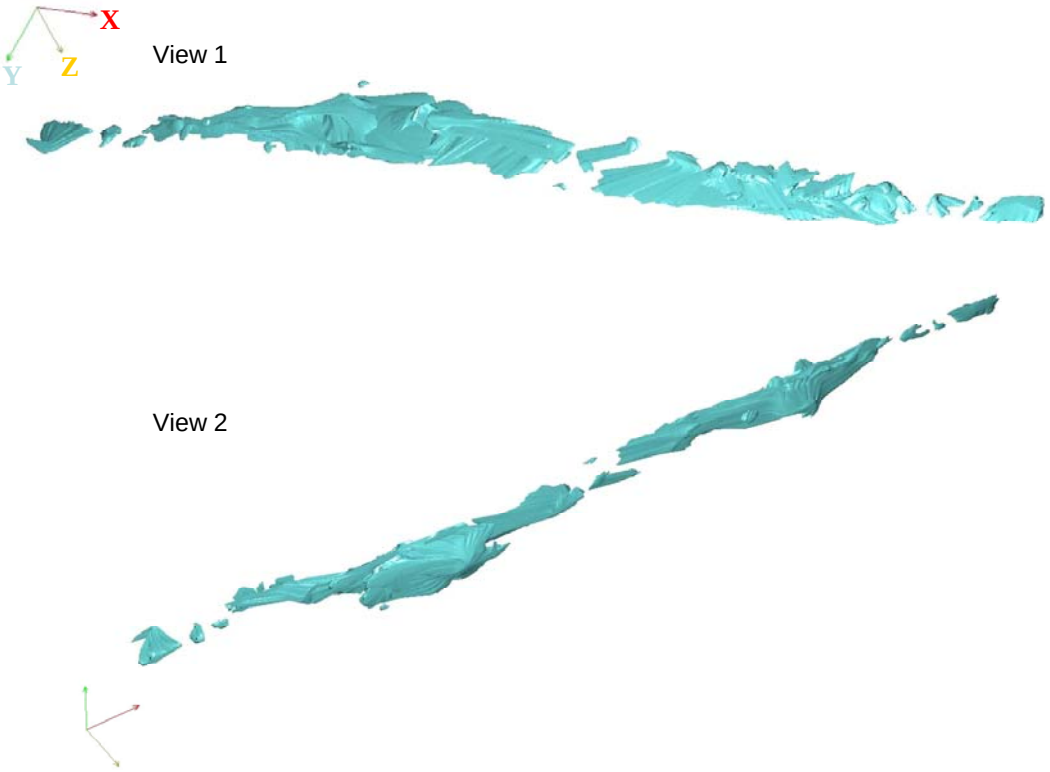
Angle views of void model for B1BW3-C:

Dimensions of B1BW3-C:

min.	max.	size
X	55	1459	1404
Y	19	190	171
Z	9	68	59

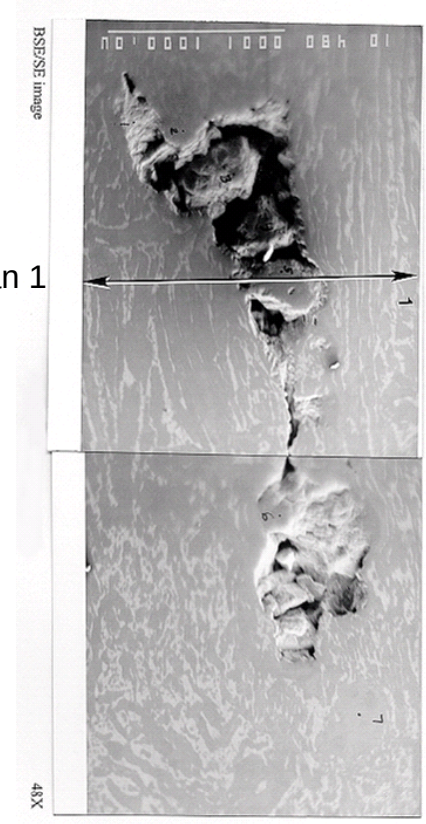
B1BW3 – C - Section 6 – 20 mils

W %		
Distance (mils)	Ti	Al	V	C	N
40	90	6.2	2.1	< 0.2	0.6
30	92	6.3	2.2	< 0.2	0.8
25	91	6.2	2.1	0.2	0.8
20	92	5.9	2.1	< 0.2	0.5
16	89	5.9	2.2	< 0.2	1.3
14	93	4.8	2	< 0.2	0.9
12	92	5.3	2.2	< 0.2	1.2
10	90	5.2	2	0.3	1.6
8	92	2.6	1.8	< 0.2	1.5
6	91	0.2	2.2	0.4	5.2
5	91	0.2	2.4	0.3	5.4
4	89	0.6	2.2	0.3	5.0
3	89	0.4	2.4	0.4	7.7
2	89	0.1	1.6	0.4	8.7
1	89	< 0.1	1.2	0.6	9.7
0	90	< 0.1	1	< 0.2	8.4
-1	86	0.2	1.5	1.1	8.4
-2	87	0.4	3.2	0.9	8.6
-3	88	0.1	1.2	0.4	8.6
-4	88	0.2	2.3	0.3	7.4
-5	88	0.4	2.4	0.3	5.4
-6	89	0.3	2.1	1.8	6.8
-8	79	1.9	1.3	0.9	2.9
-10	88	5.2	2.2	< 0.2	1.7
-12	90	5.6	2.3	< 0.2	1.5
-14	90	5.5	2.1	< 0.2	1.0
-16	93	5.7	1.8	< 0.2	0.6
-20	92	6.3	2.1	< 0.2	0.5
-25	92	6.3	1.9	< 0.2	< 0.5
-30	92	6.8	2	< 0.2	1.0
-40	91	7	2	< 0.2	0.5

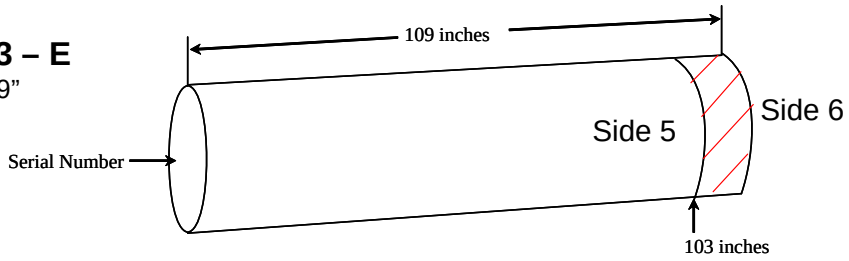
Indication: B1AW3 – E

Original billet length: 109”

Amplitude (%)	S/N	depth (in)	axial length (in)	radial length (in)
Multizone	47	2.52	1.6	.1860	.4123
Conv. Longitudinal					
Conv. Angle

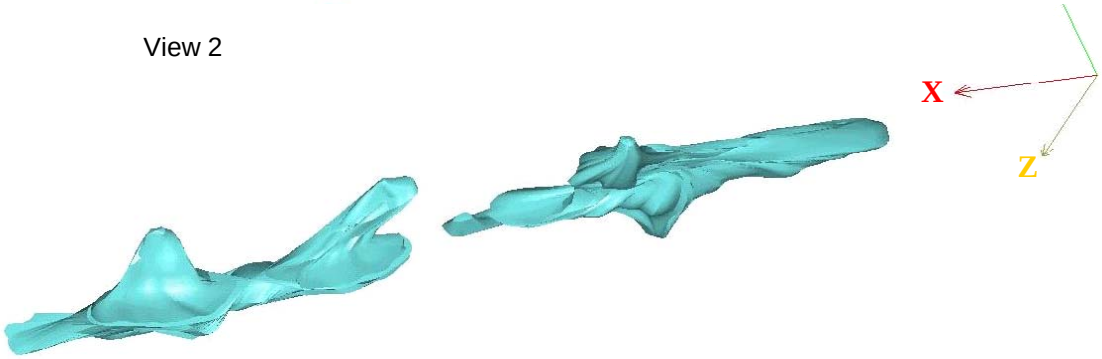
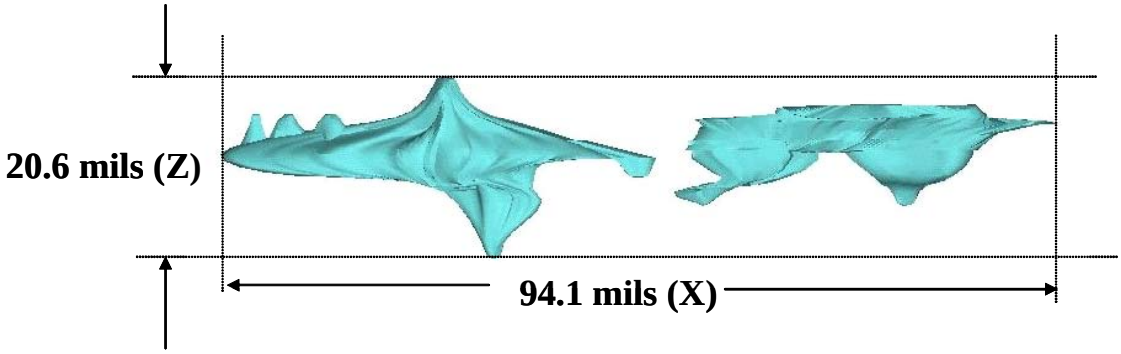
Dimensions of B1AW3-E:

min.	max.	size
X	5.49	99.57	94.08
Y	2.47	18.23	15.76
Z	16.70	37.30	20.60

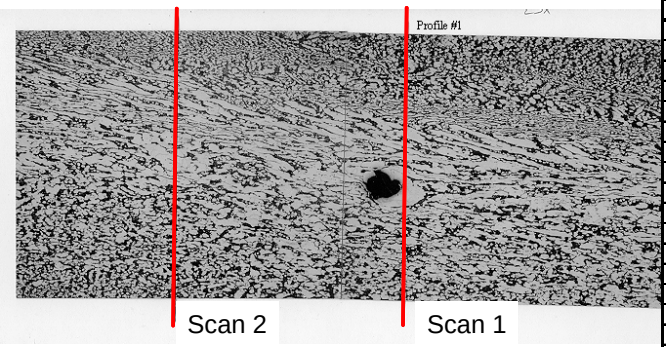
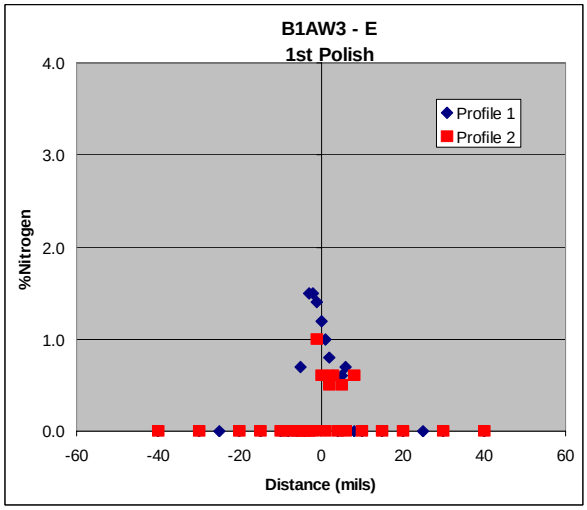
B1AW3 – E - Section 5 – 20 mils

Profile #1 - Section 5					
			W %		
Distance (mils)	Ti	Al	V	C	N
40	91	7.5	1.6	< 0.2	< 0.5
30	89	7.5	1.8	< 0.2	< 0.5
25	90	7.5	2.2	< 0.2	< 0.5
20	90	7.2	1.8	< 0.2	< 0.5
15	90	7.2	2	< 0.2	< 0.5
10	92	6.7	1.8	< 0.2	< 0.5
8	92	6.3	2.1	< 0.2	< 0.5
6	92	6.3	2.4	< 0.2	0.7
5	91	5.9	2.3	< 0.2	0.6
4	92	5.3	1.7	< 0.2	< 0.5
3	93	5.6	1.9	< 0.2	0.6
2	92	5	2.1	< 0.2	0.8
1	95	4.3	2.1	0.2	1.0
0	94	3.4	1.5	0.2	1.2
-1	94	2.3	1.9	0.3	1.4
-2	96	1.7	1.8	0.7	1.5
-3	95	2.2	2.2	0.3	1.5
-4	94	4.8	2.6	< 0.2	< 0.5
-5	92	5.6	2.5	< 0.2	0.7
-6	93	5.9	2.2	< 0.2	< 0.5
-8	91	6.6	2.2	< 0.2	< 0.5
-10	93	6.8	1.8	< 0.2	< 0.5
-15	92	6.8	2	< 0.2	< 0.5
-20	92	7.1	2.2	< 0.2	< 0.5
-25	93	7.1	2.2	< 0.2	< 0.5
-30	93	7	2	< 0.2	< 0.5
-40	92	7.3	1.9	< 0.2	< 0.5

Profile #2 - Section 5					
			W %		
Distance (mils)	Ti	Al	V	C	N
40	86	7.1	1.7	< 0.2	< 0.5
30	93	7.2	1.9	< 0.2	< 0.5
20	91	6.9	2	< 0.2	< 0.5
15	93	7	1.9	< 0.2	< 0.5
10	91	6.8	2.1	< 0.2	< 0.5
8	92	6.8	1.9	< 0.2	0.6
6	88	6.3	2	< 0.2	< 0.5
5	92	6	2.2	< 0.2	0.5
4	90	5.8	2.1	< 0.2	< 0.5
3	92	5.9	2.2	0.2	0.6
2	92	6.1	2.3	0.3	0.5
1	93	6	2.2	0.3	< 0.5
0	92	5.8	2.6	0.3	0.6
-1	90	0.1	1.8	< 0.2	1.0
-2	87	0.1	2	< 0.2	< 0.5
-3	89	< 0.1	0.8	< 0.2	< 0.5
-4	90	0.1	2	< 0.2	< 0.5
-5	91	< 0.1	0.8	< 0.2	< 0.5
-6	91	< 0.1	1	< 0.2	< 0.5
-8	90	0.1	1.9	< 0.2	< 0.5
-10	91	0.2	2.5	< 0.2	< 0.5
-15	88	0.1	1.6	< 0.2	< 0.5
-20	93	0.5	2.2	< 0.2	< 0.5
-30	93	0.5	2.2	< 0.2	< 0.5
-40	93	3.1	1.7	< 0.2	< 0.5

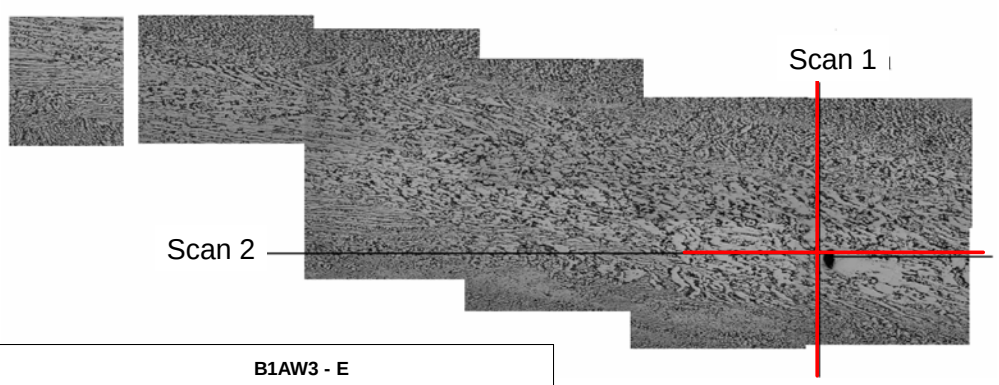
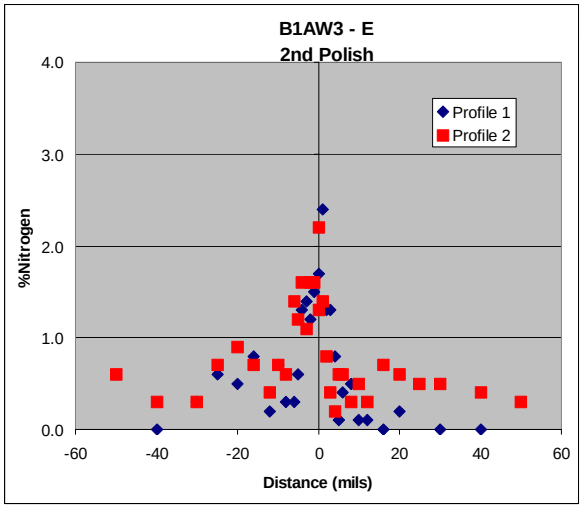
B1AW3 – E - Section 10 – 31 mils

Profile #1 - Section 10					
			W %		
Distance (mils)	Ti	Al	V	C	N
40	91	7.2	2	< 0.2	< 0.5
30	89	7.2	1.7	< 0.2	< 0.5
20	91	7.2	1.6	< 0.2	< 0.5
16	89	7	1.8	< 0.2	< 0.5
12	90	7.1	1.7	< 0.2	< 0.5
10	90	7	1.7	< 0.2	< 0.5
8	90	6.8	1.7	< 0.2	0.5
6	89	6.7	1.8	< 0.2	< 0.5
5	89	6.3	2	0.2	< 0.5
4	89	6	1.9	0.3	0.8
3	89	5.7	2	0.4	1.3
2	89	4.8	2.1	0.5	1.3
1	91	3.5	1.8	0.6	2.4
0	91	3.2	1.8	0.7	1.7
-1	92	3.6	1.5	0.8	1.5
-2	92	4.4	1.8	0.5	1.2
-3	91	4.2	1.6	0.4	1.4
-4	89	5.4	1.9	0.2	1.3
-5	91	6	1.9	< 0.2	0.6
-6	88	6.2	1.9	< 0.2	< 0.5
-8	92	6.3	1.6	0.2	< 0.5
-10	89	6.4	1.9	< 0.2	0.7
-12	92	6.7	1.9	< 0.2	< 0.5
-16	89	6.8	1.8	< 0.2	0.8
-20	91	6.8	1.8	< 0.2	0.5
-25	89	7	1.9	< 0.2	0.6
-30	88	7.1	1.8	< 0.2	< 0.5
-40	88	7.1	1.8	< 0.2	< 0.5

← Profile #2 - Section 10					
			W %		
Distance (mils)	Ti	Al	V	C	N
0	89	2.6	1.6	0.9	1.3
1	91	2.6	1.6	0.3	1.6
2	89	3.9	1.9	0.3	1.6
3	89	5.4	1.8	0.4	1.1
4	88	5.2	1.7	0.3	1.6
5	90	5.7	2.3	0.2	1.2
6	88	5.8	1.9	0.2	1.4
8	90	5.8	1.9	0.2	0.6
10	87	6	1.8	0.2	0.7
12	91	6.1	1.9	< 0.2	< 0.5
16	91	6.3	1.9	< 0.2	0.7
20	90	6.4	1.9	< 0.2	0.9
25	90	6.5	2	< 0.2	0.7
30	91	6.2	1.9	< 0.2	< 0.5
40	91	6.4	1.9	< 0.2	< 0.5
50	91	6.2	1.9	< 0.2	0.6

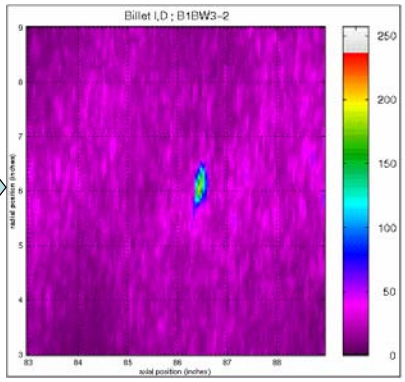
Indication: B1BW3 – D

Amplitude (%)	S/N	depth (in)	axial length (in)	radial length (in)
Multizone	74%	5.06	1.5	0.3268	0.2577
Conv. Longitudinal	%				
Conv. Angle	%

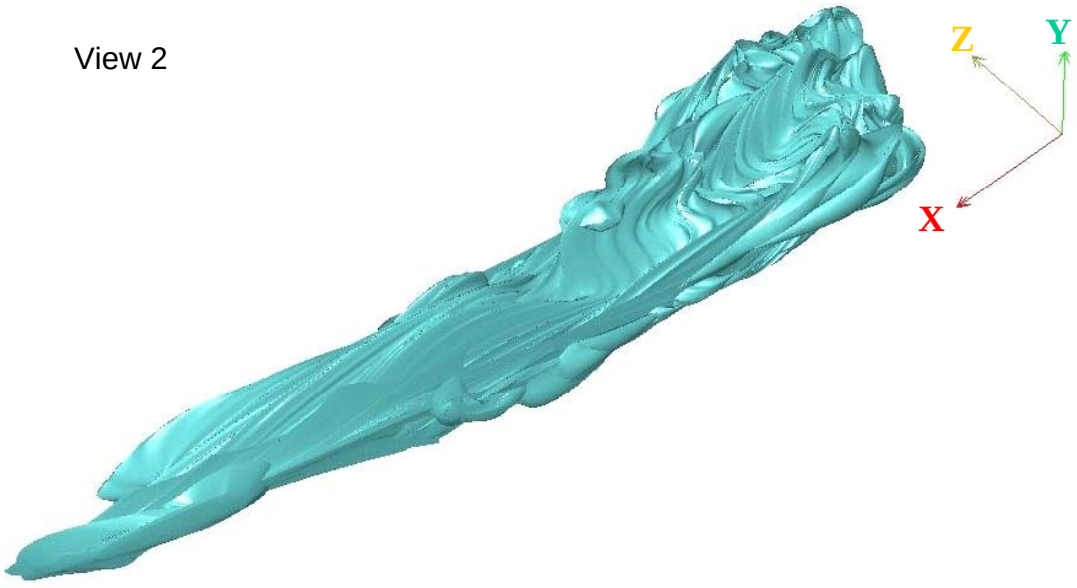
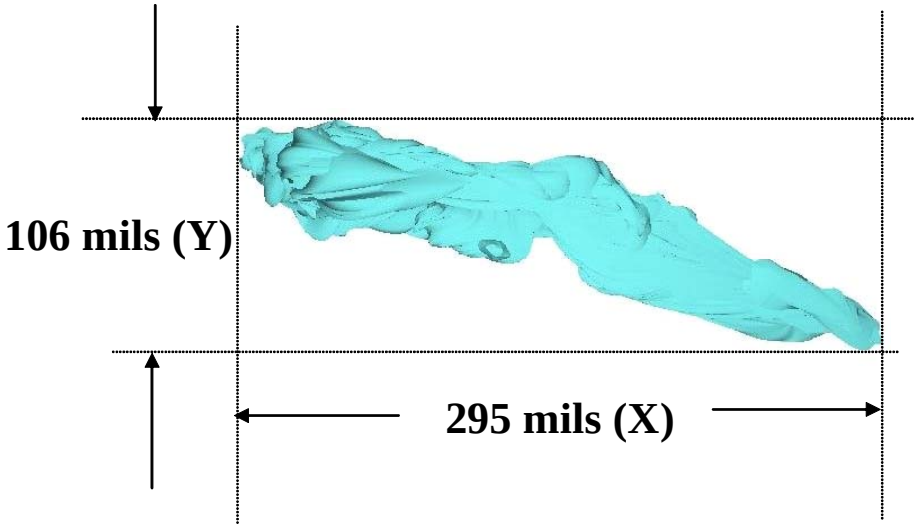
Dimensions of B1BW3-D:

min.	max.	size
X	38.24	332.76	294.52
Y	23.37	129.26	105.88
Z	-0.60	62.60	63.20

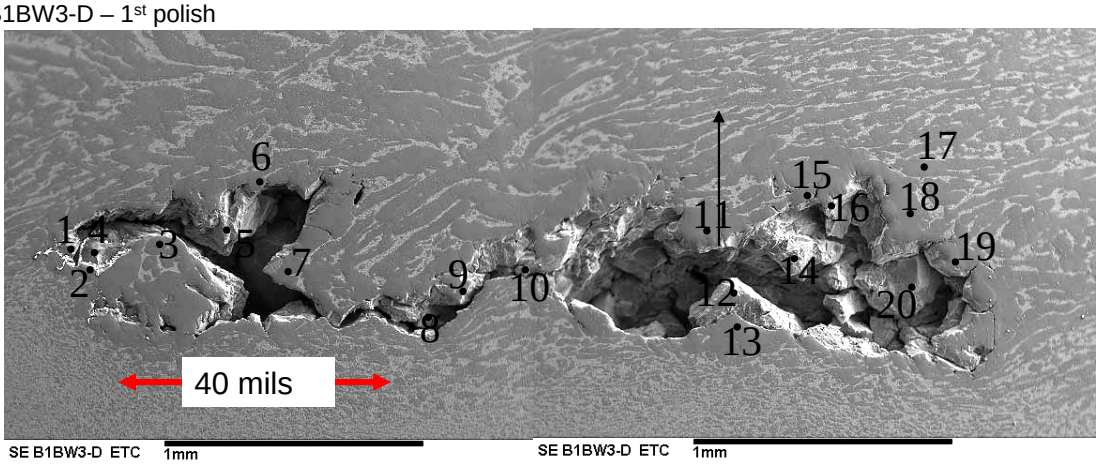
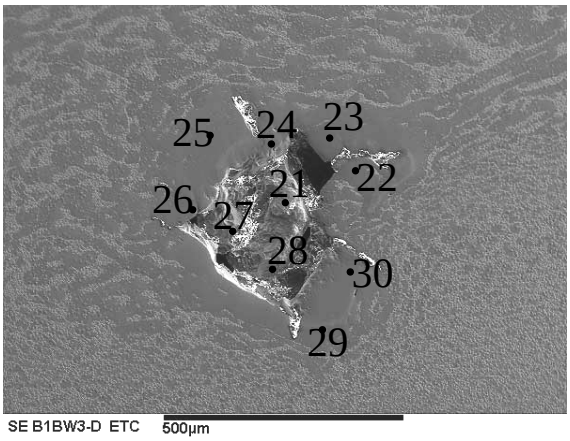
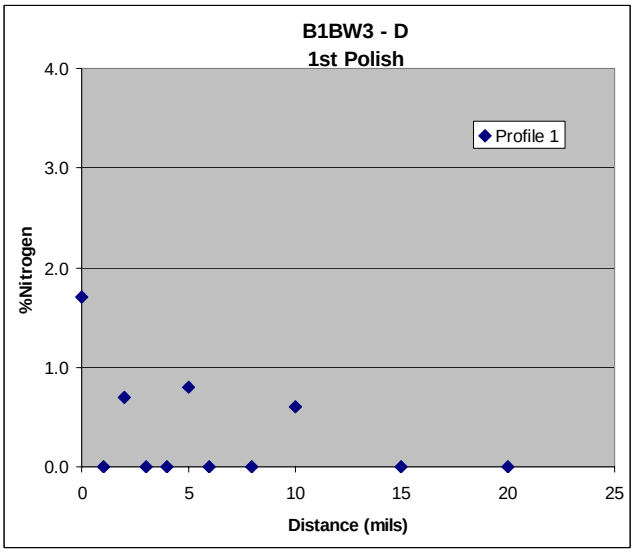
B1BW3-D – 1st polish

B1BW3 - D	W %			
Pt #	Ti	Al	V	N
1	86.4	3.4	1.7	4.9
2	90.2	5.7	2.5	1.5
3	89.9	7.5	2.9	0.9
4	92.2	2.9	1.1	5.8
5	88.6	2.7	1.4	4.7
6	85.4	5.6	2.0	0.5
7	90.6	6.5	2.8	0.8
8	88.3	4.5	1.9	2.9
9	88.1	5.8	3.2	1.4
10	89.5	2.2	1.4	4.8
11	85.5	3.2	1.3	2.1
12	90.2	1.2	1.6	6.4
13	95.0	4.0	1.5	0.8
14	87.7	2.2	1.7	4.6
15	88.5	4.9	2.3	0.5
16	88.3	1.5	1.6	2.6
17	90.6	5.7	2.2	< 0.5
18	90.6	4.7	1.7	1.0
19	90.4	2.5	1.4	2.5
20	91.1	3.4	2.0	3.9
21	83.6	0.4	0.6	9.4
22	89.0	6.0	2.0	0.5
23	89.0	4.7	1.6	0.9
24	89.8	1.6	0.9	2.5
25	88.9	4.2	1.1	1.3
26	89.3	4.5	1.6	< 0.5
27	88.7	1.4	1.1	3.7
28	85.0	0.9	1.1	8.3
29	90.6	4.9	1.7	0.6
30	87.7	1.7	1.5	5.5

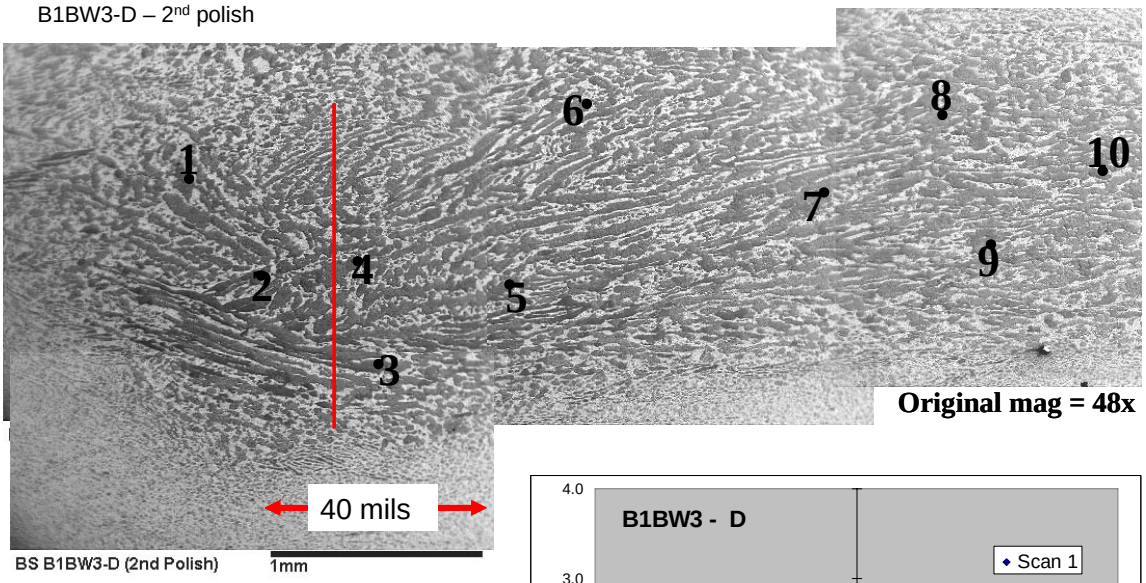
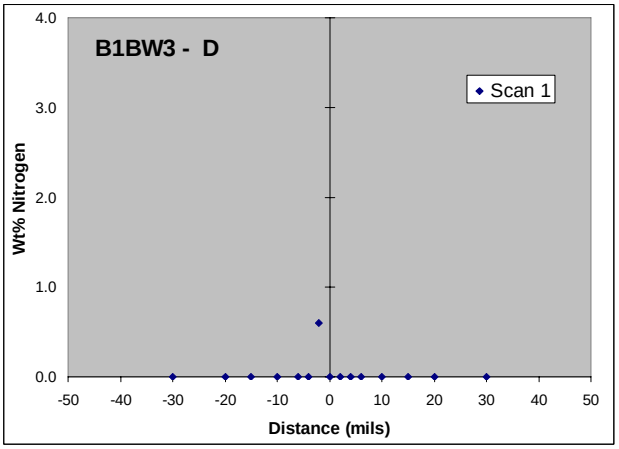
B1BW3-D – 2nd polish

Data for areas around the defect.

Pt #	Ti	Al	V	N
1	91.0	6.7	1.9	< 0.5
2	93.6	6.6	1.9	< 0.5
3	92.7	6.0	1.8	0.5
4	92.1	6.6	1.6	0.6
5	92.2	6.5	2.1	< 0.5
6	92.4	6.8	2.3	< 0.5
7	91.8	6.7	2.3	< 0.5
8	91.1	6.5	2.1	< 0.5
9	92.8	6.6	2.0	< 0.5
10	91.1	6.6	2.2	0.5

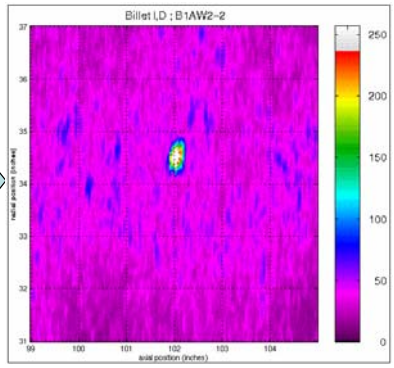
Indication: B1AW2 – D

Amplitude (%)	S/N	depth (in)	axial length (in)	radial length (in)
Multizone	134%	5.46	0.7	0.4217	0.2681
Conv. Longitudinal	50%	2.61			
Conv. Angle	%

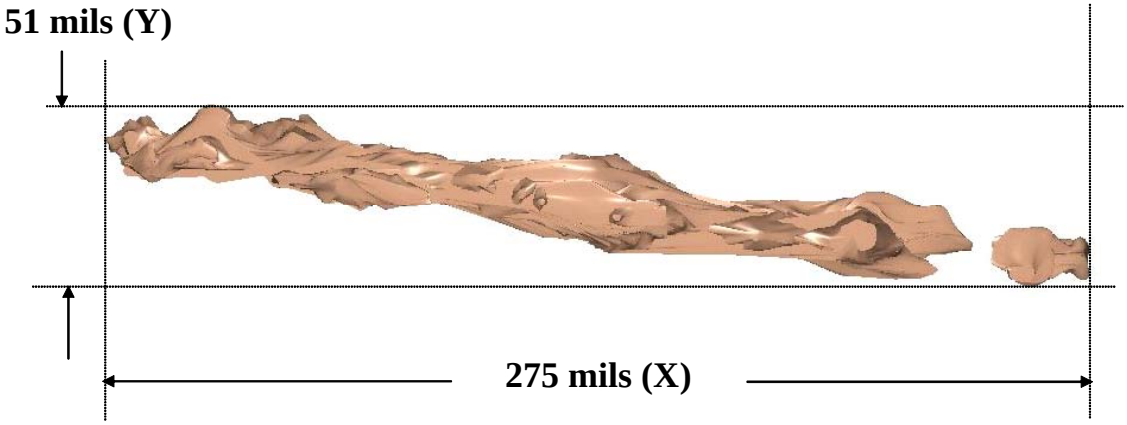
Dimensions of B1AW2 – D:

min.	max.	size
X	19	294	275
Y	30	81	51
Z	97	154	57

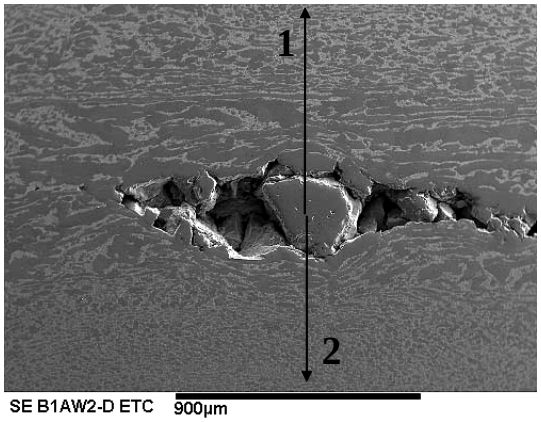
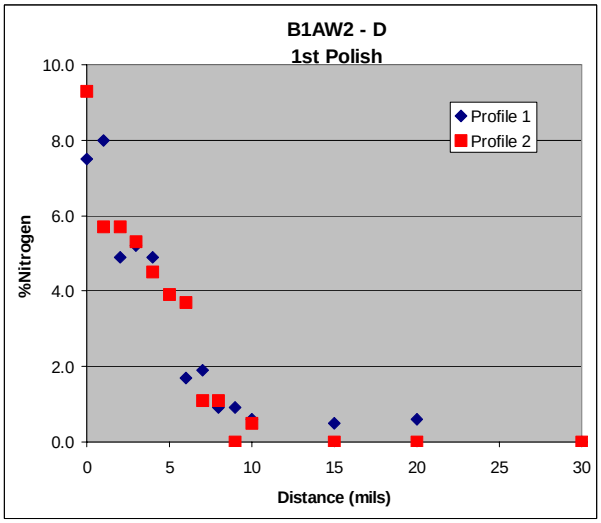
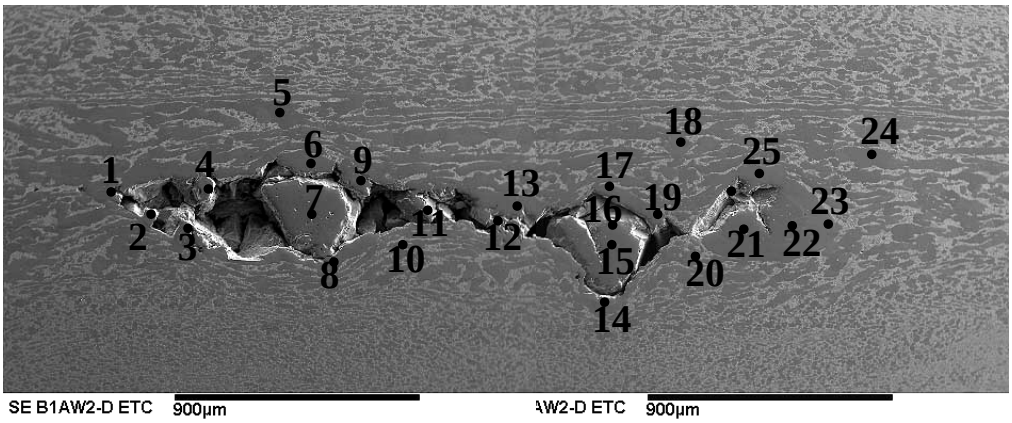
B1AW2 – D – section 15

B1AW2-D	W %			
Pt #	Ti	Al	V	N
1	91.6	0.3	2.2	4.0
2	86.9	0.1	2.2	9.9
3	88.6	0.1	1.8	9.3
4	88.5	0.3	2.0	6.6
5	90.4	6.0	2.4	< 0.5
6	90.6	4.1	1.9	1.7
7	89.9	0.1	1.4	7.7
8	89.4	4.8	1.8	1.0
9	91.7	3.8	1.7	1.1
10	91.7	6.1	1.8	0.9
11	92.1	0.4	1.6	7.0
12	90.5	0.2	2.0	4.9
13	93.5	2.5	1.4	2.7

B1AW2-D	W %			
Pt #	Ti	Al	V	N
14	94.4	1.5	1.6	2.1
15	90.7	0.1	1.3	9.5
16	91.6	0.2	2.3	5.4
17	91.0	4.6	2.0	1.5
18	92.5	6.0	1.8	< 0.5
19	93.5	4.3	1.8	1.2
20	94.0	5.2	1.8	0.6
21	93.5	0.3	3.1	2.7
22	95.9	0.3	1.8	2.5
23	95.3	4.7	1.6	< 0.5
24	94.5	5.8	1.7	< 0.5
25	93.5	0.2	2.0	4.4

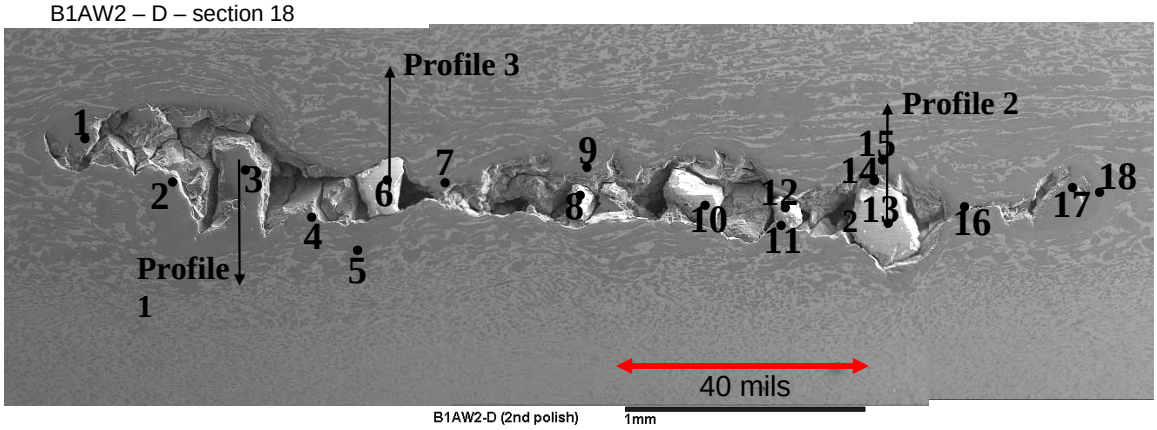
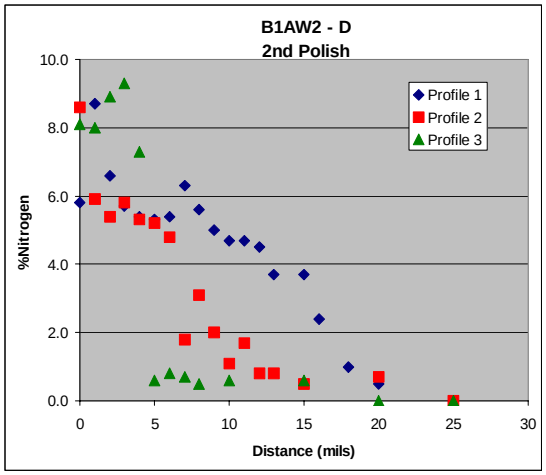
B1AW2 – D – section 18

B1AW2-D (2)	W %			
Pt #	Ti	Al	V	N
1	94.6	0.3	2.2	4.2
2	91.1	3.9	1.7	2.5
3	90.9	0.2	2.4	6.6
4	89.3	4.6	1.6	1.7
5	93.5	6.2	2.1	< 0.5
6	90.7	0.3	1.8	6.7
7	92.8	3.7	1.5	1.6
8	89.2	0.1	1.6	8.8
9	90.5	5.6	2.0	1.0
10	84.8	0.4	6.2	8.0
11	94.0	5.0	2.0	1.1
12	87.9	0.3	2.0	6.8
13	89.9	0.0	1.1	9.2
14	92.5	0.2	2.4	5
15	92.0	4.3	1.5	2.1
16	93.6	1.2	1.5	3.3
17	93.8	0.3	2.1	4.2
18	95.6	0.3	1.7	3.7

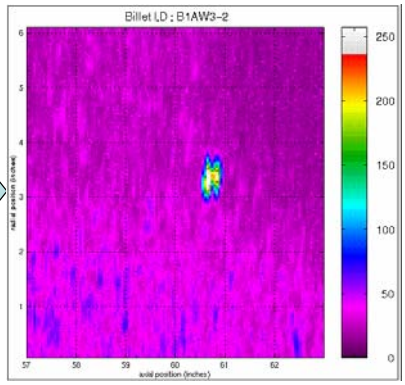
Indication: B1AW3 – A

Amplitude (%)	S/N	depth (in)	axial length (in)	radial length (in)
Multizone	142%	5.02	0.7	0.4186	0.3387
Conv. Longitudinal	50%	2.92	0.8		
Conv. Angle	60%	2.48	0.8

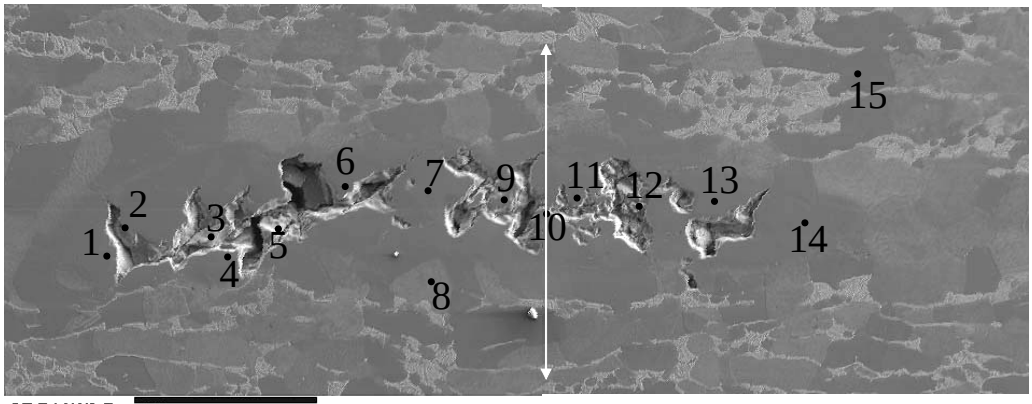
B1AW2 – B – polish 1

Data for areas around the defect.

Pt #	Ti	Al	V	N
1	97.1	0.3	1.3	2.6
2	96.3	0.3	1.6	3.1
3	92.9	0.4	1.8	5.5
4	97.1	0.5	1.4	3.9
5	92.9	0.5	1.5	6.4
6	96.2	0.3	1.7	3.3
7	91.6	1.6	1.9	4.2
8	94.1	5.9	1.8	0.5
9	92.1	0.8	1.9	5.6
10	93.3	0.3	0.9	7.3
11	92.6	0.5	1.6	6.4
12	90.9	0.6	1.7	6.5
13	95.6	0.4	1.8	3.6
14	97.3	0.8	1.3	2.1
15	93.5	5.7	2.1	< 0.5

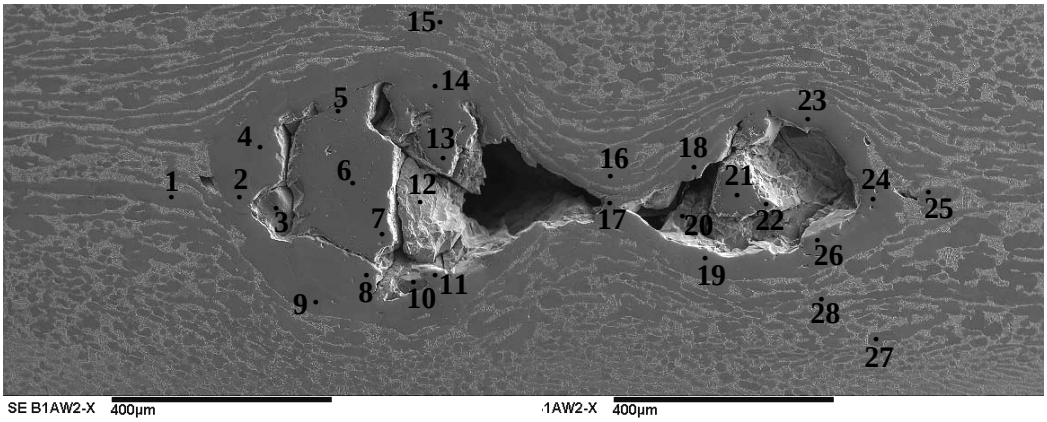
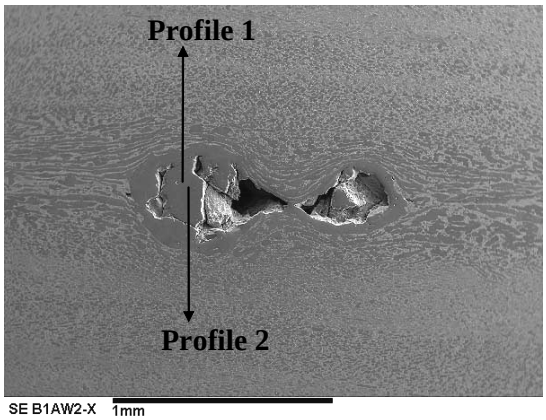
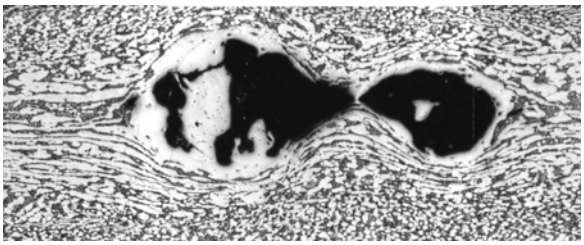
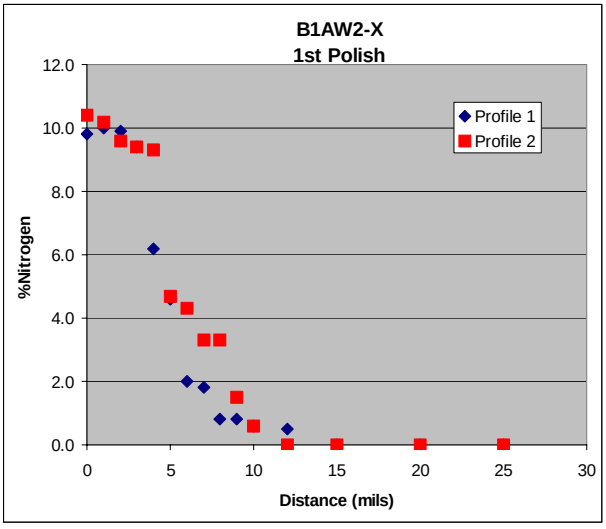
B1AW2 - X – section 10

B1AW2-X	W %			
Pt #	Ti	Al	V	N
1	90.1	5.2	2.1	0.5
2	90.9	4.4	1.7	1.0
3	89.5	2.7	1.6	2.7
4	89.1	0.4	1.6	3.0
5	91.9	0.3	2.2	4.4
6	85.5	0.3	1.8	11.2
7	88.1	0.2	1.7	9.1
8	91.0	0.3	2.4	4.1
9	92.9	4.4	1.9	1.0
10	93.5	0.2	2.0	2.9
11	92.1	0.3	2.5	4.8
12	84.9	0.3	2.1	12.3
13	84.9	0.1	2.5	9.3
14	94.0	0.6	1.8	2.6
15	89.6	6.8	2.0	0.5
16	93.0	5.2	2.1	0.6
17	95.1	2.1	1.8	2.0
18	90.1	3.2	1.9	0.5
19	94.0	2.1	1.6	1.9
20	91.5	0.8	2.2	4.4
21	86.5	0.2	1.5	9.0
22	88.0	0.2	1.6	8.4
23	92.5	2.0	1.6	1.6
24	91.5	4.1	1.7	1.3
25	91.6	4.9	2.0	0.5
26	92.6	0.4	1.8	3.6
27	89.2	6.9	1.8	< 0.5
28	90.6	6.6	2.0	< 0.5

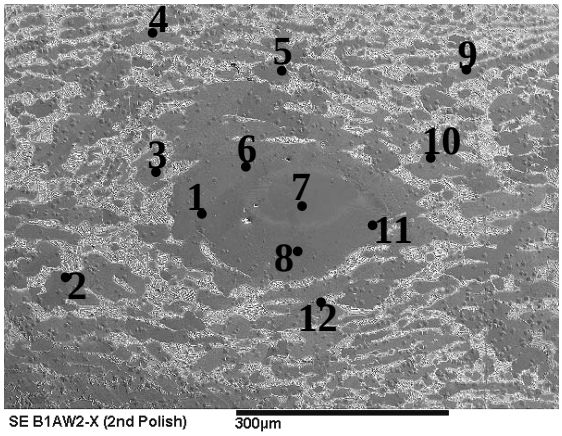
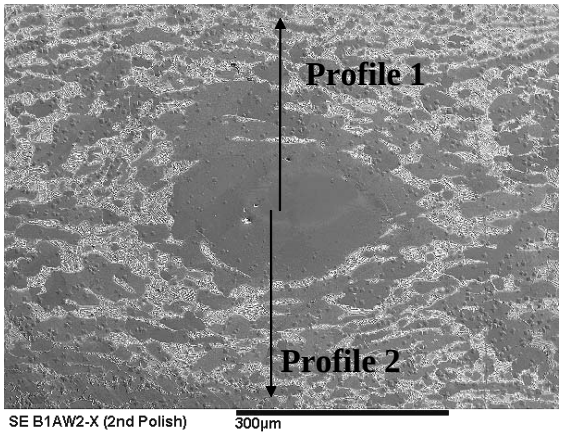
B1AW2 - X – section 14

B1AW2-X	W %			
Pt #	Ti	Al	V	N
1	90.3	4.7	1.8	1.1
2	92.3	5.8	1.9	0.5
3	90.7	5.1	1.9	0.5
4	91.1	6.9	2.0	< 0.5
5	91.5	6.6	1.8	< 0.5
6	93.9	4.1	1.9	< 0.5
7	94.6	0.6	1.8	1.8
8	93.6	4.3	1.7	0.7
9	91.1	6.9	2.1	< 0.5
10	92.8	5.8	2.1	0.7
11	93.0	4.5	2.0	0.8
12	93.7	5.6	1.9	< 0.5
