Evaluation of the 12-Second Vertical Bunsen Burner Test Used to Determine the Fireworthiness of Aircraft Duct Materials

John W. Reinhardt

October 2005

DOT/FAA/AR-TN05/36

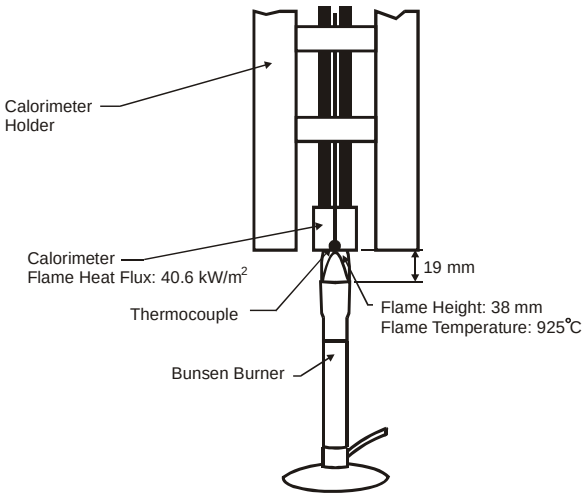
FIGURE 1. VERTICAL BUNSEN BURNER TEST

Prior to testing the sample with this standard test, the flame temperature and heat flux of the test apparatus were measured, as shown in figure 2. The flame temperature was 925°C, and the heat flux was 40.6 kW/m^2. The test results indicated that the duct material met the current federal aviation regulation, even though the material had been in service since 1980 and unknown contaminants were present. The burn length was between 6.99 and 7.62 cm; the regulation allows a maximum burn length of 20.32 cm (see figure 9). The material did not drip and flame-extinguishing time was zero (no flames after removing the burner) in two of the three tests. During the third test, the flames self-extinguished in 8 seconds. The regulation allows a maximum flame extinguishing time of 15 seconds.

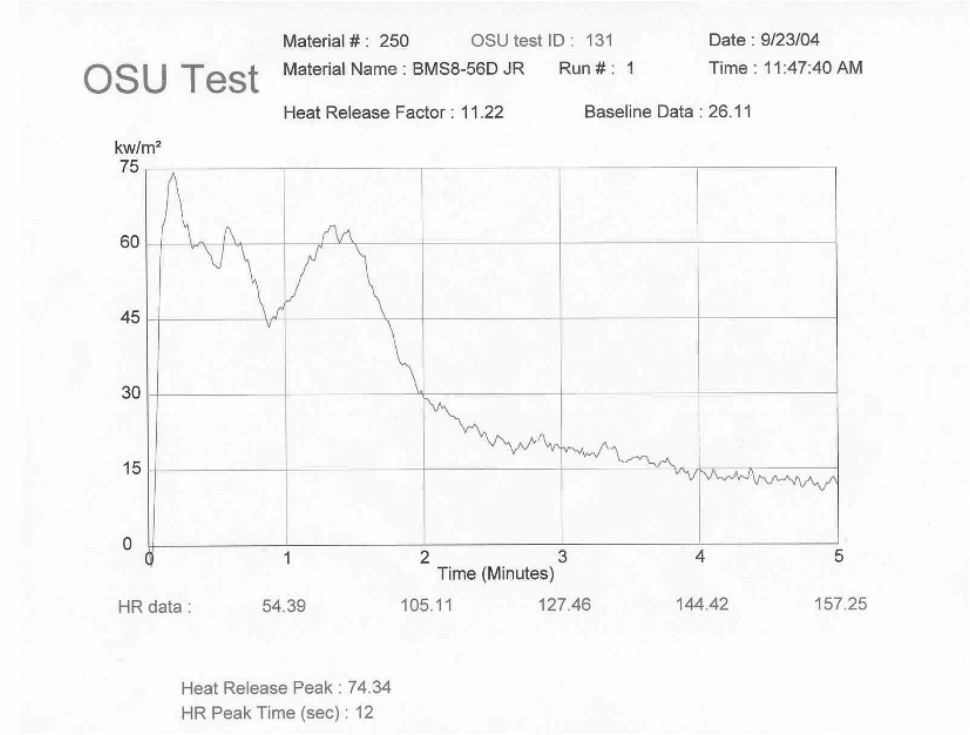
FIGURE 14. HEAT RELEASE TEST RUN 1

emitted through the exhaust stack. Figures 14 through 16 show the heat release rate histories. The double peaks appear to correspond to the burning facing initially, followed by the involvement of the urethane core. The peak heat release rate exceeded the allowable value of 65 kW/m^2. The peak heat release rates ranged from 74.34 kW/m^2 to 87.86 kW/m^2.

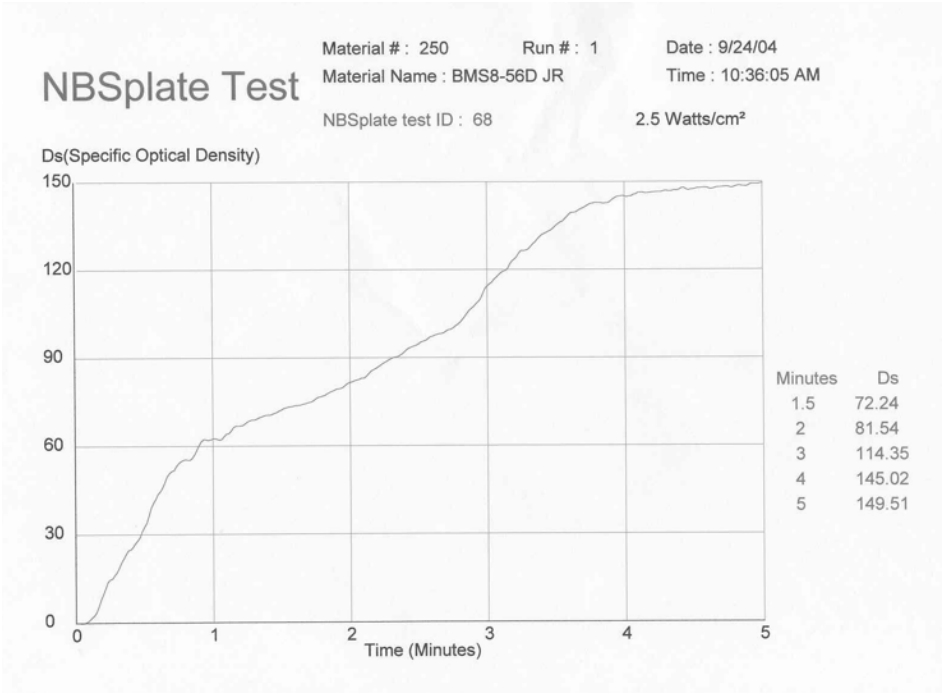
FIGURE 17. THE NBS SMOKE TEST RUN 1

The duct sample was relatively smokey, although the maximum specific optical density did not exceed the allowable 200 value. As shown in figures 17 through 20, D_m values ranged from 120 to 145.

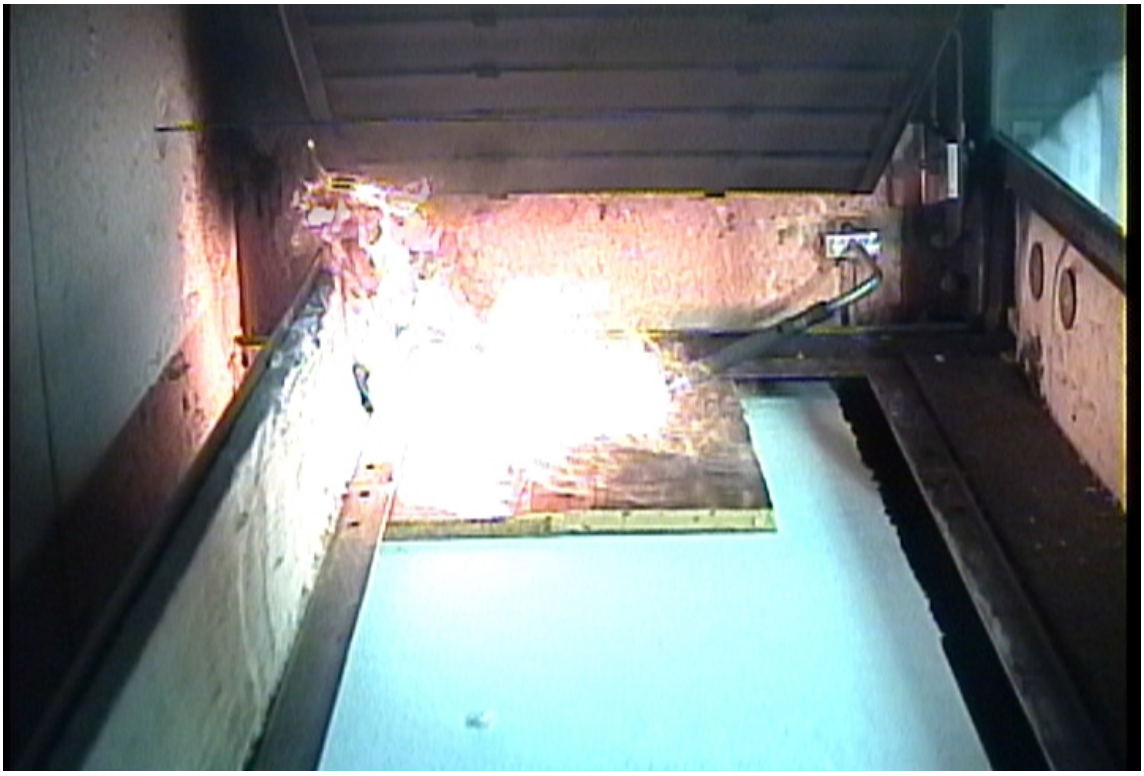
FIGURE 21. RADIANT HEAT PANEL TEST OF AIR CONDITIONING DUCT MATERIAL

The duct sample exhibited extreme flammability behavior in the radiant panel test. Only seconds after exposing the material specimen to the radiant heat and torch flame, its upper layer ignited quickly, engulfing the whole panel in flames. The test was not allowed to continue for the required duration of the test to prevent fire damage to the radiant panel. Two material specimens were tested and both performed similarly, as shown in figures 21 and 22.
