# CULTURAL RESOURCE MANAGEMENT PLAN

## Fayette Historic Townsite

Delta County, Michigan

Final Submission  
December 1996

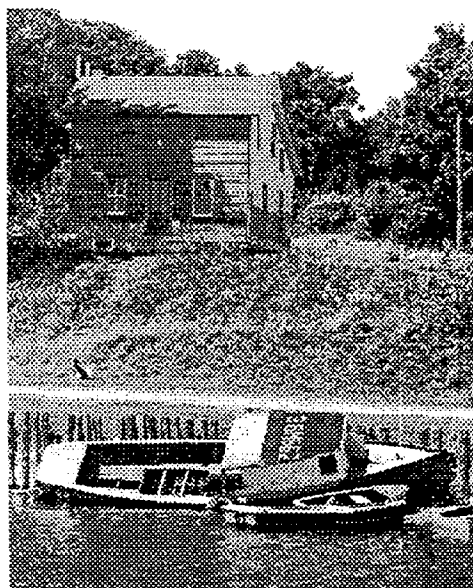
**Figure IV-10**

*View of a company supervisor's residence (Bldg. #4)*

*Note: The docks have deteriorated extensively; the sill plate and subsequent clapboard replacement has taken place at the building. The chimney has been constructed, part of the alterations to use it as the park manager's residence.*

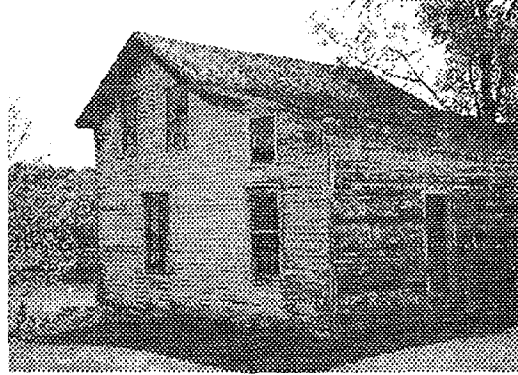
Figure 27

*View of the north and west elevations, 1996.*

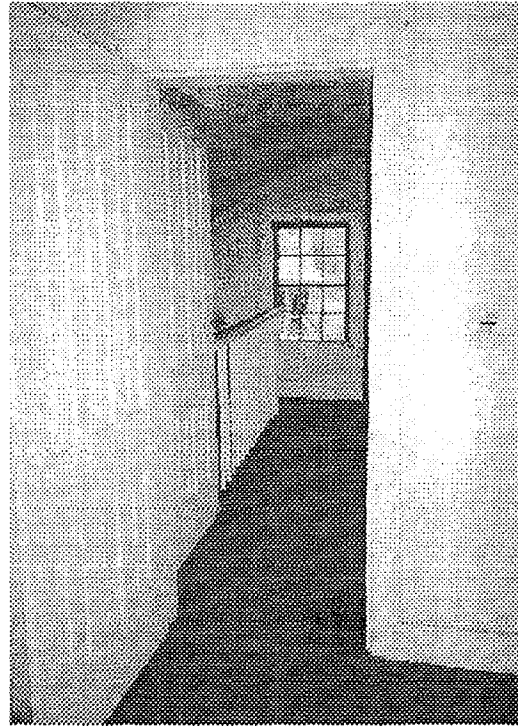
Figure 29

*View of the second floor interior, 1996. Note that overall the materials and finishes are in better condition at the second floor.*

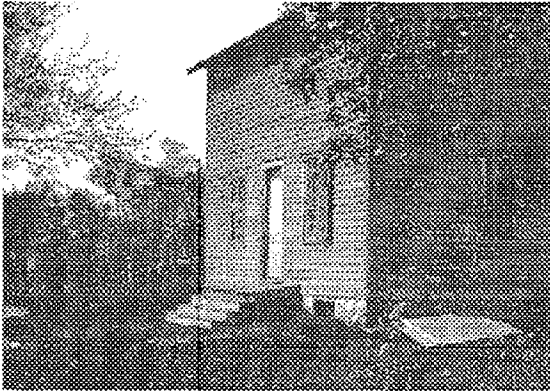
**Figure 30**

*View of the east and north elevations, 1907. Note that there are shutters on the windows and a porch and steps at the front entrance.*

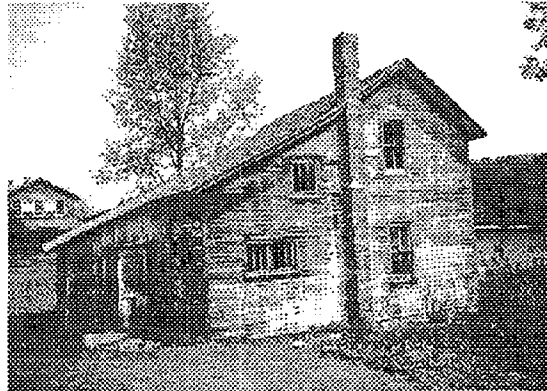
**Figure 31**

*View of the south elevation, 1996. Note the chimney and air vents that were added in 1960 when the house was remodeled for use as the park manager's residence.*

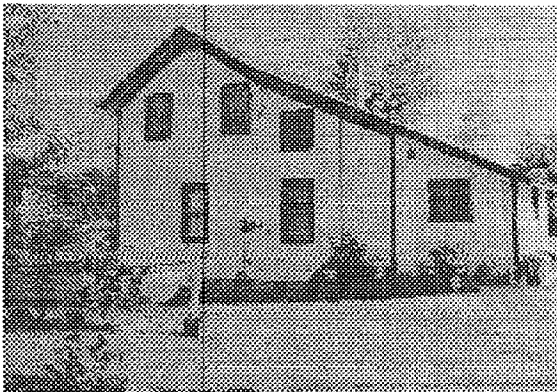
**Figure 32**

*View of the north elevation, ca. 1960s. Note the paint scheme with dark trim elements; this was when the house was used as the park manager's residence. Also visible are the vents, one located near the top of the gable and one at the shed-roof addition.*

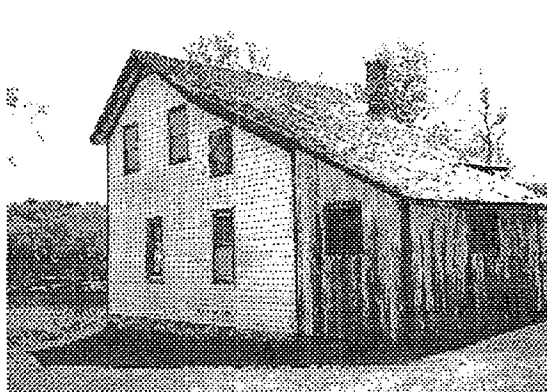
**Figure 33**

*View of the north elevation, 1996. This is one of the only structures that has an extensive amount of paint left on it. Note that it appears that the lean-to kitchen addition was painted a darker color.*

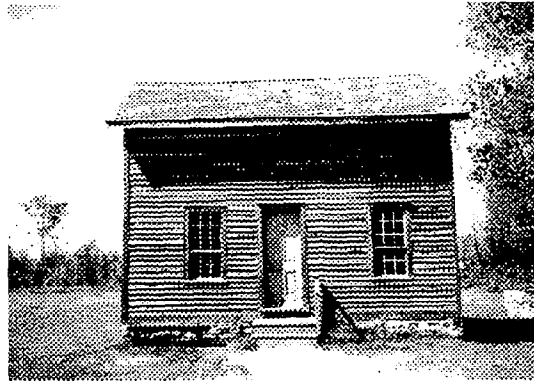
Figure 35

View of north elevation, 1996. Note that the porch has been reconstructed, and the door has been replaced with a four-panel door.

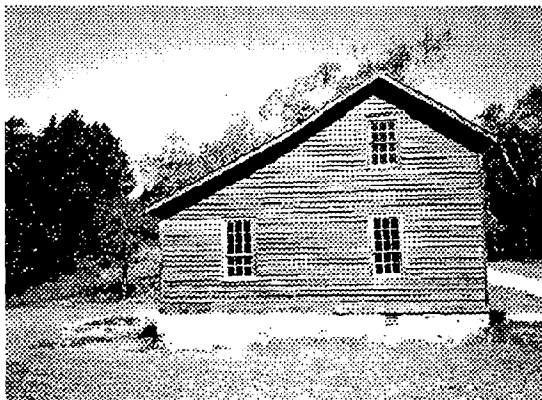
Figure 36

View of the east elevation, 1996. Note the foundation from the former kitchen addition at the south end. Was the vent in the foundation wall added by park?

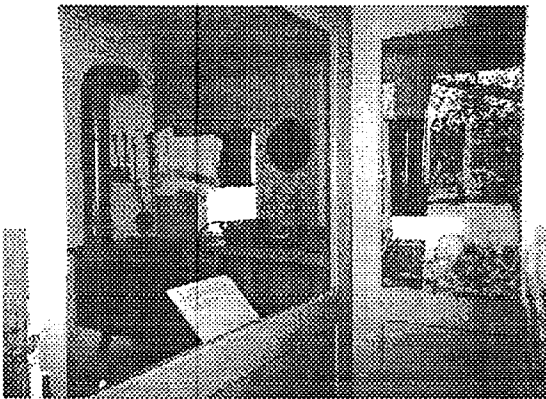
**Figure 39**

*View of the interior looking from the rear public entrance, 1996. A wood and plexiglass partition has been constructed to create a viewing vestibule just inside the door.*

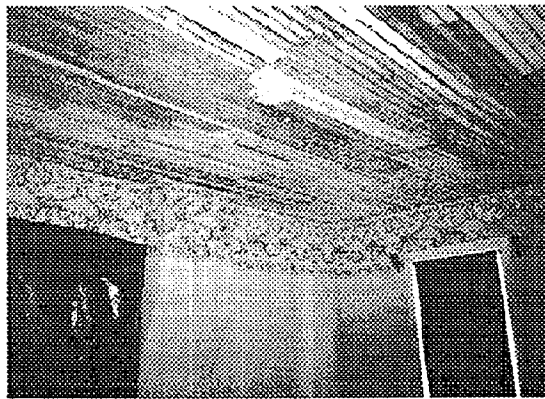
**Figure 40**

*View of the ceiling of the dining room, 1996. This room was in the process of treatment when the photograph was taken. Note that areas of deteriorated lath have been replaced at the ceiling prior to the installation of new plaster.*

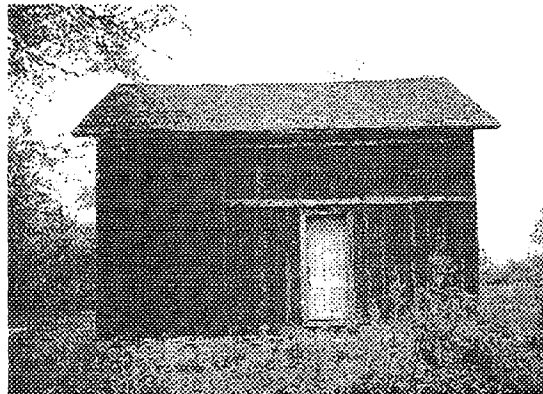
Figure 42

View of the east elevation, still faced in the original board and batten siding. Note the nailing boards that the rafters and ceiling joists of the former one-story addition were attached to.

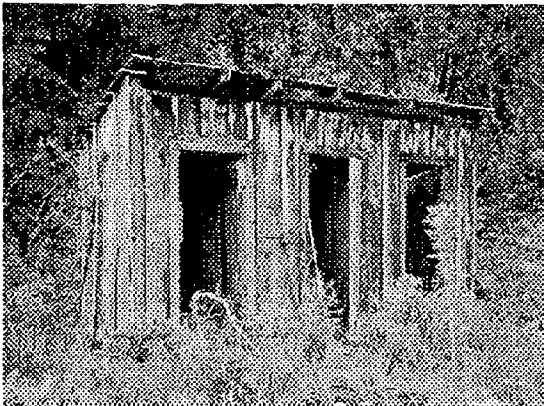
Figure 43

View of the three-part privy located northwest of Building #18. This privy is presumably original to the site and served a few of the Supervisor's Residences.

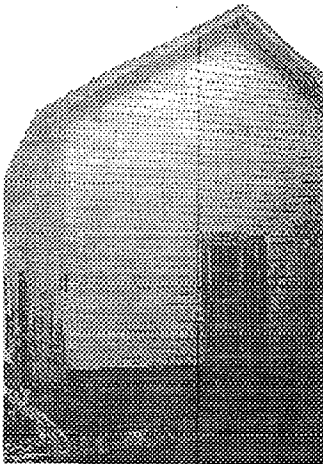
**Figure 46**

*View of the north elevation, ca. 1960s. This photograph was taken during the sill replacement. Note that the clapboard siding has been removed from the east elevation.*

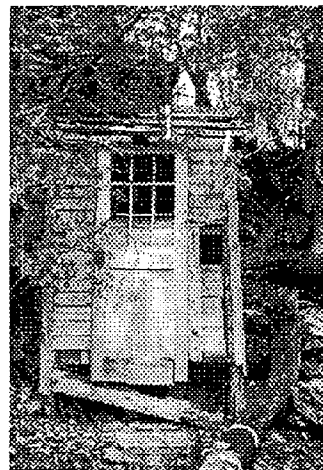
**Figure 48**

*View of the privy located in the hillside behind (east of) Building #25.*

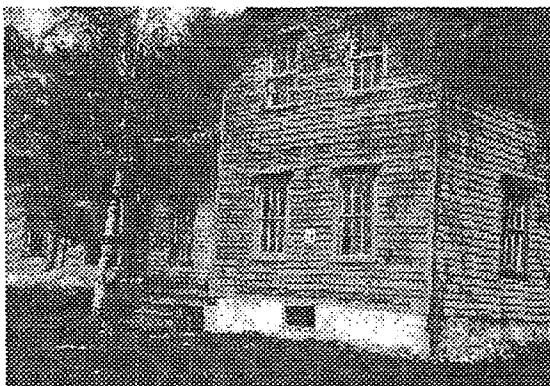
Figure 49

View of the west and south elevations, ca. 1907. Note the porch leading to the two front entrances.

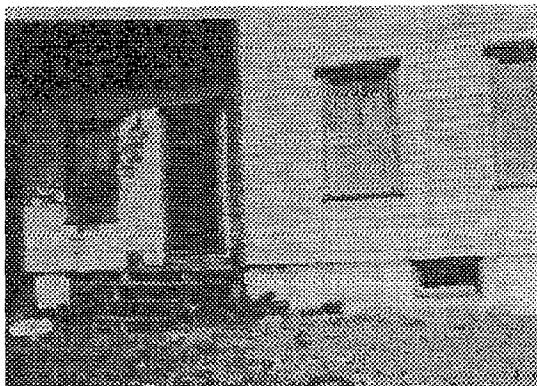
Approximately the bottom two feet of clapboard siding has been replaced around the entire perimeter of the building. This was most likely done in conjunction with the replacement of the deteriorated sill plate in the 1970s. There are also selective areas of replacement clapboard located elsewhere on the building. Historically, there was a wood porch and steps located at the two entrances of the west elevation (at the reentrant corner) (Figure 49). Figure 50 shows this porch was rebuilt by 1907 and had open risers. No evidence of this porch remains.

View of the west elevation, ca. 1920s. Note the paint scheme that consists of a light field and dark trim (window frames, corner boards, etc.) Note the front porch with open riser stairs.

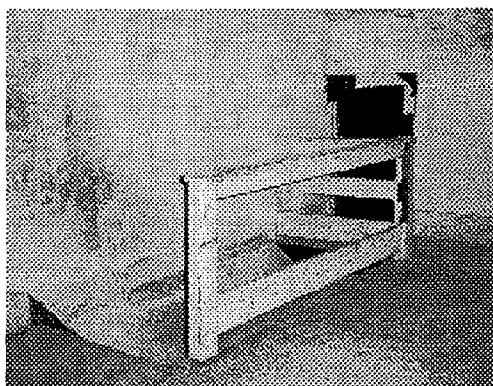
Figure 52

View of the stair at the second floor, 1996.

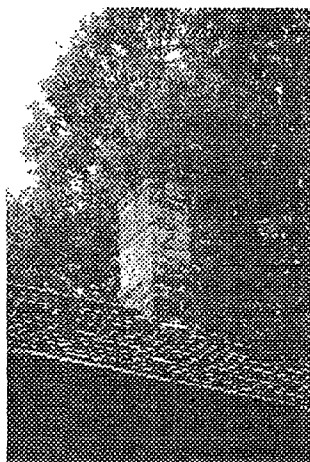
Figure 53

View of the chimney, 1996. Note the two types of bricks indicating that it may have been reconstructed.

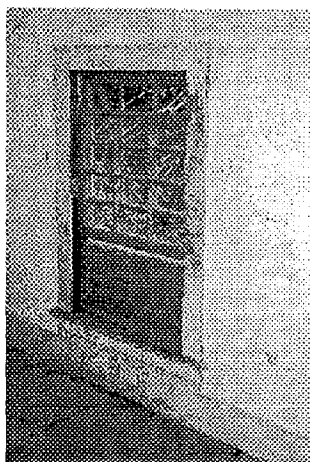
Figure 54

View of one of the second floor windows at the rear (east end) of the building, 1996. Note the wood louver vent installed in the bottom portion of the opening.

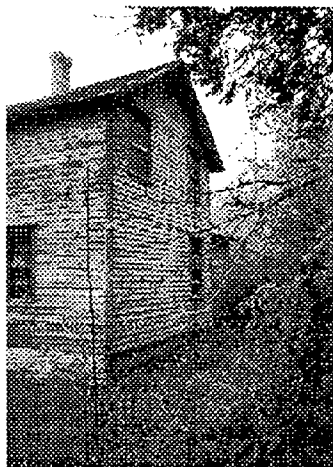
Figure 57

View of the north and east elevations, 1996.

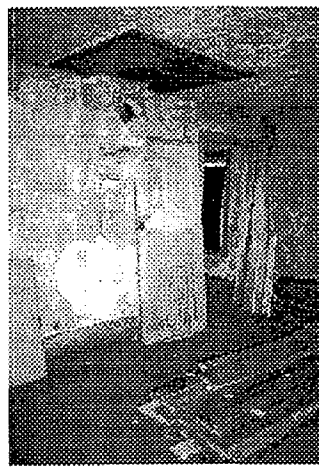
Figure 59

Interior view of the kitchen, 1996. Note the chimney along the north wall, typical chimney configuration in most of the residences.

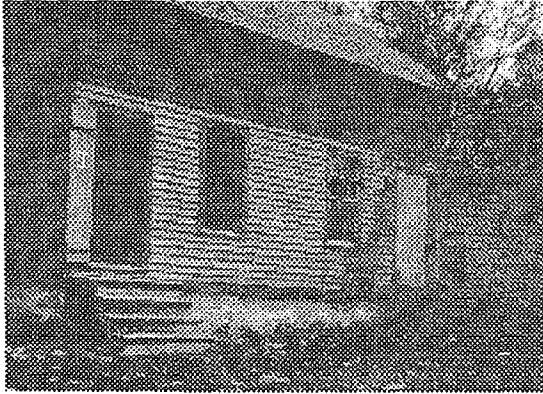
Figure 60

View of the west elevation, ca. 1997. Note the wood steps constructed at each of the entrances. Also note that the doors are vertical boards rather than panel configuration.

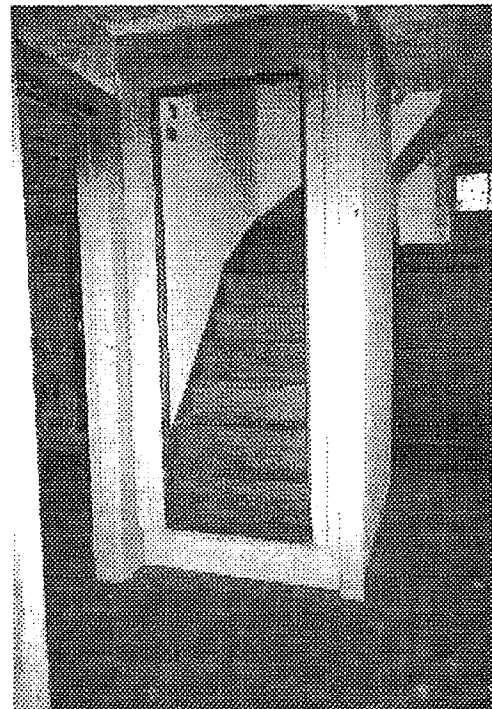
Figure 63

View of one of the interior stairs leading to the second floor, 1996.

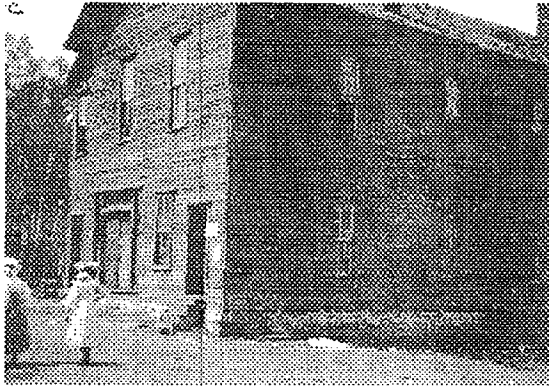
**Figure 64**

*View of the south and east elevations, ca. 1907.*

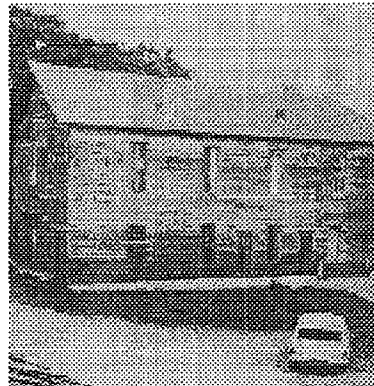
**Figure 65**

*View of the east and south elevations, ca. 1960s. Note that the platform outside of the entrances at the east elevation is gone.*

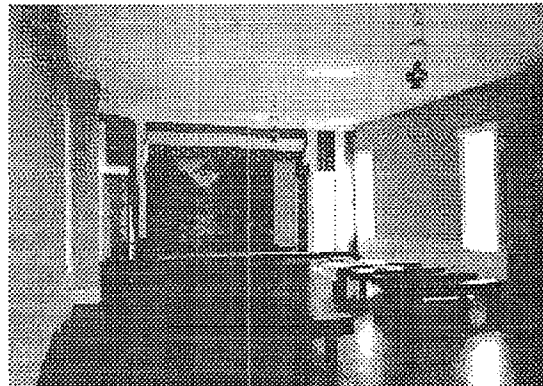
**Figure 69**

*Interior view of the second floor auditorium / meeting space, looking toward the stage, 1996.*

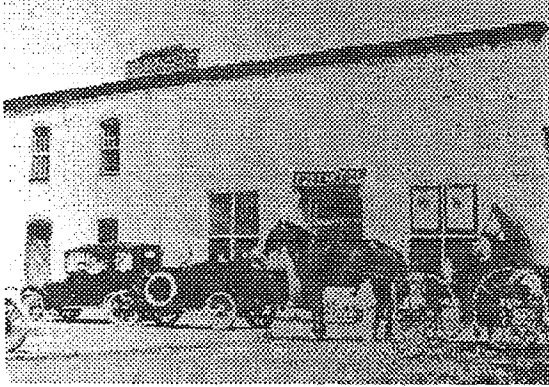
Figure 70

View of the south elevation, ca. 1907? Still in operation? Prior to the fire that gutted the building and destroyed the roof.

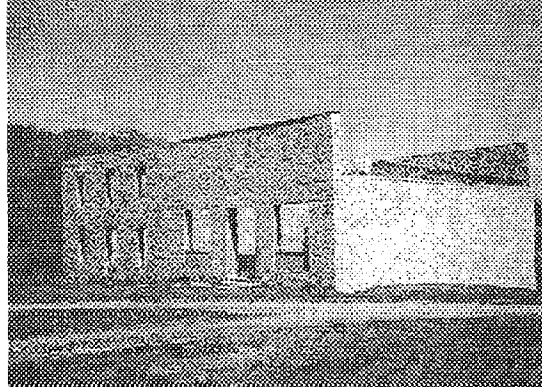
Figure 71

View of the south and east elevations, 1998. Note that the walls, especially near the top and near openings have been stabilized and capped with limestone.

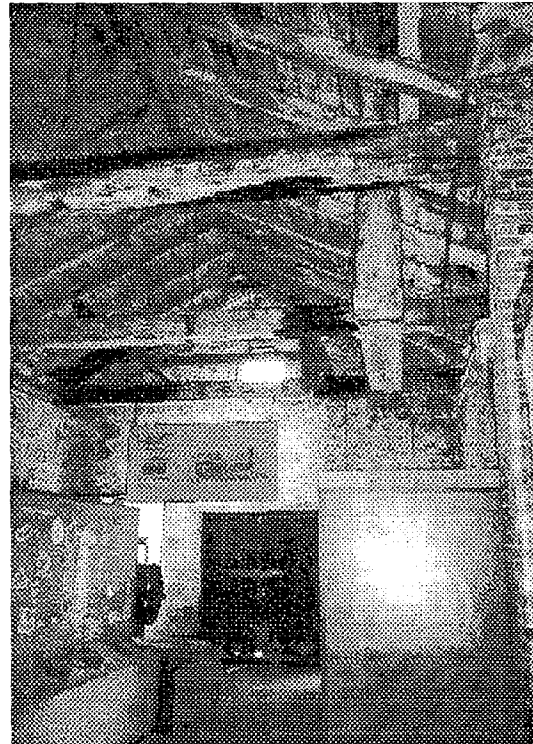
Figure 73

Most of the original interior finishes of this building have been maintained and a non-destructive exhibit depicting life at Fayette has been installed (Figure 73).

View of the interior looking east, 1996. Note that materials have been stabilized and exhibits placed within.

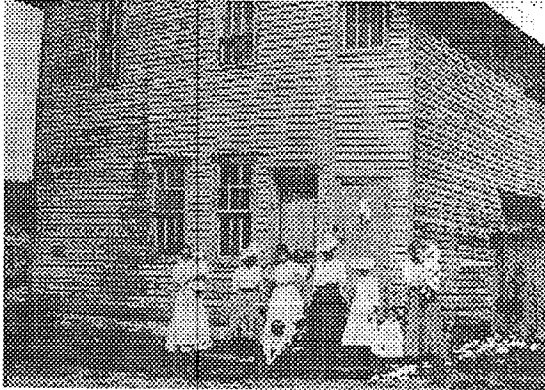
**Figure 74**

*View of the west elevation, ca. 1907. Note the wing at the south side that contained the stair leading to the second floor.*

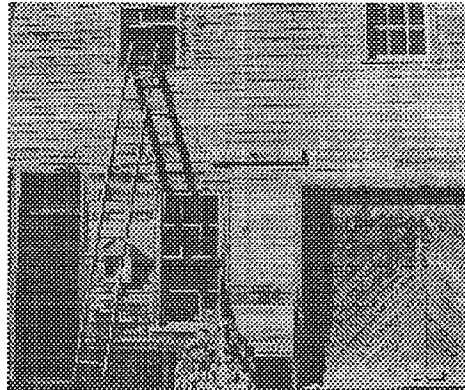
**Figure 75**

*View of the east elevation, ca. 1970. This photograph was taken just prior to the restoration work that removed the large garage-type door from this elevation. The ladder is the only access to the second floor because the stair has been removed.*

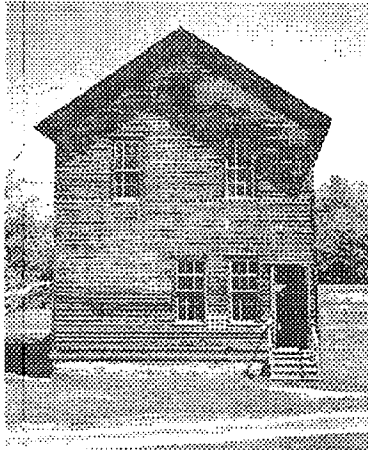
**Figure 76**

*View of the west elevation, 1996. Note that the enclosed stair at the south elevation is gone.*

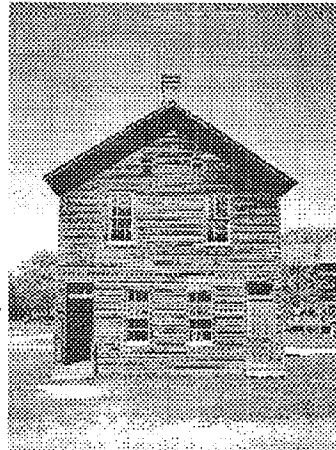
**Figure 77**

*View of the east elevation, 1996. Note that the original fenestration pattern has been reconstructed.*

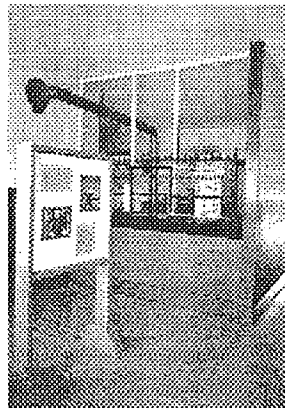
**Figure 78**

*View of the interior of the lobby portion of the office, looking from the west entrance, 1996.*

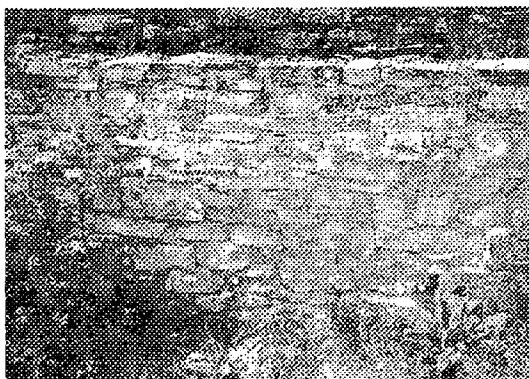
**Figure 81**

*Foundation of a Supervisor's Residence (Building #10)*

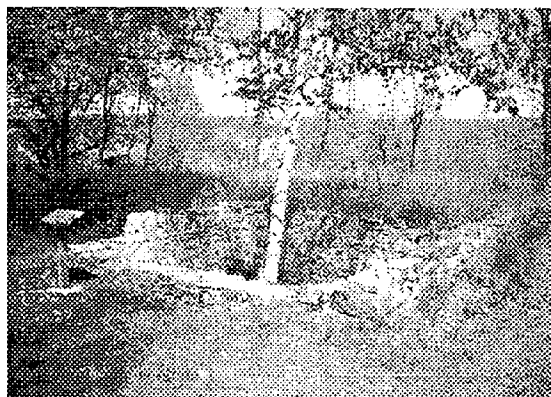
**Figure 82**

Physical observation revealed that vegetation is growing on top of several areas of the foundation walls. In addition, large trees have grown within the perimeters of the foundations (Figures 80 and 82). In several areas, the vegetation has damaged these ruins. Furthermore, earth pressure against these walls has resulted in bowing and sagging in several areas. The current slope of the grade adjacent to several of the foundations facilitates drainage toward the walls rather than away from them, which is preferred.

*Foundation of the Boarding House (Building #5)*

It is recommended that all detrimental vegetation be "scrubbed" adjacent to all extant buildings, especially those buildings that are not open to the public. This will help to mitigate continued mildew growth on the wood surfaces and moss on the roofs. Most of this growth is thought to have been the result of a lack of sunlight or ventilation due to the overgrown vegetation, especially on the north sides of the houses along the back street (Buildings #18, 25, 26, 27, and 30/31). This treatment is important, especially as more and more historic fabric is restored and refinished. The "scrubbing" should maintain vegetation at a minimum distance of 10 - 15 feet from each building. It is also recommended that vegetation scrubbing from the extant foundations ruins be continued on a yearly basis.

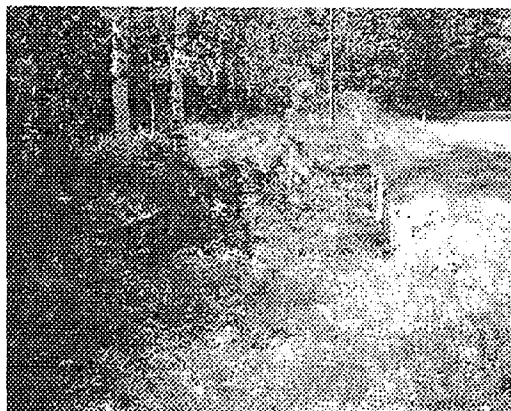
**Figure 83**

*Foundation of a Supervisors' Duplex Residence  
(Building #11/12)*

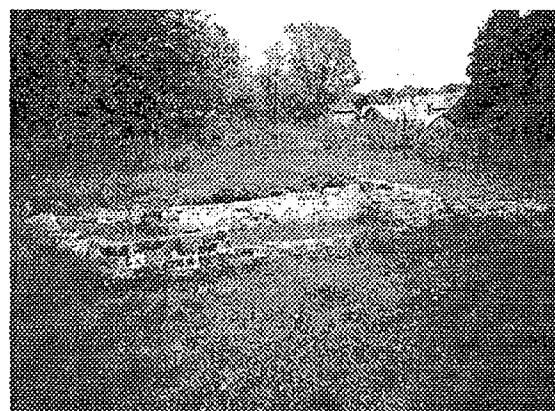
**Figure 84**

*Foundation of a Supervisor's Residence (Building #18)*
