Preliminary Report:
Archeological and Engineering Expedition
Monitor Marine Sanctuary

August 1-26, 1979

Gordon P. Watts, Jr.
Roger W. Cook
Kenneth Morris

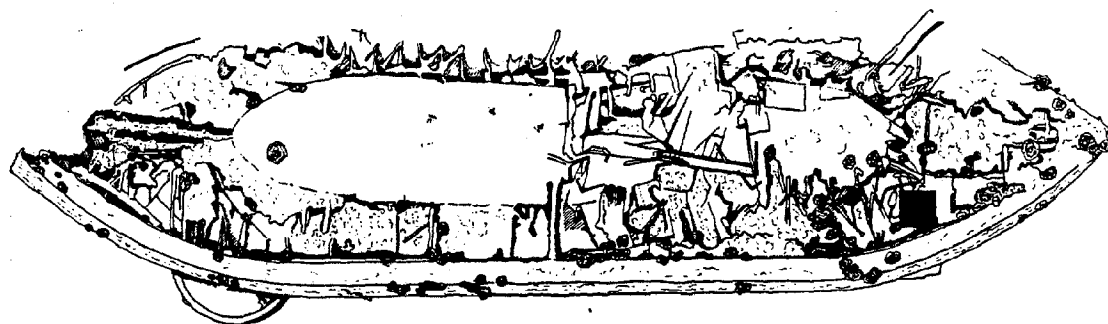
Figure 2.

inboard of the armor belt had been tentatively selected based upon an analysis of photographs taken from the ALCOA SEAPROBE in 1974 and the JOHNSON SEAL-LINK II in 1977. The reconnaissance confirmed the first choice as the best locations for an excavation (Figure 2). With the exception of a small area adjacent to the armor belt in the vicinity of the pilot house, most of the wreck is covered by large fragments of plating from the lower hull.
