SHORE EROSION STUDY

**SHORELINE EROSION AND BLUFF STABILITY ALONG LAKE MICHIGAN
AND LAKE SUPERIOR SHORELINES OF WISCONSIN**

SOUTHERN AND CENTRAL MANITOWOC COUNTY

APRIL 1977

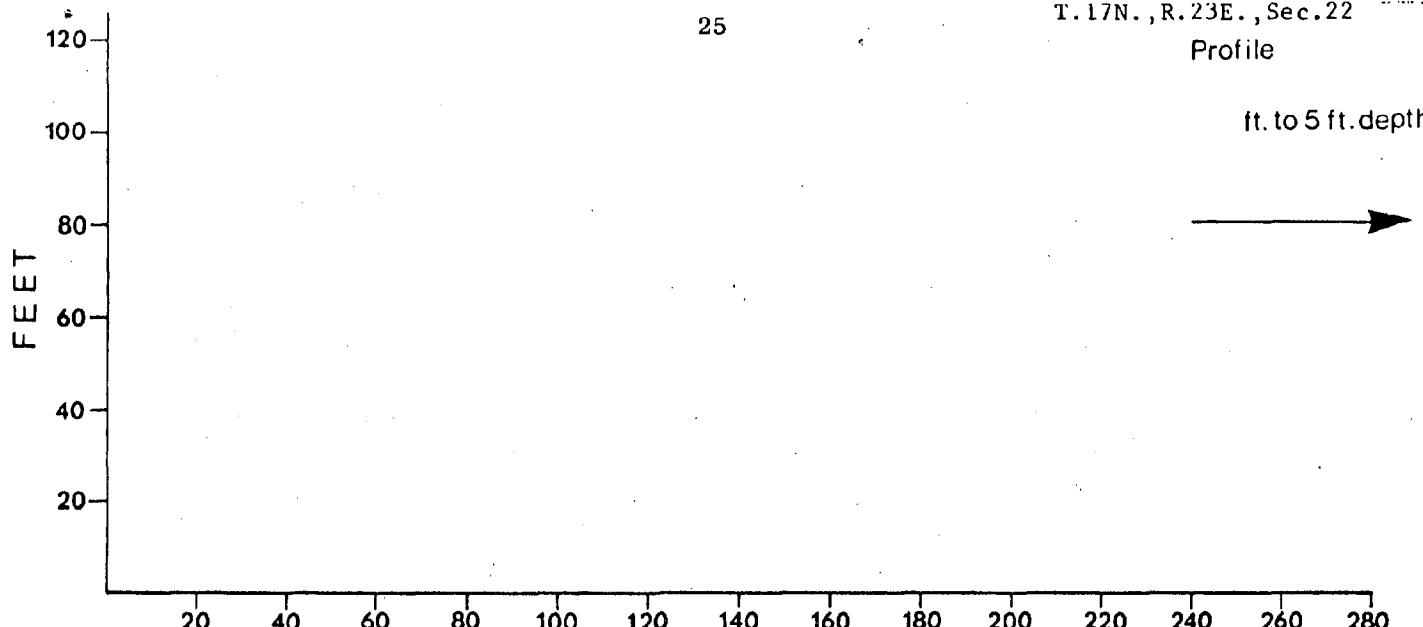
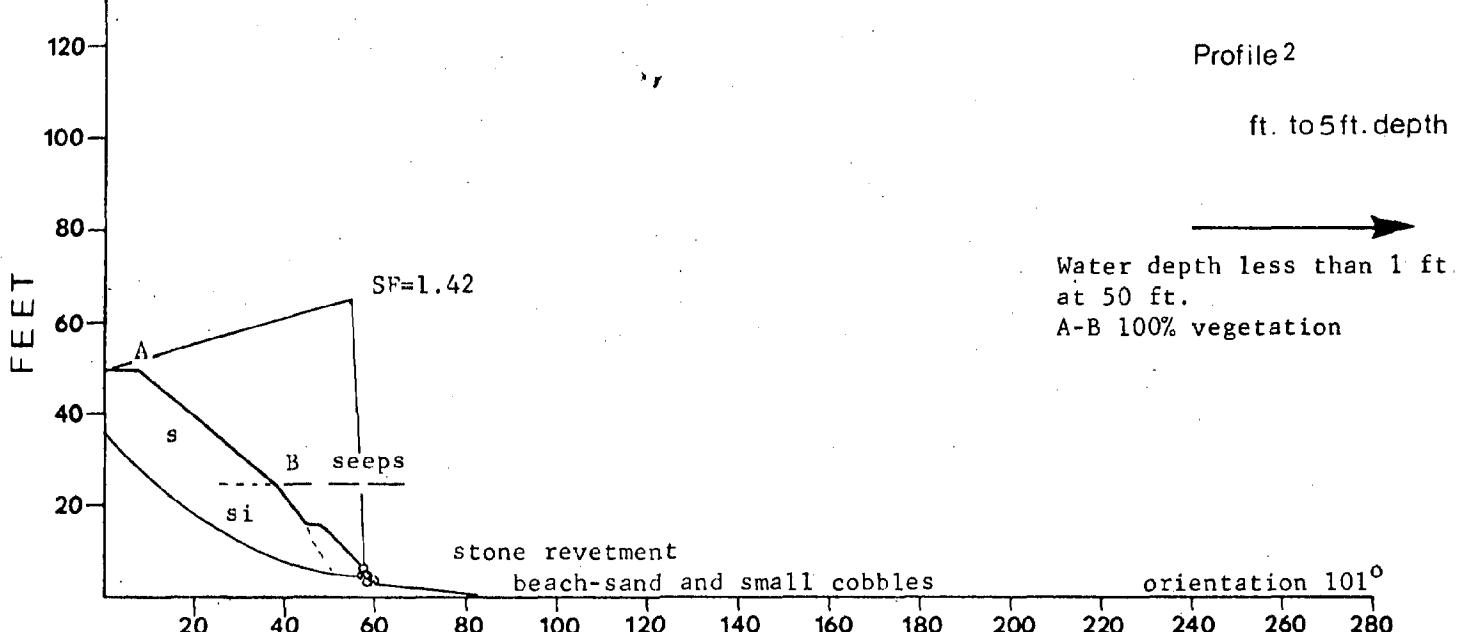
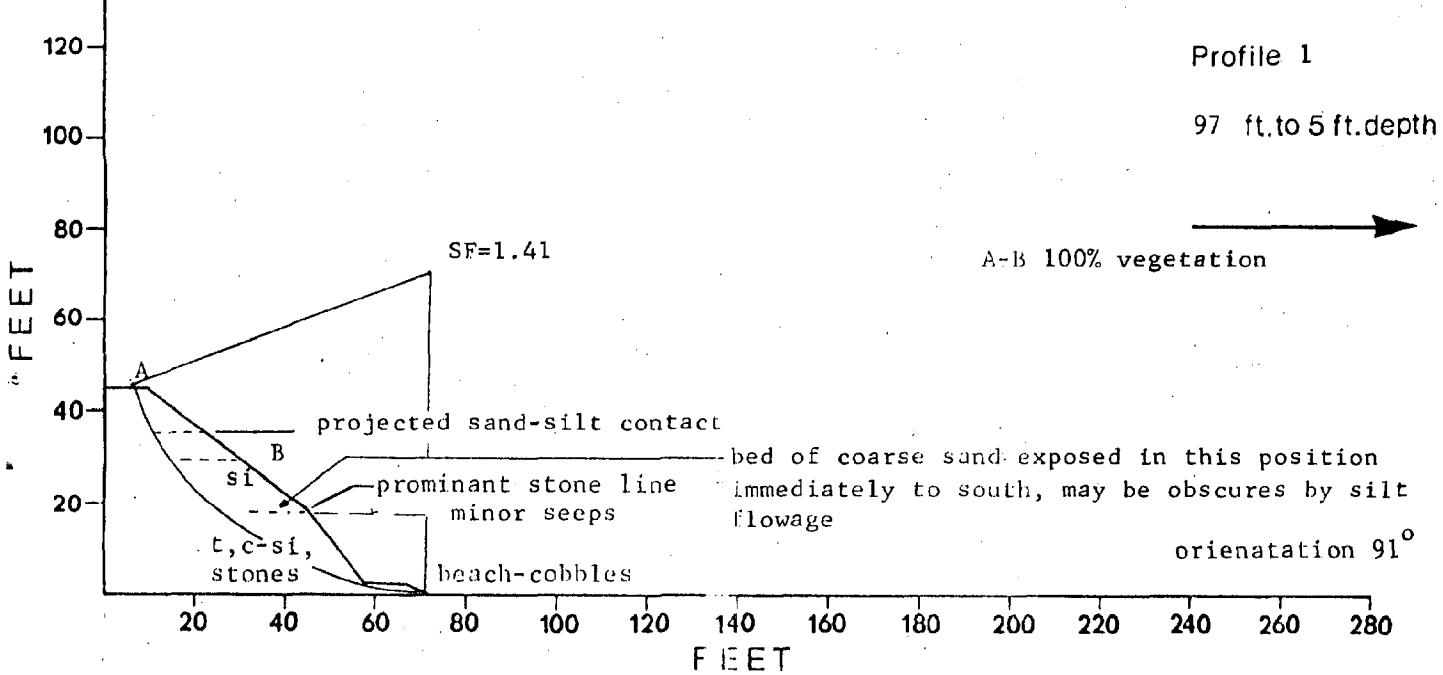
1. BLUFF	a-stable, fully vegetated bluff protected by terrace	b-2-15 ft. near vertical cut face in very stiff till; 2-5 ft. of coarse sand above; slope fully vegetated above cut face	c-closely spaced slumped areas; some full face, but most involving only lower 2/3 of slope; significant subsequent flowage of slumped silts.	
2. TOE	a-sands of terrace	b-stiff red-brown clayey silt till, few stones.	c-primarily slumped and flowed silts; scattered till exposures.	
3. BEACH	a-30-50 ft. beach; largely sand but cobbles in shoreward portion.	b-30-50 ft. cobble beach	c-30-50 ft. m-c sand beach	d-0-15 ft. cobble beach
	e-0-20 ft. c. sand beach	f-0-15 ft. cobble beach in front of revetment	g-0-10 ft. cobble beach behind revetment	h-0-25 ft. sand and cobble beach

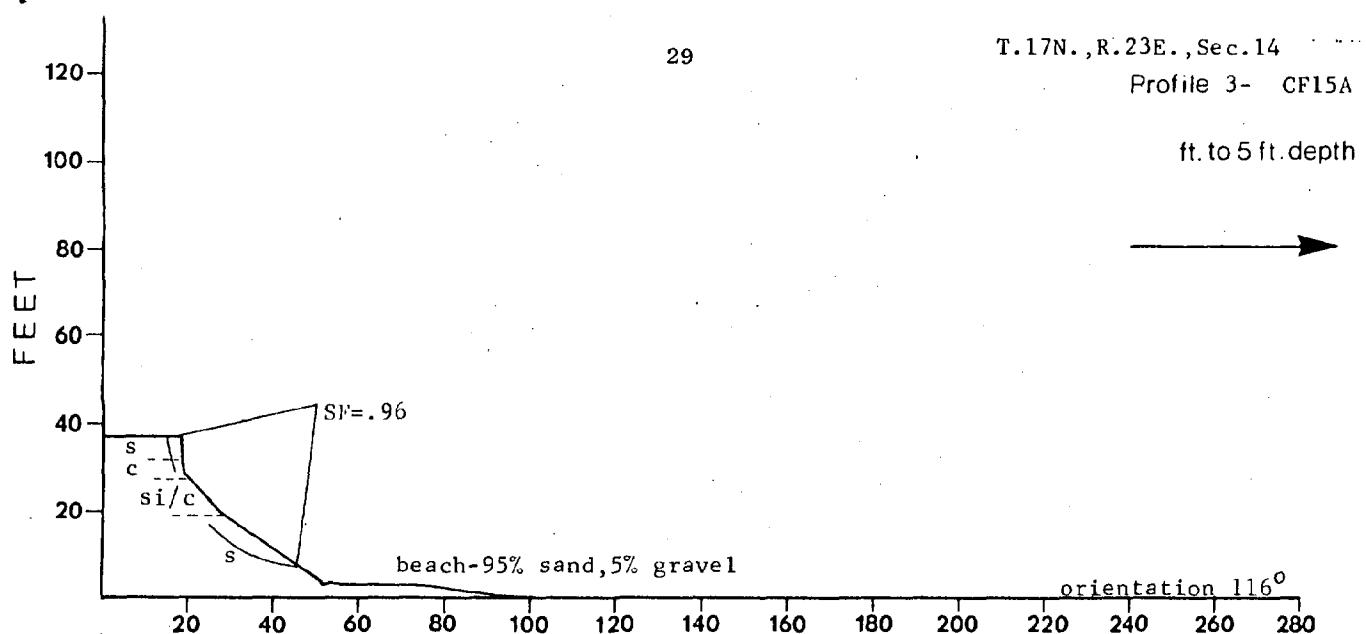
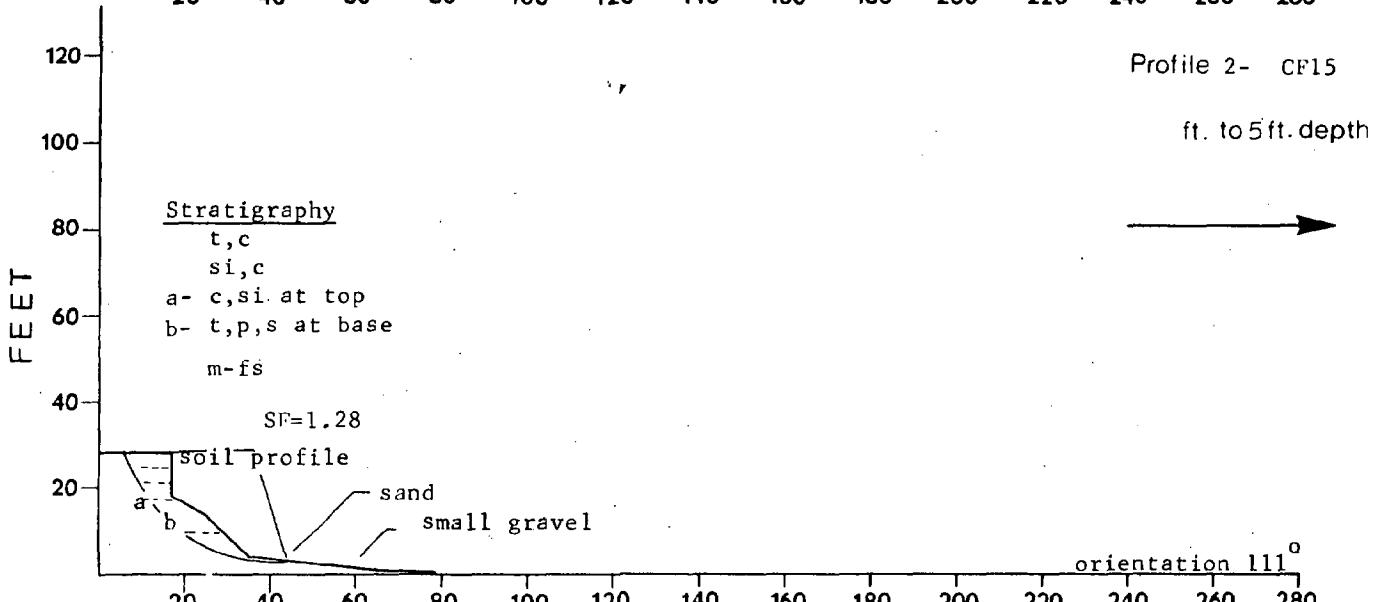
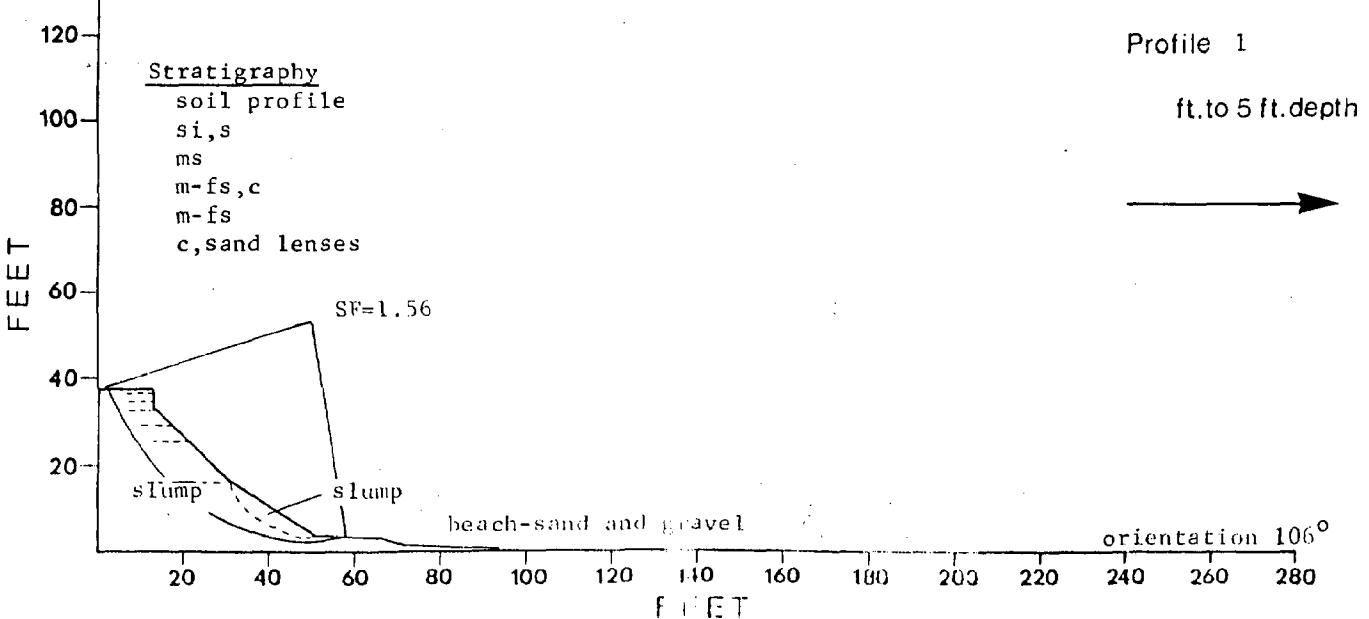
Fig. N.R. 23 E, Sec. 14

1. BLUFF	a-slumping and soil fall	b-vegetated and stable		
2. TOE	a-rip-rap	b-sand	c-rip-rap	d-slumped clay and silt, some sand
	e-sand			
3. BEACH	a-0-65 ft. sand	b-no beach	c-0-40 ft. sand	d-no beach
	e-0-40 ft. sand	f-no beach	g-0-25 ft. sand	h-no beach
	i-0-45 ft. sand	j-0-30 ft. sand

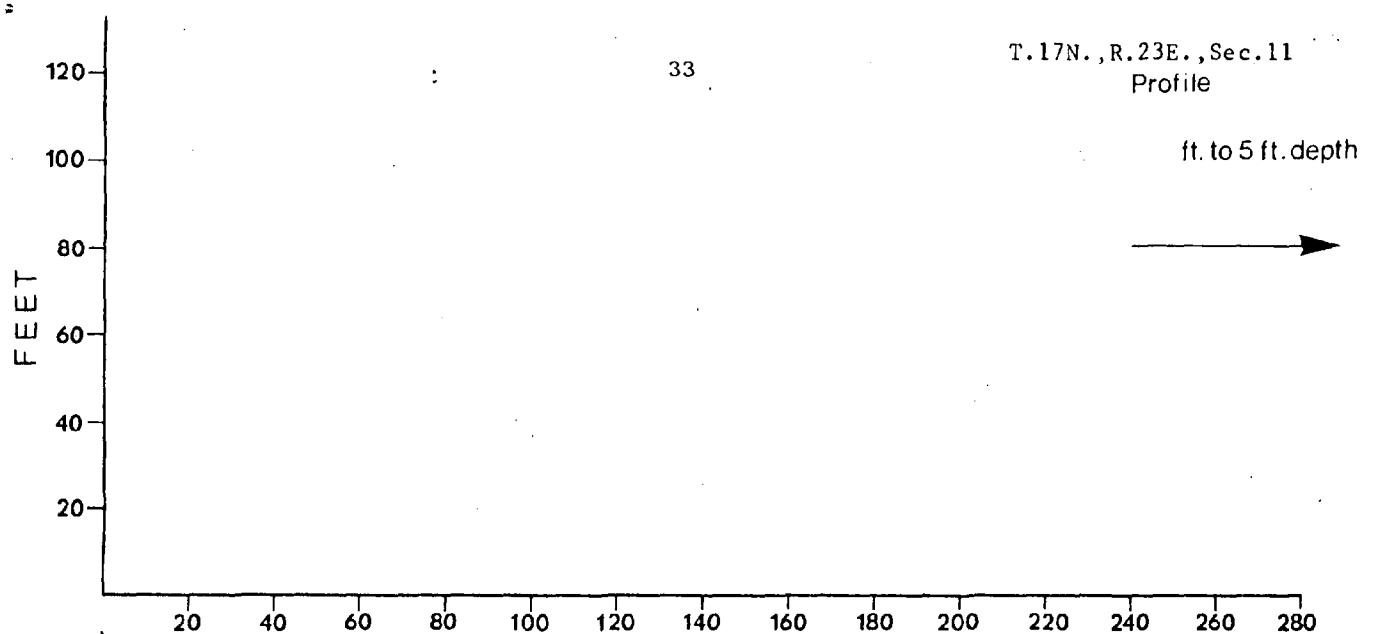
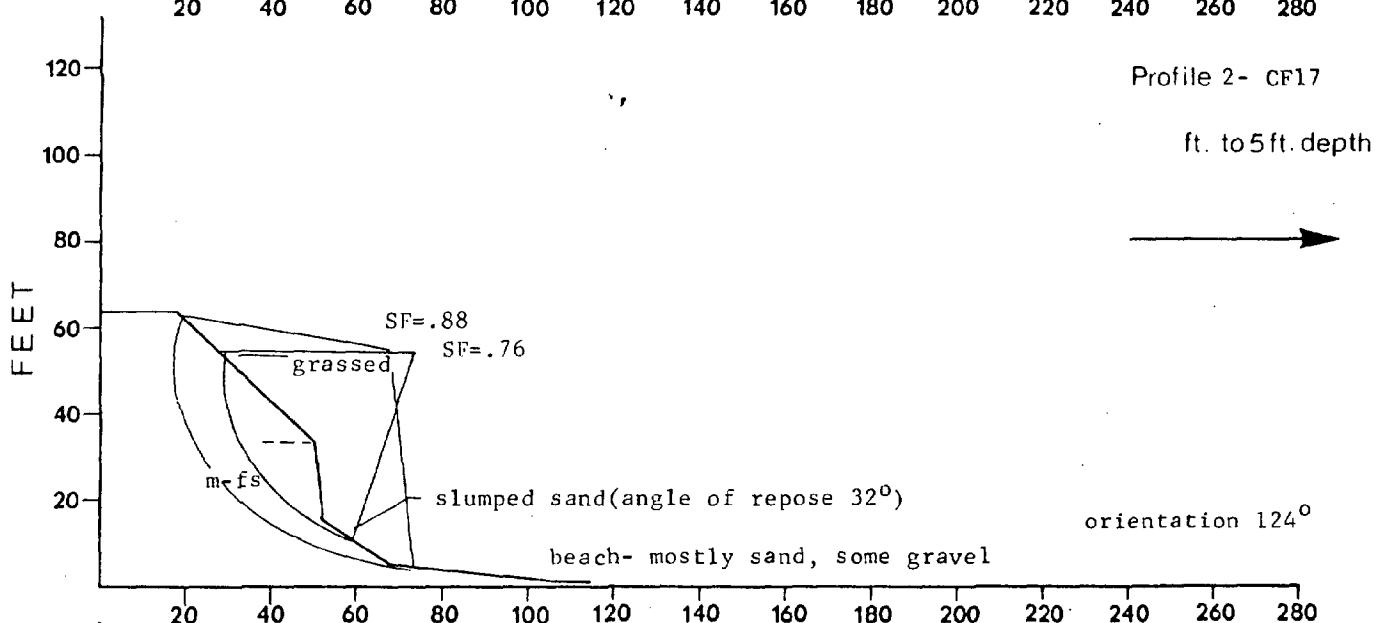
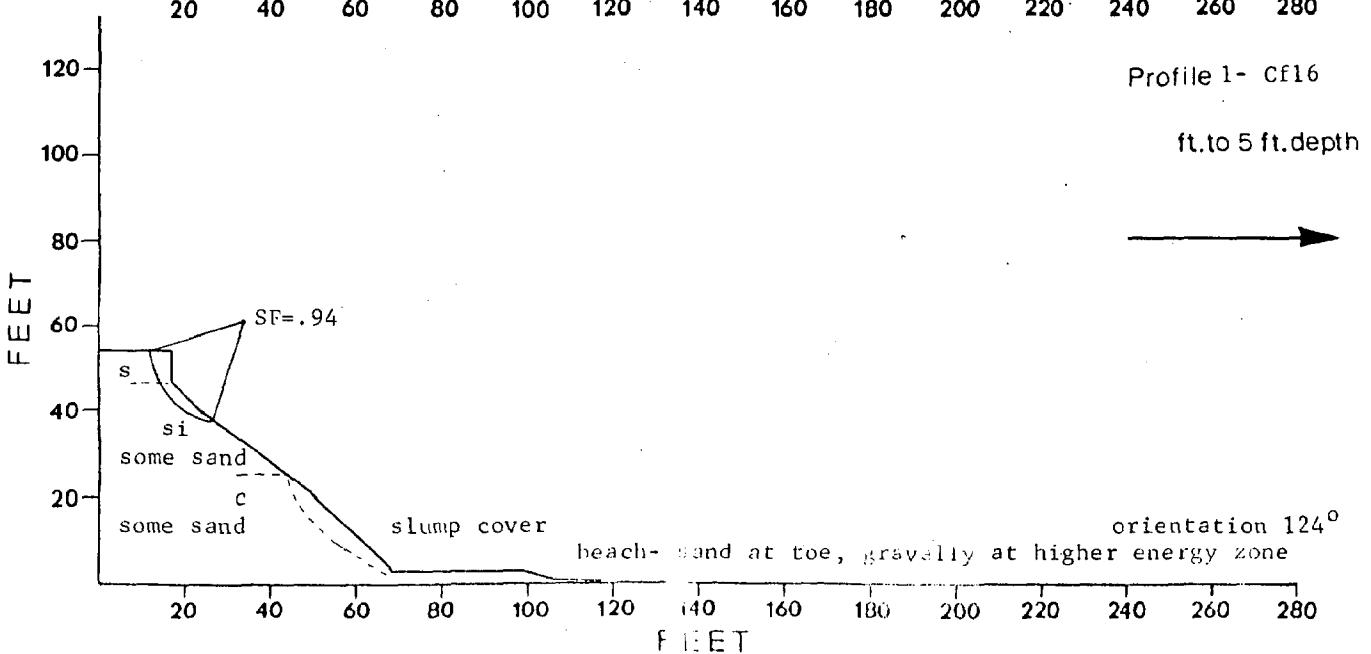
T.17 N., R.23 E., Sec. 11

1. BLUFF	a-undercutting and soil fall	b-slumps and shallow slides in sand	
2. TOE	a- till 3A and slumped sand, silt and clay	b-slumped sand	
3. BEACH	a-sand and gravel, greater than 30 ft.	b-50-80 ft. sand

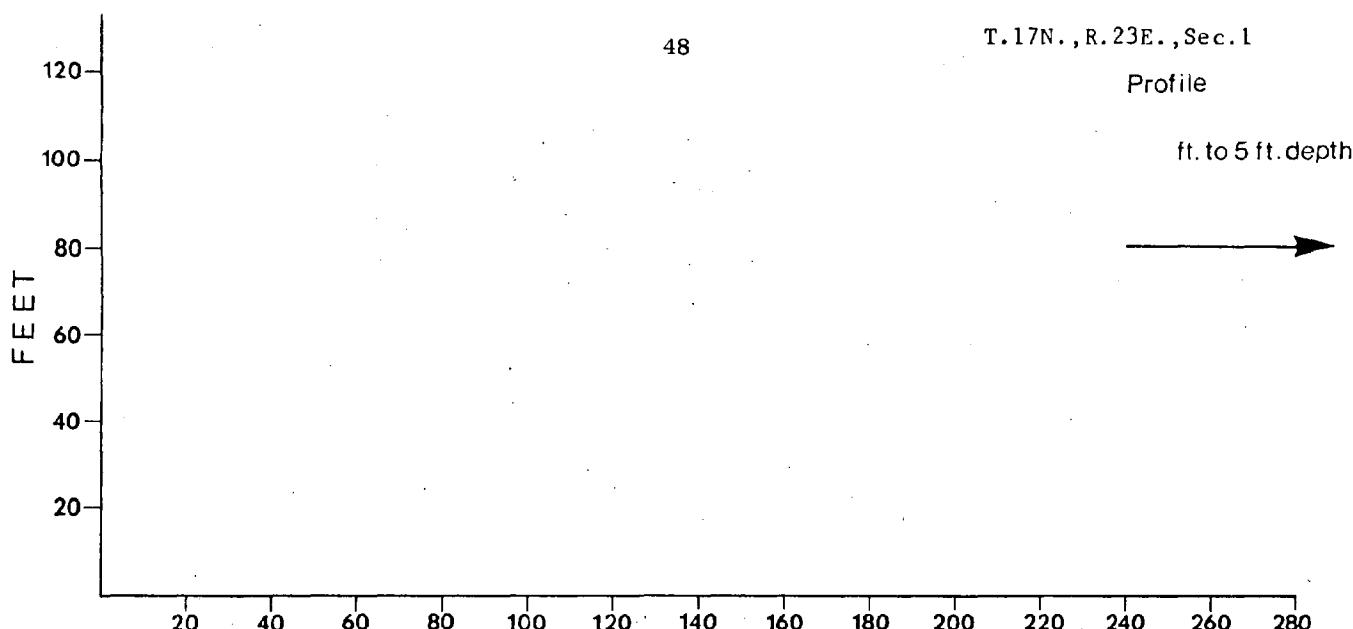
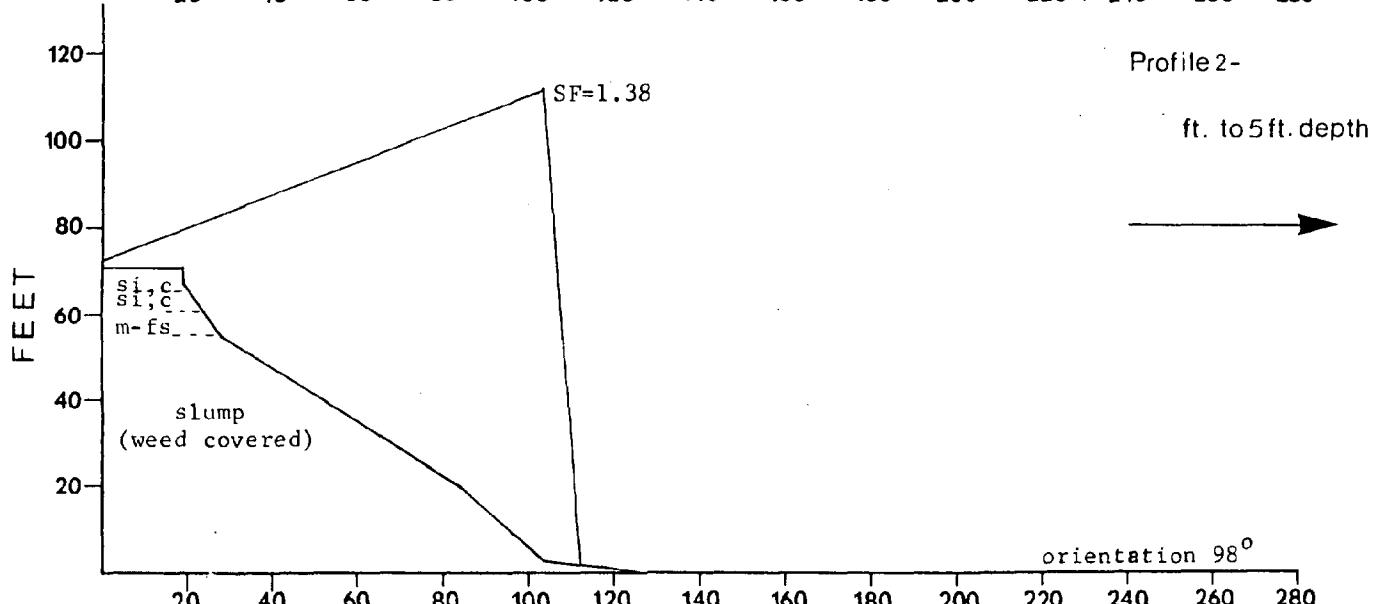
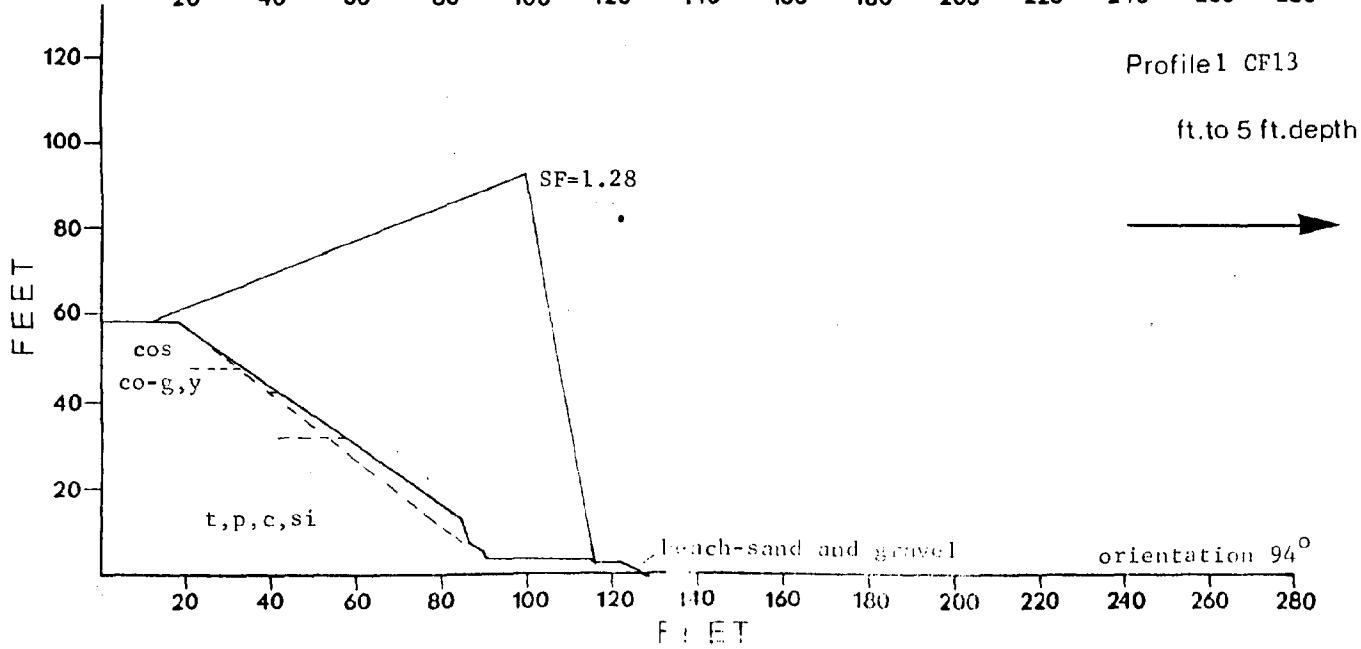
T.17 N., R.23 E., Sec. 1

1. BLUFF	a-high angle slumping, upper $\frac{1}{2}$ of slope remains vegetated.	b-large scale slumping, full face involved.	c-undercutting and soil fall; full face involved.	d-undercutting and soil fall, usually involves only the lower 1/3 of bluff; upper slopes remain vegetated.
2. TOE	a-till '3A'	b-sand and slumped sand	c-till '3A' and slumped sand	d-slumped till, silts, and clays
3. BEACH	a-30-55 ft. of sand, some gravel near lake margin.

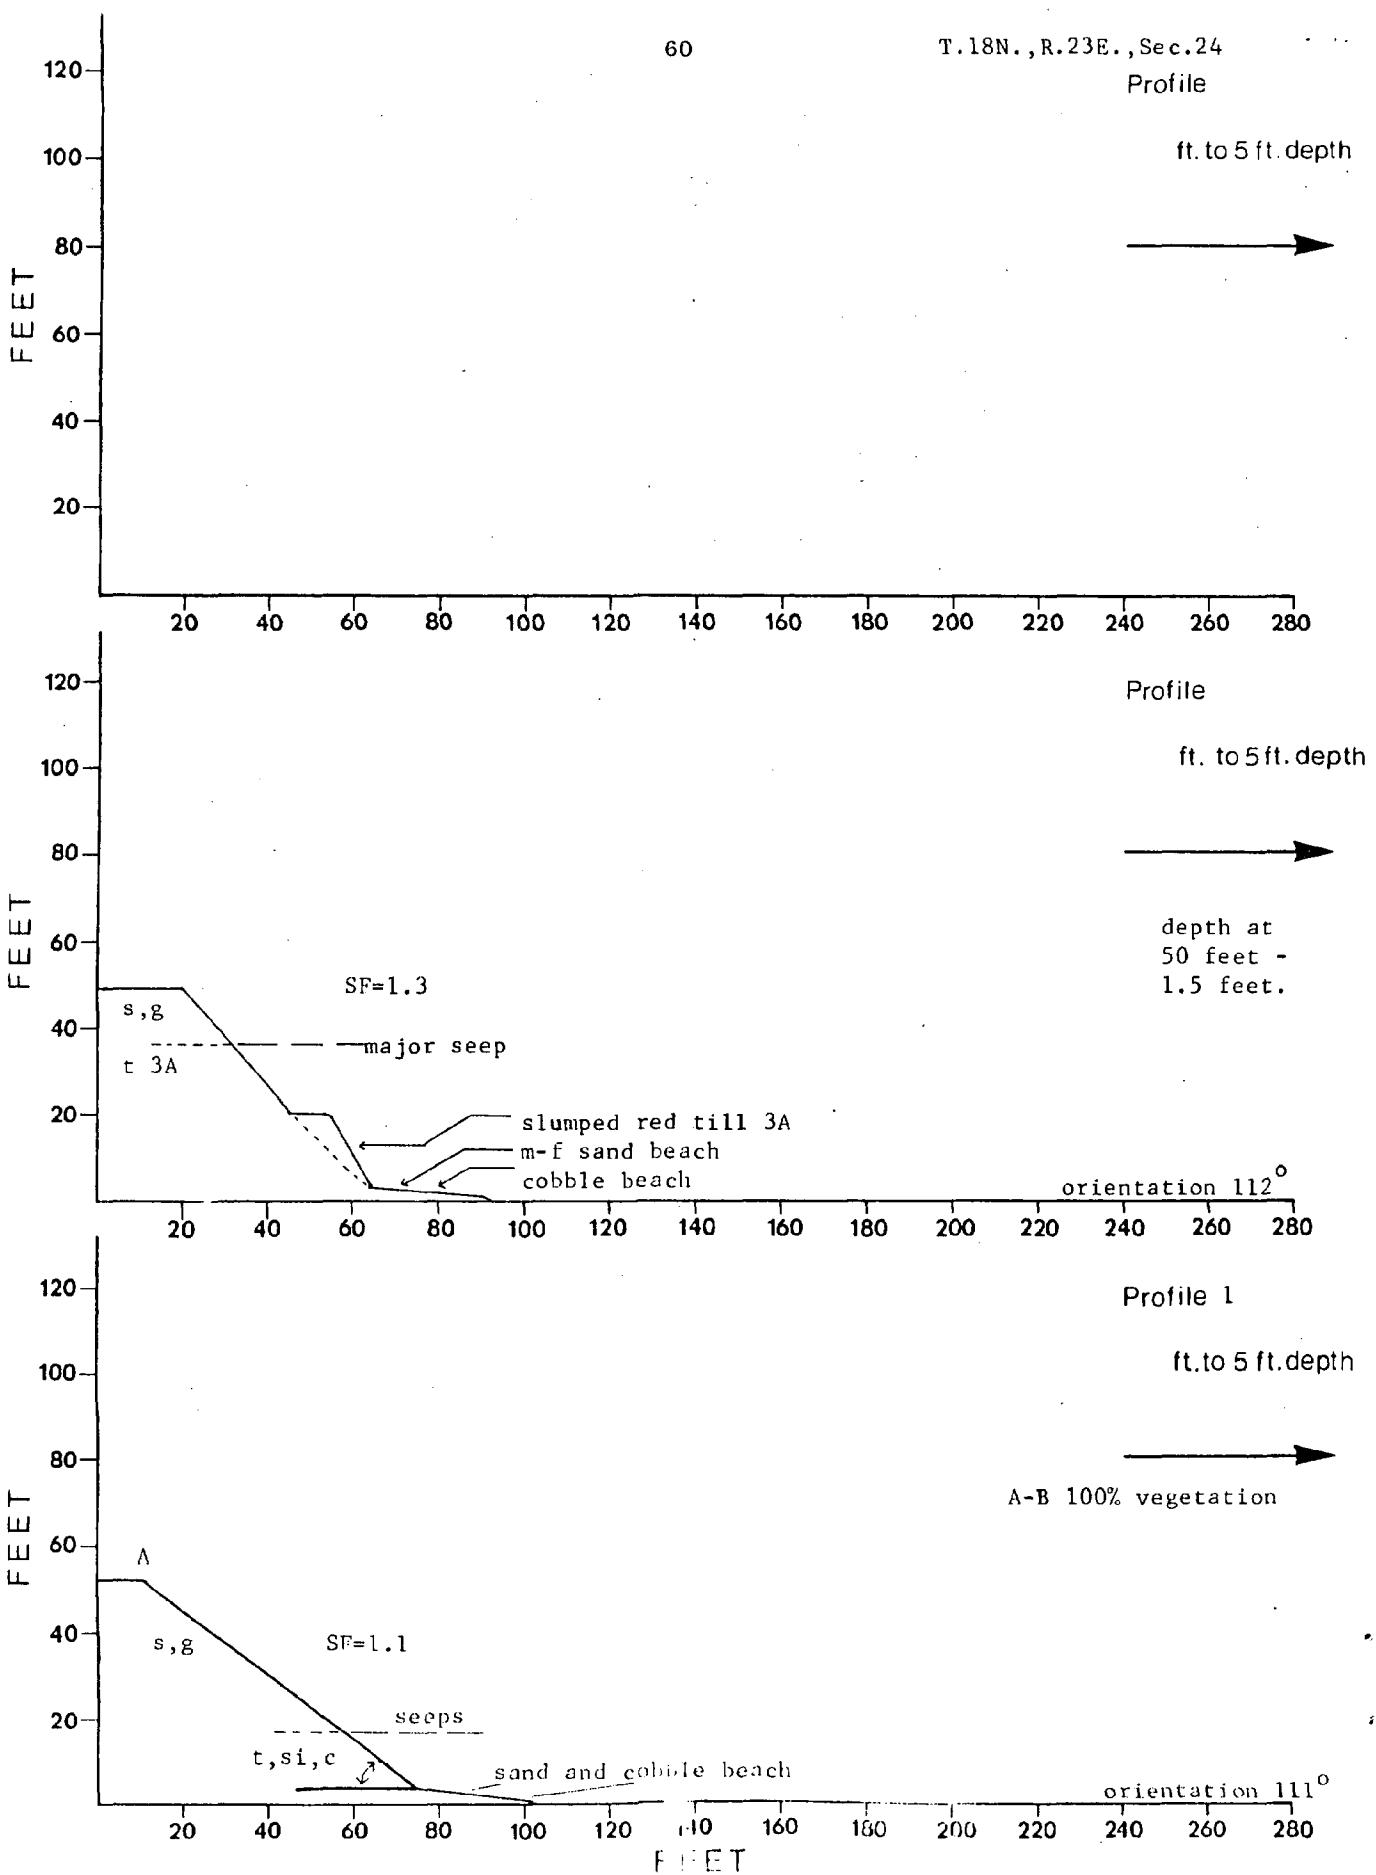
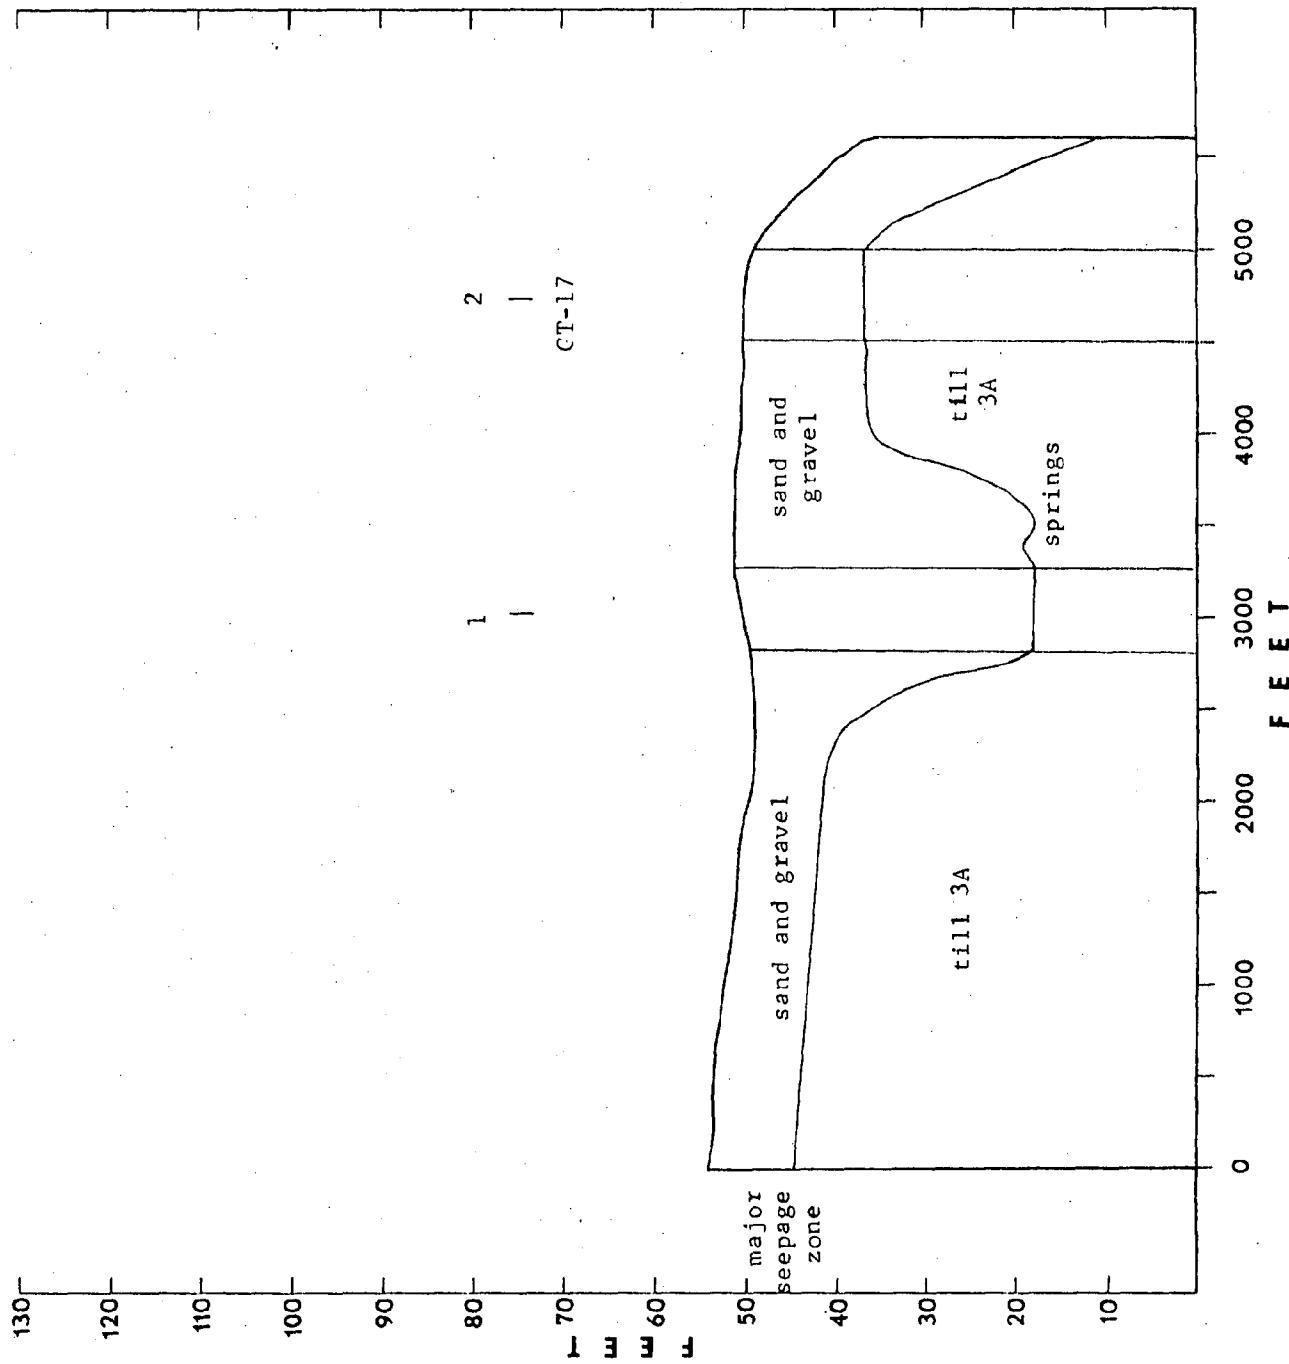
1. BLUFF	a-moderately steep bluffs with considerable slumping in the lower 1/3 of the slope; the upper 2/3 generally vegetated with grasses	b-large slumps of the total face; vegetation still in place on the slump blocks	c-rapid erosion resulting in high angle slumping and soil falls; at some locations only the lower slopes are involved	
2. TOE	a-till '3A' together with slumped till and sand and gravel	b-slumped sand and gravel	c-till '3A' and slumped till and sand and gravel	
3. BEACH	a-20-30 ft. of cobbles	b-no beach	c-0-30 ft. of cobbles

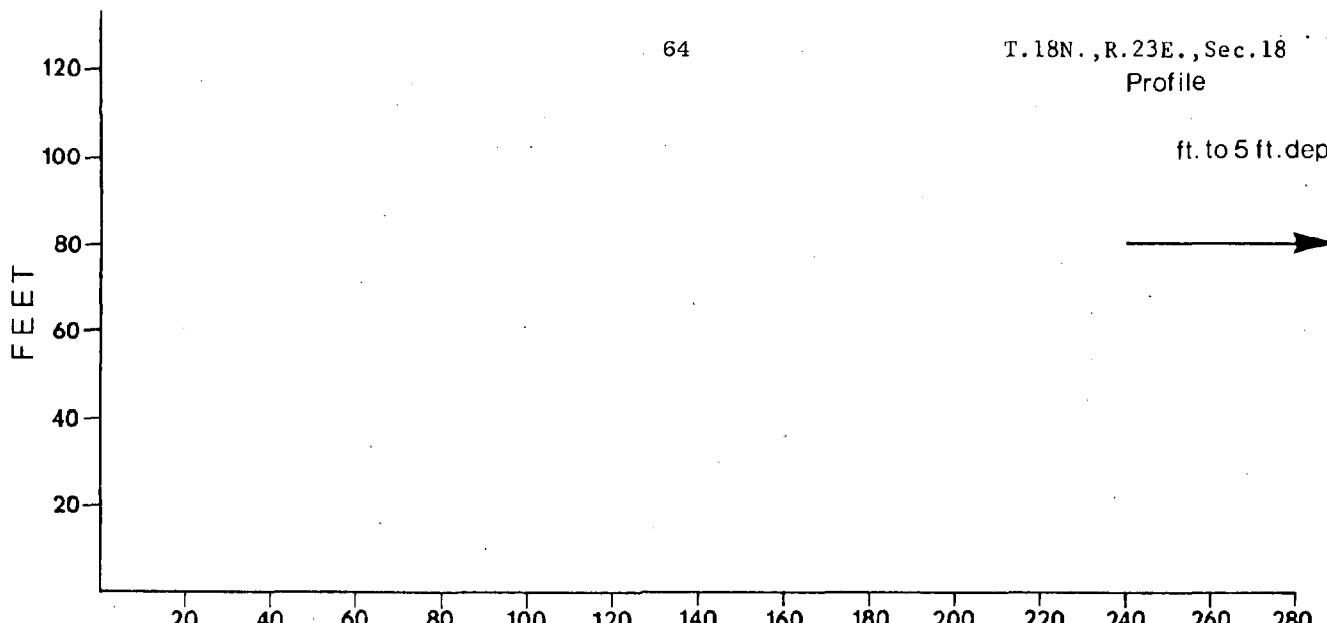
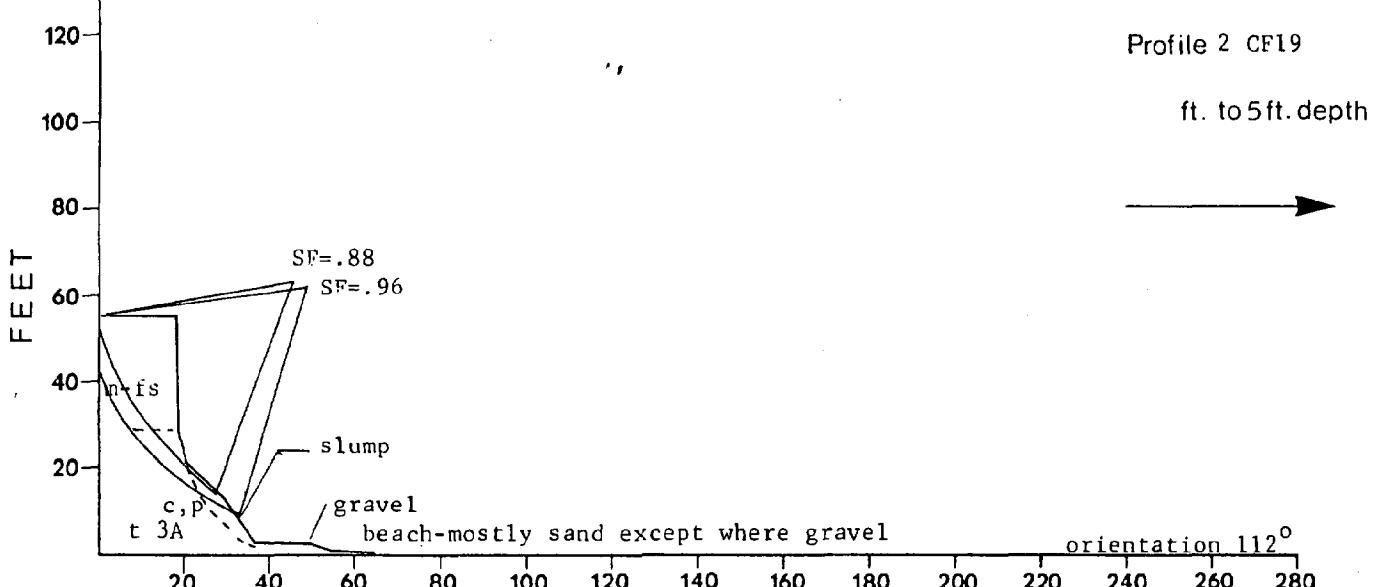
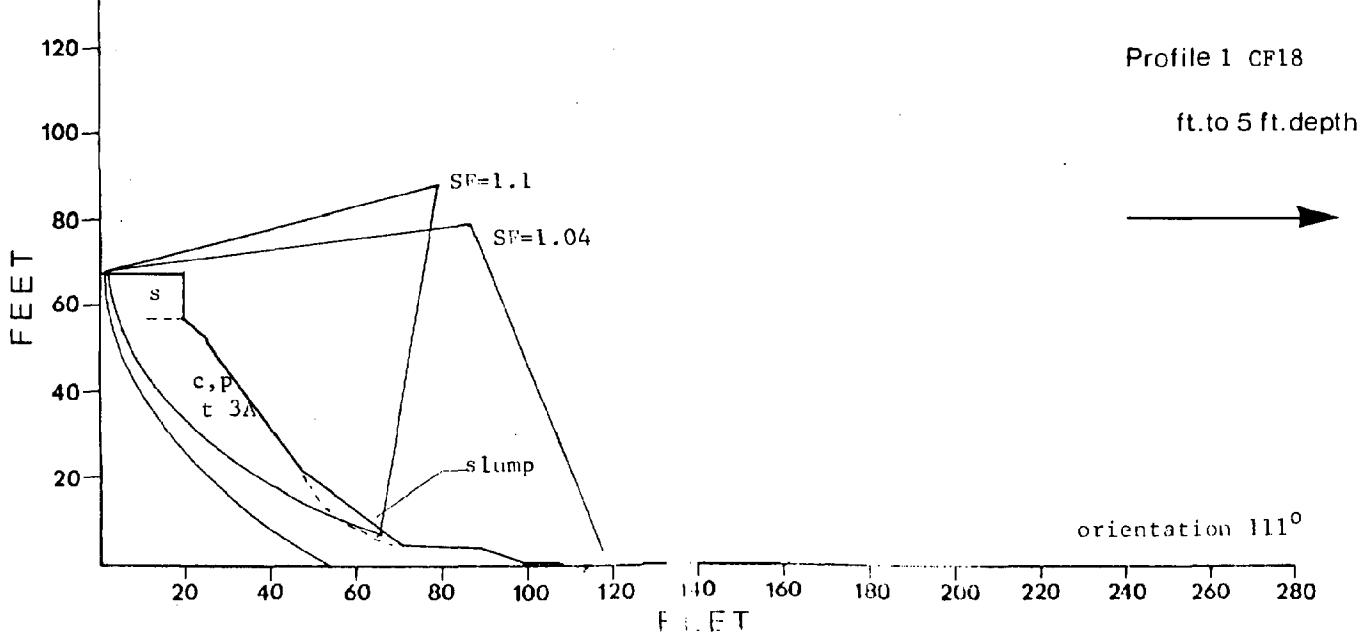
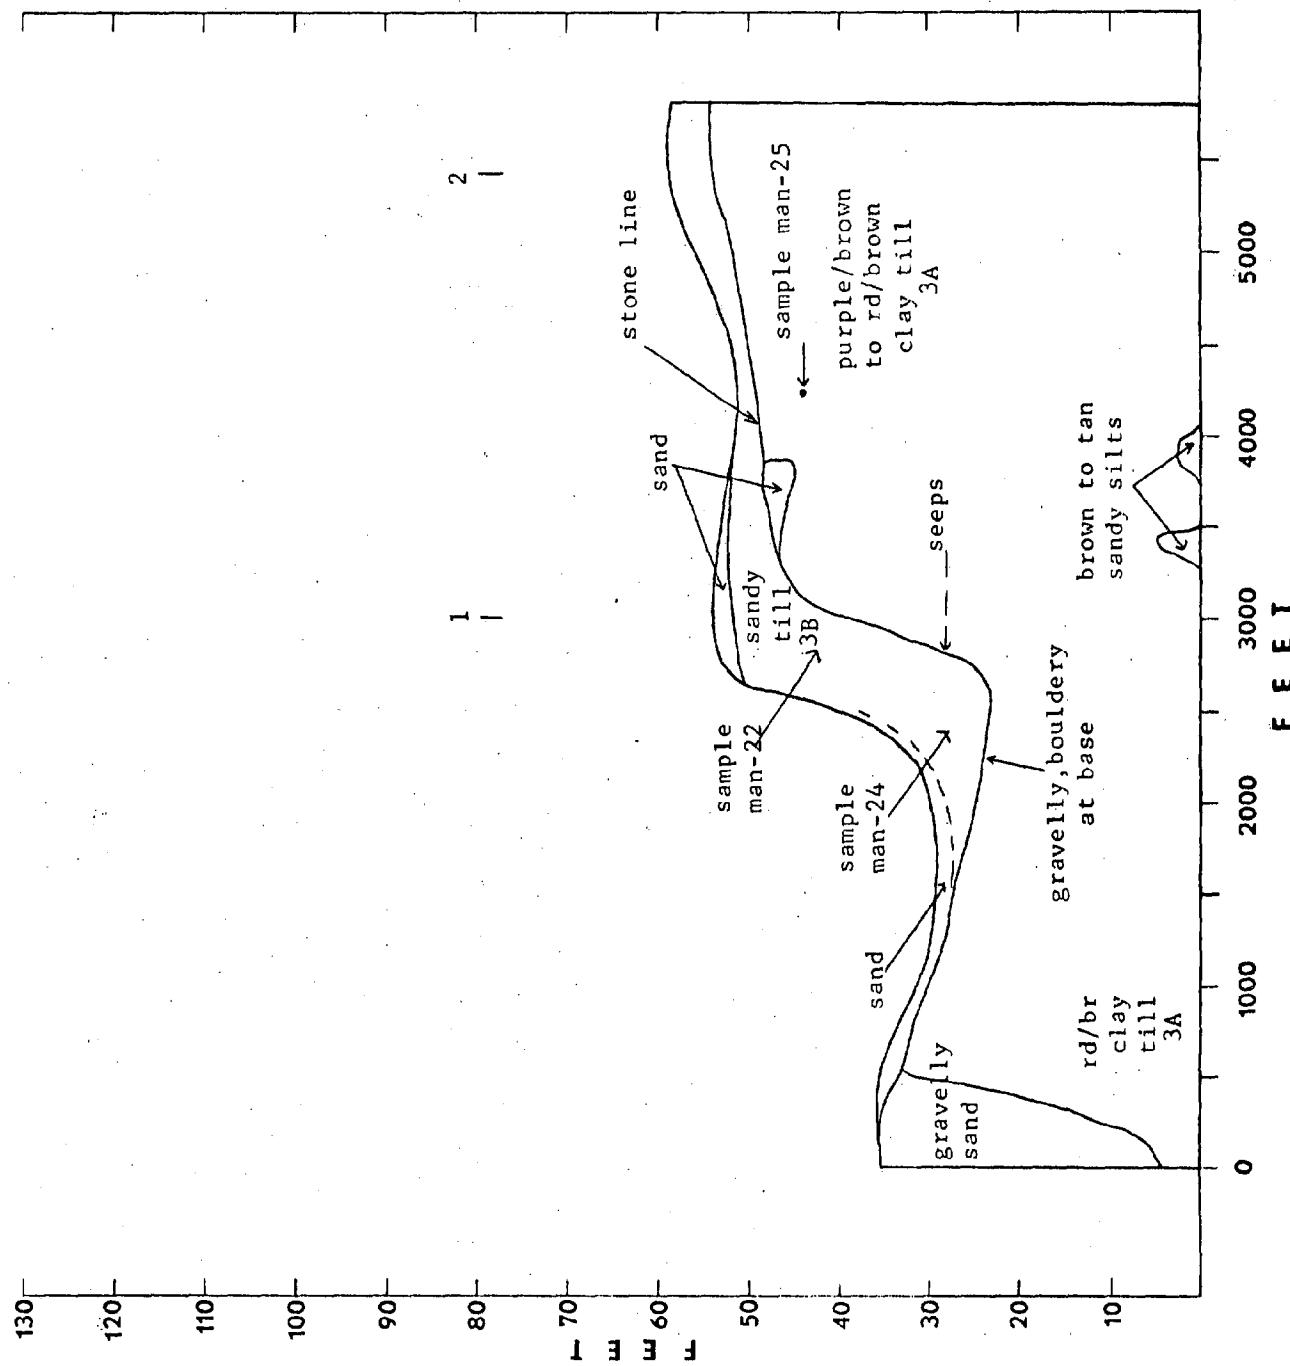
1. BLUFF	a-primarily soil falls, high angle slumping secondary		
2. TOE	a-slumped till '3A', some slumped sand		
3. BEACH	a-20-30 ft. gravel and cobbles	b-5-50 ft. gravel and cobbles
