SHORE EROSION STUDY

**SHORELINE EROSION AND BLUFF STABILITY ALONG LAKE MICHIGAN
AND LAKE SUPERIOR SHORELINES OF WISCONSIN**

SOUTHERN AND CENTRAL MANITOWOC COUNTY

APRIL 1977

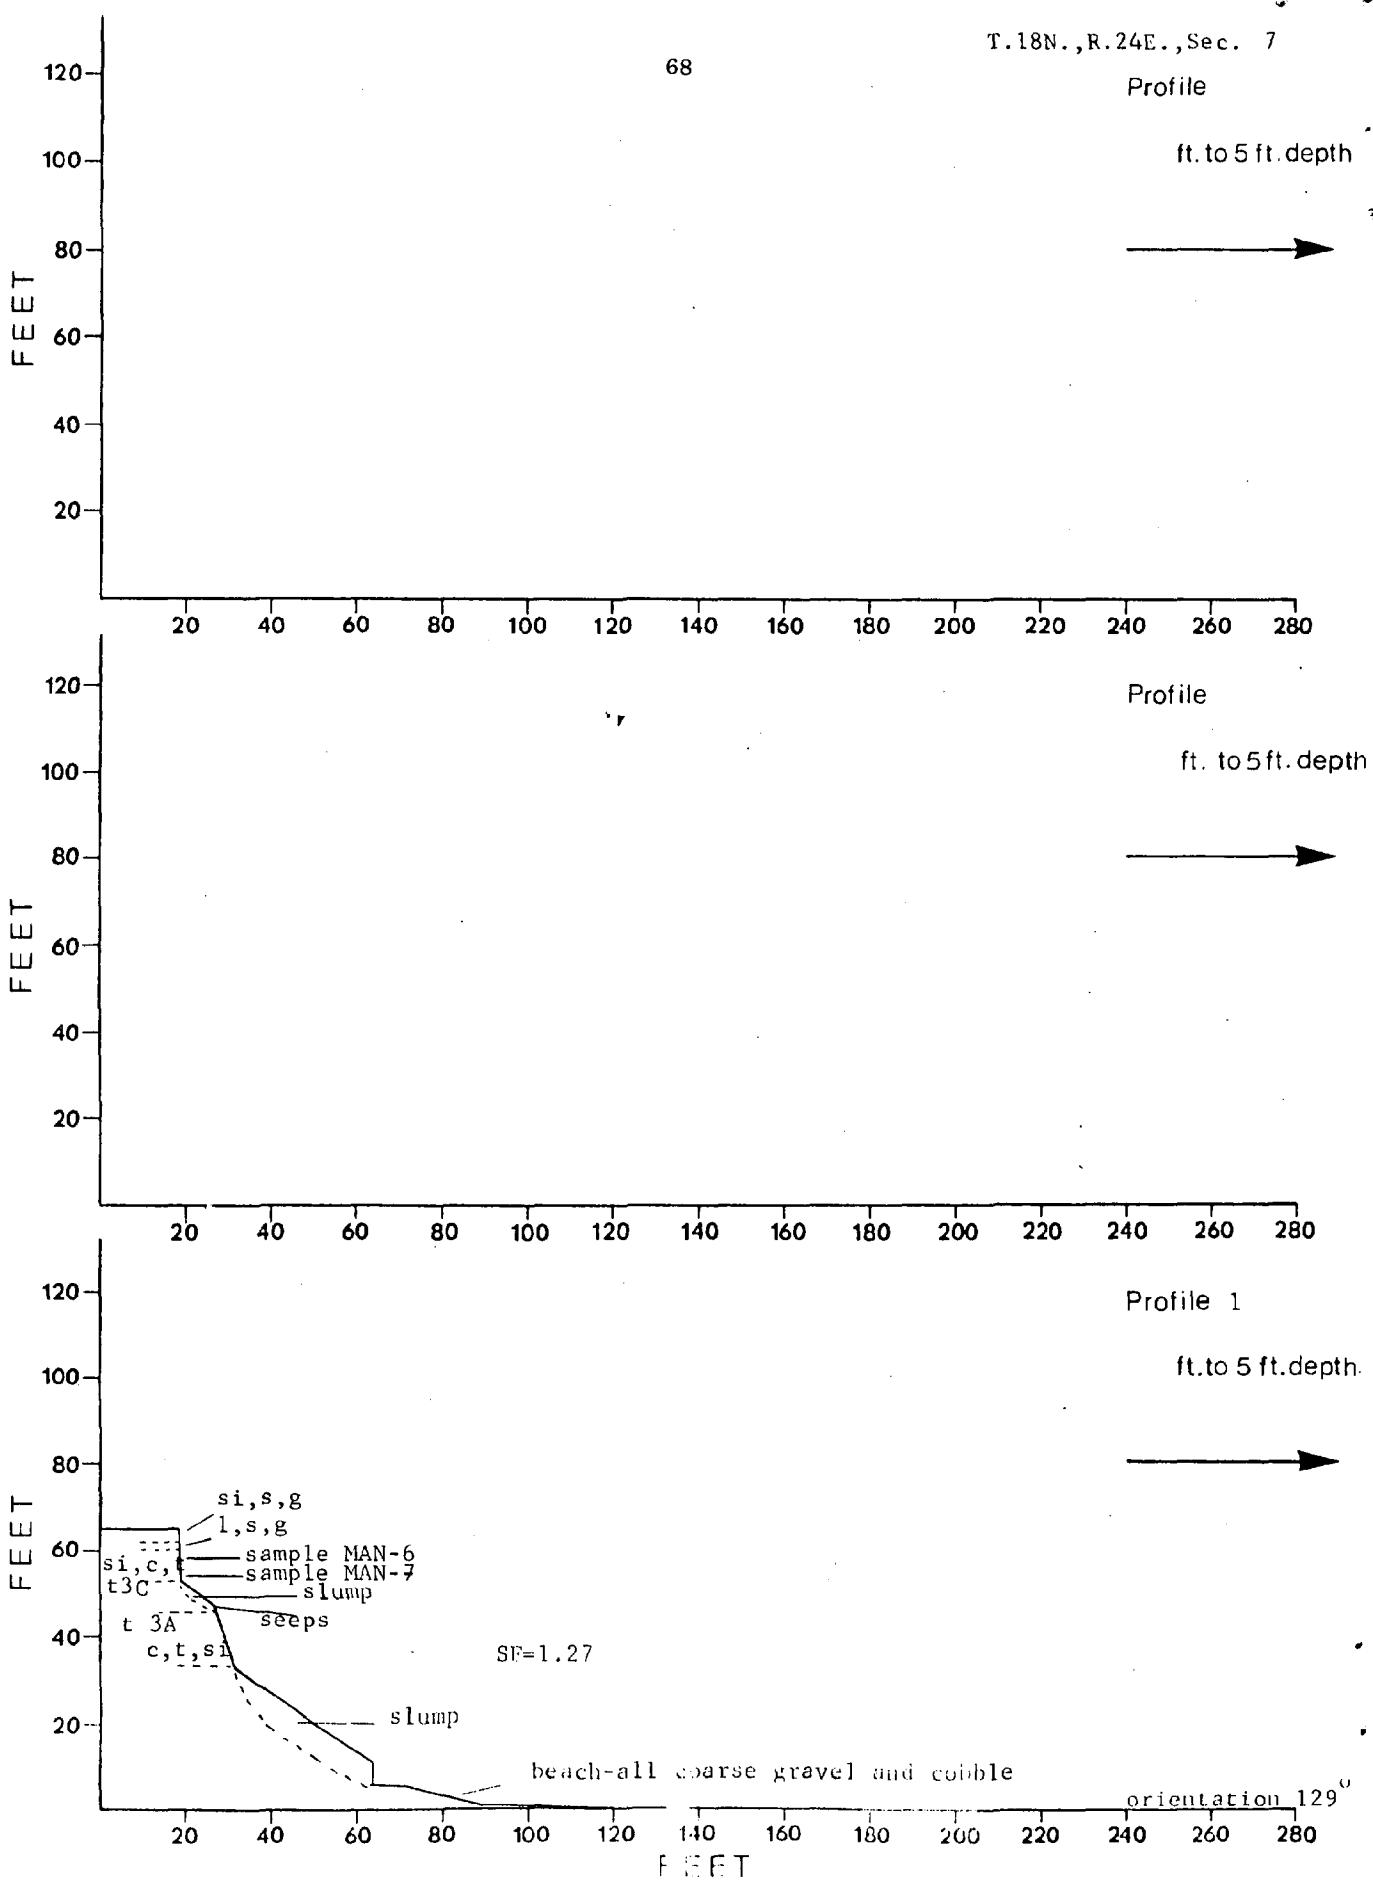
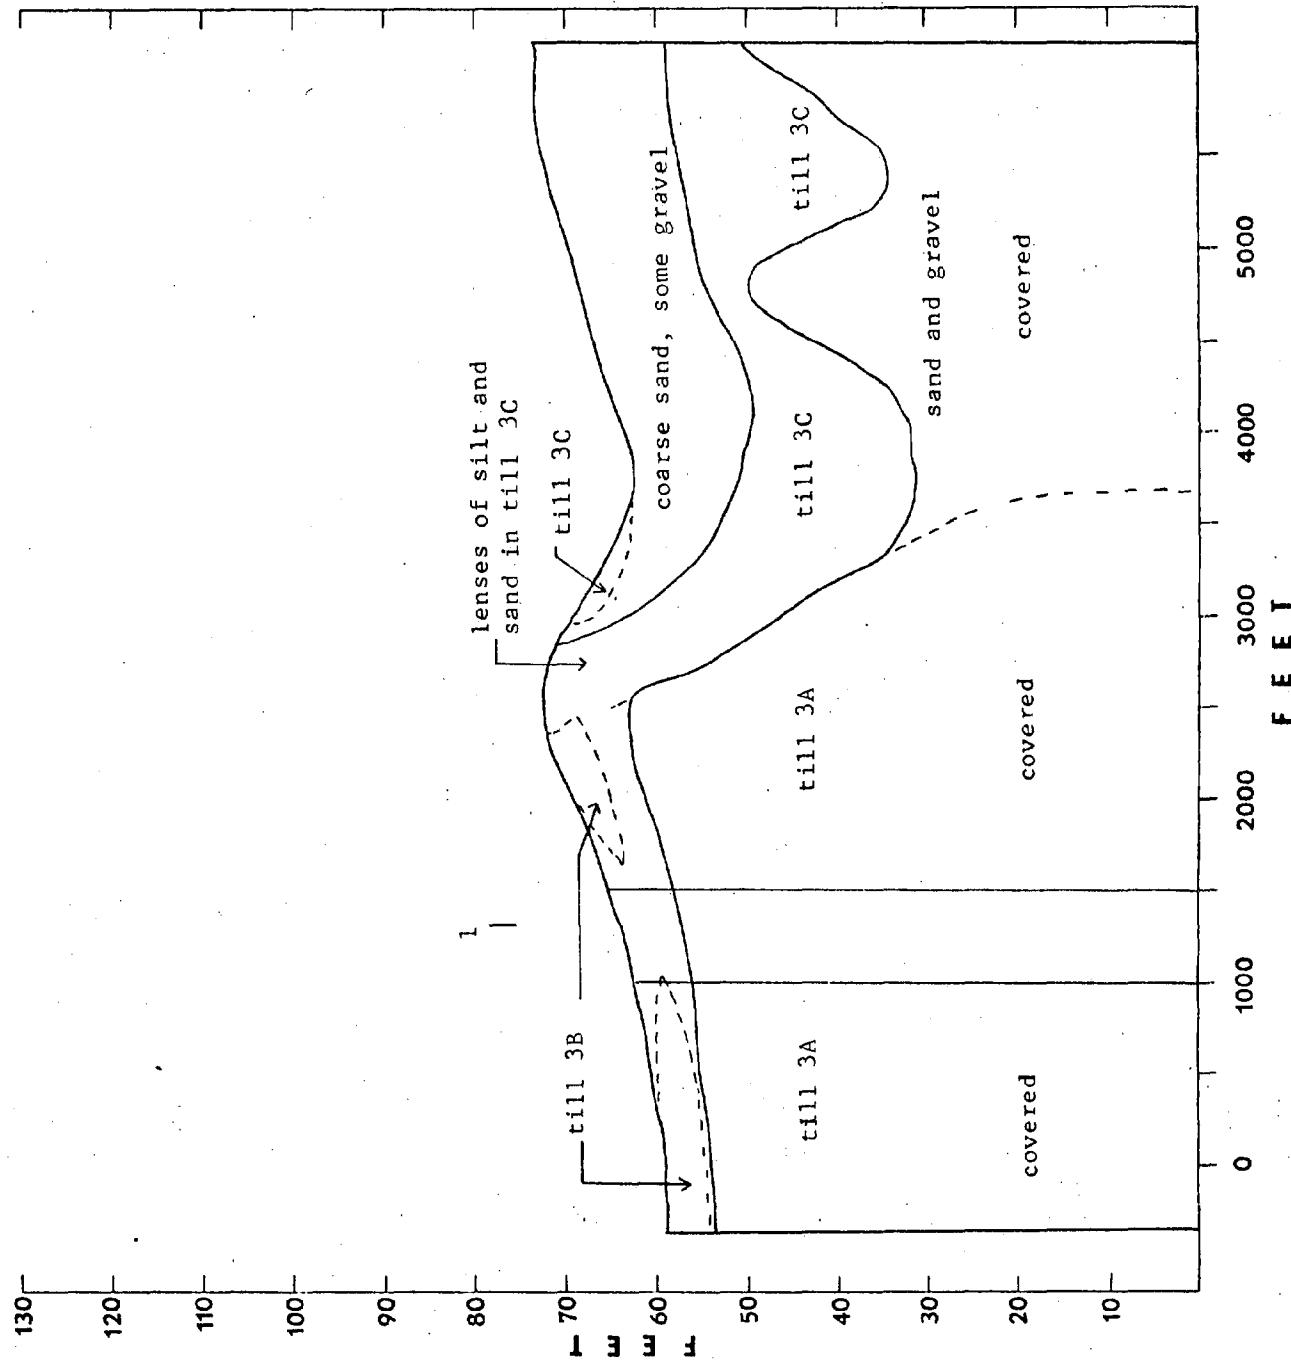
1. BLUFF	a-steep rapidly eroding bluffs; high angle slumps and soil falls; lower slopes covered by slumped material.	b-full face slumping; slump block heavily vegetated.	c-same as segment 'a'	
2. TOE	a-primarily slumped till '3A'	b-slumped till '3A' and over-lying lacustrine sediments	c-mainly slumped till '3A'	d-slumped till '3C' and sand and gravel
3. BEACH	a-20-30 ft. cobbles	b-20-30 ft. cobbles and boulders	c-20-50 ft. sand and cobbles	d-20-30 ft. cobbles

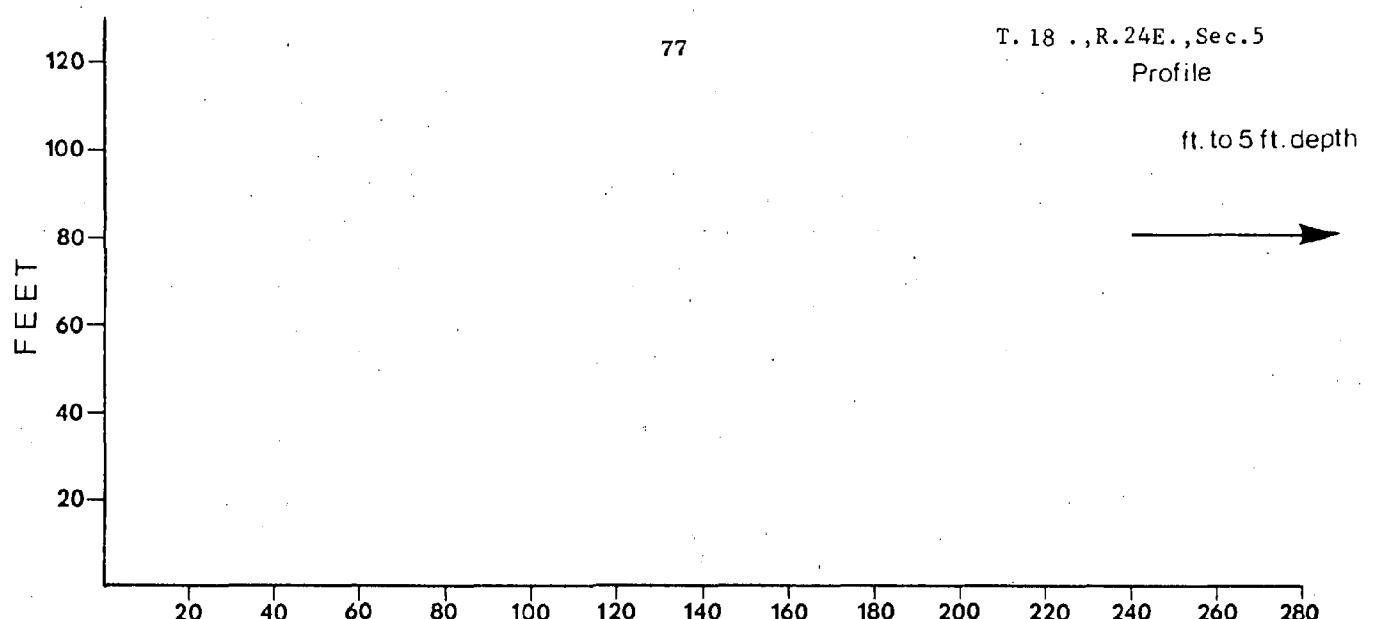
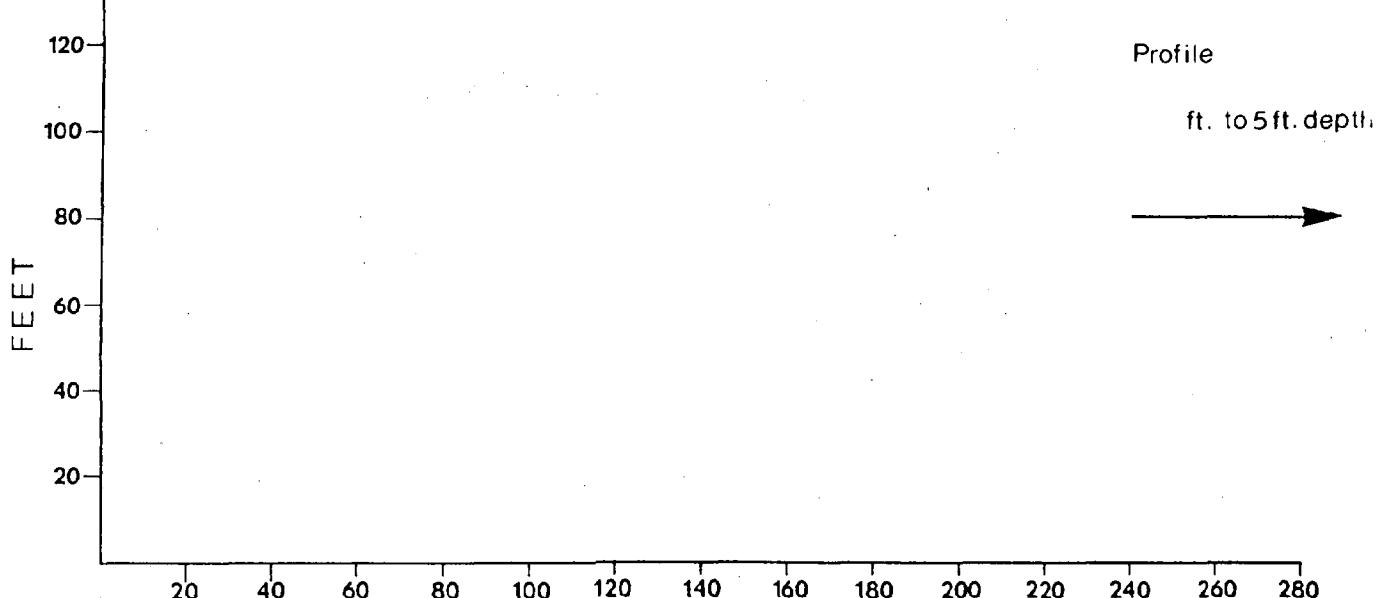
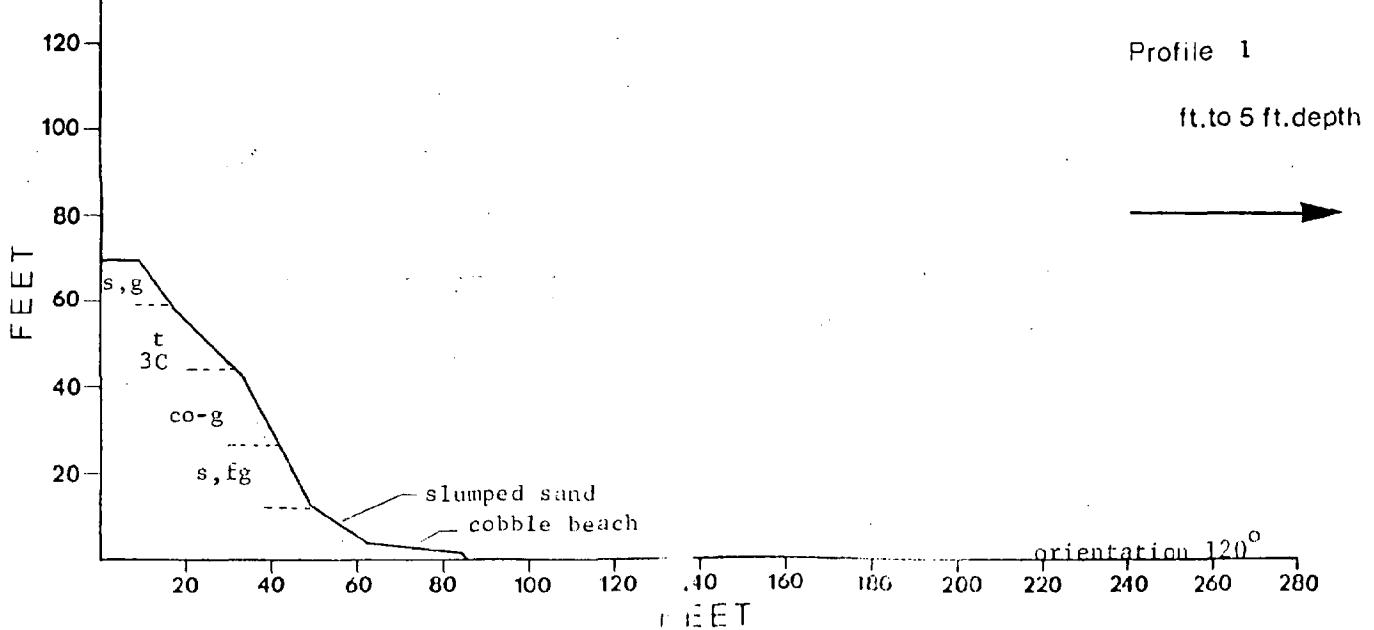
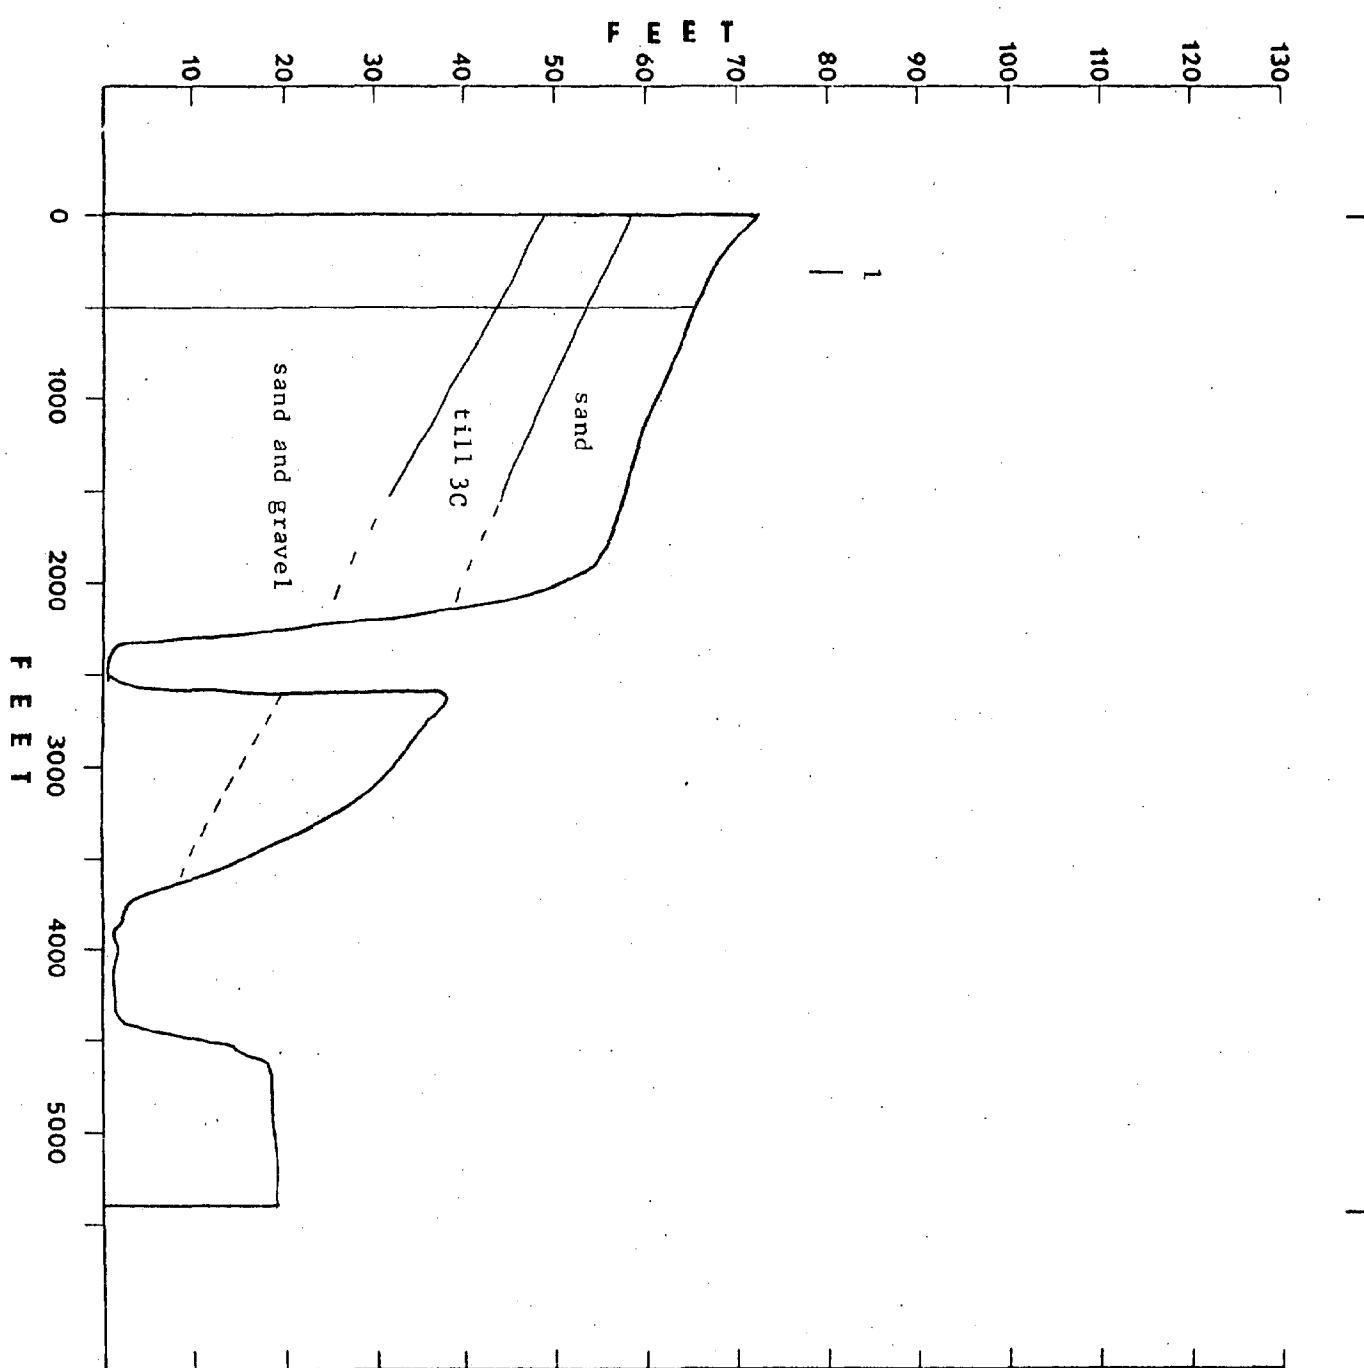
T18 N., R24 E., Sec. 5

1. BLUFF	a-rapidly eroding high bluff; slumping and sliding, largely based in sand and gravel in lower half of the slope	b-large scale slumping; slump blocks vegetated	c-no bluff	d-grass covered stable slopes
2. TOE	a-slumped sand and gravel	b-slumped till '3C'	c-slumped till '3C' and sand	d-slumped till '3C'
	e-slumped till '3C' and sand	f-sand		
3. BEACH	a-20-40 ft. sand and cobbles	b-0-20 ft. sand	c-greater than 50 ft. of sand

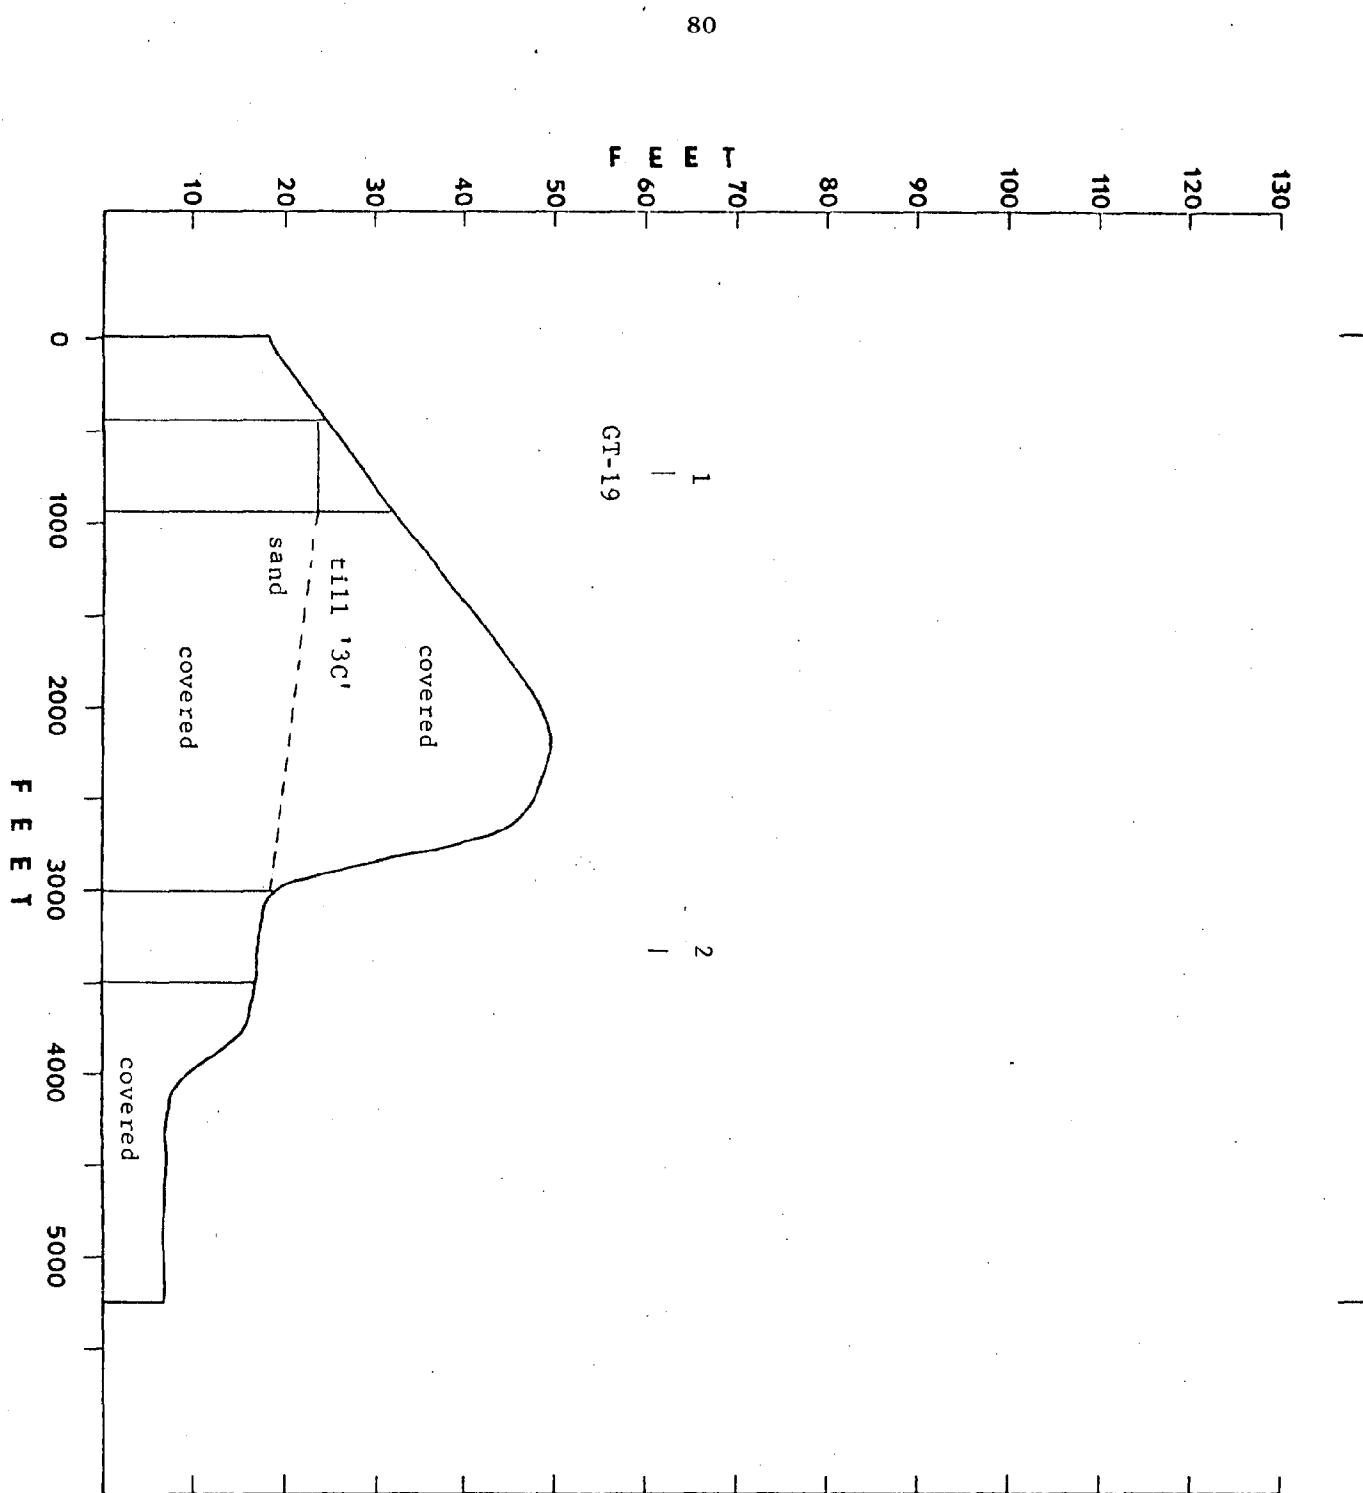
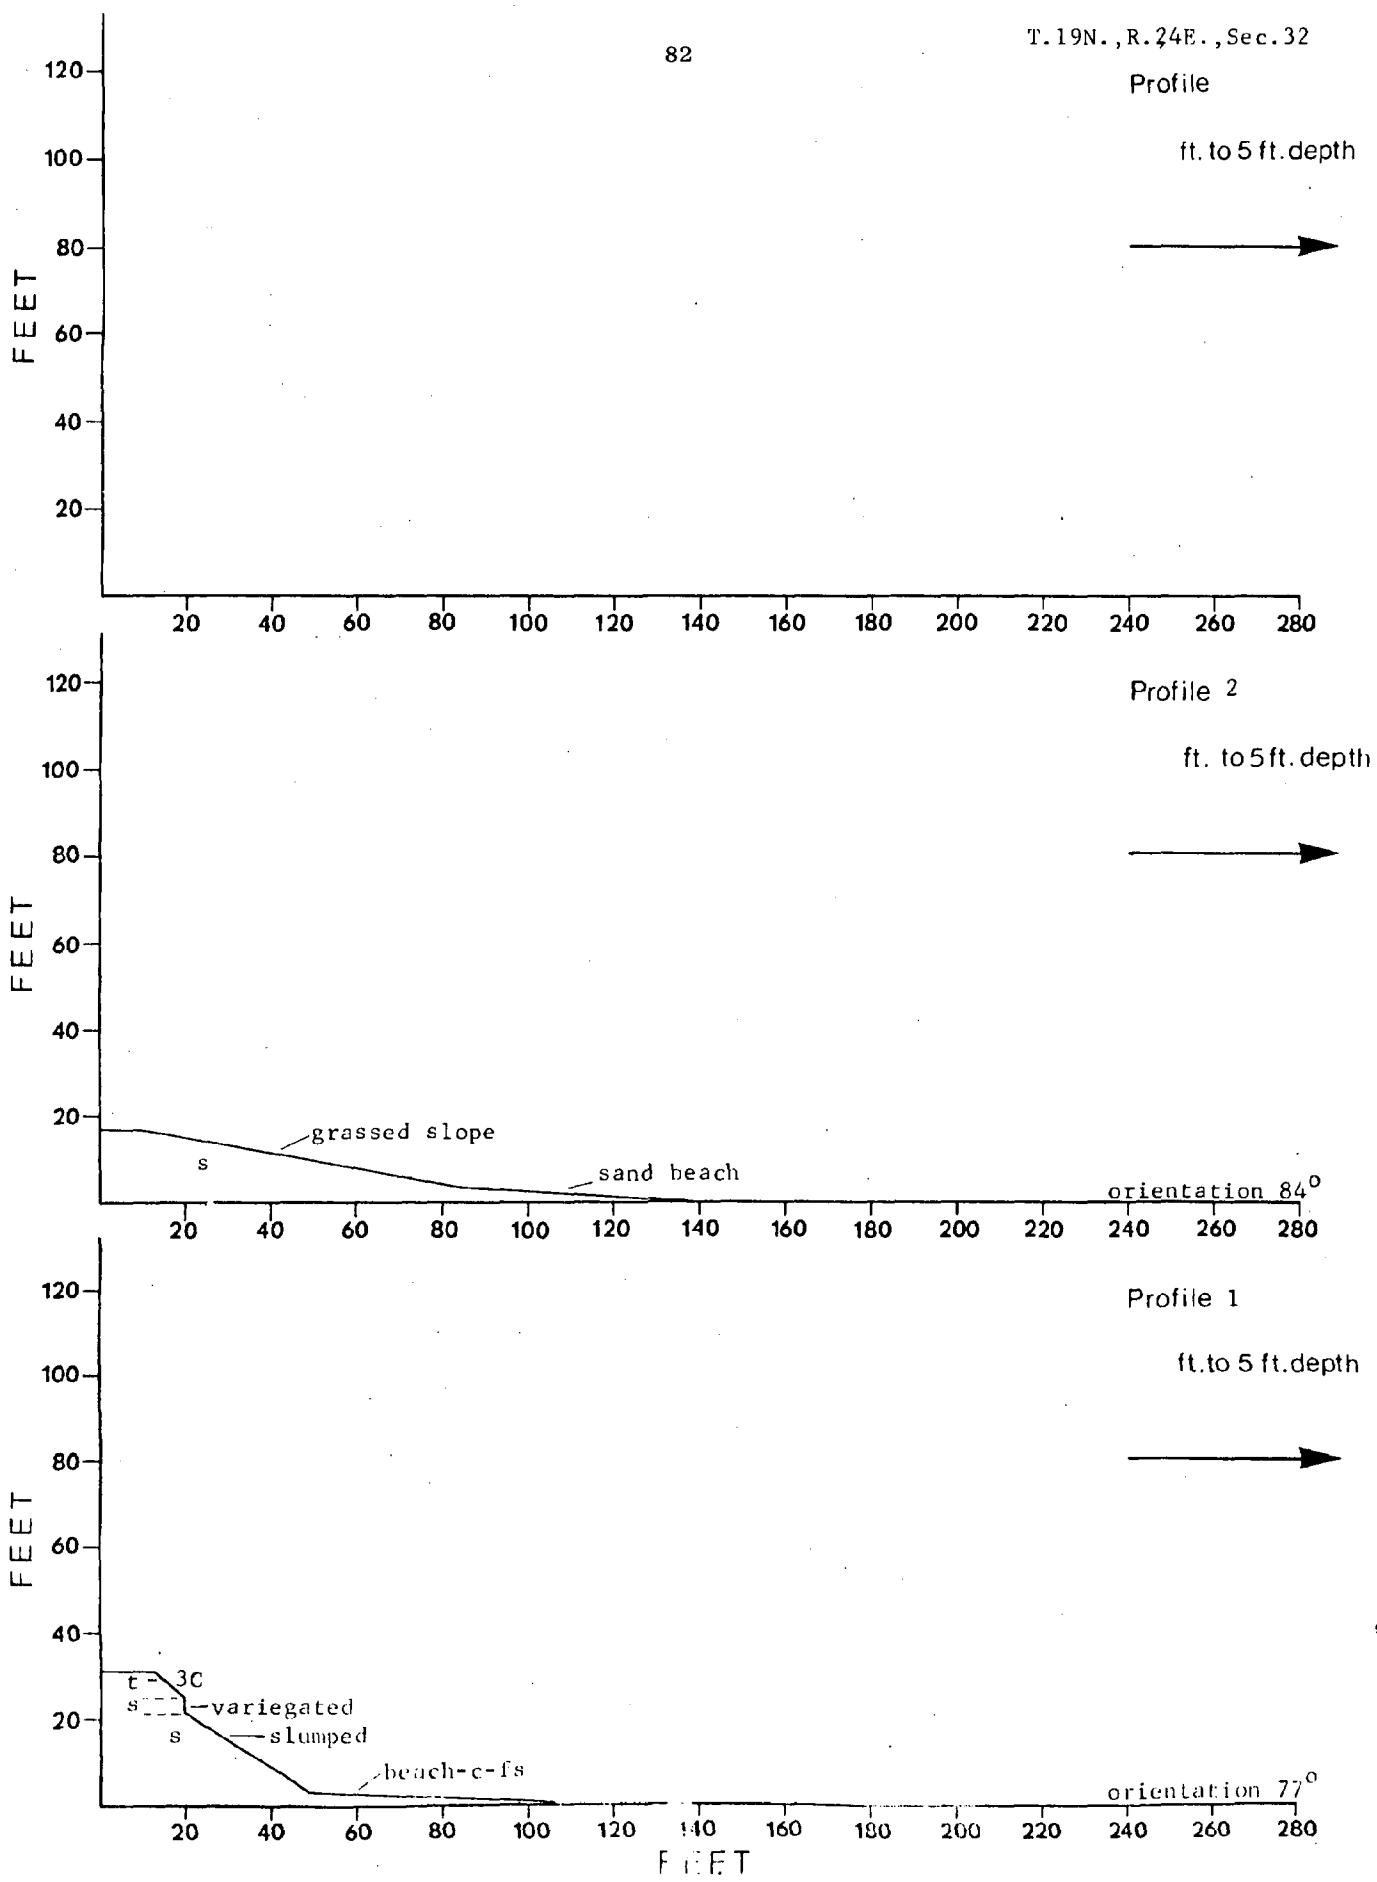
T. 19N., R. 24 E., Sec. 32

1. BLUFF	a-low bluff, mostly slumped till and sand	b-high bluff, fully vegetated and much of the slope has a veneer of fill	c-no bluffs; sand
2. TOE	a-slumped sand and till '3C'	b-sand	
3. BEACH	a-30-50 ft. sand	b-0-20 ft. sand

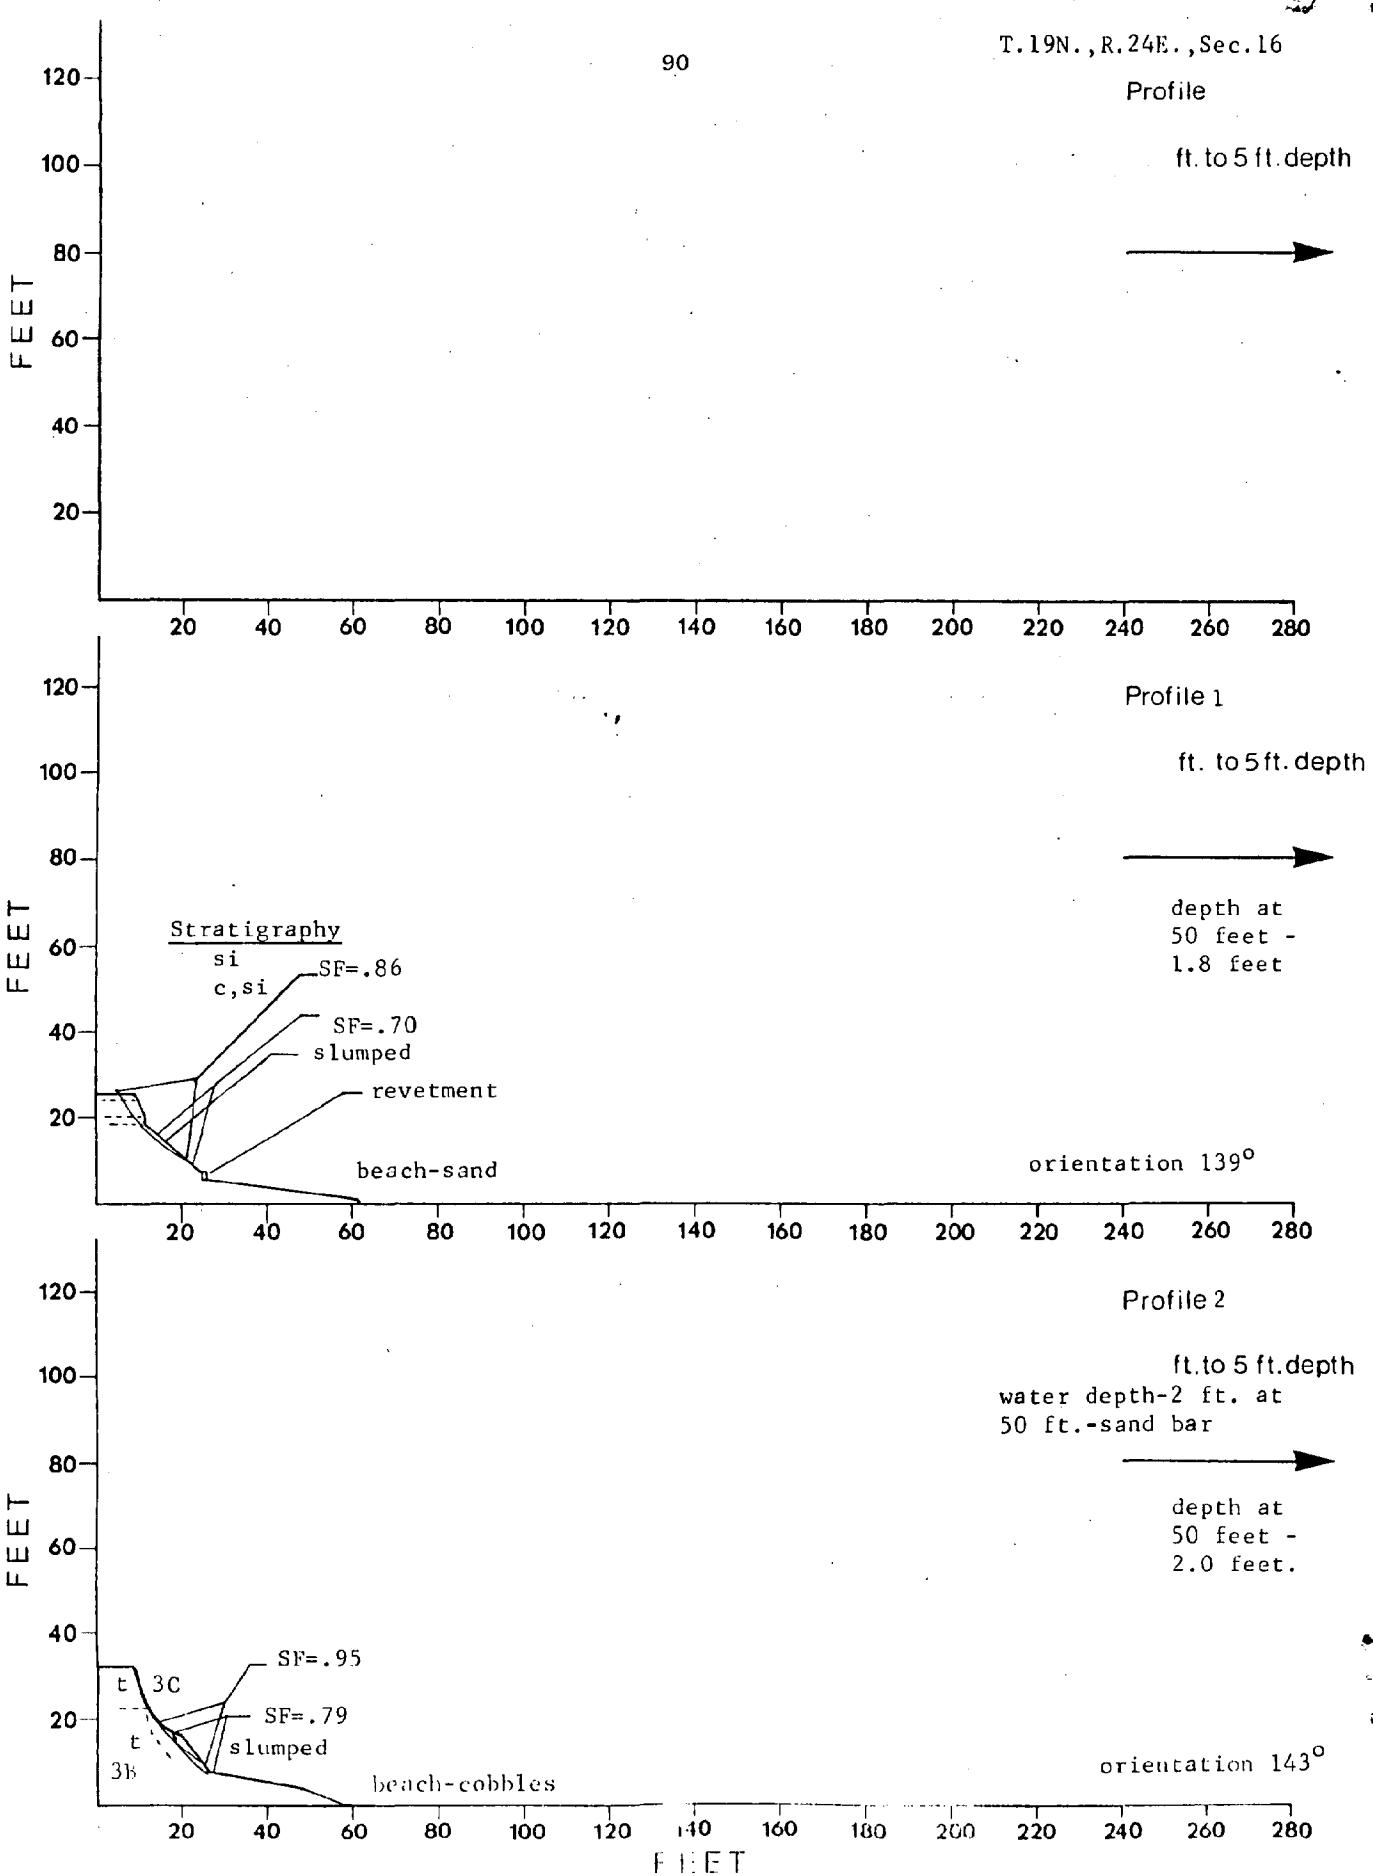
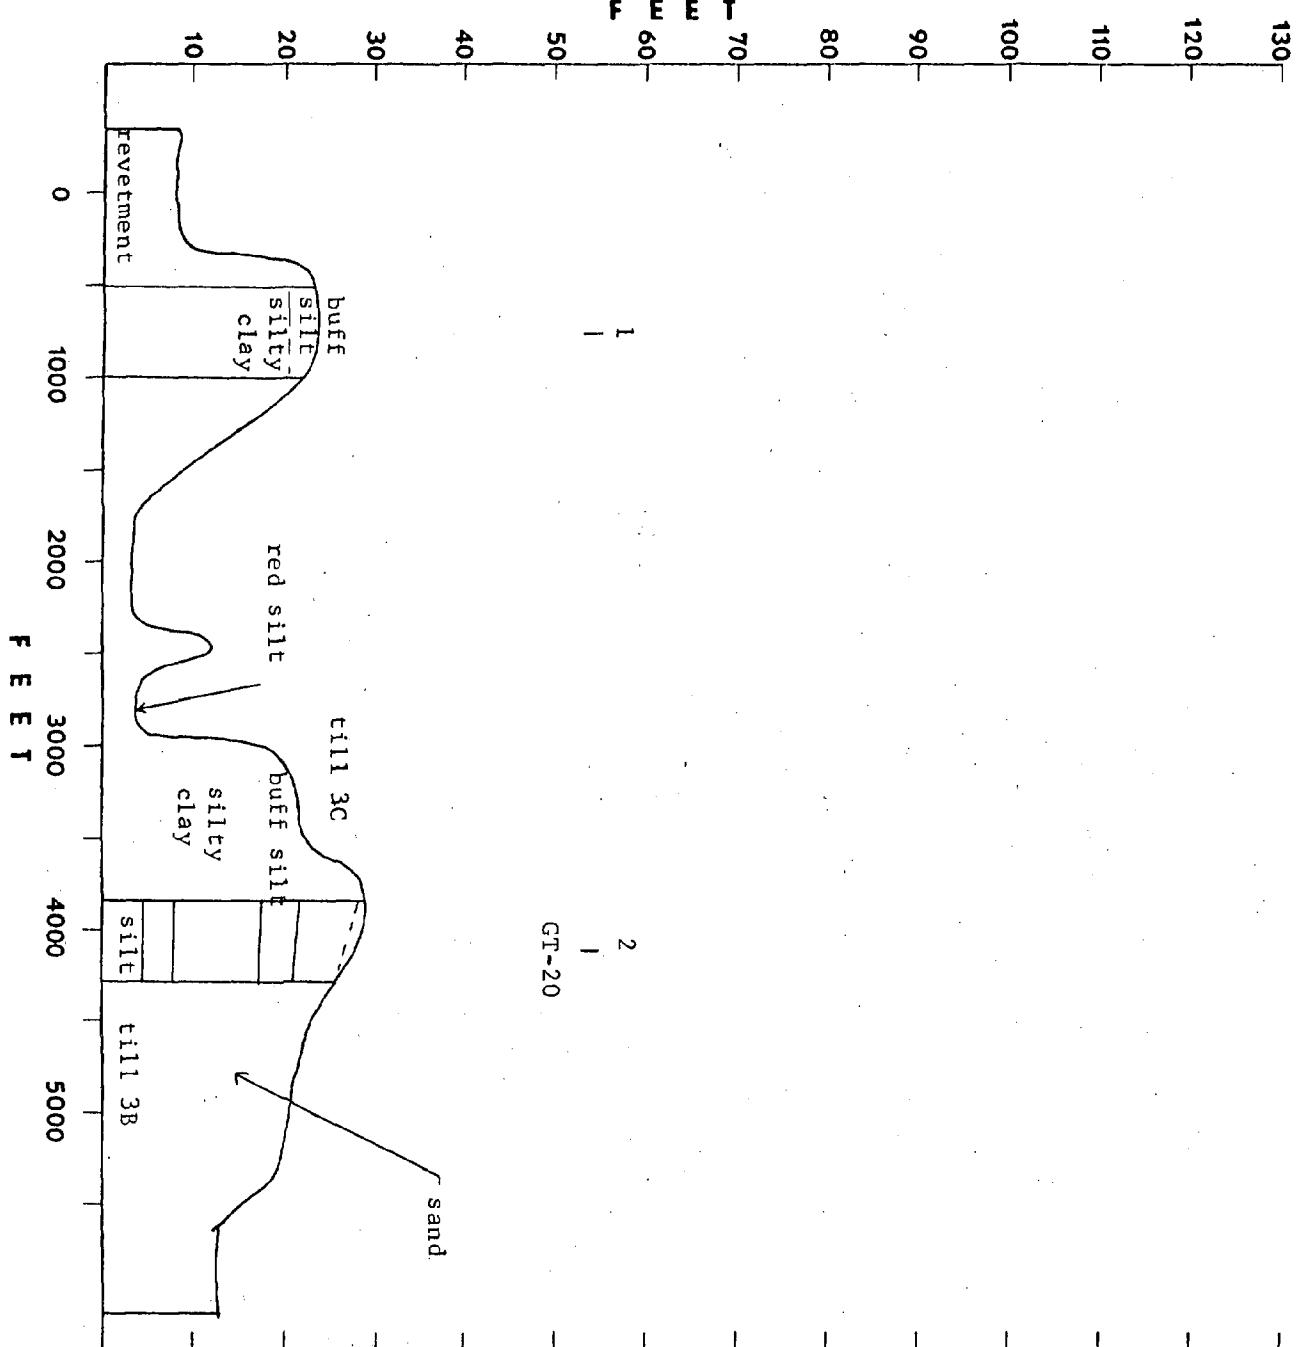
T.19 N., R. 24 E., Sec. 16

1. BLUFF	a-no bluff	b-low bluff; slumps and flows	c-no bluff	d-steep medium to low bluff, sapping and soil fall
2. TOE	a-revetment	b-slumped silt and clay behind revetment	c-cobbles and fill	d-silt
	e-slumped silt and clay	f-sand and silt	g-till '3B'	h-silt
	i-till '3C'			
3. BEACH	a-0-20 ft. sand	b-30-50 ft. sand	c-no beach	d-30-50 ft. sand
	e-0-20 ft. cobbles	f-no beach	g-200 ft. cobbles	h-30 ft. sand and cobbles

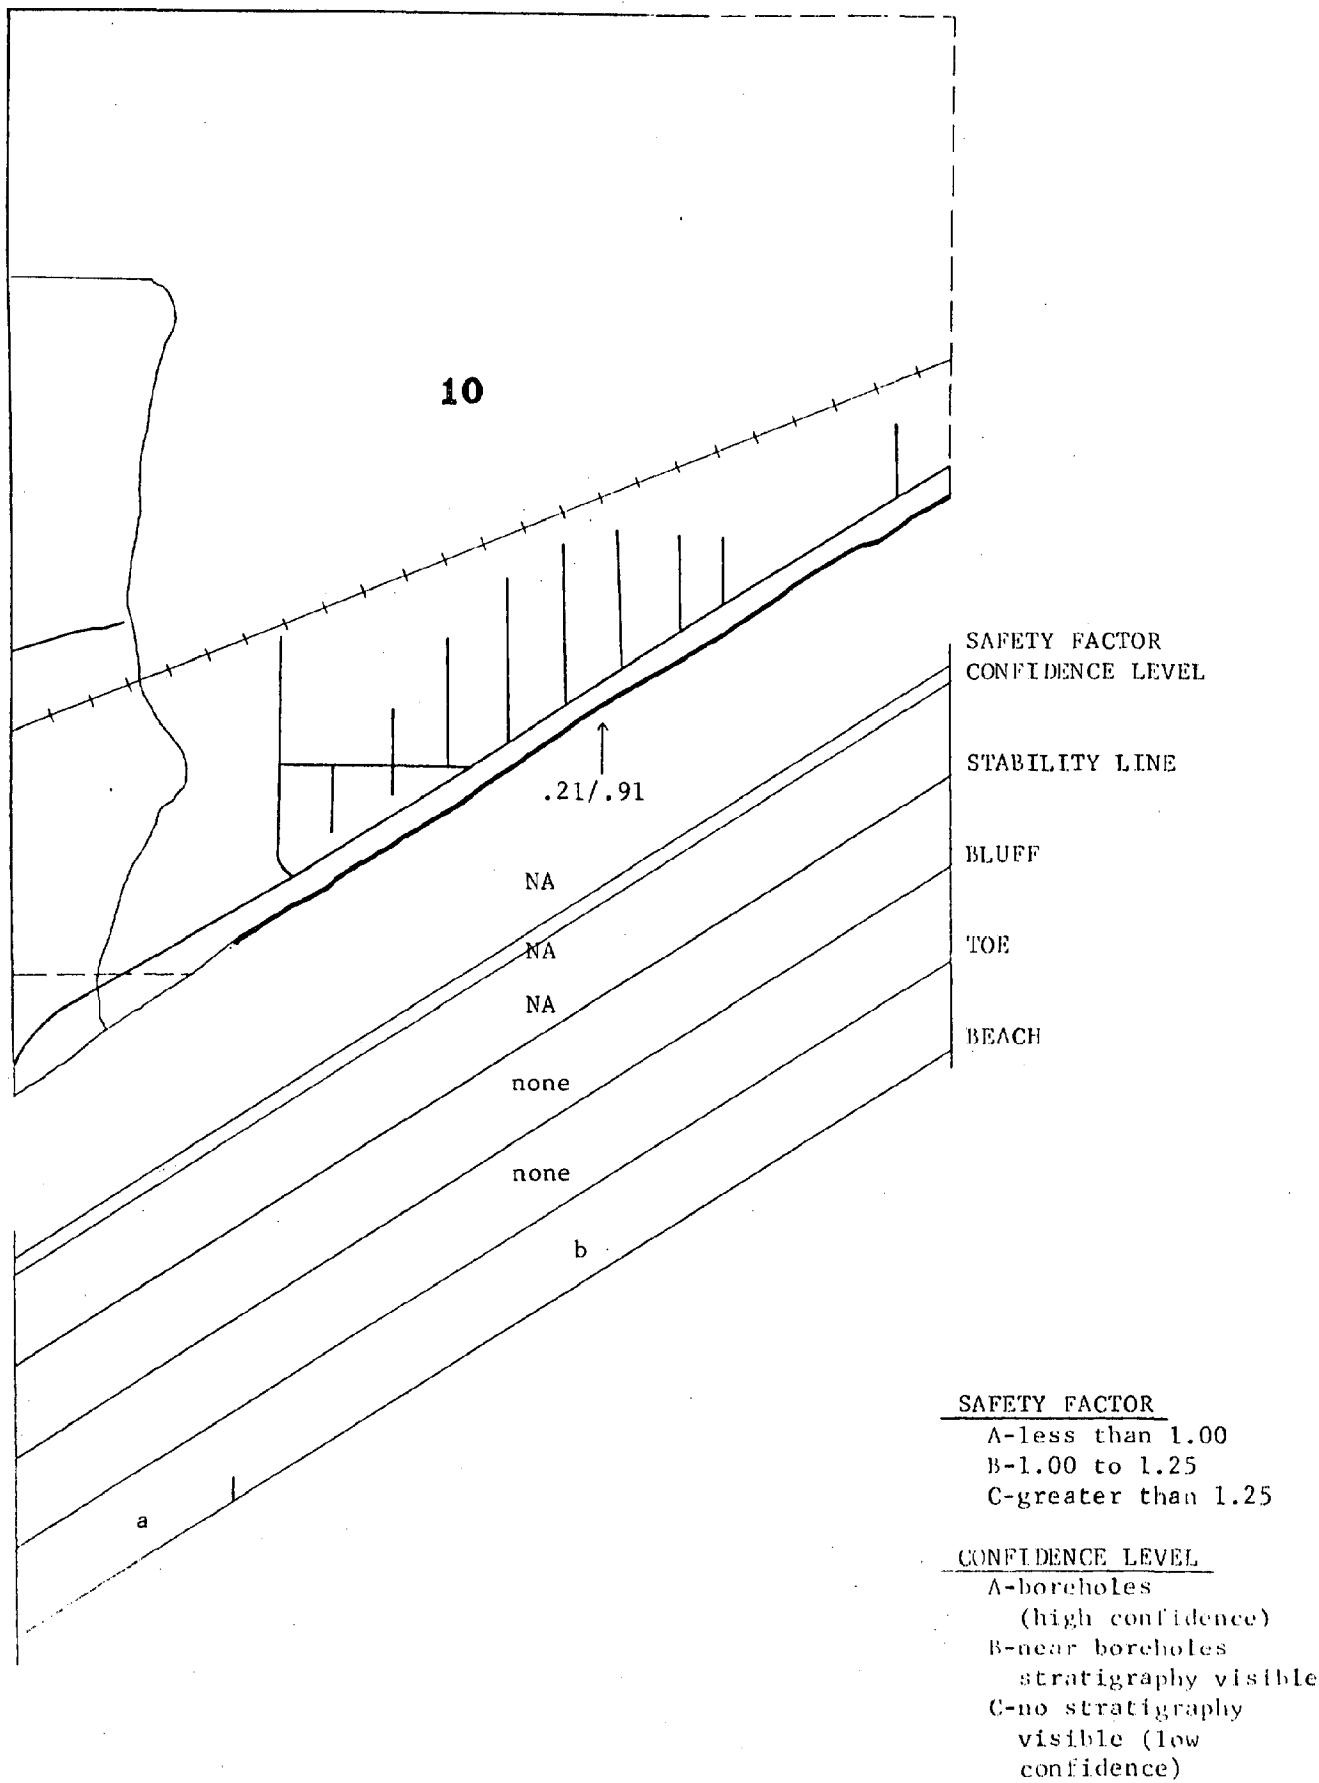
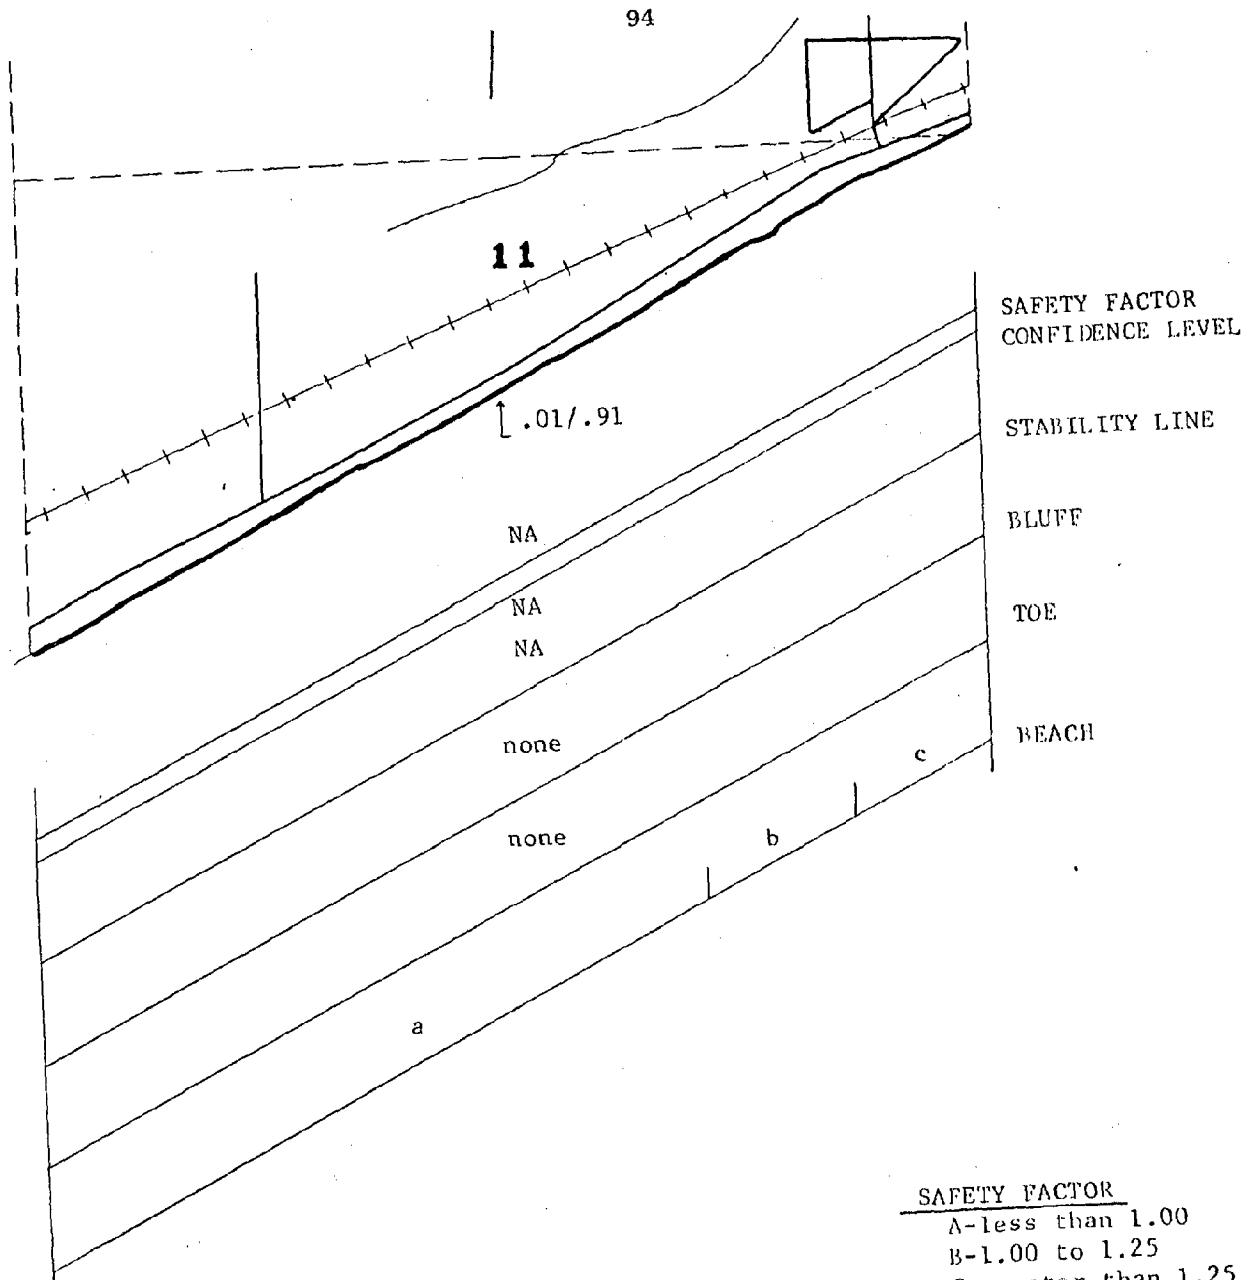
1. BLUFF	none		
2. TOE	none		
3. BEACH	a-20-30 ft. sand	b-no beach
