SHORE EROSION STUDY

**SHORELINE EROSION AND BLUFF STABILITY ALONG LAKE MICHIGAN
AND LAKE SUPERIOR SHORELINES OF WISCONSIN**

SOUTHERN AND CENTRAL MANITOWOC COUNTY

APRIL 1977

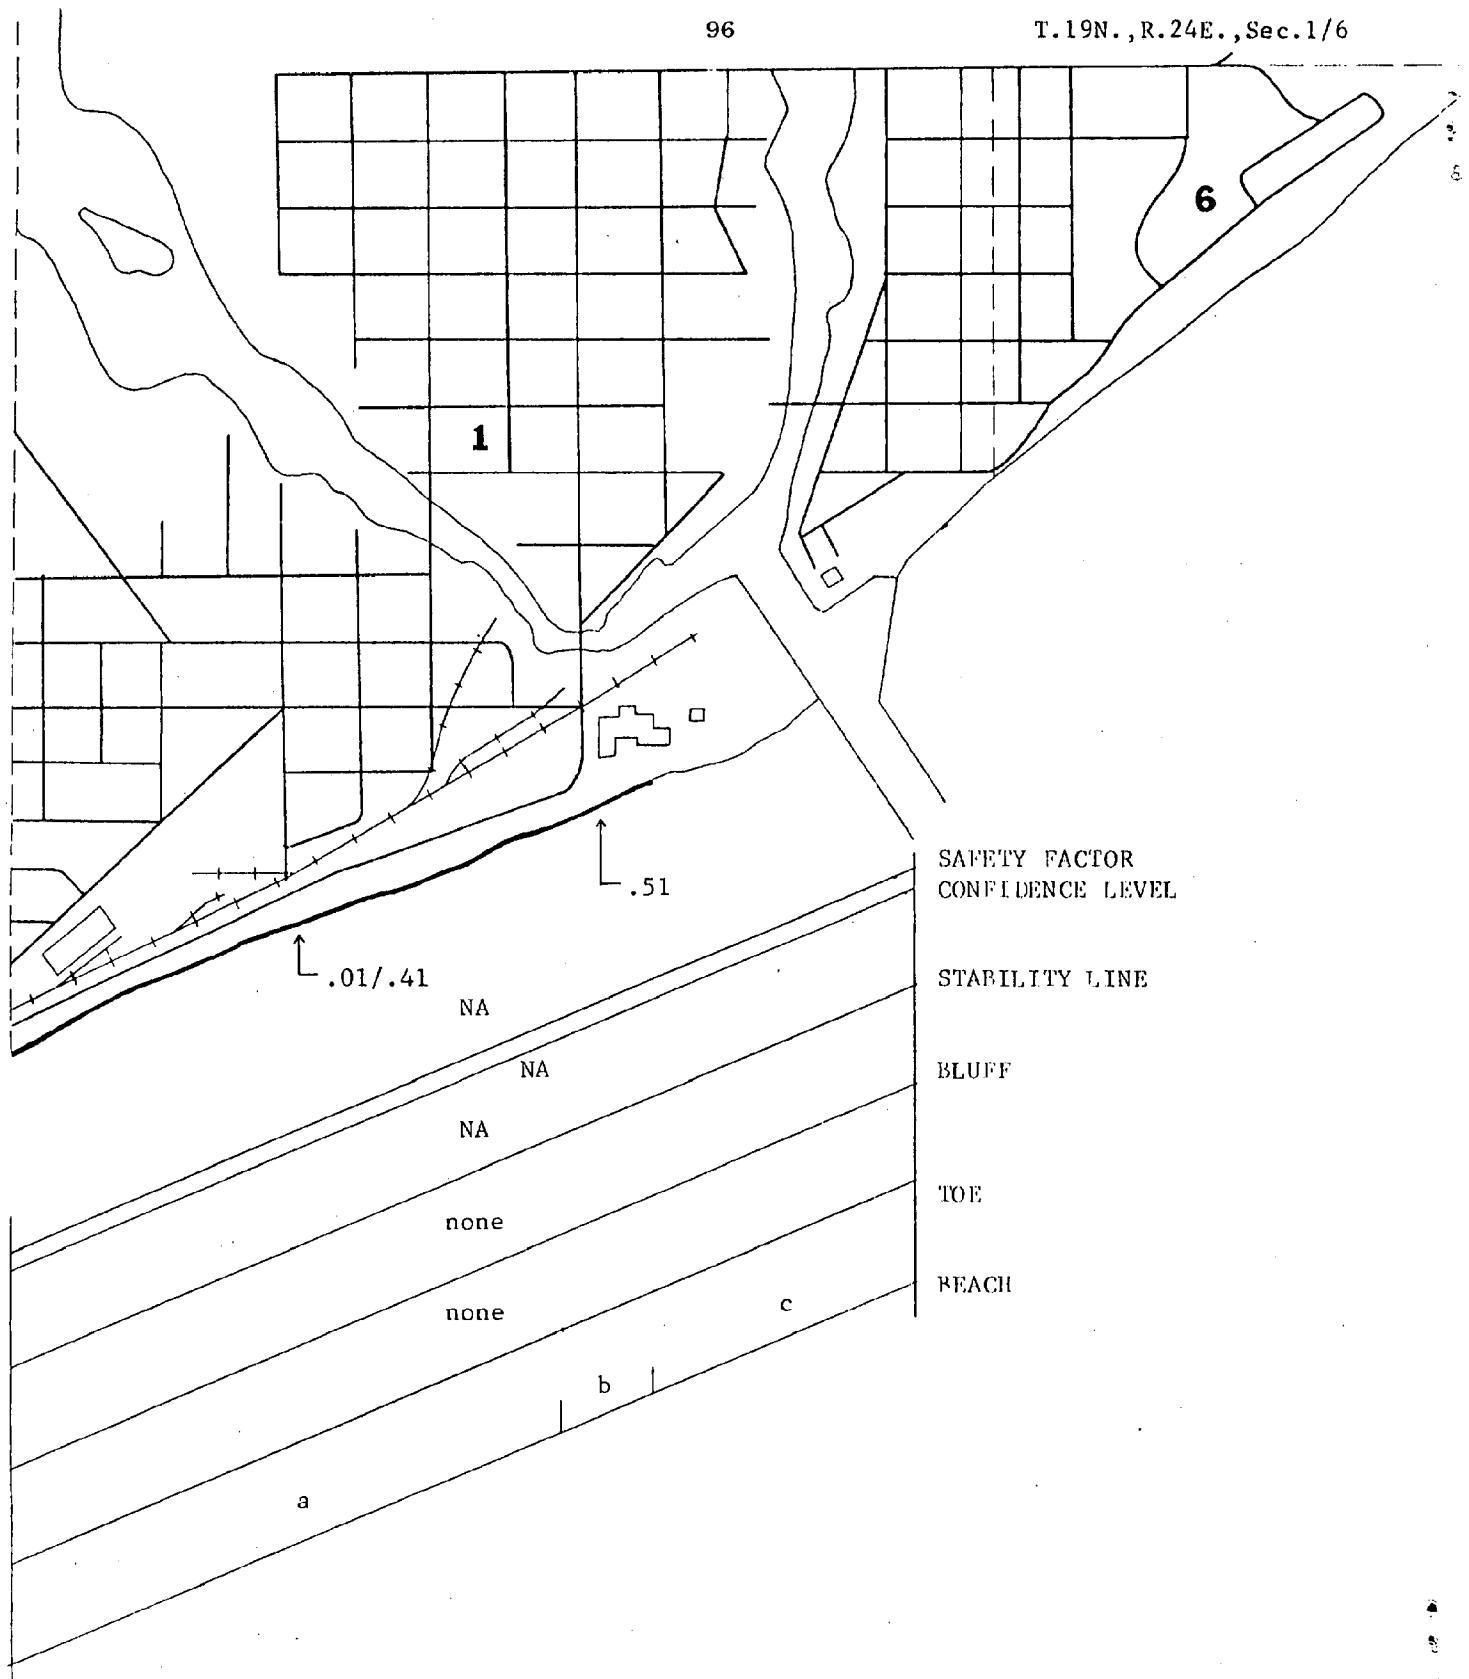
1. BLUFF	none			
2. TOE	none			
3. BEACH	a-no beach	b-20-30 ft. sand	c-no beach
